**DETAILED WORK PLAN FOR
SITE RESTORATION ACTIVITIES**

Blanchard River Station

07 September 1999

Royal Roads University Applied Research Division and
UMA Engineering Ltd.

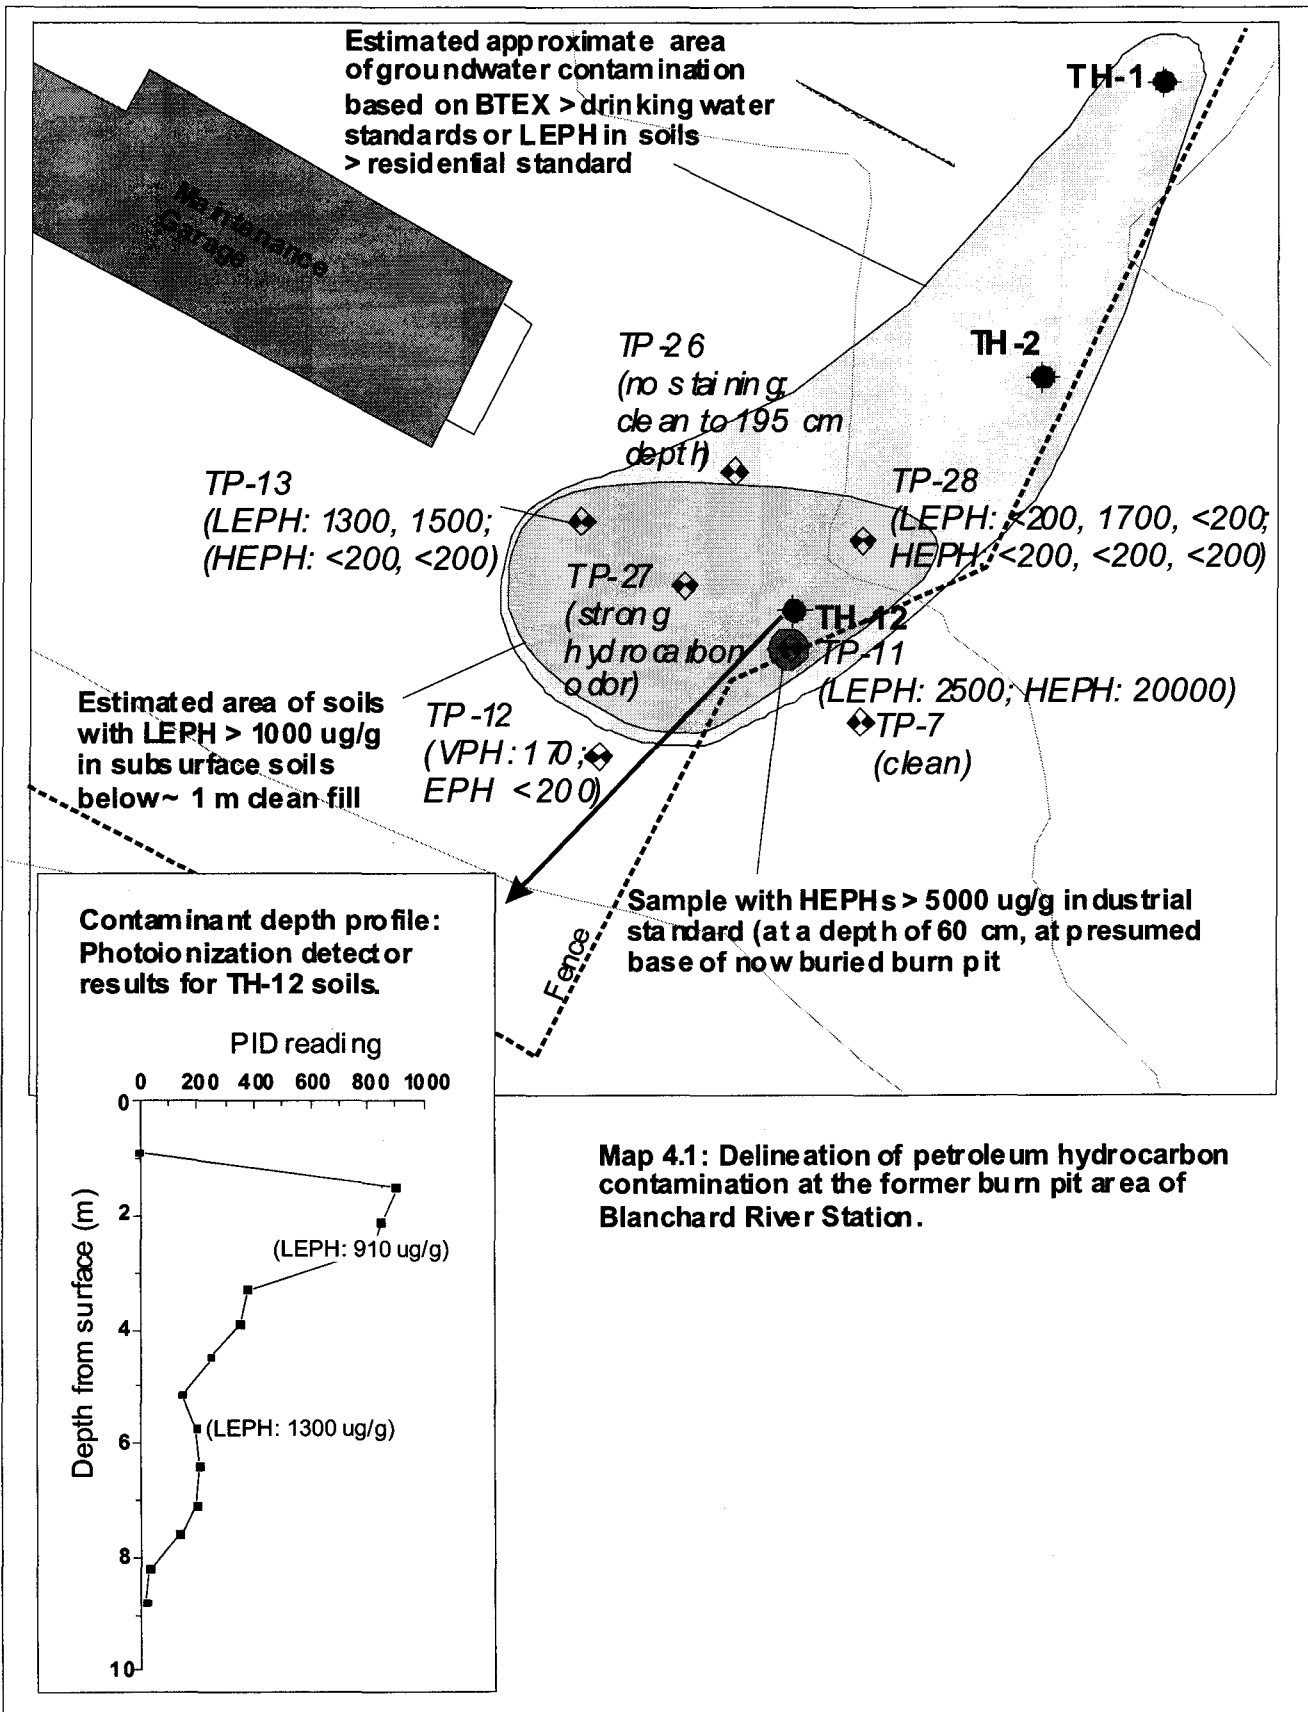
Figure 4.1: Vertical distribution of hydrocarbon contamination down gradient from bun pit area.

The maximum observed concentration of petroleum hydrocarbons in shallow subsurface soils beneath the former burn pit area was 19,000 µg/g HEPHs and 2,500 µg/g LEPHs. This occurred in a test pit sample collected from near the centre of the former location of the burn pit, at a depth from the present-day surface of 0.6 m. These concentrations exceed both the Yukon industrial and residential/parkland standards for extractable petroleum hydrocarbons. The maximum LEPH concentration observed in borehole TH-12 was 1,300 µg/g in sample TH12-5, at a depth of 2.5 to 3 meters. Soil samples collected below the presumed bottom of the burn pit prior to burial did not exhibit concentrations of LEPHs, HEPHs or other petroleum hydrocarbon constituents at concentrations in excess of industrial standards. Soils that were contained within the former burn bit during the time when it was used undoubtedly represent a special case: The hydrocarbon signature in these soils is influenced by both fuel oil release and combustion, resulting in a dominance of heavy hydrocarbon fractions.

- The general procedure to be followed will be to excavate from the burn pit area 0.5 m of clean fill, lying above the hydrocarbon contaminated soils. Following this, the scientific authority on site will define the outer boundary of soils within the next 0.5 meter contaminated with petroleum hydrocarbons in excess of residential/parkland standards. These soils will be excavated and removed to the treatment facility. The next stratum will then be tested, down to a depth of 2 m from the present day surface, and soils within a boundary defined by residential/parkland standards will be excavated.

- Lateral excavation will be considered to be sufficient when, within the top two meters, field analytical techniques fail to detect soils with concentrations exceeding residential/parkland soil standards. The vertical extent of excavation will be deemed to be sufficient for soils greater than 2 m if field analytical techniques fail to detect soils with concentrations exceeding industrial soil standards.
