**PHASE 1 AND 2
VENUS MINE TAILINGS REHABILITATION PROGRAM
NEAR CARCROSS, YUKON**

**EBA ENGINEERING CONSULTANTS LTD.
Whitehorse, Yukon**

**Public Works and Government Services Canada
Environmental Services**

Project No. 0201-98-13604

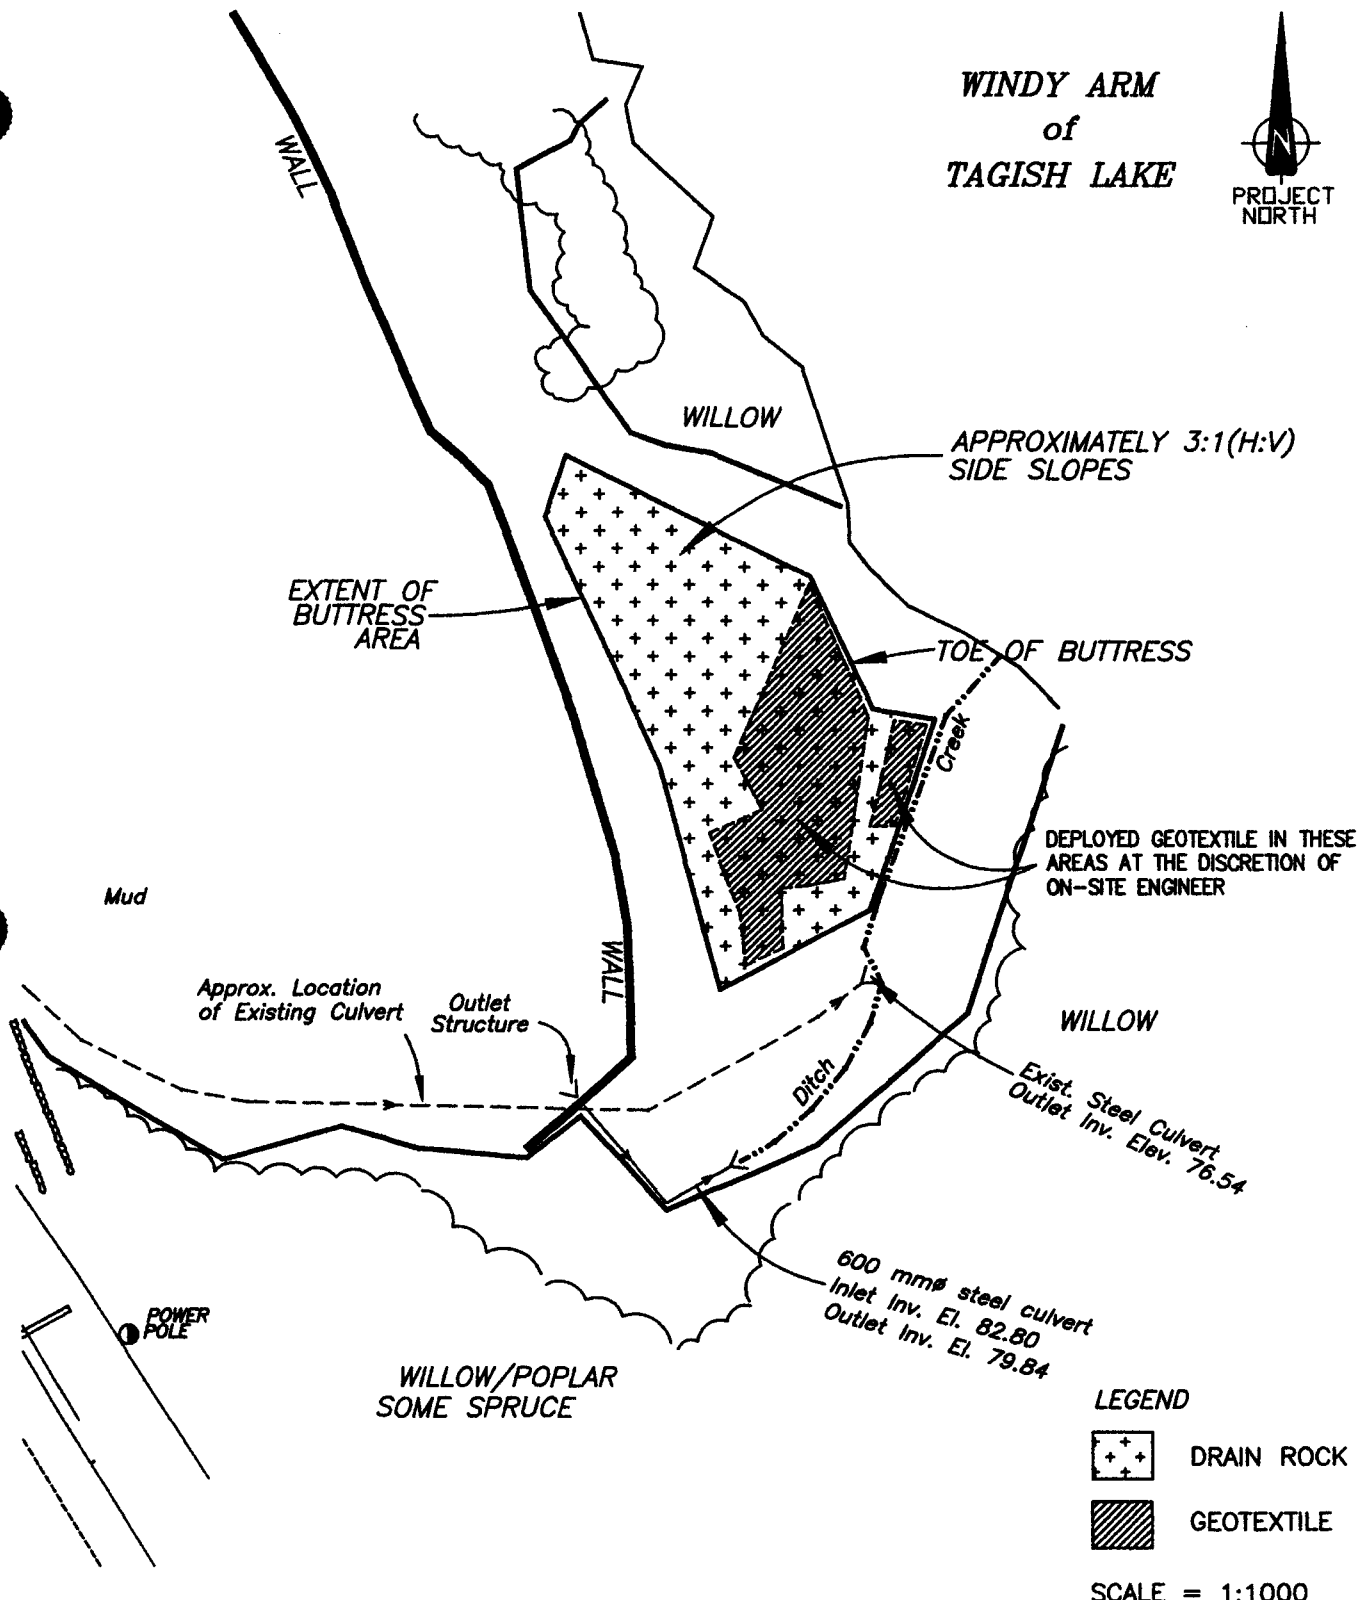
| FILE NO. 0201-98-13604 | | FIGURE 1 |

The buttress construction is described in Section 1003 of the Program specifications (Appendix A). The construction initially involved placing a non-woven geotextile over the saturated, soft soil areas. Pit run material was then hauled to the site and placed in the appropriate areas to meet the required buttress specifications. EBA representatives Mr. Ed Grozic, P. Eng., or Mr. Chad Cowan, E.I.T., or Mr. Mike Billowits, P. Eng, were on site during the construction of the buttress, which commenced on November 2nd, 1998 and finished on November 7th, 1998. Daily Reports, located in Appendix B, describe the procedure followed for construction of the buttress. During the construction it was noticed that there was a soft spot in an area of groundwater seepage between the buttress toe and small creek to the east. To alleviate this problem, additional drain rock, geotextile, and pit run were placed in the area. Figure 1 shows the location of actual geotextile that was placed beneath the buttress fill material and also identifies the approximate completion boundaries of the constructed buttress.

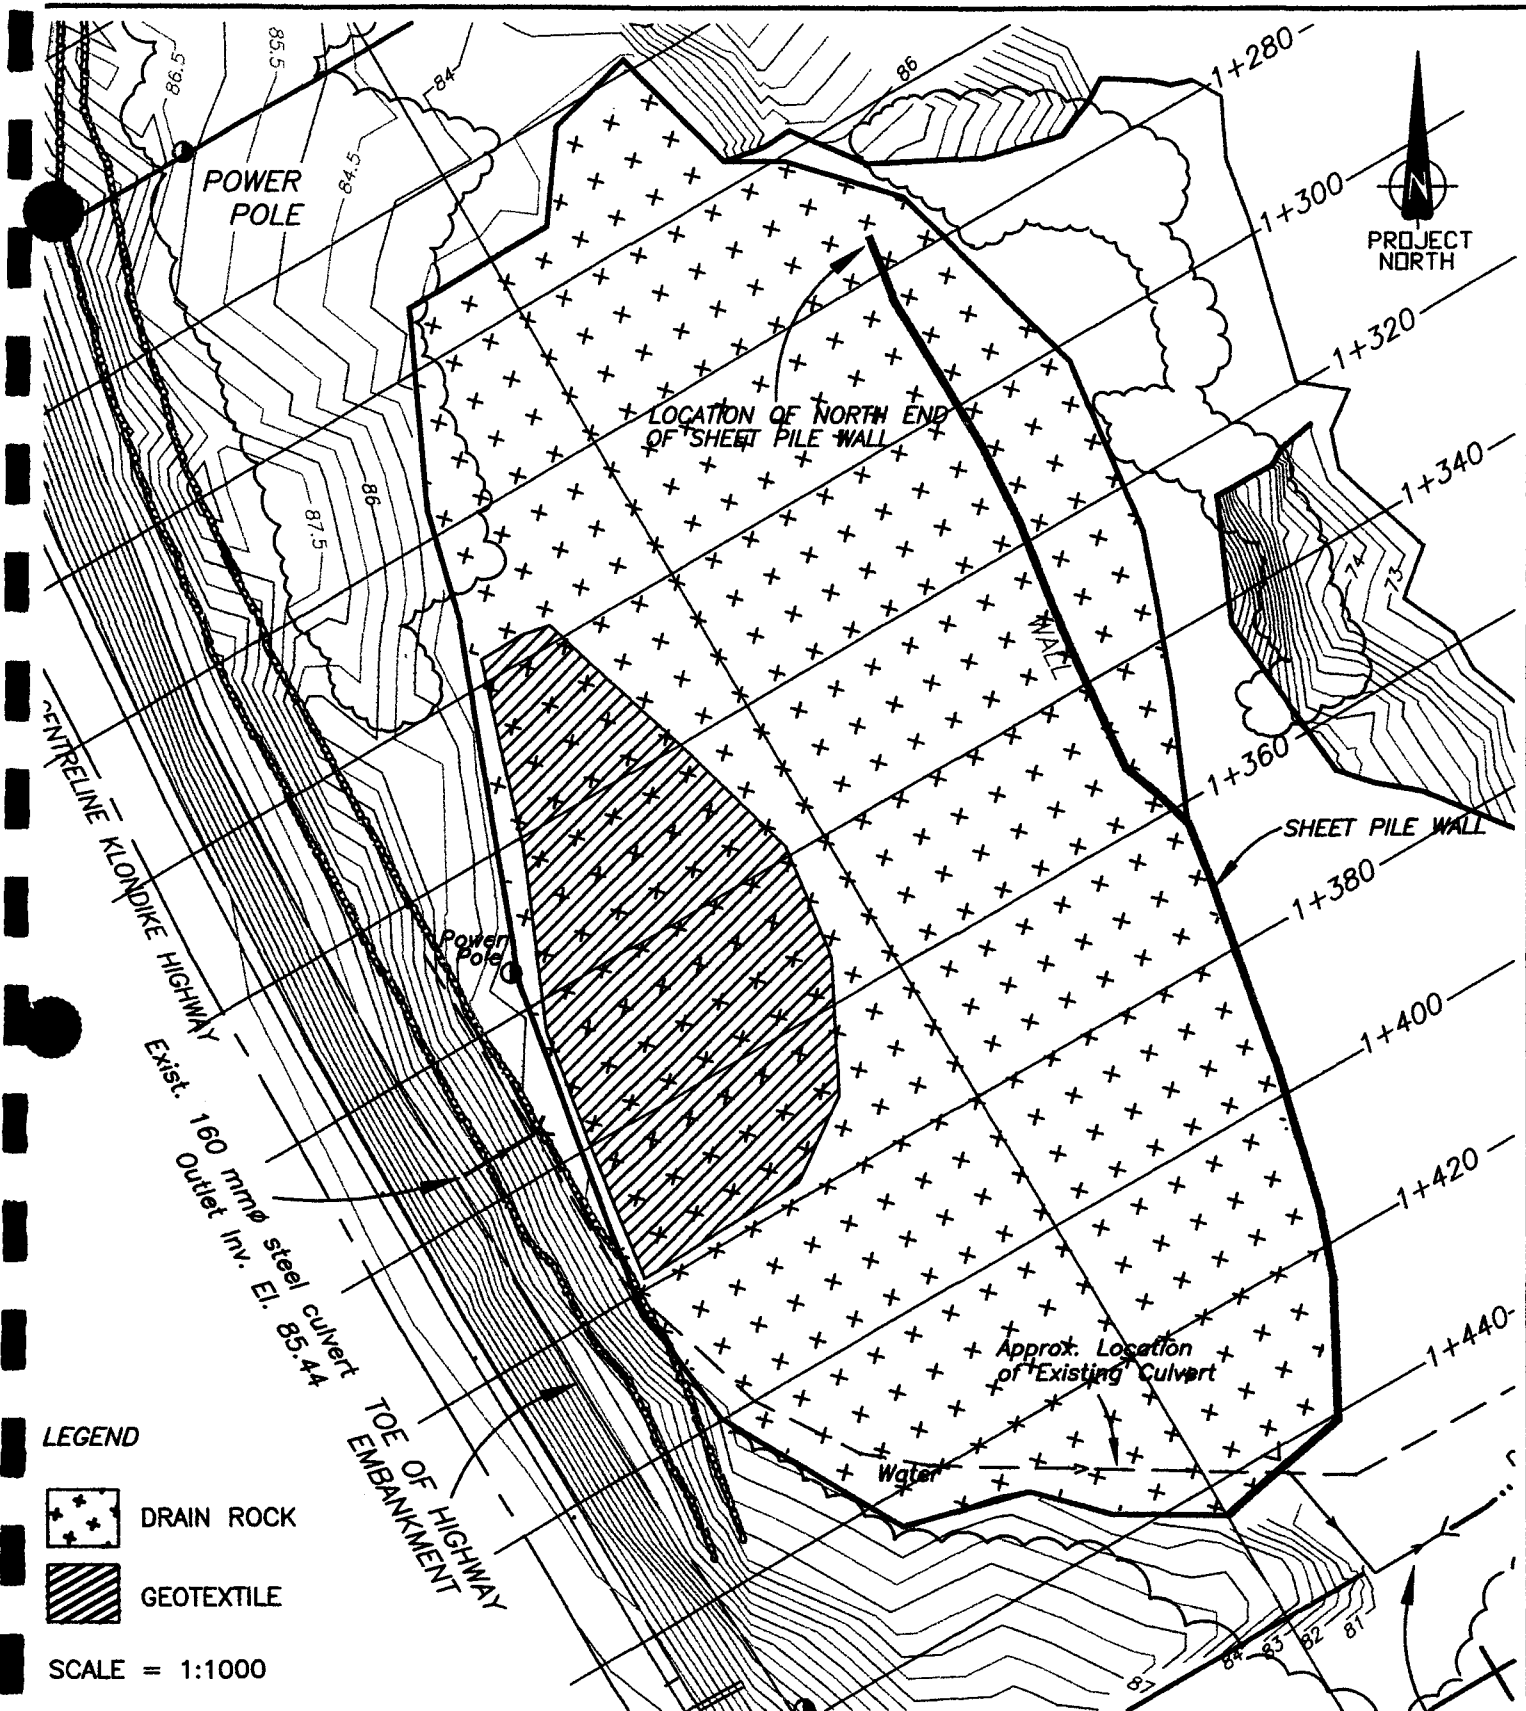
FILE NO. 0201-98-13604 FIGURE 2

The Drain Rock placement is described in Section 1004 of the Program specifications (Appendix A). Mr. Michael Billowits, P. Eng., or Mr. James Buyck, Eng. Assist., were the EBA representatives on site during this part of the Program which was performed between March 3rd, 1999 and March 9th, 1999. The Daily Reports included in Appendix B summarize the work that was completed during this phase of the Program. The Program tasks for Drain Rock placement involved laying out non-woven geotextile in the appropriate areas and then spreading Drain Rock on top of the tailings area including the area of geotextile. The boundaries for the geotextile and Drain Rock placed on the site are shown on Figure 2. In general the Drain Rock placement was conducted in accordance with the Program specifications with the exception of one item that has yet to be completed. The Drain Rock at the site requires a final grading which is scheduled for May, 1999.
