**INDIAN AND NORTHERN AFFAIRS CANADA
ABANDONED CLINTON CREEK
ASBESTOS MINE
1998 SITE RECONNAISSANCE**

APRIL, 1999

PREPARED BY
UMA ENGINEERING LTD.
ENGINEERS AND PLANNERS
1479 BUFFALO PLACE
WINNIPEG, MANITOBA
R3T 1L7

Reference: Abandoned Clinton Creek Asbestos Mine – 1998 Site Reconnaissance

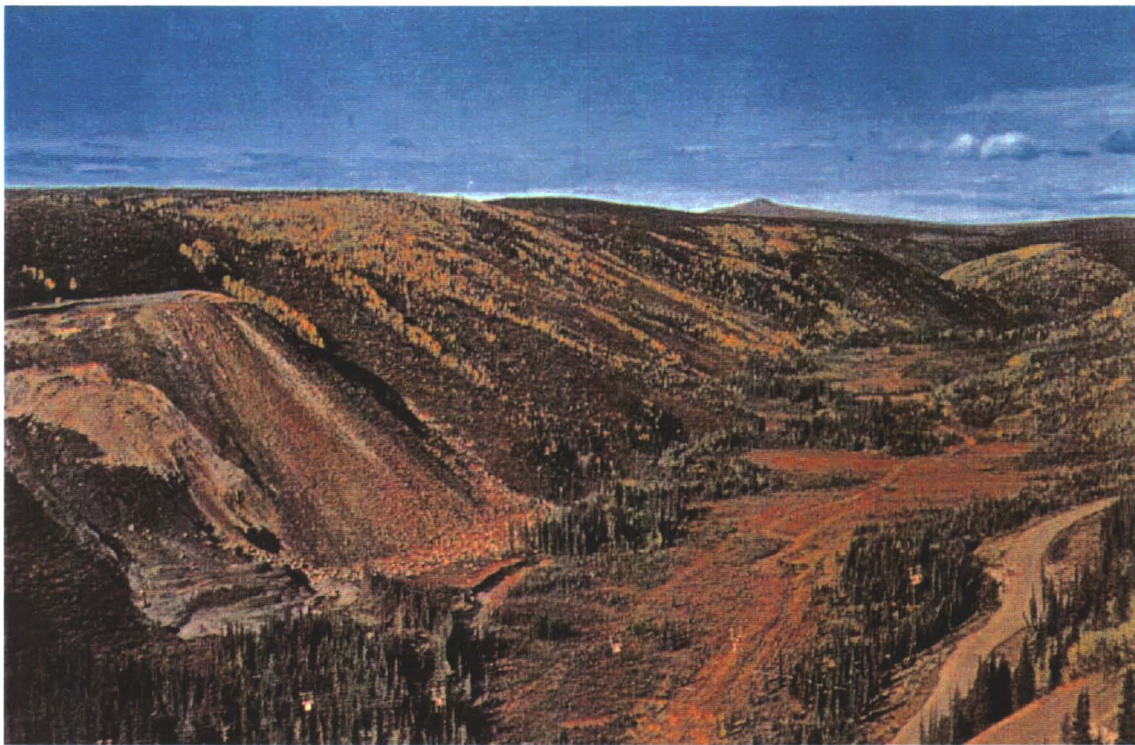
The waste rock from Porcupine Pit was initially placed along the south valley slope west of the mine as shown on Photo CC-01, probably taken around 1970 (Geo-Engineering, December, 1986). It is apparent that the waste rock was unstable at this early stage as evidenced by visible slumping of the east section of waste rock. This early photograph, looking upstream, also illustrates Clinton Creek along its original alignment in the center of the valley (now Hudgeon Lake).

Photo CC-01: Clinton Creek Waste Rock Dump (Circa 1970)

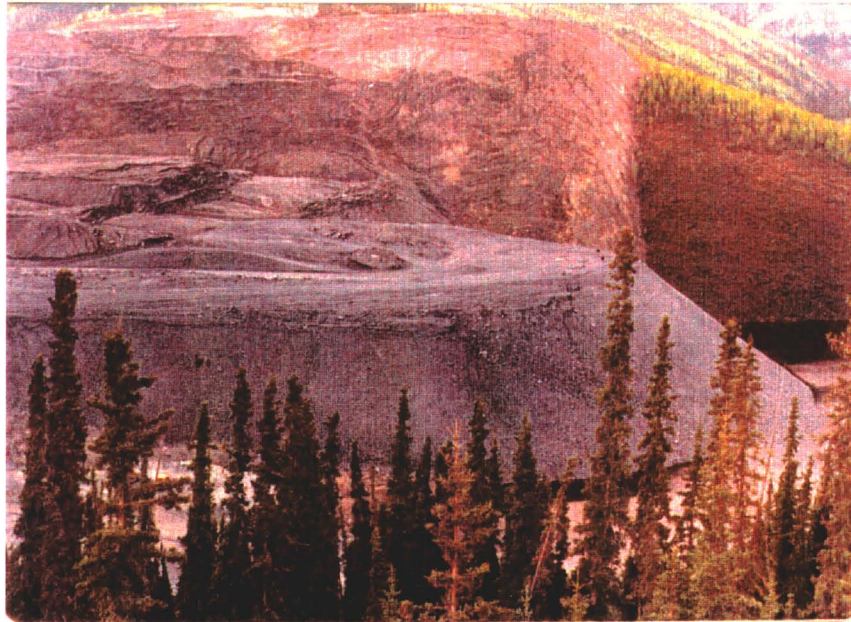
Between 1970 and 1975, a considerable volume of waste rock was dumped across the valley as shown on Photo CC-03 taken in May, 1975. The resulting valley blockage impounded water from the Clinton Creek watershed creating Hudgeon Lake.

Photo CC-03: West end of Waste Rock Dump (May, 1975)

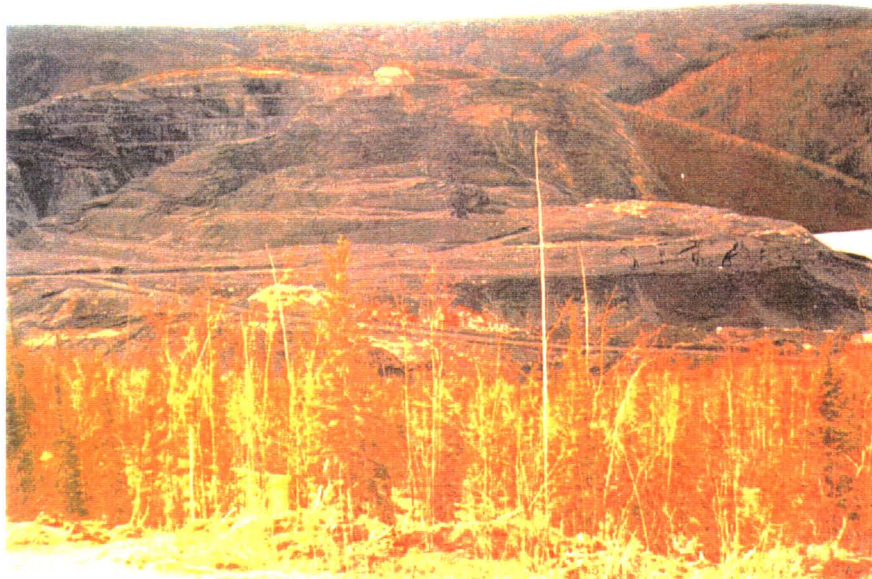
Significant lateral spreading of the rock fill, in particular at the west end of the dump towards Hudgeon Lake, occurred as a consequence of the continued placement of waste rock. Photo 1, taken in about May 1976 (Golder Associates, April 1977), shows tension cracks along the crest of waste rock adjacent to Hudgeon Lake. By 1985, the west end of the waste rock dump had slumped considerably towards, and into, Hudgeon Lake (Photo 2, Klohn Leonoff, September, 1986).

Photo 1: Tension Cracks at West End of Waste Rock Dump (1976)

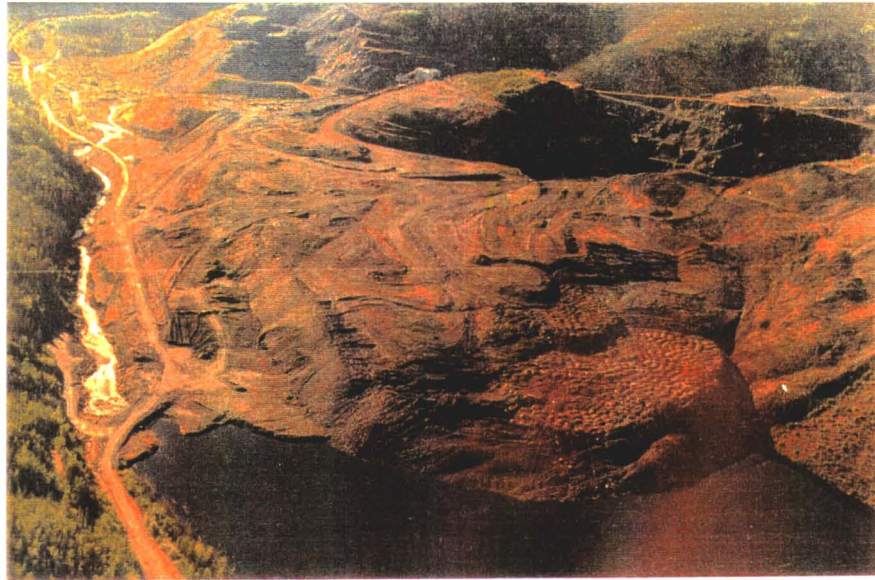
Photo 2: View South at Waste Rock Dump (1985)

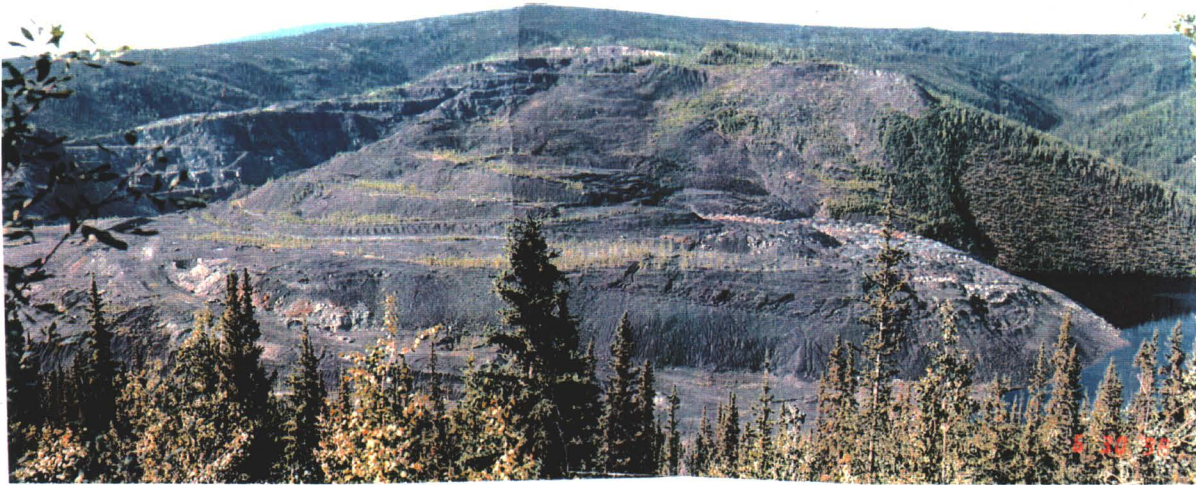
Based on observational records, active movement of the waste rock dump has continued since mine closure in 1978, although the magnitude of this movement has not been quantified since that time. Prior to mine closure, surveys of movement monitoring targets were conducted to assess the rate and magnitude (vertical and horizontal) of waste rock movement. With the exception of several targets along the south bank of the creek channel, most of the monitoring points are intact. Targets located during our reconnaissance are indicated on Drawing 02. Visible movements of the waste rock pile were reported in Geo-Engineering's July, 1998 report (Photo 17). Examination of the area near the center of Photo 17 (sparsely covered with young poplar trees) in September revealed that many of the tension cracks associated with slump blocks had been infilled, possibly suggesting reduced slope movement at this end of the dump (UMA Photo 9-3). More recent multiple tension cracks which further confirm on-going lateral movements of the waste rock were observed farther east along the access road during our September, 1998 site reconnaissance (UMA Photo 2-18, Appendix A).

Photo 17: Tension Cracks in Waste Rock Along Sparsely Treed Area (1998)

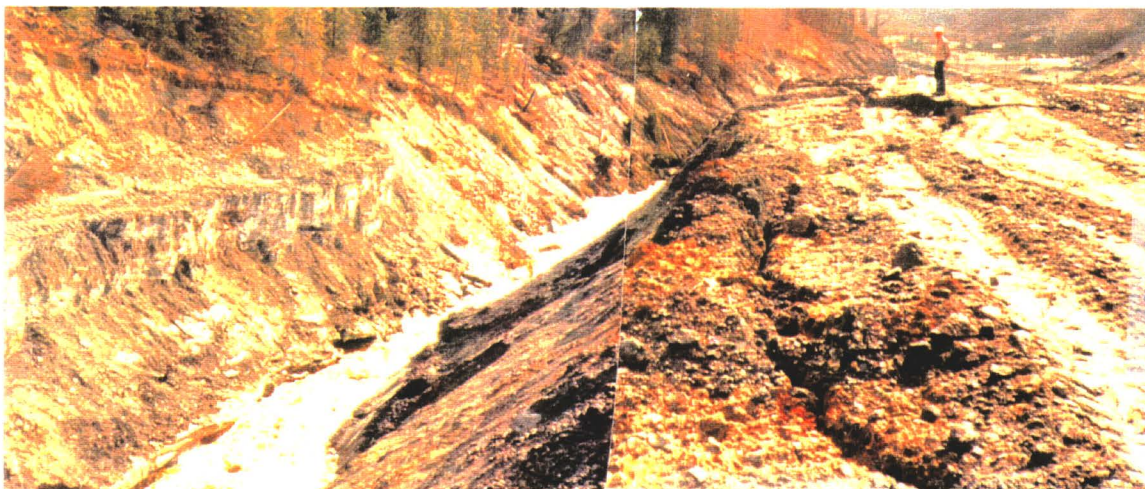
A new access road with a wide shoulder was subsequently constructed through the rock fill along the south side of the creek channel. However, the waste rock was undercut and began slumping soon after it was constructed as shown on Photo 5, (Golder Associates, April 1977). Slumping on the north side of the channel also began to undercut the natural valley slope can also be seen in Photo 5.

Photo 5: Erosion and Slumping of New Access Road on South Side of Creek (1976)

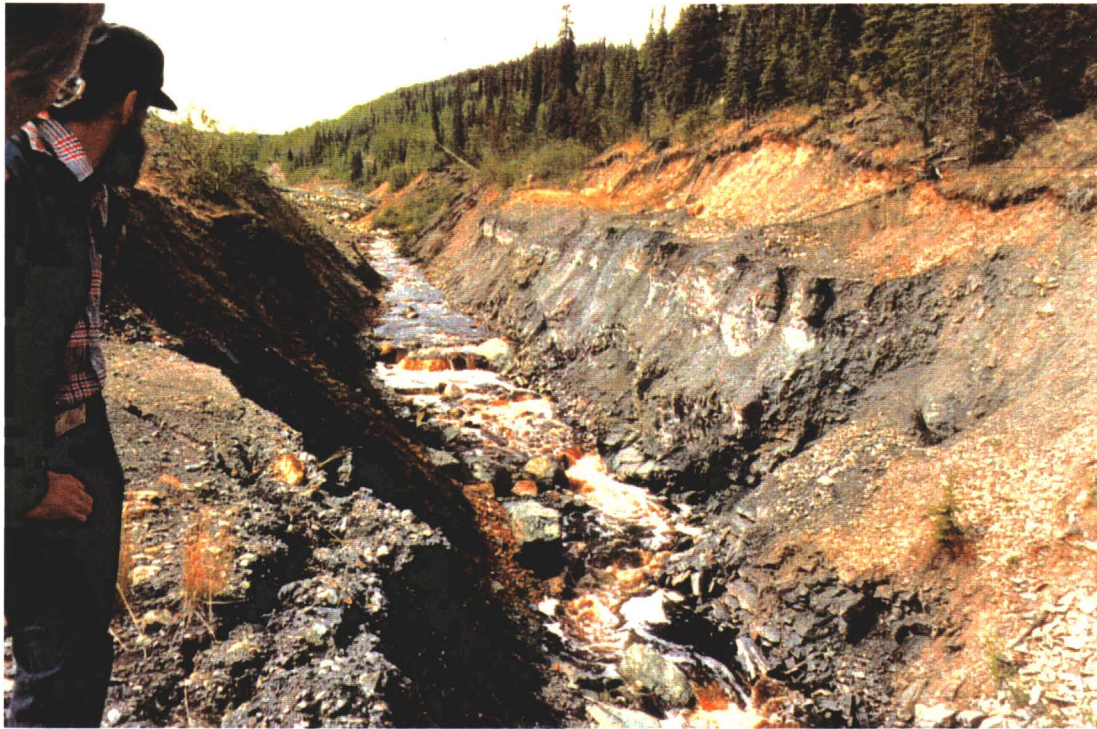
Significant channel erosion and down-cutting is also evident downstream of the weir (Photo 4 Klohn Leonoff, August 1983).

Photo 4: Channel Erosion Downstream of Weirs (1983)

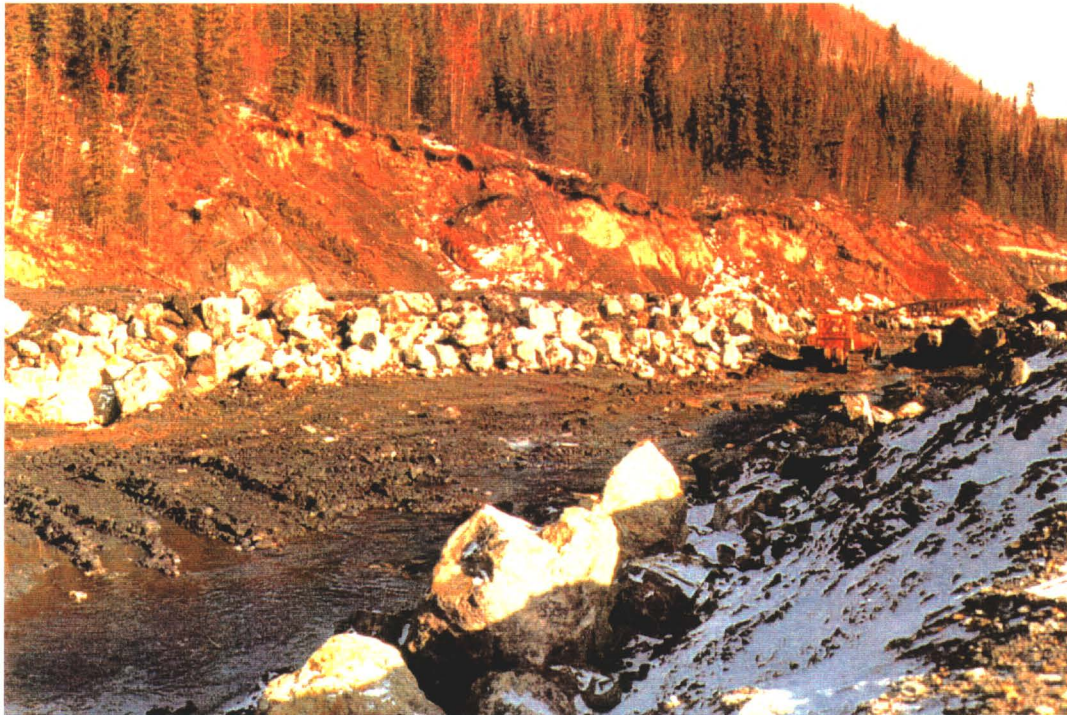
Photo 7: Armouring of North Side of Channel (1983)

Remedial work was again undertaken in the fall of 1983 to reduce channel erosion. Flow was diverted along the south side of the rock weirs while the north side of the channel and the culvert outlets were armoured with rip rap as seen in Photos 7 and 10, respectively (Klohn Leonoff, November 1983). Woven geotextile was placed beneath the rip rap on the north side of the channel (Photo 6 Klohn Leonoff, November 1983).

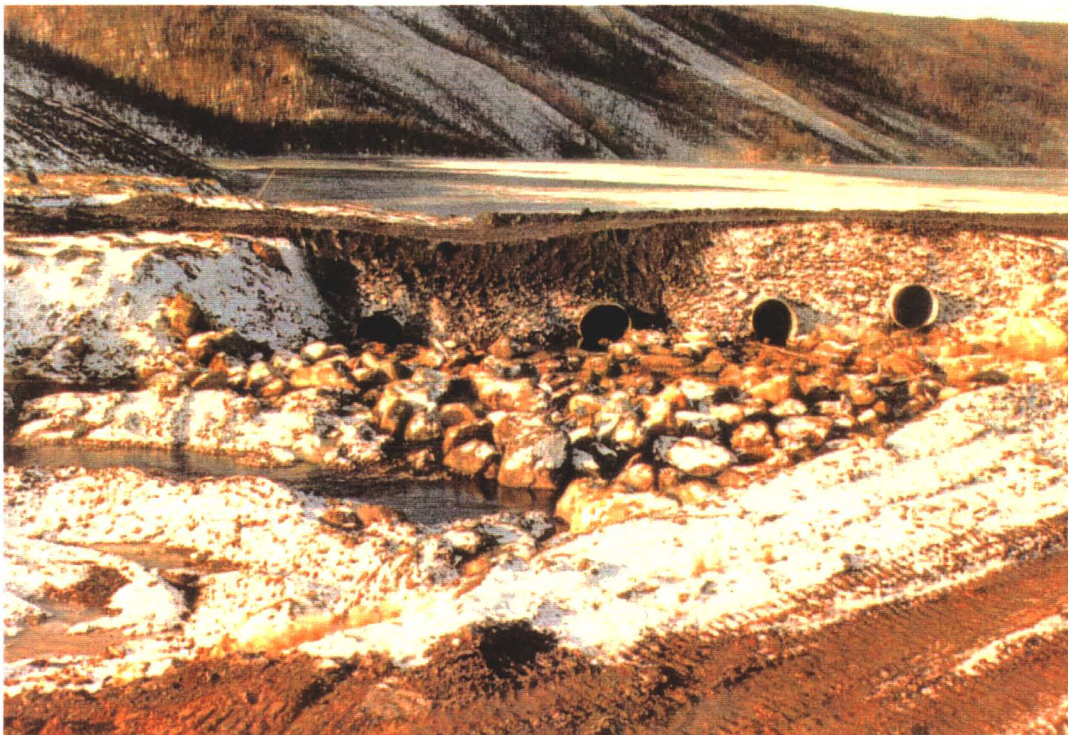
Photo 10: Channel Lining at Culvert Outlets (1983)

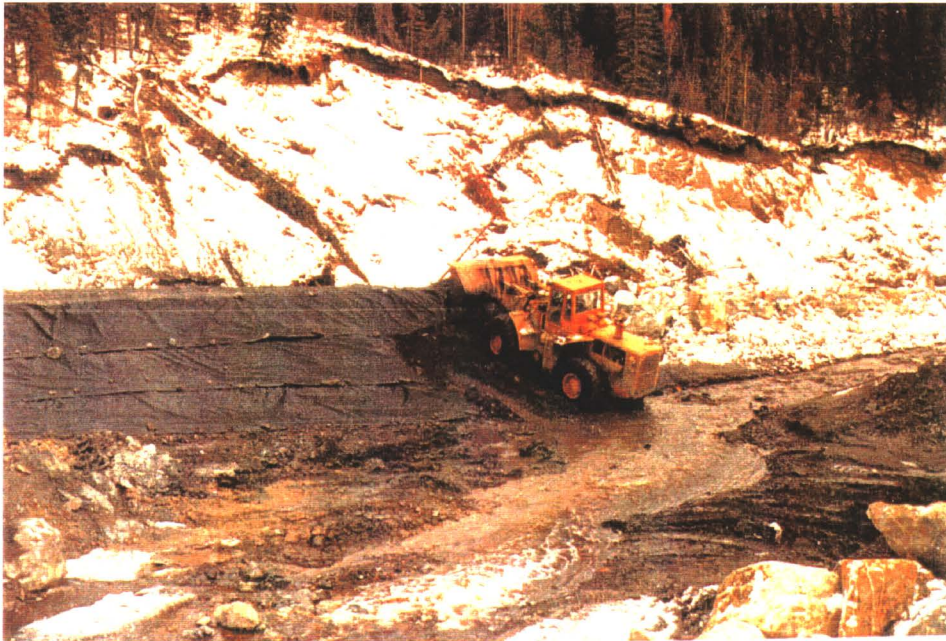
Photo 6: Channel Repairs (1983)

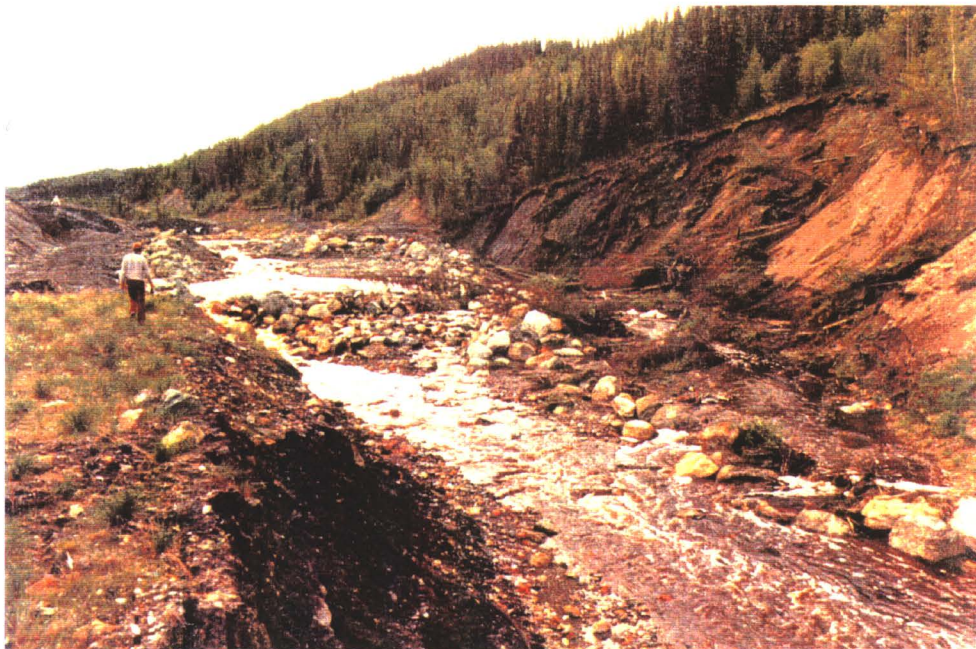
In June 1984, the channel was beginning to by-pass the last downstream rock weir (Photo 2 - Klohn Leonoff, August 1984). Photos 3 and 4, taken in June, 1985 illustrate the minor modifications made to the north side of the channel.

Photo 2: Channel Bypassing Rock Weirs (1984)

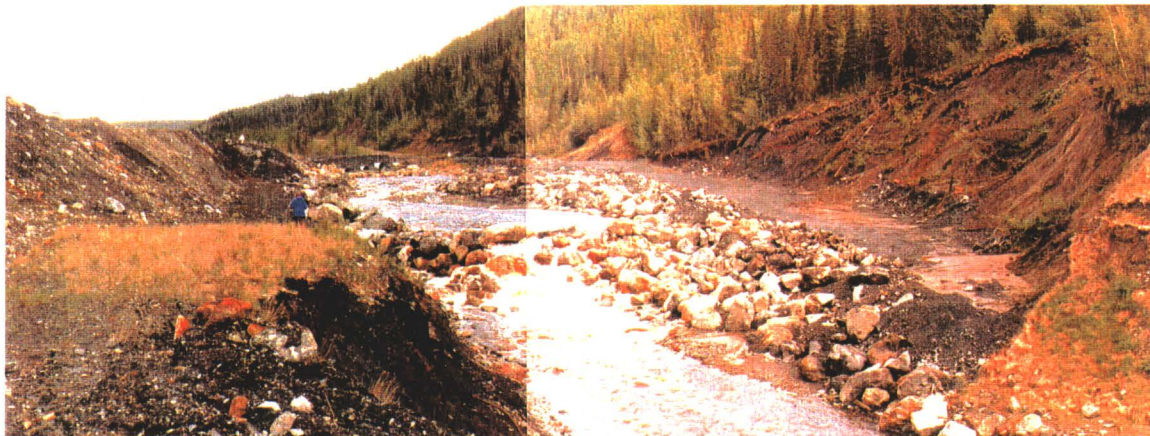
Photos 3 and 4: Channel repairs (1985)

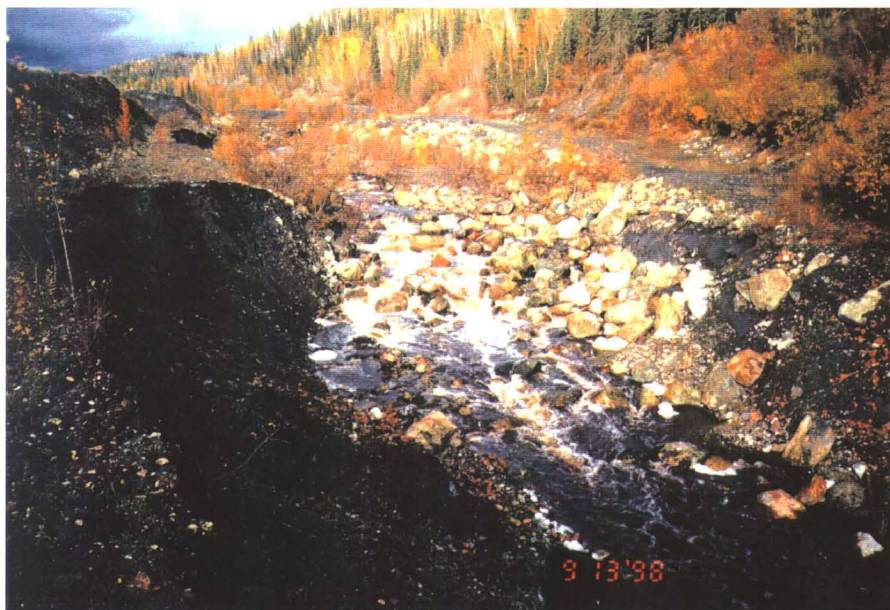
Spring run-off in 1997 destroyed the rock weirs. Since that time, significant channel erosion and incising has occurred downstream of the washed out culverts, apparently down-cutting the channel by up to about 2m (UMA Photo 7-24). Down-cutting of the channel is also apparent farther downstream when Photo 4 (Page 9) is compared with UMA Photo 7-17. At present, numerous slumps and localized slope failures are occurring on either side of the channel as material is eroded (UMA Photos 7-6 and 7-18 and 7-25 in Appendix A). Once material has failed or slumped into the channel, flow is often forced to meander around the debris initiating erosion of the opposite bank.

UMA Photo 7-24: Channel Down-Cutting (1998)

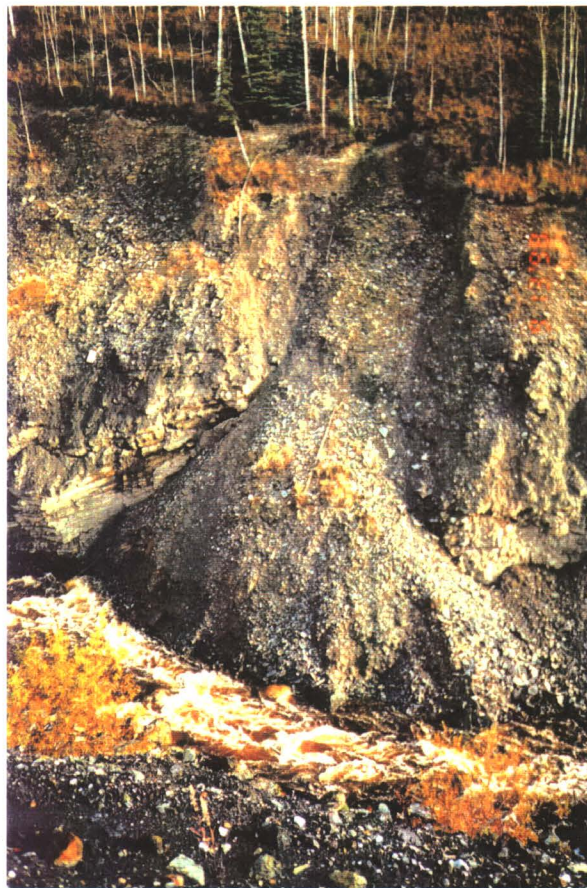
UMA Photo 7-6: Sloughed Till in Channel From Localized Bank Failure (1998)

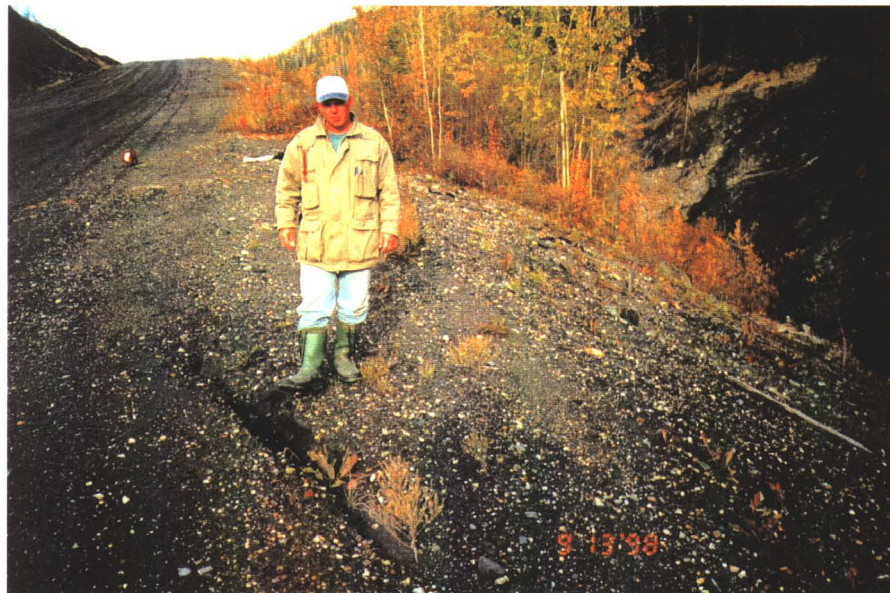
This process has begun to impact the integrity of the access road along the waste rock dump as evidenced by tension cracks along the north shoulder of the access road (UMA Photo 7-14). Slumping has resulted in considerable narrowing of one section of the access road (UMA Photos 2-8 and 7-5 in Appendix A) and it is likely that the access road will become impassible in the near future as this process continues (Drawing 02).

UMA Photo 7-14: Tension Crack Along Access Road (1998)

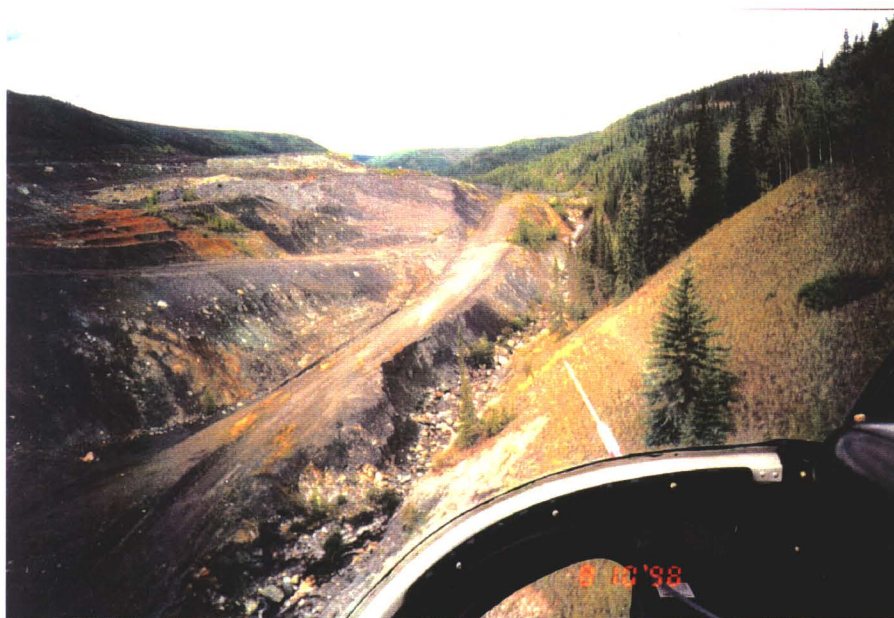
UMA Photo 2-8: Failure Along Access Road Shoulder (1998)

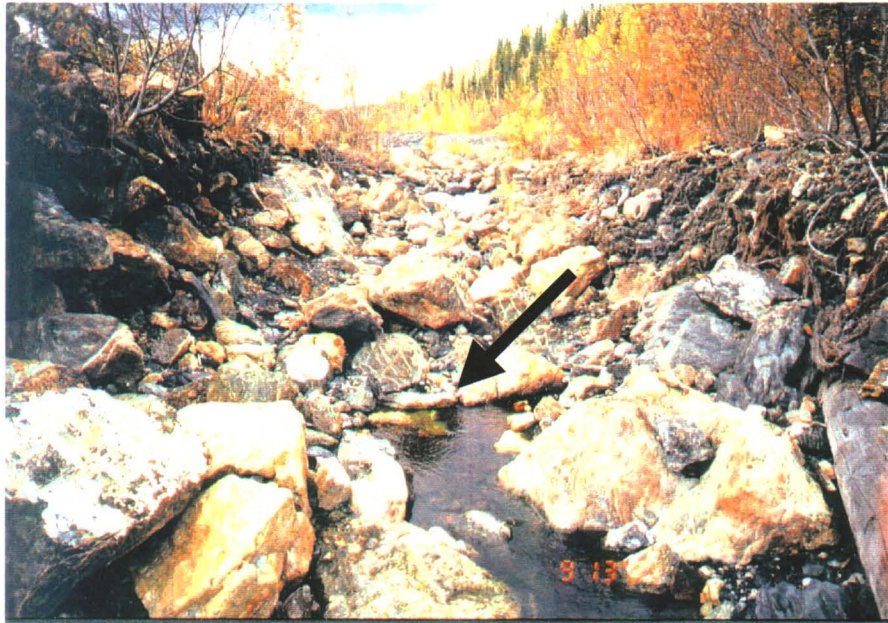
Two springs were observed exiting from the waste rock just downstream of the lake outlet. The first spring exits from what is believed to be the old creek bed, between the island and south bank (Drawing 02 and UMA Photo 8-16). The second spring exits about 2 metres above the creek water level on the south bank (UMA Photo 8-19 and Drawing 02). The water from both springs was clear with no evidence of fines. Brown slime was growing over the rocks at the downstream spring and the water had a noticeable hydrogen sulphide odour. A water sample was collected from the spring by RRU.

UMA Photo 8-16: Spring in Creek channel Remnant (1998)

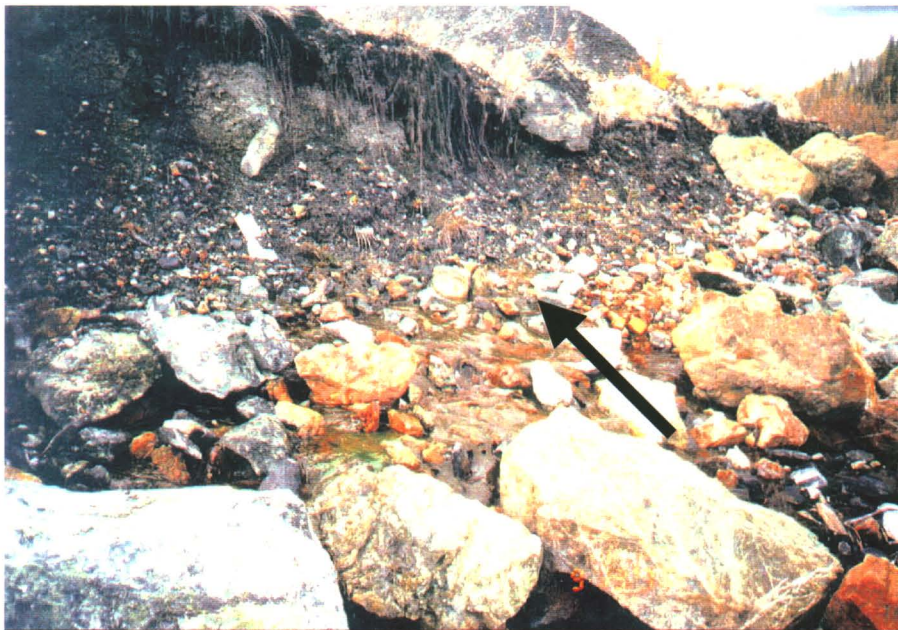
UMA Photo 8-19: Spring on South Bank

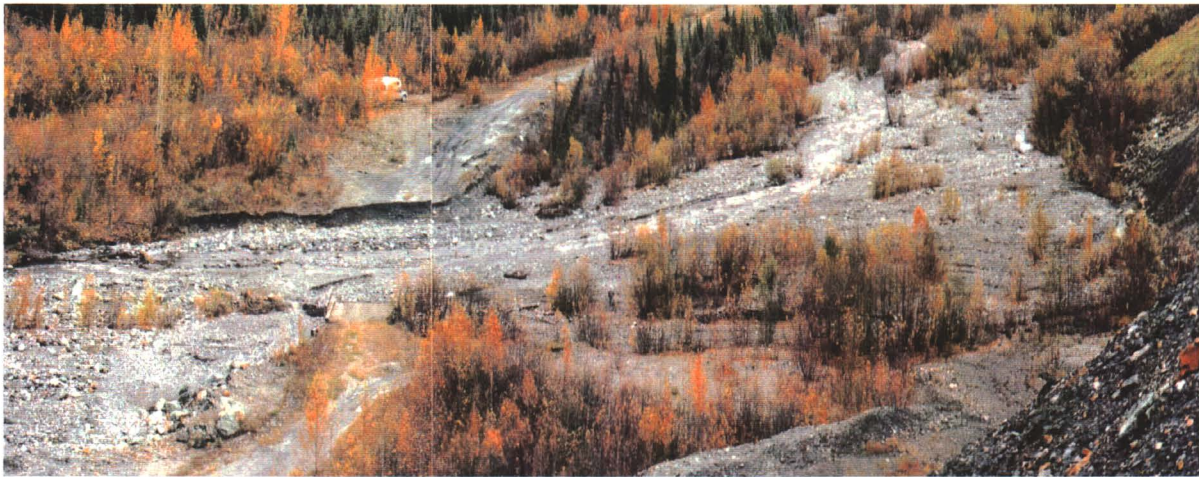
Downstream of the washed out bridge at the east end of the waste rock dump, a single creek channel now meanders through a considerable area of flow debris consisting of gravel to 200mm diameter rock (UMA Photos 13-17 and 13-18, Drawing 02). There appears to be considerably more flow debris downstream of the bridge now (UMA Photo 2-7) as compared with Photo 7 taken in 1986 (Geo-Engineering, November 1986). Several channel remnants and evidence of significantly wider historic channel flow are visible. High water marks in trees in the area are about 600mm above the ground surface, or about 1.5 to 2 metres above the existing creek water elevation. At locations as far as 200 metres downstream of the bridge, trees and brush have trapped flow debris (UMA Photo 11-22 note leaning trees). Beaver dams several hundred metres downstream of the bridge have flooded a large area near the junction of Wolverine and Clinton Creek.

UMA Photo 13-17 and 13-18: Clinton Creek at washed out bridge

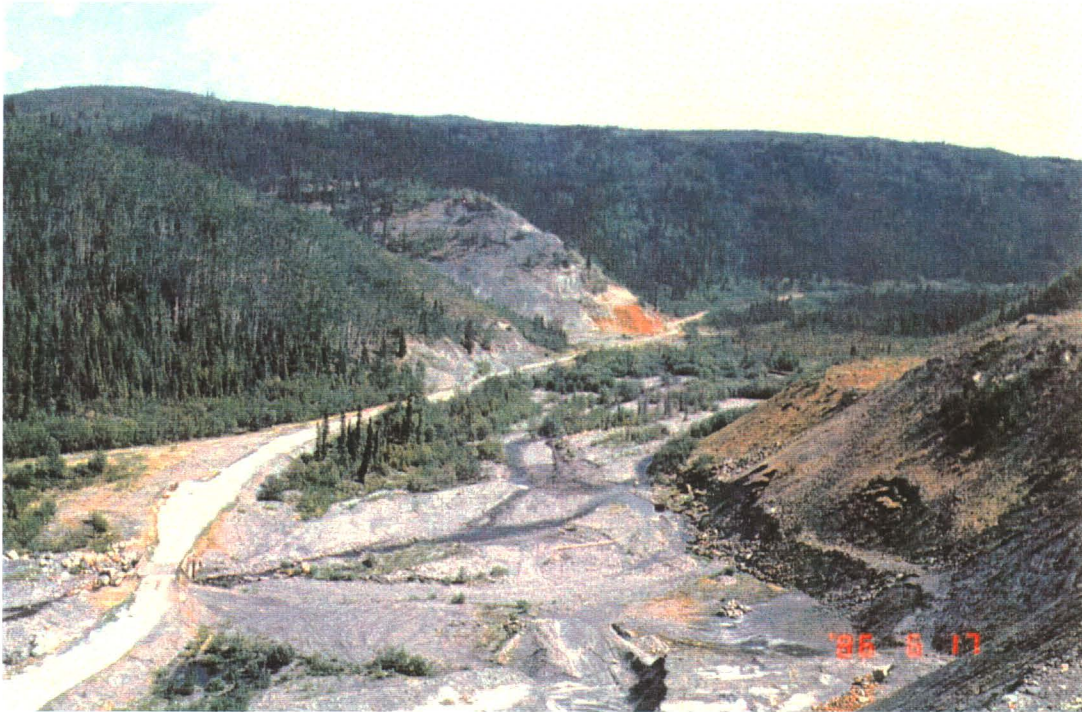
Photo 7: Clinton Creek Bridge Crossing (1986)

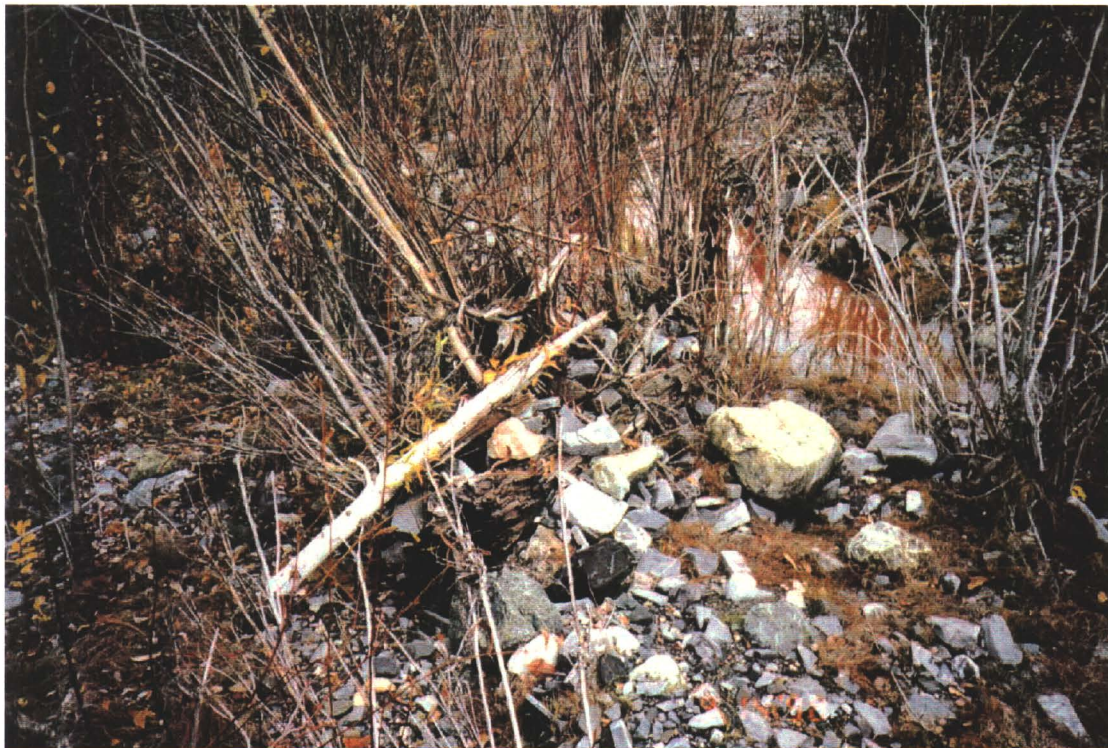
UMA Photo 11-22: Flow Debris in Treed Area

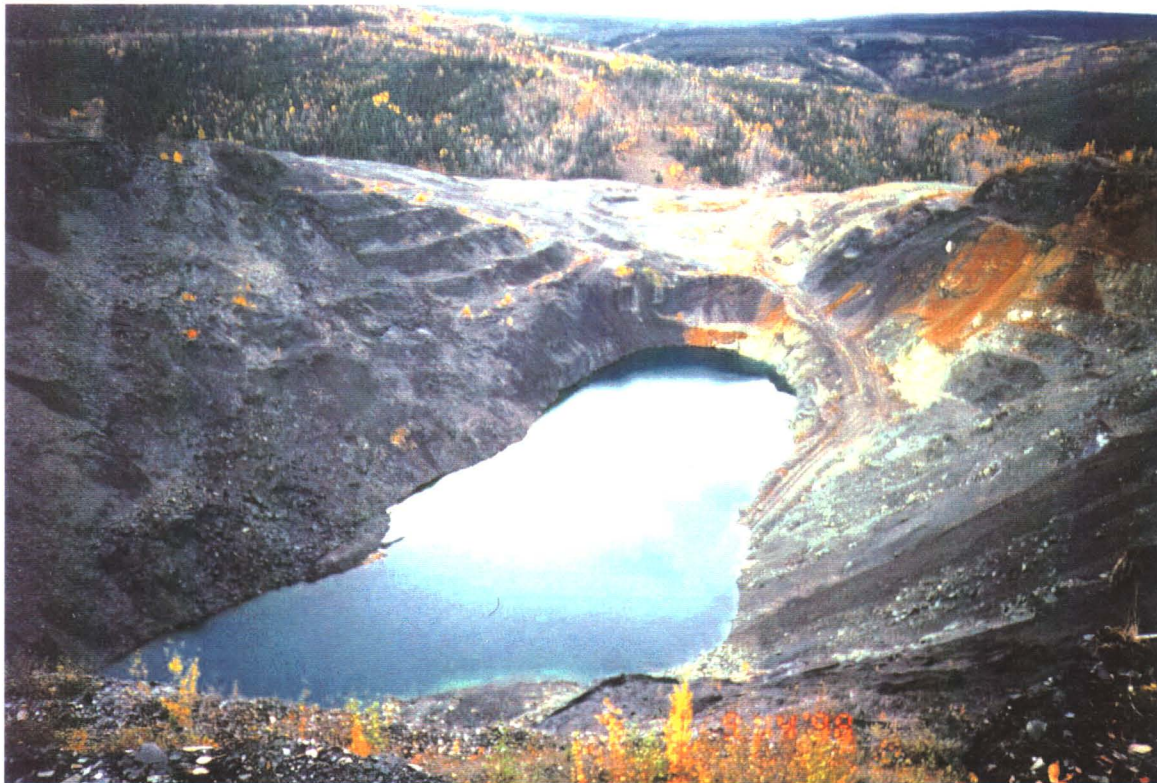
Instabilities of the open pit (Porcupine Pit) sides-slopes have been on-going since closure of the open pit mine. Recent tension cracks were observed during our site reconnaissance, in particular at the crest along the entrance to the mine as shown on UMA Photos 9-10 to 9-12 and along the west edge of the crest where a significant slump block has developed (Drawing 03). Continued sloughing of the over-steepened pit walls is clearly evident and is expected to continue for an indefinite time period (UMA Photo 11-1). Debris could occasionally be heard falling into the water while completing our reconnaissance in the area.

UMA Photo 11-1: View Northeast at Porcupine Pit (1998)

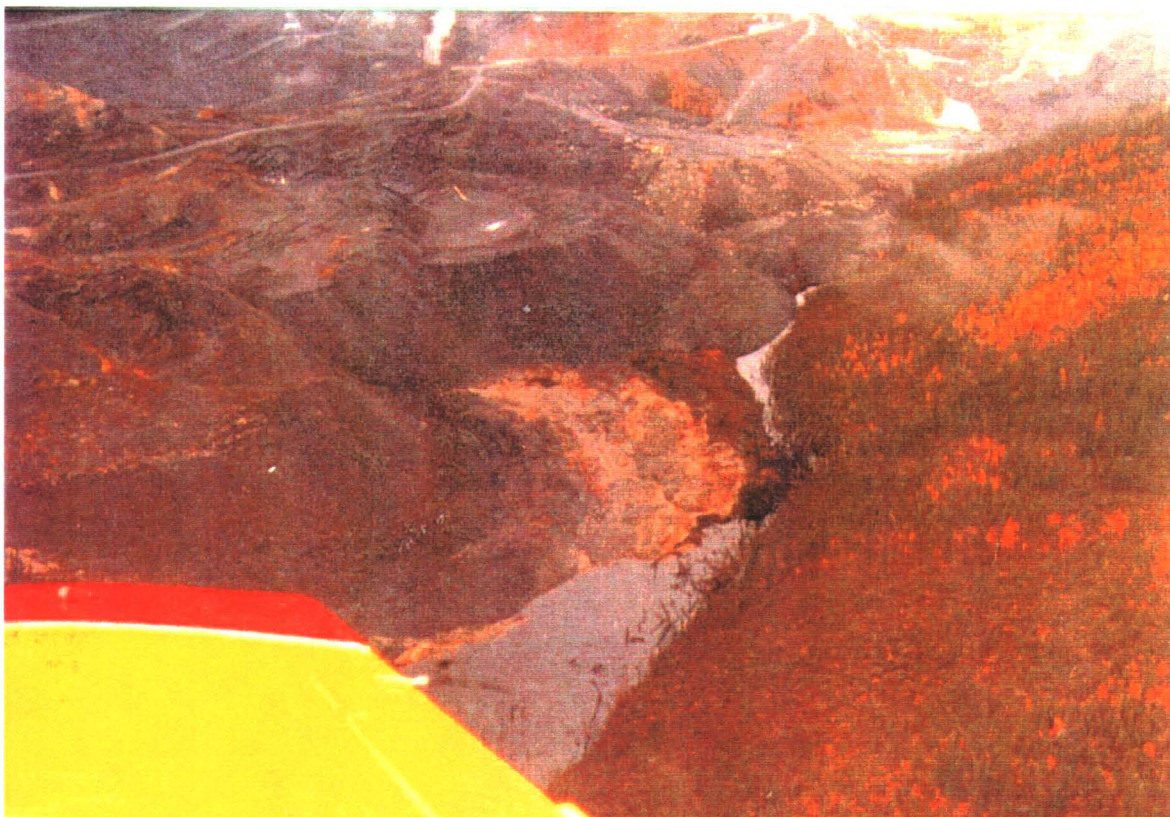
Waste rock was placed across the Porcupine Creek valley slope as shown on Drawing 04 and in Photo 12, one of the earliest aerial photographs of the area taken in 1976 or 1977 (Hardy, 1977). The most northerly section of the dump was placed at least partially up the east valley wall. This area has remained relatively stable. Sections near the centre of the dump which were placed farther away from the east valley toe, however, have experienced slumping creating blockages at two locations, as indicated on Drawing 03.

Photo 12: East Edge of Porcupine Creek Waste Rock Dump (1977)

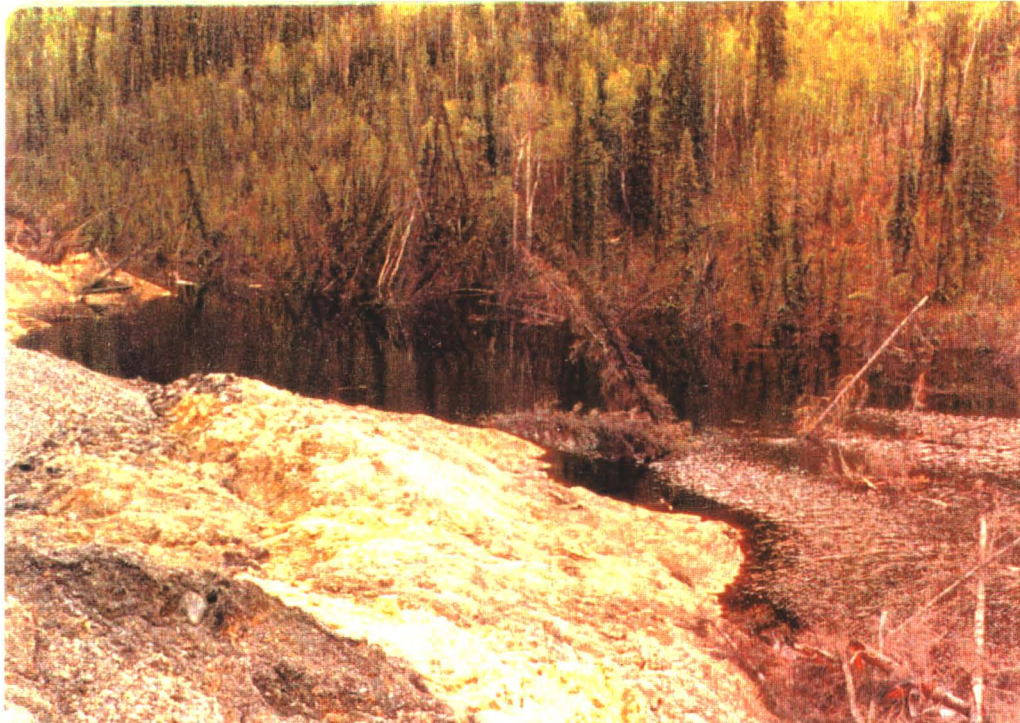
The southern section of the waste rock dump has undergone extensive movement at the toe and crest due to both the volume of waste rock and the method of placement. Dumping probably would have begun at or near the crest of the original valley slope but was only advanced across a portion of the valley. Instabilities of the waste rock pile have heaved the valley floor several metres as shown in Photo PC-03 (May 1975). The heaving (up-thrusting) of the valley floor is the primary reason for the impoundment of water from Porcupine Creek.

Photo PC-03: Till Up-Thrust at Toe of Failed Waste Rock (1975)

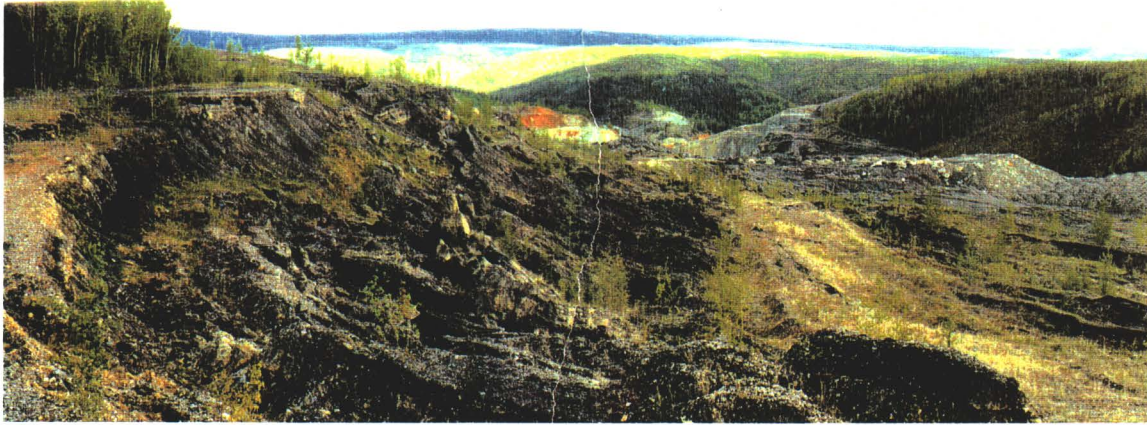
Near the crest of the waste rock dump, movement has resulted in numerous tension cracks and backscarps as shown in Photo 11 (Geo-Engineering, November 1988) and UMA Photos 10-24 to 11-0 in Appendix A. At present, considerable downslope movements are continuing in the upper slope of this section of the waste rock dump as evidenced by recent tension cracks and backscarps. It is anticipated this movement will continue until the waste rock has become geometrically stabilized, a process that could greatly increase the size of the upstream impoundment.

Photo 11: Crest of Unstable Waste Rock (1988)

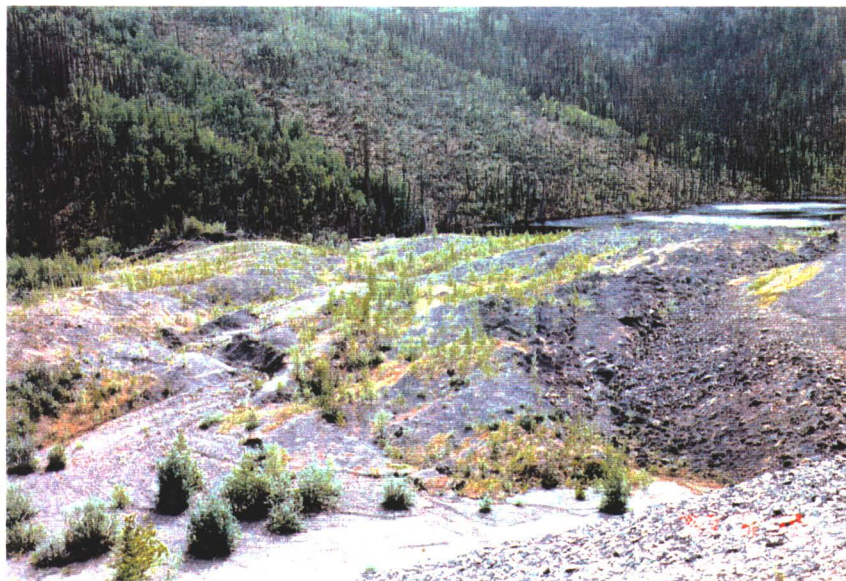
Drainage of the Porcupine Creek watershed through the waste rock dump occurs in two ways. The majority of the water drains through the waste rock pile, entering at a point along the southern limit of the stable waste rock pile (Drawing 03). Water drains from the pond to the waste rock via a drainage channel incised through the slide debris from the unstable southern portion of the waste rock. Evidence of this channel was observed by Geo-Engineering during their July 1987 inspection, although at that time, the channel was dry (Photo 9). During our site reconnaissance, water was entering the waste rock pile through an opening that was estimated to be about 0.3m^2 located at the toe of the waste rock (UMA Photo 10-9 in Appendix A).

Photo 9: Dry Inlet Channel From Pond to Waste Rock Pile (1987)

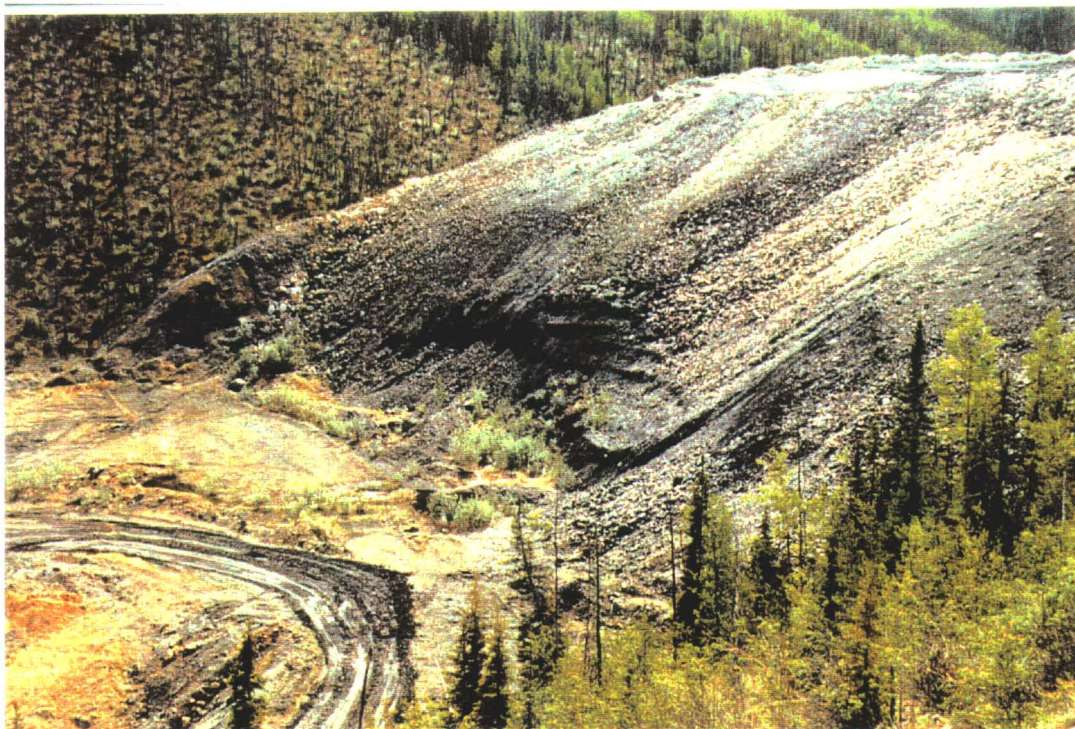
The discharge point is believed to be through the toe of the northern slope of the waste rock dump, or about 550 metres to the north of the inlet (Spring A). At the time of our reconnaissance, discharge at the outlet was estimated to be in the order of 6 to 9 l/s (100 - 150 gpm) approximately 5 m above ground surface. A second outlet point, about 2m above the ground surface, discharges about 1 to 2 l/s (15-20 gpm). Localized slumping is evident where water discharges the core rock slope as seen in Photo 13 (Geo-Engineering, November 1988) and UMA Photo 11-3 (Appendix A). Water is conveyed via a drainage course that has been incised along the south edge of the road (Photo 13).

Photo 13: Outlet and Drainage Ditch on North Waste Rock Slope (1988)

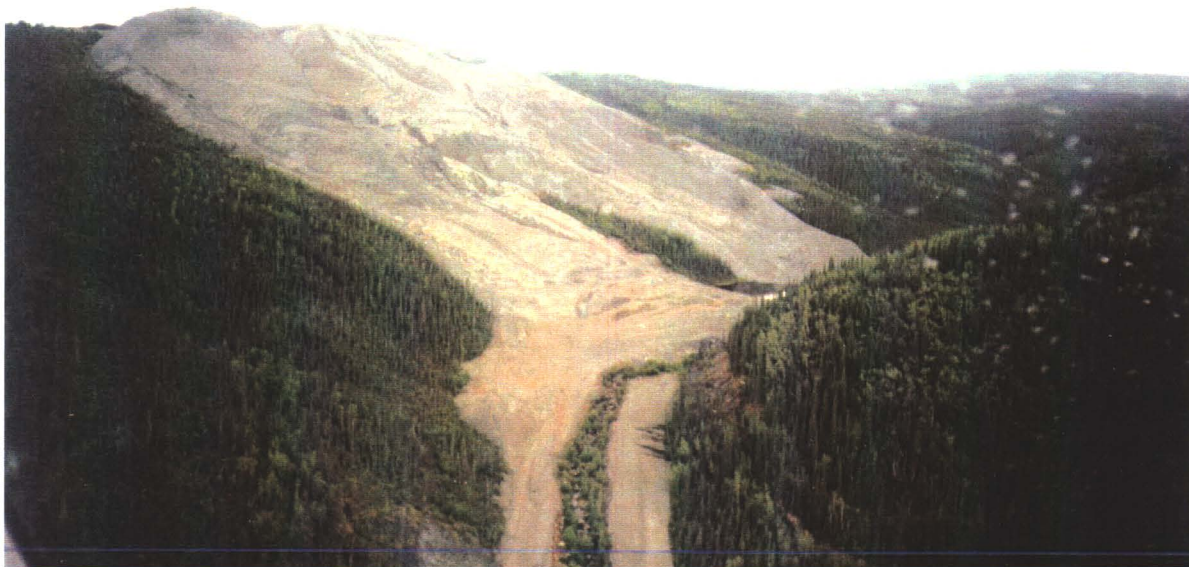
Since the failure of the asbestos tailings pile, the tailings piles have historically been referred to as the south and north lobes (UMA Photo 3-5 and Drawing 04). Each tailings lobe is discussed separately as follows:

UMA Photo 3-5: View North at South and North Tailings Lobes (1998)

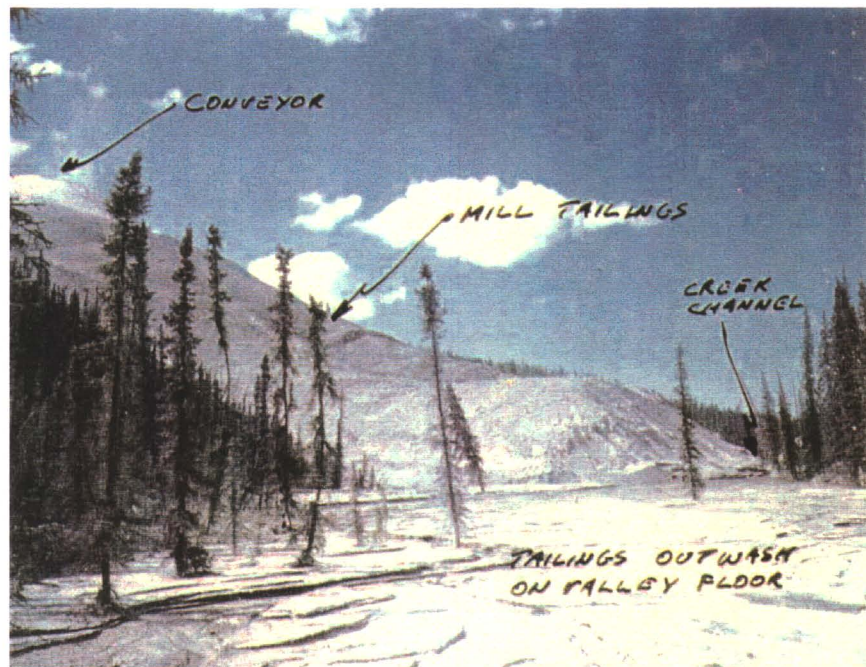
The southerly portion of the tailings pile (south lobe) failed suddenly in early 1974. The tailings moved down the west valley slope and completely blocked the existing creek channel. The blockage was subsequently breached releasing a significant amount of water borne tailings which were deposited downstream of the blockage as shown in Photo 7 (W.B. Bowie, June 1974). Remedial works, including removal of tailings from the channel, were implemented soon after the breach occurred (Photo WC-01, July 1974).

Photo 7: Tailings Deposition After Breach (1974)

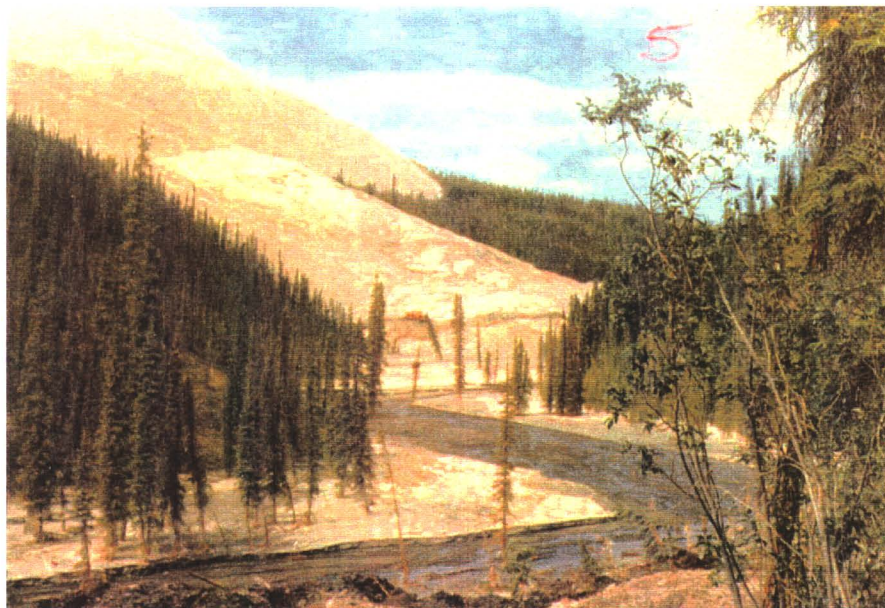
Photo WC-01: Creek Channel Downstream of Breach (1974)
