**INDIAN AND NORTHERN AFFAIRS CANADA
ABANDONED CLINTON CREEK
ASBESTOS MINE
1998 SITE RECONNAISSANCE**

APRIL, 1999

PREPARED BY
UMA ENGINEERING LTD.
ENGINEERS AND PLANNERS
1479 BUFFALO PLACE
WINNIPEG, MANITOBA
R3T 1L7

Reference: Abandoned Clinton Creek Asbestos Mine – 1998 Site Reconnaissance

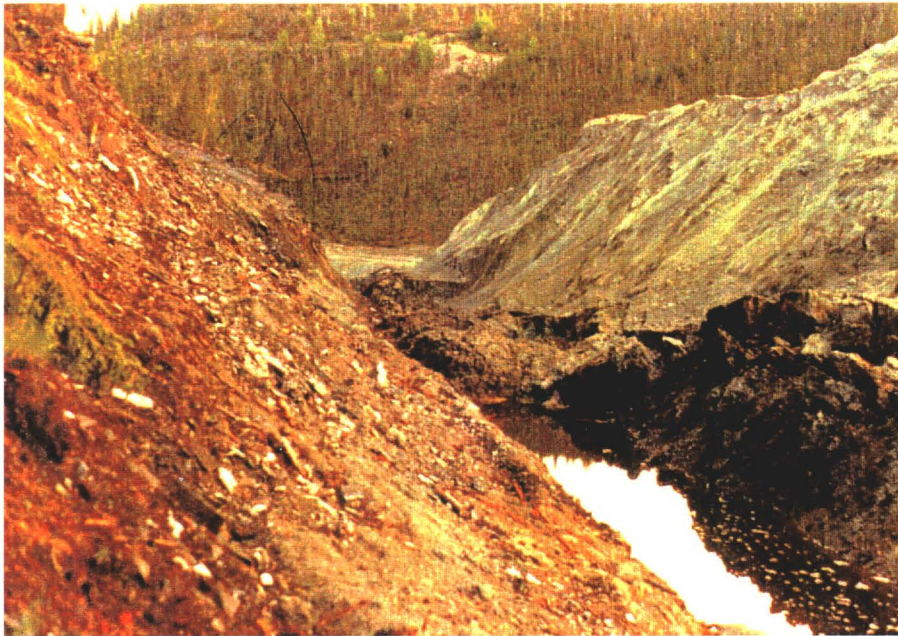
Following the 1974 failure, downslope movement of tailings continued resulting in occasional channel blockage as shown in Photos WC-06 (June 1976).

Photo WC-06: Channel Blockage (1976)

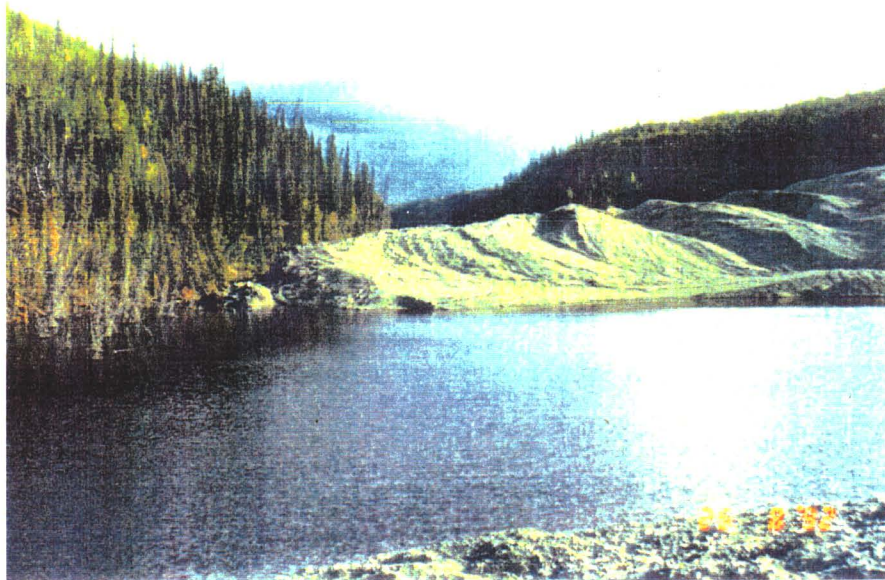
In 1978 a mid-slope portion of the south lobe was regraded (terraced) in an attempt to off-load this area and slow the advancement of the lobe (Drawing 04). The regraded area has since failed and evidence of the terraced slope is visible as inclined benches at the toe (Photo 18 Geo-Engineering, May 1993) and UMA Photos 3-6 and 5-11 in Appendix A.

Photo 18: Impoundment Upstream of South Lobe (1992)

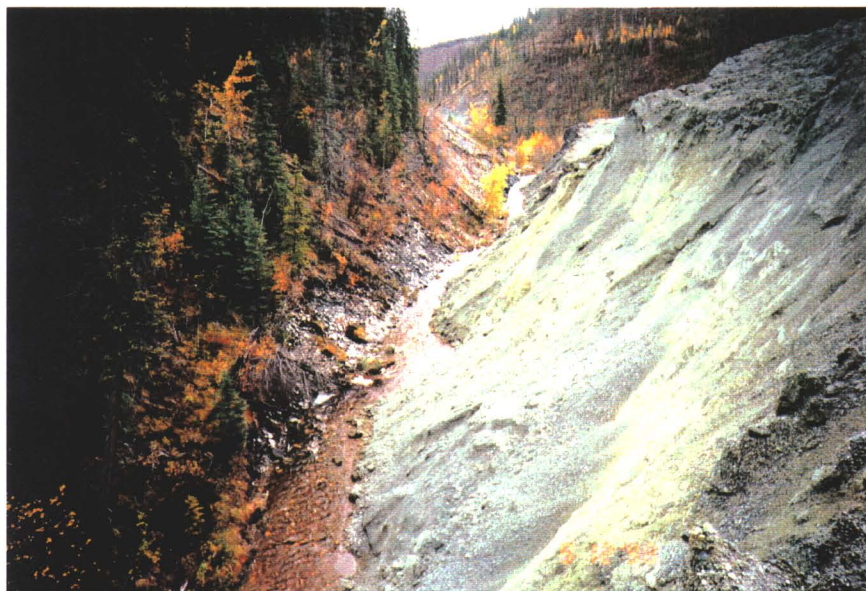
As the tailings continue to move down-slope, they are eroded and transported downstream. A comparison of the position of the leading edge of the tailings in Photo 12 taken in June, 1988 by Geo-Engineering with UMA Photo 5-20 indicates the gradual advancement of tailings into the creek channel.

UMA Photo 5-20: Toe of South Lobe in September (1998)

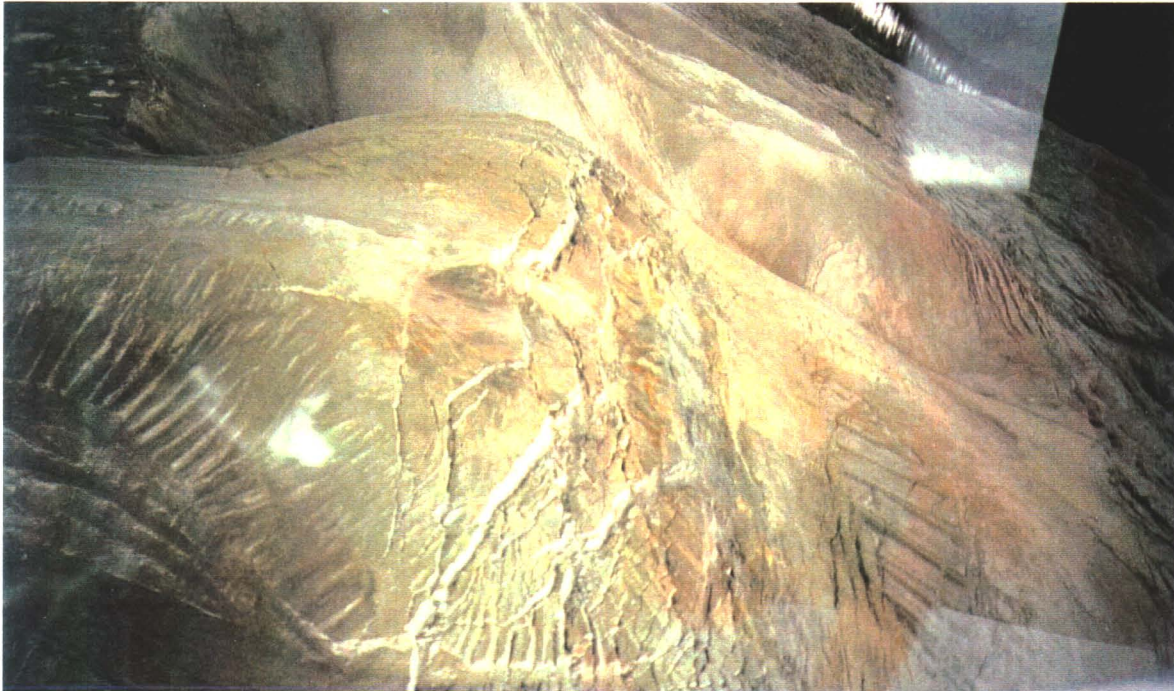
It is clearly evident that the south lobe remains active as evidenced by numerous tension cracks and slump blocks between the crest and toe (UMA Photo 3-13). Although the magnitude of this movement has not been confirmed since mine closure, it is anticipated that sufficient up-slope material exists to continue the advancement of tailings for an indefinite period of time.

UMA Photo 3-13: Tension cracking of Upper Slope (1998)

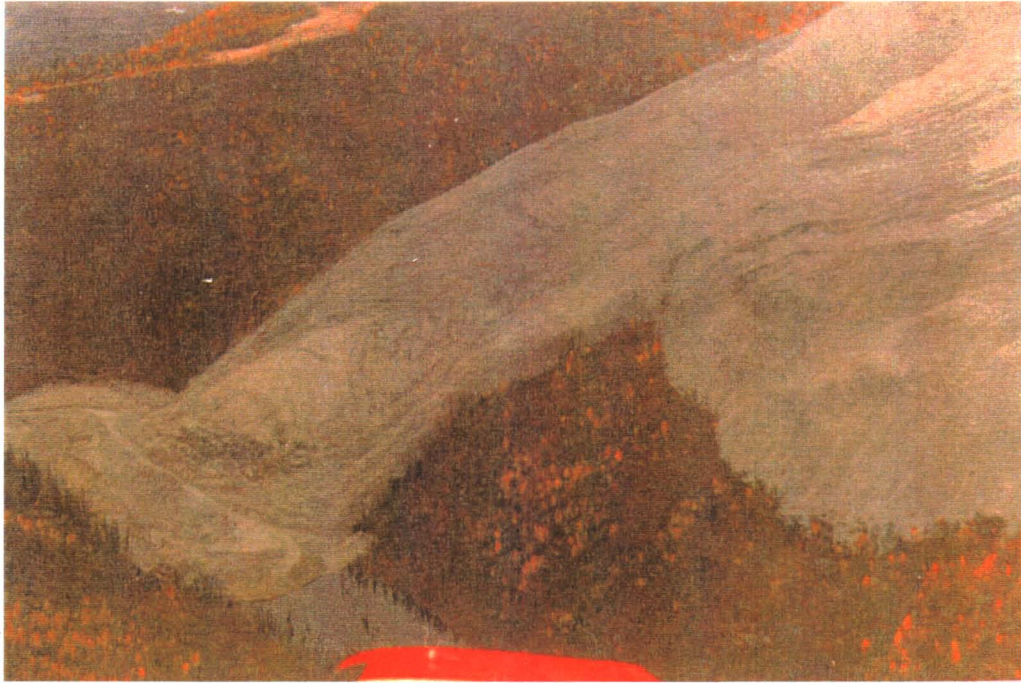
One of first aerial photographs of the unstable north lobe was taken in 1977 (Photo 1, R.M. Hardy and Assoc.). Downslope movement of the north lobe was not as sudden as that which occurred on the south lobe. However, the tailings gradually moved down-slope and within 10 years reached the pond created by the south lobe blockage (Photo 7, Klohn Leonoff, 1984).

Photo 1: Aerial View of Advancing Toe of North Lobe (1977)

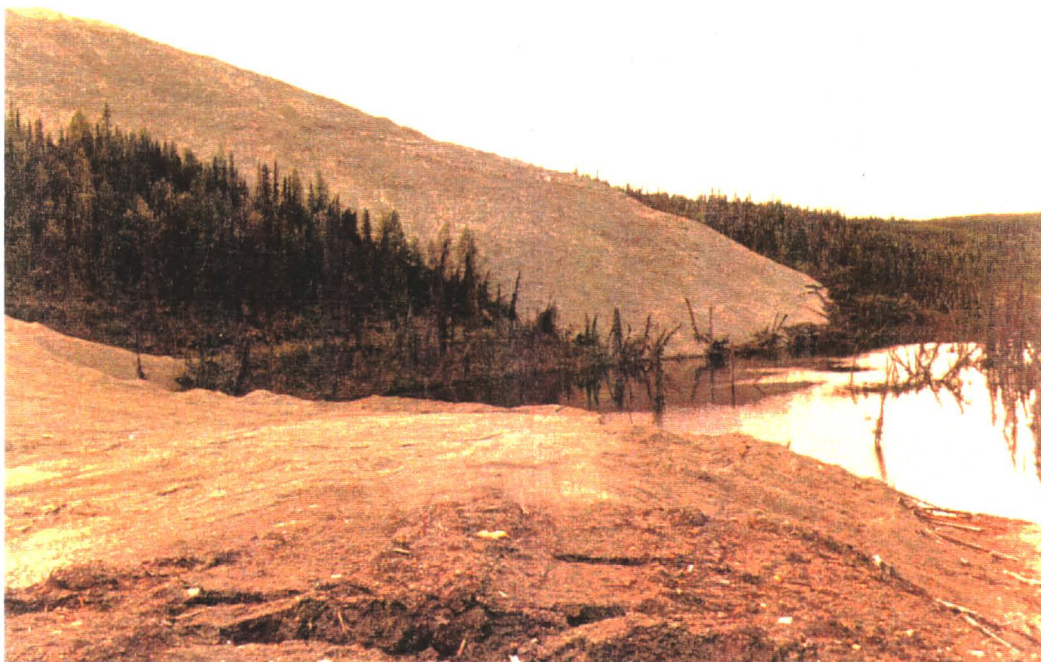
Photo 7: North Lobe at Edge of Pond (1984)

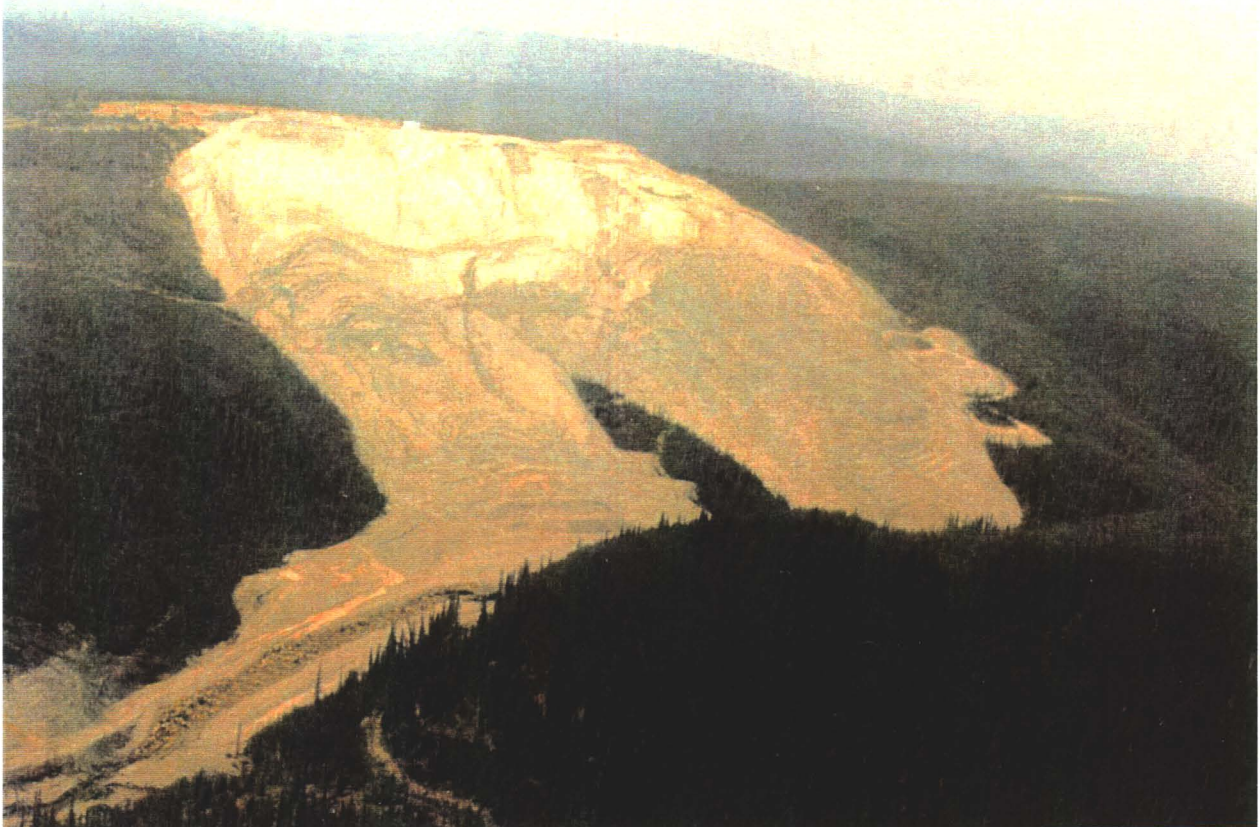
By July, 1986, the north lobe had nearly reached the east valley slope as shown on Photo 8 (Klohn Leonoff, September 1986). The lighter tailings areas in the upper portion of the tailings pile were relatively undisturbed in the photo. The darker areas in the mid and lower portion of the slope are indicative of heavily disturbed material as the north lobe advanced. These observations were verified with monitoring data in Hardy Associates (1978) Ltd.'s 1984 report that indicated upper-monitoring locations moved significantly less than mid and toe monitoring locations.

Photo 8: Failed North Lobe Near Valley Slope (1986)

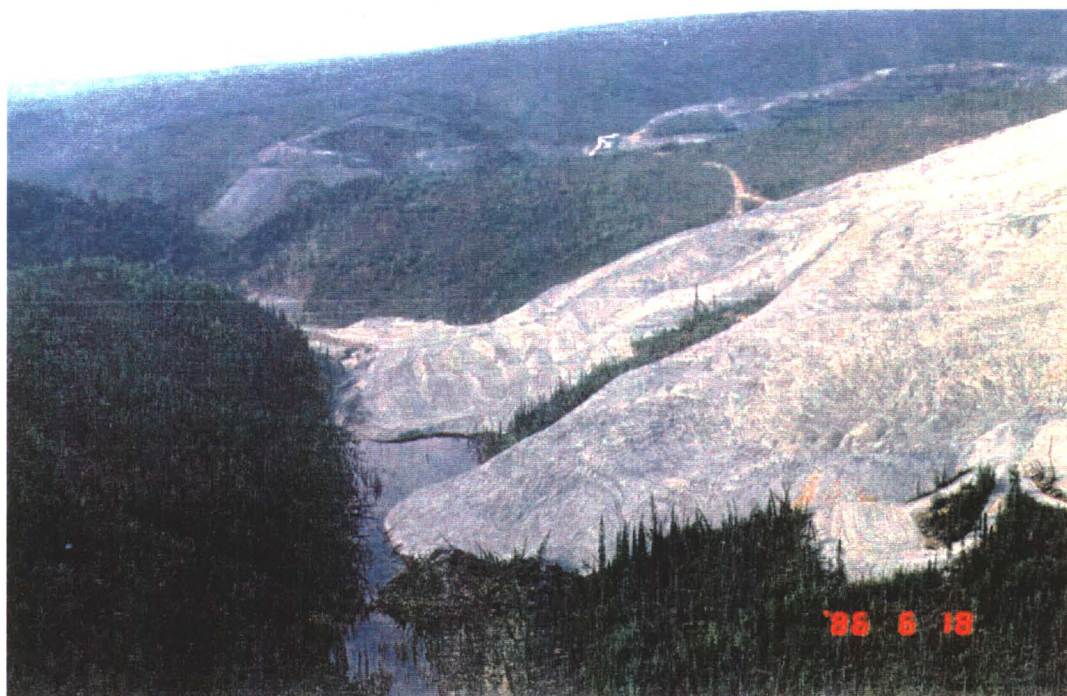
Photo 8: Toe of North Lobe Approaching Valley Slope (1986)

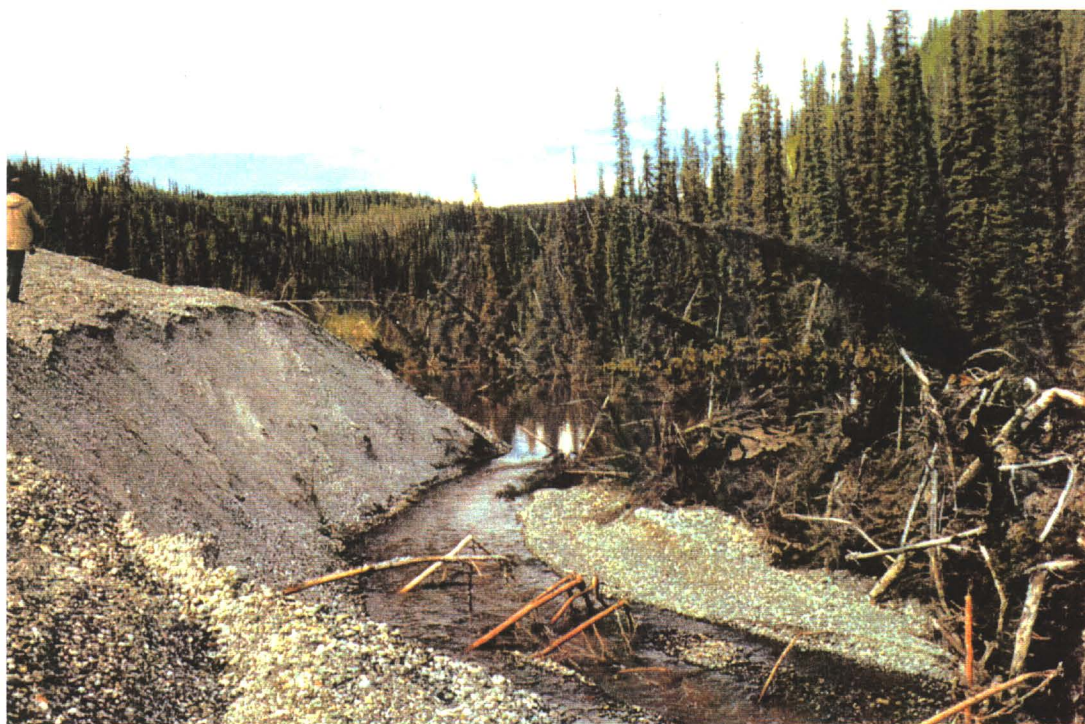
Significant heaving (up-thrusting) of the valley floor also occurred along the north side of the lobe resulting in a narrowing of the upstream section of the channel and the formation of an upstream pond (Photo 8, Geo-Engineering, November 1986). Continued advancement of the north lobe heaved the valley floor directly in the path of the lobe resulting in additional channel constriction as seen in Photo 19 (Geo-Engineering, November 1988) and UMA Photos 1-3, 5-9 in Appendix A.

Photo 19: Erosion of Toe of North Lobe and Heaved Valley Floor (1988)

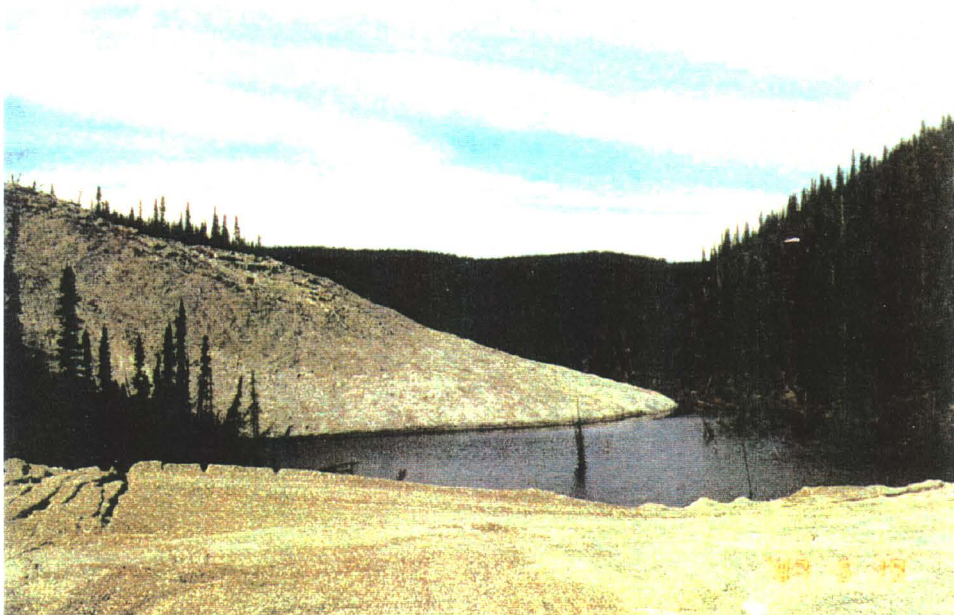
Recent photographs suggest the tailings are advancing faster than they are being eroded as evidenced by mounding near the toe. This can be seen in a comparison of Photo 17 (Geo-Engineering, 1988) with Photo 22 (Geo-Engineering, 1998) and UMA Photo 5-17 (Appendix A), taken 10 years later.

Photo 17: Toe of North Lobe (1988)

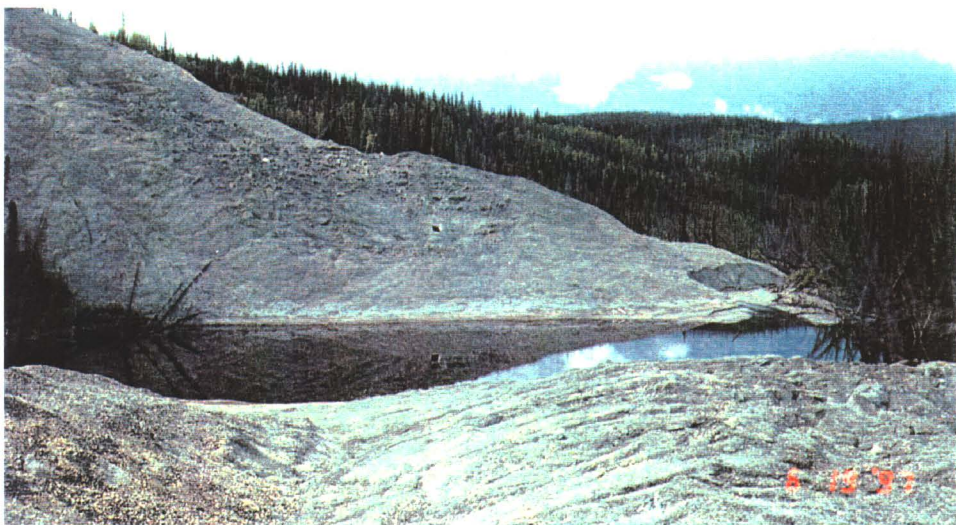
Photo 22: Toe of North Lobe (1998)

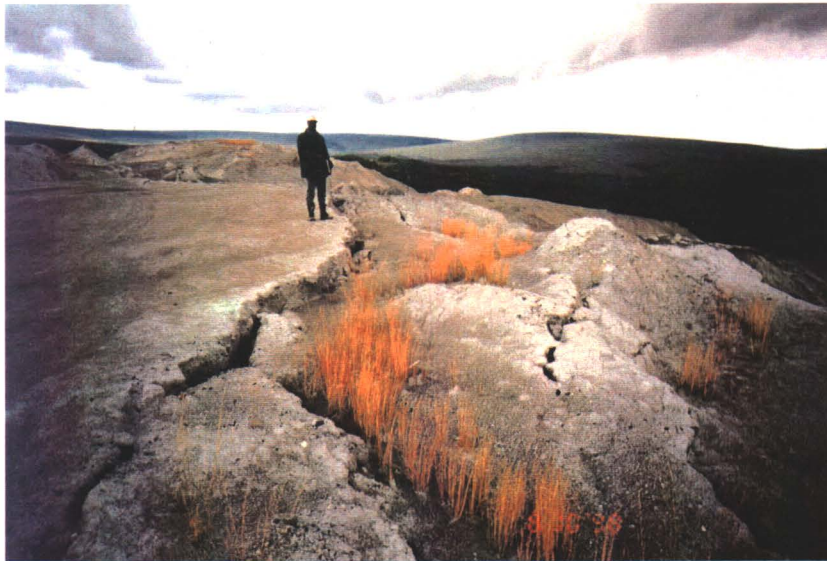
Continued erosion at the toe will undoubtedly trigger retrogressive failures and continued downslope movement. Recent tension cracks were observed in the mid and upper portions of the north lobe in 1998 confirming on-going movement (UMA Photos 1-6 and 1-5, 1-12 and 4-2 in Appendix A). Tension cracks and slumping are evident at and beyond the crest of the slope supporting the observations of continued movements (UMA Photo 1-15).

UMA Photo 1-6: Back Scarps at Crest of North Lobe (1998)

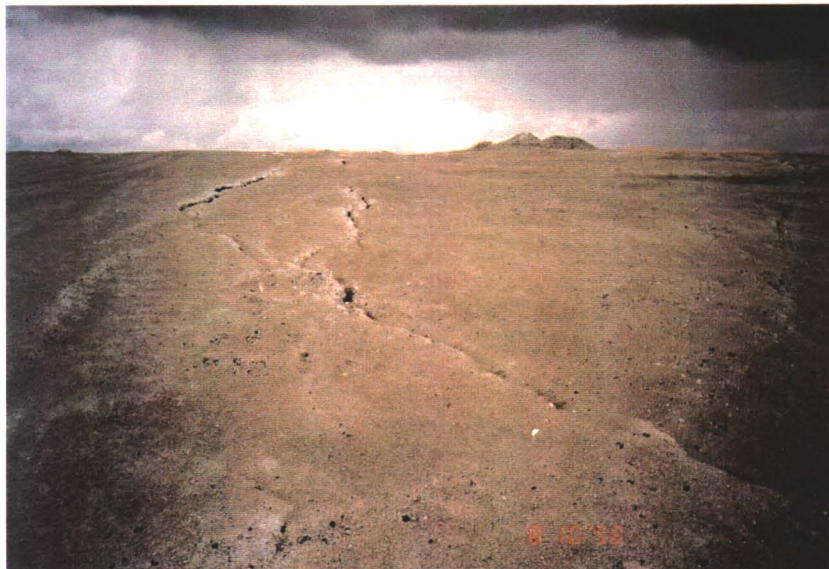
UMA Photo 1-15: Tension Cracks Upslope of North Lobe Crest

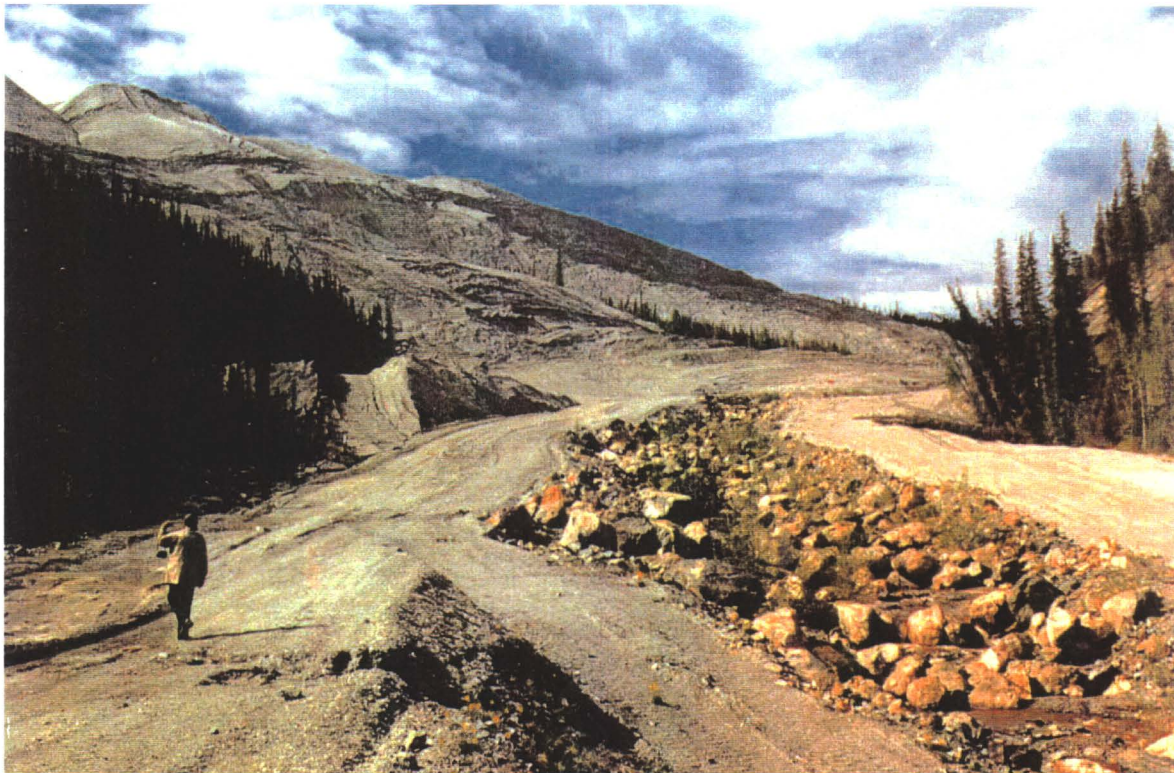
Between 1978 and 1981, channel improvements downstream of the south lobe were undertaken including a series of rock weirs as shown on Drawing 04 and Photos 22 (Geo-Engineering, November 1986) and 12 (Geo-Engineering, November 1988). These channel improvements have remained relatively intact since construction. The secondary channel between the downstream channel improvement and the east valley slope noted in Geo-Engineering's 1986 report was visible, but dry during our September 1998 reconnaissance.

Photo 22: Armoring of Wolverine Creek Channel Downstream of the South Lobe

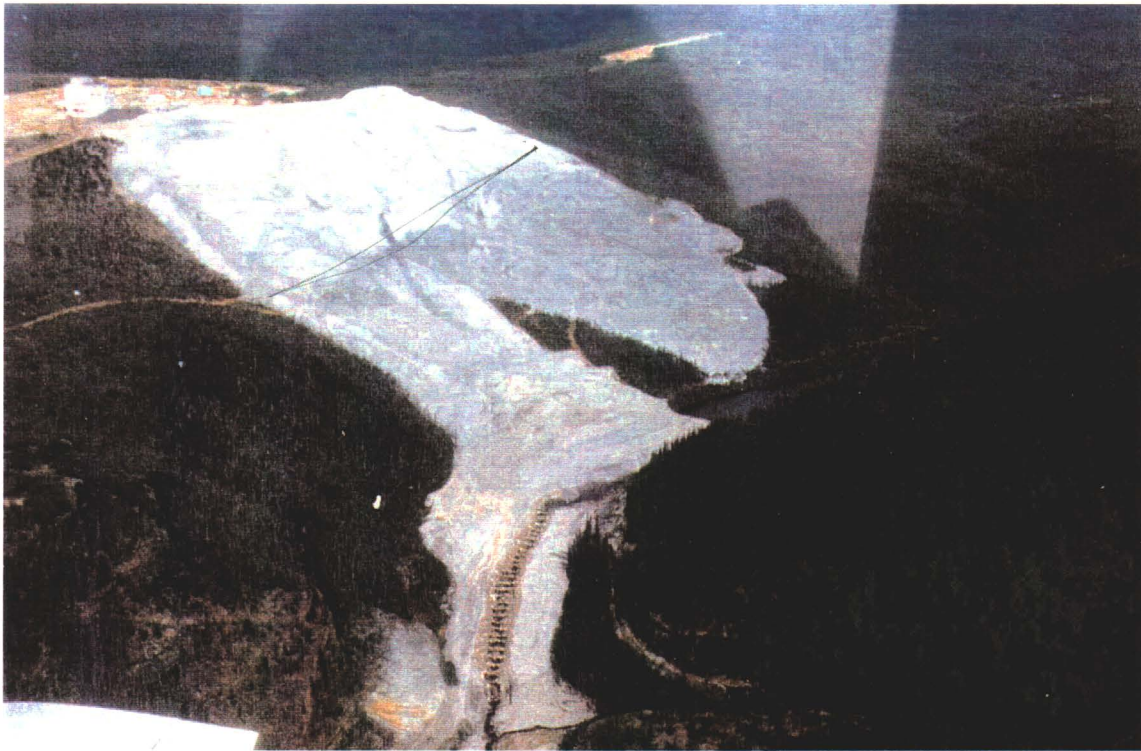
Photo 12: Weirs Downstream of South Lobe (1988)

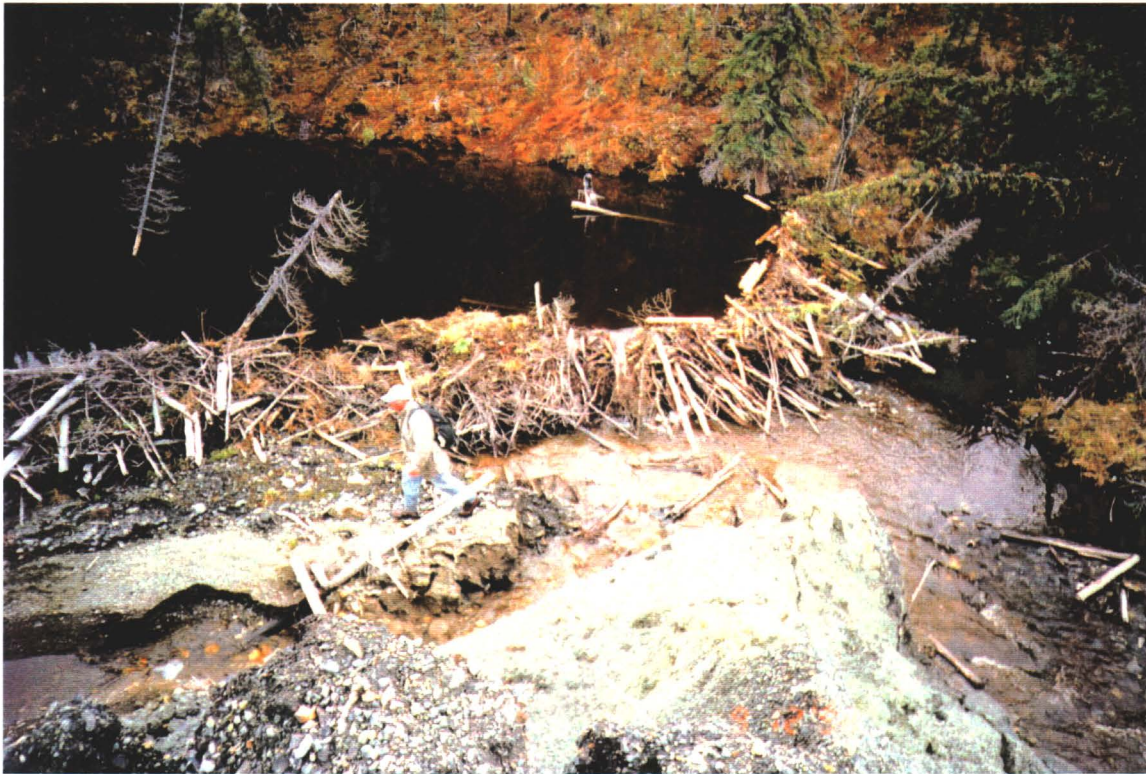
The second beaver dam, located between the upstream end of a small channel island and the toe of the north tailings lobe does not impound a significant amount of water. The third beaver dam is located at the upstream end of the south lobe as shown in UMA Photo 5-18

and is responsible for raising the water in the pond between the two tailings lobes by at least a metre.

UMA Photo 5-18: Beaver Dam 3 (1998)

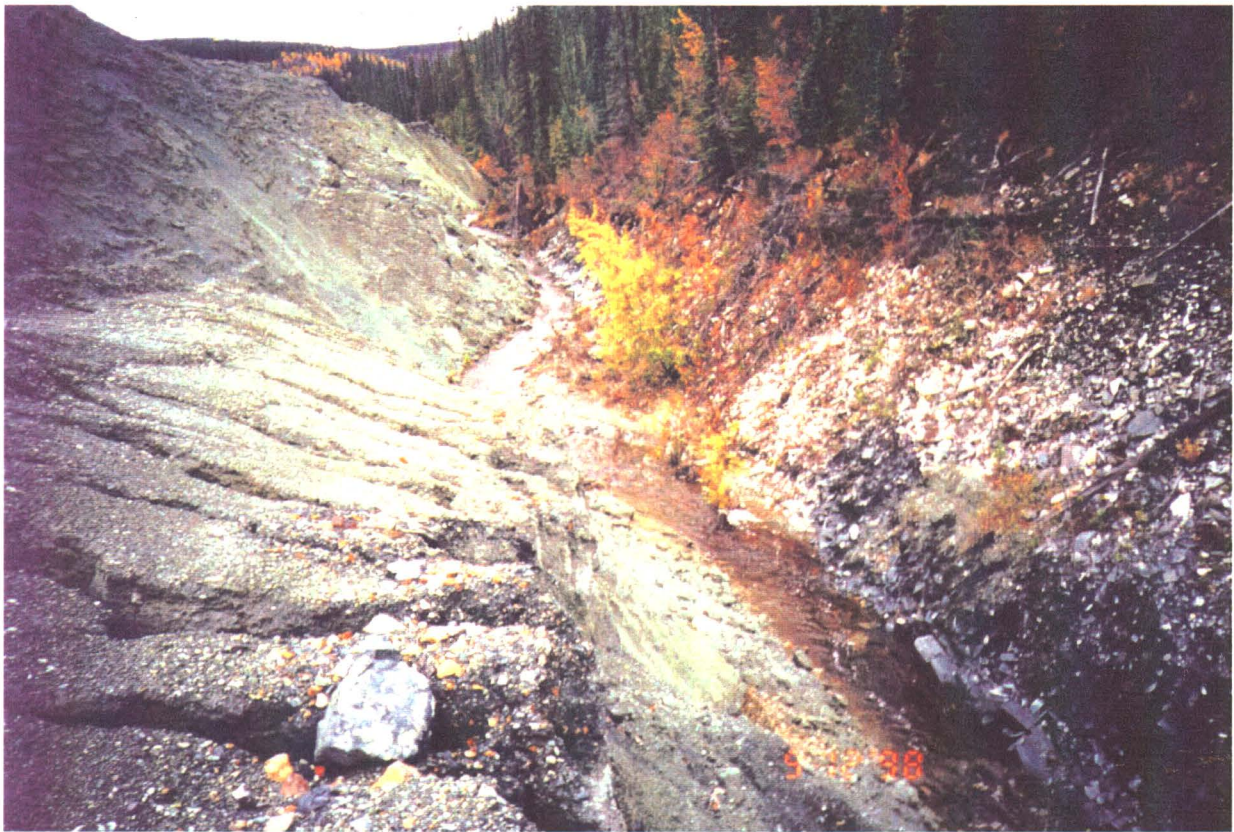
The four beaver dams have significantly reduced channel velocities and erosion of the channel where the tailings piles meet the valley slope. Downstream of beaver dam No. 4 however, velocities increase significantly as the channel narrows and the channel slope steepens. Between the beaver dam and the rock weirs, the channel has down-cut into the underlying weathered argillite bedrock resulting in surficial slumping of the overburden soils (UMA Photos 5-23 and 5-21, 6-1 and 6-2 in Appendix A). Downstream of the south lobe, flow appears to be contained within the original modified channel with no significant erosion or down-cutting observed.

UMA Photo 5-23:
View Upstream of South Lobe Toe and East Valley Slope
