## Environmental Assessment, Casino Mine/Camp, Yukon Region – Final Report

*(Call Up No. 98-6195-04)*

**Environmental Assessment, Casino Mine/Camp –  
Yukon Region**  
**MDA Project no. 99-09-04**

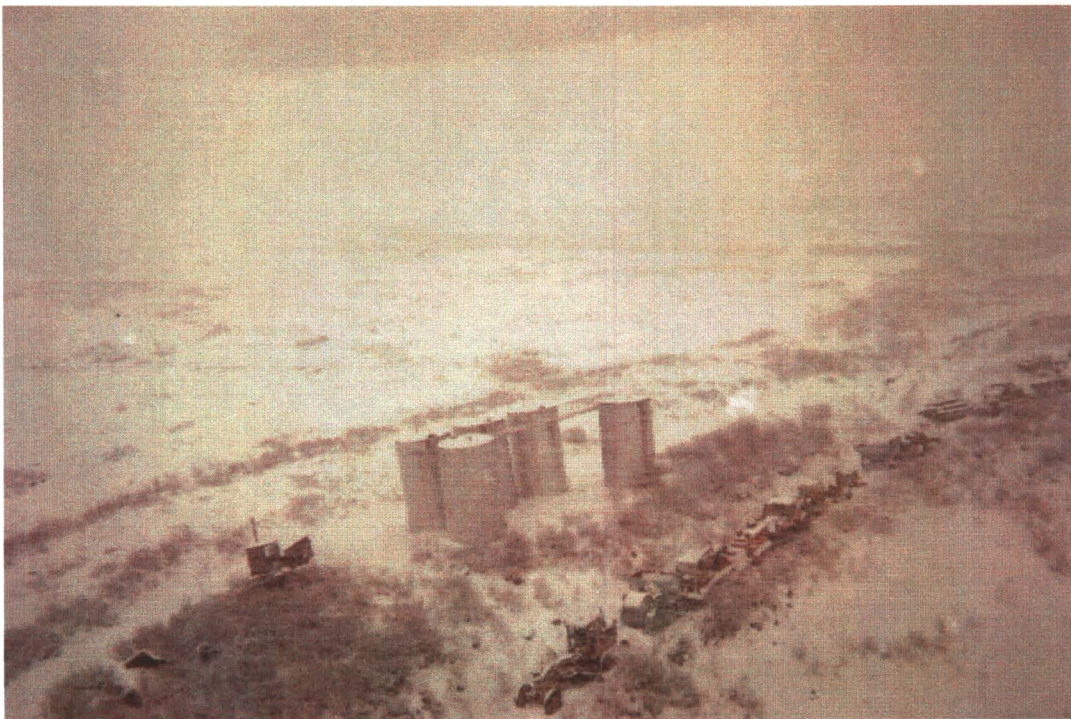
*Photograph 1: Aerial overview of the tank farm and equipment storage area of the placer mining site on the headwaters of Canadian Creek at Casino mine/camp site. The quality of the photograph is limited by the heavy snow falling at the time of the visit.*

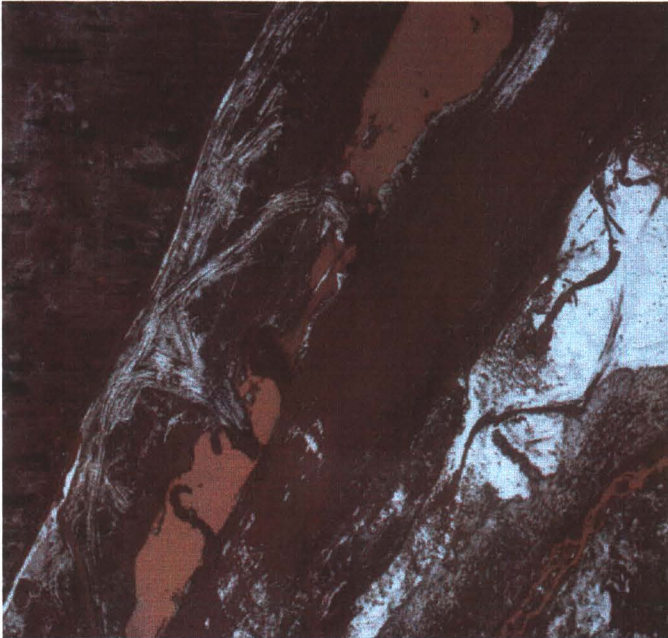
*Photograph 2: Aerial view of active placer mining operation on Canadian Creek, downstream of Casino site and above confluence with Britannia Creek*

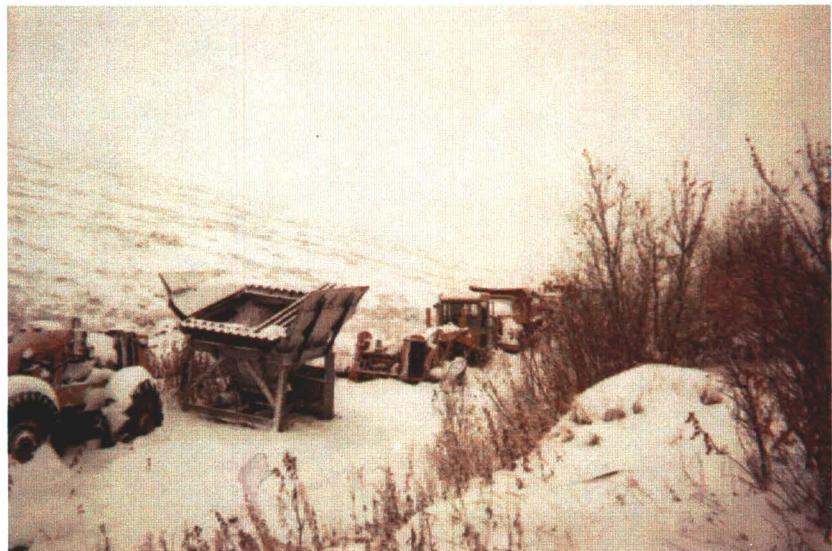
*Photograph 3: View of tank farm area and construction equipment stored on roadway in front of the tanks*

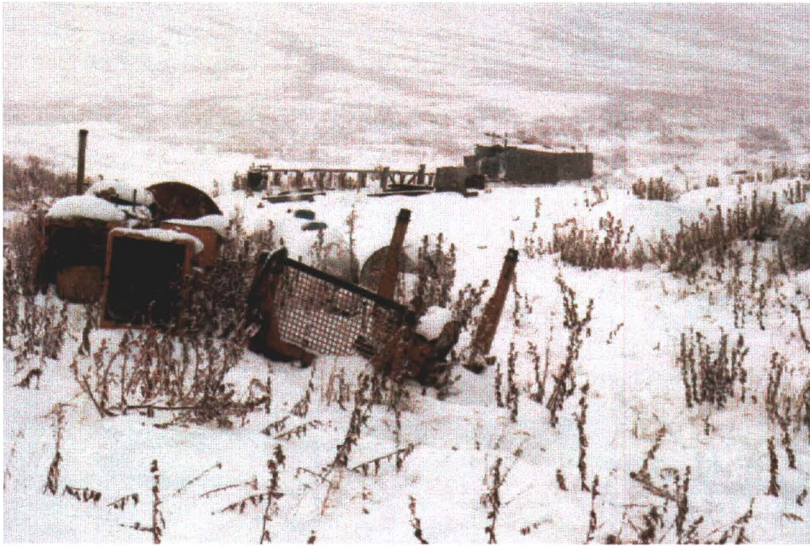
*Photograph 4: View toward maintenance shed with disassembled dozers in foreground and conveyor in the middle ground*

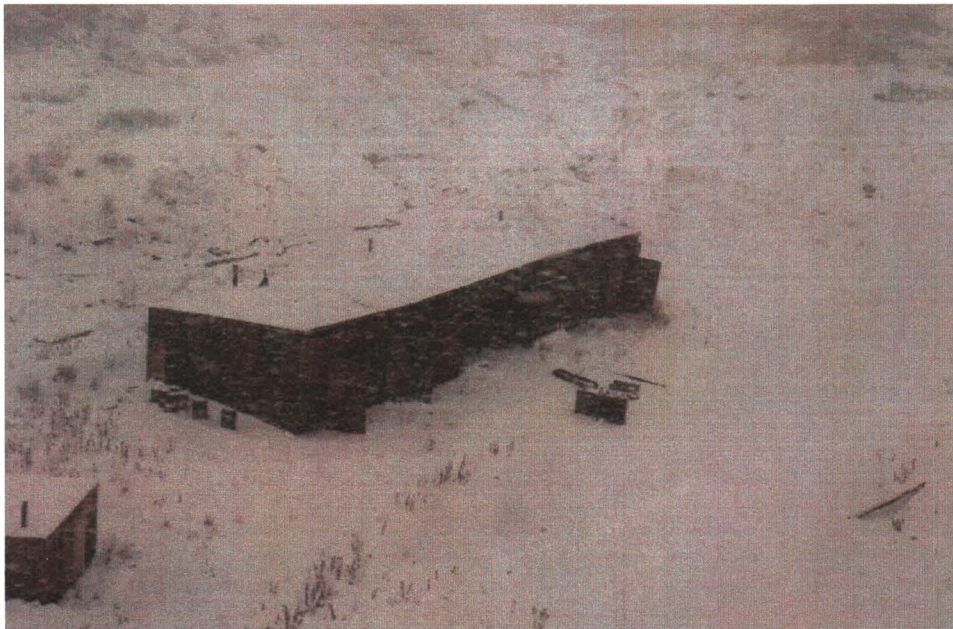
*Photograph 5: Frame maintenance shed with drums and transformers located at the "near" end of this shed and small cabin (to the left)*

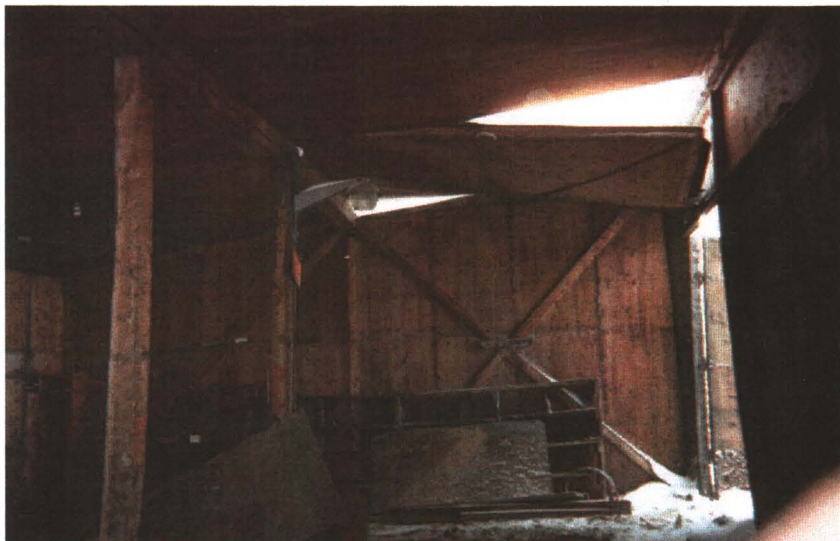
maintenance shed is starting to deteriorate and a section of the roof (see Photograph 6) is precariously perched and could be in danger of collapse as the weight of snow increases. The smaller building (to the left) is a cabin, which appears to be used periodically by transient personnel. The latter building is old but still in reasonably good condition, although the interior is untidy.

*Photograph 6: Section of roof on maintenance shed that is in danger of collapse as weight of snow increases*

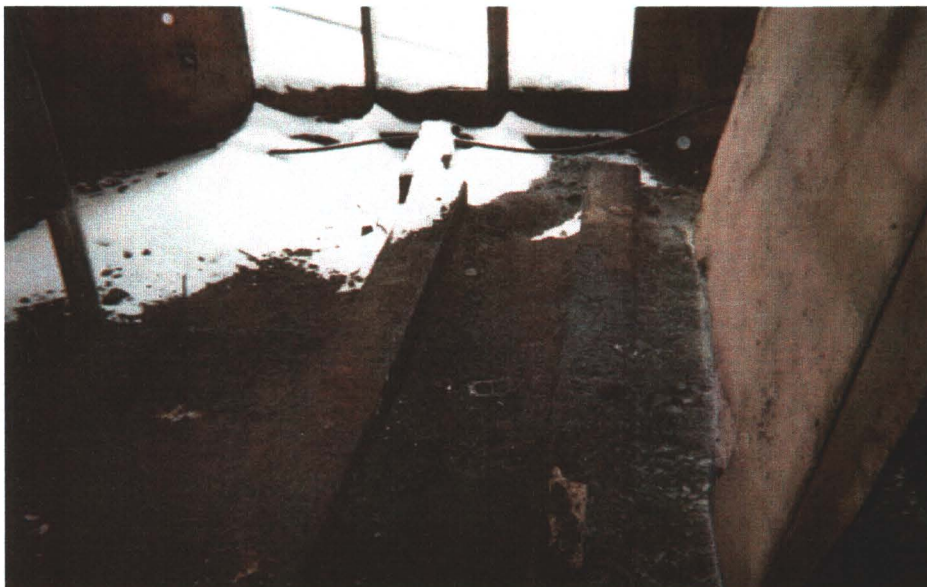
*Photograph 8:  
Stained soil on  
floor of generator  
part of  
maintenance shed  
(Site 2 sample)*

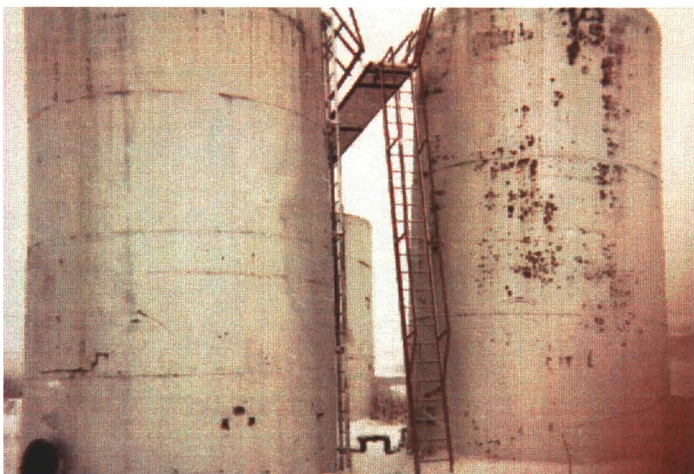
*Photograph 9: Three vertical storage tanks on tank farm showing open manhole cover.*

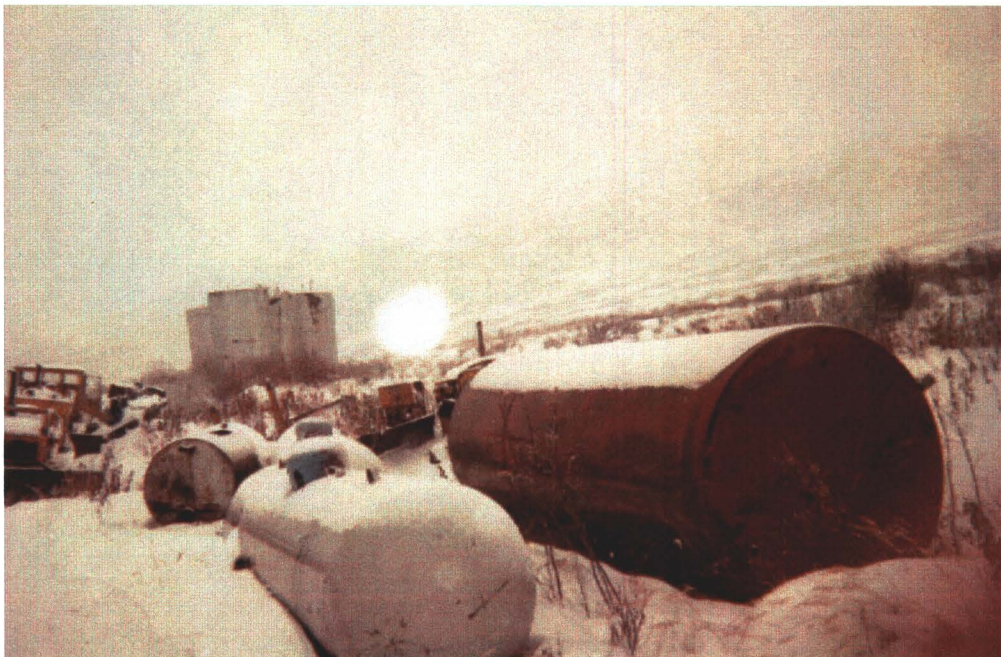
*Photograph 10: Two smaller empty horizontal steel tanks and propane tank containing propane*

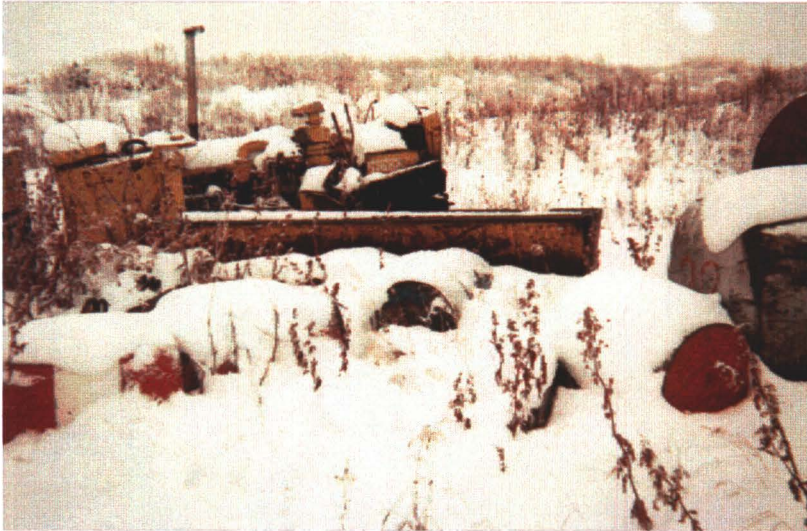
Photograph 11 shows four drums. These are located just behind the large, empty, horizontal fuel tanks shown in the previous photograph. Three of these drums were empty but one was unlabelled but full of an unknown liquid. This drum was secure and apparently not leaking.

*Photograph 11: Drums, all empty but one, located in same area as tanks*

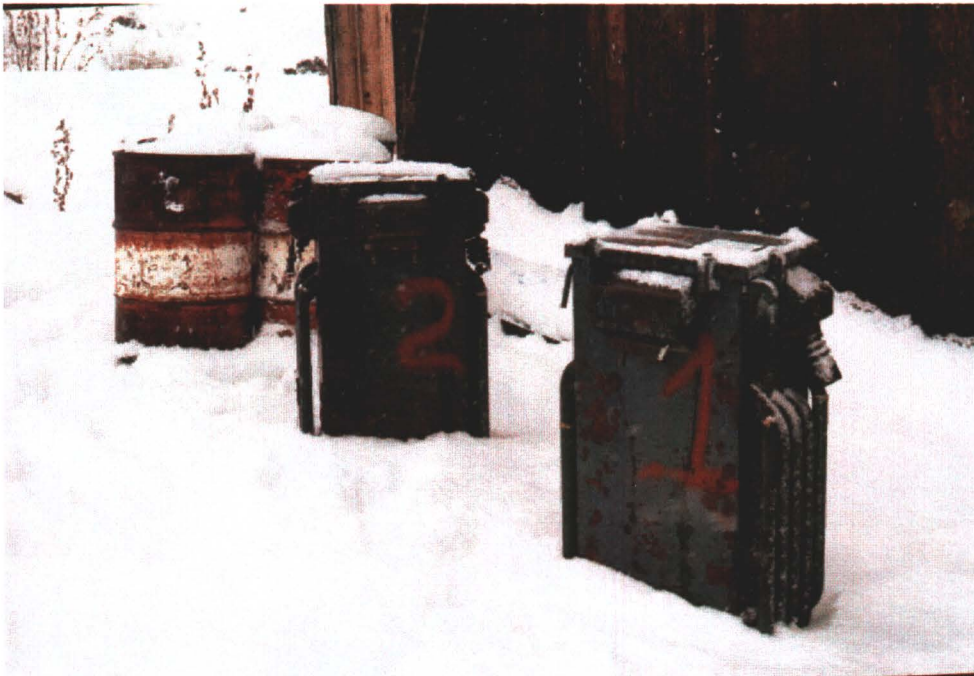
*Photograph 12: Five drums located adjacent to generator section of maintenance shed – one contained gas, two contained waste oil and two were empty plus two transformers*

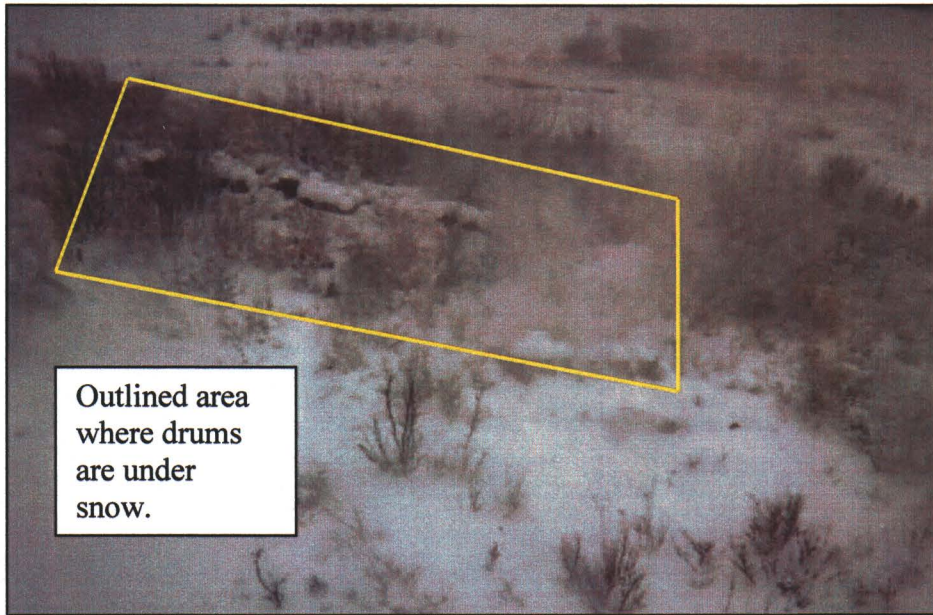
**Photograph 13:**  
*Debris located  
on the west side  
of Canadian  
Creek, across  
from the  
maintenance  
shed*

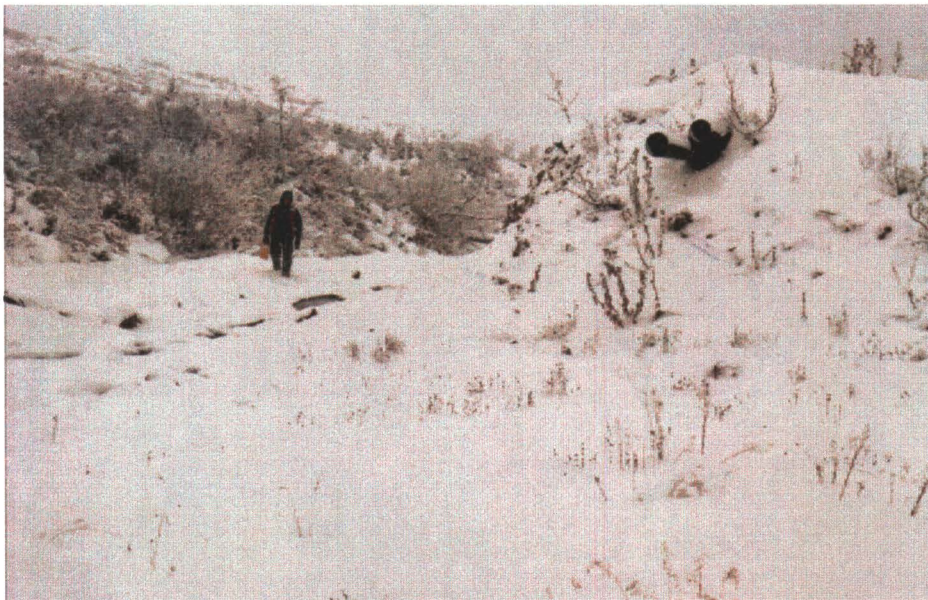
**Photograph 14:**  
*Steel decant  
pipes in  
constructed  
ponds along the  
water course*

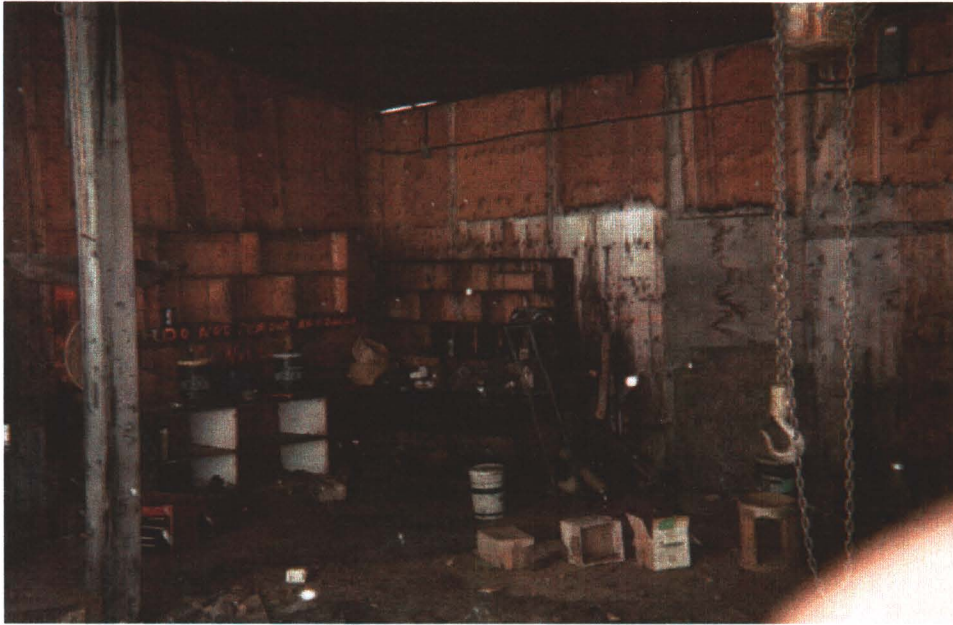
*Photograph 15:  
Assorted debris  
in the  
maintenance  
shed including  
partially full  
pails of  
lubricants*

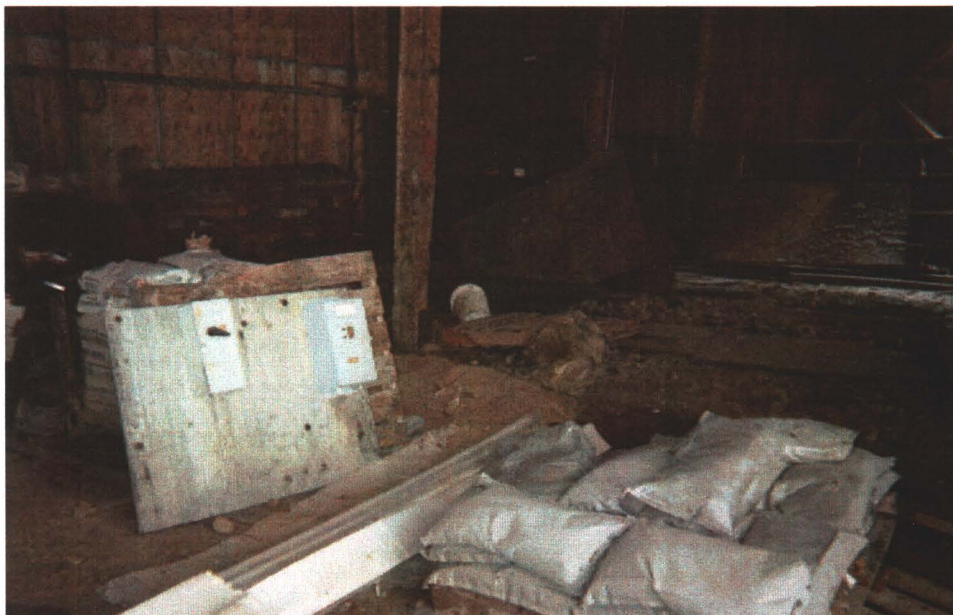
*Photograph 16:  
Bags of silica  
sand stored in  
maintenance  
building*

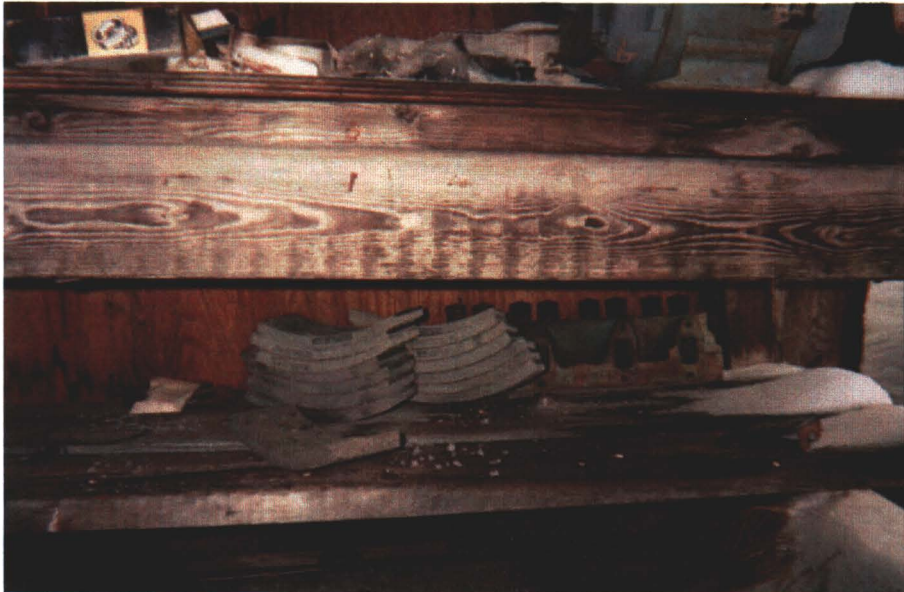
*Photograph 17:  
Asbestos brake pads  
stored in  
maintenance  
building.*

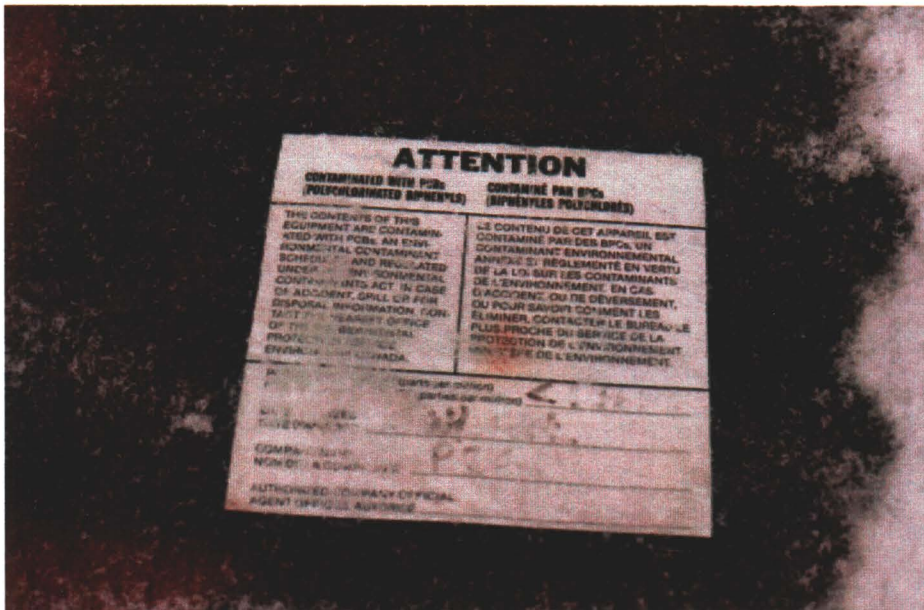
A total of three (3) transformers were located at the site. Two, shown in Photograph 12, are sitting outside of the maintenance/generator shed. Both of these transformers were placarded as having less than 1 ppm of PCBs (see Photograph 18). The third was just inside of maintenance shed, near the generator part of the building (Photograph 19). This transformer had a patent date of 1905 and appeared to be a sealed, cast iron unit. It is likely that this transformer precedes the use of PCBs but this should be confirmed.

*Photograph 18:  
Placard on two  
transformers  
stating that PCBs  
have been tested  
and are less than  
1 ppm*

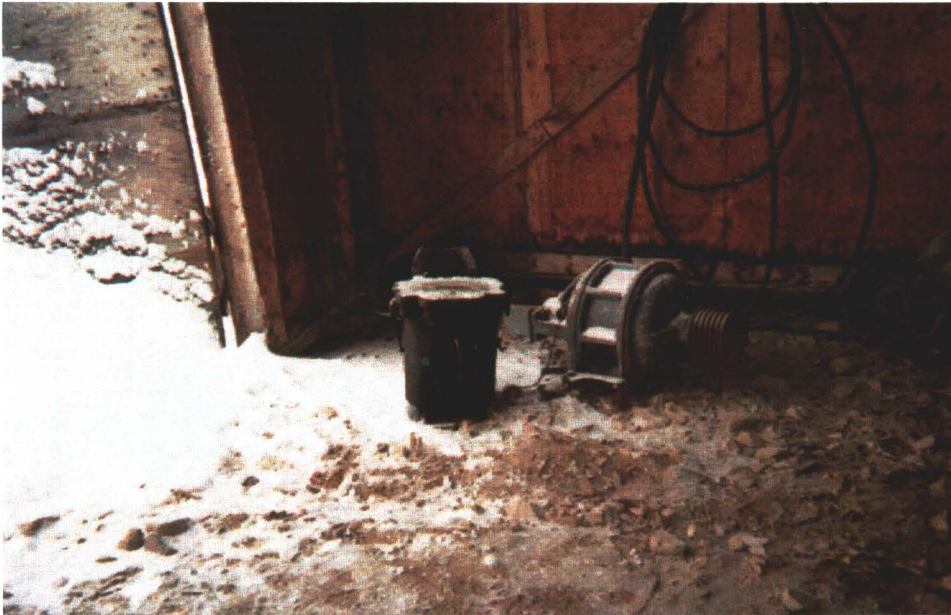
*Photograph 19:  
Old cast iron  
case  
transformer  
inside  
maintenance  
shed*

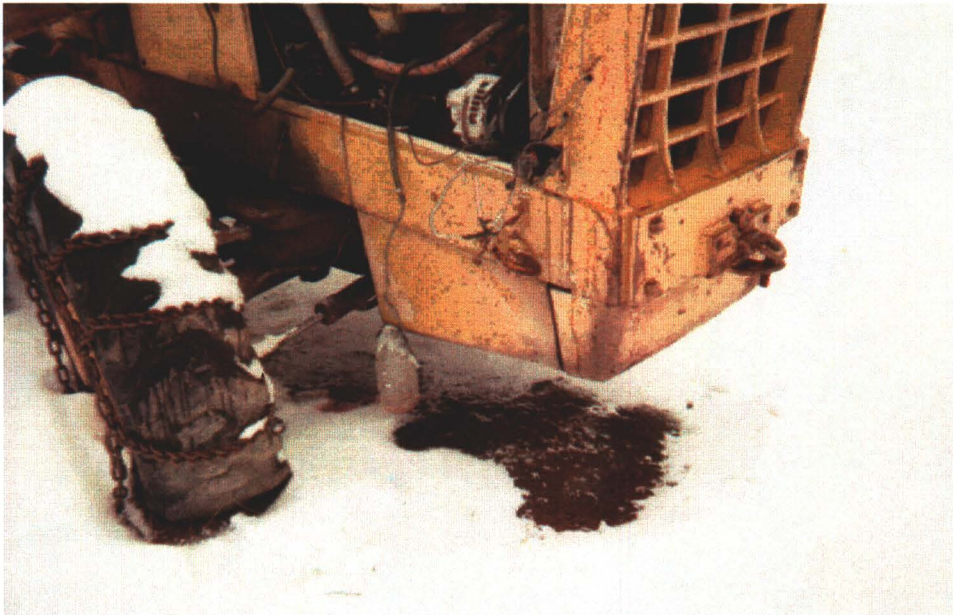
The only equipment at the airstrip at the Casino site was an older rubber tired loader shown in Photograph 20. This equipment is leaking oil and will be considered further in Section 4.4.3.

*Photograph 20:  
Rubber tired  
loader at  
airstrip showing  
oil stained soil*

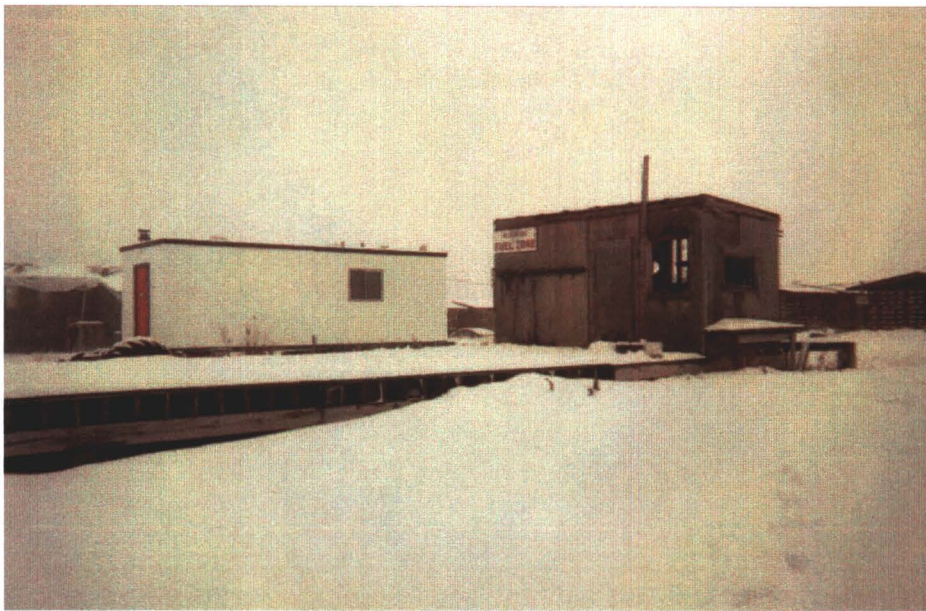
**Photograph 22:**  
*View of  
explosives/fuel  
shed and attached  
ramp with metal  
clad laboratory  
trailer in  
background*

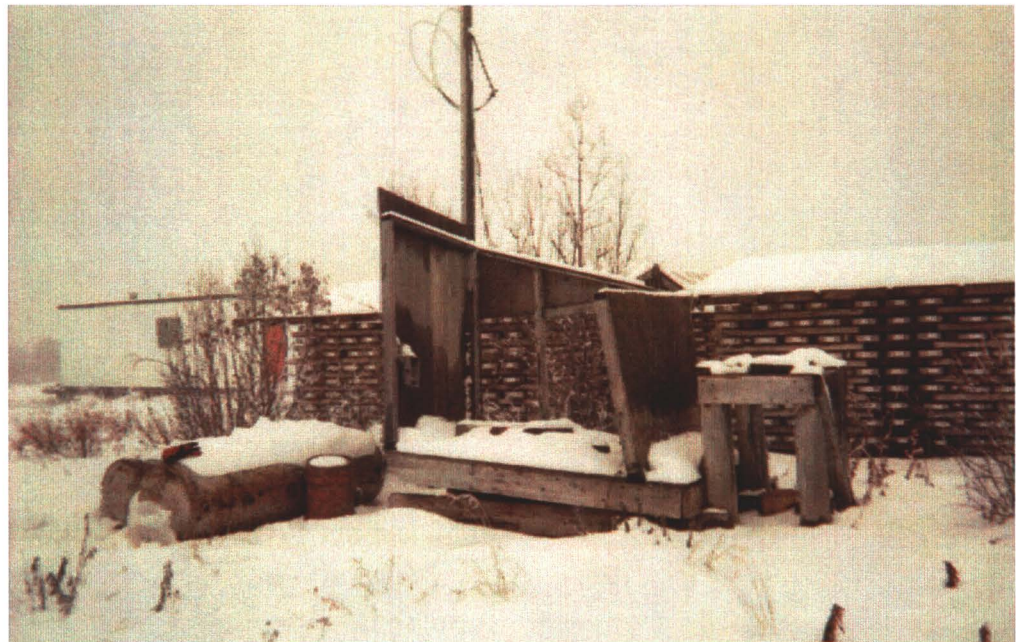
**Photograph 23:**  
*Collapsed shed  
presumably used  
for refueling or  
storage of related  
products.*

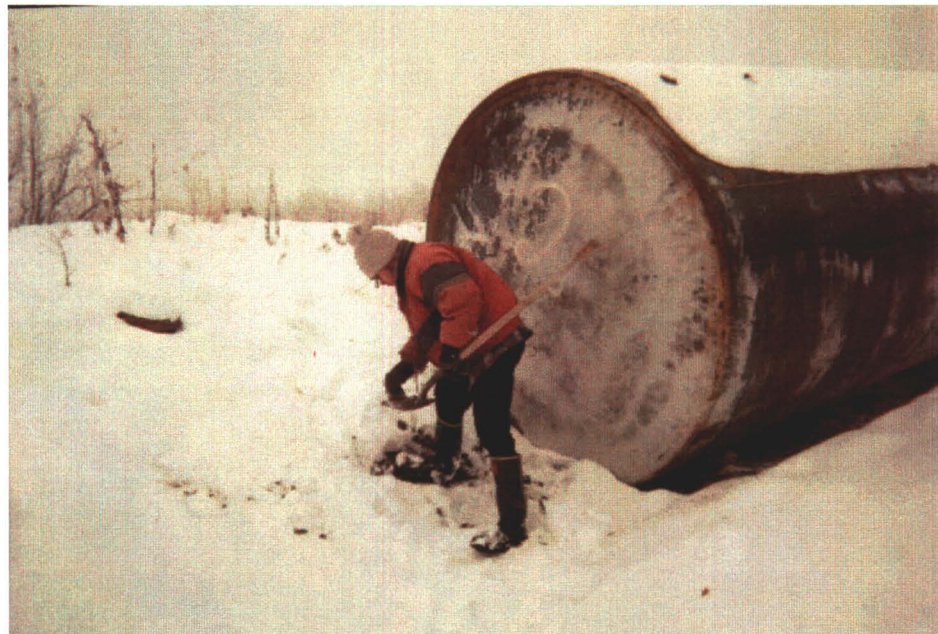
Soil in the vicinity of the Tanks 2 and 3 within the bermed fuel storage area were sampled for hydrocarbon contamination (Photographs 27 and 28). Soil in the vicinity of a third tank (referred to here as PSC and shown in Photograph 29) was also sampled. These sampling locations were chosen near the drains to the tanks; however, the snow cover precluded further definition of the area of the stained soil. The area of these stained soils could be extensive and other areas could exist which were not obvious at the time of the site visit. Areas for further investigation should include the refueling shed and the other storage tanks.

*Photograph 27:  
Soil sampling at  
fuel tank # 2  
showing earthen  
berm in  
background*

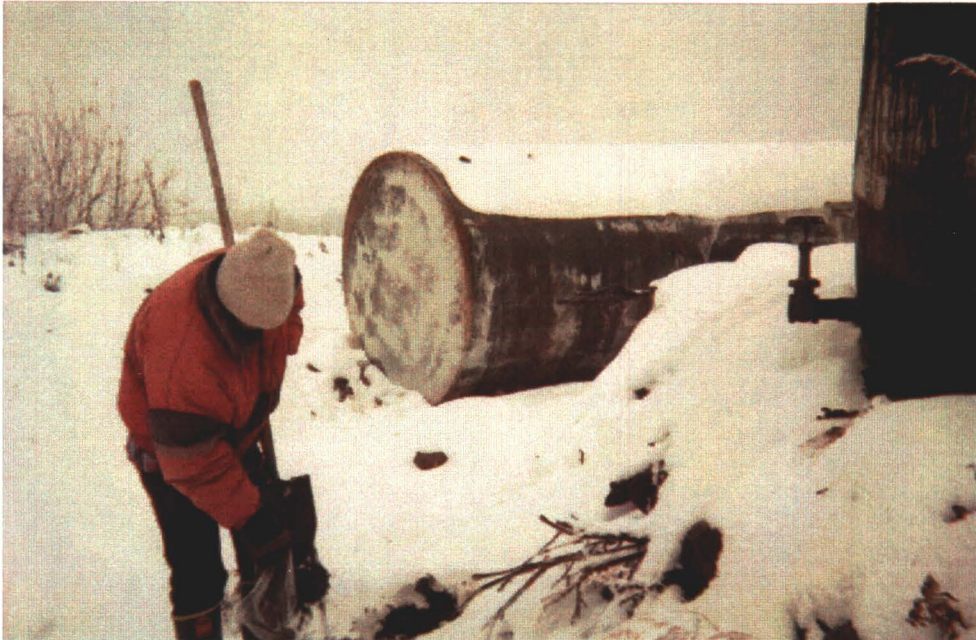
*Photograph 28: Soil sampling at fuel tank # 1 showing berm and tank # 2 in background*

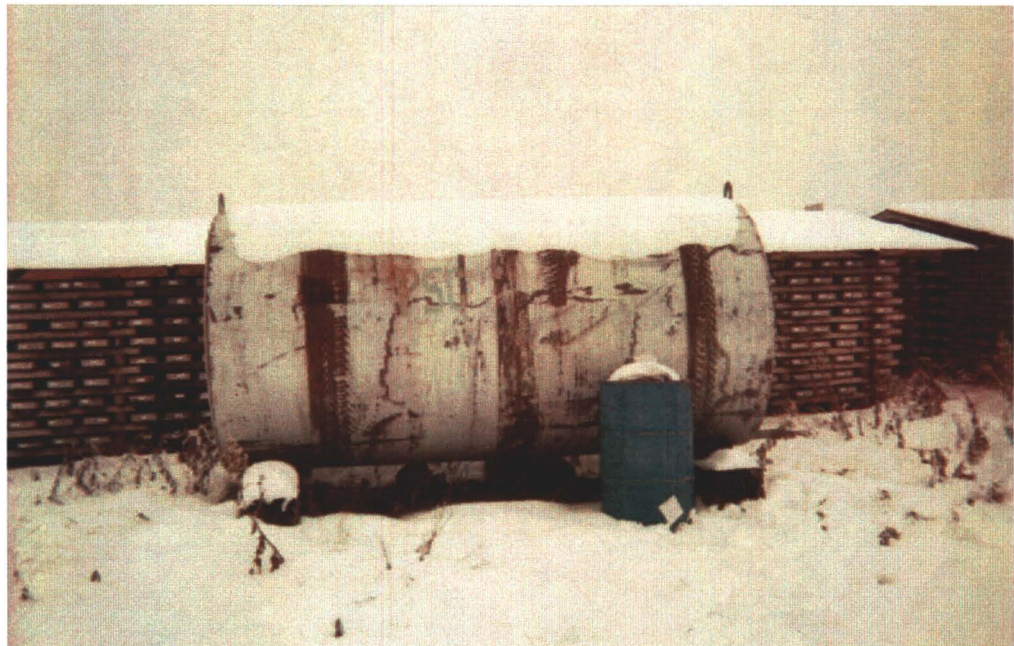
*Photograph 29: "PSC" fuel storage tank outside of bermed area*

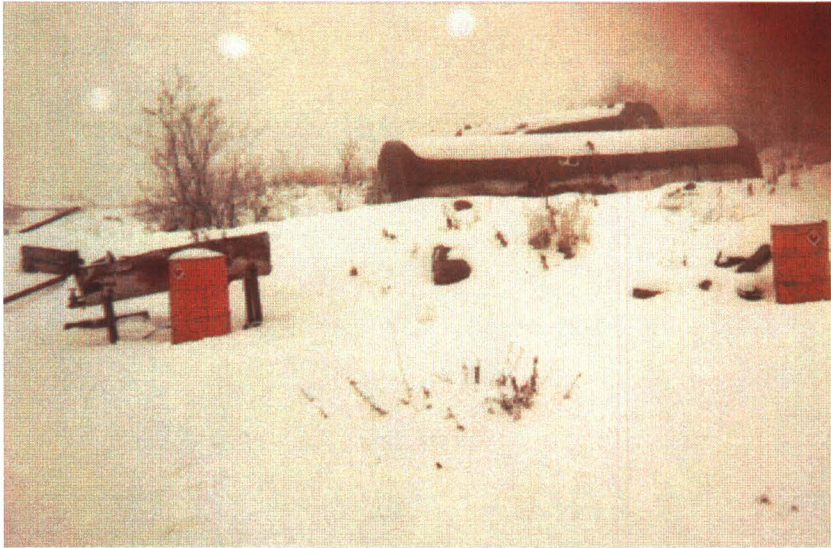
*Photograph 30: Two of a total of 6 Avgas drums found at the airstrip with two large fuel tanks inside of earthen berm in background*
