ABANDONED CLINTON CREEK ASBESTOS MINE

RISK ASSESSMENT REPORT

APRIL, 2000

UMA JOB NO. 41 01 4440 038 01 02

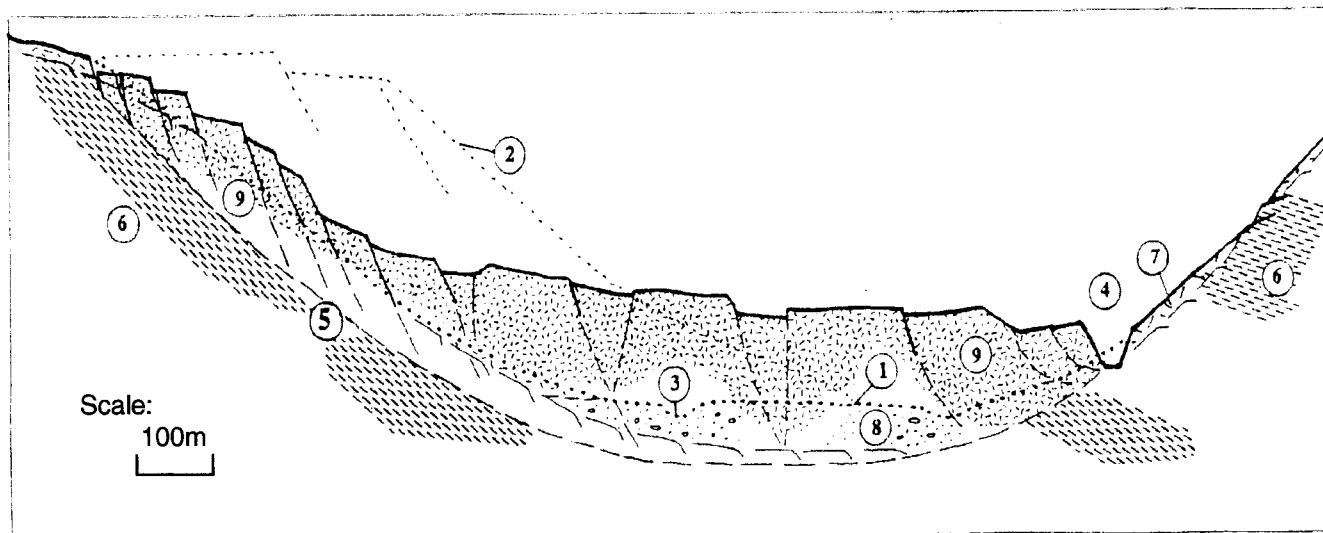
Figure 2-2
Waste Rock Slide
Looking Upstream

A significant slope failure of the waste rock dump into the Clinton Creek valley occurred in 1974 (Figure 2-2). The resulting landslide dam blocked natural drainage through the valley creating a 74 ha lake (Hudgeon Lake) as shown in Photo 2 (Klohn, 1986). A new creek channel (UMA Photo 7-17) was subsequently formed along the interface between the landslide material and north valley slope, some 25 metres above the original valley bottom at the Hudgeon Lake outlet. Within the area now occupied by the waste rock dump, the creek channel is approximately 700 m long with a gradient ranging from 3 to 5.5 percent compared to its natural gradient of approximately 0.075 percent.

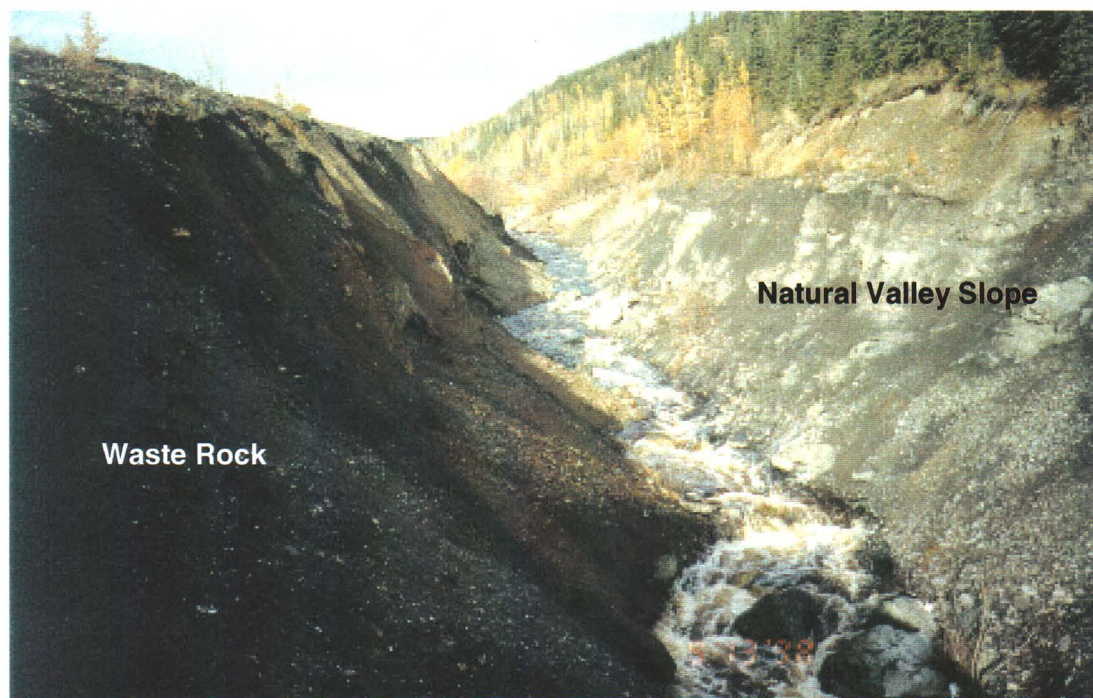
UMA Photo 7-17
Clinton Creek Channel Downstream of Hudgeon Lake Outlet

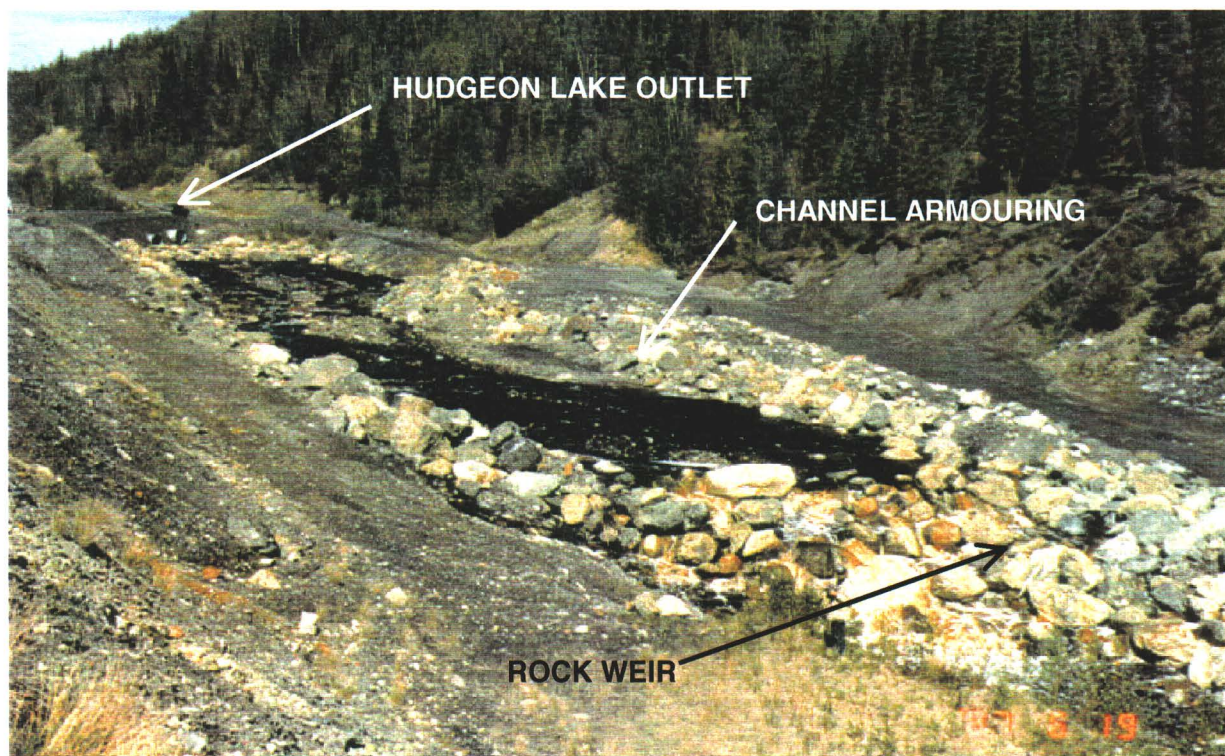
Photo 5
Rock Weir and Channel Armouring

Channel erosion protection measures were constructed between 1979 and 1984, including a rock weir and channel armouring just downstream of the Hudgeon Lake outlet (Photo 5, Geo Eng., 1987). These erosion control works have since proven to be largely unsuccessful and were almost completely destroyed in the spring of 1997. Since that time, significant erosion of the channel, in particular, down-cutting near the Hudgeon Lake outlet has occurred (UMA photo 8-13). The extent of the downcutting is evident when comparing the channel profile in 1999 with the profiles generated in 1983, 1984 and 1986 (Drawing 04). Up to 2 to 3 metres of incising has occurred immediately downstream of the outlet where the channel bed is bounded to the south by waste rock and to the north by natural colluvial soils overlying bedrock on the valley slope. Farther downstream, less down-cutting is evident, likely because of the less erodible exposed bedrock bounding the channel at lower elevations and/or downstream sediment transportation and deposition.

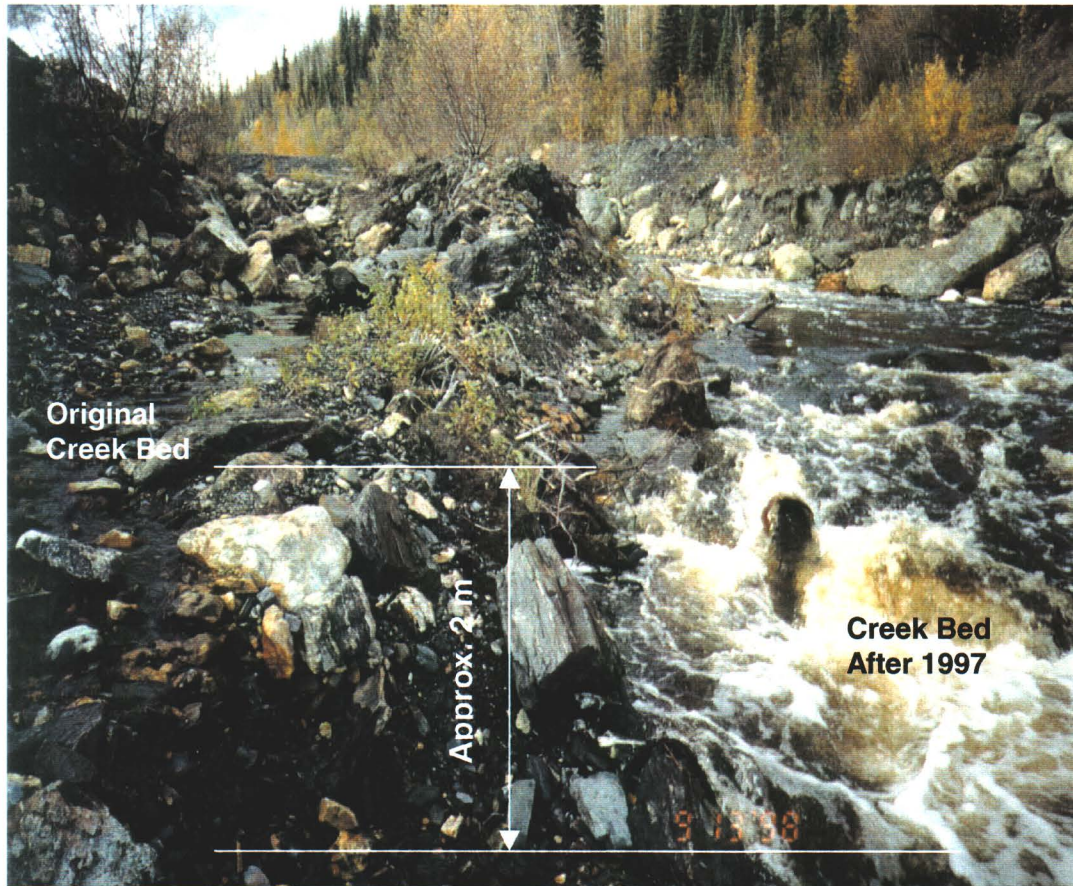
UMA Photo 8-13
Channel Down-cutting Immediately Downstream of Hudgeon Lake Outlet

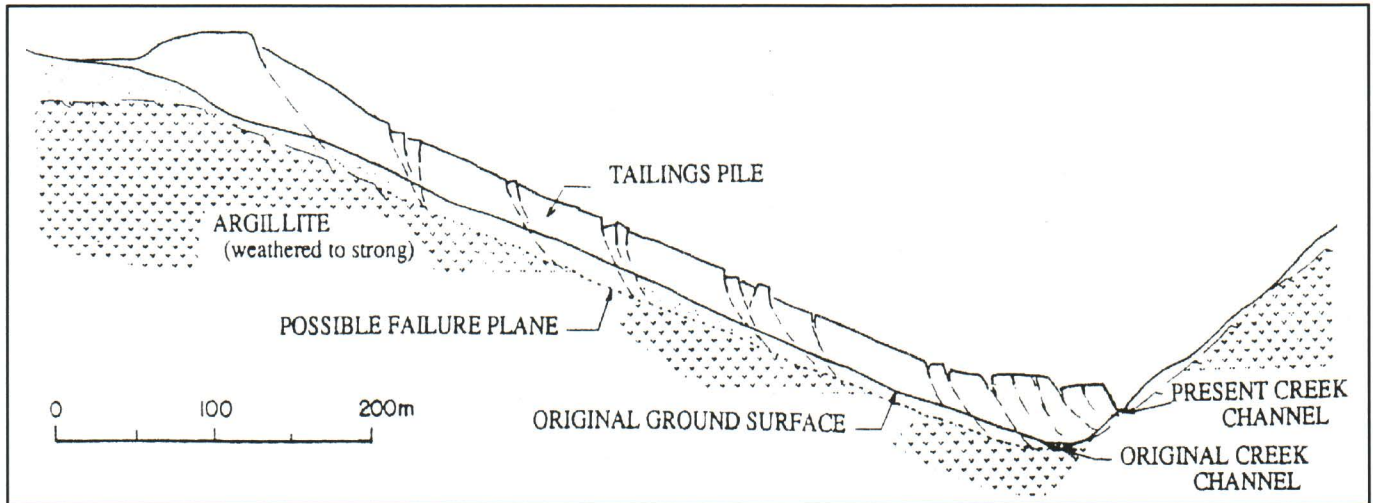
Figure 2-3
Section Through South Tailings Lobe

The southerly portion of the tailings pile (south lobe) failed suddenly in 1974, completely blocking the existing Wolverine Creek channel (Figure 2-3). Upon formation of a small upstream lake, the blockage was breached releasing a significant amount of water borne tailings downstream of the tailings piles. Following the 1974 event, the north tailings lobe failed (UMA Photo 3-5). A series of rock weirs were subsequently constructed downstream of the tailings piles to minimize erosion, and to date, these measures remain intact. Remedial measures to stabilize the tailings lobes, including slope flattening and terracing were unsuccessful. Downslope movements of the tailings pile lobes are still occurring, resulting in continued erosion of landslide material at the downslope toe.

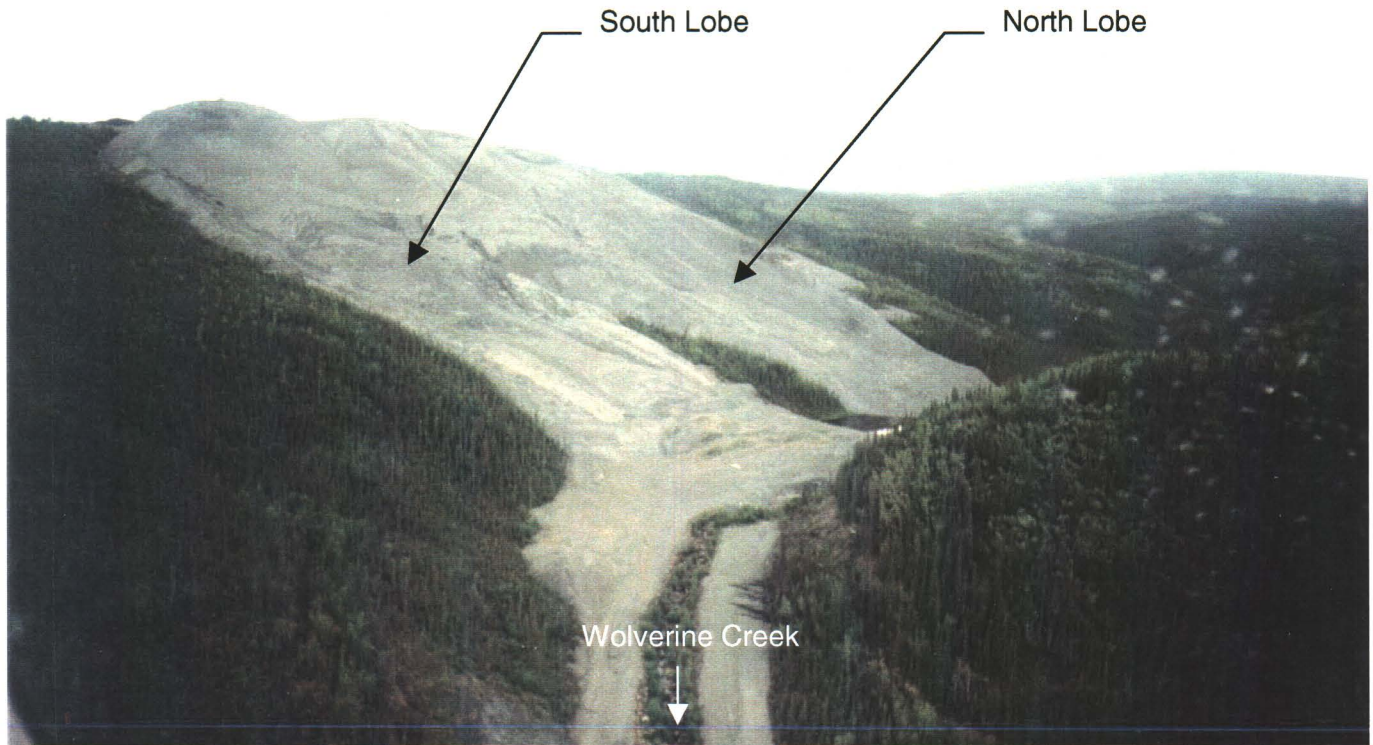
UMA Photo 3-5
Asbestos Tailings Pile

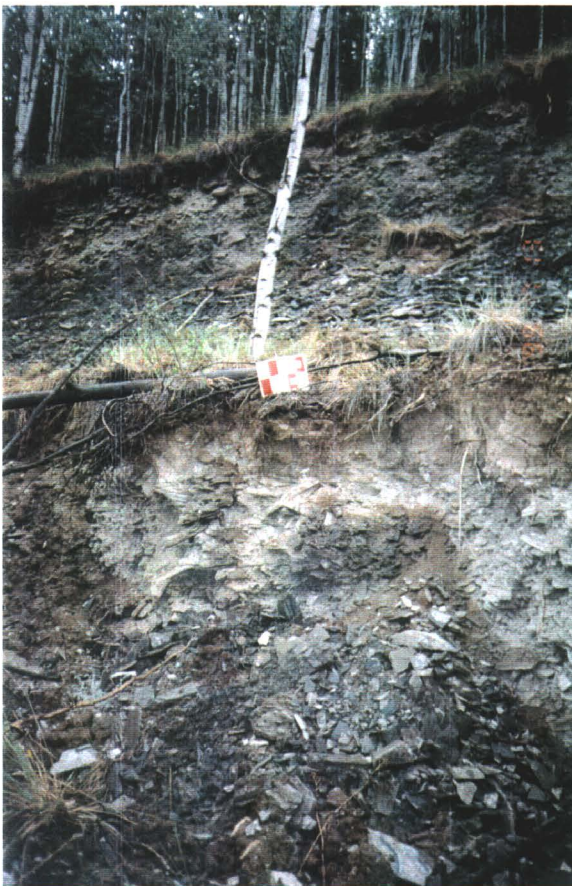
- Slumping of the north valley slope within the immediate vicinity of the creek channel is evident, in particular along the lower half of the reach through the waste rock. Retrogressive slump blocks 2 to 3 metres high have developed about 500m downstream of the lake outlet exposing the weathered argillite bedrock along the backscarps (UMA Photo 14-2A). Significant slumping has also occurred about 350m downstream of the outlet where a 5 m backscarp and vegetated lower bench are clearly visible (UMA Photo 14-12A). Photo locations are indicated on Drawing 03.

UMA Photo 14-2A
Valley Slope 20m W of Piezometer P4

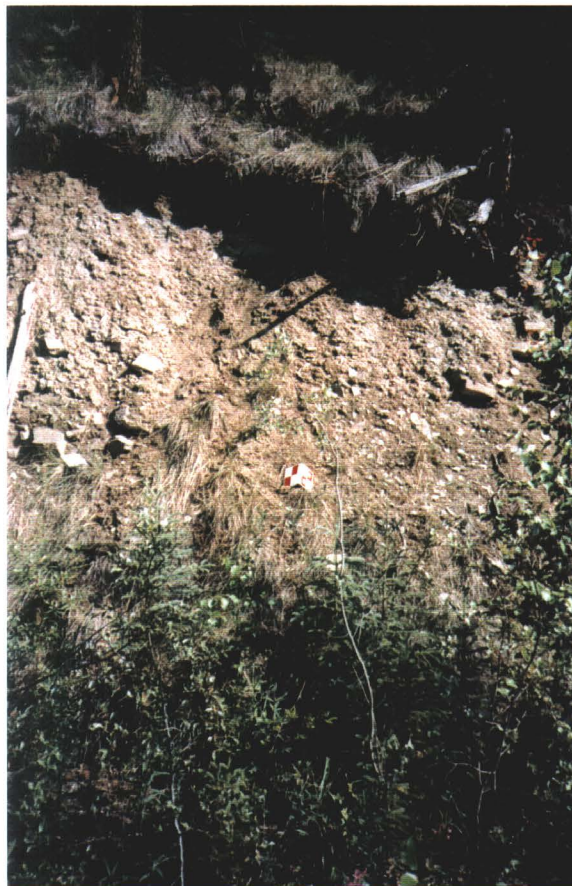
UMA Photo 14-12A
Valley Slope 30m Upstream of Section A-AA

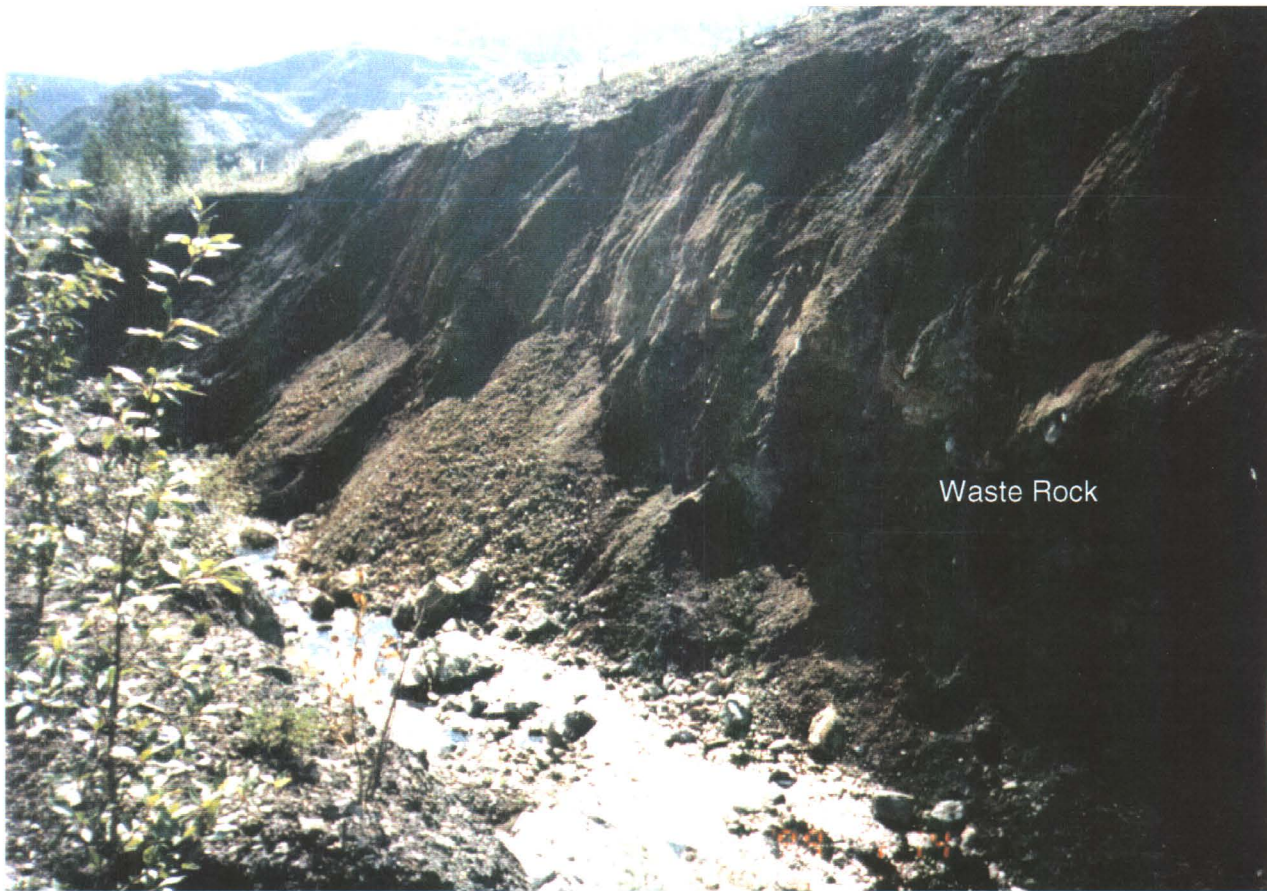
- Recent slumping of the oversteepened waste rock slope can be seen from the north side of the creek channel, in particular in the vicinity of cross-channel reference line A-AA (UMA Photos 14-11A). The localized slides typically block about one half of the creek channel bottom and active erosion is evident at the toe of the slide debris in the channel.

UMA Photo 14-11A
Waste Rock Slumping at Sec A-AA

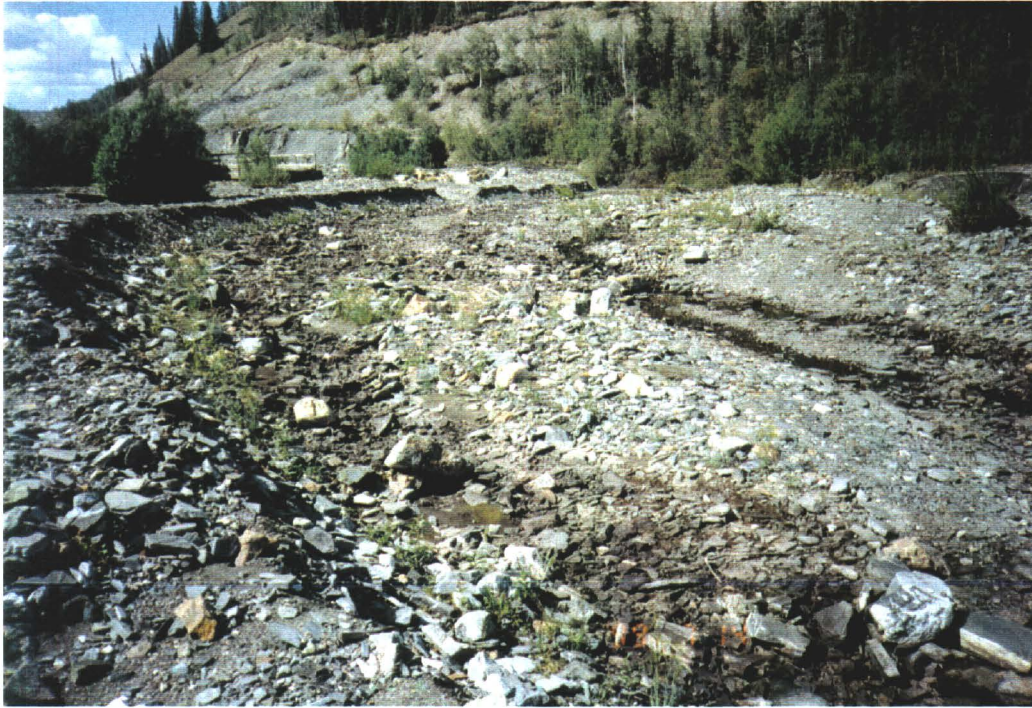
- The creek channel was dry at the Hudgeon Lake outlet with flow occurring through the 2m diameter culvert which is badly out of round. The channel remnant (which was flowing during our 1998 reconnaissance) is about 18-20m wide.
- Open channel flow in Clinton Creek terminated at the east end of the waste rock dump just before reaching the washed out bridge. The channel is dry from this point to about 100m downstream of the bridge (UMA Photo 15-4A). The water in the channel at this location (the old bridge) was at least 0.5 to 1m deep in 1998 during our site reconnaissance (UMA Photo 11-10).

UMA Photo 15-4A
Clinton Creek Channel Downstream of Bridge

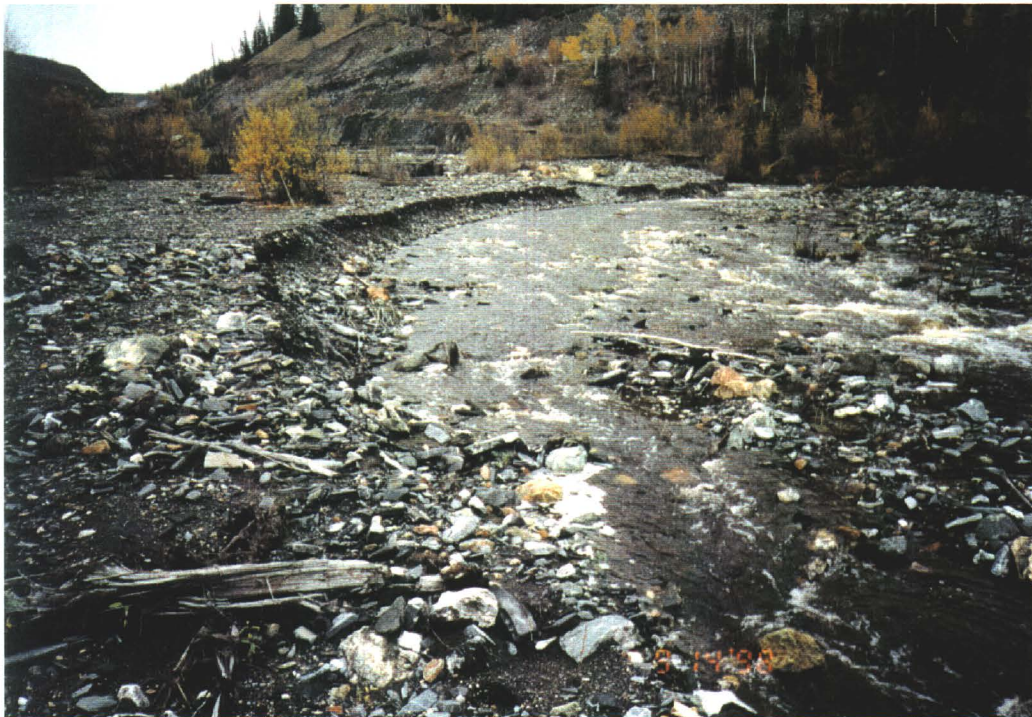
UMA Photo 11-10
Creek Channel in September 1998

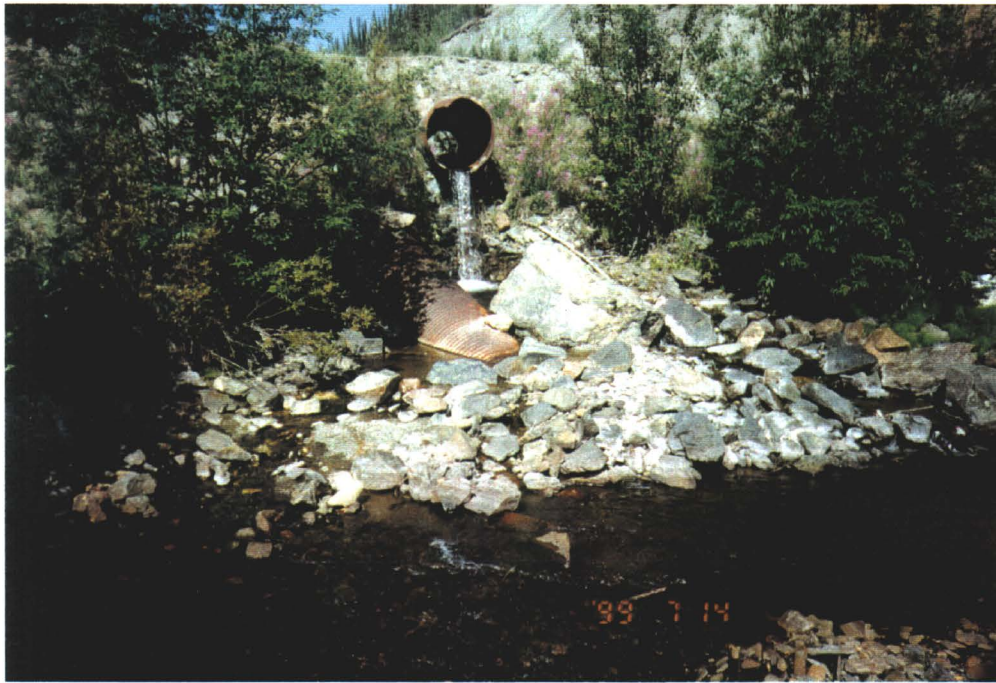
- Flow from Wolverine Creek normally discharges into Clinton Creek through a 1200mm diameter steel plate (19mm thick) culvert elevated about 2m above the channel bottom (UMA Photo 15-10A) . The culvert is in good condition. No flow was visible through a corrugated metal culvert which was partially embedded into the channel bed, nor was any flow occurring through the 1200mm culvert set at a higher elevation. Interestingly there was a significant flow in Clinton Creek just upstream of Wolverine Creek in comparison with little to no flow observed just downstream of the old bridge.

UMA Photo 15-10A
Wolverine Creek Outlet Culvert

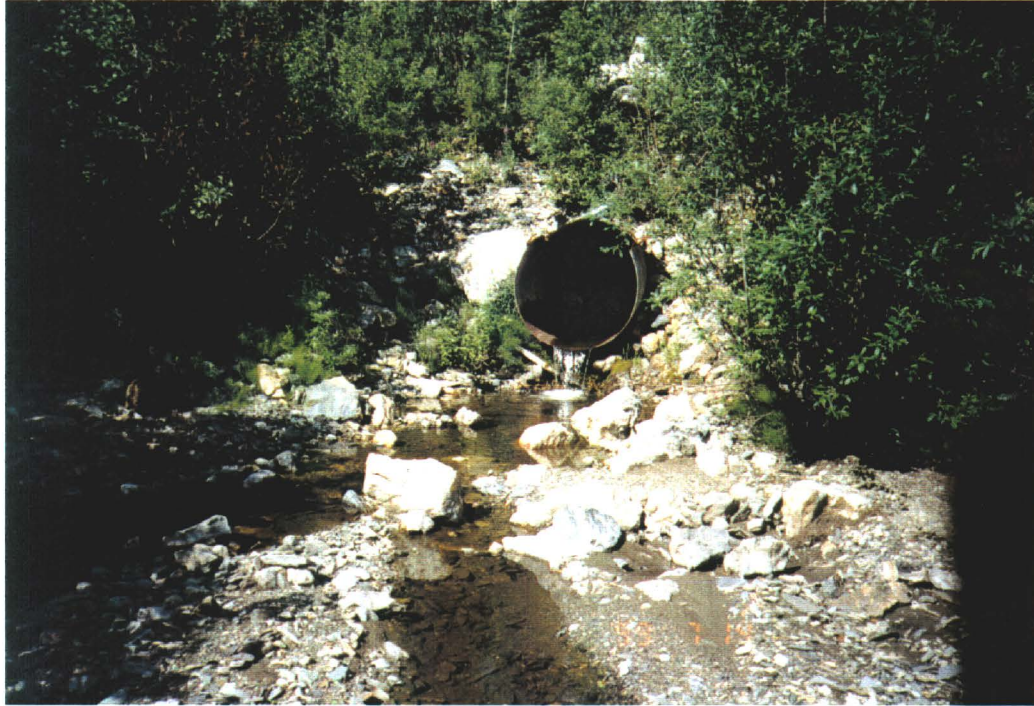
- Eagle Creek drains into Clinton Creek through a 1600mm diameter corrugated metal pipe about 3 km downstream of the mine as shown on Drawing 01 (UMA Photo 15-15A). Discharge from the culvert at the time was estimated to be 7 l/sec. The culvert has been vertically deformed by about 300mm beneath the roadway. An old timber bridge is located about 20m upstream of the culvert, likely along a previous access road alignment (UMA Photo 15-16A). The timber bridge is in poor condition.

UMA Photo 15-15A
Eagle Creek Culvert

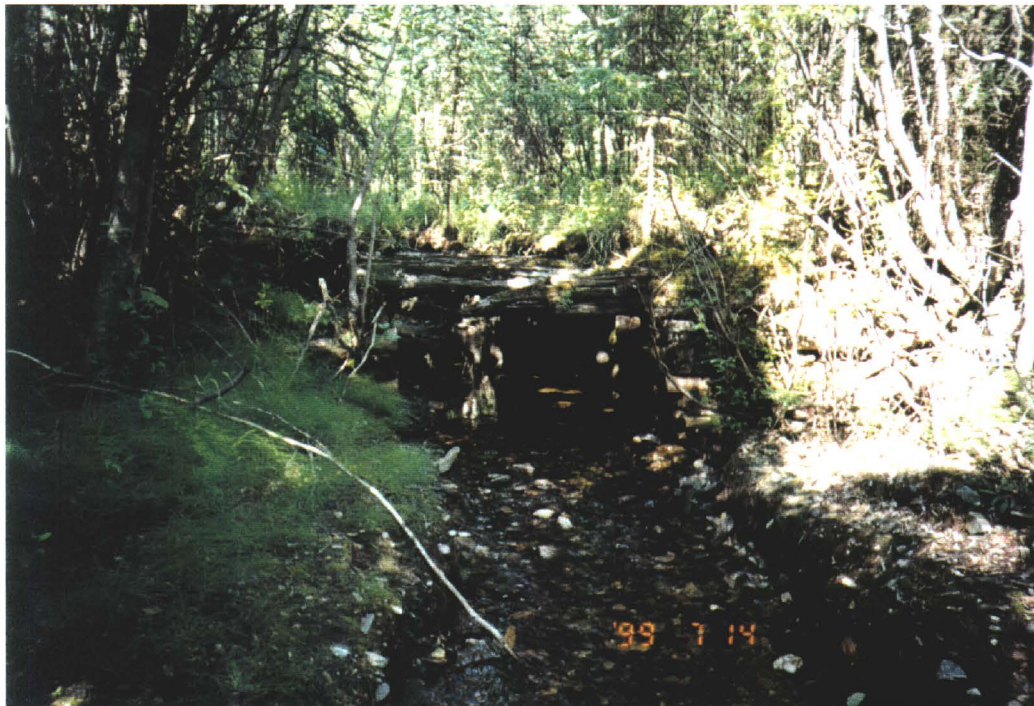
UMA Photo 15-16A
Eagle Creek Timber Bridge

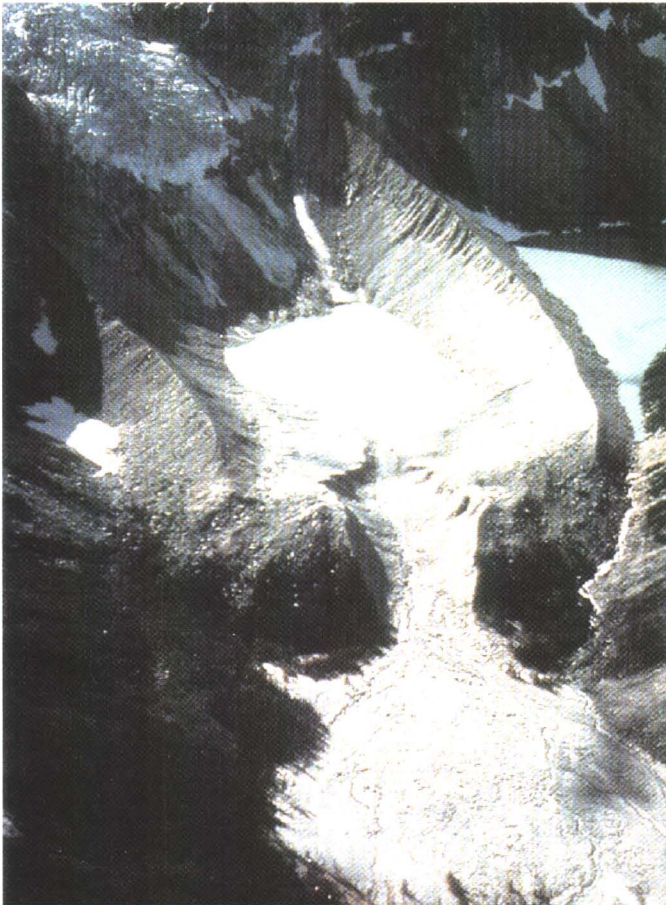
Nostetuko Lake drained through a steep channel cut through a 40 m high landslide moraine on a gradient of 0.19, floored by large boulders derived from the moraine (Photo 7-1). The frequency of boulders, however, was too small to permit re-armouring before erosion became catastrophic. When the moraine breached, almost the entire lake drained into the downstream valley in 5 hours. Very rapid down-cutting and the draining resulted from sudden channel erosion. Once down-cutting commenced, lowering of the outlet permitted increased flow from the lake, increasing erosion. The moraine breach volume was $1.2 \times 10^6 \text{ m}^3$. The volume of water released was $6.5 \times 10^6 \text{ m}^3$. A similar breach failure occurred in a moraine dam on the Klattasine Creek in the early 1970's (Blown and Church, 1985, Clague et al, 1985).

Photo 7-1
*Nostetuko Moraine Dam
After Breach Failure*
(Photo From Geological Survey of Can.,
Bulletin 464)

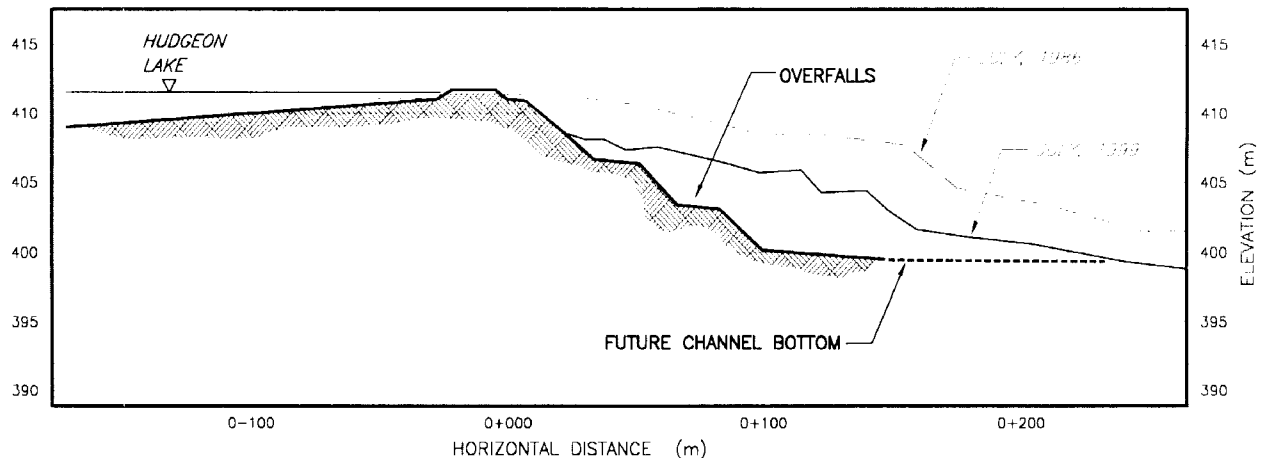
Figure 7-6
Outlet Erosion

The sediment transport mechanism described however, does not recognize the continual channel degradation (down-cutting) downstream of the outlet observed since 1986. Degradation of the downstream slope is described by AlQaser, 1993, and involves the formation of a number of overfalls or steps as seen during inspections at Clinton Creek. As this process continues downstream of the lake outlet, headward cutting continues and the plug at the outlet becomes increasingly susceptible to a sudden failure in the classical dam breach fashion. While the breach associated with an overtopping of the plug would not initially be as large as described in the worst-case scenario, the volume of water suddenly released could greatly accelerate degradation (erosion) of the downstream channel, leading to additional breach development (Figure 7-6). The presence of springs along the edge of the channel just downstream of the outlet could further contribute to the channel erosion at this critical location.

If overtopping of the plug does not initiate a breach, it is possible that the continued degradation of the channel immediately downstream of the plug will create an increasingly unstable geometry at the outlet dam. Rudimentary slope stability analysis indicates the factor of safety against slope failure could reach unity (1.0) with an additional 4m of down-cutting which would create a dam in the order of 7m high. If the entire slope failed into the channel, the resulting initial breach would be in the order of 10 m deep, 50m wide at the top and 30m wide at the base. A sudden release of water in this scenario, however, could quickly exceed the ability of the channel to armour itself against the rapid development of a larger more catastrophic breach.
