ABANDONED CLINTON CREEK ASBESTOS MINE

**REPORT
ON
JUNE AND JULY 2000 SITE INSPECTIONS**

Prepared by:
GEO-ENGINEERING (M.S.T.) LTD.
Calgary, Alberta

August 2000
G1000

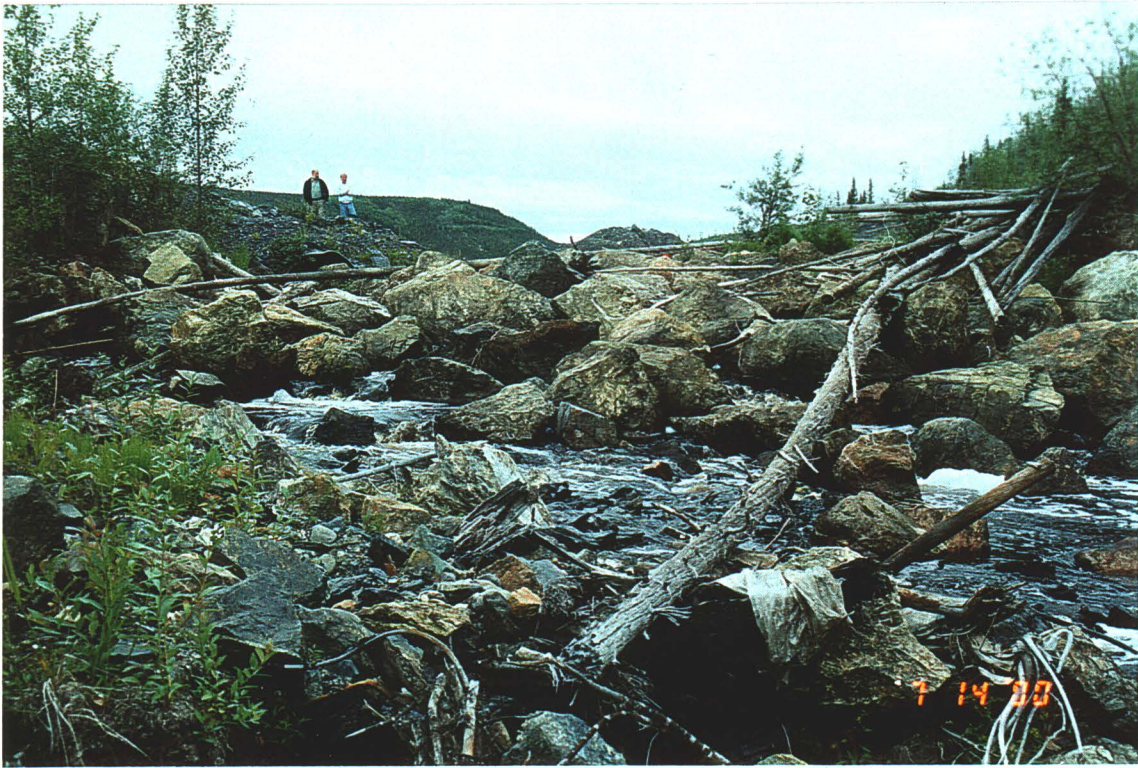
- erosion steps (only about 100 mm high) have developed in the lake outlet channel,
- the outlet channel bottom, covered with small to medium-sized shale/sandstone fragments is soft,
- the armoured section, immediately downstream from the lake outlet, sagged and some of the boulders were possibly dislodged (Photos 1 and 2),
- the channel bottom downstream from the rip-rap section was further downcut (by about 500 mm and slumps developed on the banks (Photos 3 and 4),
- total grade difference between the lake level and the channel downstream from the lake outlet is now estimated to be in the order of 3 m, and
- further downstream, lateral erosion triggers on-going instabilities of both channel banks (Photos 5 and 6).

Photo 1: Looking upstream at the rip-rap segment of the Hudgeon Lake outlet. The left side appears to sag relative to the right side.

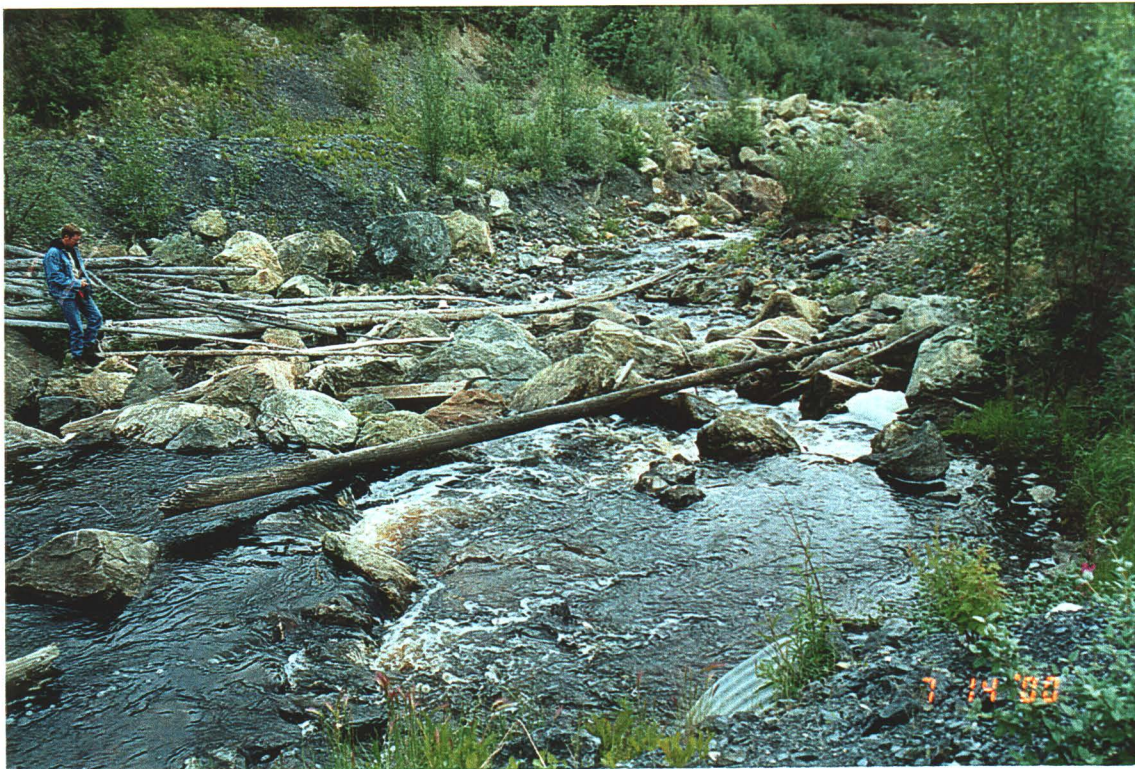
Photo 2: Hudgeon Lake outlet, looking downstream at the armored section.

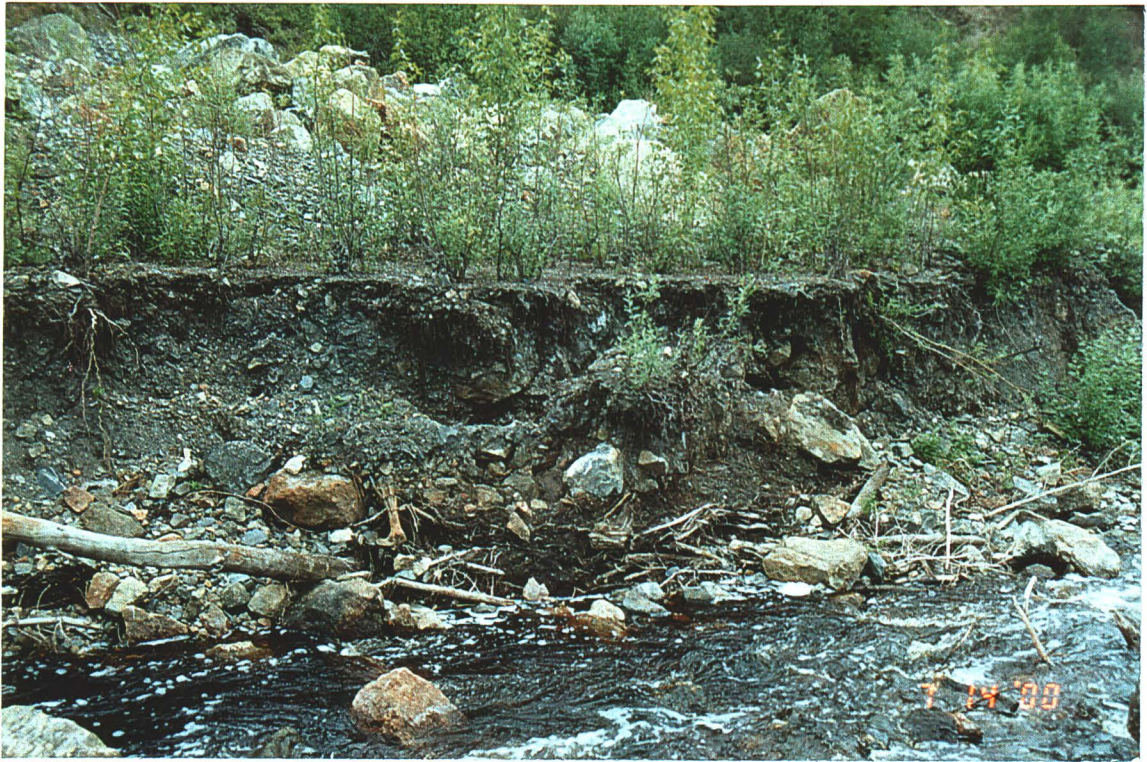
Photo 3: Downcutting of the channel (which occurred during this year's spring break-up) triggered slumping of creek banks downstream from the lake outlet.

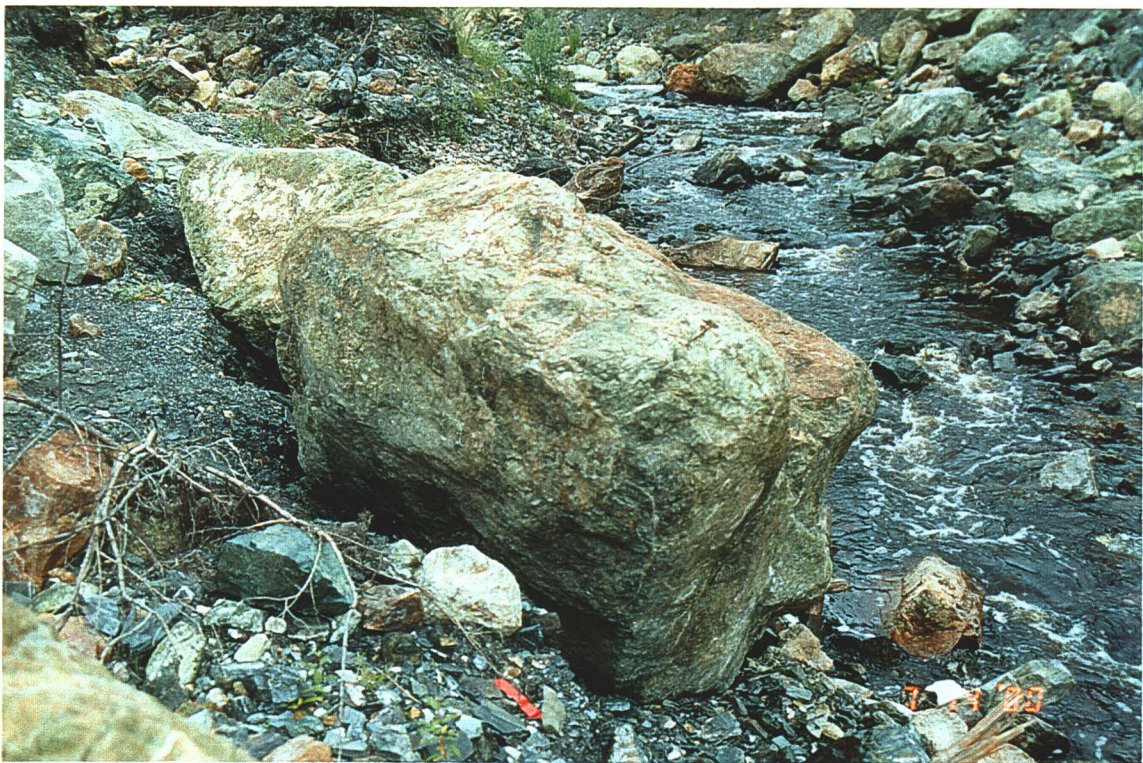
Photo 4: Downcutting dislodged large boulders on the channel banks.

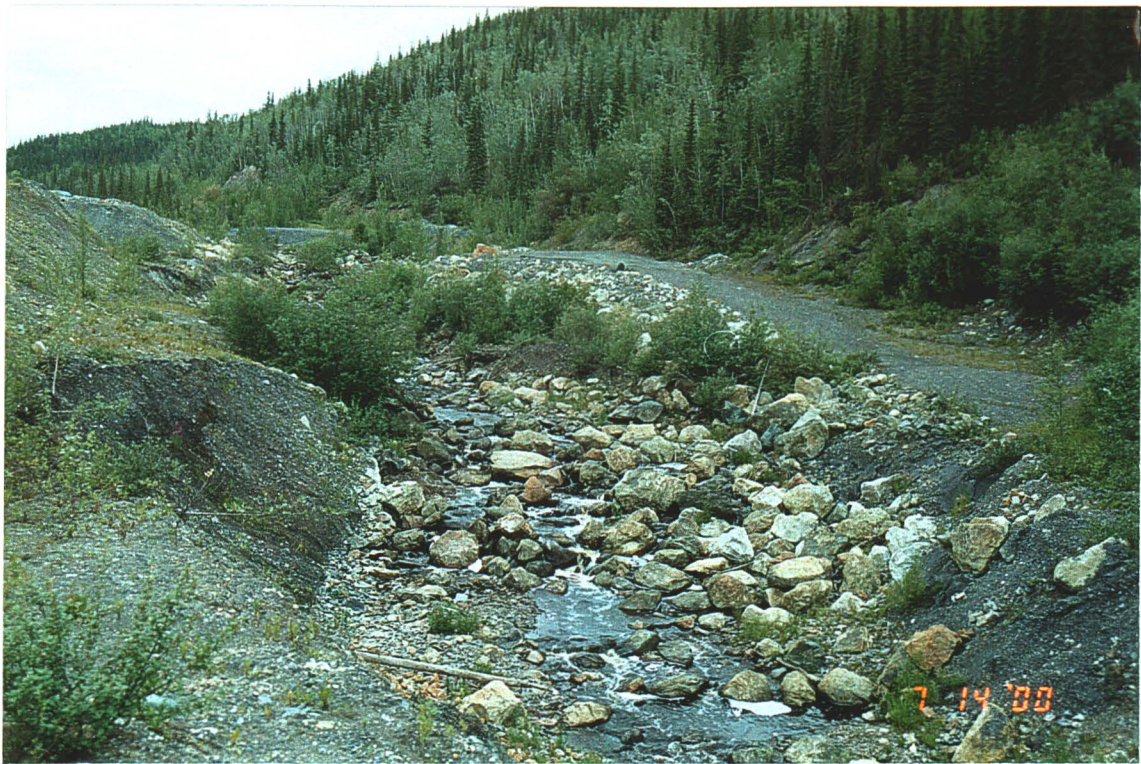
Photo 5: View of former rock weir and increased lateral erosion of both channel banks.

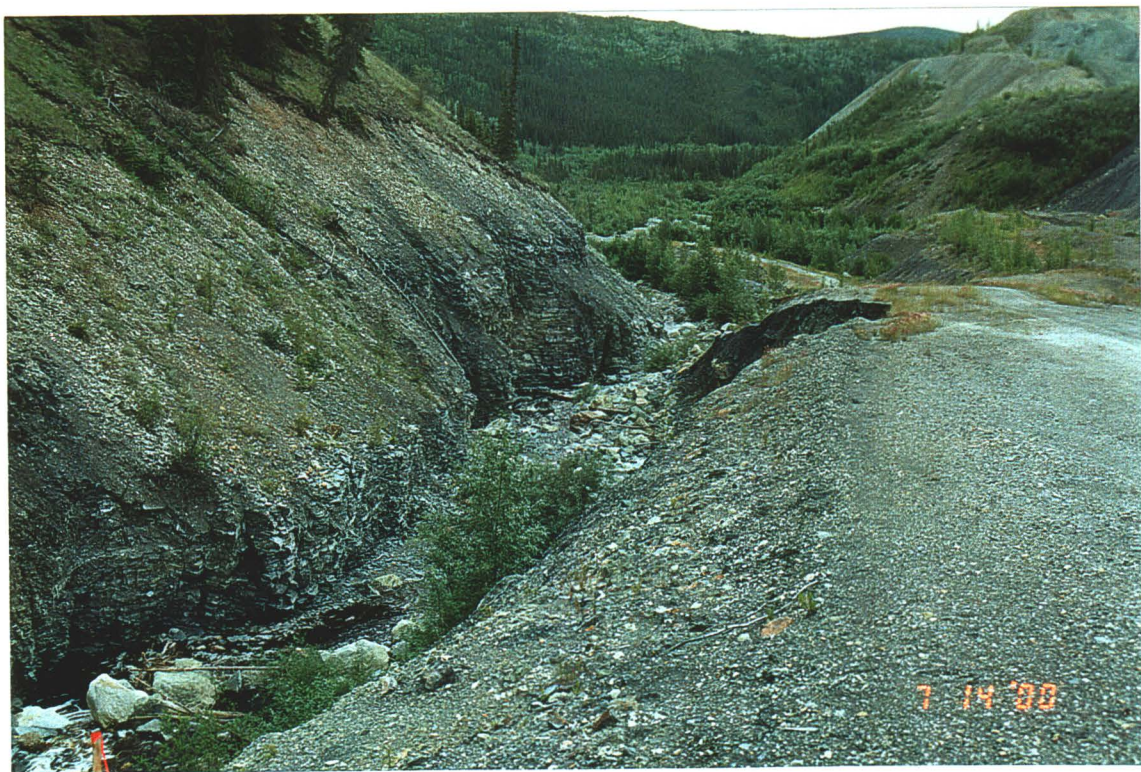
Photo 6: View of the downstream segment of the Clinton Creek channel. Note ongoing erosion of both channel banks.

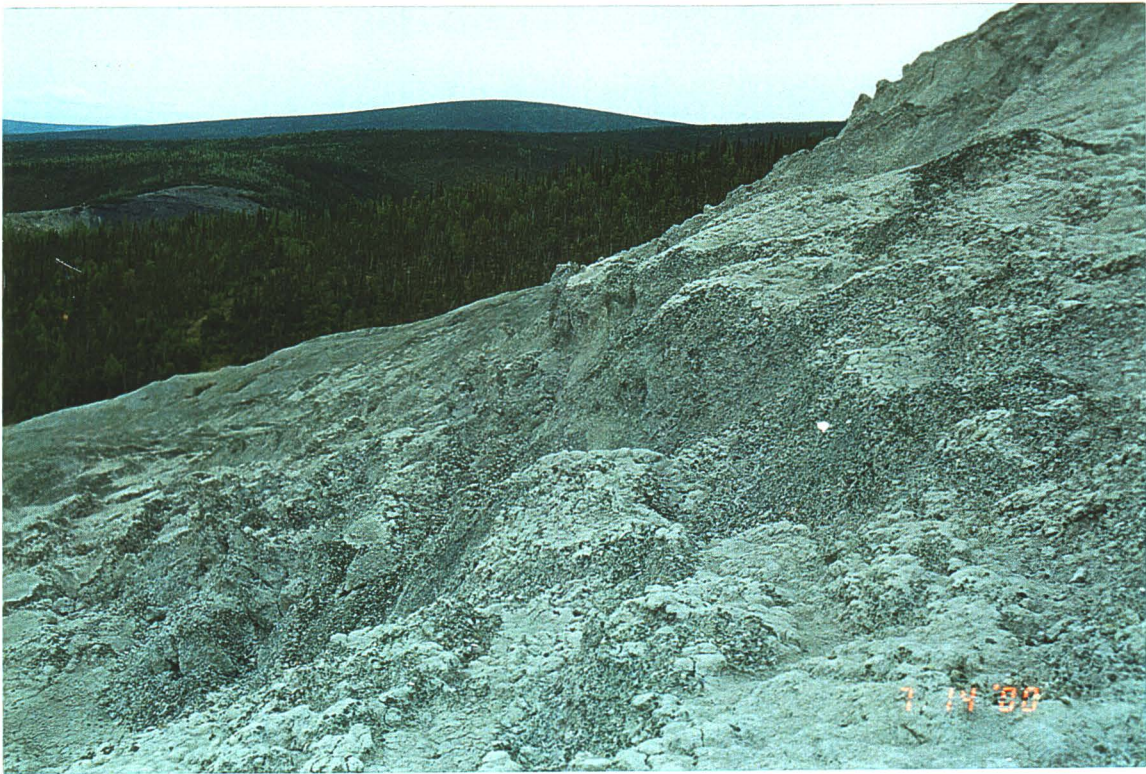
The general appearance of both south and north pile lobes is similar to that observed during previous site visits. However, the piles remain unstable and movements of these segments are irregular, reflecting the displacement of main dump blocks. For example, when a lower block moves, the adjacent slope segment accelerates and the failure gradually progresses to the top of the pile (Photo 7).

Photo 7: Wolverine Creek tailings pile. View of one of several active headscarps.

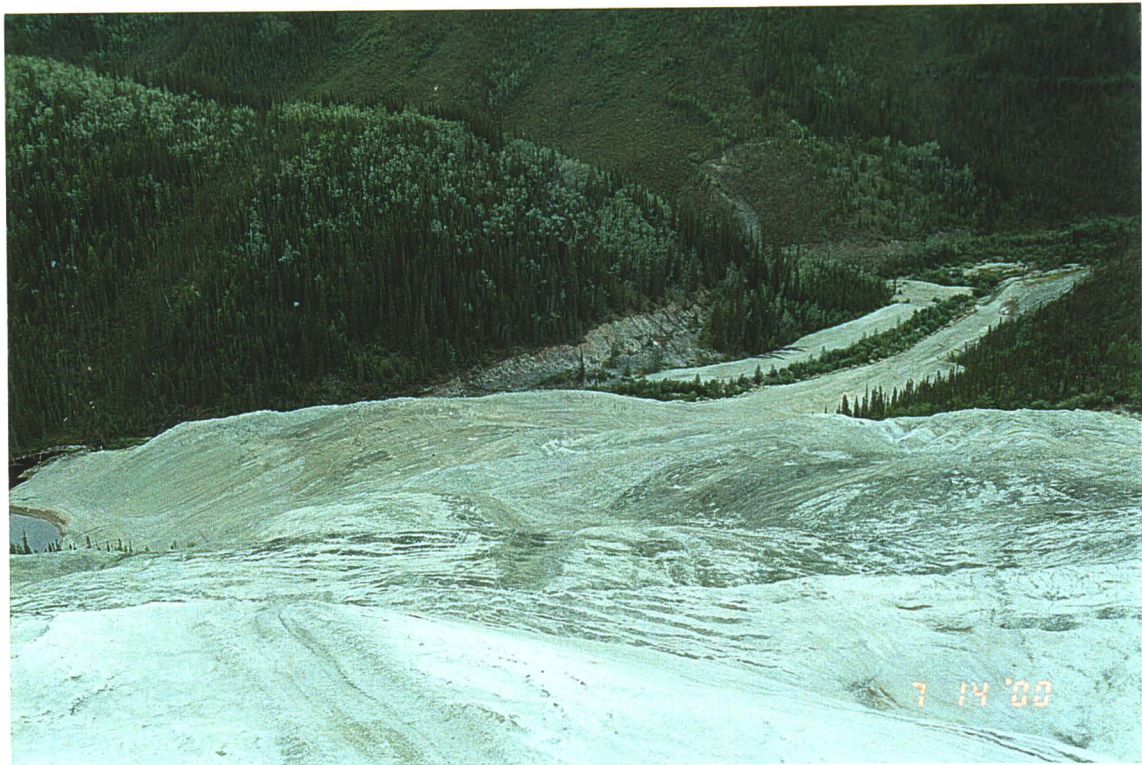
In 1997, the southern lobe (Photo 8) temporarily blocked the creek channel and the blockage has now been eroded away during larger flow events. It appears that the blockage may be a yearly event, reoccurring during the fall and winter low flow seasons. It appears that continuing movements discouraged or destroyed the local beaver colony. Their dam was pushed up and a new channel cut (Photo 9).

Photo 8: View of the south tailings pile lobe and the Wolverine Creek spillway weir.

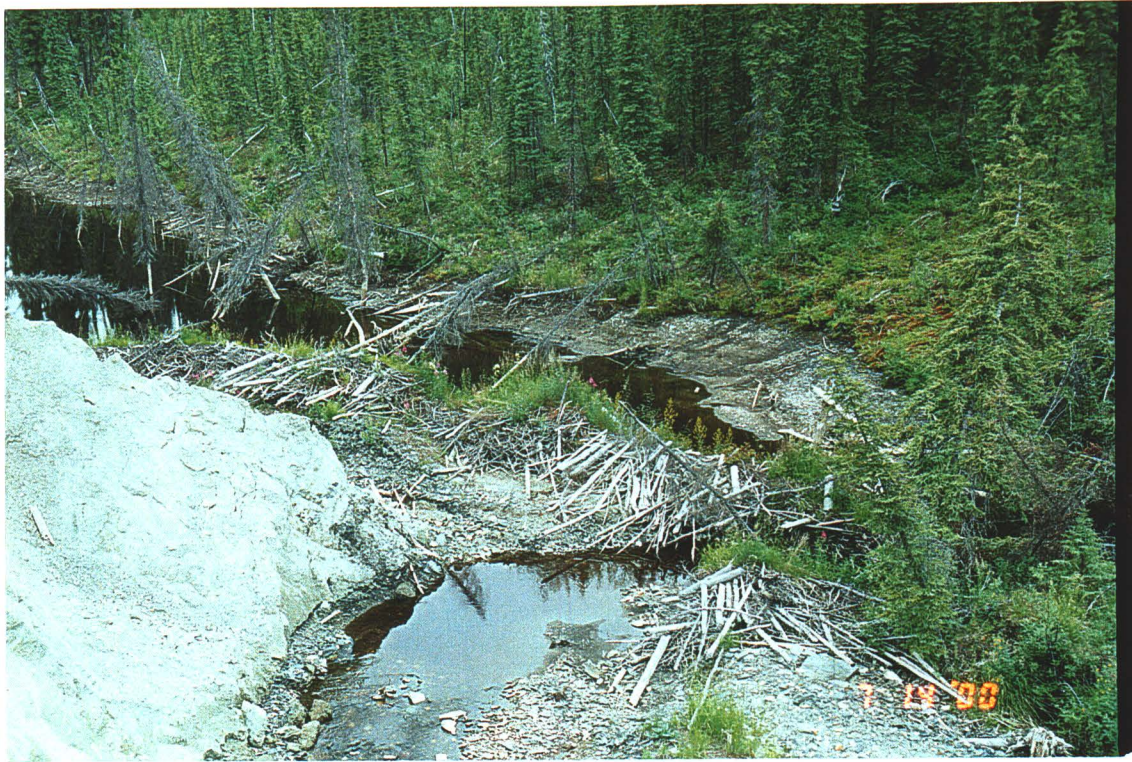
Photo 9: View of the beaver dam located at the upstream edge of the south tailings pile, uplifted by ongoing ground movements.

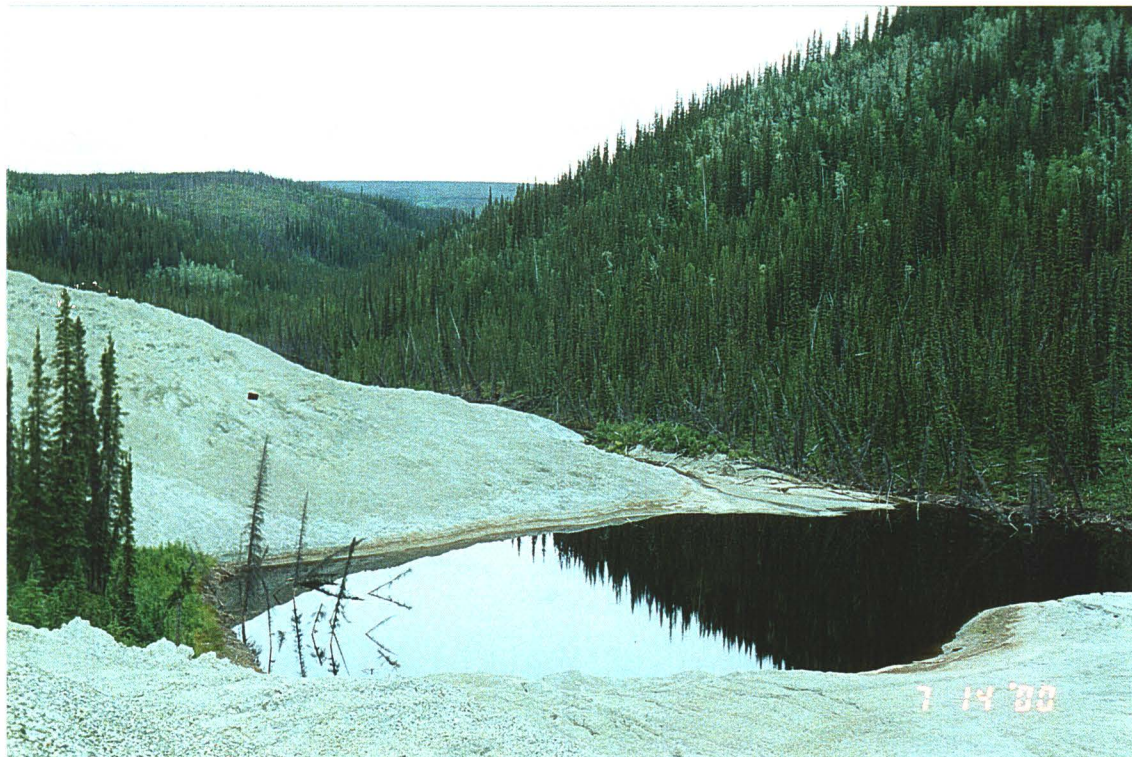
The north lobe reached the valley bottom in 1985 and temporarily blocked the creek flow in 1987. The original valley bottom was "bulldozed" up and against the east valley wall. This created another small lake. However, beavers now control its level. The flow from this lake overtopped easily erodible tailings and cut a new channel through the toe of the north lobe (Photo 10). The rate of the north lobe advance appears to be slower than the rate of the south lobe since the channel blockage did not reoccur at the north lobe. However, fresh cracks in the lower and middle segments of this lobe are indicative of the ongoing movement.

Photo 10: View of the toe of the north tailings pile lobe.

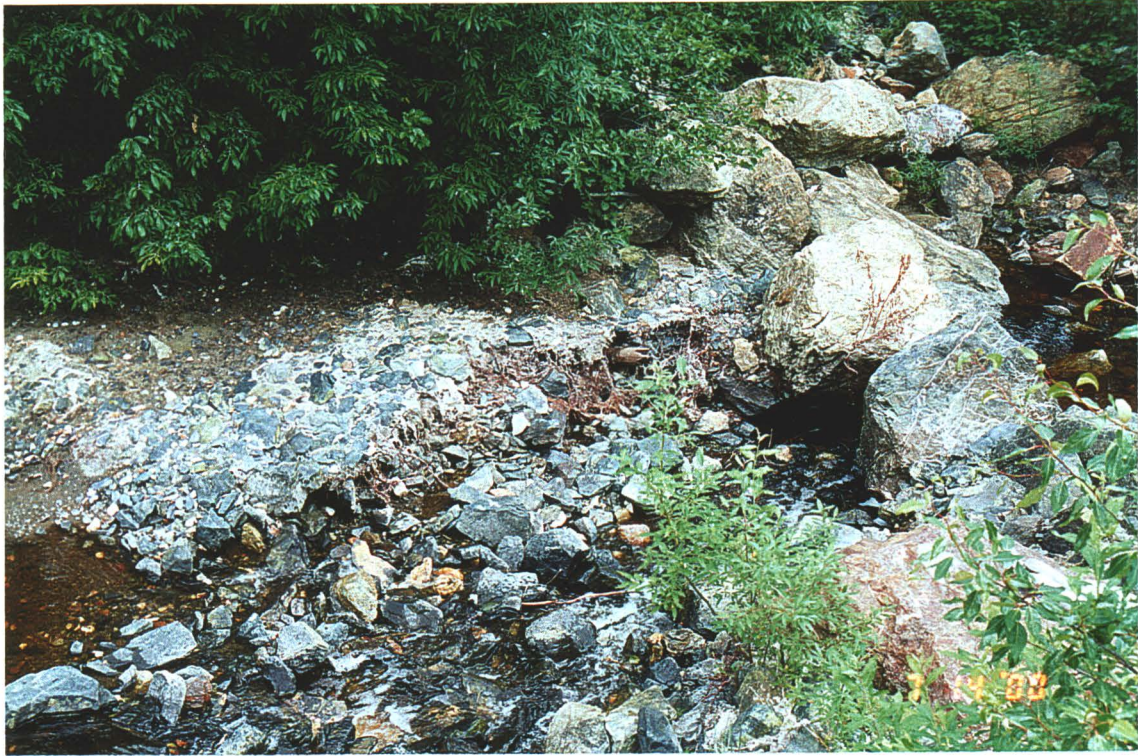
The Wolverine Creek spillway weir continues to perform well except for the lowermost weir which was dislodged and the channel undercut by about 300 mm (Photo 11).

Photo 11: View of the Wolverine Creek lowermost rock weir, currently dislodged. Note the channel erosion.
