**INDIAN AND NORTHERN AFFAIRS CANADA**

**ABANDONED CLINTON CREEK ASBESTOS MINE  
ENVIRONMENTAL LIABILITY REPORT**

**UMA Job No. 4440 038 02**

**May 2002**

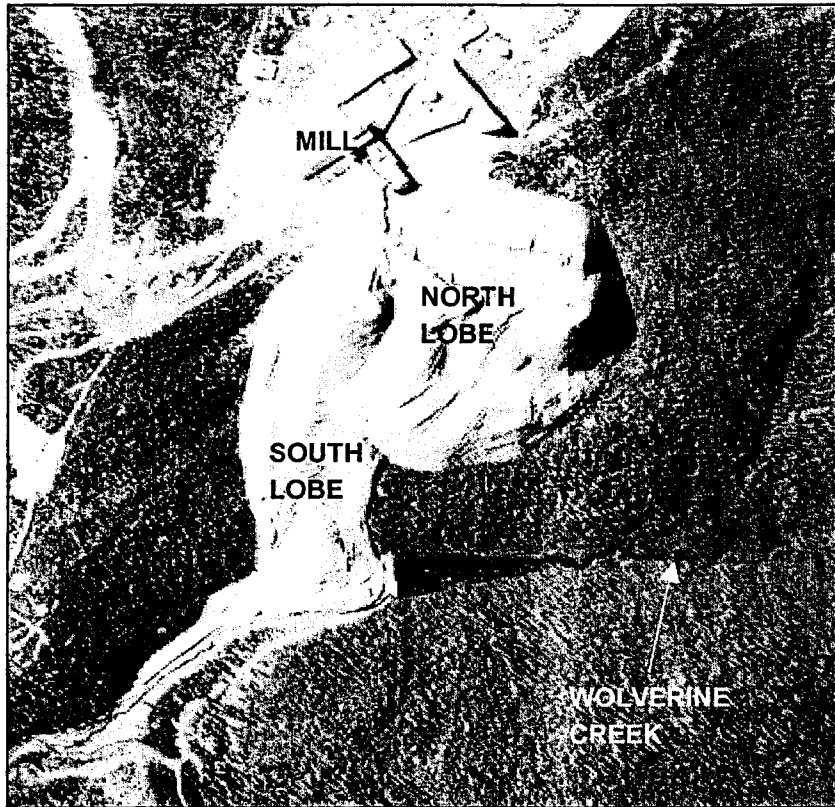
Figure 4-1  
Failed South Lobe  
(1976)

Between 1968 and 1974, tailings were deposited on the upper portion of the west slope of the Wolverine Creek valley (referred to as the south lobe). A failure of the south lobe in 1974 resulted in blockage of natural flow in Wolverine Creek, backing up approximately nine metres of water behind the landslide material (Figure 4-1). In the spring of 1974, a sudden breach of the tailings occurred resulting in a flash flood down Wolverine creek to the confluence with Clinton Creek. The eroded tailings were deposited several metres deep in the creek valley downstream of the tailings. Although the majority of the tailings are believed to have been deposited upstream of the access road, some of the finer material including asbestos fibres entered the Clinton Creek channel where it was deposited possibly as far downstream as the Forty Mile River.

Following failure of the south lobe, a 9 metre deep channel was excavated across the toe of the tailings to facilitate creek flow and a new tailings pile was established north of the failed mass (north lobe). By 1977, the north lobe was showing signs of instability and during the last months of mine operation the tailings were placed in the northwest corner of the north lobe. Partial re-grading of the north and south lobes was undertaken in 1978 and 1979 in an unsuccessful attempt at stabilizing the tailings. In 1978, channel stabilization measures were constructed across the tailings immediately downstream of the south lobe. These measures consisted of a rock-lined channel and a series of rock weirs (Figure 4-2). To date, these measures have performed well although some deterioration was noted during the 2001 site visit.

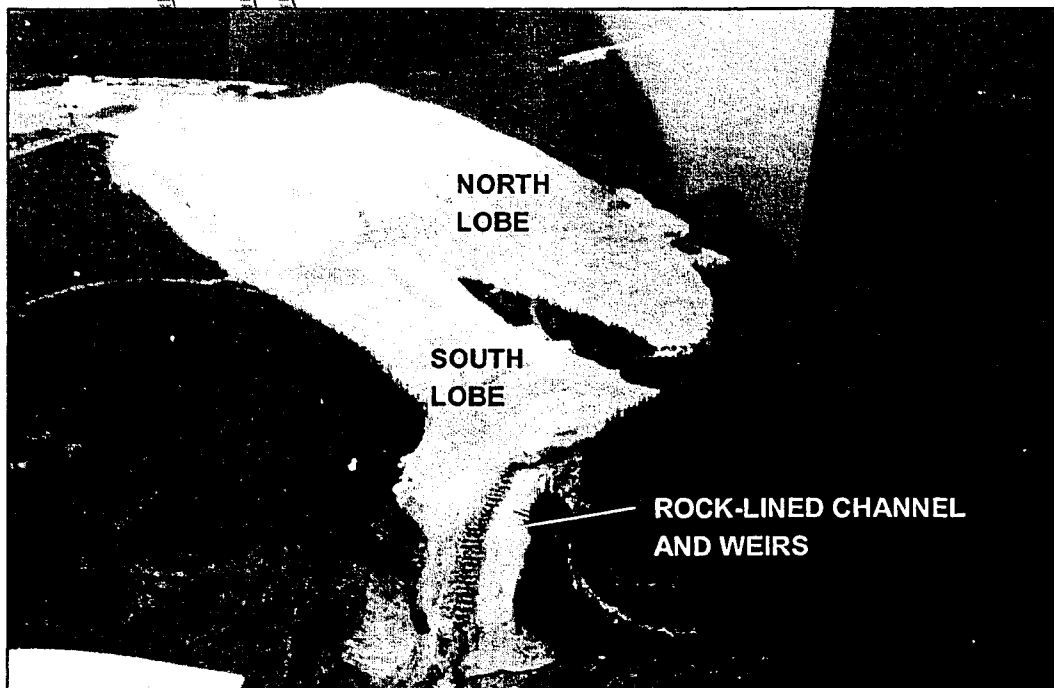
Figure 4-2  
Rock-Lined Channel and Weirs

- The toe of the north lobe has entered the lake in the valley bottom and extends an estimated 6m beyond the 1983 shoreline.
  - The rock-lined channel constructed over the failed mass of the south tailings lobe has continued to perform well. (*Rock-lined channel was constructed in 1978*).

Recommendation made to install a rip-rap apron downstream of the last weir and to rehabilitate any damaged weirs.

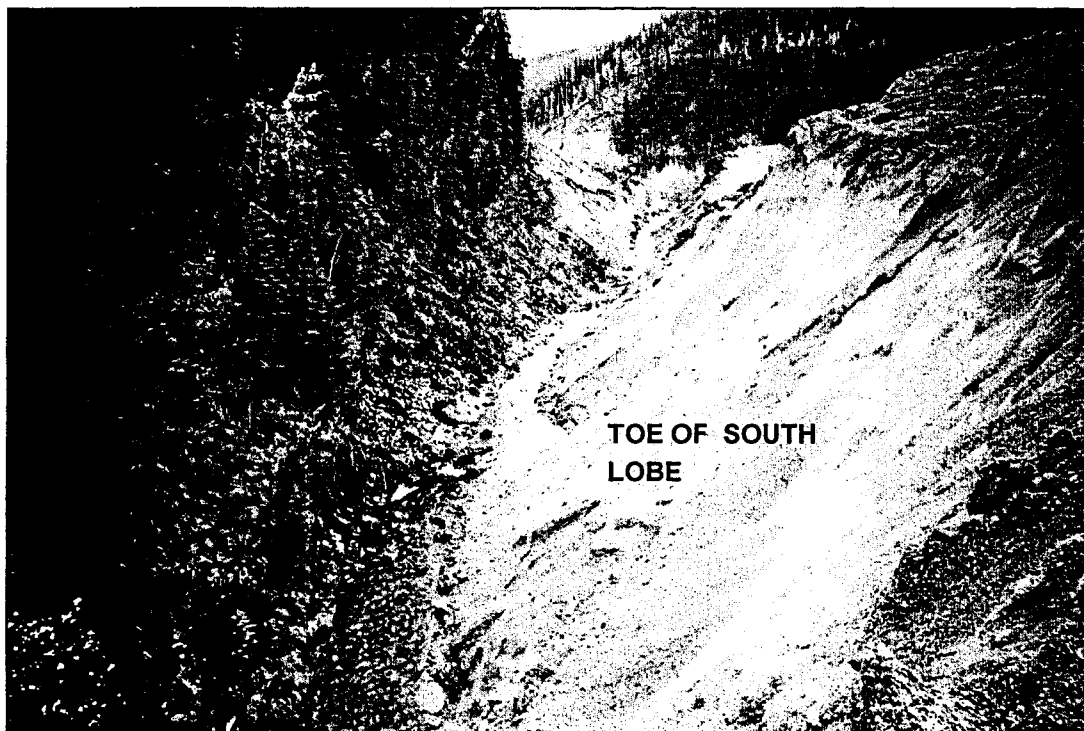
**Figure 4-3**  
**Erosion at Toe of South Lobe, View Downstream (1998)**

A plan view of the existing tailings piles and Wolverine Creek profile are shown on Drawing 09. Representative creek channel cross sections are illustrated on Drawing 10. As a result of the channel blockages, the alignment and elevation of Wolverine Creek is now about 25 metres further to the east and about 13 metres higher than it was naturally. This new alignment has resulted in erosion of the east valley slope and the tailings that form the west bank of the creek (Figure 4-3).

Four beaver dams between the upstream side of the north lobe and the downstream side of the south lobe are believed to have reduced channel velocities and erosion as evidenced by the relatively flat channel gradient through this stretch. Immediately downstream of the last beaver dam however, velocities increase significantly as the channel narrows and the gradient steepens. Between the downstream beaver dam and the rock weirs, the channel has down-cut into the

underlying weathered argillite bedrock resulting in slumping of the valley slope. Downstream of the south lobe, flow appears to be contained within the original modified channel with no significant erosion or down-cutting observed, and the rock lined channel and rock weirs remain largely intact.

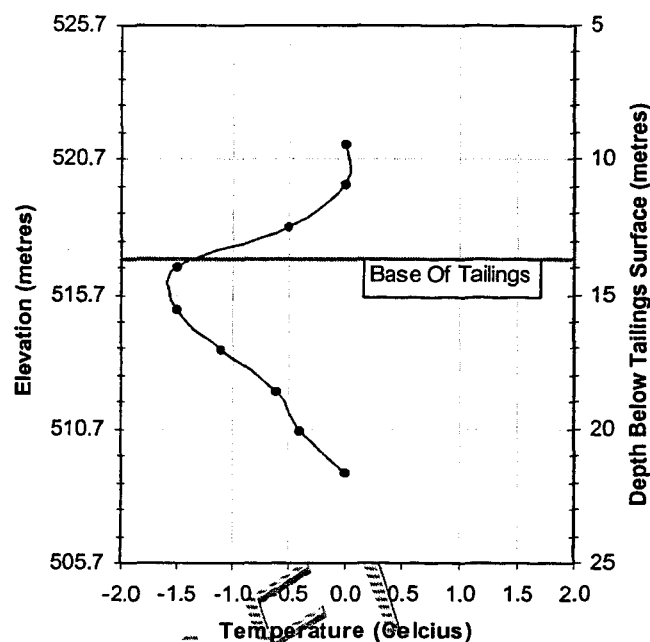
Figure 4-7  
Temperature Profile for T7

Thermistor T7 is located near the northern edge of the tailings pile. The data indicated that the tailings and foundation soils were frozen with the coldest temperatures (-1.6 degrees C) just below the interface of the tailings and foundation soil. The temperatures of the foundation soils appear to gradually increase from -1.5 degrees C at the interface to nearly 0 degrees approximately 6 m below the tailings. It is possible that these tailings were placed during the winter season which would help to insulate the frozen overburden soils. This also might explain the cooler temperatures of the tailings just above the overburden soils.

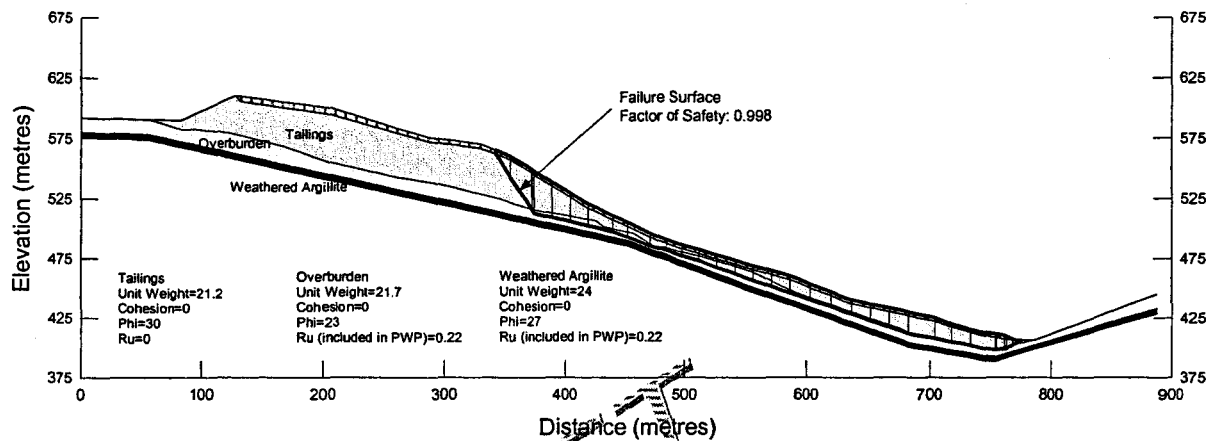
Figure 4-8  
North Lobe - Existing Geometry

Sensitivity analyses were subsequently carried out to determine the failure surface and the Ru value necessary to provide a factor of safety near 1.0. The resulting failure surface geometry and associated parameters are shown in Figures 4-8 and 4-9.

The analysis indicates that a combination of residual shear strengths and high pore-water pressures in the overburden material are required to achieve a FS of unity. This observation provides further evidence that unique geological conditions, in particular a shallow weak layer within the overburden, the slope of the valley and lack of toe support are responsible for continued movement of the tailings pile. Almost certainly, disturbance of the thermal regime, in particular thawing of the permafrost resulting from the placement of tailings over the valley slope has been a contributing factor. Although detailed knowledge of the changes to the thermal regime that occurred during and following active placement of tailings is not known, it is possible that the thermal regime has still not reached a state of equilibrium.

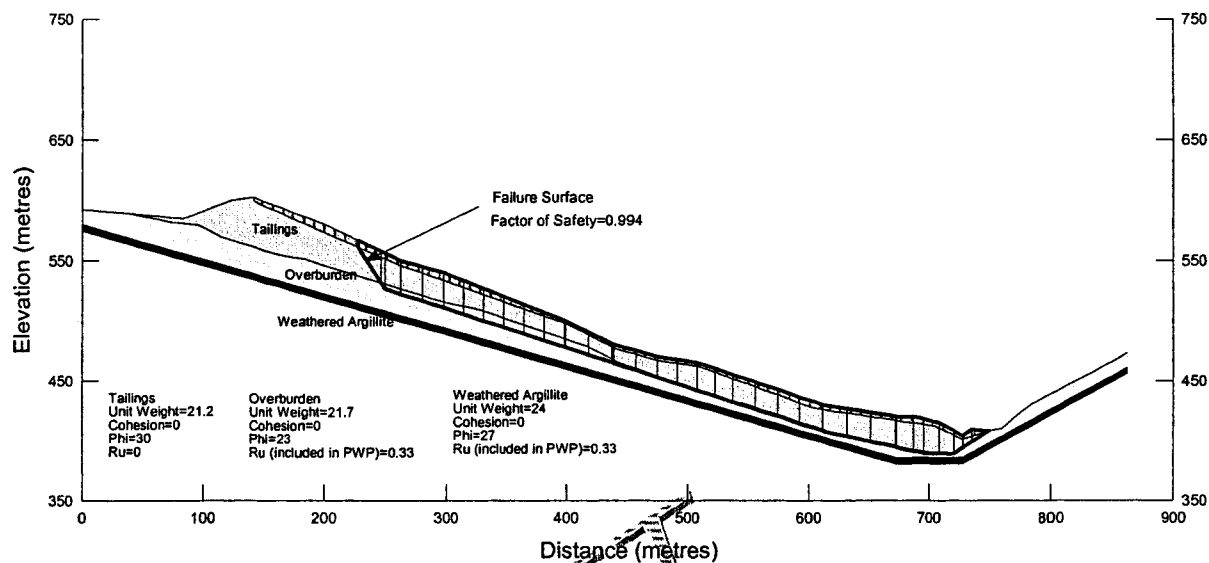
Figure 4-9

Given the limited site-specific geological information, there is considerable uncertainty in the absolute values calculated from the back analysis. The model is however, considered sufficient to comment on and assess the relative improvement available through remedial options for the purposes of comparing remediation alternatives (stabilization) and selecting a preferred long term strategy for the same.

South Lobe - Existing Geometry

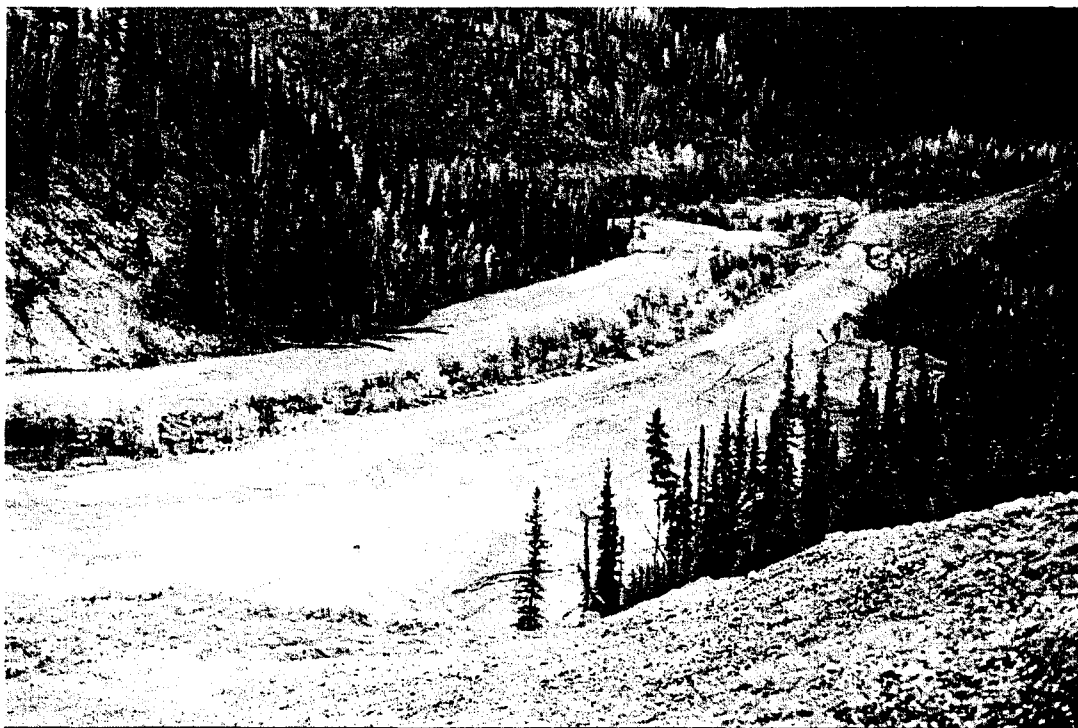
**Figure 4-10**  
**Vegetation Along Rock-Lined Channel**

Since the existing rock-lined channel and rock weirs downstream of the north lobe have performed reasonably well it is desirable to leave them in place. To reduce the erosion potential of the tailings adjacent to the rock-lined channel it is recommended that this area be graded towards the rock-lined channel and that the small gully along the outer edges of the tailings be filled to blend in with the natural valley slopes. Placement of rocks across the tailings in a 'V' pattern pointing downslope will help direct surface runoff to the rock-lined to channel and minimize the development of erosion channels in the tailings adjacent to the lined channel. The presence of vegetation along the rock lined portion of the channel suggests that it may be possible to establish vegetation in the tailings adjacent to the rock-lined channel if moisture can be preserved to support plant growth (Figure 4-10). Since the establishment of vegetation would help to provide long-term stabilization of the tailings, growth could be encouraged by spreading organic matter such as wood chips, mulch or coniferous trees over the tailings in this area. Rehabilitation of the channel outlet at the confluence with Clinton Creek should also be considered to prevent future overtopping of the road and erosion at the downstream end of the culverts.
