**KENO VALLEY/DUBLIN GULCH  
ENVIRONMENTAL BASELINE ASSESSMENT**

**VOLUME IV: Keno Valley Sites #41 to #66, #68 to #70**

Prepared for  
Waste Management Program  
Indian and Northern Affairs Canada

March, 2000

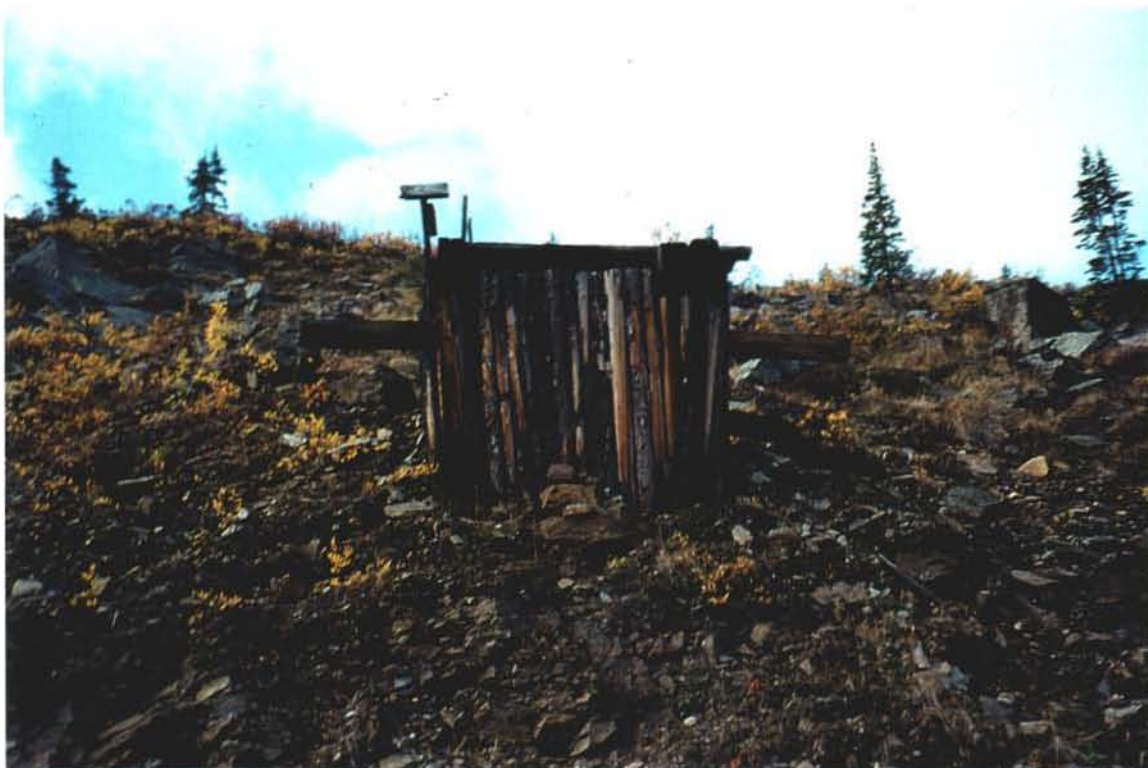
Photo 42-1 : Faith. Faith timber shaft cover building (Building 42-B). (Azimuth 200°)

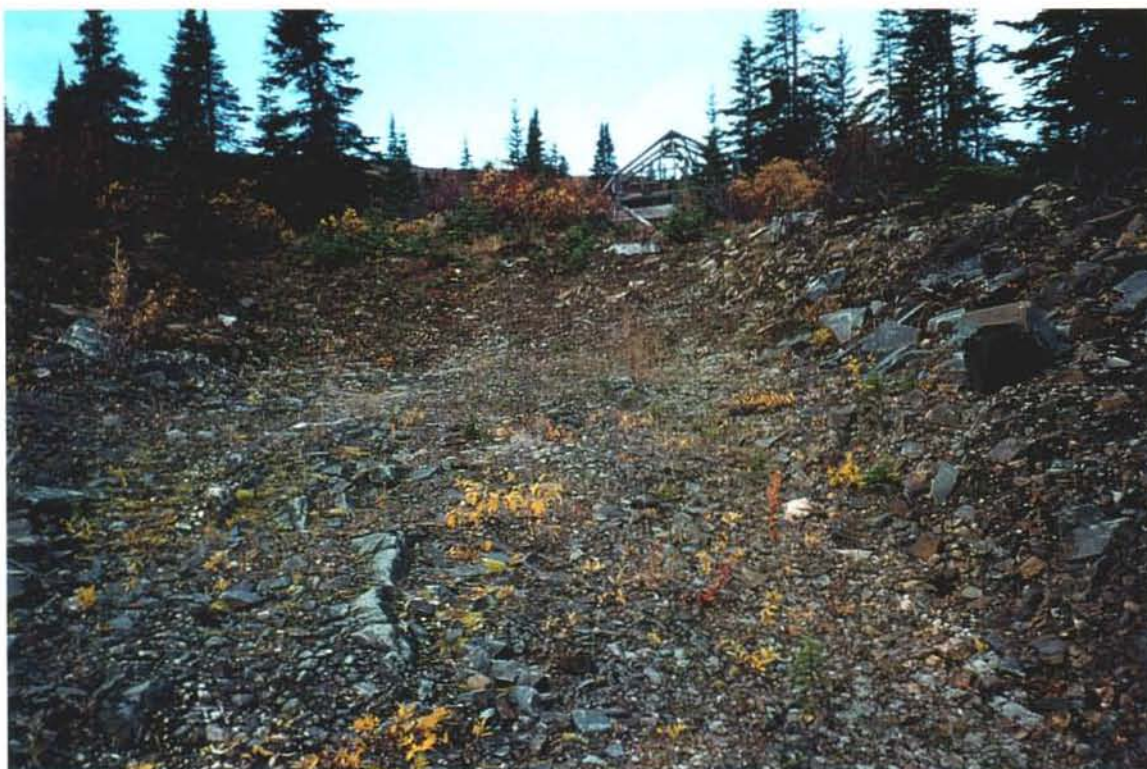
Photo 42-2 : Faith. View along trench (Trench #3) at tent brame (Building 42-A). (Azimuth 230°)

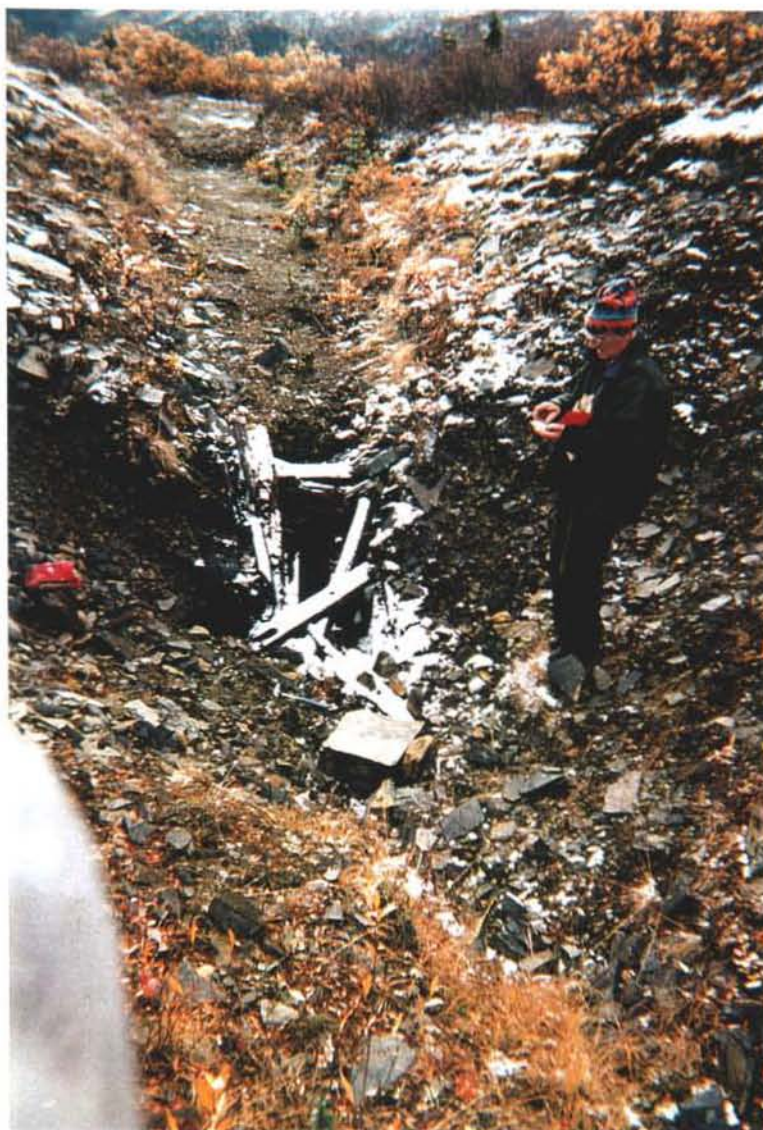
Photo 48-2: View of Shaft 1 in Trench 3 at Apex site. (AZ 132)

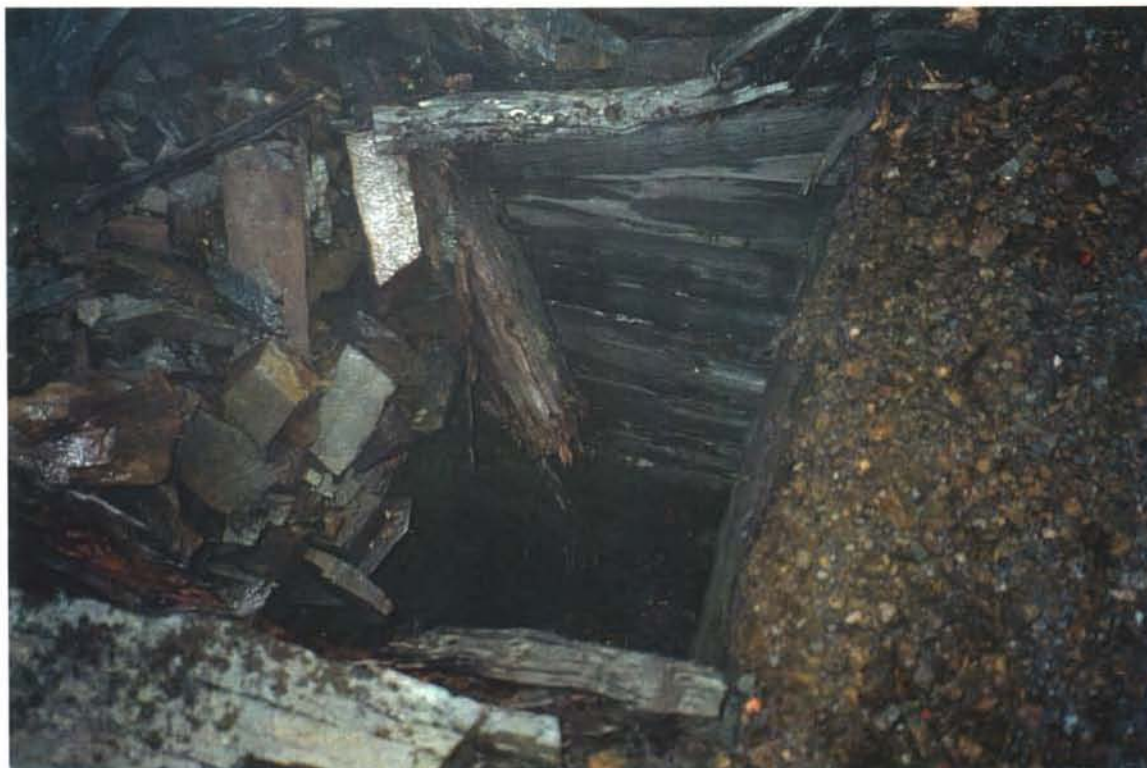
Photo 49-3 : Vanguard. Shaft #4 is still open and in fairly good condition.

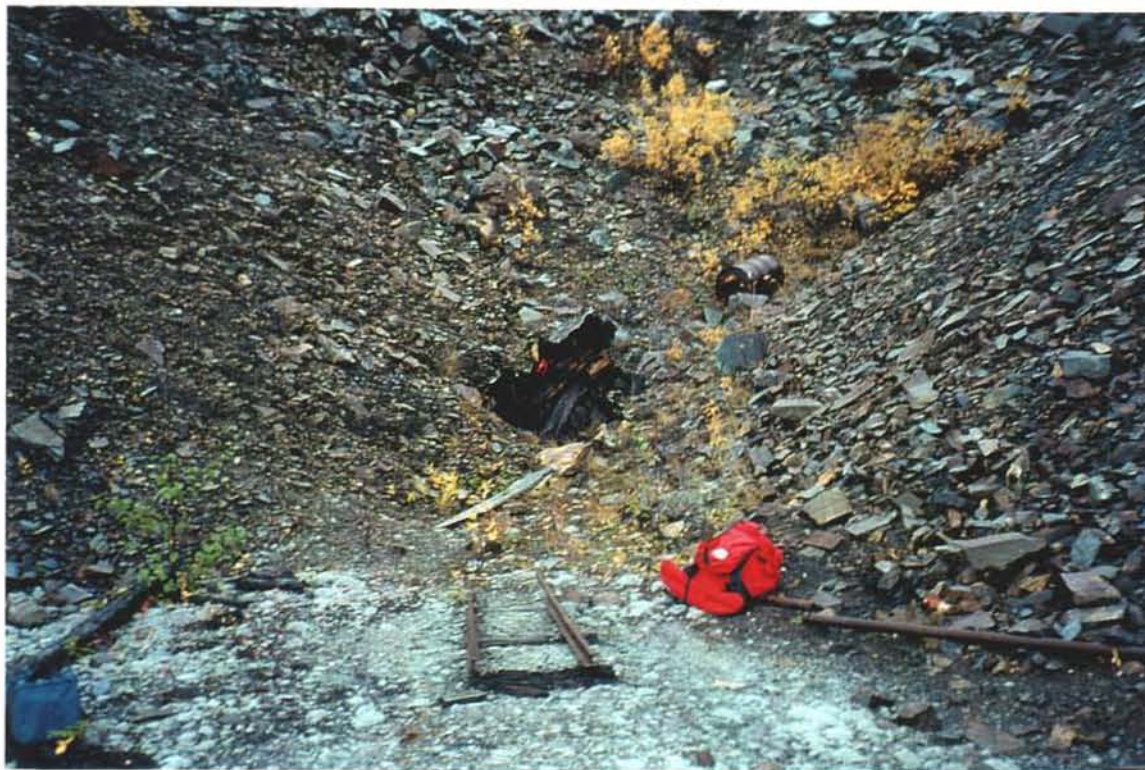
Photo 49-4 : Vanguard. The pile of broken logs and sheet metal marks the entrance to the Vanguard Adit. The first 30m of the adit have collapsed. (Azimuth 290°)

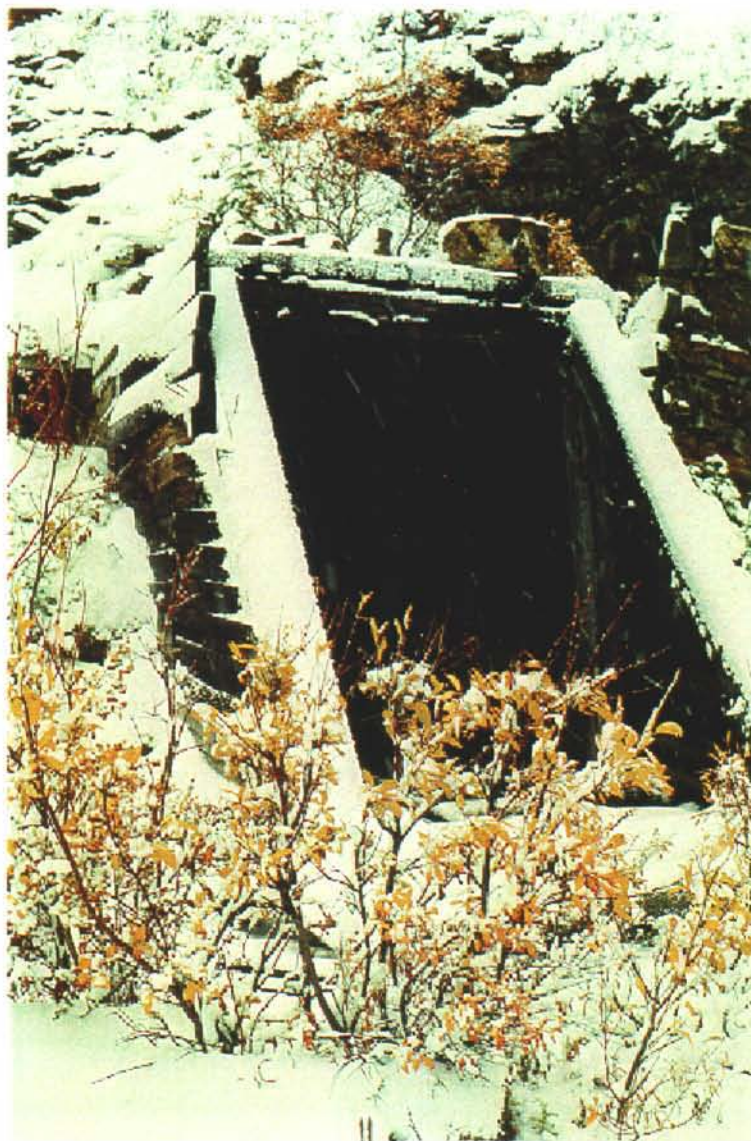
Photo 50-1: The large wooden structure is the portal to the Homestake adit. (Azimuth 225°)

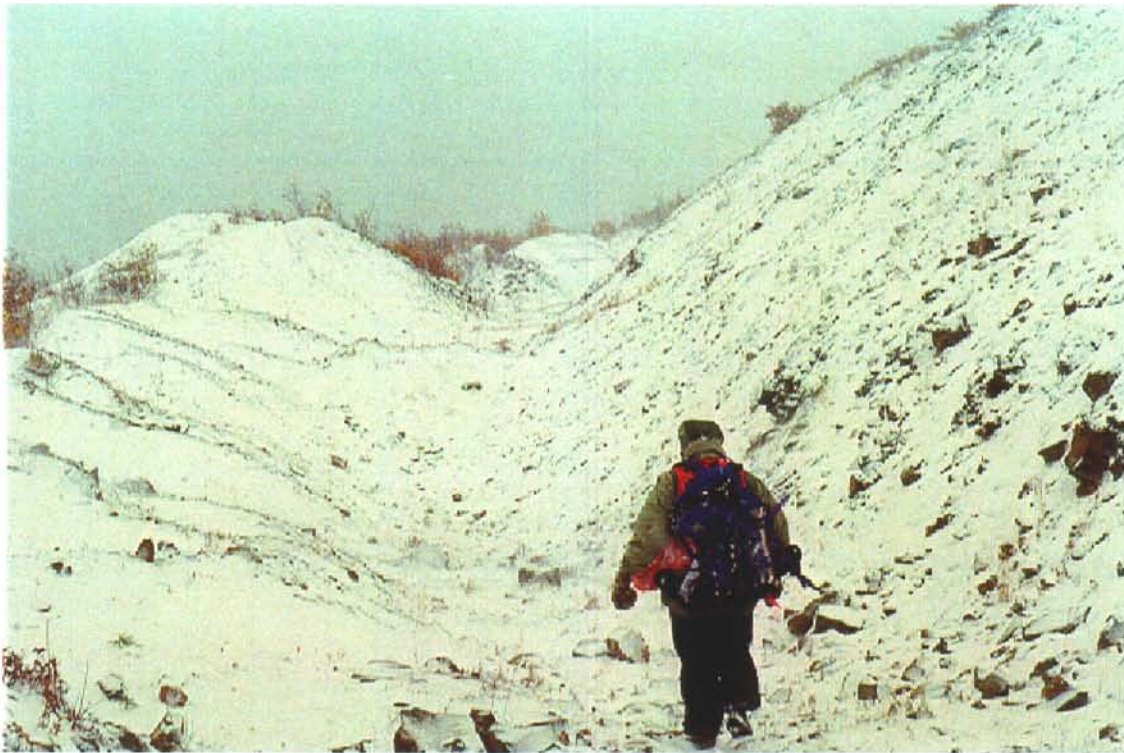
Photo 50-2: Trench 1, the largest trench at the site. (Azimuth 235°)

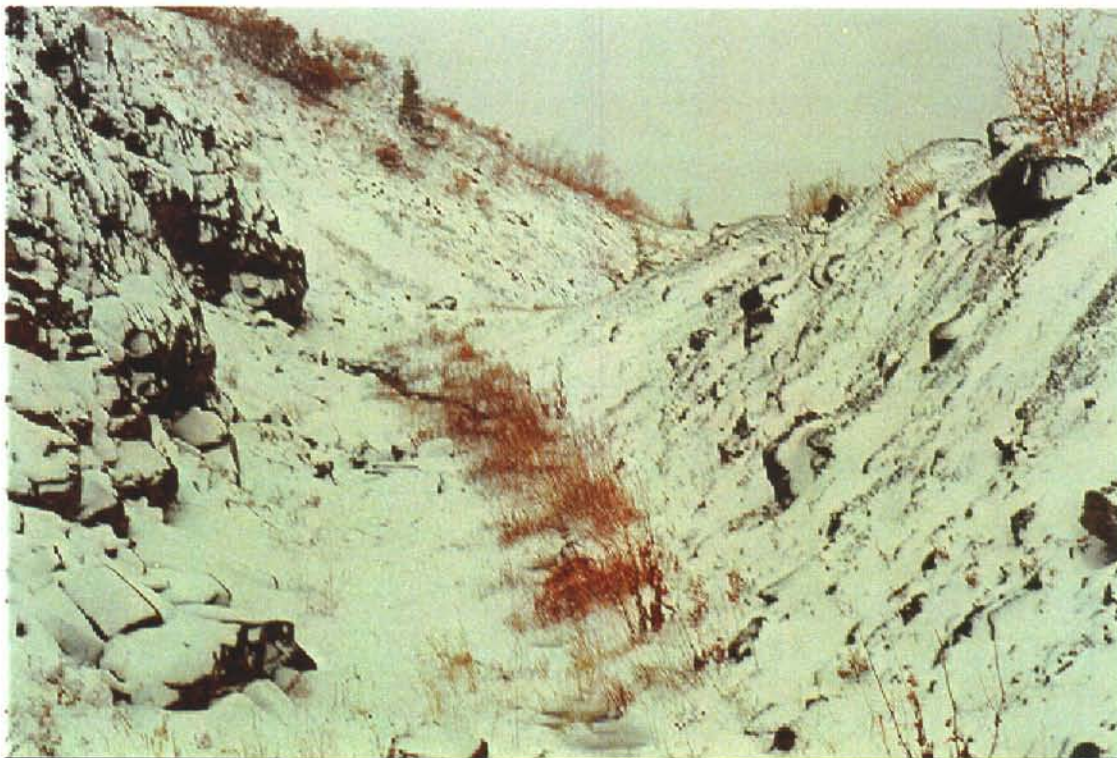
Photo 50-3: Trench 4. Note the high trench walls on the left and waste rock pile #2 on the right. (Azimuth 260°)

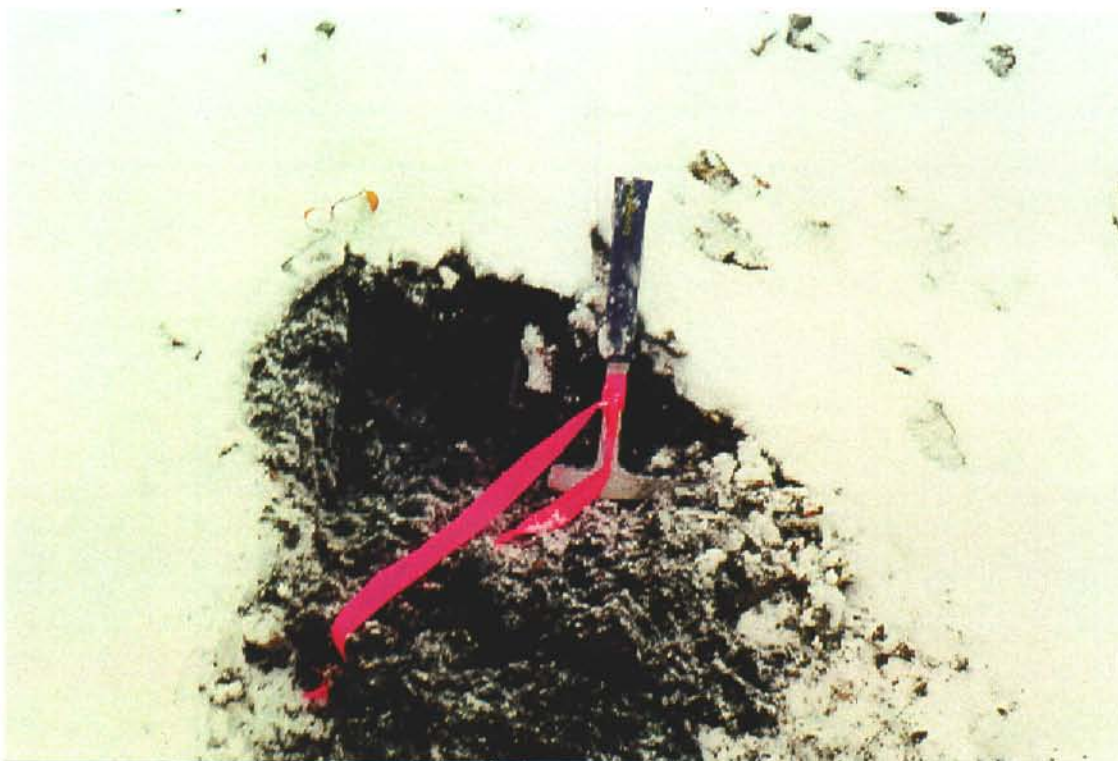
Photo 50-4: Test pit 1, waste rock pile #1. Note there is no oxidized horizon, only minor Fe-staining at the surface. (Azimuth 350°)

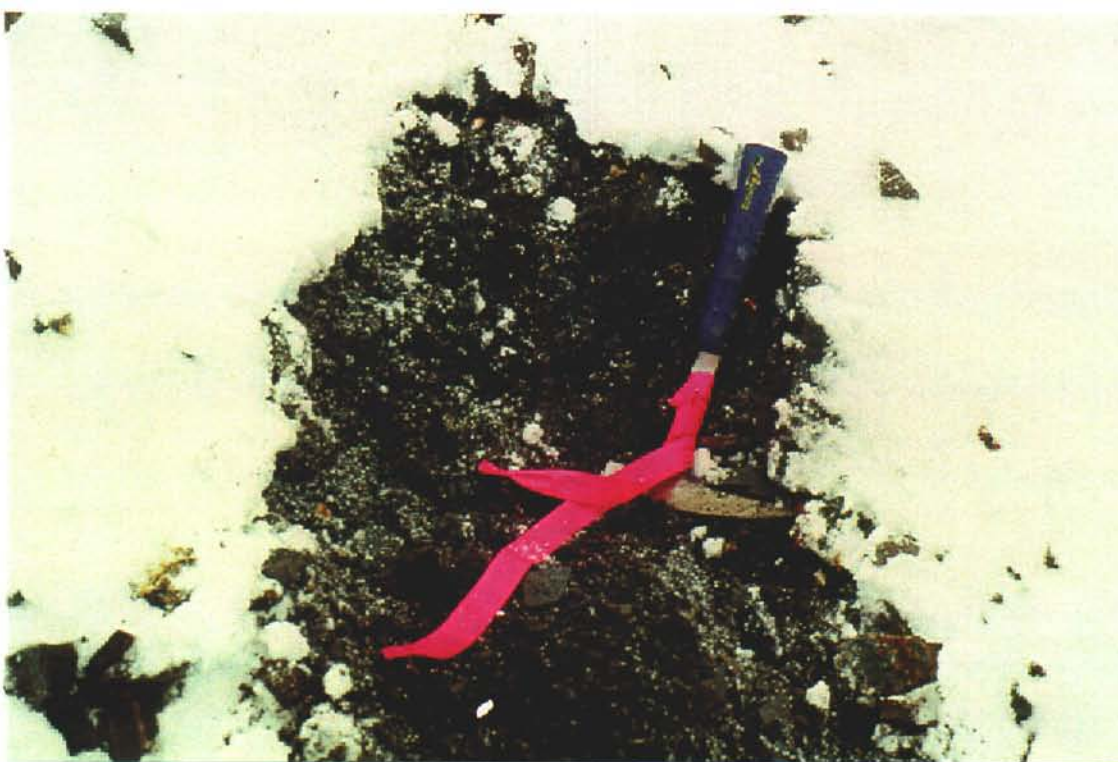
Photo 50-5: Test pit 2, waste rock pile #2, minor Fe-staining at the surface. (Azimuth 000°)

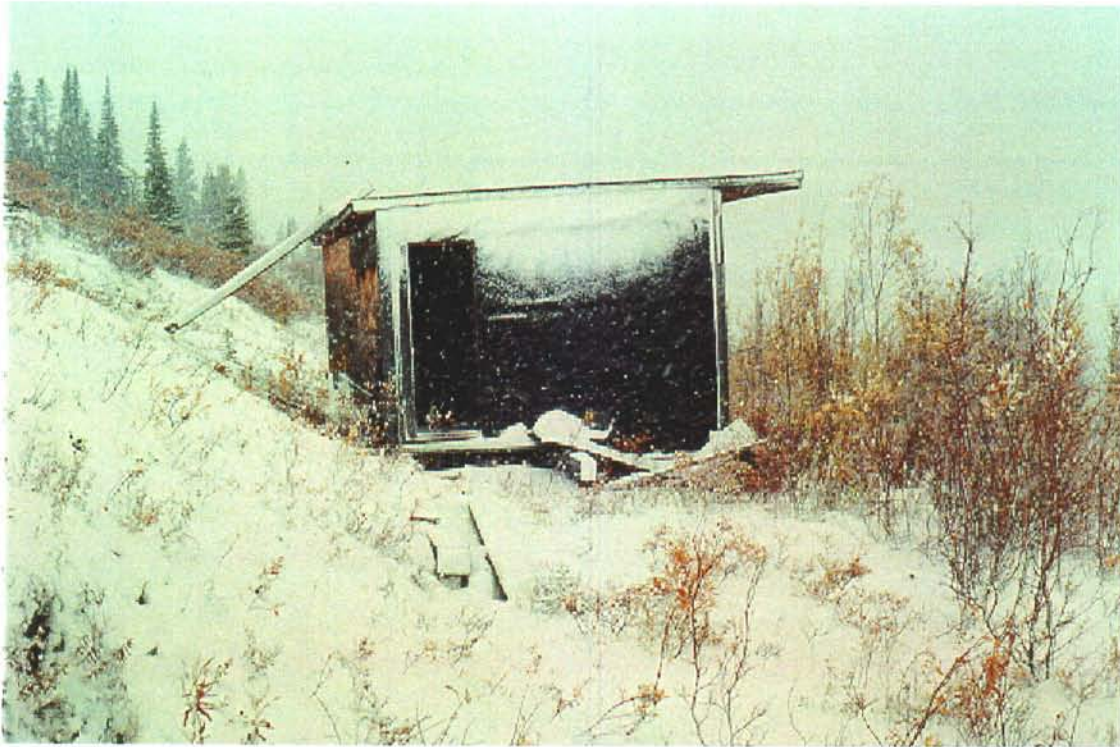
Photo 50-6: Building 50A with a small pile of wood debris out front (Azimuth 270°)

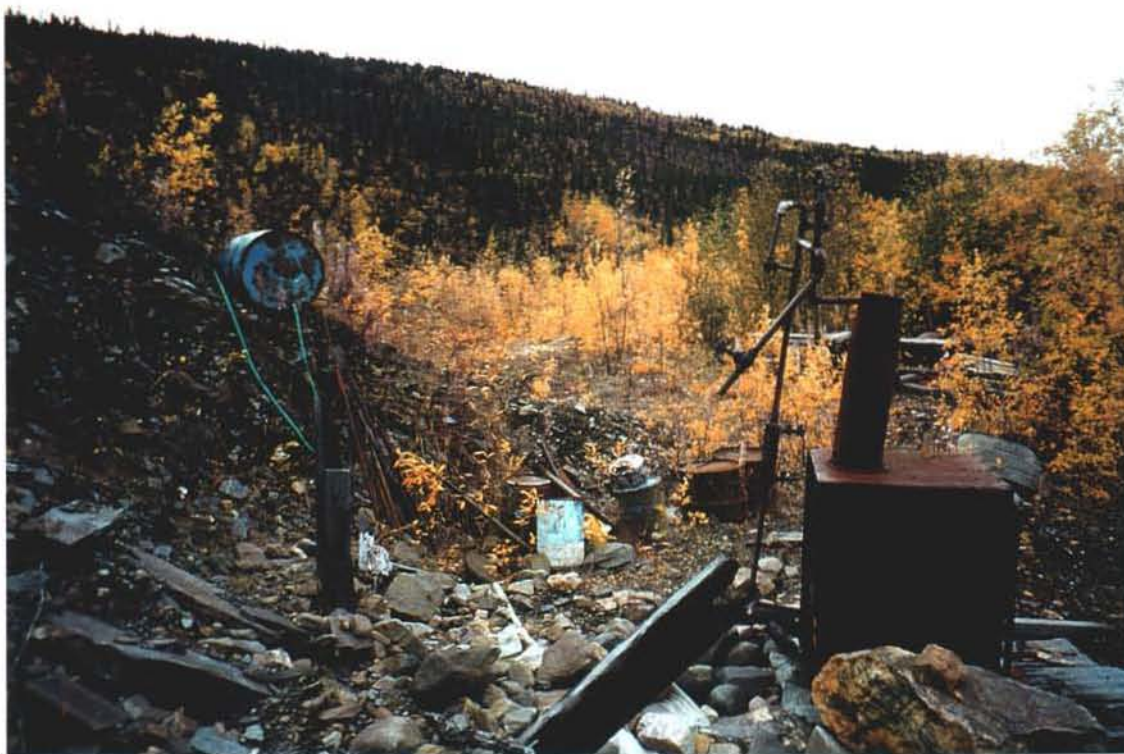
Photo 53-2: View of Adit 1 at Maybrun site. AZ 234  
 Photo 53-2: View of collapsed shaft (Shaft 1) at Maybrun located above Adit 1. (AZ 300)

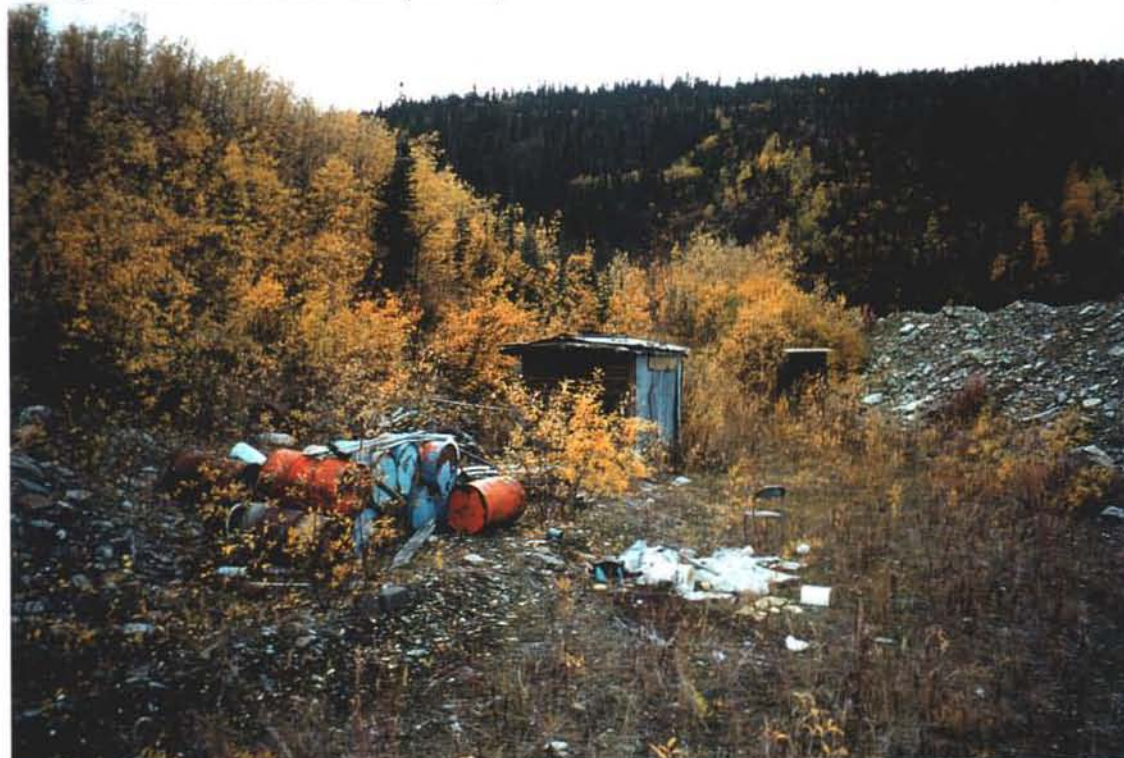
Photo 53-3: Abandoned shack, empty barrels and scattered debris located at Maybrun.

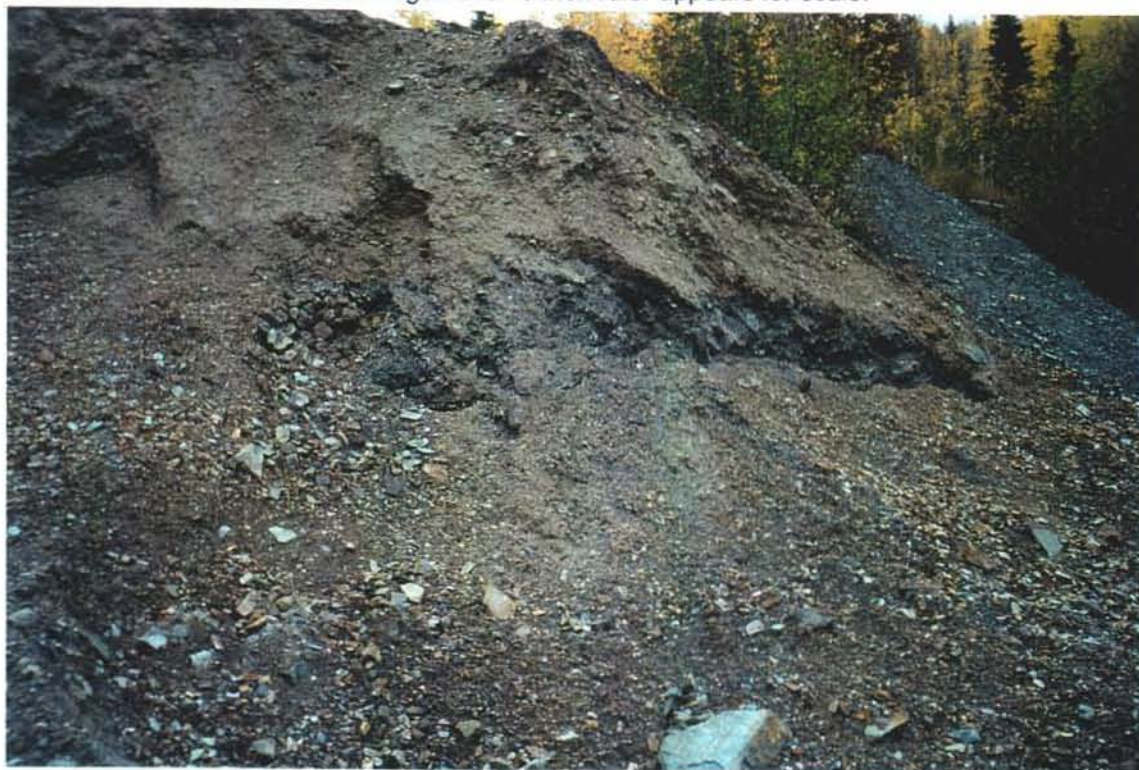
Photo54-4: Weathering of west side of waste rock dump at Hogan site.

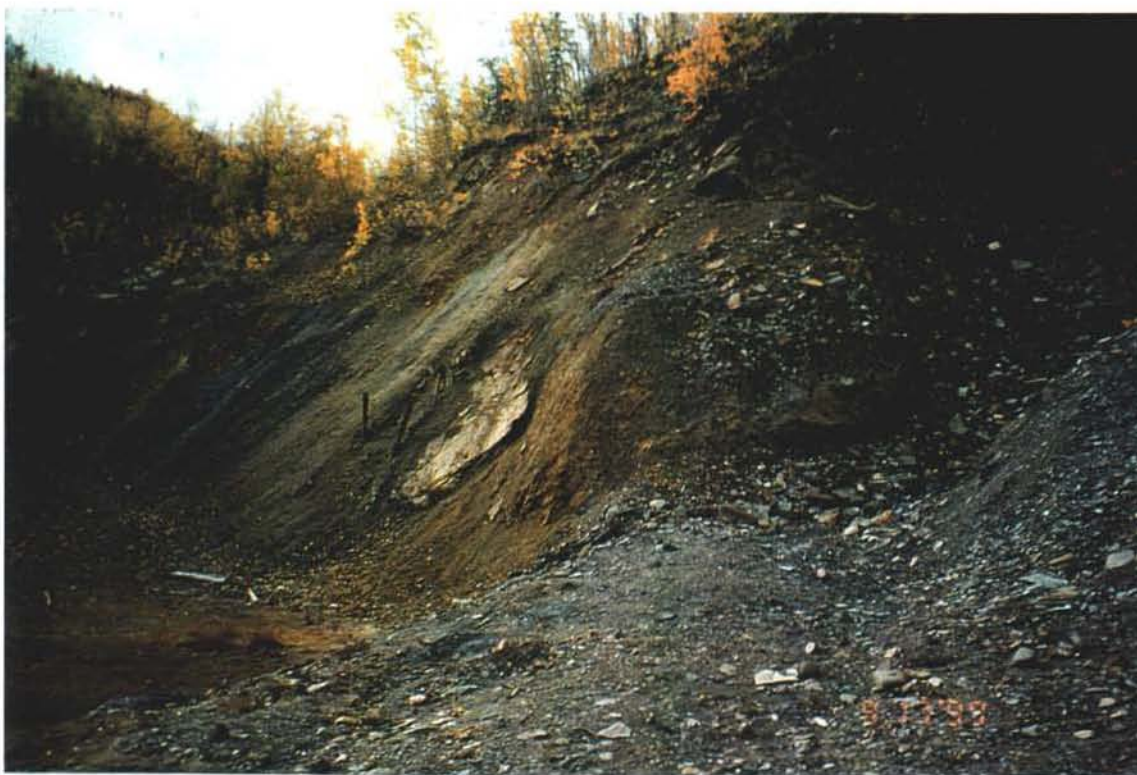
Photo 57-1: Remains of shaft on slope at upper workings.

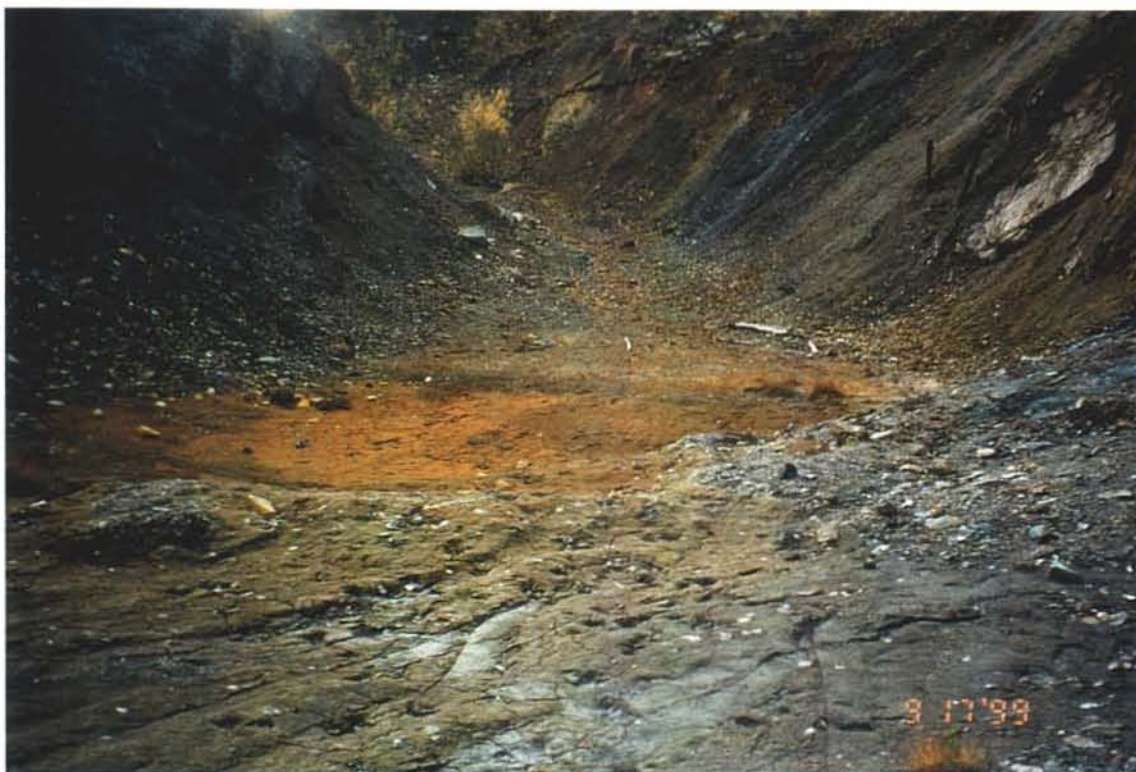
Photo 57-2: Bottom of slope at upper workings where water has ponded in past.

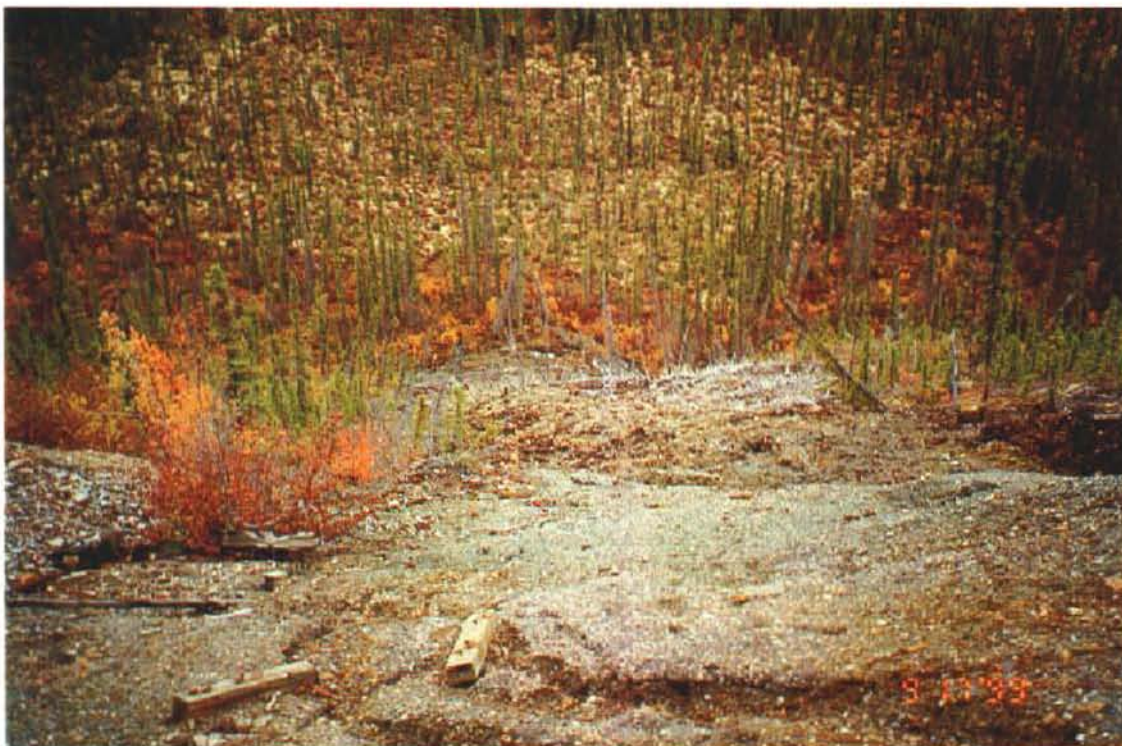
Photo 57-5: Waste rock below lower workings. Note Christal Creek at bottom.

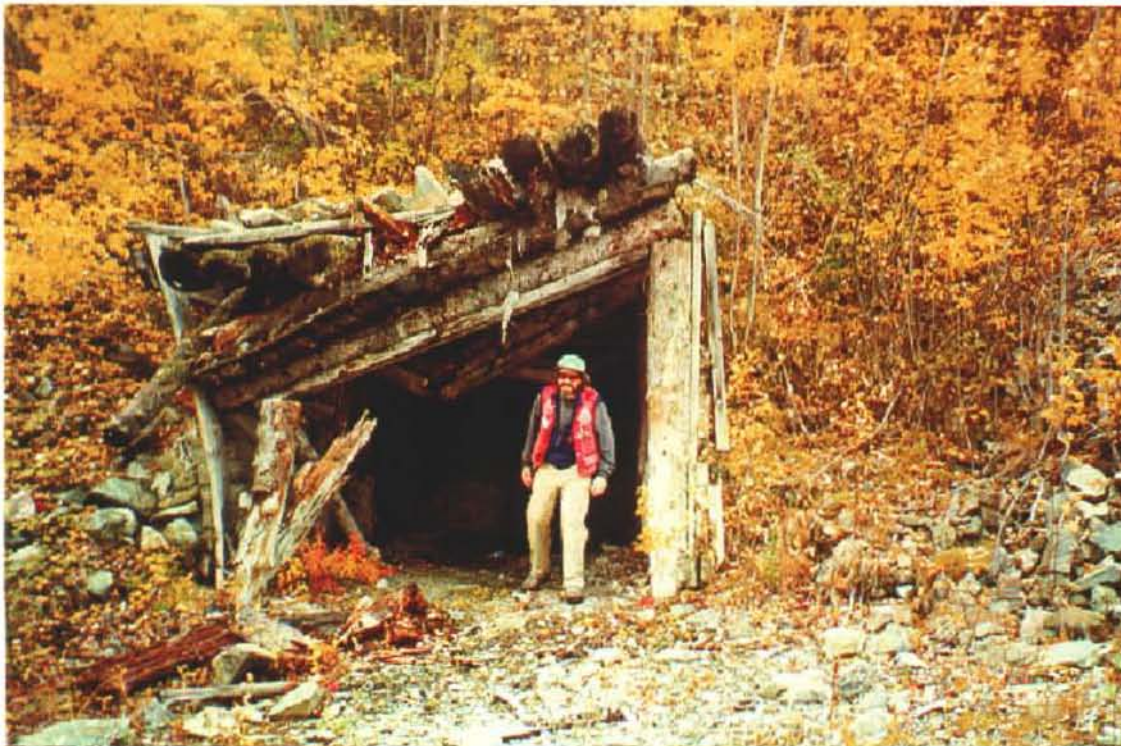
Photo 58-2: Open adit.

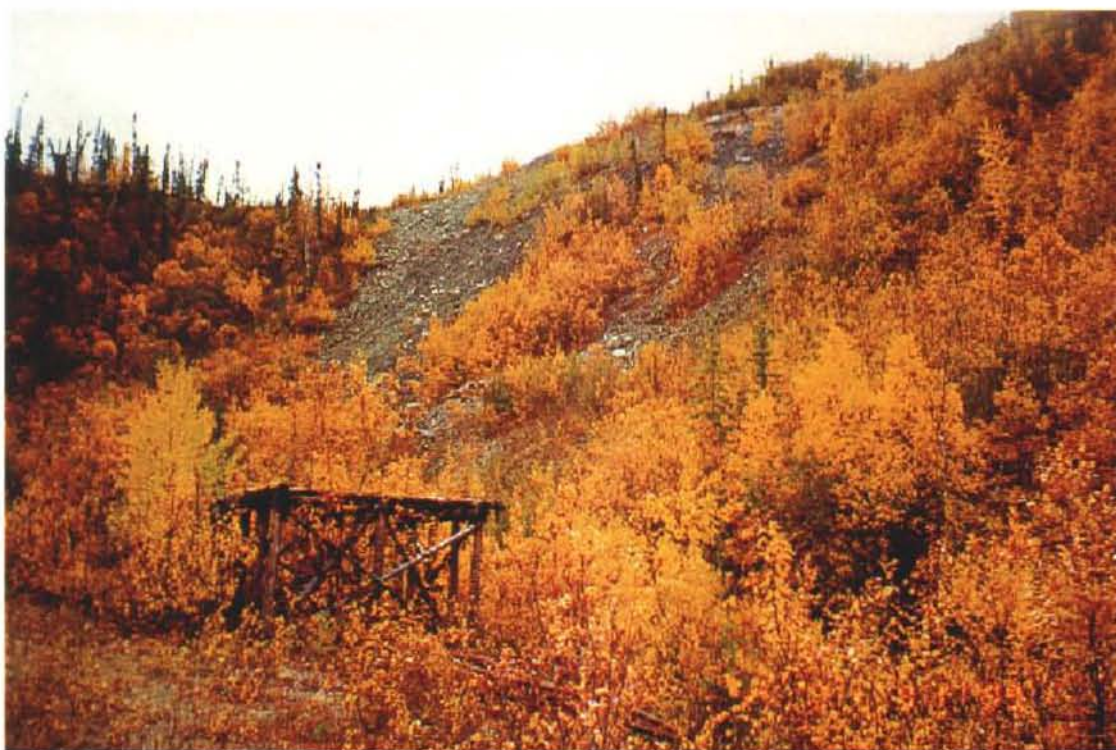
Photo 58-6: Waste rock on slope adjacent to adit.

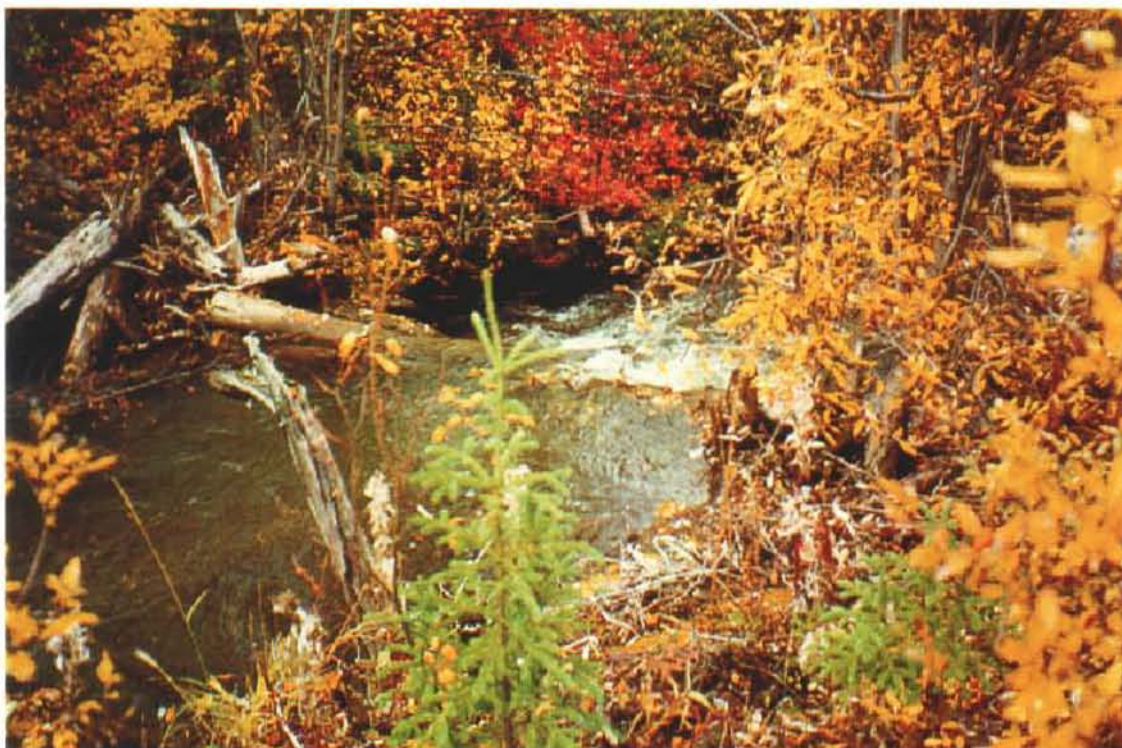
Photo 58-9: Second collapsed bridge downstream of site.

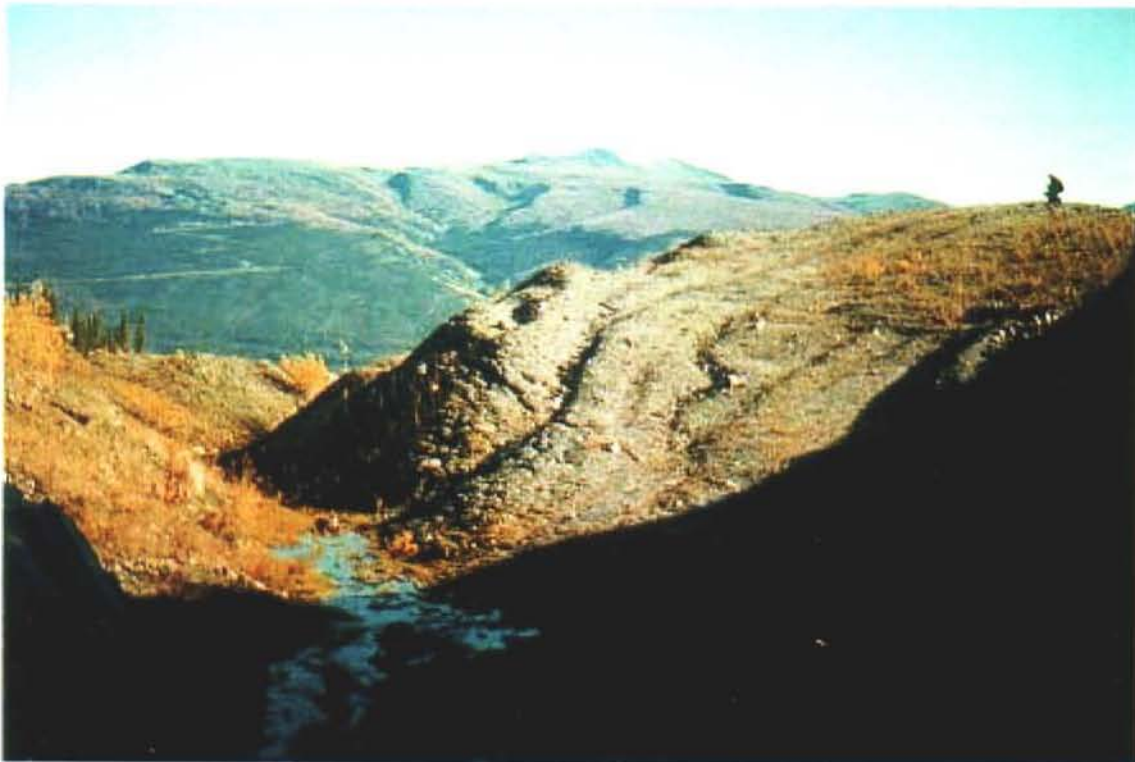
Photo 59-3. Main waste rock pile, looking east. Note water from seep and revegetation of waste rock.

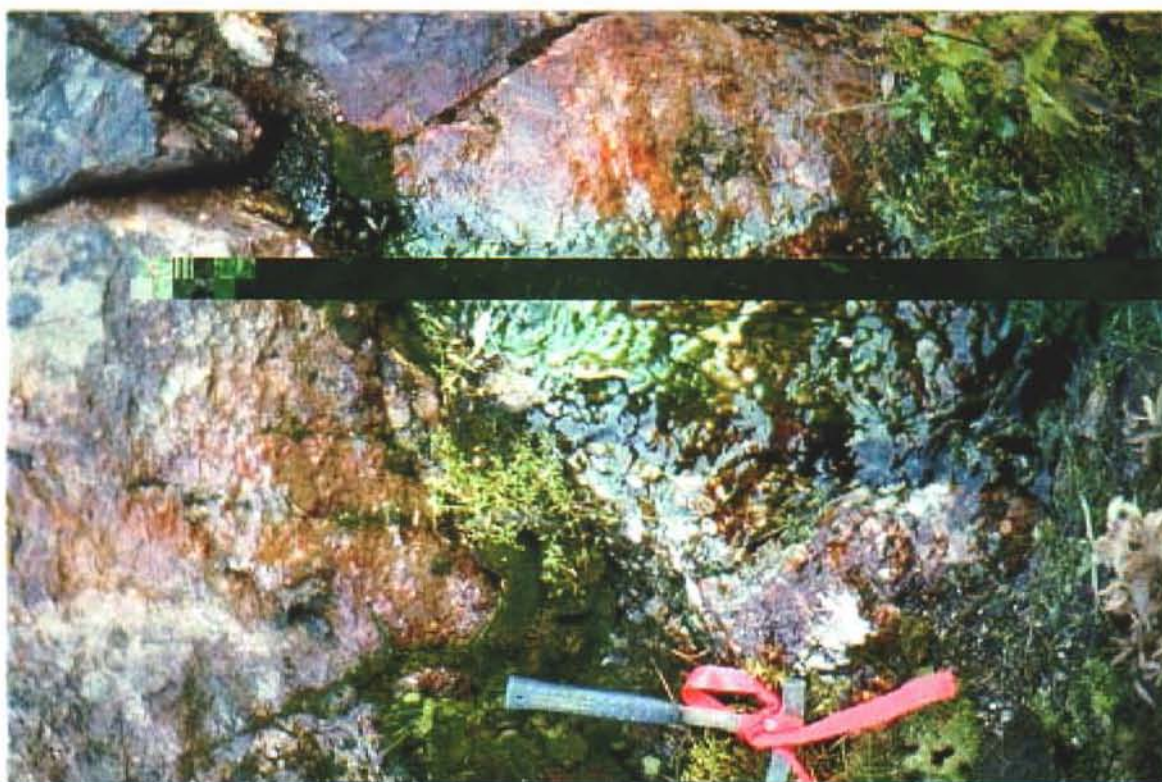
Photo 59-5. Seep from the rock around the vein. Note green moss growing in water.

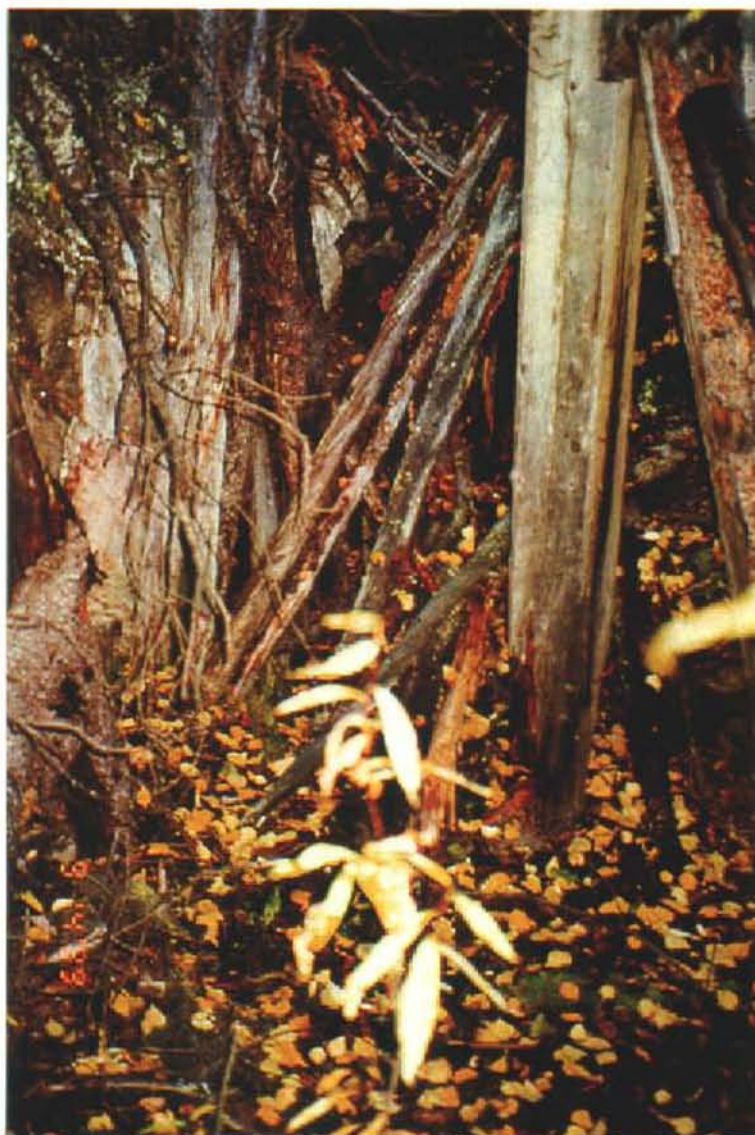
Photo 61-1: Timbers partially obscuring entrance to collapsed adit.

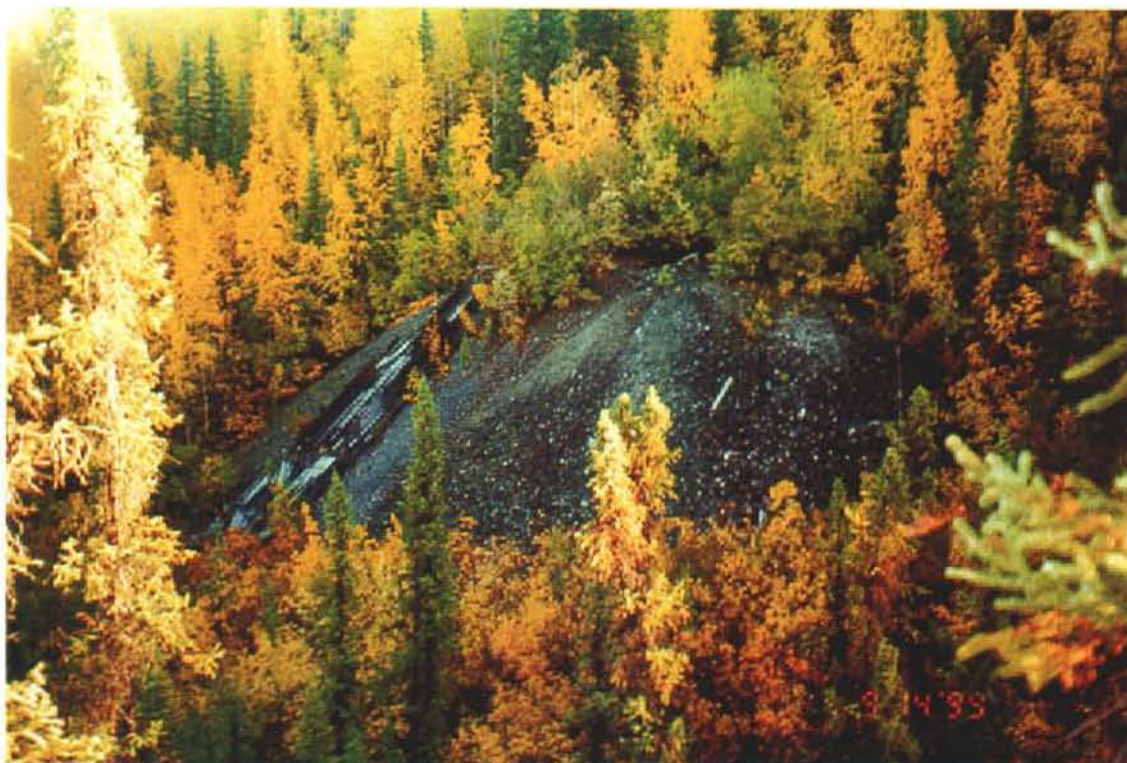
Photo 61-2: Waste rock and loadout structure below adit.

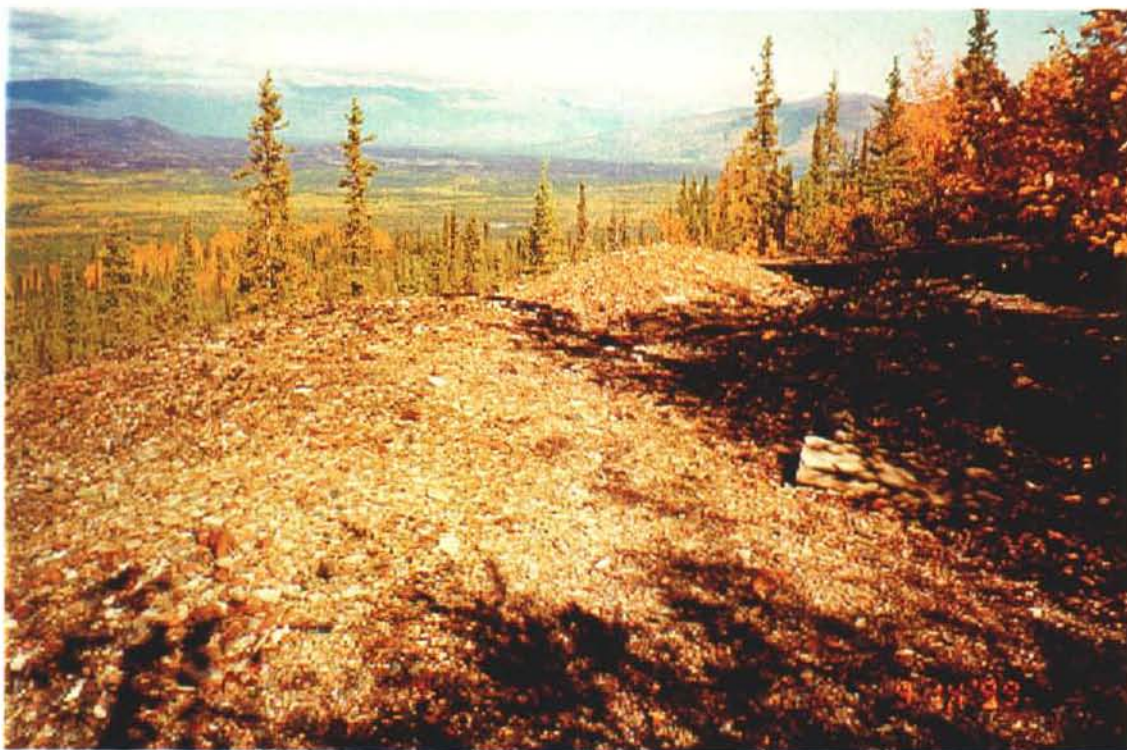
Photo 61-3: Waste rock on slope adjacent to headframe.

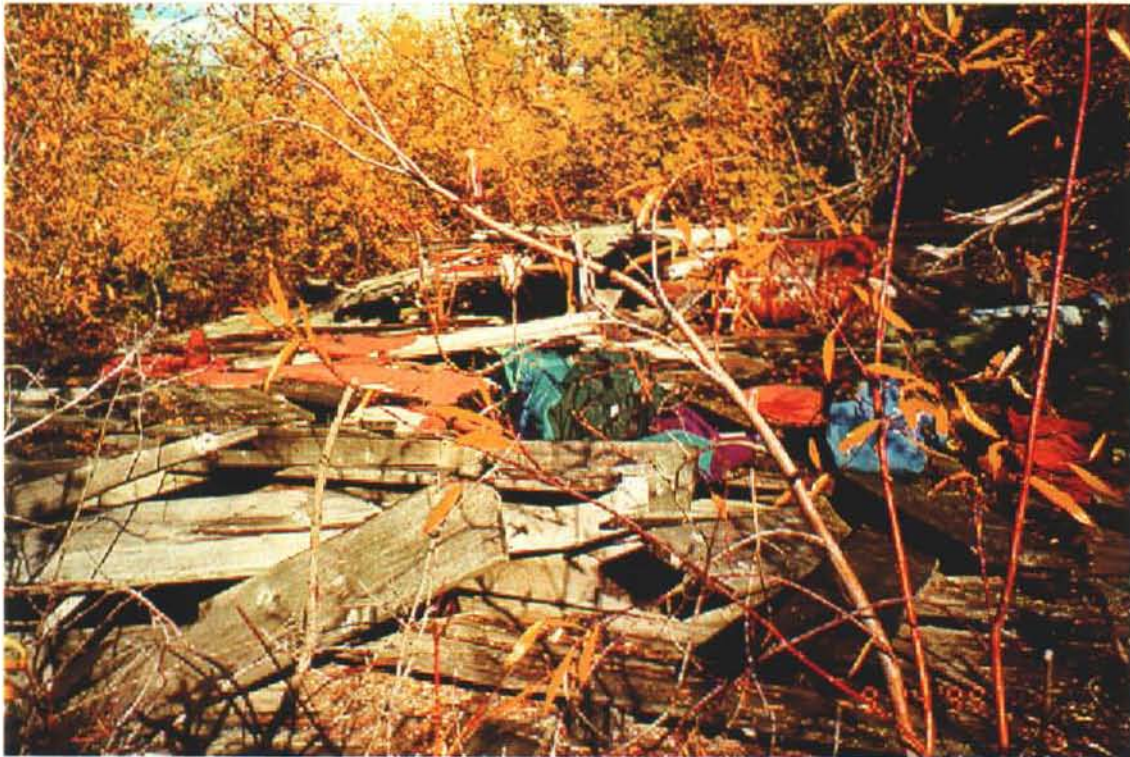
Photo 61-5: Wood debris at former bunkhouse/cookhouse building 61B.
