**KENO VALLEY/DUBLIN GULCH  
ENVIRONMENTAL BASELINE ASSESSMENT**

**VOLUME IV: Keno Valley Sites #41 to #66, #68 to #70**

Prepared for  
Waste Management Program  
Indian and Northern Affairs Canada

March, 2000

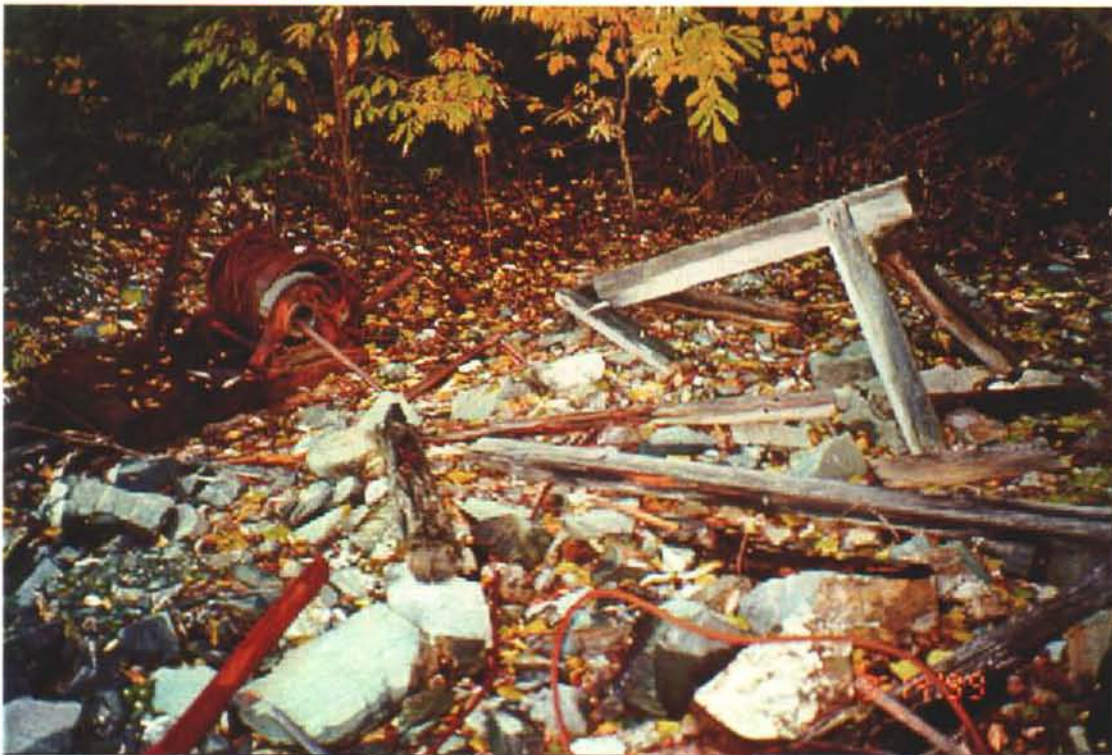
Photo 61-6: Wood and metal debris near entrance to adit.

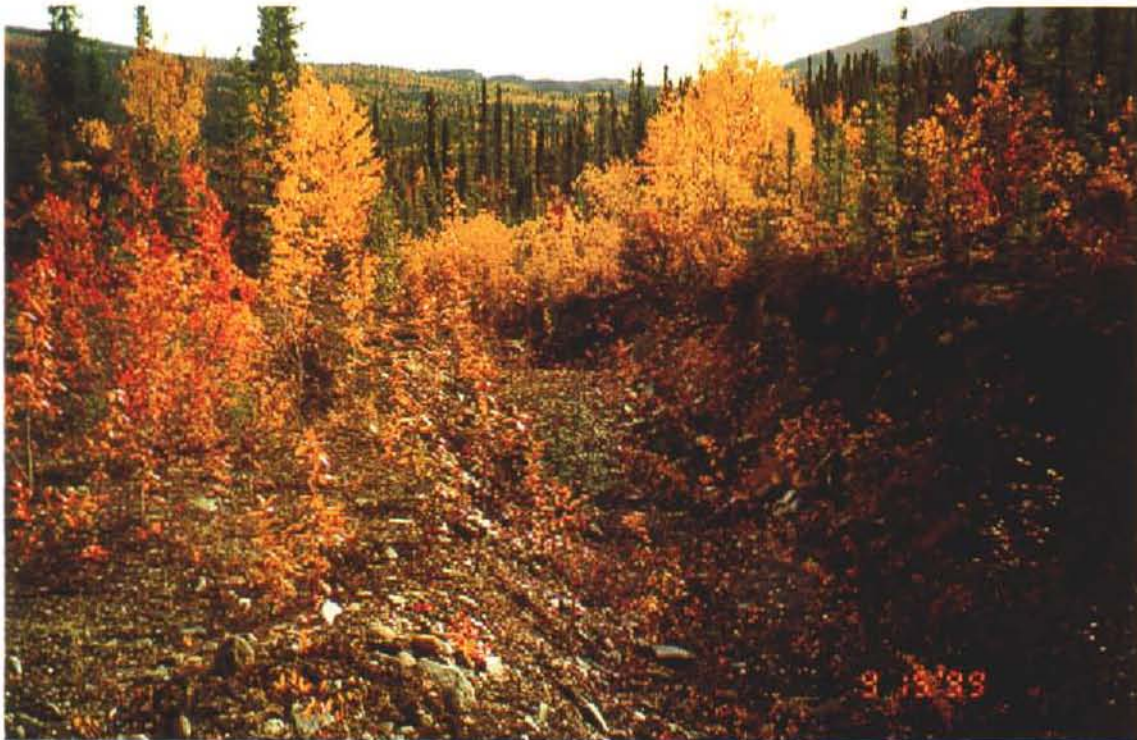
Photo 62-1: Partially overgrown trench adjacent to road.

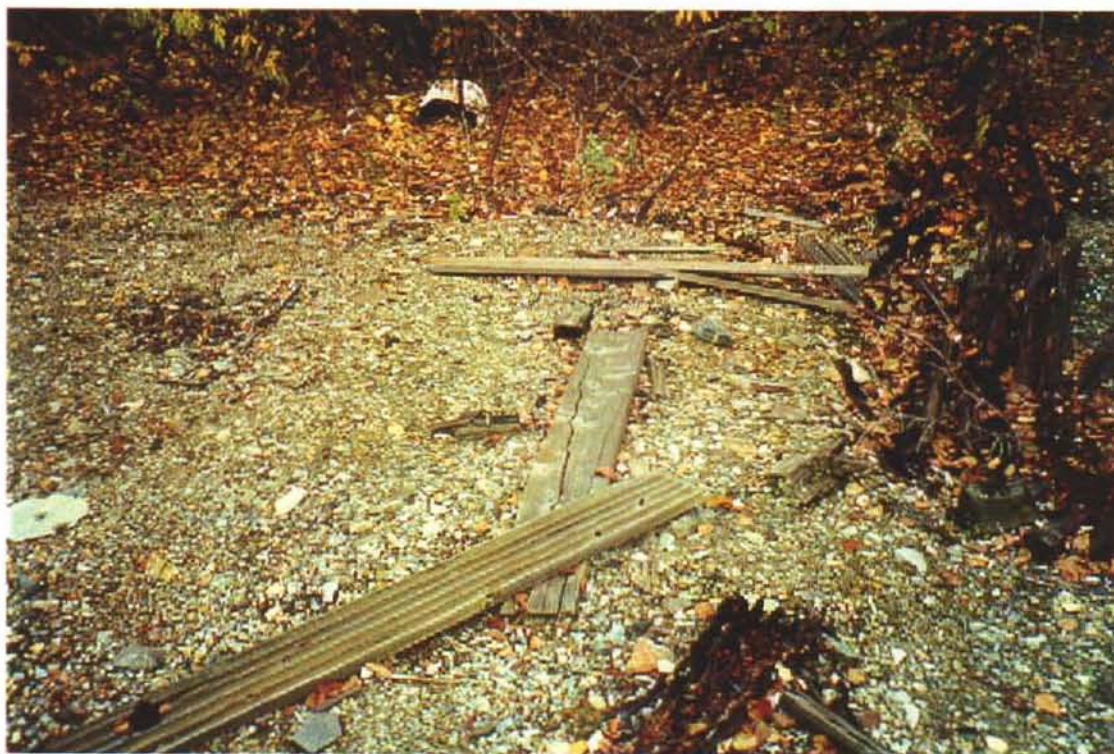
Photo 63-2: Core boxes and other debris lying in trench 1. (Azimuth 170°)

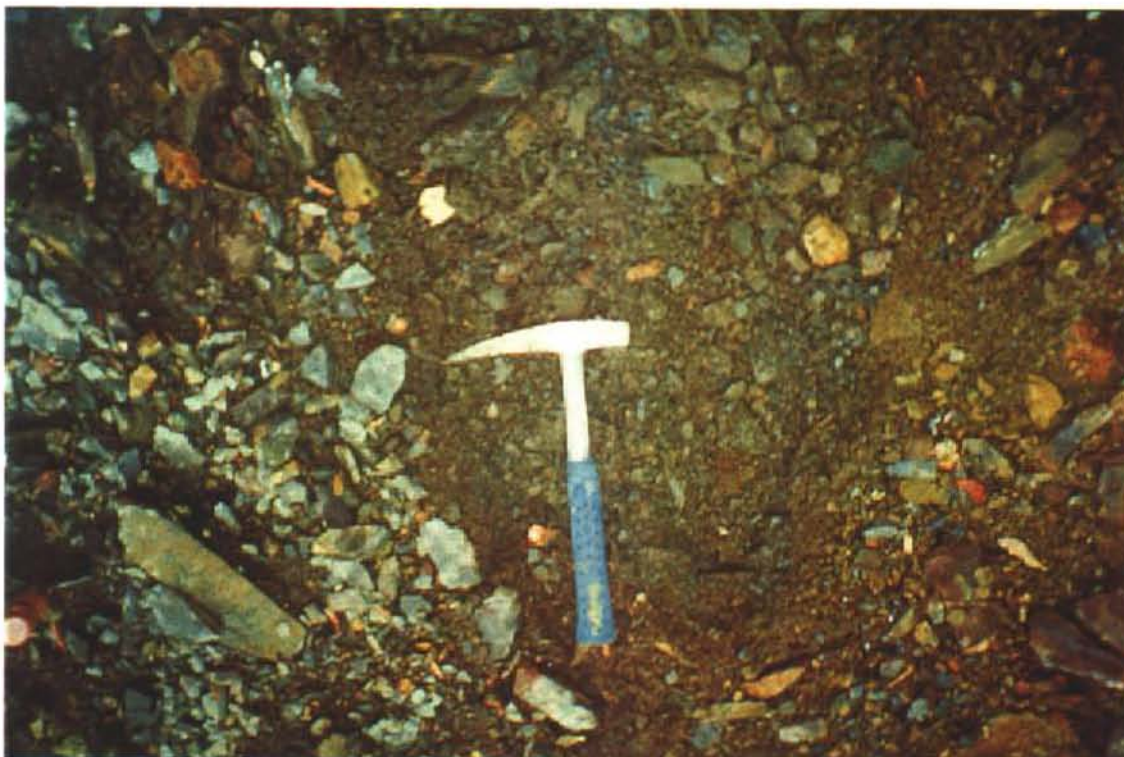
Photo 63-3: Test pit from waste rock pile #2. Note the shallow oxidation horizon. (Azimuth 170°)
