ASSESSMENT REPORT

105D-02-3

ARCTIC CARIBOU

DIAND TECHNICAL SERVICES

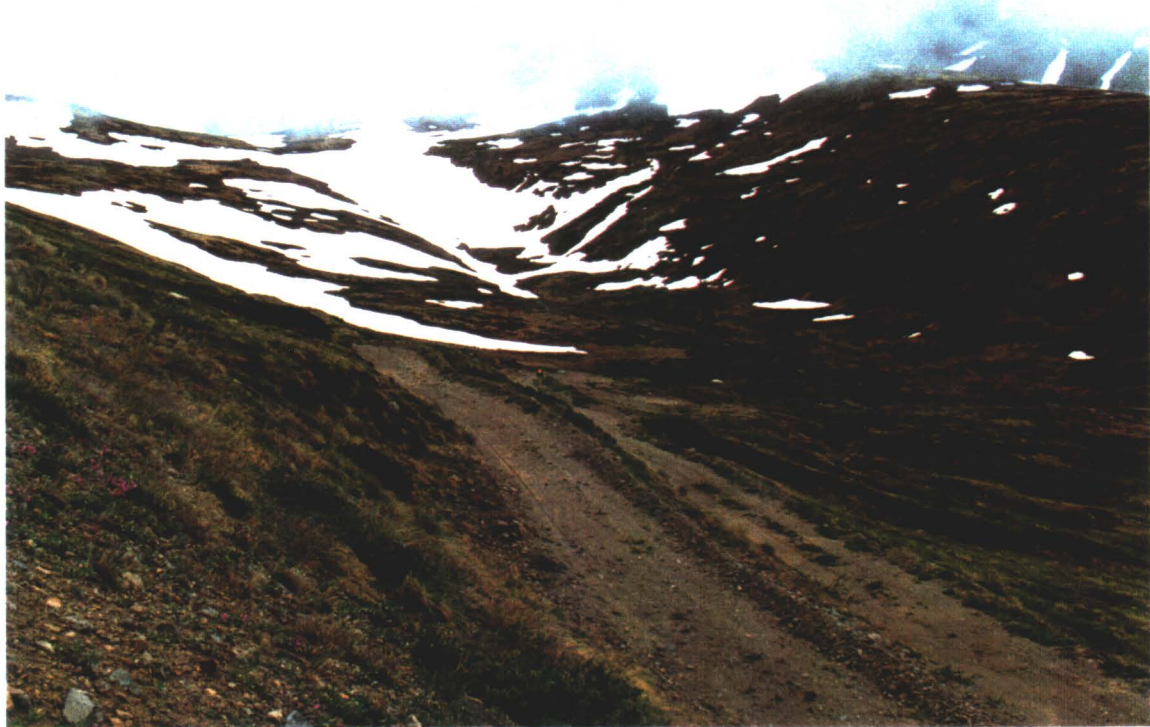
ARCTIC CARIBOU EXPLORATION AREA

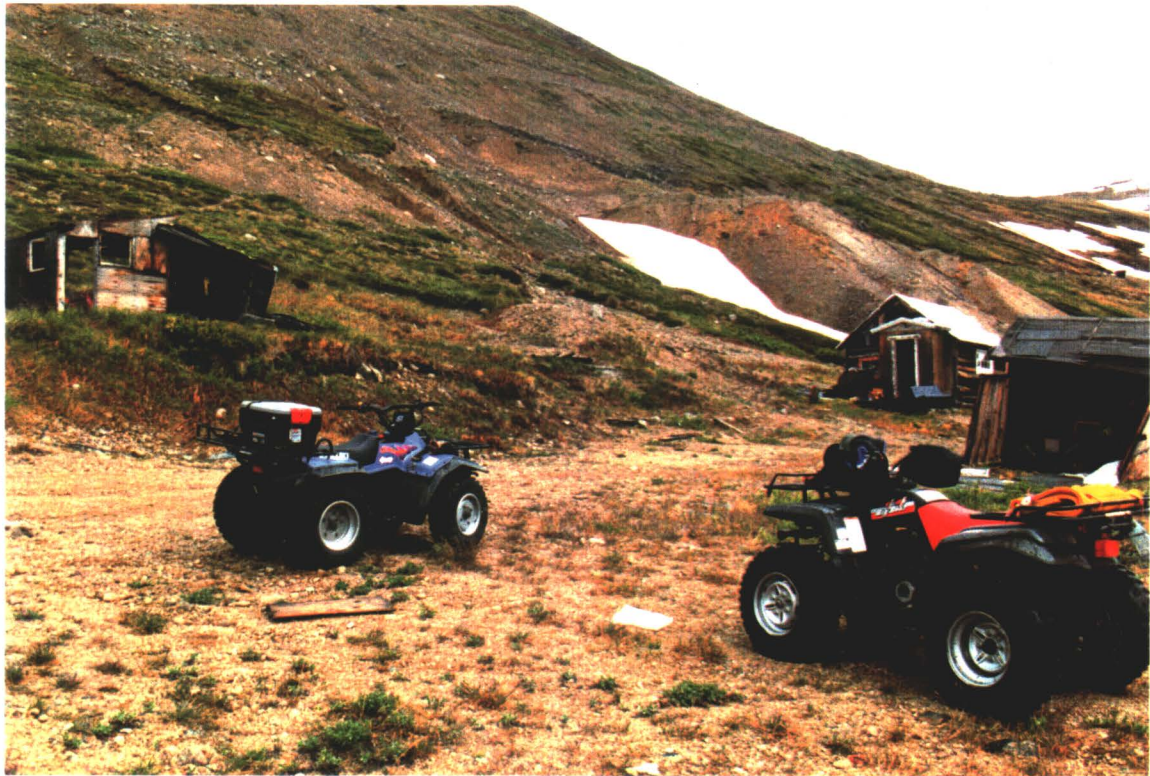
Three small buildings are still on-site. These buildings include;

- 1 - 4x3m log cabin,
- 1 - 2x3m wooden shed, and
- 1 - 4x3m wooden shed.

These buildings are old and collapsing and are effectively worthless.

MINE EXPLORATION BUILDINGS (ADIT IN BACKGROUND BEHIND SNOW)

- the three remaining wooden buildings be dismantled and burned in an acceptable area,
- all metal waste including barrels and rail be removed from the site.

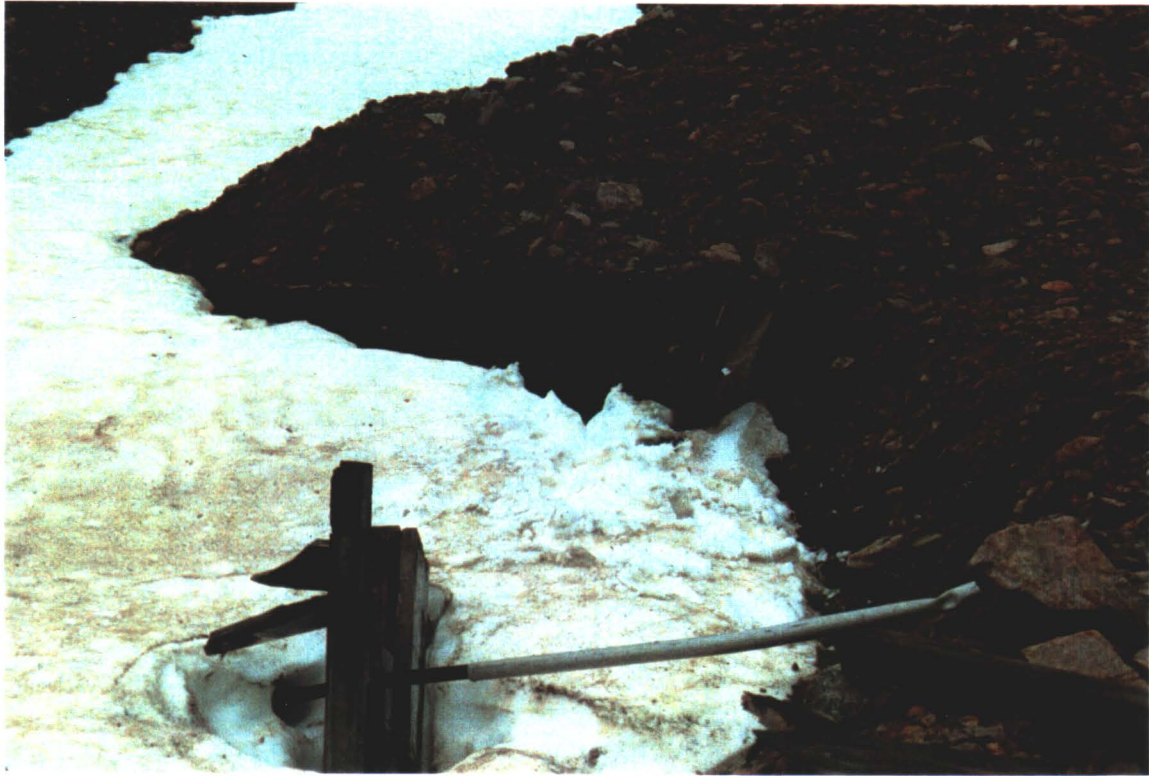
An open exploration adit remains at the site. At the time of inspection on 1993/06/21 the entrance to the adit was still covered by snow. This entrance to the adit is accessible to the public. The waste rock extending beyond the adit entrance covers an area approximately 30x50m. The thickness of the waste rock pile extends to 20m deep.

The mine adit is unsecured and open to the public. Because this site is accessible by road and close to populated areas (Whitehorse and Carcross), the open adit should be considered a safety hazard. The adit should be sealed to prevent the public from entering it. If the adit is left unsecured a potentially **HIGH** level of risk remains for an accident to occur.

MINE ADIT

However, public safety of the open adit should be considered a **HIGH** level of risk if left unsecured and accessible, and it is recommended that closure of the adit be completed.

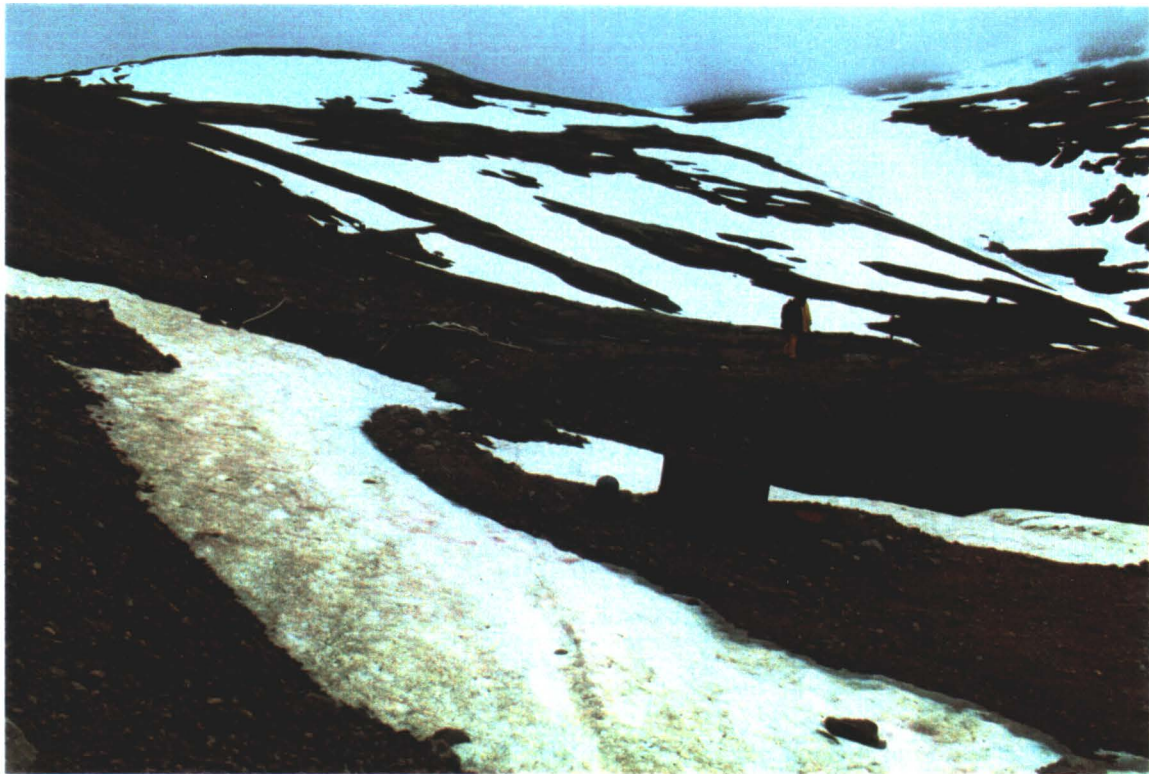
The waste area has been developed by dumping the waste rock over the slope below the adit. This was developed by extending railway track from the adit to the edge of the slope. As noted, the waste rock was dumped down the slope below the adit and is steeply sloped between 35-40 degrees. Because of a small gully above the site, snowmelt has been channeled through the waste area resulting in severe erosion above and below the adit.. Some avalanching may also have occurred at some time in the past. The result is waste material is being transported downslope and spreading onto the valley floor below. Approximately one hectare of vegetation has been destroyed at the time of inspection. It appears that most of the waste pile erosion has happened, however the erosion process is expected to continue for some time. This will result in additional deposition of material downslope, most of which will remain on the deposit that has been created. Some new material will eventually deposit along the leading edge of the fan resulting in some further destruction of the vegetation.

- deposition of the material has destroyed approximately one hectare of vegetative cover,
- additional damage will result if the erosion process is allowed to continue unimpeded,
- the damage to date is not encroaching on any streams or affecting any fish habitat,
- because the erosion is occurring, the possibility exists for triggering a slide of the remaining waste dump.

EROSION GULLY THROUGH EXPLORATION SITE

- constructing a toe berm on the eroded outwash to contain any future erosion,
- backsloping the eroded gully through the waste dump and riprapping the sides of the waste material to reduce the risk of future erosion, or
- diverting flows from the gully to eliminate the potential for erosion.

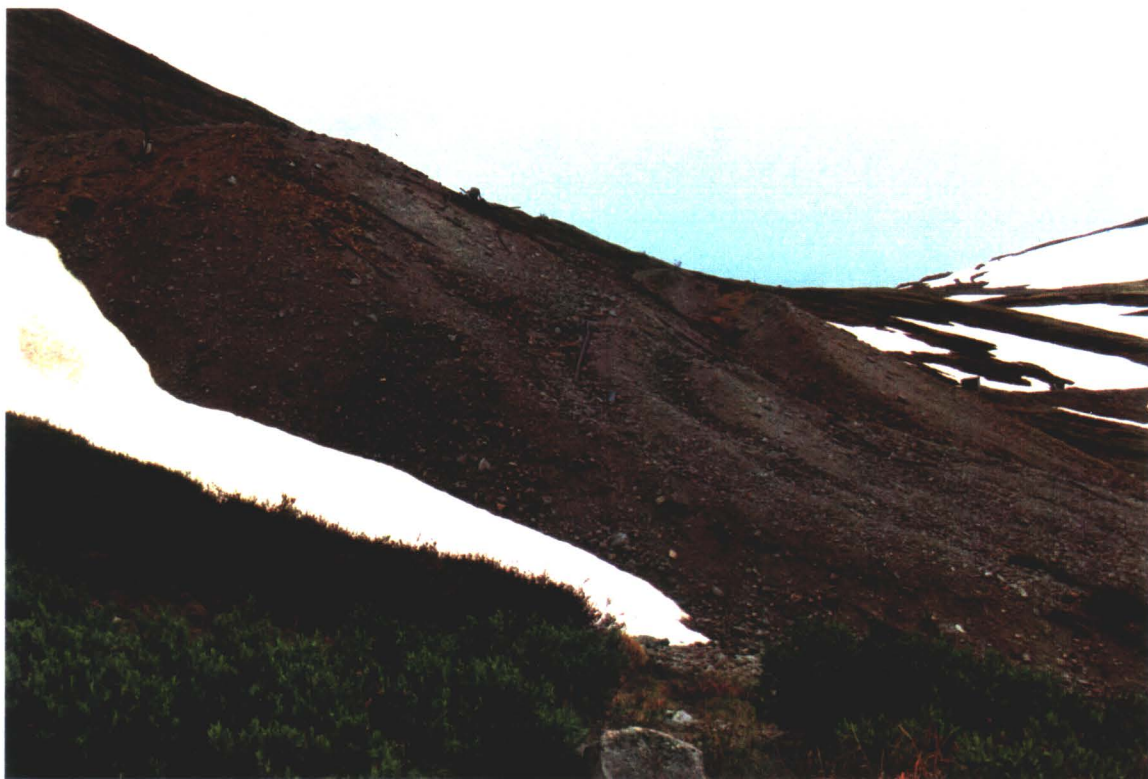
WASTE ROCK DUMP

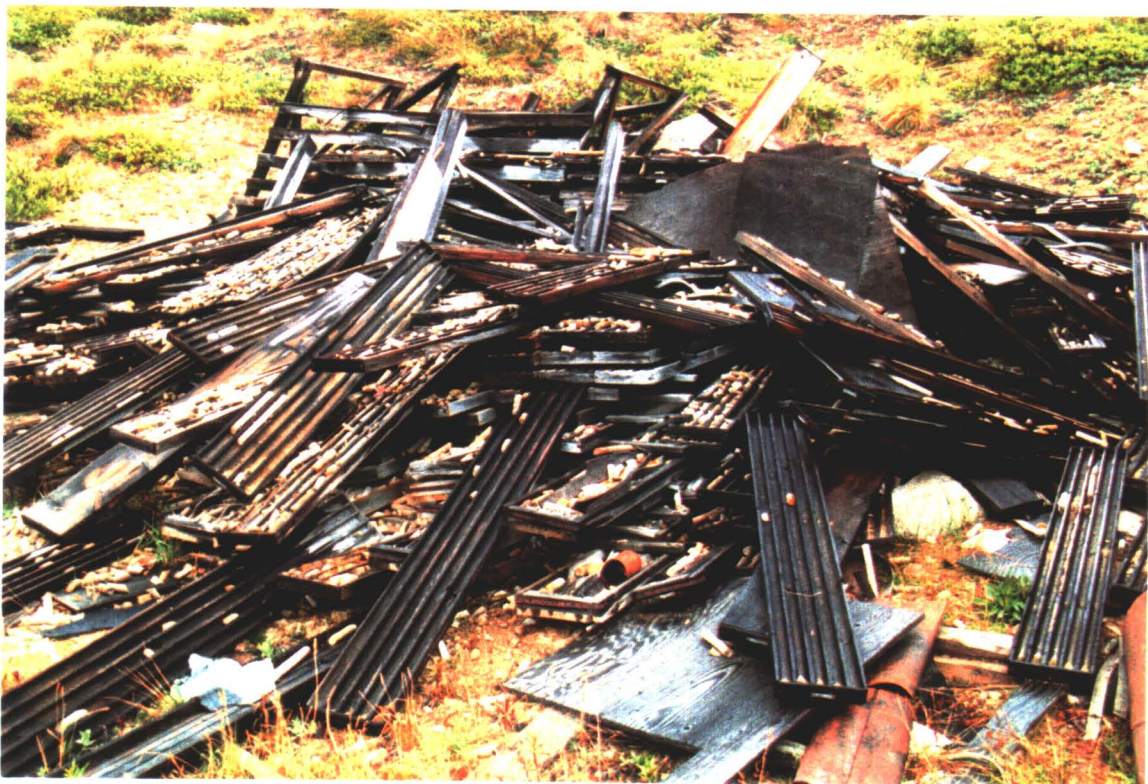
Metal waste consisting of mostly pipe and rail is scattered over the site and dumped over the waste pile. Approximately 100m of railway track is in place outside the adit. A pile of core boxes with core has been left on-site. Two old empty barrels were also found at the site.

ROCK CORE

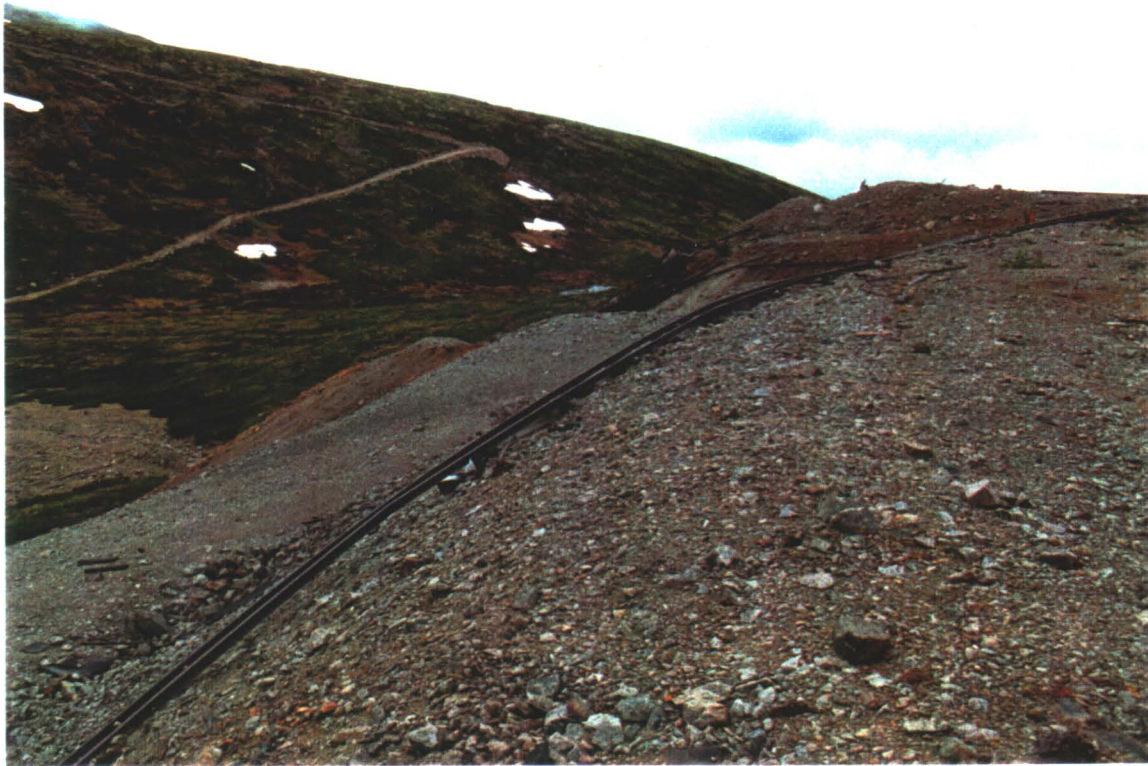
Railway track once used by ore cars is still in place extending from inside the exploration adit to the waste dump. Once outside the adit, the track extends onto the waste dump and down the waste pile slope. Over 100m of rail is still in place across the waste rock dump. As noted, a portion of this track is now in an eroded gully in the waste rock dump. It appears that severe erosion has taken place above and below the adit and some avalanching may have also occurred at this site resulting in the track dropping downslope.

TRACK DOWNSLOPE ON WASTE ROCK DUMP

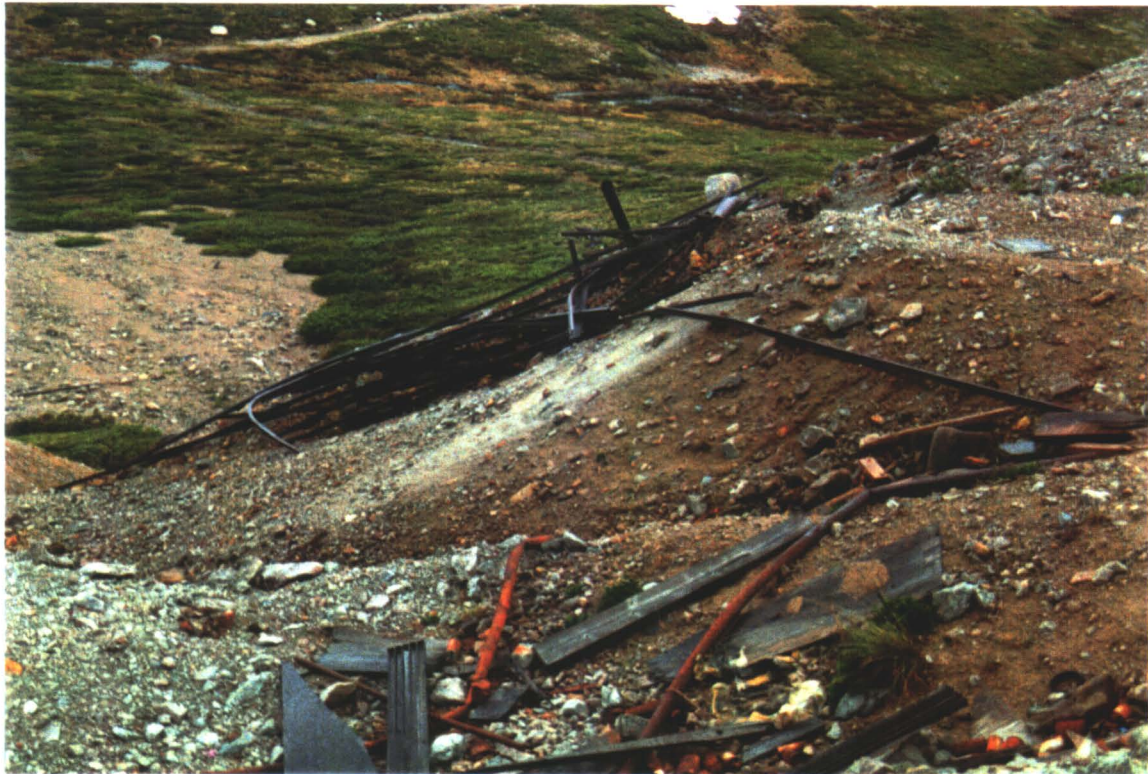
METAL WASTE (FOREGROUND) AND NEW ALLUVIAL FAN FROM WASTE EROSION

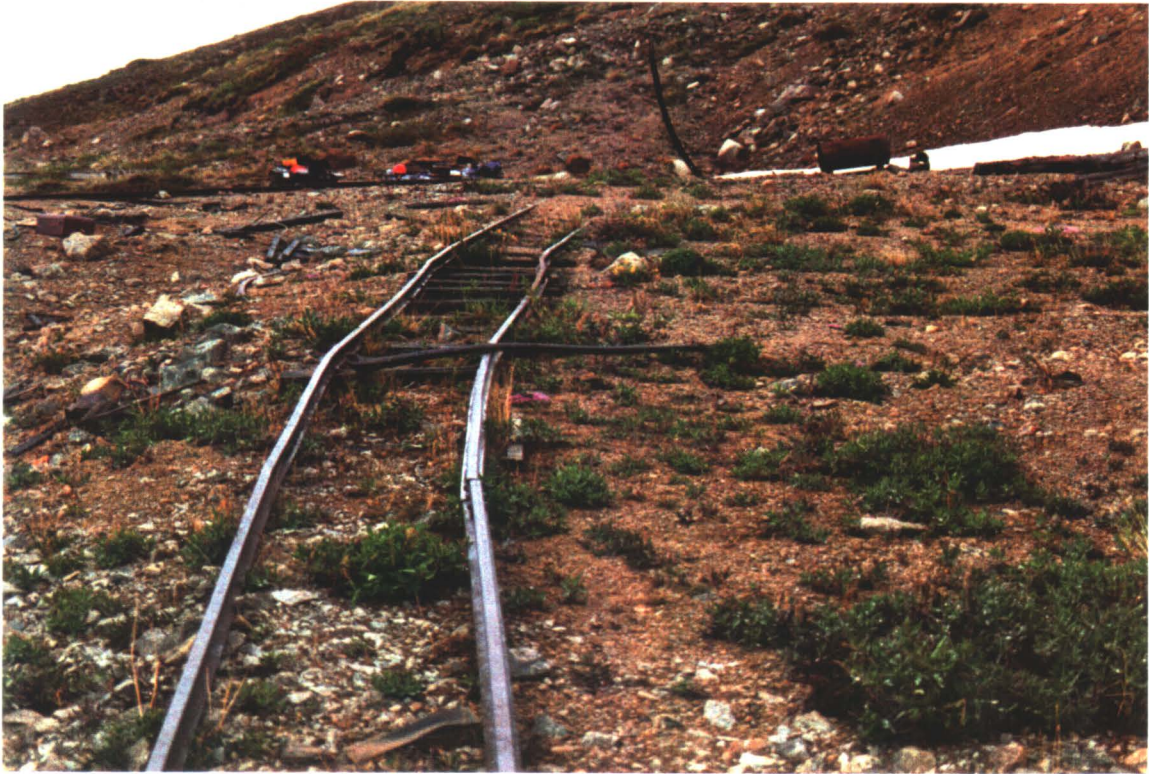
RAIL ADJACENT TO ADIT
