**ASSESSMENT REPORT**

**105D-03-2**

**BECKER COCHRAN**

**DIAND TECHNICAL SERVICES**

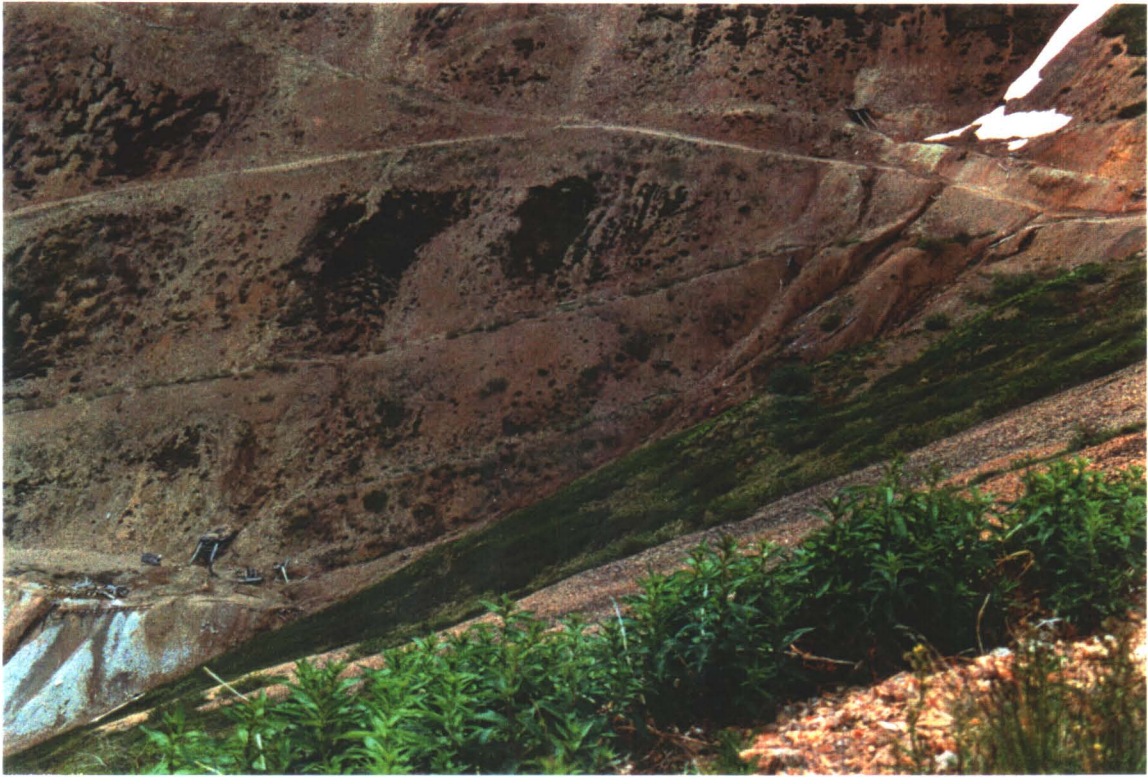
Approximately 2000 cubic metres of waste rock from both adits was dumped over the steep bank in front of each entrance. Avalanche tracks above the exploration adits are filled with snow and annual melt is causing erosion through the waste rock piles and into the valley below. The waste rock at the lower adit contains sulphides and was giving off a distinct odour of sulphur at the time of inspection.

UPPER AND LOWER ADITS AND WASTE DUMPS (NOTE EROSION)

The waste area has been developed by extending railway track from the adit to the edge of the slope and dumping the waste rock over the slope below the adit. As noted, the waste rock was dumped down the slope below the adit and is perched at a steep angle between 35-45 degrees. Because of development in the area with road cuts, and wasting material over the slopes, the exploration area in the very confined gully has been oversteepened. This material is susceptible to both wind and water erosion, both which are occurring. The obvious erosion is caused by the snowmelt channeled through the waste area. Whether or not any of the metal waste in the gully below the site was caused by this erosion or was originally dumped downslope, is unknown. As the dumped material is so coarse, it is unlikely that much of it has found its way into one of the tributaries to Becker Creek below the site. **It may be possible that the sulphides are being dissolved in the water and a weak acid is being generated.** If this is the case this likely has been occurring naturally for a long time. **It is recommended that water samples be taken and analyzed to determine the water chemistry from this area.** Because the local streams are so steep fish habitat is not suspected in the vicinity of the site. This erosion process is expected to continue as part of a much larger geologic weathering process in the area, so the downstream impacts from this one site are expected to be minimal. It is recommended that the site not be disturbed any more to avoid any additional impact in the area. Revegetation of the area is also considered impractical in an area that is so dry, steep and void of organic cover.

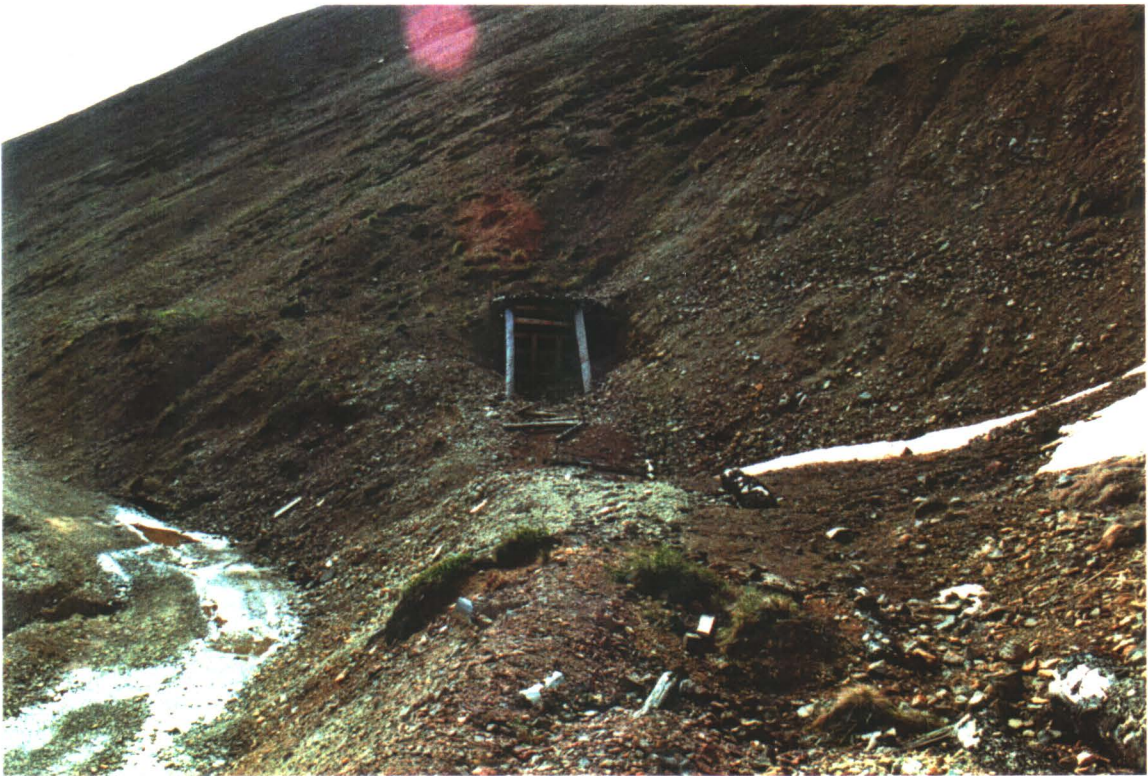
UPPER ADIT

A total of three adits were found at the time of inspection on 1993/06/24. Of the three accessible adits at the time of inspection, one adit is collapsed at the entrance and the other two adits are still intact. Both adits are sealed with widely spaced wooden cross bracing. Access to each adit could be gained by crawling through the openings in the bracing. Low volumes of water (less than 3-4 litres/minute) was flowing from both adits at the time of inspection. Most of the flow appears to be from snowmelt inside the adits.

The mine adits are secured against entry, but still accessible to the public because of the way the adits were sealed. As this site is accessible by road and relatively close to populated areas (Whitehorse and Carcross), it is recommended that the adits should either be better secured or at least posted against entry.

**Posting of the adits against entry should be completed to warn the public about the potential danger if these adits are entered.**

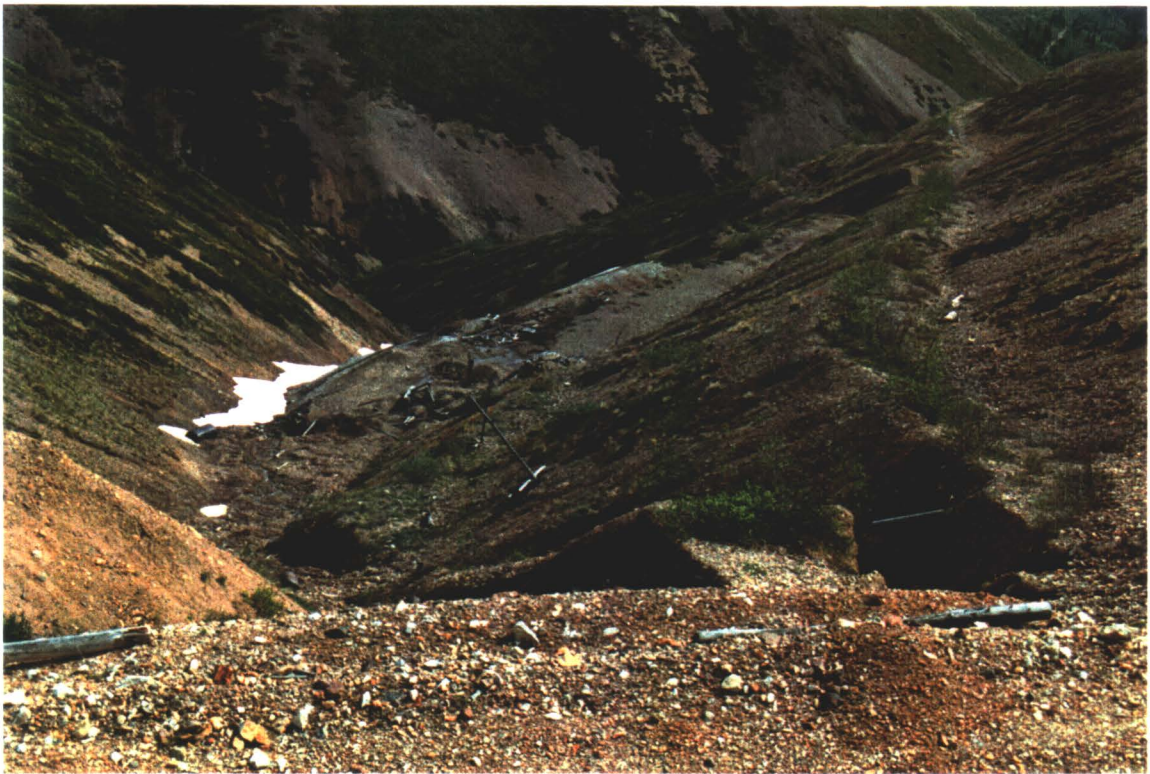
LOWER WASTE ROCK DUMP AND EROSION IN GULLY

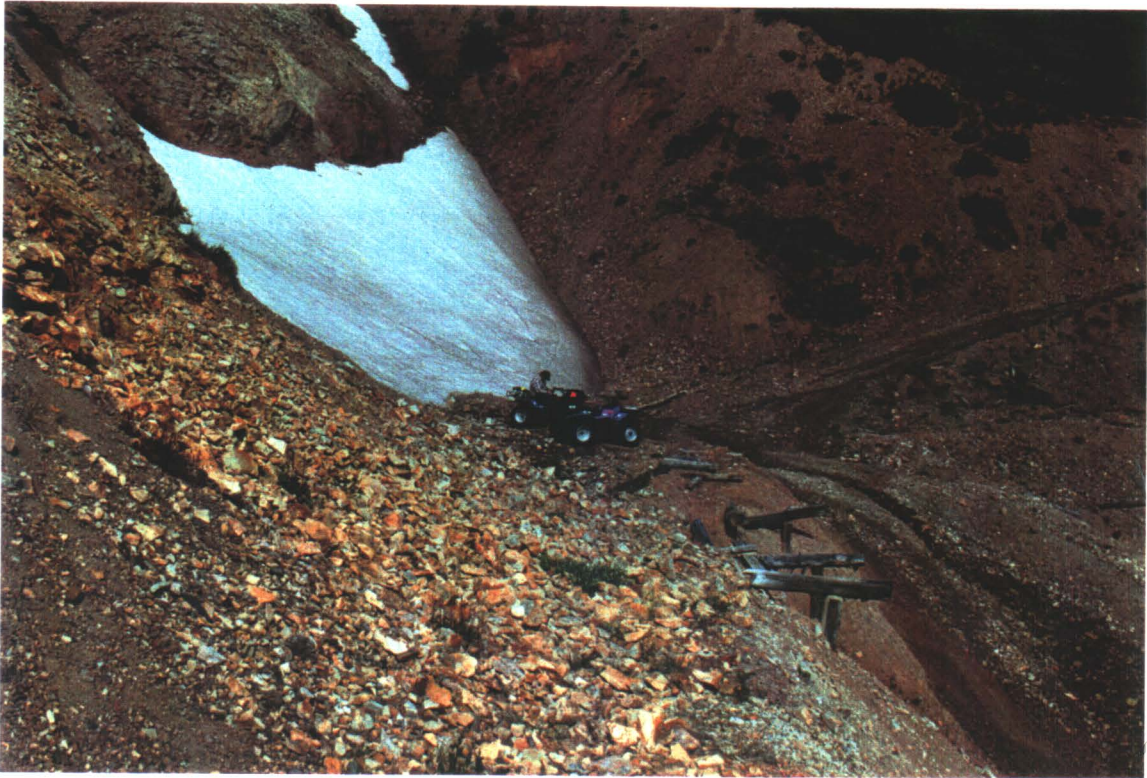
UPPER WASTE ROCK DUMP AND GULLY

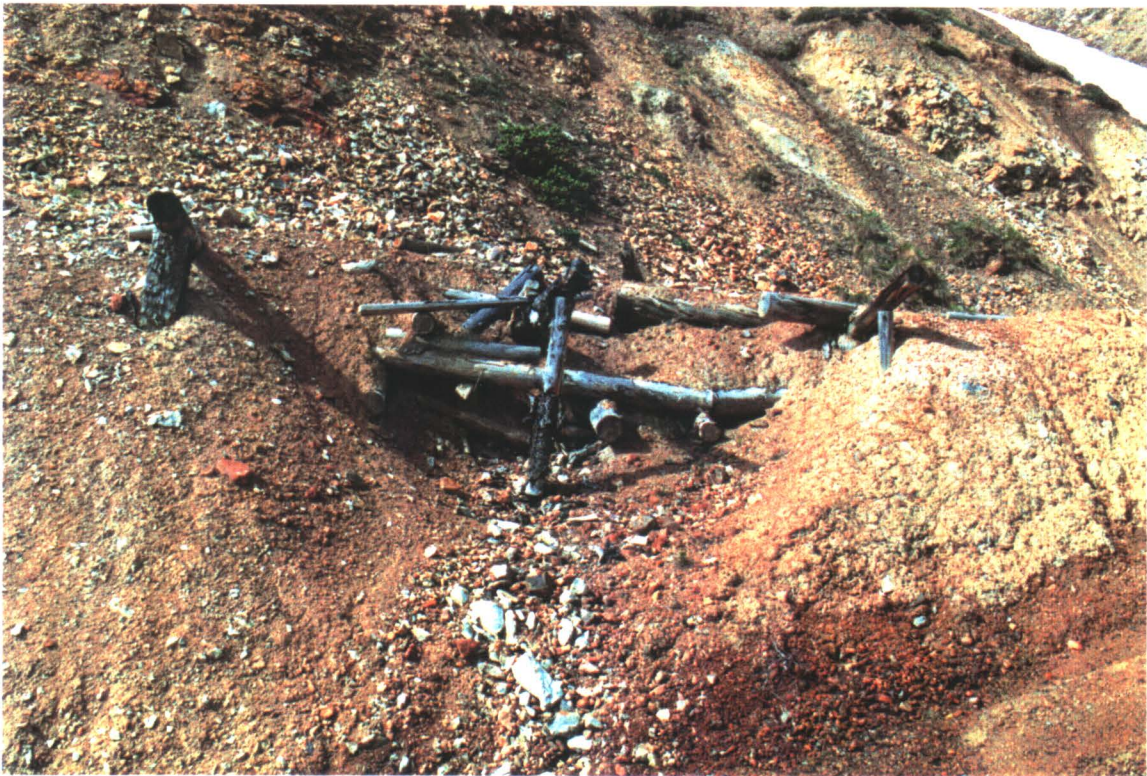
COLLAPSED ADIT

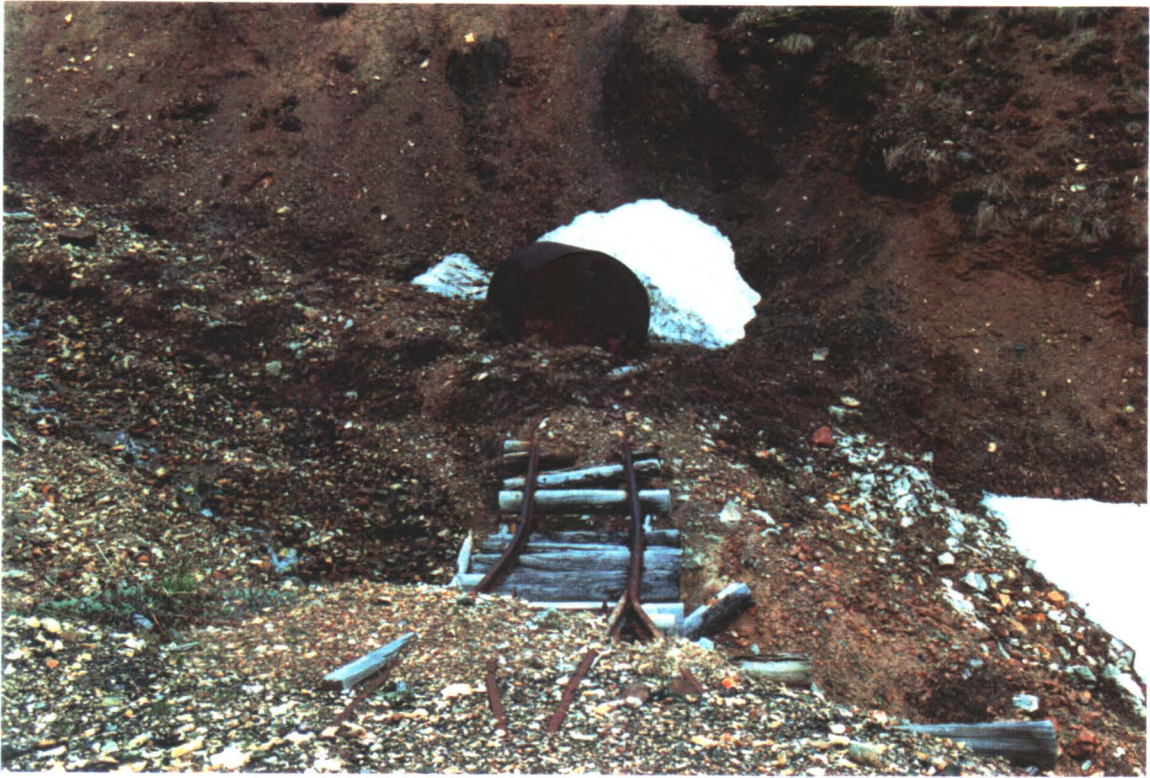
The only remaining infrastructure at this site is one empty metal tank (approximately 2000 litres), less than 50m of rail and track, various pieces of metal waste including barrels, pipe, tin cans and general purpose refuse that has been dumped or washed down the gully below the lower adit. Some wood waste is also scattered around the site.

Railway track once used by ore cars is still in place extending from inside the lower exploration adit to the waste dump. Once outside the adit, the track extends to the edge of the waste dump.

TRACK AND TANK AT LOWER ADIT

If a waste clean-up program is implemented in the area, it is recommended that the metal waste be gathered and removed from the site. At the same time, the remaining wood waste should be piled and burned in an acceptable location. This work should be considered a **LOW** priority at this location.

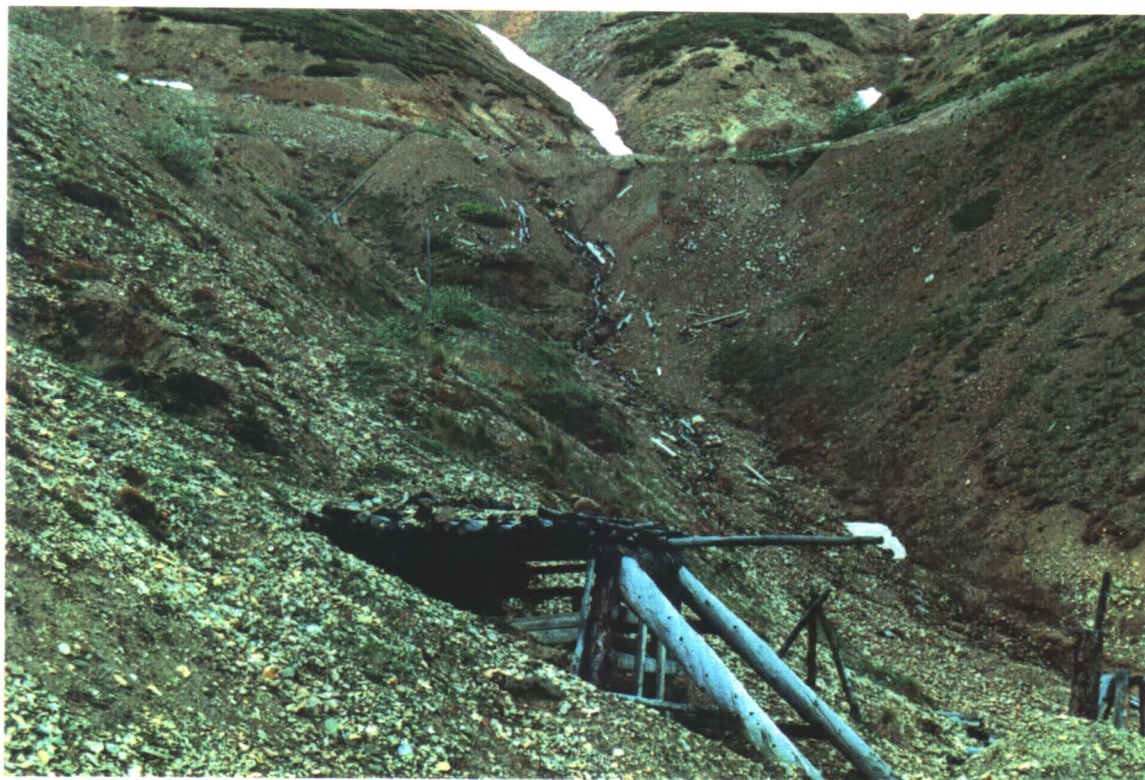
LOWER ADIT LOOKING UPSLOPE (NOTE WASTE IN GULLY FROM UPPER ADIT)

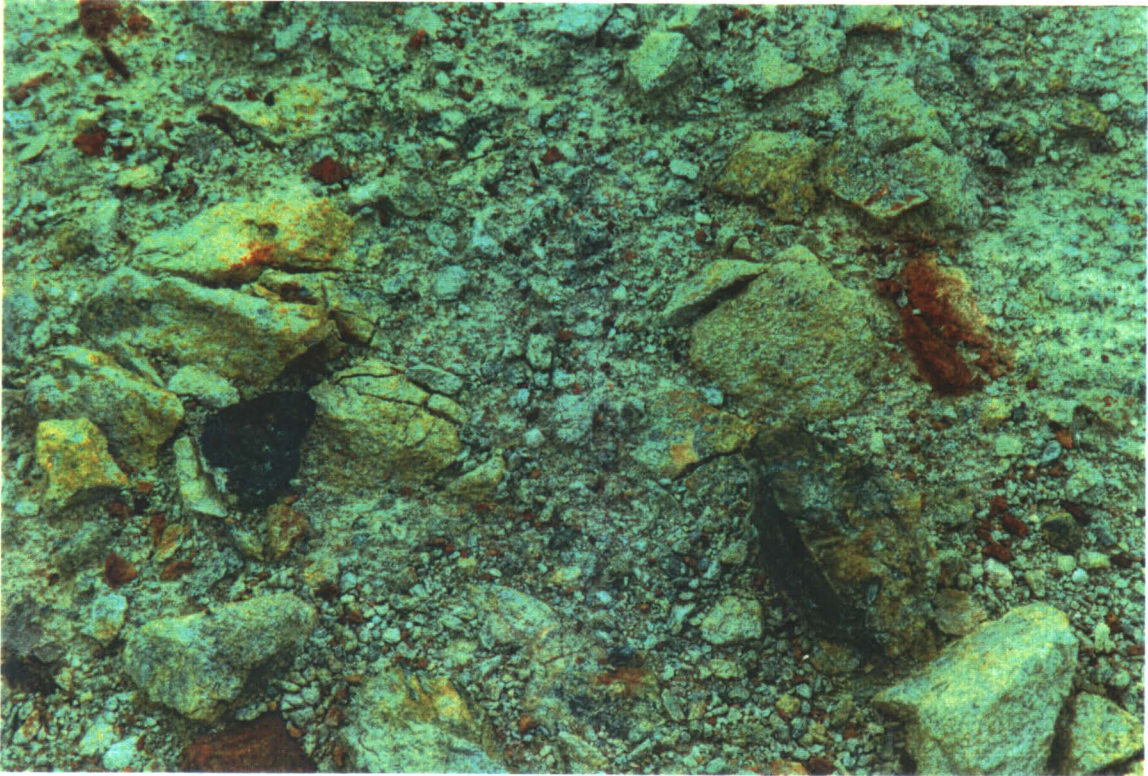
SULPHIDES IN LOWER WASTE ROCK DUMP

Overall, some environmental damage has occurred and is continuing from erosion at the site. Eliminating the potential for further erosion would be difficult and costly to accomplish. It is recommended that, before embarking on an expensive site remediation program for this relatively small, remote site where the wildlife or fish habitat does not appear to be impacted, that reinspection of the site should take place periodically instead. **However, it is recommended that water samples be taken and analyzed to confirm water quality in the area.**

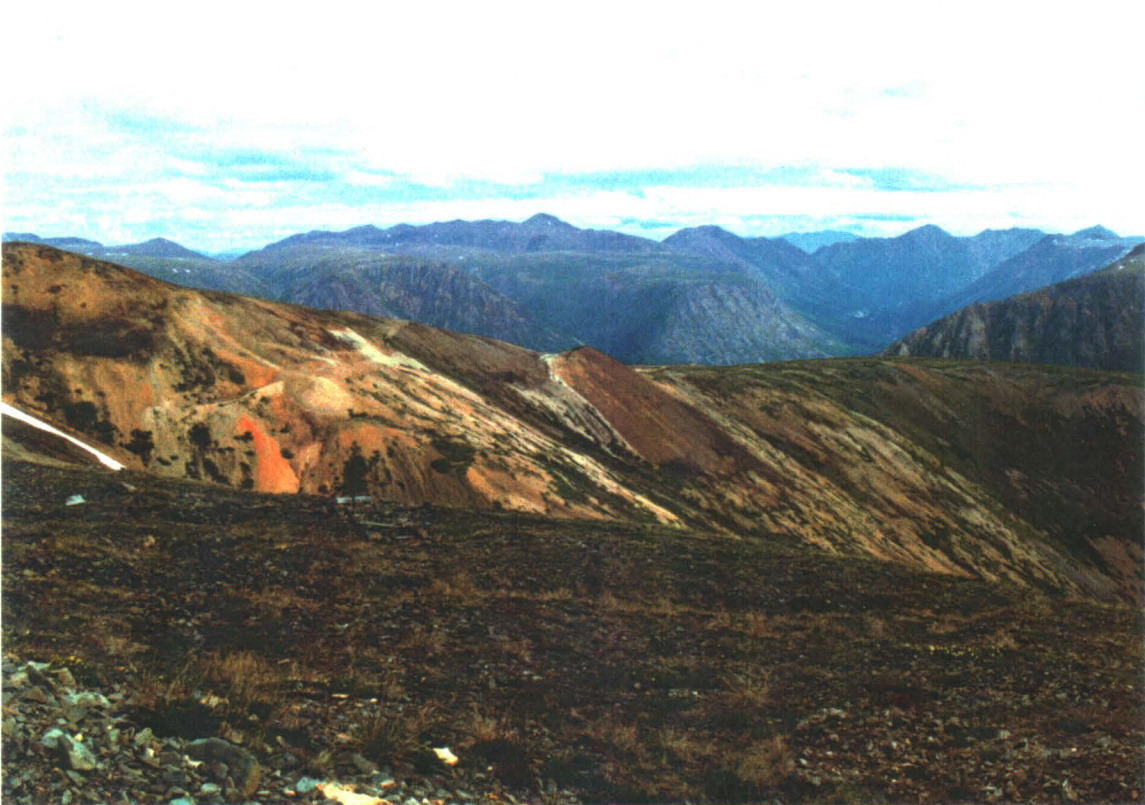
TRENCHING

Across the gully, trails have been extended on the plateau to the west. These trails extend approximately 5km across this plateau to a variety of trench and drill sites. One specific area of trenching has been left with large piles of excavated material.

The road development and trenching is situated in an area on the top of a mountain that is made up of weathered bedrock, is very dry, and supports very little vegetation cover. Very little revegetation appears to have taken place since the road construction and trenching was completed.

Damage to the vegetative cover appears to be the only significant impact to the area because of the all the drill access roads and trenching completed in the area. There is little evidence that erosion, slope failures, contamination of water courses, etc. have been caused from the past activity.

Site remediation, if it was considered would consist of reshaping cut slopes to blend with the natural slopes, refilling trenches, and attempting to revegetate this work once it was completed. However attempting to complete this work is expected to be very costly and delay any natural recovery that has started. The benefits to attempting this kind of expensive remediation program in this remote area are not evident. This work should be considered as a **VERY LOW** priority.

Revegetating roads, drill sites, and trenching sites is considered a **LOW** priority for this area.
