ASSESSMENT REPORT

105D-02-2

BIG THING

**OCTOBER, 1993**

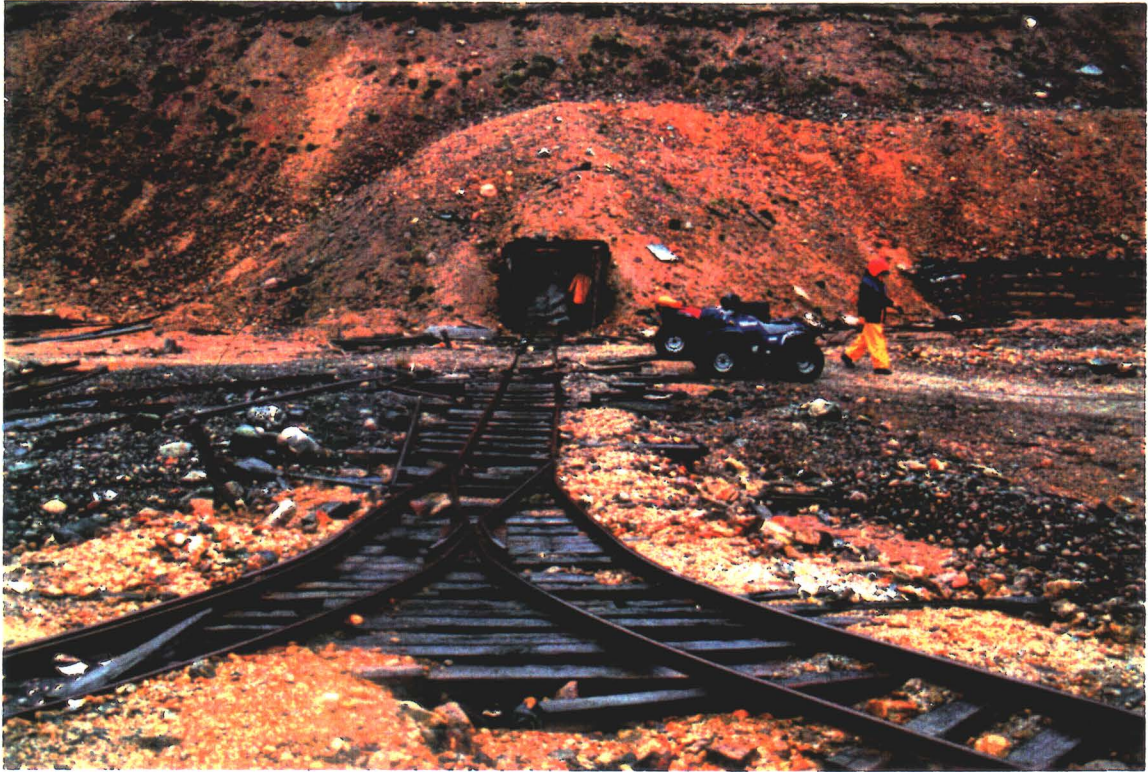
An open mine adit, first developed in 1965, remains at the site. At the time of inspection on 1993/06/21 the entrance to the adit was filled with snow. Ice was slowly melting from the adit and water was flowing from the entrance. The entrance to the adit is accessible to the public.

1. ENTRANCE TO MINE ADIT

The mine adit is unsecured and open to the public. Because this site is accessible by road and close to populated areas (Whitehorse and Carcross), the open adit should be considered a safety hazard. The adit should be sealed to prevent the public from entering it. If the adit is left unsecured a potentially **HIGH** level of risk remains for an accident to occur.

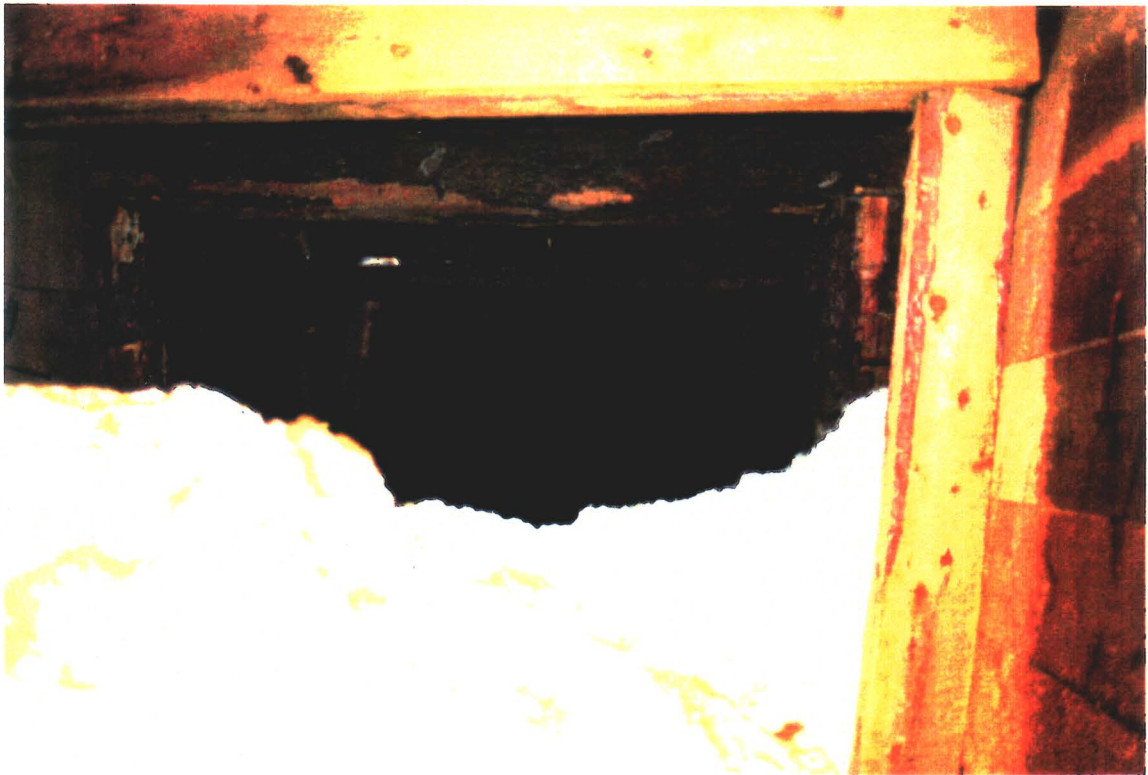
2. INSIDE MINE ADIT

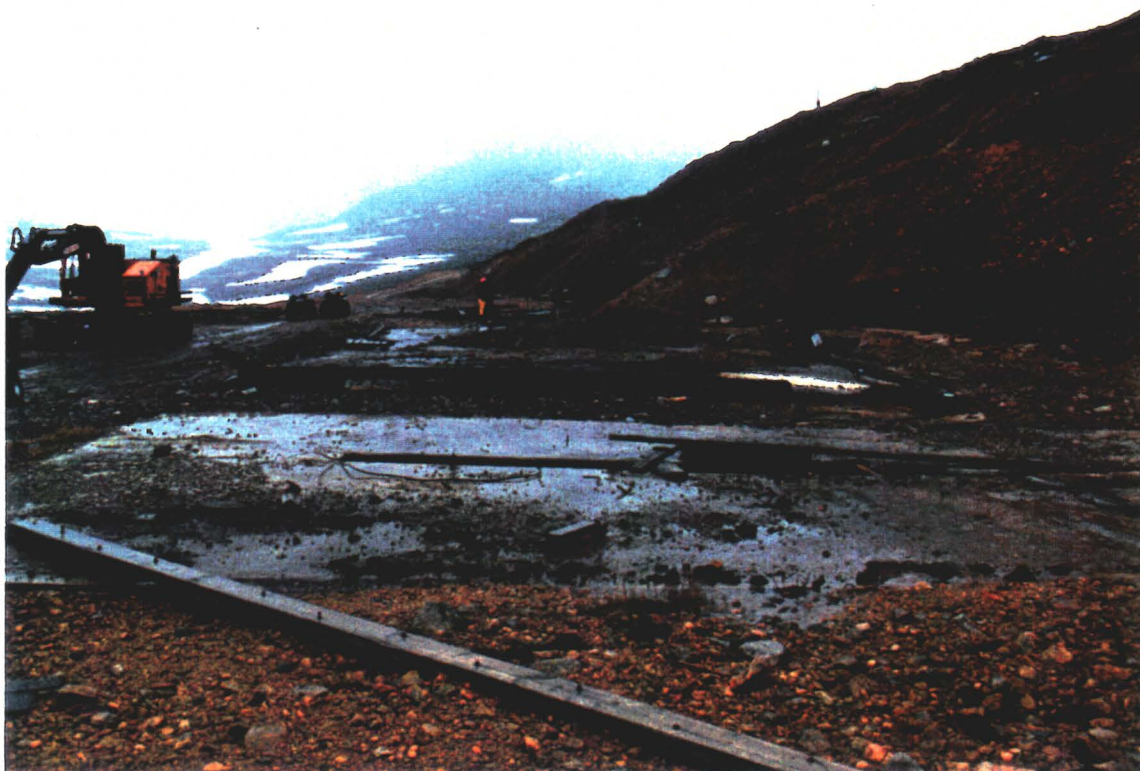
A large tracked excavator is on-site. This excavator does not appear to be in working order and may have been abandoned.

**3. MILL FOUNDATIONS AND EXCAVATOR**

Ownership of the excavator should be confirmed. Once ownership is verified the excavator should be removed from the site.

Work to clean-up the metal waste or removal of the excavator should be considered a **LOW** environmental priority.

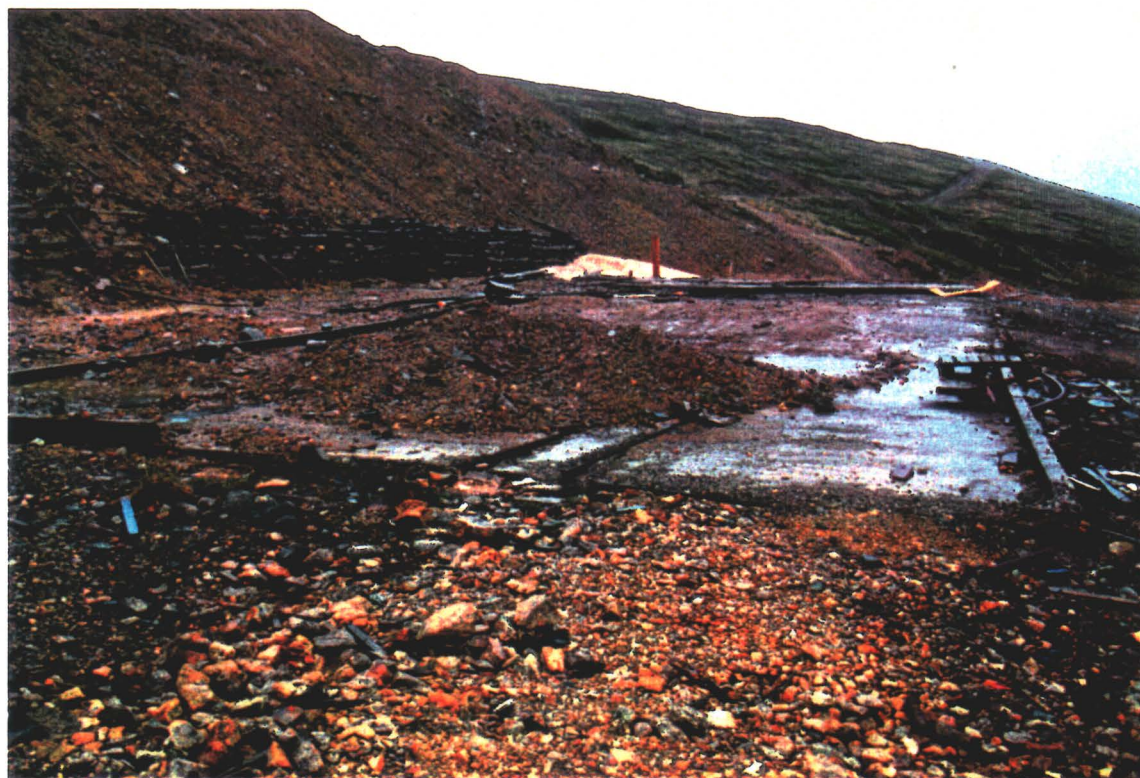
Concrete foundations and floor slabs remain from a 272 tonne mill constructed in 1967. These foundations, from two separate buildings measuring 9.1x24.4m and 6.1x9.1m, are located directly to the east of the adit. Railway track is embedded in the floor slab closest to the adit. The concrete appears sound and in reasonably good condition.

**4. MILL FOUNDATIONS**

The concrete mill foundations are not considered a serious environmental hazard and should be left in place. Attempting to remove them will be costly, create further disturbance, and require disposal to another area. Any loose metal waste on-site should be collected and removed from the site if a clean-up program is initiated.

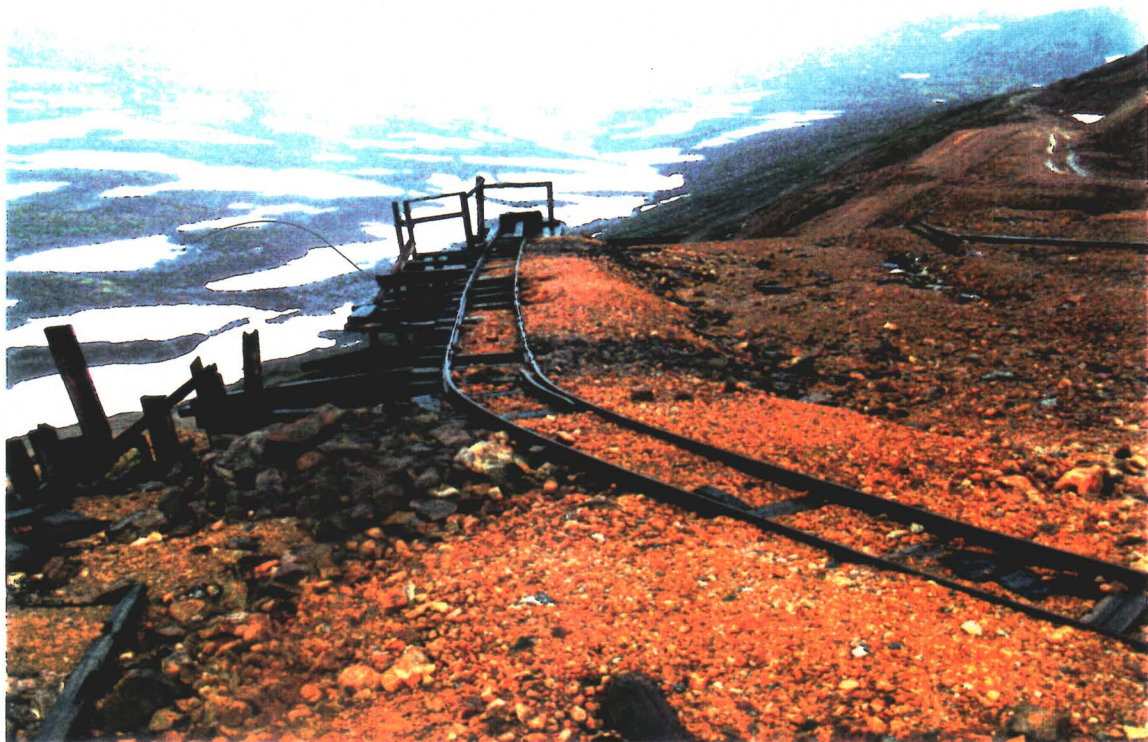
Railway track once used by ore cars is still in place extending from inside the mine to the waste dump. Once outside the adit, the track extends in opposite directions, one going to the waste area, and the other going to the loadout. The track extending to the waste area is constructed on a wooden trestle for approximately 60-80m. This trestle was constructed using local timber, is old, decaying, and is starting to collapse. This structure is not safe and should be considered a hazard. The track extending to the loadout area is constructed on waste rock and is supported on a wooden retaining structure approximately 10m high. This retaining structure is old, decaying, and is also beginning to collapse from the weight of the retained backfill. This situation is expected to worsen with time and should be considered unsafe.

5. TRACK TO LOADOUT AREA

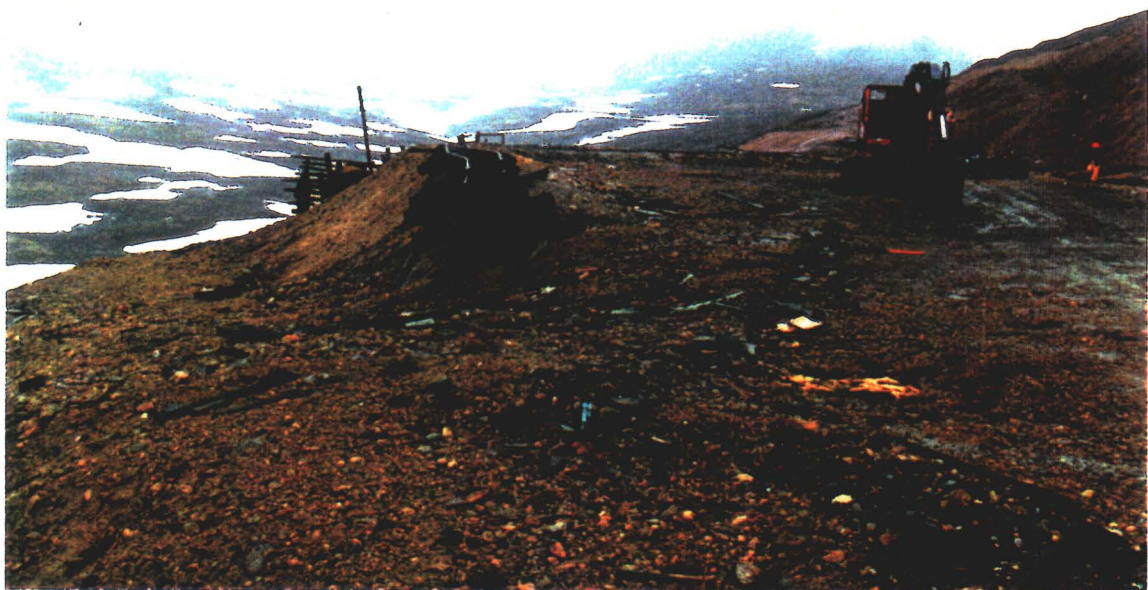
6. TRACK TO WASTE DUMP

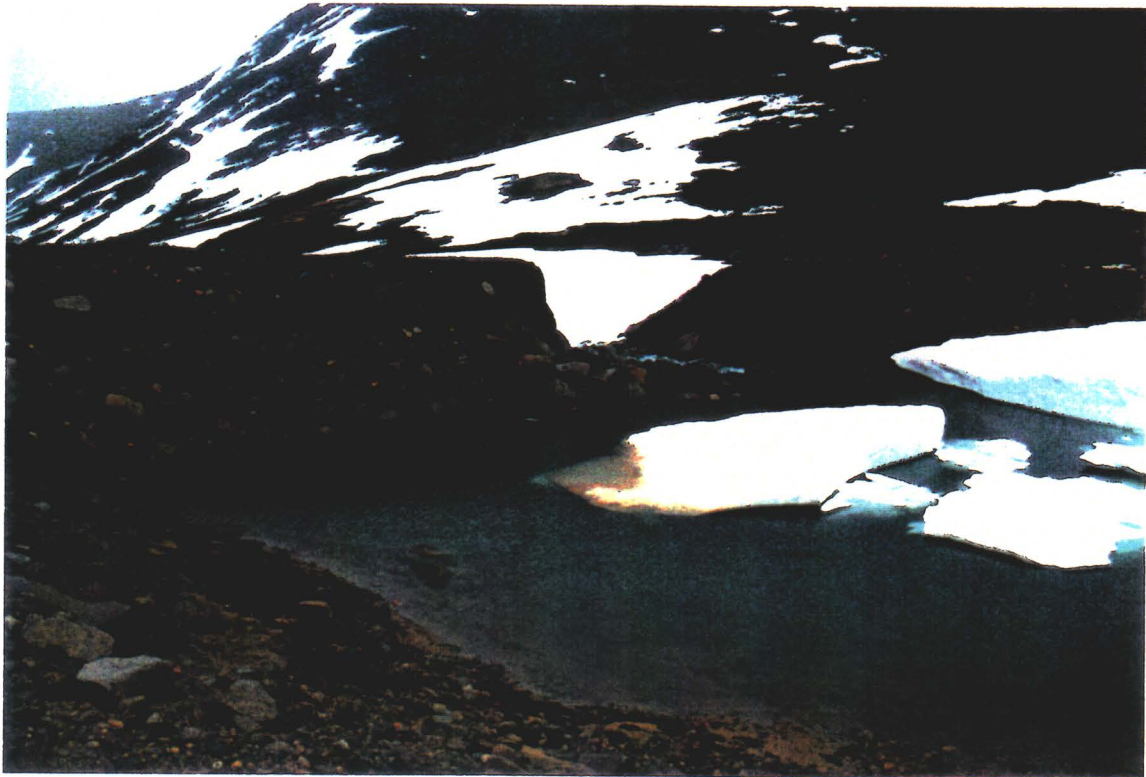
The dam across the creek appears to have been constructed using local granular fill and is between 2-3m high. An overflow pipe was installed within the top 0.5m of the dam. The dam has failed and the creek has re-established unconfined flow through the middle of the dam. The material from the centre of the dam appears to have been eroded and washed downstream. There is no evidence to suggest that this dam was deliberately removed during any shut down phase of the mine as the remaining opening does not appear to have been machine excavated. If this did occur, above normal siltation would have taken place in the creek below the dam until the embankment was eroded to its present condition.

9. REMAINS OF DAM ACROSS BIG THING CREEK

- backsloping the eroded face of the dam on the creek sides to a 3:1 (horizontal:vertical) slope,
- removing the remaining culvert from the dam fill, and
- dismantling and burning the wooden pumphouse building.

This work is considered to be a **LOW** environmental priority as the physical changes once made to the site no longer appear to be affecting the stream flow. It is unknown whether the past site work has affected the chemical nature of the water. To determine present water quality, samples should be taken, tested, and analyzed according to established protocols.

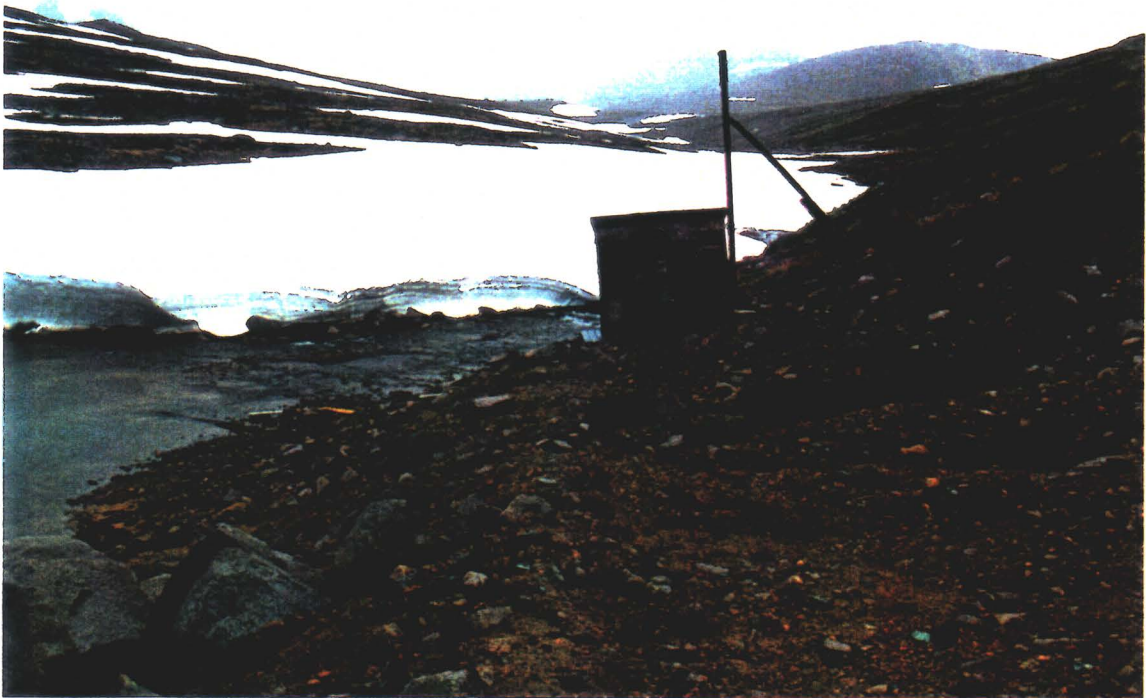
At one time, likely when the mill was in operation during 1968 and 1969, Big Thing Creek below the mine and mill site was dammed and a water storage reservoir was created. The water was likely pumped from a plywood pumphouse building measuring 3.0x3.0m on the north shore of the creek to the mine and mill site. The old pumphouse remains on the bank of Big Thing Creek, however no water pipe was found.

10. PUMPHOUSE ON BANK OF BIG THING CREEK

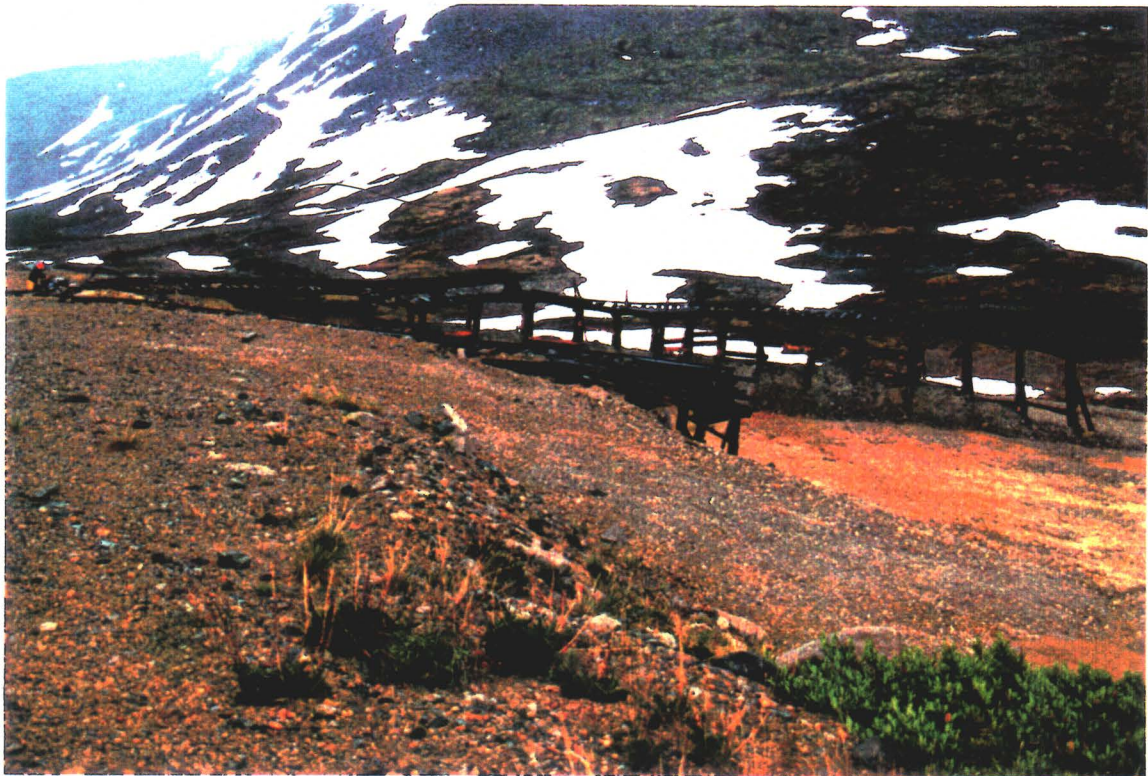
**7. TRESTLE INTO WASTE DUMP**

The waste area has been developed by dumping the waste rock over the slope below the adit. This was developed by extending railway track from the adit to the edge of the slope and beyond with a trestle supporting the track. The trestle and loadout retaining structure were constructed with local untreated timber, are old, decaying, and unsafe. They should be posted as unsafe and dismantled as soon as possible.

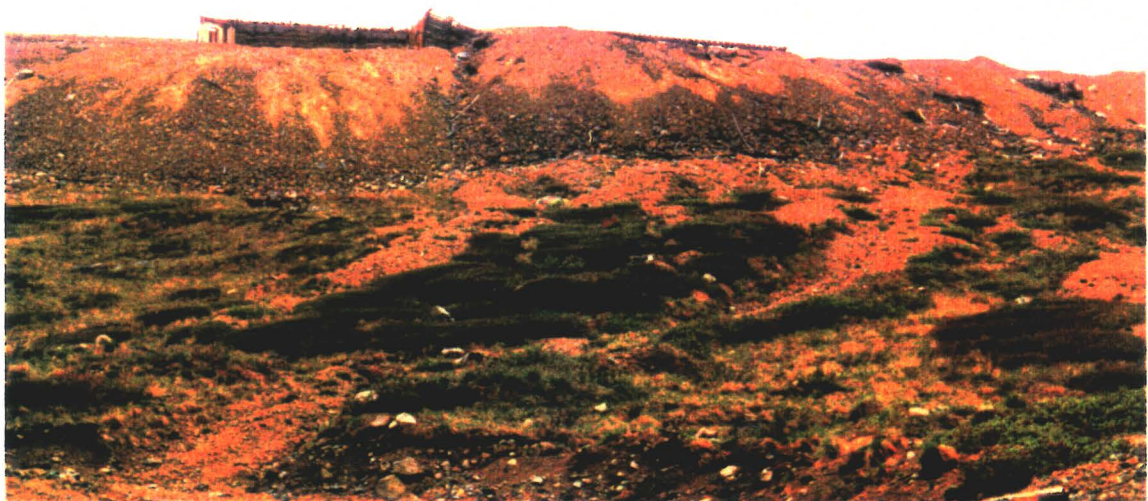
The waste rock has been dumped and is sitting at its natural angle of repose. It is unlikely that this waste rock will cause any additional slope instability. Revegetation of this waste material as well as areas where trenching occurred is not practical as the material is dry and void of organics needed to support vegetative growth. Further disturbance of this material will disturb any natural revegetation that is taking place.

**8. LOADOUT (LEFT) AND WASTE ROCK DUMP (RIGHT)**
