ASSESSMENT REPORT

105M-14-5

COMSTOCK

DIAND TECHNICAL SERVICES

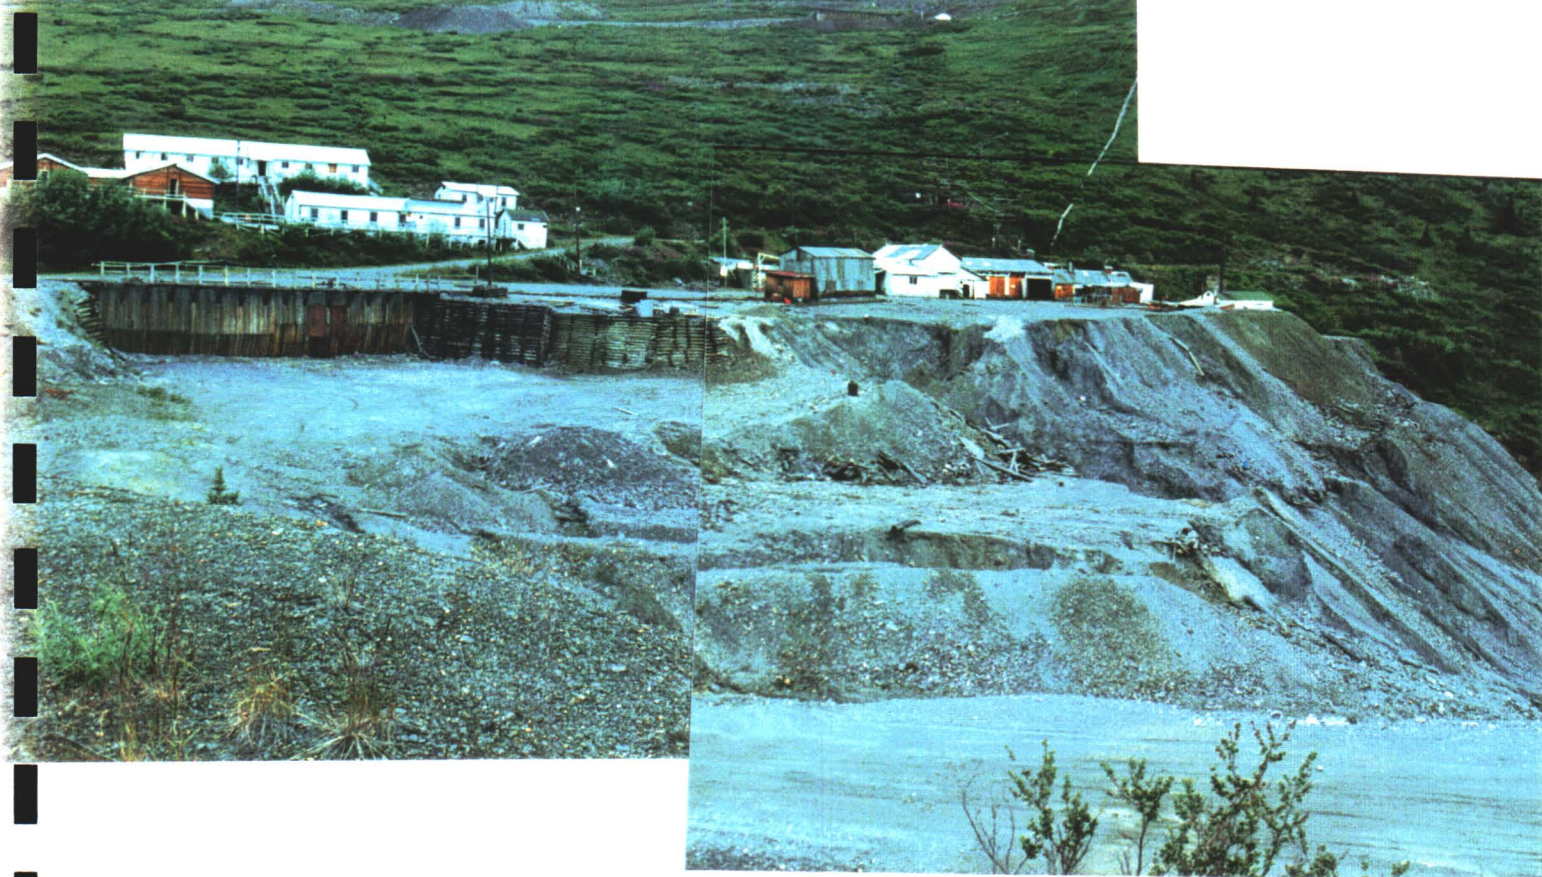
Below the loadout structure rock waste has been dumped into a gully below the mine site. This rock waste has slumped and appears to have been washed downslope from mine water channeled into this gully. This waste rock extends 300-400m downslope along with alot of other wood and metal debris from the mine.

The rock waste dump was placed in a gully downslope of the mine site. It appears that water and waste water from the camp and mine were also channeled into this gully, resulting in severe erosion of the waste material. This has resulted in the waste material being washed noticeably about 400m downslope killing vegetation over any area that was covered by this debris. Mixed in the waste rock is wood, metal, and other debris from the mine. It appears this site served as a general dump area. This waste rock dump is quite unsightly and should be improved. **It is also recommended that water quality testing be completed downstream to determine if any contaminants are being carried into the streams.**

LEVEL 700 SITE WITH WASTE DUMP IN FOREGROUND

It is likely that most of the erosion took place when the mine was in operation. It does not appear that the small amount of existing surface runoff is now contributing much to ongoing erosion. However, a plan to improve this waste rock dump should be developed and implemented. One method of containment would be to construct a toe berm.

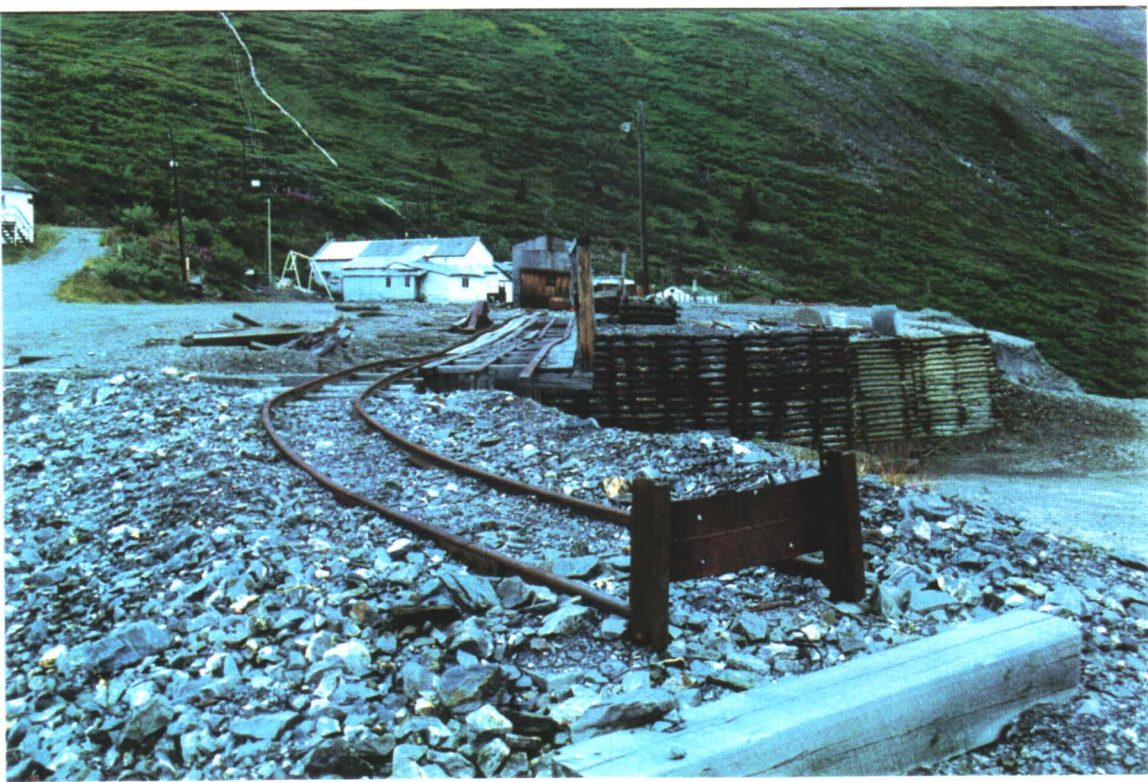
A timber retaining structure has been constructed with creosote timbers which served as a loadout structure. Rail extended to this loadout and beyond for the ore cars from the mine site to unload.

LOADOUT AT LEVEL 700 SITE

The loadout structure will continue to deteriorate and will eventually become unsafe. It is recommended that this structure be posted to warn anyone in the area of any potential danger.

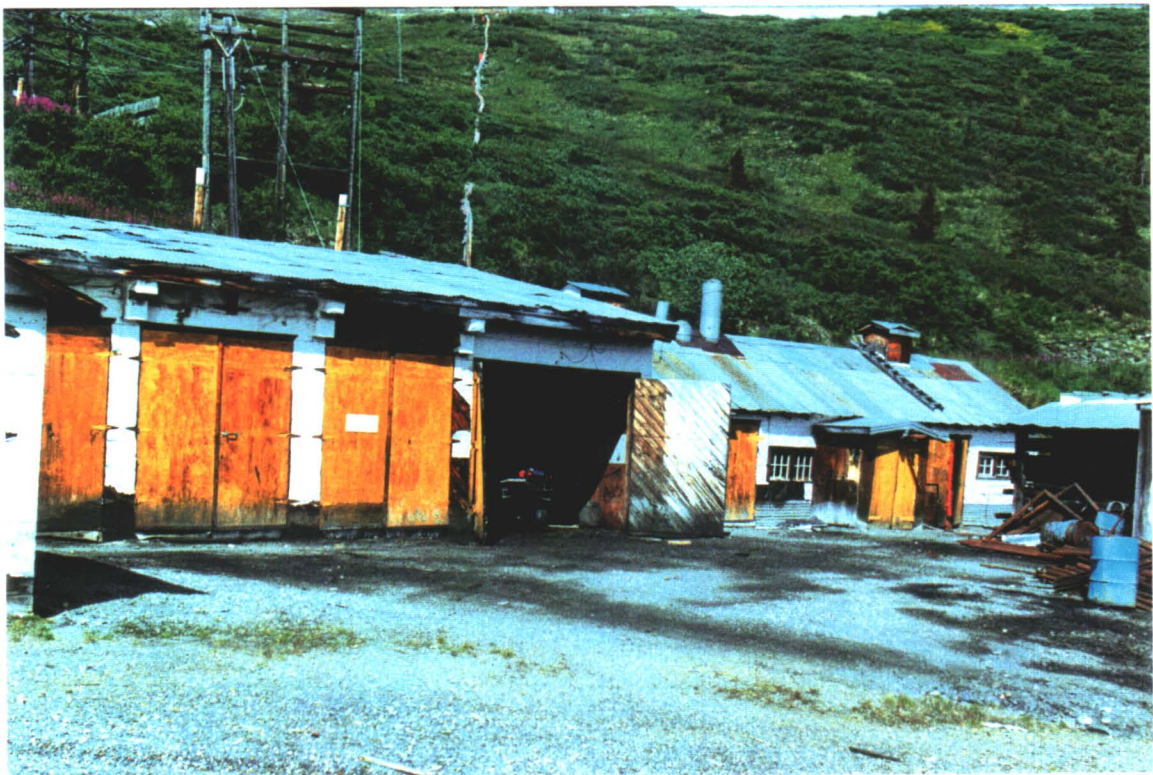
This building is a 4.9x29.0m four bay garage complete with a generator and 4D24 power unit. Oil has been spilled across the garage floor and outside in front of the garage. Oil staining is quite extensive in and around this building. At least one barrel of oil remains in the garage. Several empty 204 litre barrels are scattered in and around the garage. Small pieces of equipment including a barrel stand, various small tools, miscellaneous pieces of pipe, hoses, ladders, insulation, etc. is scattered around the building.

4 BAY GARAGE AND GENERATOR BUILDING (AT RIGHT)

Any hydrocarbon products should be considered a **HIGH** priority and removed from the site as soon as possible. As the quantity found is very small this task can be completed quite easily. As noted earlier in this report, it is apparent that hydrocarbon products have

been spilled in and around the garage. It will be necessary to conduct a subsurface soil and groundwater sampling and analysis program to determine the extent of the hydrocarbon contamination. Once this is completed the extent and risk from this contamination can be assessed.

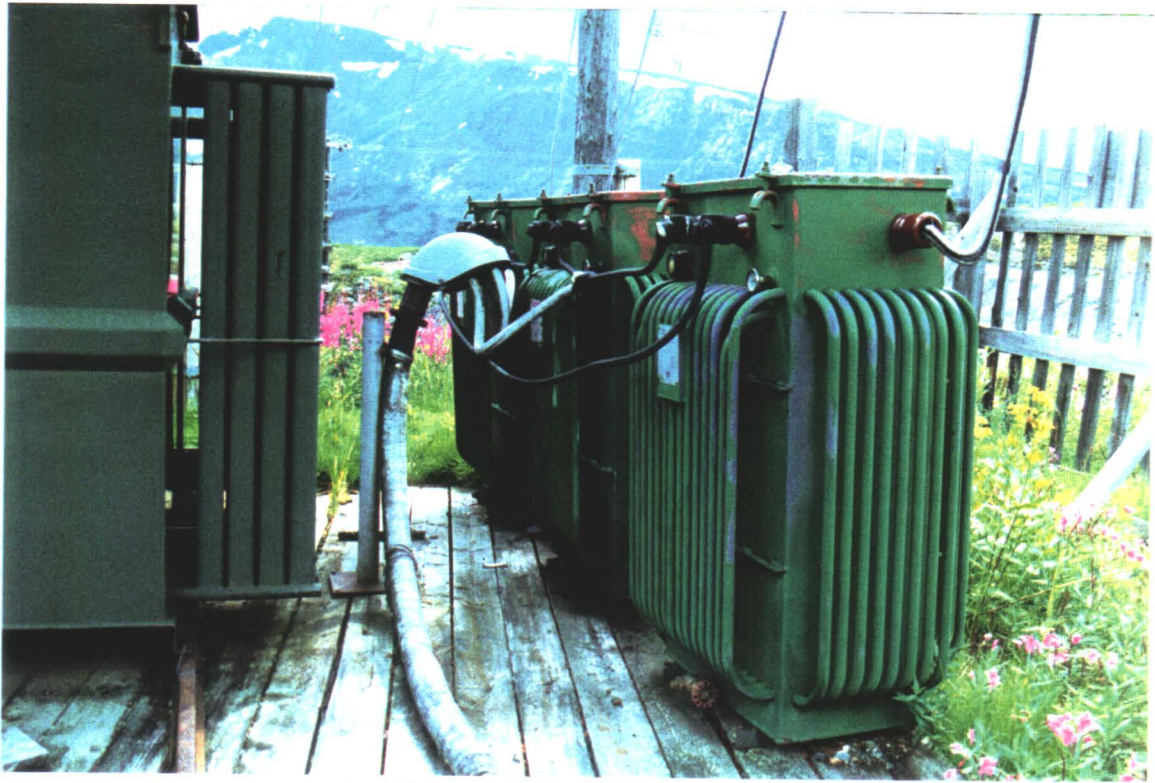
Overhead electrical service connected all buildings. Power poles and wire are still in place from the central transformer base. Five large transformers are still in place in an area northeast of the main camp and mine site. The transformers found at this location include;

- 2 - 500kVA single phase transformers manufactured in 1956 by Supreme Power Supplies Ltd.
- 3 - 150kVA distribution transformers manufactured by Pioneer Electric.
- 1 transformer (90 litre capacity) supported on a wooden platform above ground.

TRANSFORMERS AT LEVEL 700 SITE

The large transformers left at this site are a potentially **HIGH** environmental risk. These transformers need to be inspected by a qualified inspector to determine the degree of hazard they pose. Once these transformers and any other associated electrical equipment are evaluated, an action plan can then be established.

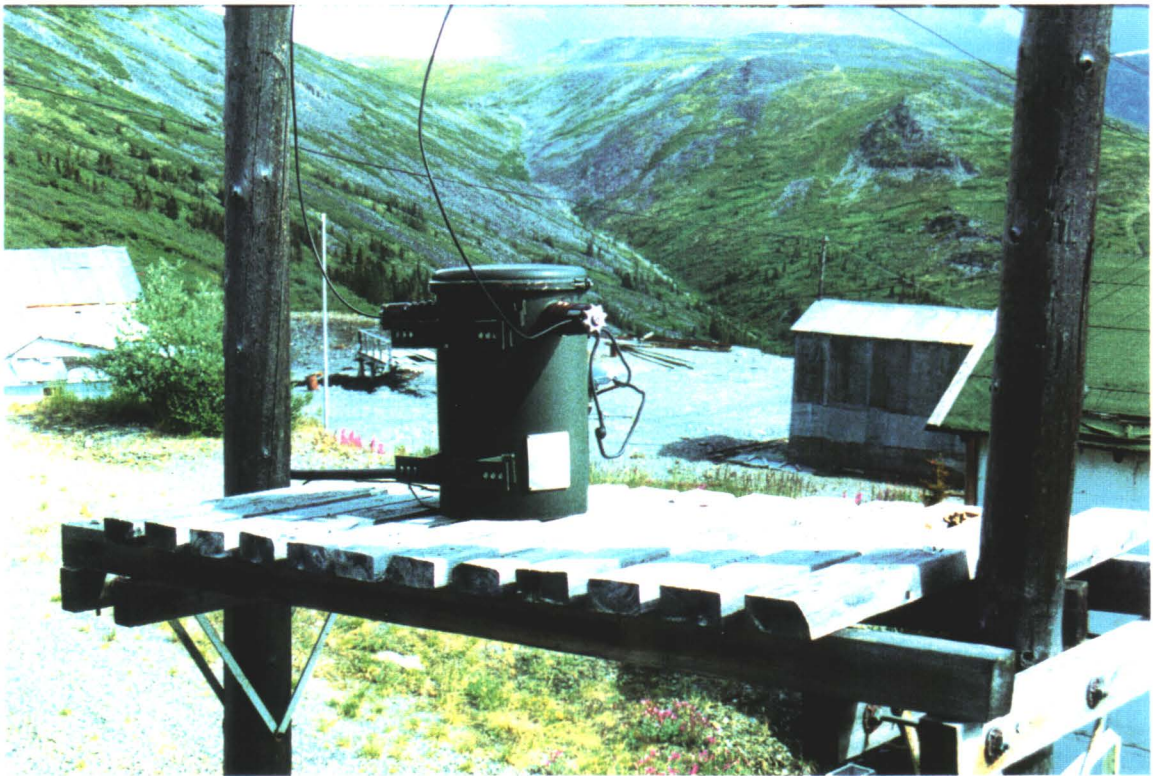
TRANSFORMER AT LEVEL 700 SITE

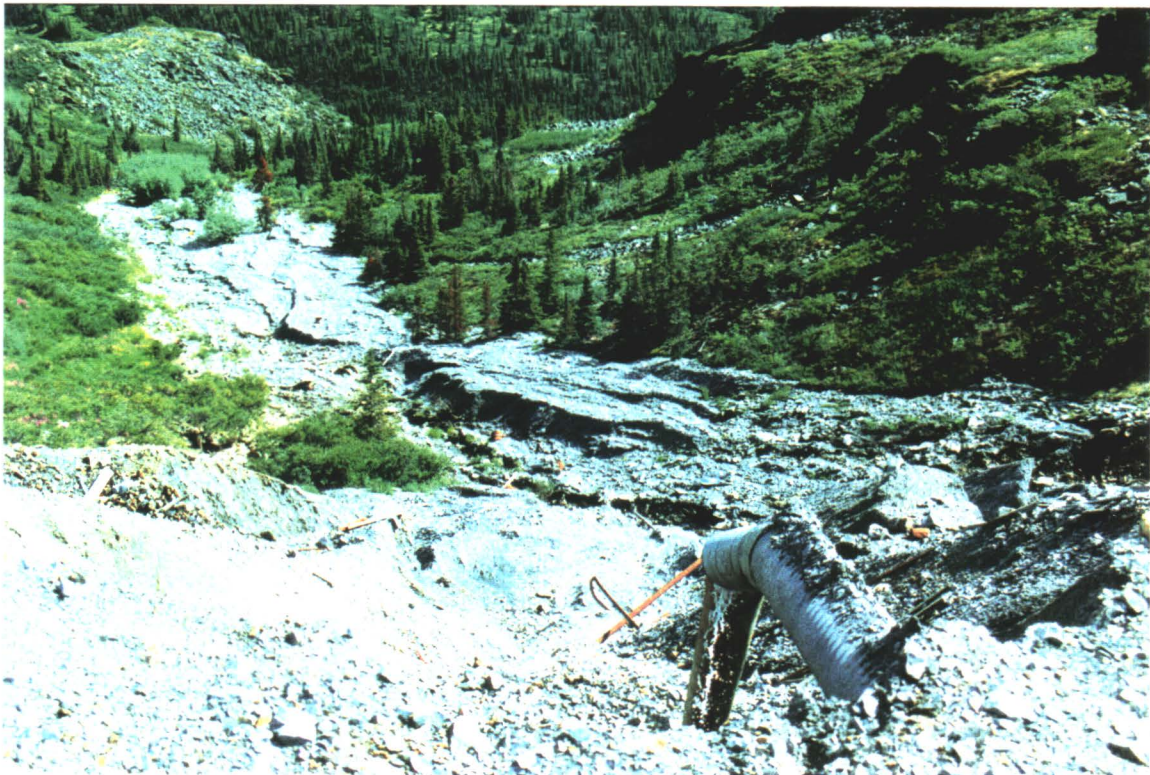
WASTE MATERIAL WASHED DOWN GULLY BELOW LEVEL 700 WASTE DUMP

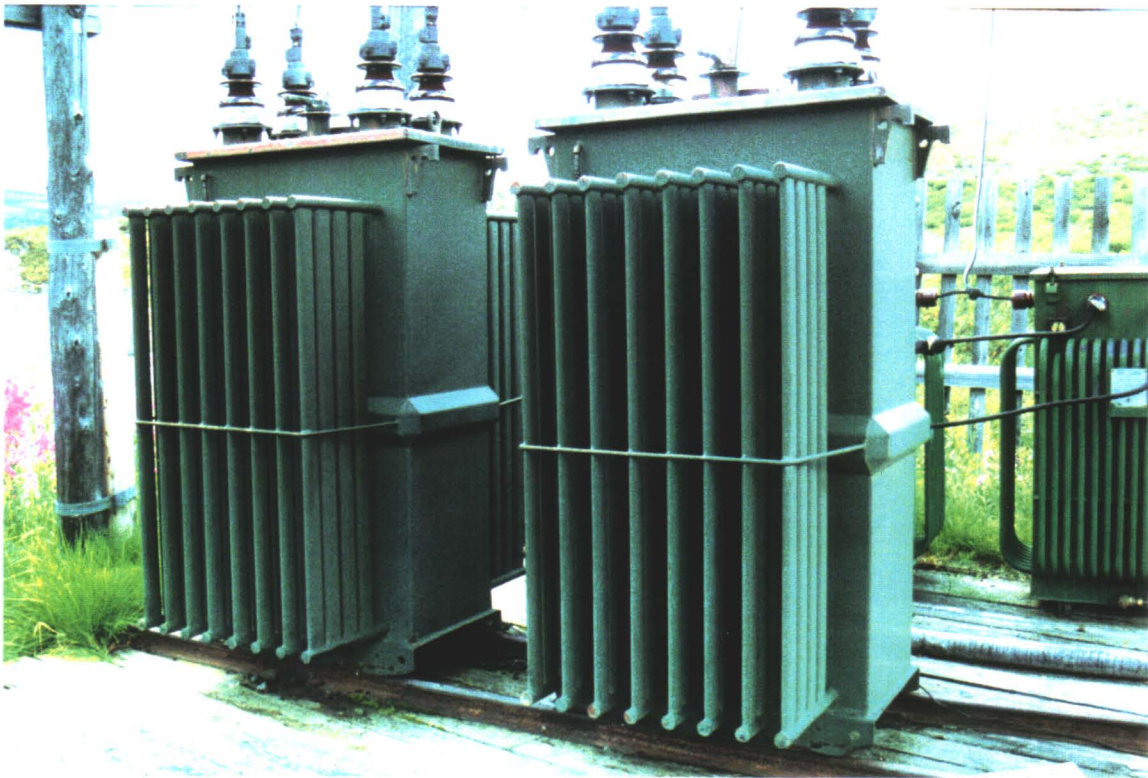
TRANSFORMERS AT LEVEL 700 SITE

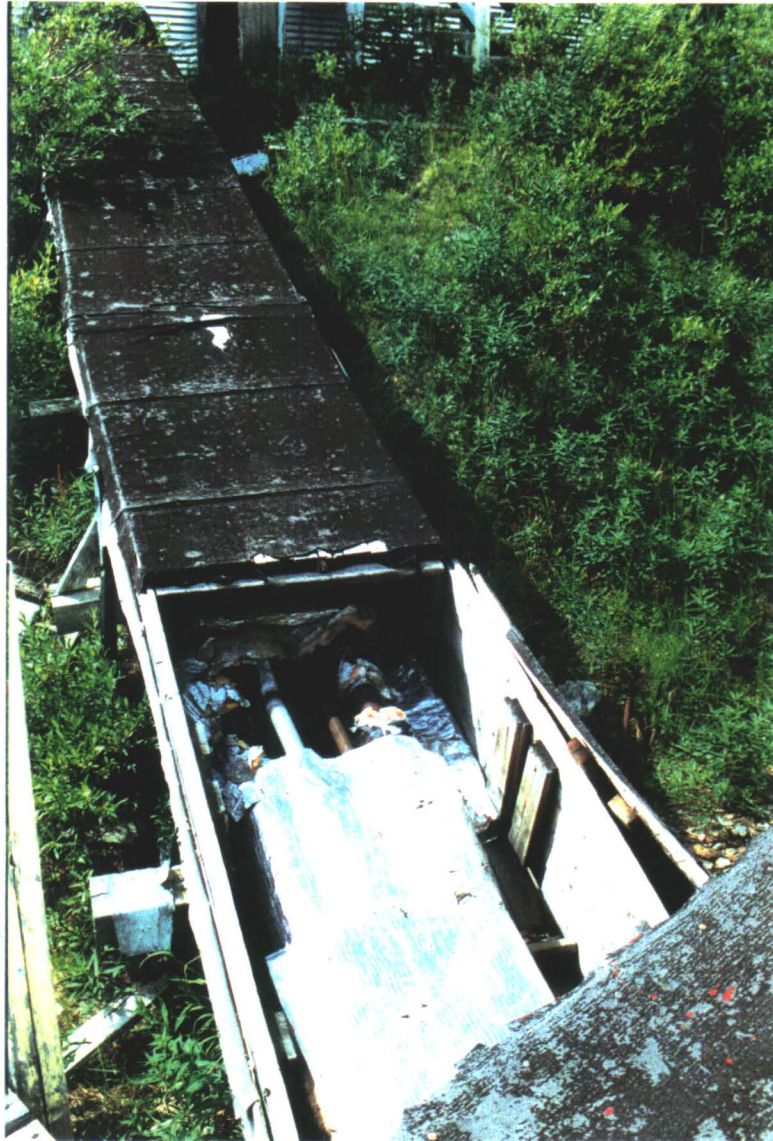
UTILIDOR WITH PIPING

The utilidor housing the water, sewer, and heating lines is quite unsightly but does not appear to be any particular ongoing threat to the environment. If a clean-up program is considered for the site it is recommended that this utilidor line be removed if **LOW or MEDIUM** priority items are considered. Care should be taken to identify any asbestos pipe or insulation and remove and dispose it according to approved methods.

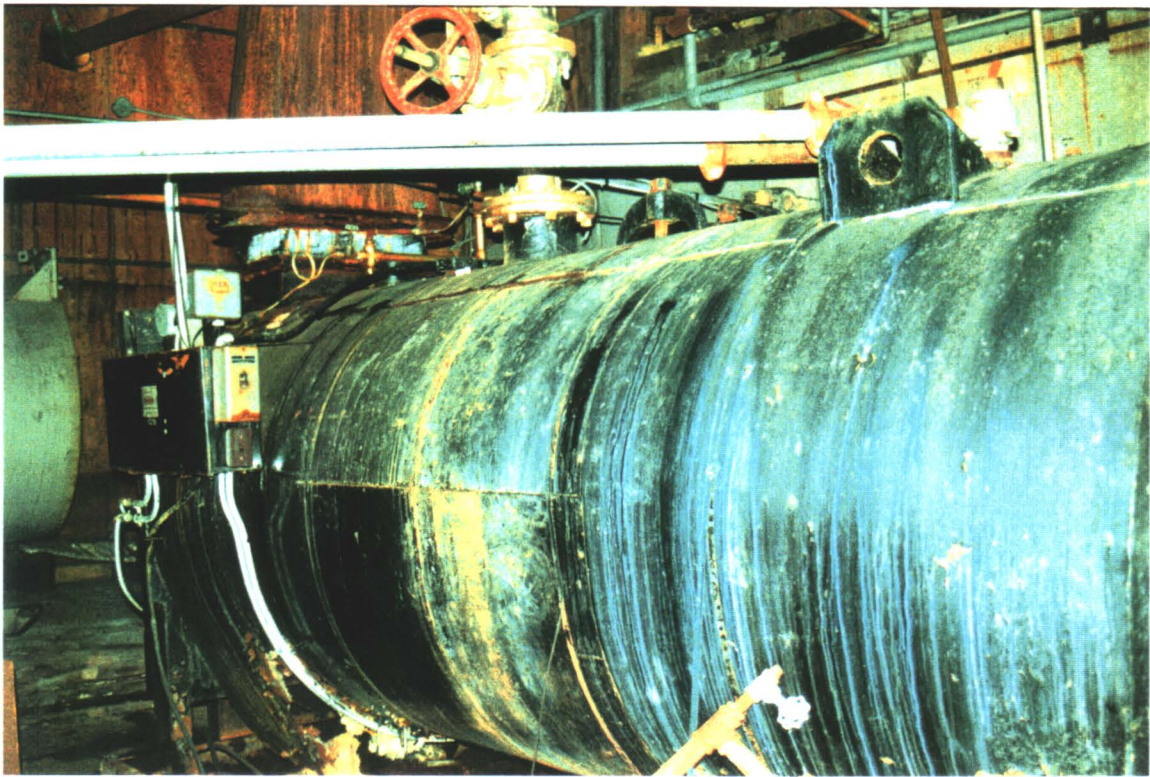
The boilers and water storage tanks are showing substantial corrosion and rusting. A metal exhaust stack extends approximately 10m above the top of the roof.

BOILER AND PIPING

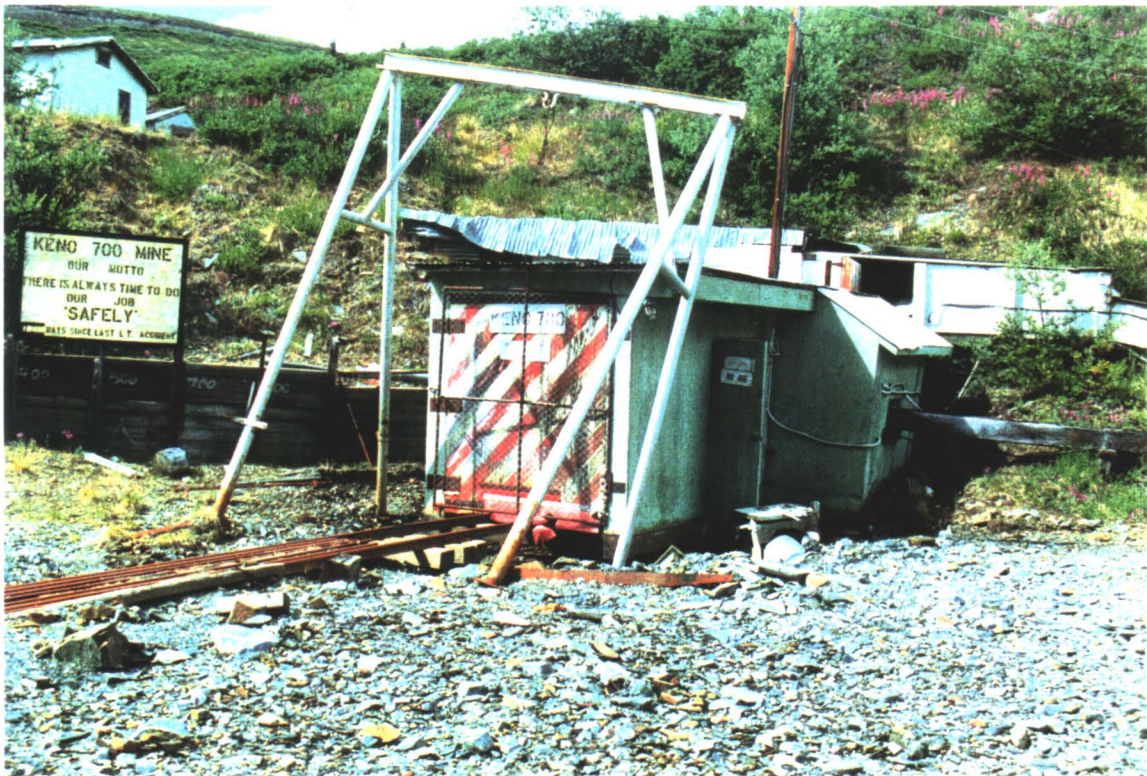
The mine adit extends from the sidehill and is sealed with wooden doors and a metal gate. A side entrance to the adit through a man door was unlocked, and the adit was accessible. No water was seeping from this adit at the time of inspection.

ENTRANCE TO ADIT AT LEVEL 700

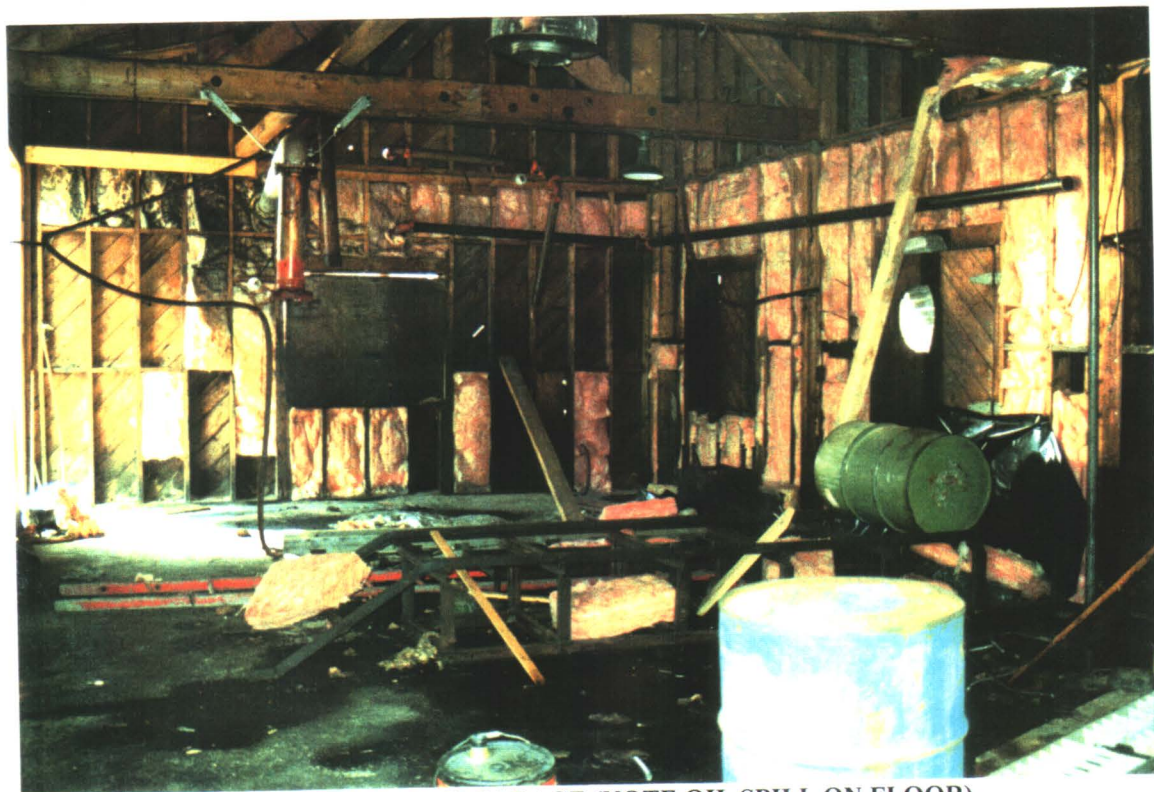
INTERIOR OF 4 BAY GARAGE (NOTE OIL SPILL ON FLOOR)

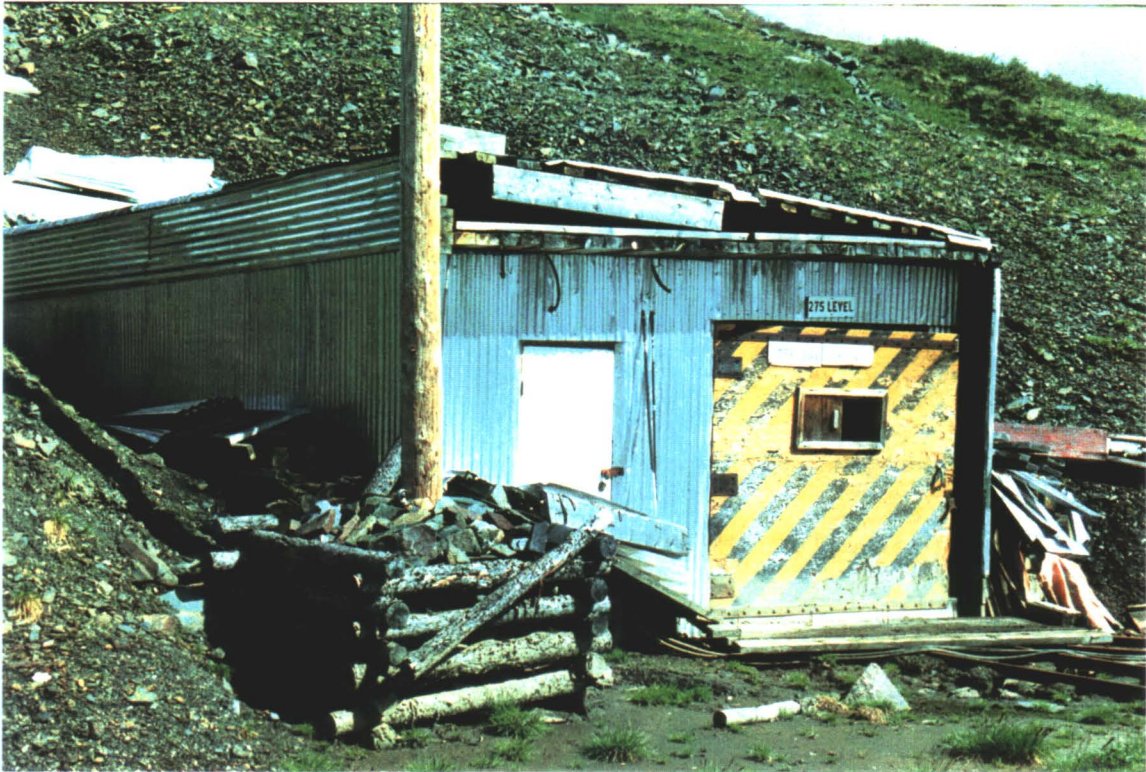
ADIT BUILDING AT ENTRANCE TO LEVEL 275

The adit, as at the other sites needs to be secured to prevent access from the public. This can easily be completed by properly securing the doors at the adit entrance. This should be considered a **HIGH** priority for reasons of public safety.

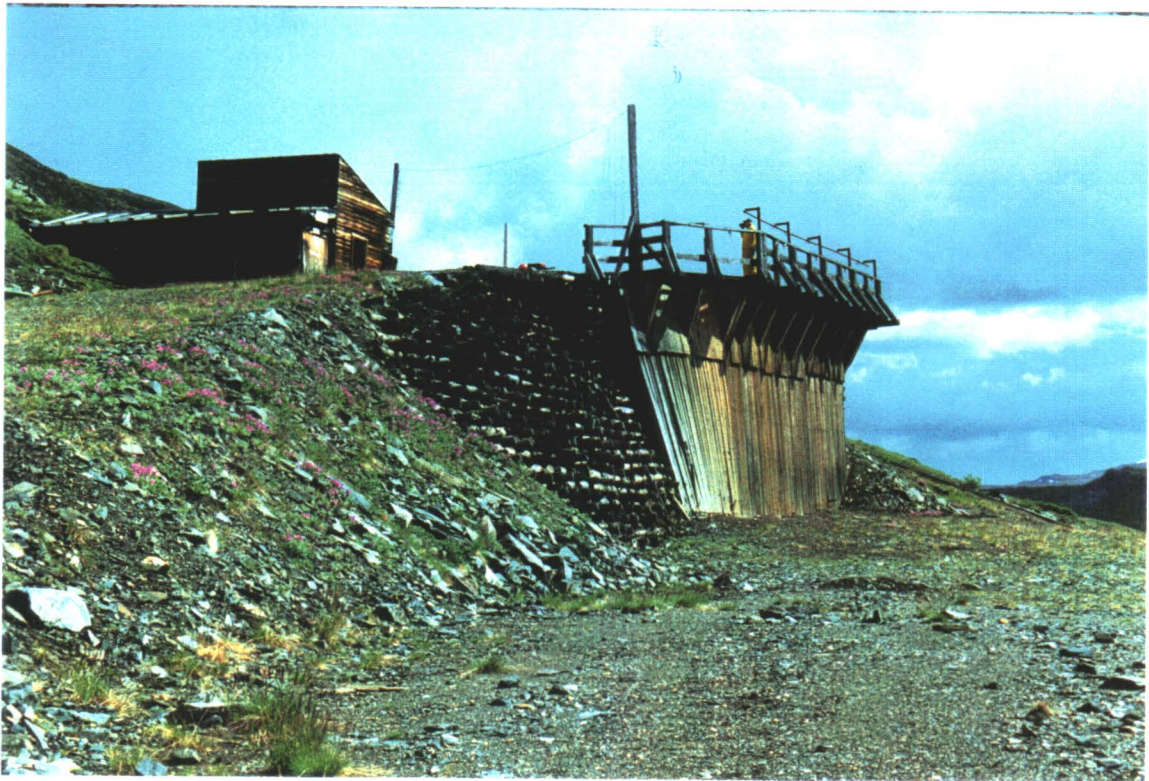
LOADOUT AND ADIT BUILDING AT LEVEL 150

The loadout structure should be posted to warn anyone in the area that it is a potential safety hazard. As time goes on this structure will rot and become unsafe.

The open adit is considered a public safety hazard, and although in a remote location, should be sealed off from the public. This work should be given a **HIGH** priority. Closing off the building beside the adit and adit enclosure is likely the easiest way of sealing the adit. For this reason it is recommended that the existing structure in front of the adit be left intact and used to close off access to the adit.

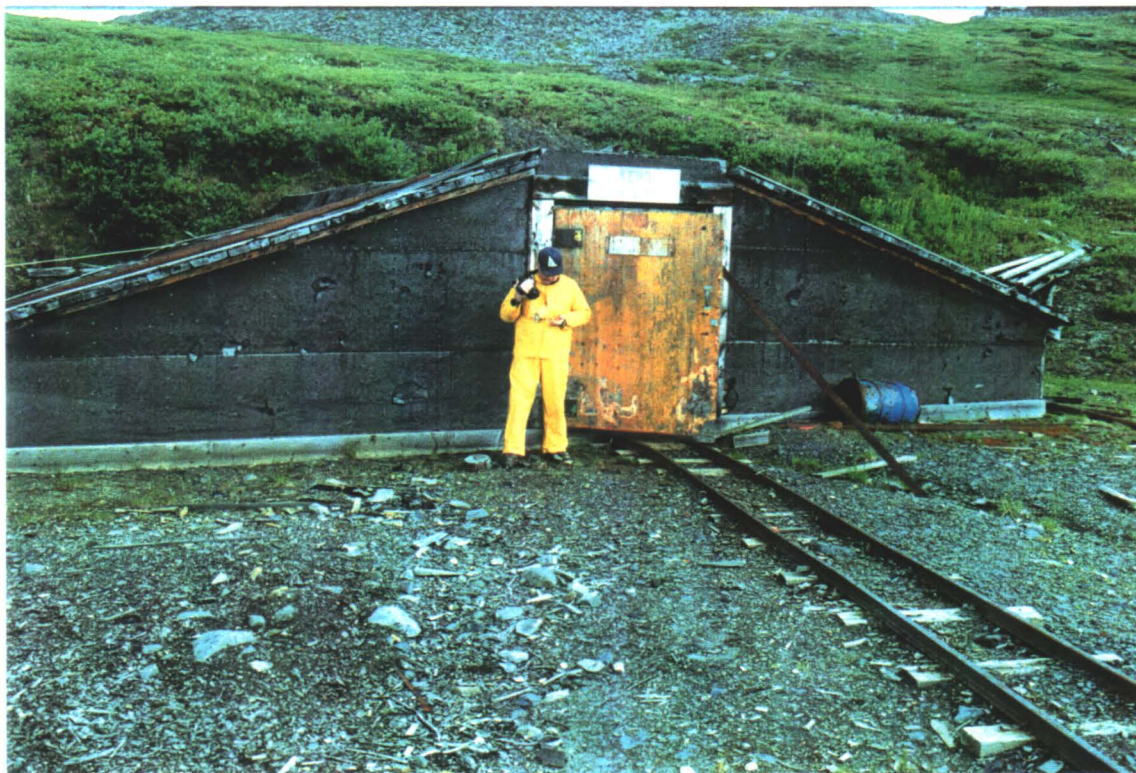
ADIT ENTRANCE TO LEVEL 200

Open access to the adit should be considered a safety hazard and proper closure and sealing of the adit should be considered a **HIGH** priority. It is recommended that the structure surrounding the adit be kept and properly sealed to prevent access.

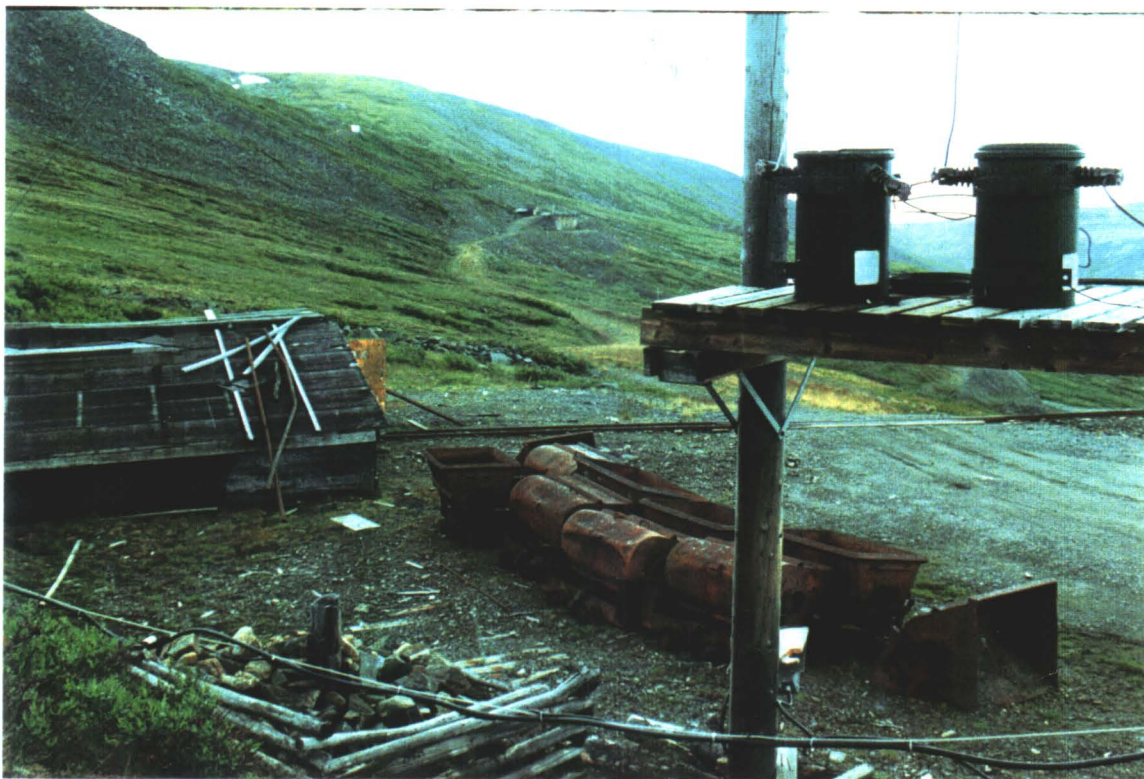
ORE CARS, TRANSFORMERS, AND ADIT BUILDING AT LEVEL 200

The most critical work that needs to be completed at this site is the testing of the transformers to determine whether or not polychlorinated biphenols (PCBs) are present. This work should be considered a **HIGH** priority. Once it is determined whether or not PCBs are present, removal of the transformers and a plan to assess if any ground contamination has occurred can be initiated. If ground contamination is suspected then a plan to conduct a more detailed assessment of any suspected problem can be undertaken. Using criteria that could include assessing the remoteness of the site, the potential to contaminate any surface or groundwater sources, etc. will determine the need to conduct further analysis of the site. If it is necessary to assess the site in more detail, then a soil and groundwater sampling and analysis program will need to be conducted to complete this assessment. Further site remediation can be established once this program is completed.

Other work that could be done at this site includes the removal of the ore cars, remaining railway track, the wire, and any other metal waste that is around the site. This clean-up is not considered essential, and is considered a **LOW** priority to improve the environmental condition at this site. Any loose wooden debris, including power poles, could be piled and burned to also contribute to clean-up of the site.

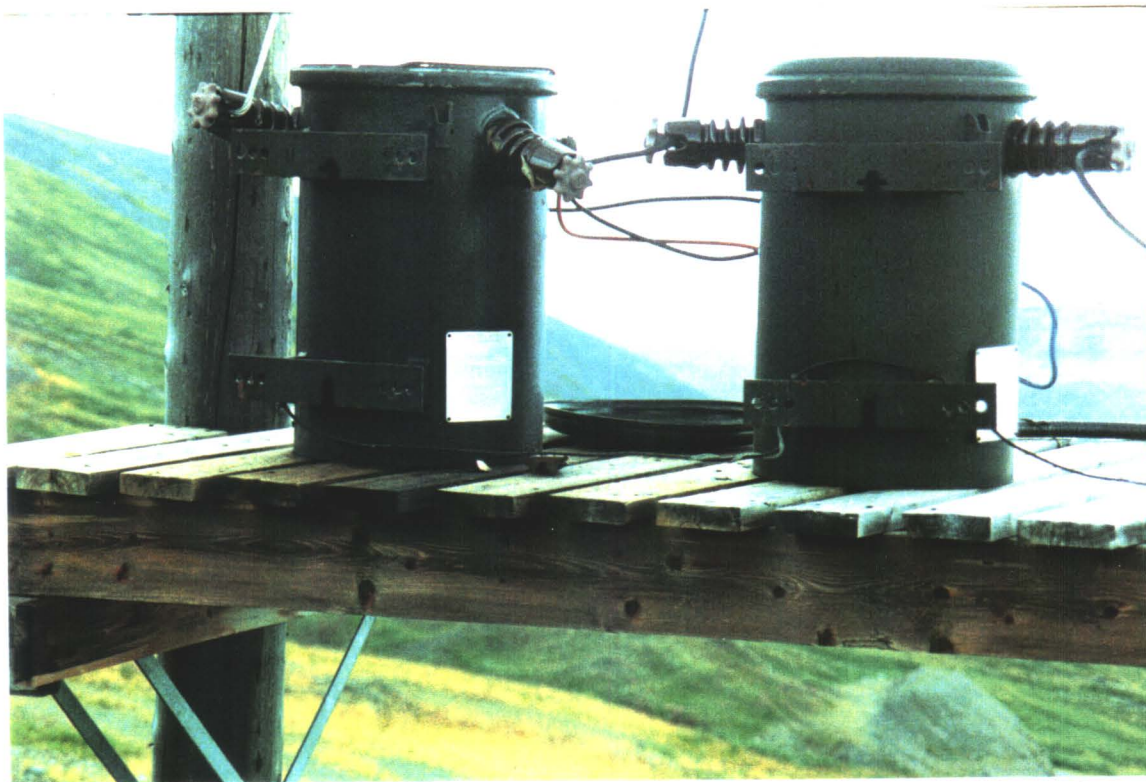
- 10 ore cars (1 inside the adit),
- approximately 100m of rail,
- 2 transformers (65 or 90 litre capacity). **These appear to have leaked.**
- approximately 30m of wire cable,
- several hydro poles, two that supported a transformer base, and
- timber cribbing supporting the loadout structure.

TRANSFORMERS AT LEVEL 200
