ASSESSMENT REPORT

105B-04-2

LOGJAM

DIAND TECHNICAL SERVICES

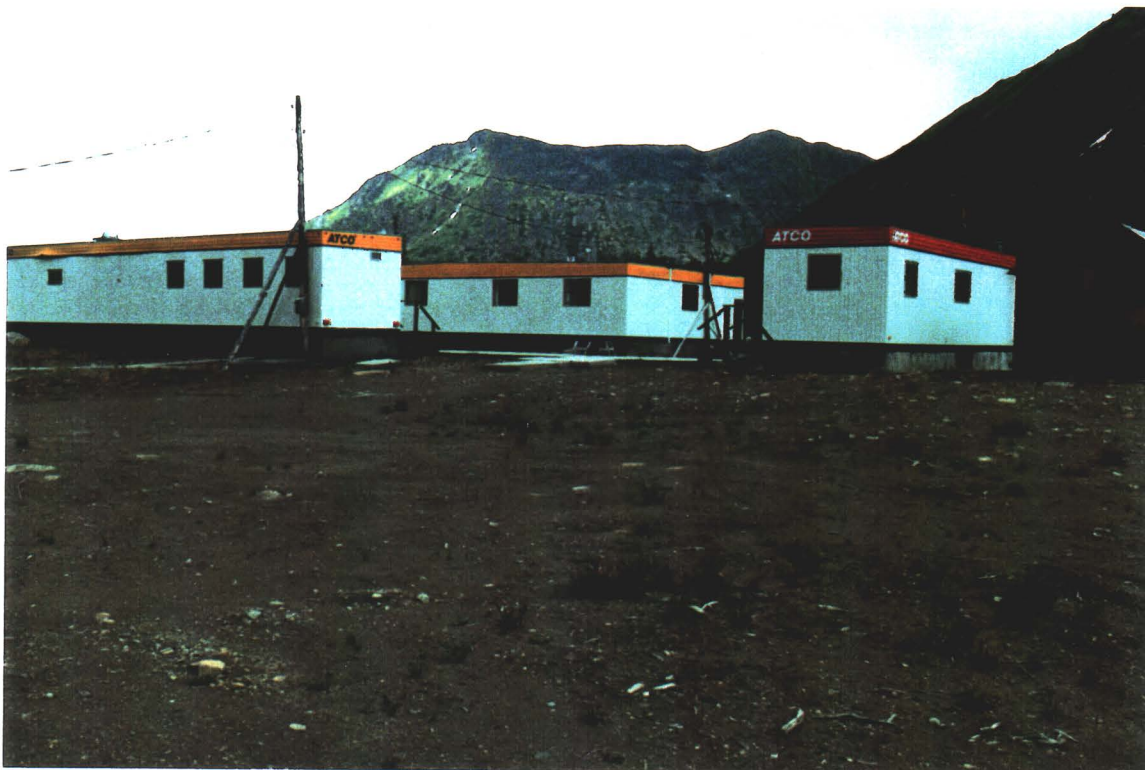
1. CAMP SITE

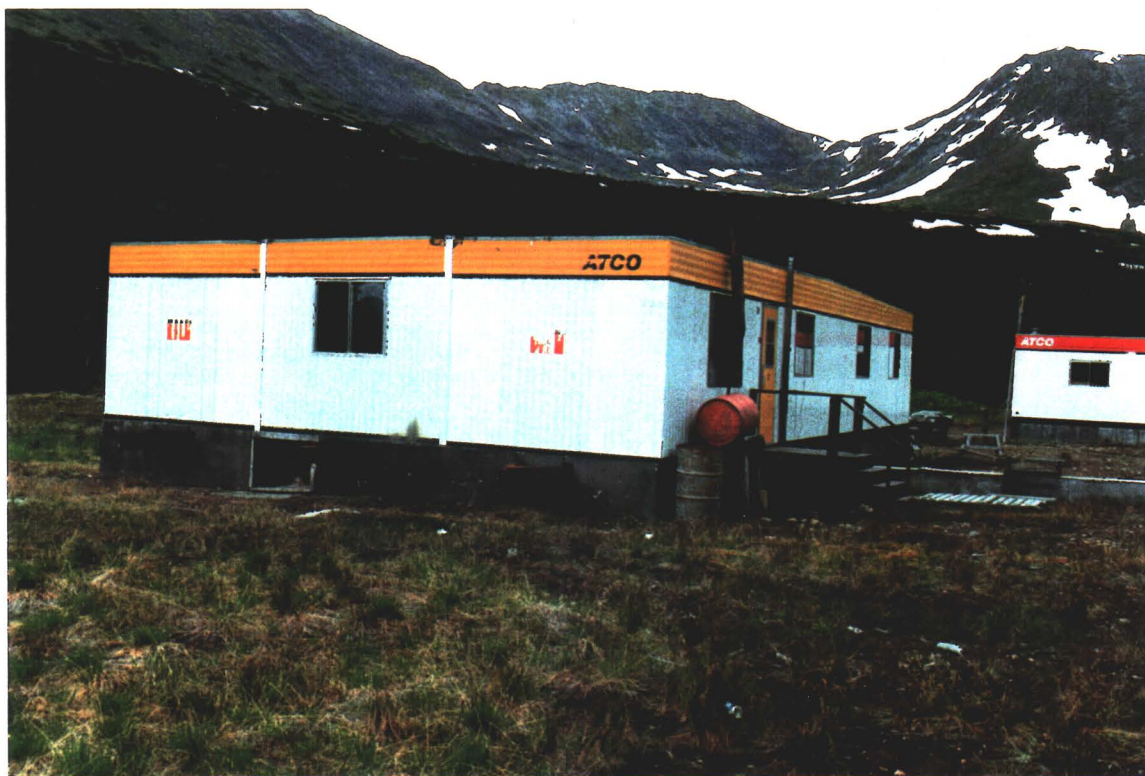
The trailers are in reasonably good condition considering that they do not appear to have been used or maintained for at least five years. The rate of deterioration will likely increase if these trailers are left unattended much longer.

2. SLEEPING UNIT TRAILERS

The five ATCO trailers and four small storage sheds have been in place for approximately 12 years and are beginning to show signs of deterioration. These buildings are not likely to cause any specific environmental hazard, however the longer they are left at this site any residual value will disappear with time, and salvage will become more difficult.

- unhooking all sewer lines, water lines, and electrical service connections to the trailers,
- separating all trailers,
- repairing the Logtung road,
- loading all trailers and moving them over the Logtung road to the Alaska Highway,
- dismantling the largest tank,
- cataloguing all remaining rock core, loading and hauling it to an acceptable storage site,

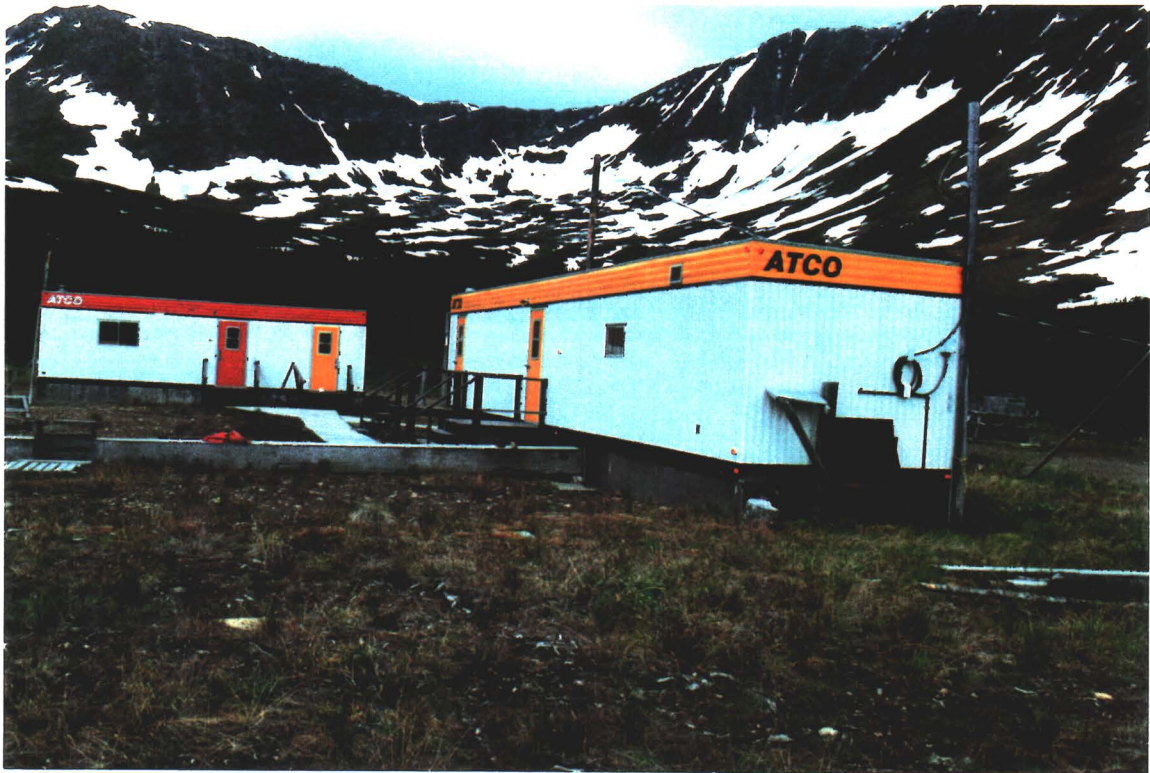
3. KITCHEN TRAILER (YELLOW TRIM) AND OFFICE (RED TRIM)

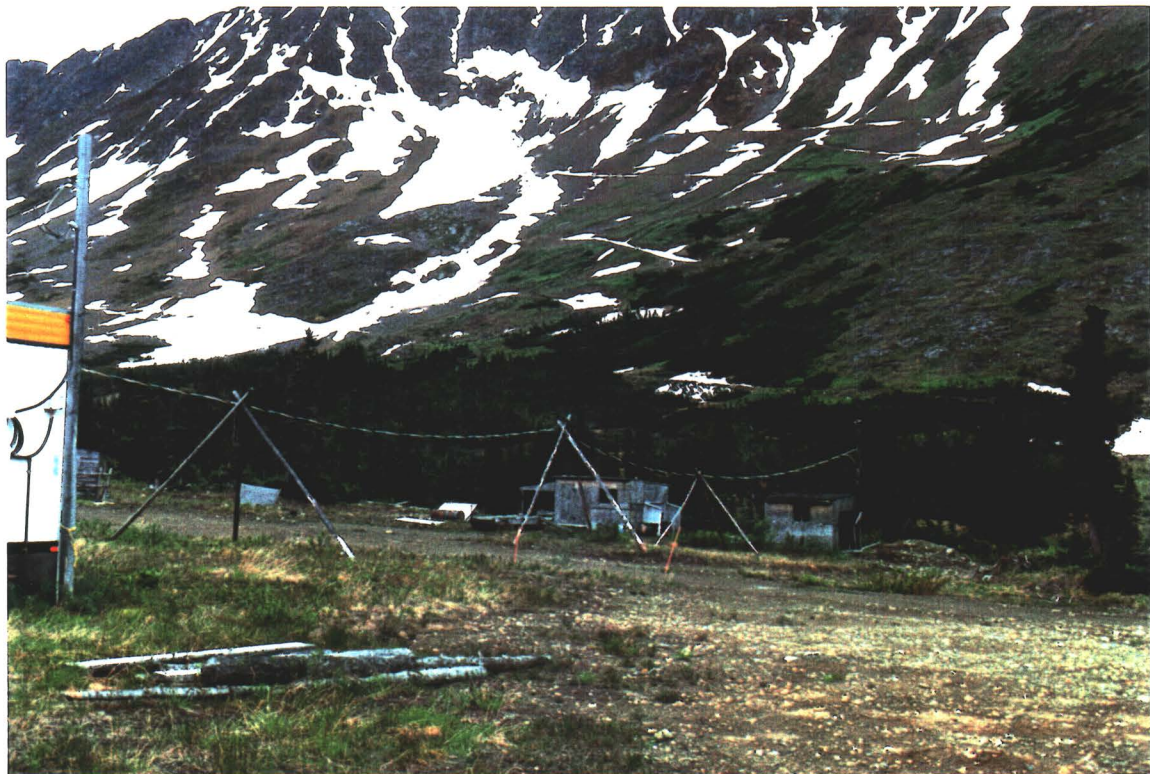
The trailers have not been dismantled and are in a "set up" condition. Plumbing is connected to some form of underground sewage disposal system on the downslope (north) side of the trailer camp. Overhead electrical service is connected between the generator building and the trailer compound, however the diesel generator has been removed. Remnants of a PVC water line between the creek, to the east of the camp site, and the trailer compound is also still in place. The pump has been removed.

4. ELECTRICAL SERVICE LINE FROM GENERATOR BUILDING

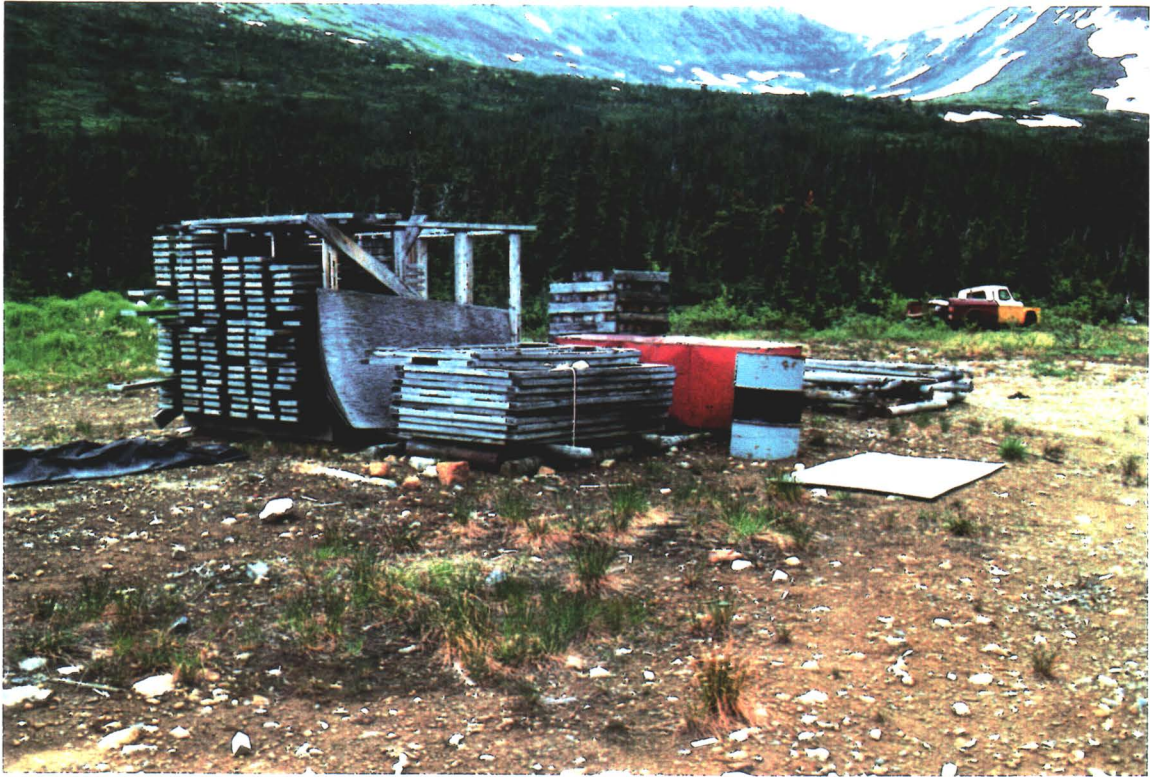
5. CORE STORAGE AND TRUCK

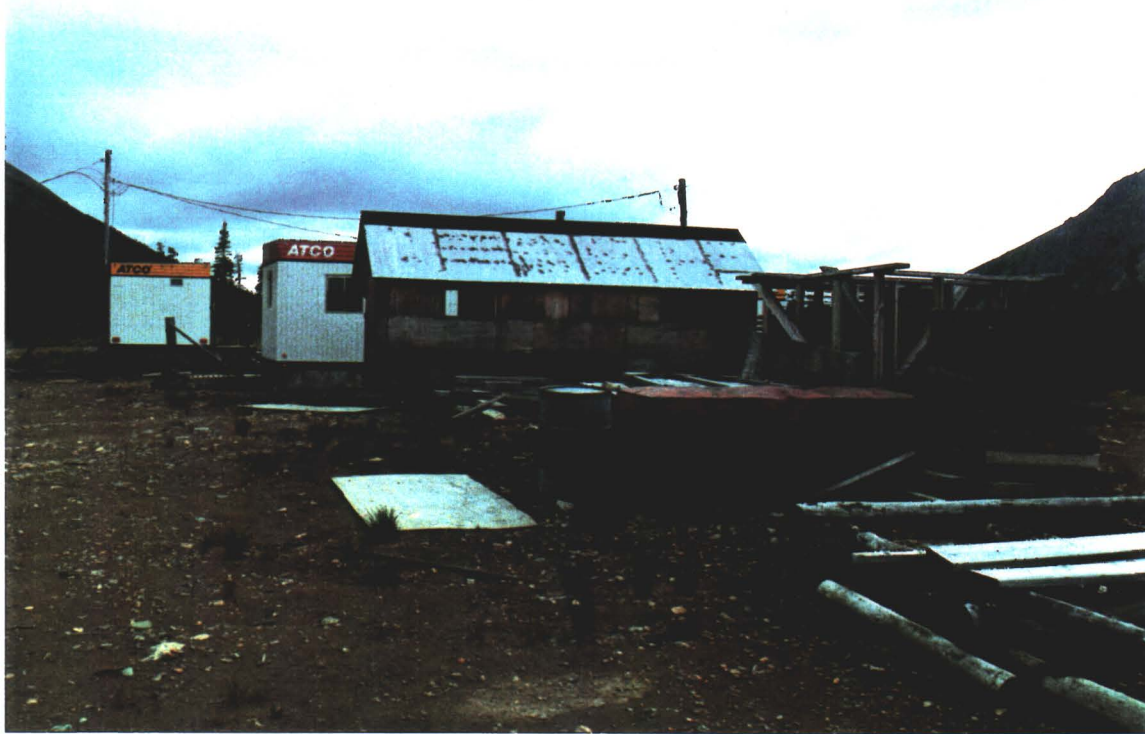
The remaining outbuildings are simple plywood or wood clad sheds and storage buildings. These buildings are unpainted and deteriorating from the weather.

6. CORE STORAGE AND PLYWOOD SHED (CAMP IN BACKGROUND)

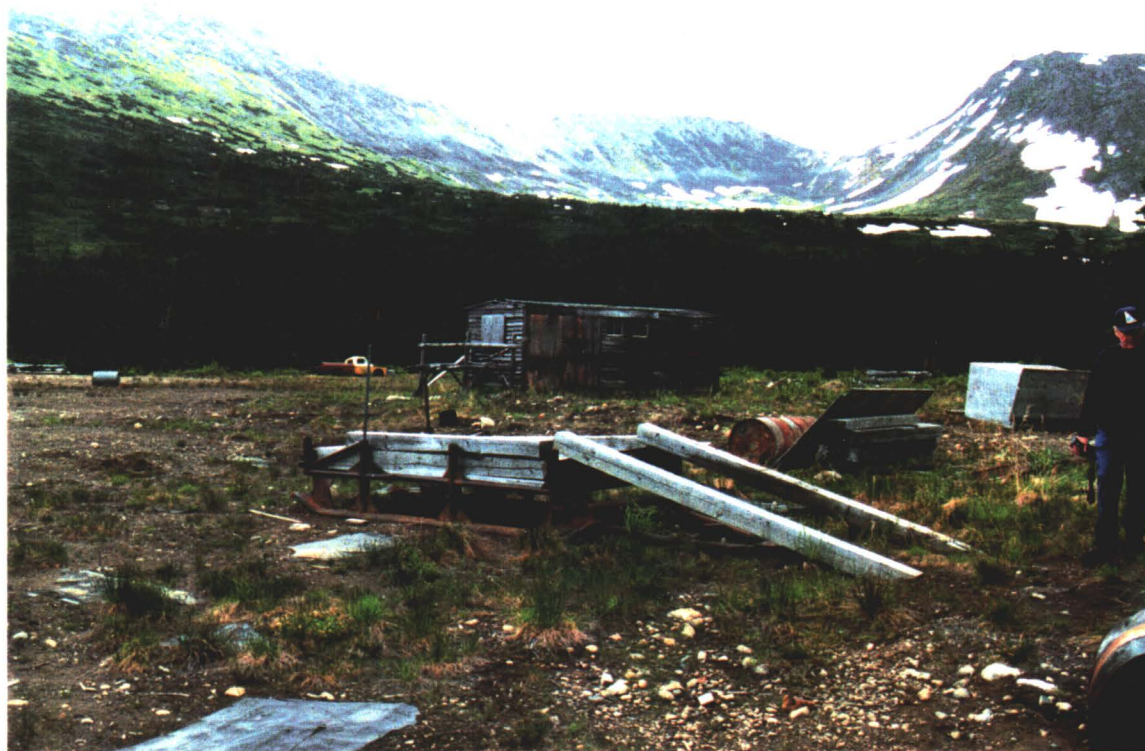
7. SLEIGH AND TOOL SHED

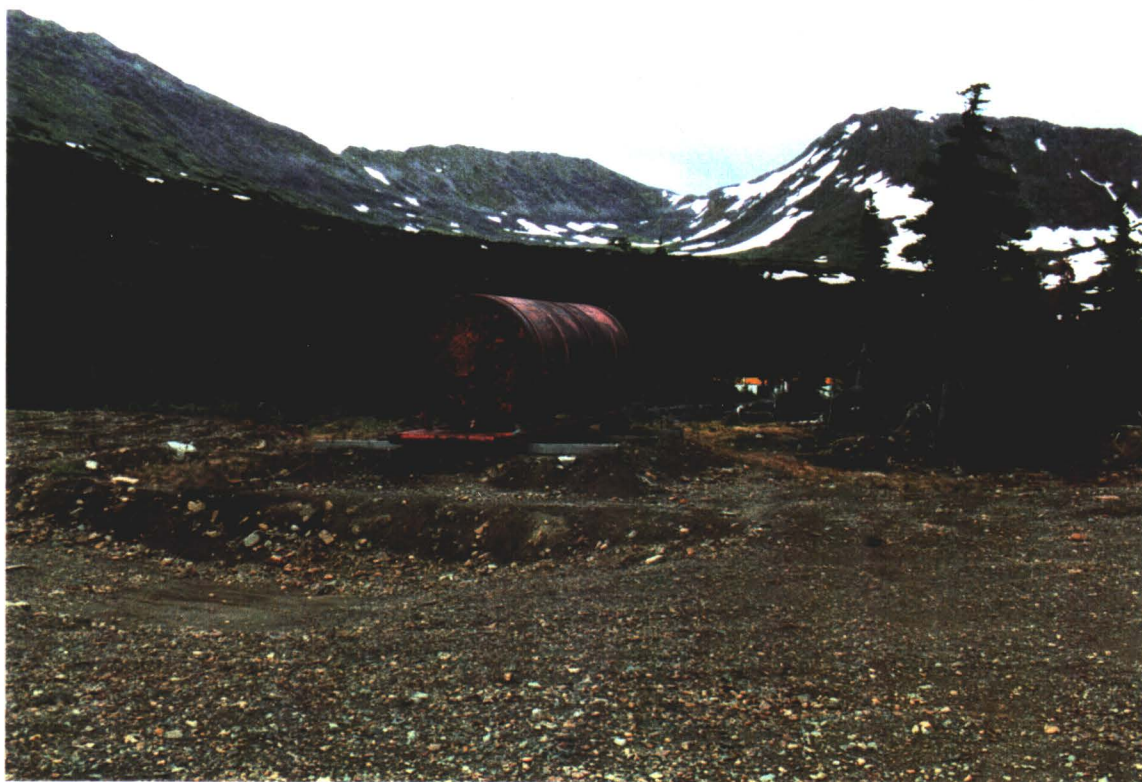
All fuel storage tanks and barrels have been emptied and no hydrocarbon products were found at this site.

8. FUEL STORAGE TANK ON SKID FRAME

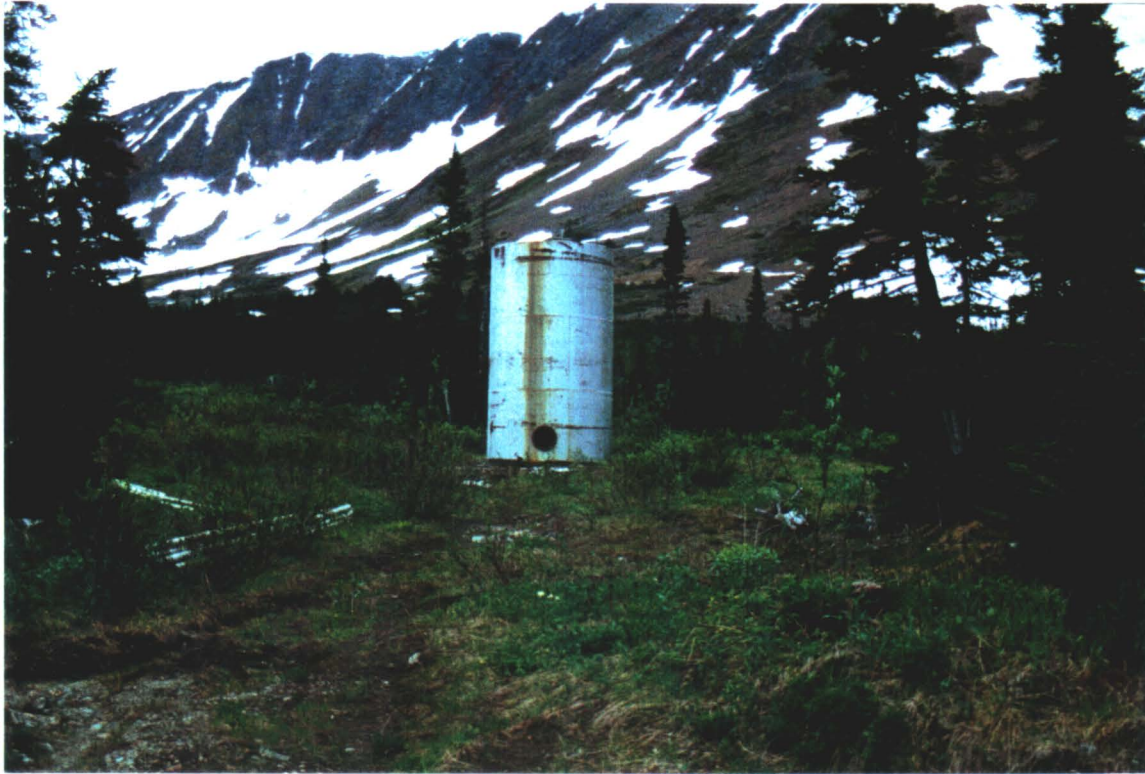
9. VERTICAL FUEL STORAGE TANK

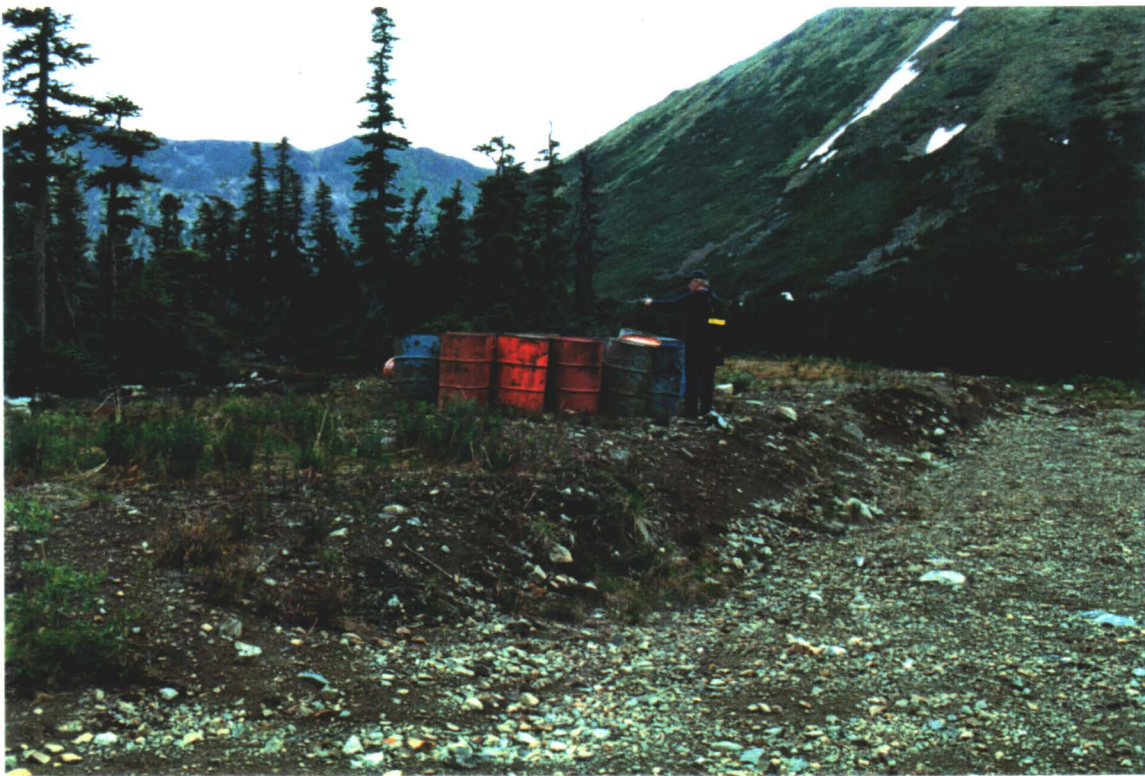
10. EMPTY BARRELS

- loading and hauling all tanks, barrels, and other metal waste from the site to the Alaska Highway, and
- dismantling, piling, and burning all wood buildings and other wood waste.

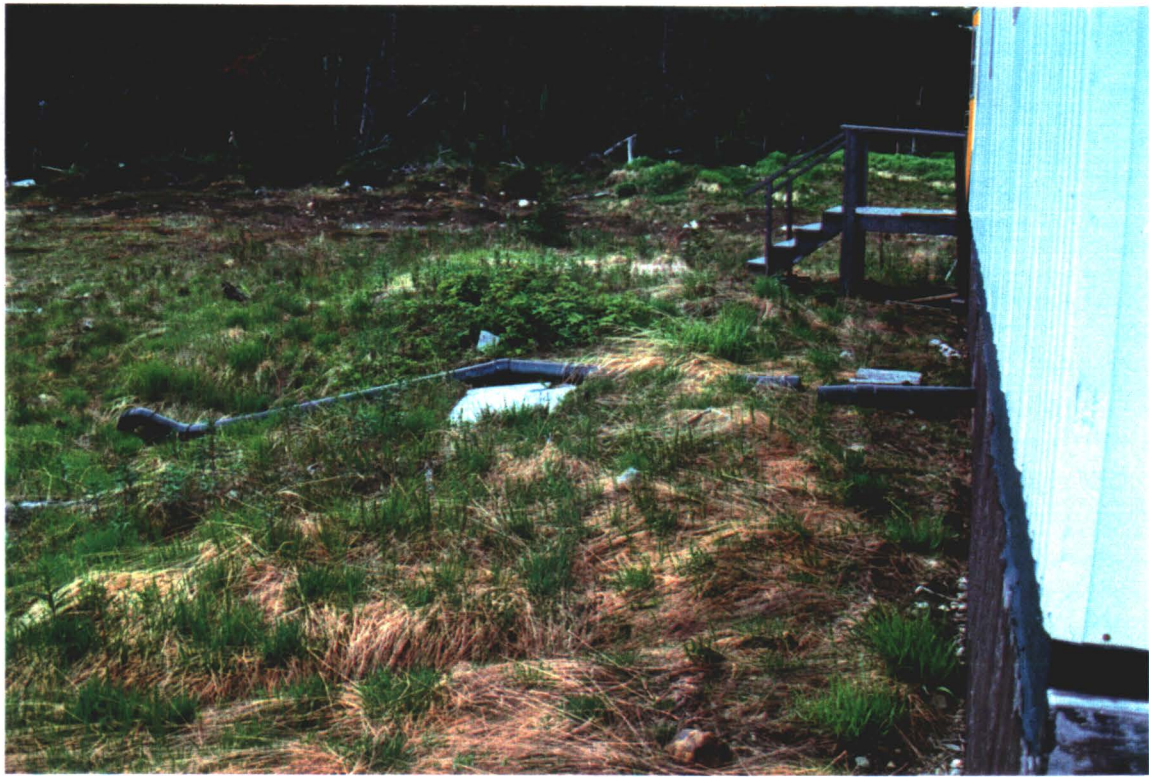
11. SEWER LINE FROM CAMP

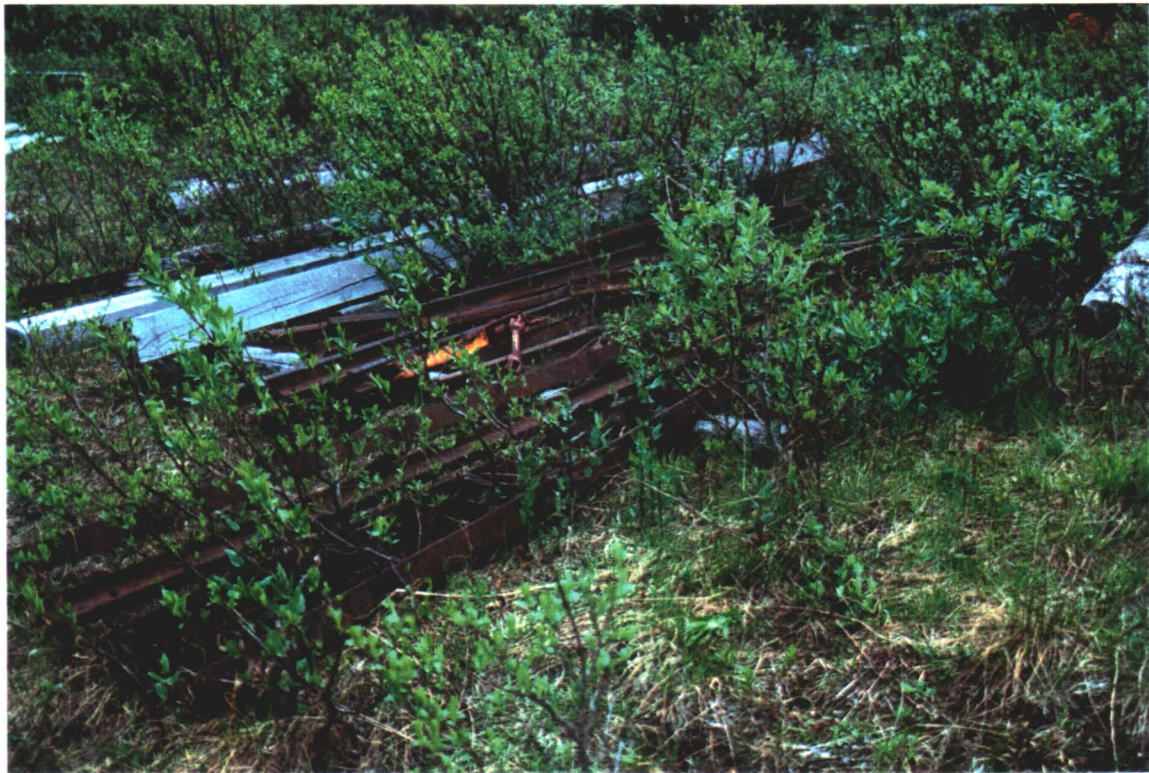
The aluminum irrigation pipe and the rail have been stacked in one location adjacent to the vertical storage tank on the east side of the camp.

12. OLD RAIL

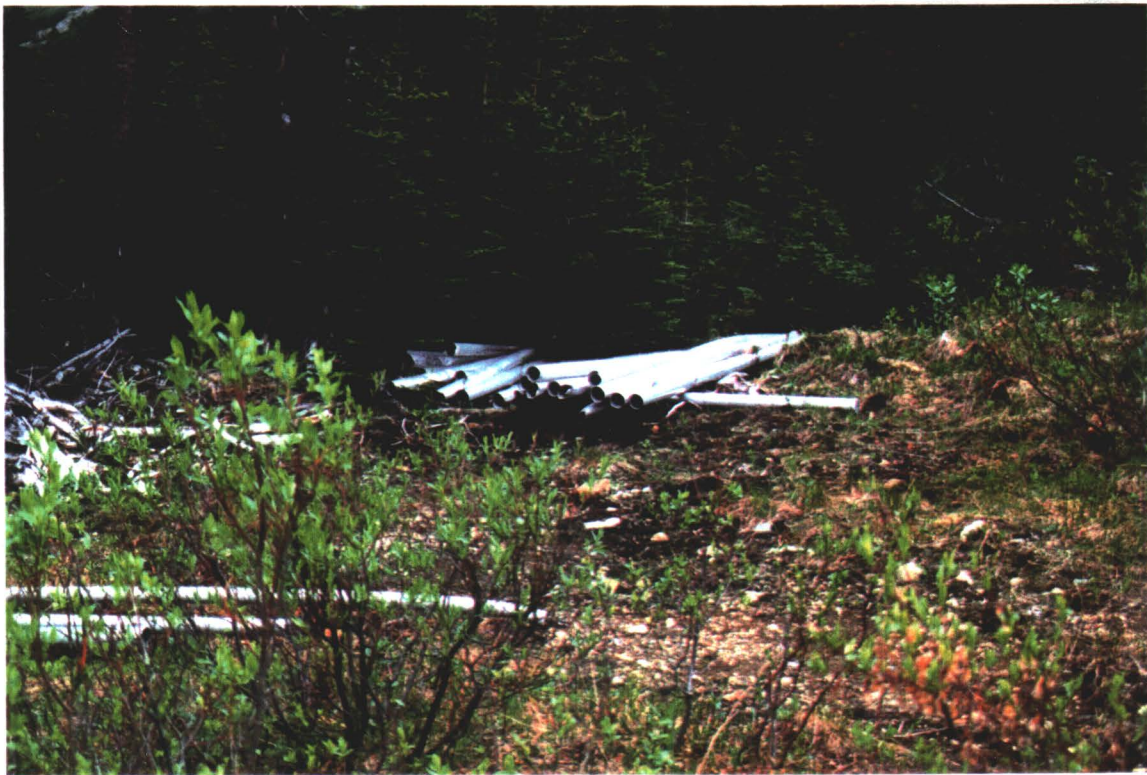
13. ALUMINUM IRRIGATION PIPE

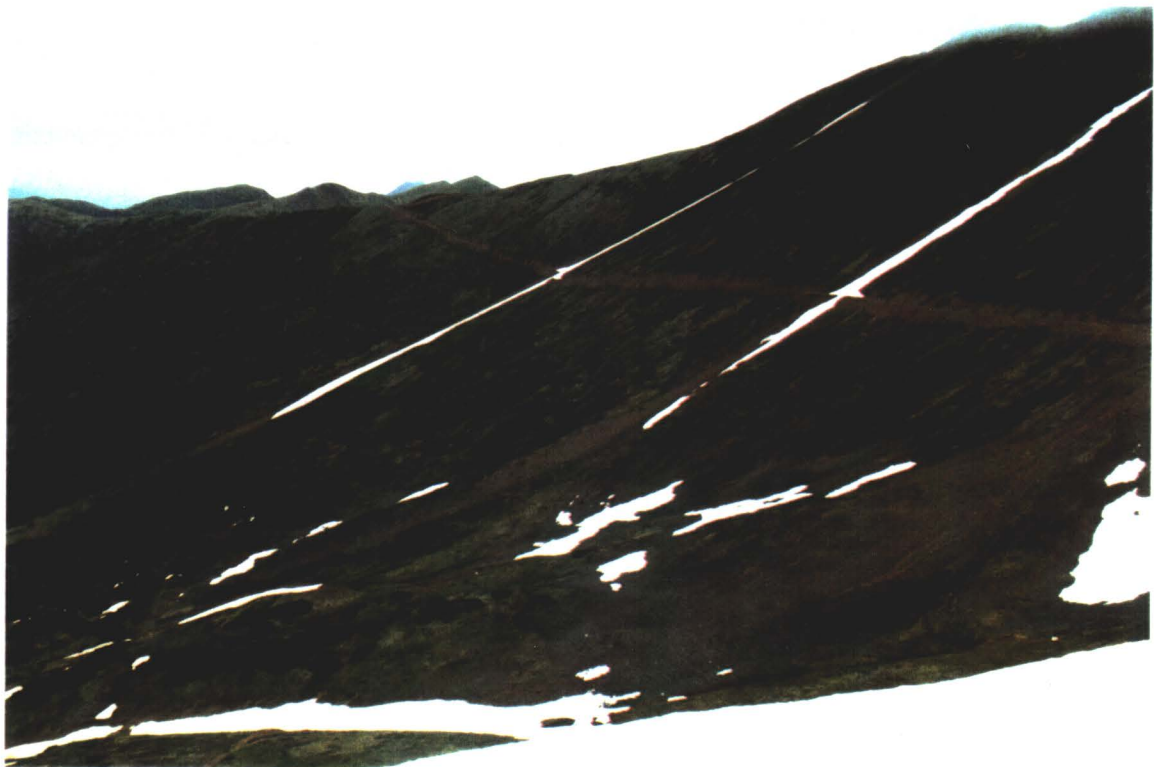
Recent road access appears to have taken place from the Logtung exploration site. This alternative access crosses the mountain ridges between the two sites, a distance of approximately 10km. The distance from the Alaska Highway using this alternate route is 25km. This access is useable for a very limited time, as this trail is snow covered for at least 10 months of the year. At the time of inspection on 1993/06/20 this road was still snow covered and inaccessible with all-terrain vehicles. This access road is also very steep.

14. ACCESS ROAD BETWEEN LOGTUNG AND LOGJAM

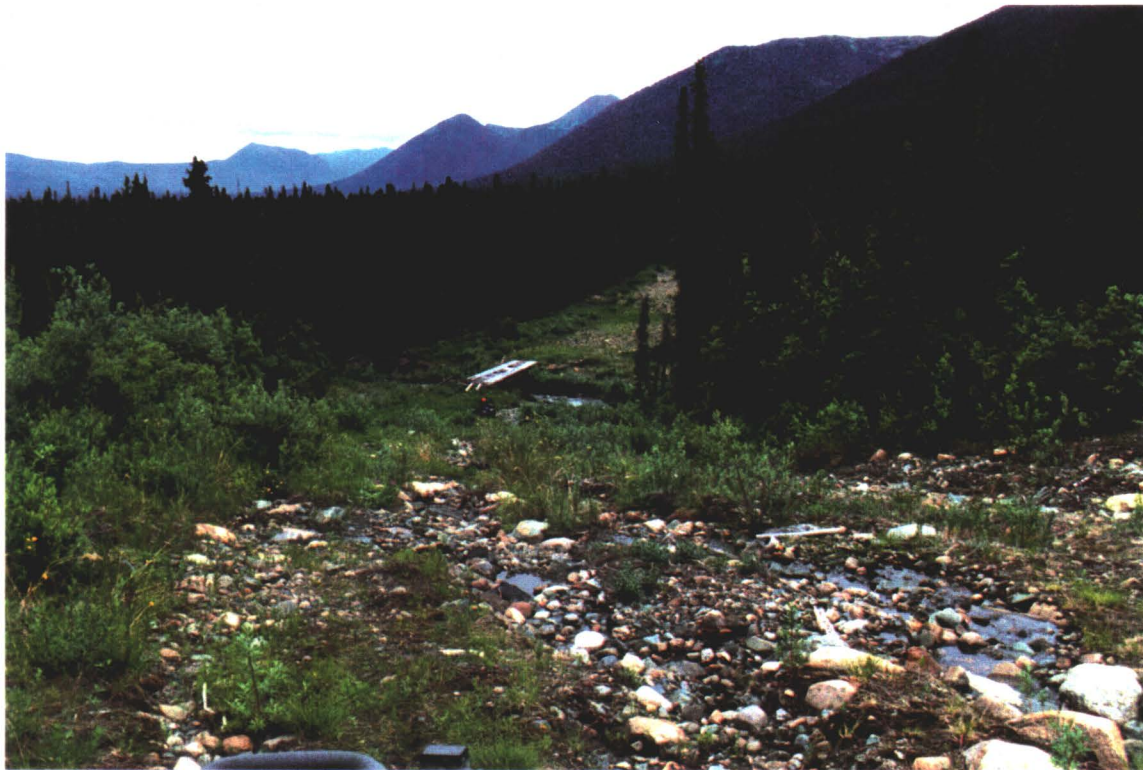
Access to the site is by a 20km trail from the Alaska Highway near Mile 756 and follows along the east side of the Smart River. The access road fords several small tributaries to the Smart River, the deepest at the time of inspection (1993/06/20) being approximately 0.4m deep. A bridge crossing Two Ladder Creek just north of the British Columbia-Yukon border is in very poor condition with the approaches washed out, and the decking in poor condition. The integrity of the foundations and superstructure would need to be checked in detail if this bridge is to be used. The last 5 kilometers of the road is impassable with several deep seated slides across the road. Most of the road is overgrown and would need significant work to re-establish this road corridor before it could be used.

15. ABANDONED ACCESS TRAIL AND BRIDGE ACROSS TWO LADDER CREEK

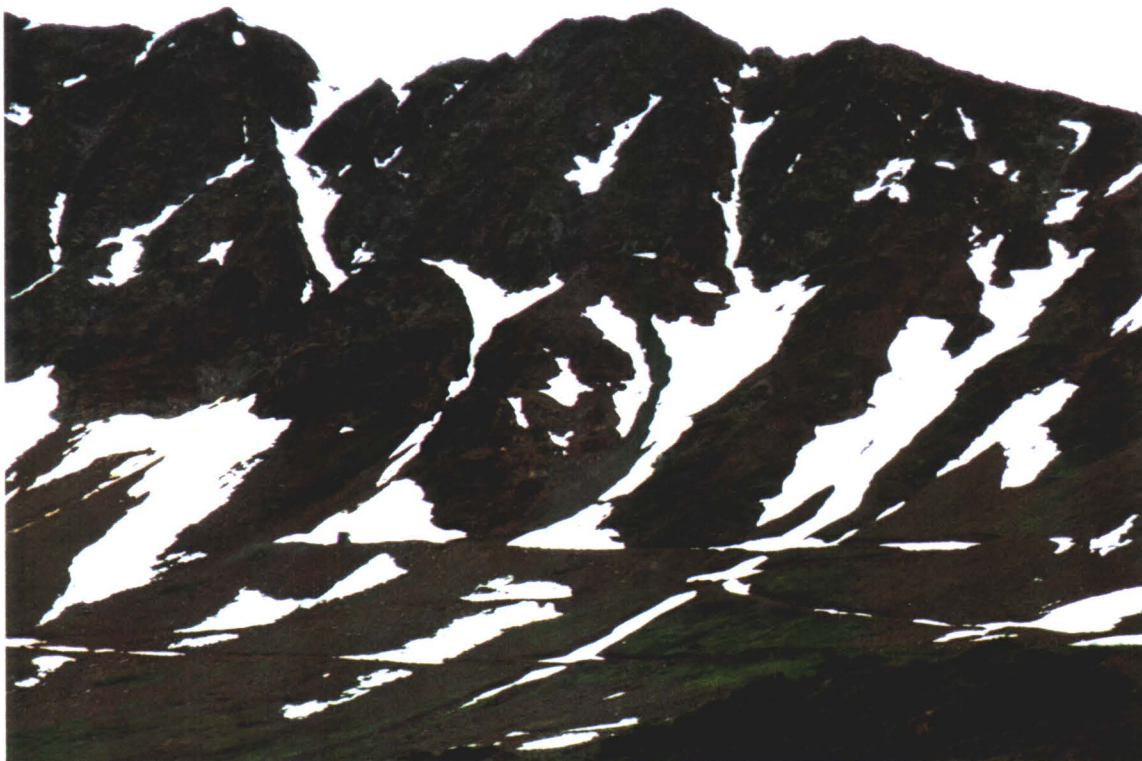
An exploration adit is situated near the base of the steep mountain slope. The entrance to this adit, on a north facing slope, was covered with snow at the time of inspection, so an inspection of the adit entrance condition could not be completed. A relatively small pile of waste rock has been dumped over the face of the slope and is at its natural angle of repose. The other adit, mid-point on the steep mountain face appears to have a wooden structure supporting rails and a dump. Rock waste has been dumped off this structure and has formed a "chute" of waste rock to the base of the mountain. This second adit appears to be quite old.

16. LOWER AND UPPER ADIT SITES

Adit - The entrances to the adits at the time of inspection were inaccessible, one was covered in snow and the other is located on a very steep rock face. Closure of the higher adit would not likely be practical to complete as it is in a very remote and dangerous location. The lower adit, if it has not been properly sealed, appears to be covered by snow for likely at least 10 months of the year in a very remote location. An inspection of this adit during the last two weeks of July would be the best time to verify conditions at this adit. Recommendations could be made after this inspection is completed.

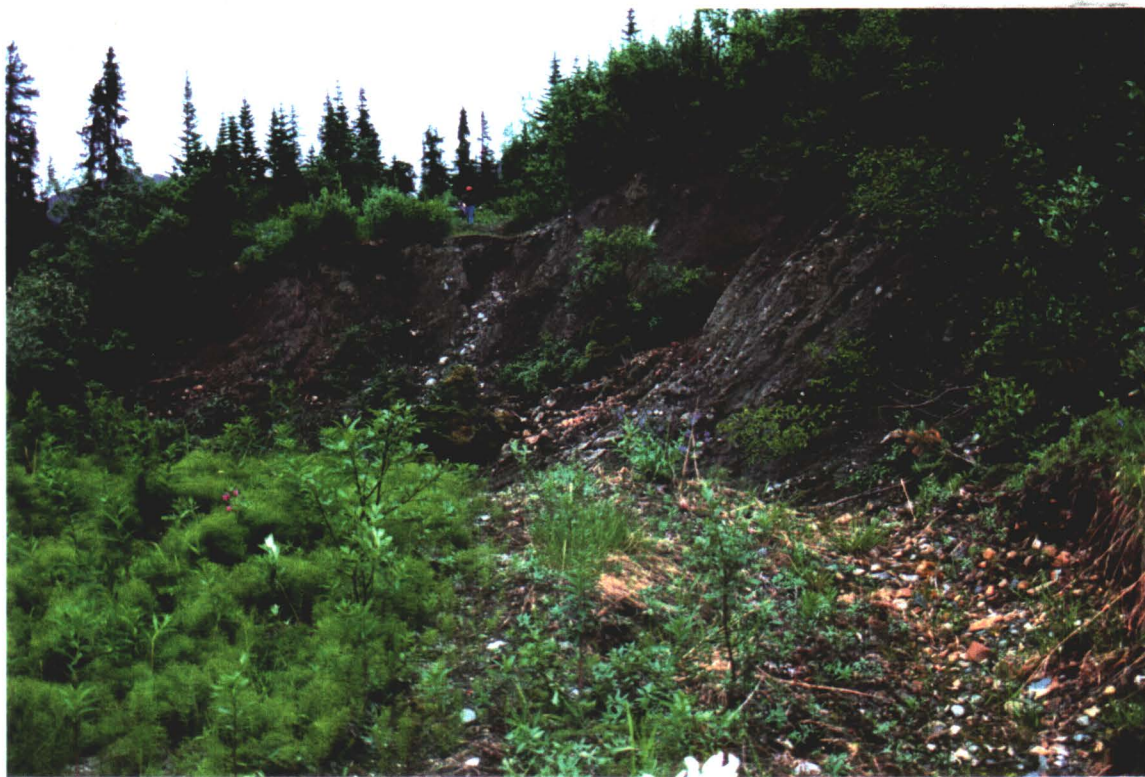
17. SLOPE FAILURE ACROSS ROAD
