**ASSESSMENT REPORT**

**105F-07-1**

**STORMY**

**DIAND TECHNICAL SERVICES**

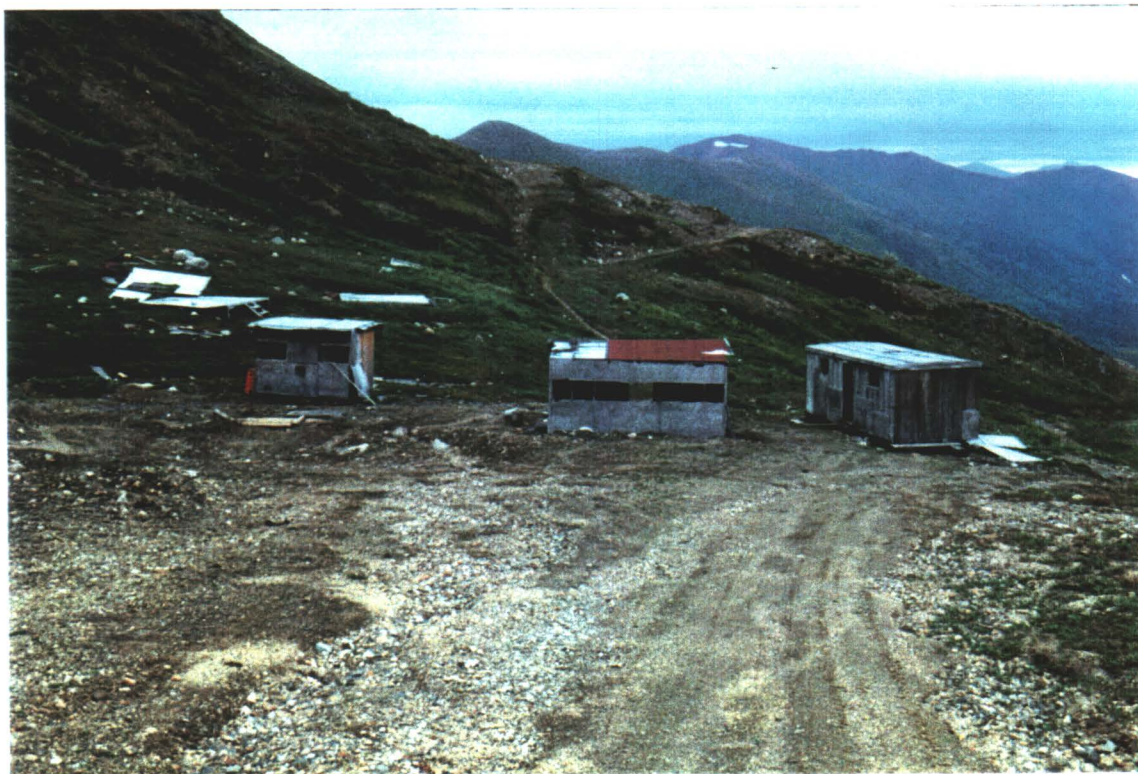
BUILDINGS AT CAMP SITE

- plywood clad wood frame building, measuring 3.1x7.3m, once used as a cooking facility.
- plywood clad wood frame building, measuring 4.9x4.9m, used to store approximately 8.5 cubic metres of core.
- plywood clad wood frame building, measuring 2.4x3.7m, once used for showers.
- 2 wooden tent frame bases, each measuring 4.3x4.9m.

The remaining part of the camp does not provide significant environmental hazard to the area. The wooden buildings will continue to deteriorate and should be demolished and removed or burned, however they pose no real hazard to the surrounding environment. This is considered a **LOW** priority to improve the environment in this area.

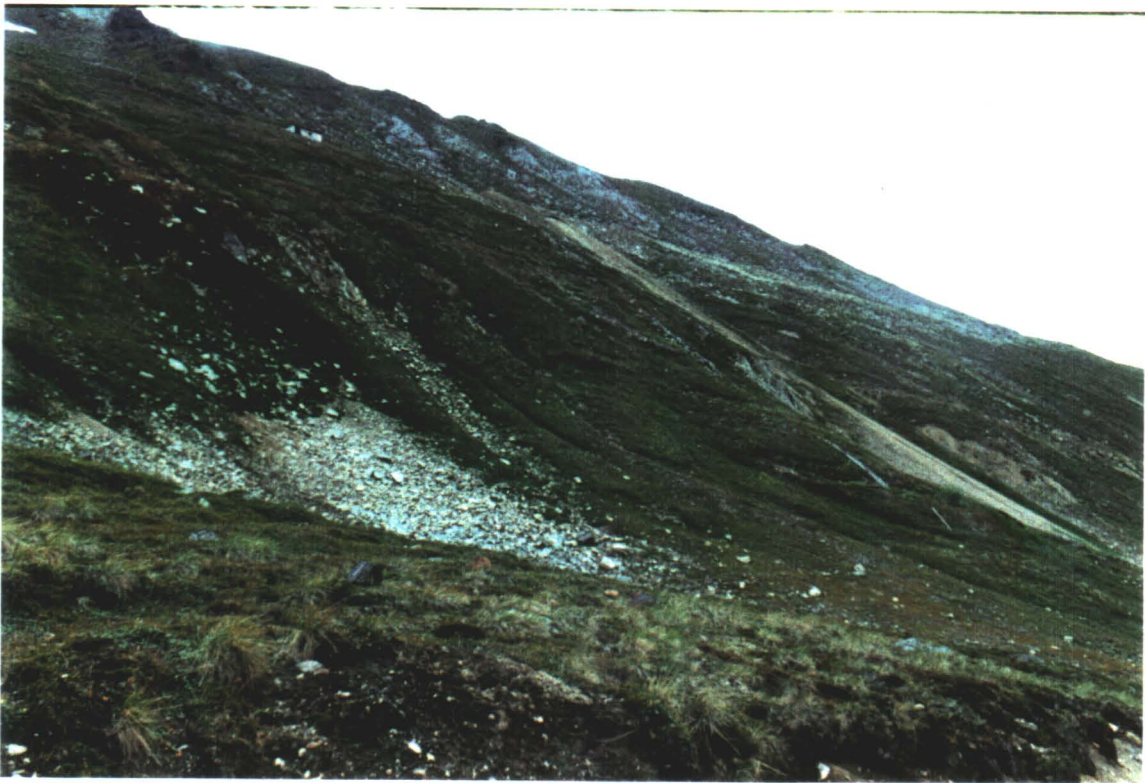
ADIT SITE

A relatively small amount of waste rock (less than 1000 cubic metres) was dumped over the steep bank in front of the entrance to the adit. This waste rock effectively blends in with the surrounding talus, and is not overly visible on the slope.

- plywood clad wood frame building, measuring 3.7x6.1m, used as a storage building.
- a pile of old rail, pipe, and 10 wooden timbers was located outside the entrance of the adit.

If a waste clean-up program is implemented in the area, it is recommended that the metal waste be gathered and removed from the site. At the same time, the remaining wood waste should be piled and burned in an acceptable location. This work should be considered a **LOW** priority at this location.

Site remediation of the waste rock is not considered practical and would not improve the environment without causing additional damage to the area. The revegetation that has started on the waste rock dump, the trench area, and the access road should not be damaged and allowed to regenerate naturally.

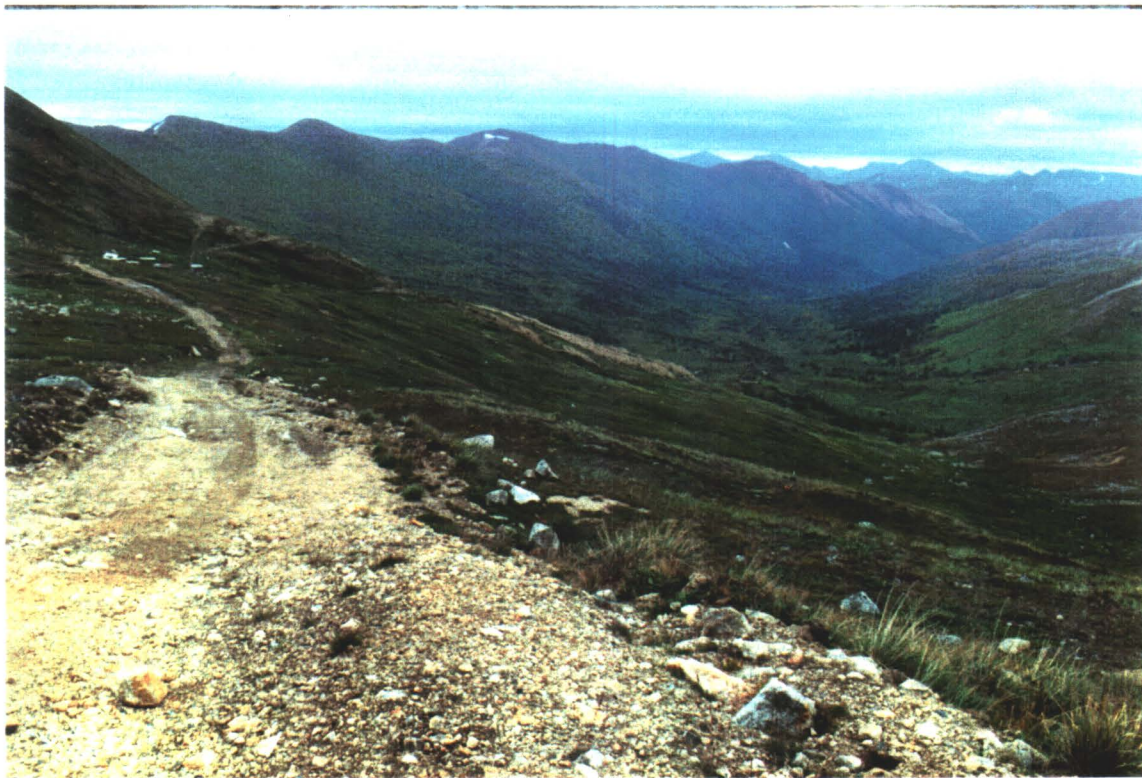
ACCESS ROAD NEAR EXPLORATION SITE

Construction of the access road to the exploration site has impacted the environment from clearing of right of way and crossing many streams without bridges or culverts.

The once cleared right of way is overgrown with new vegetation except for a one lane trail that remains open due to local traffic. The road near the exploration site was constructed on a very steep, dry, but stable slope, leaving a visual impact from the "cut and fill" method of construction used. Remaining impact should only be visual which would be very expensive and initially cause more damage if repairs were initiated. This is not recommended.

This road crosses several small creeks. Damage may have once occurred from downstream siltation from the initial construction, however it is unlikely that there is any further damage caused from the very limited local traffic that uses this road as the creek

bottoms are typically covered with cobbles and boulders. Ongoing damage from the local traffic is a **LOW** environmental impact.

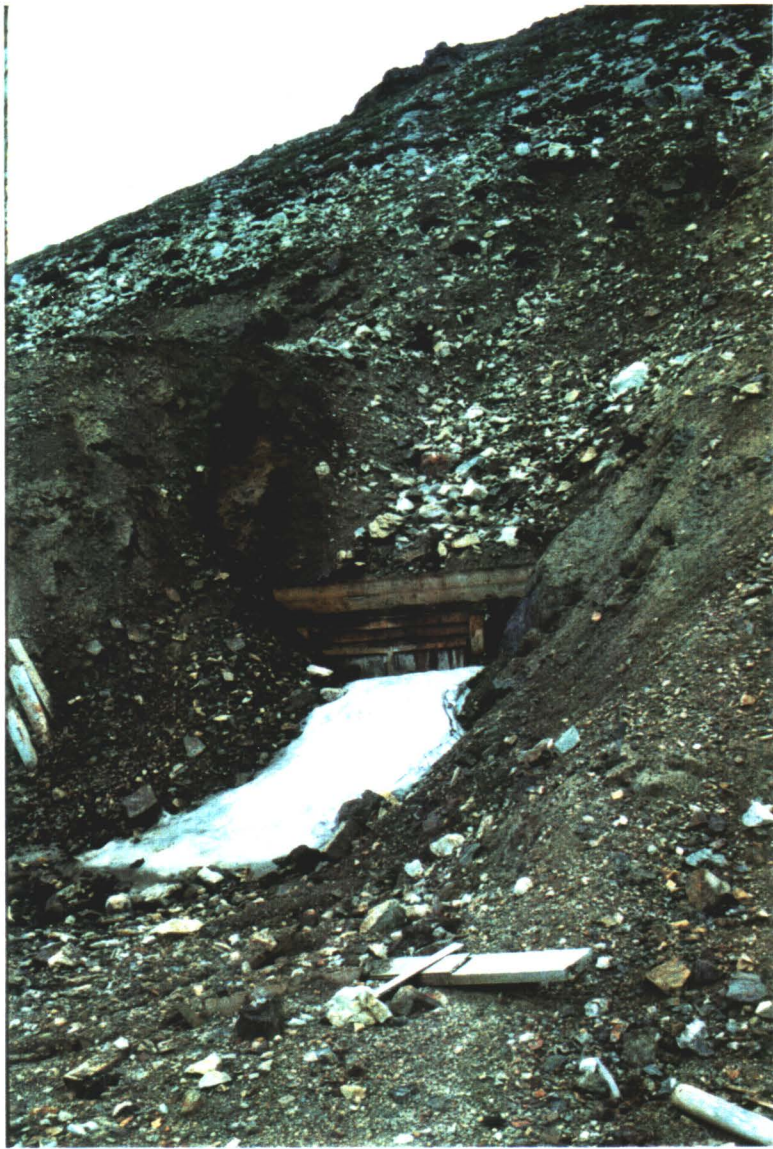
ADIT

One adit was found which was partially blocked by snow. The upper half of the adit entrance was exposed which showed that it was well sealed with a solid wooden timber gated structure. The only seepage from the adit appears to be from snowmelt. No groundwater seepage was evident.

As noted, the adit is well sealed, is effectively covered with snow year round, and does not appear to pose any concern for public safety. Nothing needs to be done to better secure this adit at this time.
