**ASSESSMENT REPORT**

**105D-02-1**

**VENUS**

**DIAND TECHNICAL SERVICES**

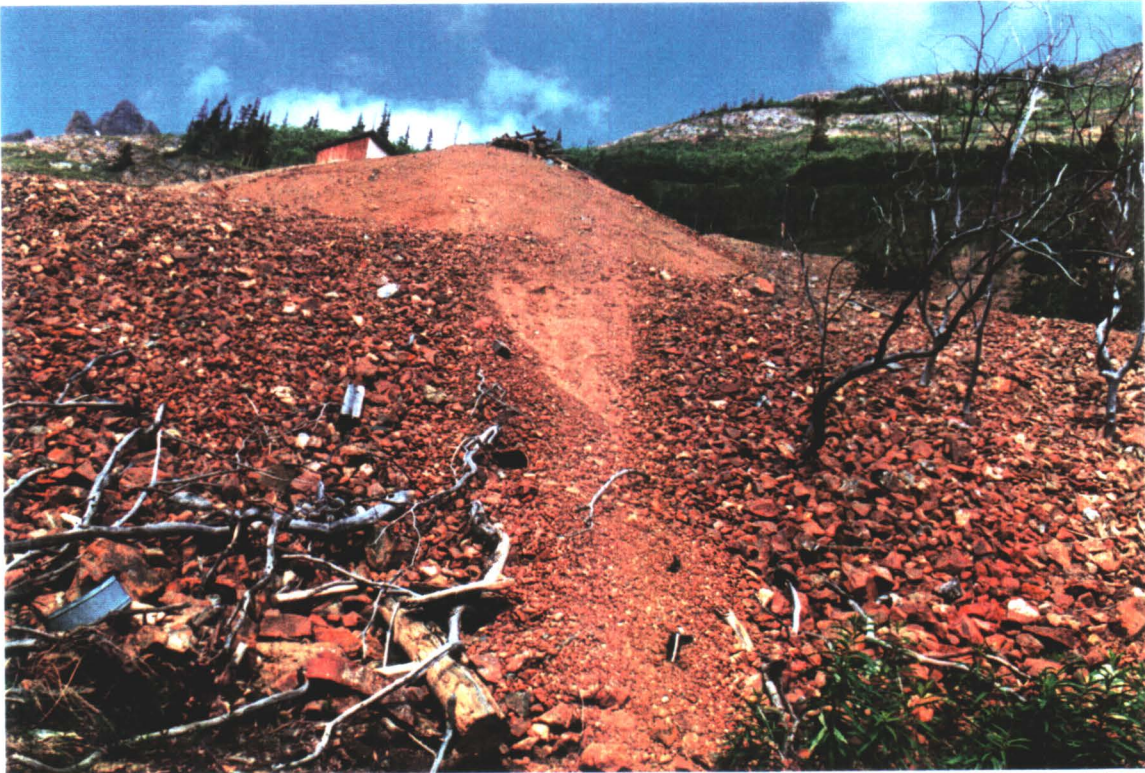
A large pile of waste rock has been placed downslope of the adit. This waste rock was dumped in the easiest way, down the slope outside the entrance to the adit, spilling down the slope to a point where the natural angle of repose of the rock intersects the natural slope angle.

WASTE ROCK FROM ADIT #1

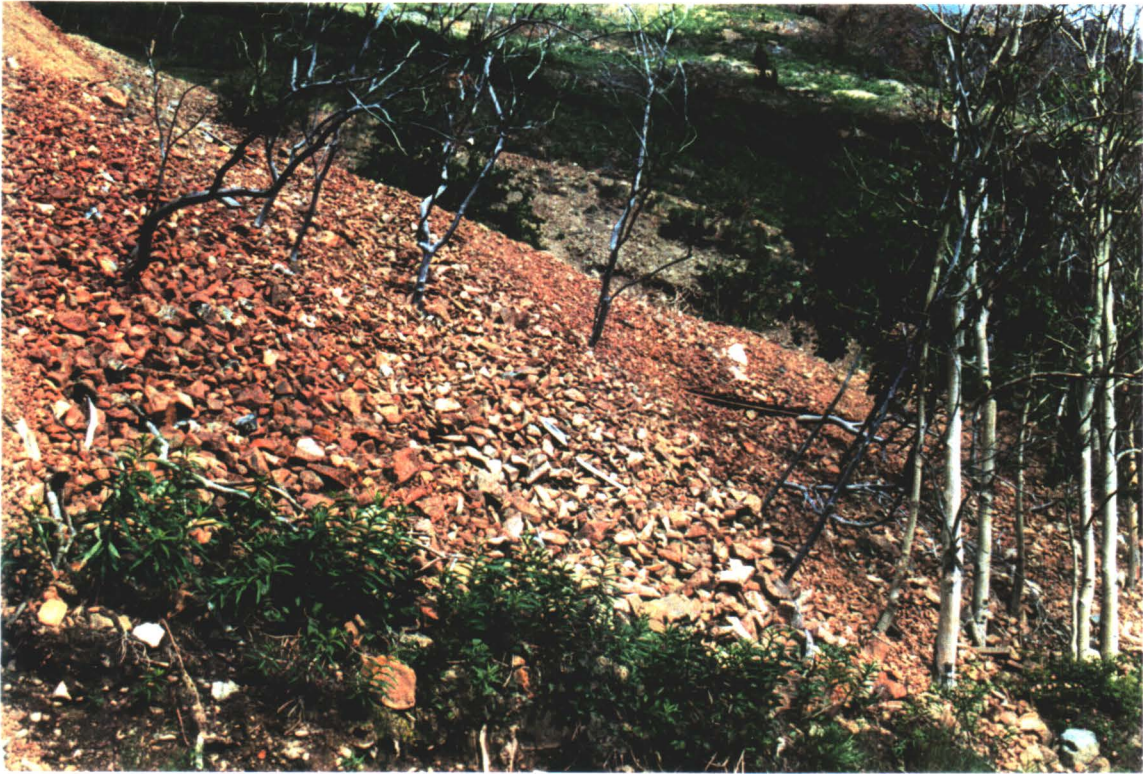
The site is sparsely vegetated partly because the area is so dry and partly because the site is so rocky and without surficial soils. The vegetation across the site consists of stunted poplar 3-5m high, black spruce, grasses, and stunted willows. Generally the vegetation is growing better in depressions and flatter areas, and gets thicker closer to the lake. The vegetation has been removed or has died wherever site disturbance has occurred. For instance it was observed that vegetation partly covered at the toe of waste rock piles has died.

DEAD VEGETATION AT TOE OF WASTE ROCK

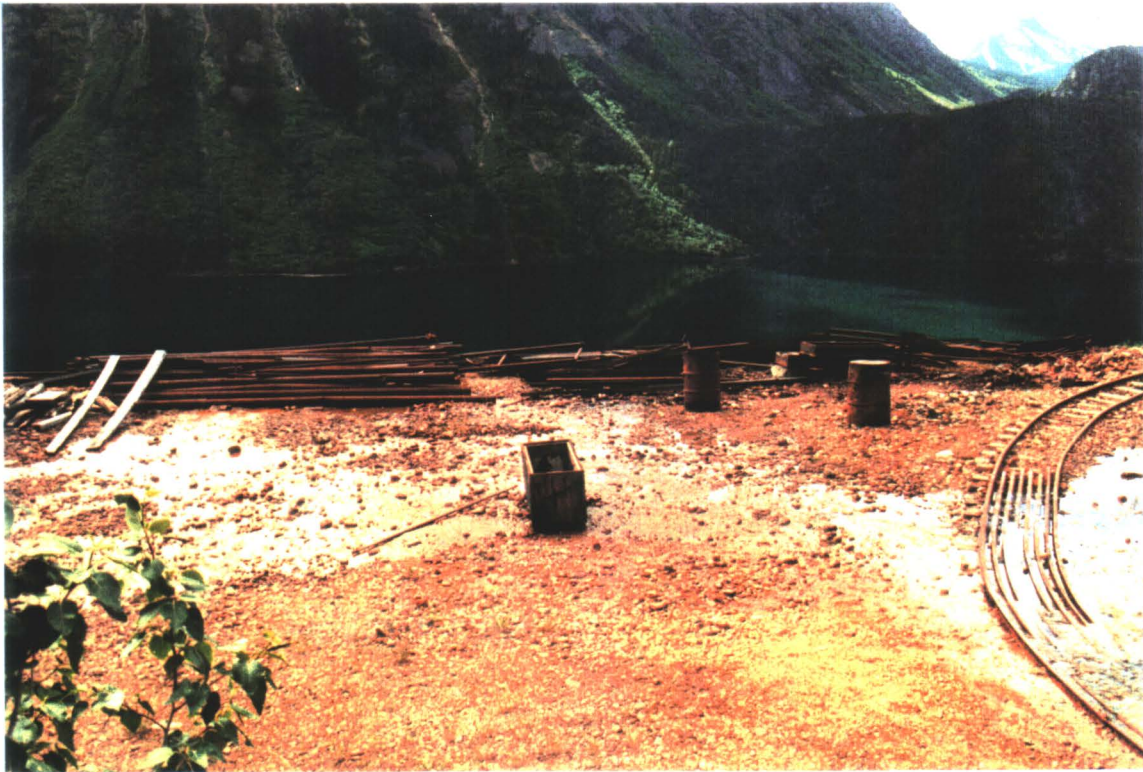
- a large pile of rail and other metal junk equal in size to the pile of pipe,
- 2 - 205 litre rusted barrels,
- pieces of cable, pipe, etc. scattered on the slope of the waste rock pile.

RAIL, BARRELS, AND PIPE ON WASTE PILE TO ADIT #1 (NOTE DRAINAGE)

- \* The adit has been well sealed and is inaccessible to the general public. This adit should not be considered a safety hazard at this time. Periodic inspections should be completed to ascertain that these conditions do not change.
- \* The three remaining small wooden buildings will continue to deteriorate. Eventually these structures may pose a small hazard to personal injury, however this risk should be slight.
- \* A large amount of material has been left on site including galvanized ventilation ducting, water pipe, victaulic couplings, up to 300 pieces of 6m long pipe, rail, barrels, cable, cable spools, wooden pallets, spools of conveyor belt, etc. This material does not pose a significant hazard to the environment, however it is considered a mess and is unsightly. This material should be removed from the site if a clean-up program is initiated for the area.

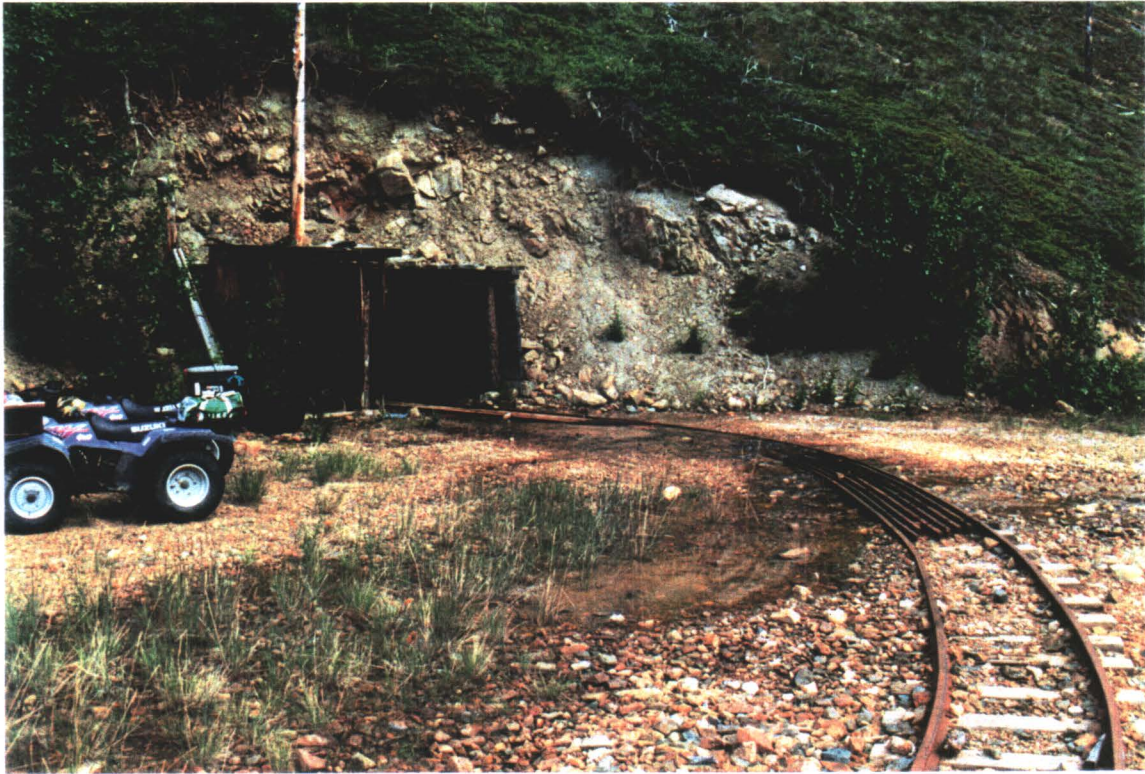
- large amount of 915mm diameter galvanized ventilation ducting,
- sealed adit with water draining out the entrance, estimated between 90-125 litres/minute  
This adit is well sealed. The surface water seeps into the waste rock and seeps out the bottom of this waste rock.

ENTRANCE TO ADIT #1

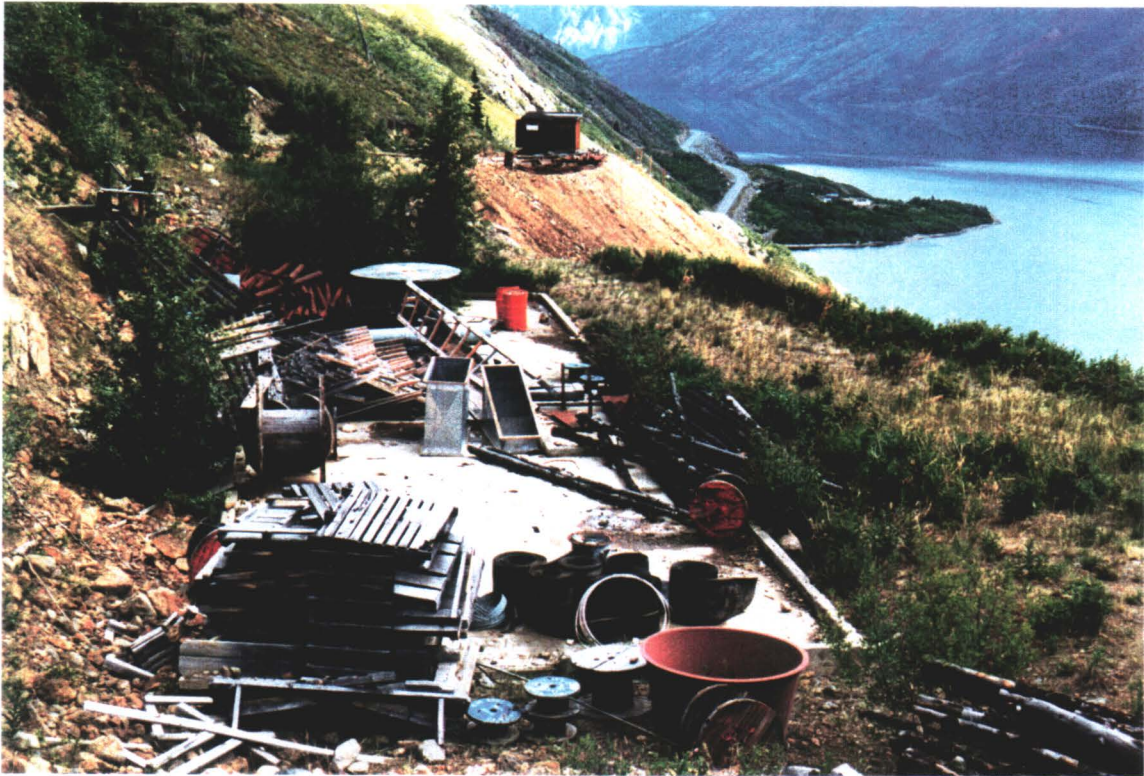
- concrete foundations and floor slab measuring 7.6x30.5m, with in-floor plumbing/heating ducts and a wood retaining wall (partly collapsed) against the back slope,

CONCRETE FLOOR SLAB, FOOTINGS, AND DEBRIS  
WITH WASTE ROCK IN BACKGROUND

- \* The large concrete foundations and floor slab should be left in place. It is recommended that the collapsing retaining wall behind the floor slab be removed or placed on the floor slab. The oversteepened slope above should then be flattened by covering the foundation and floor slab with slope material to reduce any risk of future slope failure in the area.
- \* Any wood waste should be piled and burned using acceptable methods.
- \* The remaining core, if recoverable, should be properly recorded, removed from the site and stored in a suitable location.
- \* Water from the adit should be sampled and analyzed to determine if it is a source of chemical contamination.

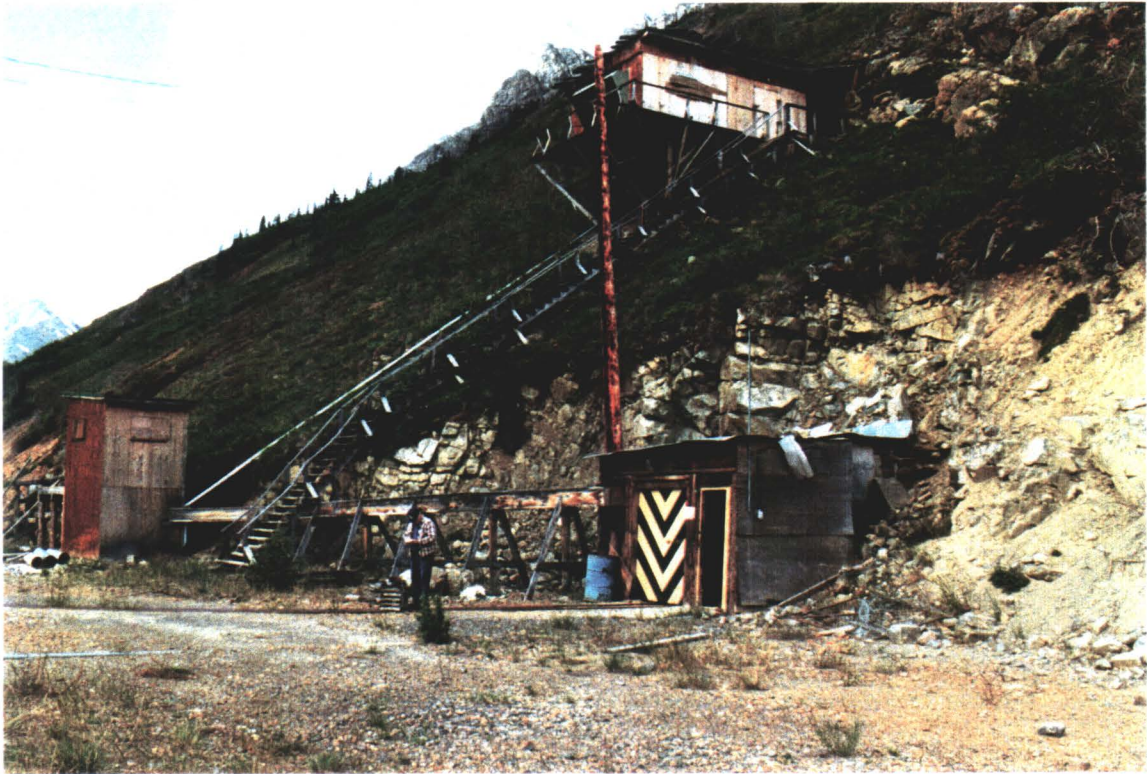
- several wooden power poles strung with electrical cable,
- 4.9x7.3m ventilation building housing mine ventilation equipment perched on a steep slope about 15m above the adit,

ADIT #2 AND VENTILATION BUILDING

- The largest building is the 4.9x7.3m ventilation building which is perched approximately 15m above the adit on a very steep slope. This building is precariously supported on vertical posts. This building is housing large ventilation equipment extending into the adit. This building is exposed to rapid deterioration from the weather, with exposure to snow slides. It is expected that within the next few years this building could start collapsing depending on snow loads and rate of deterioration of the supporting timbers. Plans to remove this structure and equipment as well as closure of the ventilation shaft should be made.

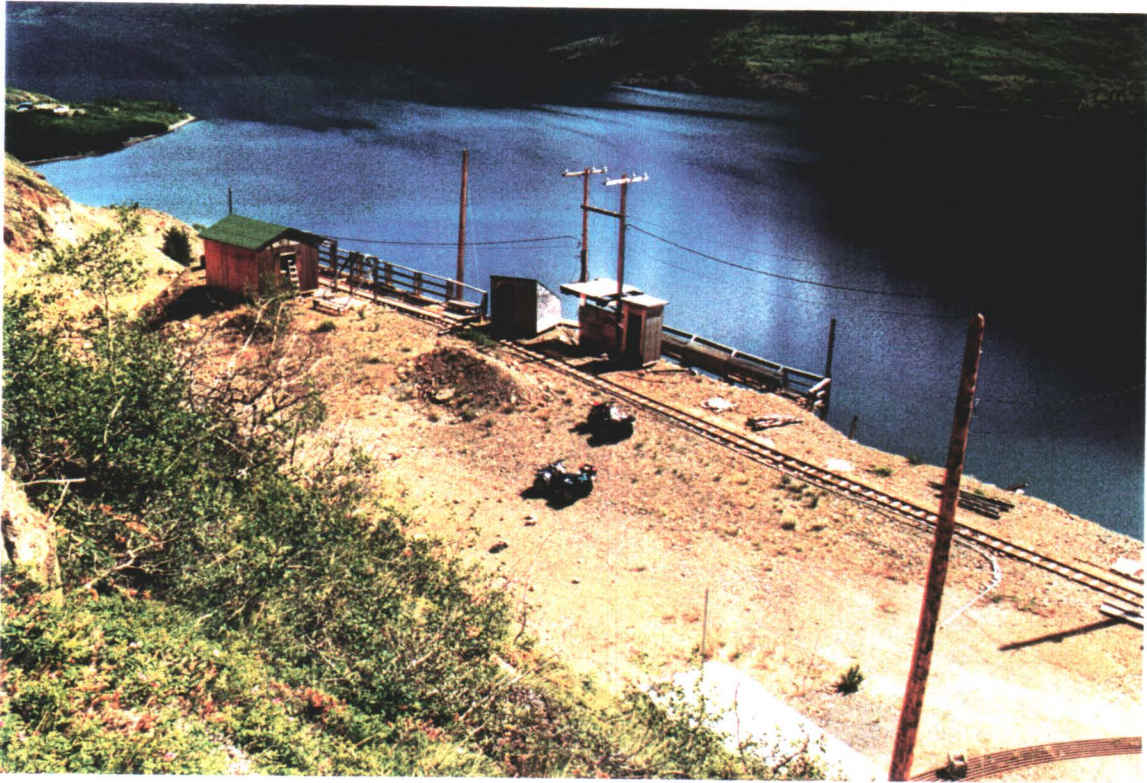
Once again this waste rock was dumped over the slope outside the entrance to the adit, spilling down the slope to a point where the rock embankment angle of repose intersects the natural slope angle. The result is that approximately 100m of slope has been covered with waste rock.

ADIT #2 DUMP AND LOADOUT

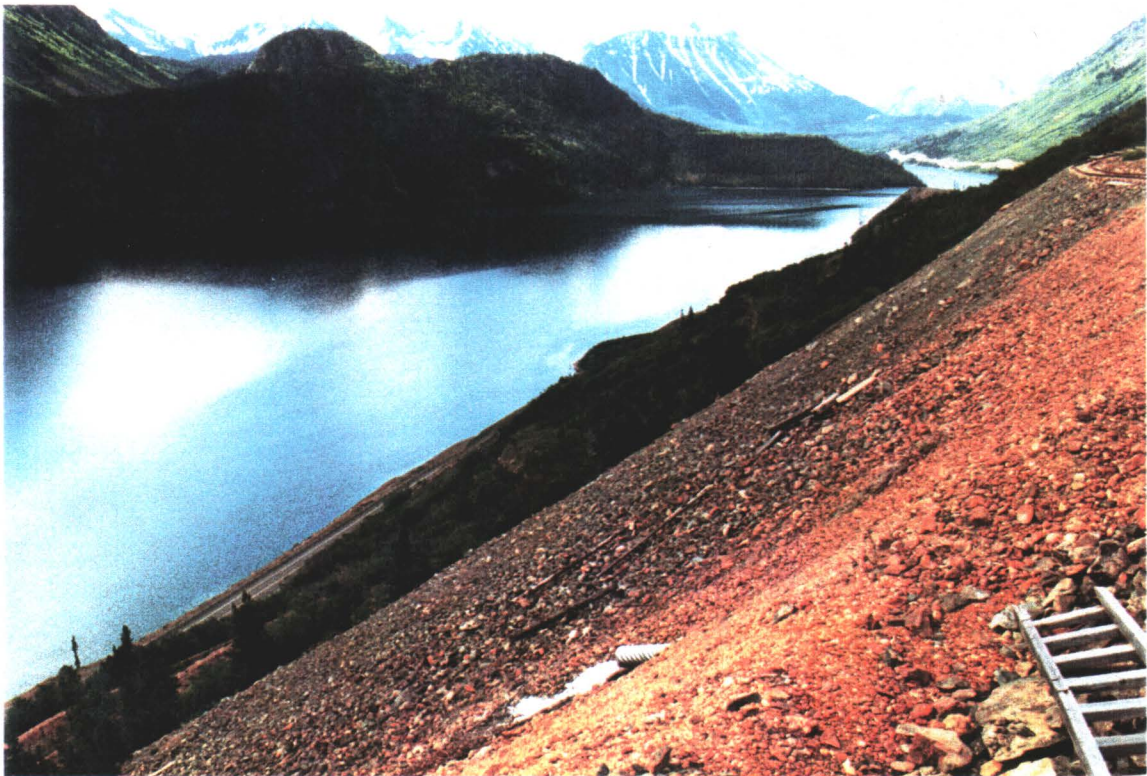
Water from the adit has been piped from the adit through a 600mm diameter drainage pipe below the waste rock outletting midpoint down the slope of the waste rock embankment.

DRAINAGE OUTLET ON WASTE ROCK SLOPE

- \* In winter the drainage from the adit outlets on the waste rock slope resulting in icing downslope to the highway. These icing problems on the highway create an ongoing maintenance problem for the Yukon Department of Highways and Transportation. This may be solved by eliminating this concentrated flow, however care must be taken not to create more stability problems from redirecting or blocking this flow completely. It is recommended that discussions be completed with the Yukon Government to properly quantify the problem.

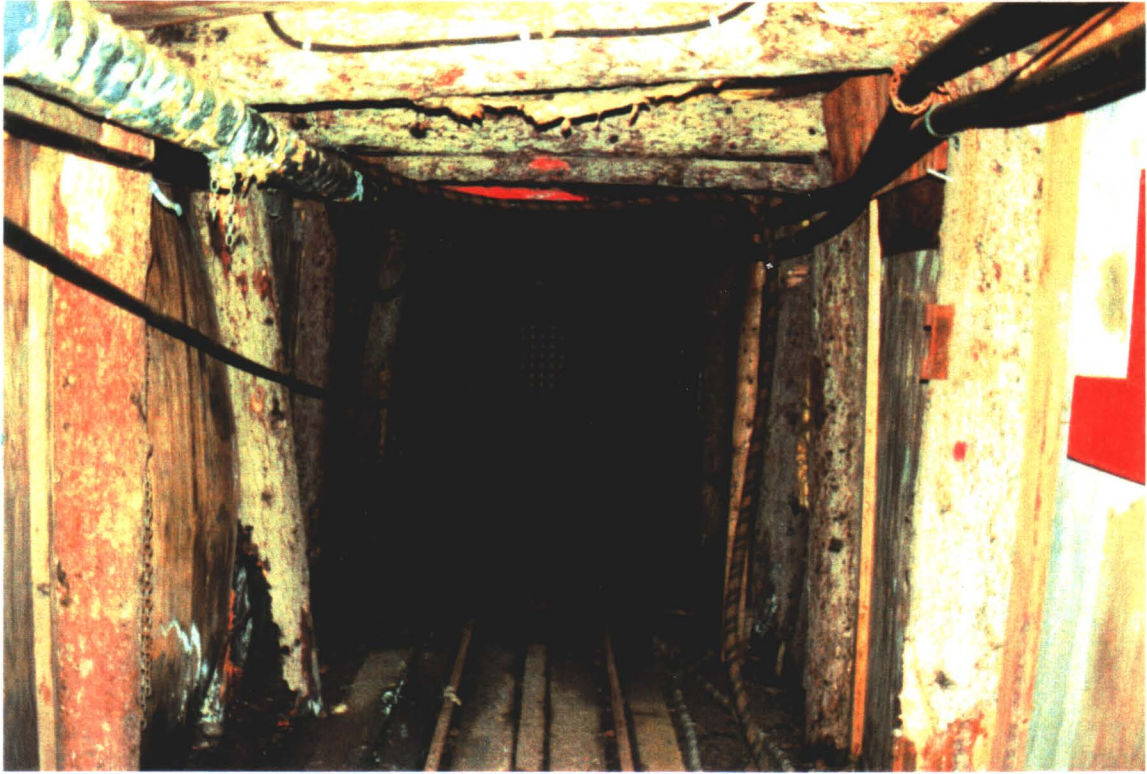
This adit is partially sealed. A man door at the adit was unlocked allowing access to the adit. Inside the entrance to this adit is one 204 litre barrel of gear oil.

INTERIOR OF ADIT #2

- \* The adit entrance is sealed but has a man door that was unlocked at the time of inspection on 1993/06/22. This door should be locked to prevent access by the public into the adit.

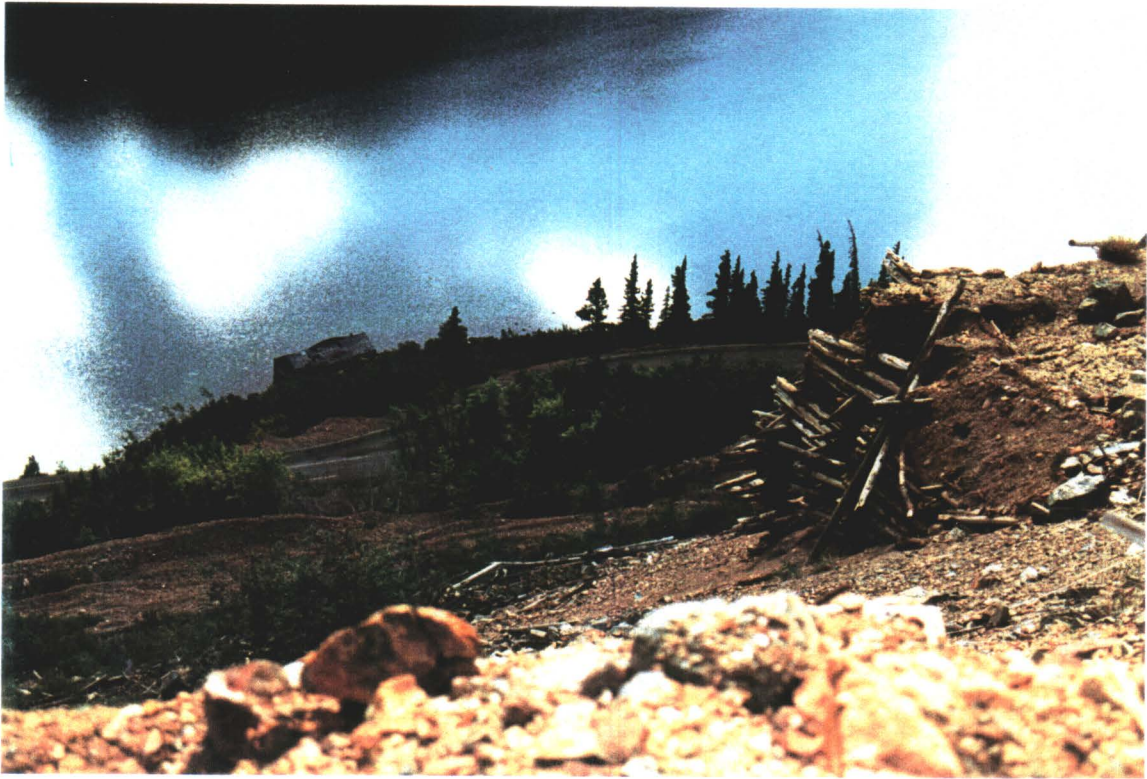
- 1 - 204 litre empty gear oil barrel,
- several hundred metres of rail, and
- two log frame structures with retaining walls and cribbing constructed as an ore loading structures. The lower structure is very old, constructed of locally cut logs, is rotting, and is supporting several hundred tonnes of waste rock.

DOWNSLOPE OF LOADING STRUCTURE.  
NOTE DETERIORATING RETAINED WASTE ROCK

- \* The loadout structure will continue to rot and deteriorate with time and eventually start to collapse. Climbing or walking on or below this structure is considered dangerous now and will only worsen with time. Once the upper loadout structure and the lower retaining structure start collapsing, material behind these structures will begin sloughing and ravelling downslope. It is possible that some of the larger material could reach the highway below, especially if it was to fail suddenly. Because this area is close to the highway and accessible to the public, this site should be posted to alert people to the potential danger. Alternatively these structures could be removed, however this is not a very practical solution as it will be difficult, costly, and dangerous to remove.

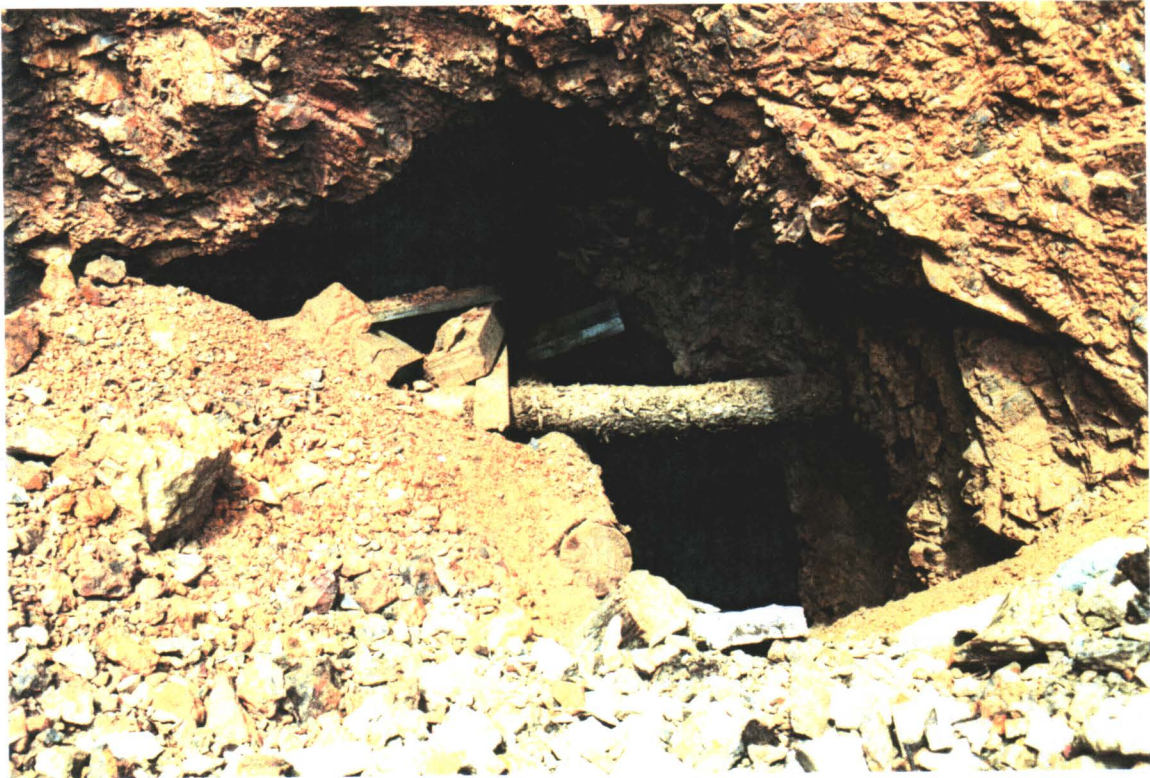
On the slope above these two adits, another four hand excavated adits were found. The entrances to these adits are open and quite inconspicuous. It is quite possible that other adits exist but were not found. These can be reached from a narrow steep trail above the two developed adits. One other shallow adit was found close to the highway at the beginning of the trail.

ADIT UPSLOPE OF DEVELOPED ADITS

- \* Five other adits were found on the slope. Others could exist but were not found. These adits are shallow hand excavated holes that are not well marked. These adits are not causing any notable environmental damage, however they do pose a safety hazard if someone unsuspectingly fell into one. For this reason it is recommended that these adit entrances be covered.

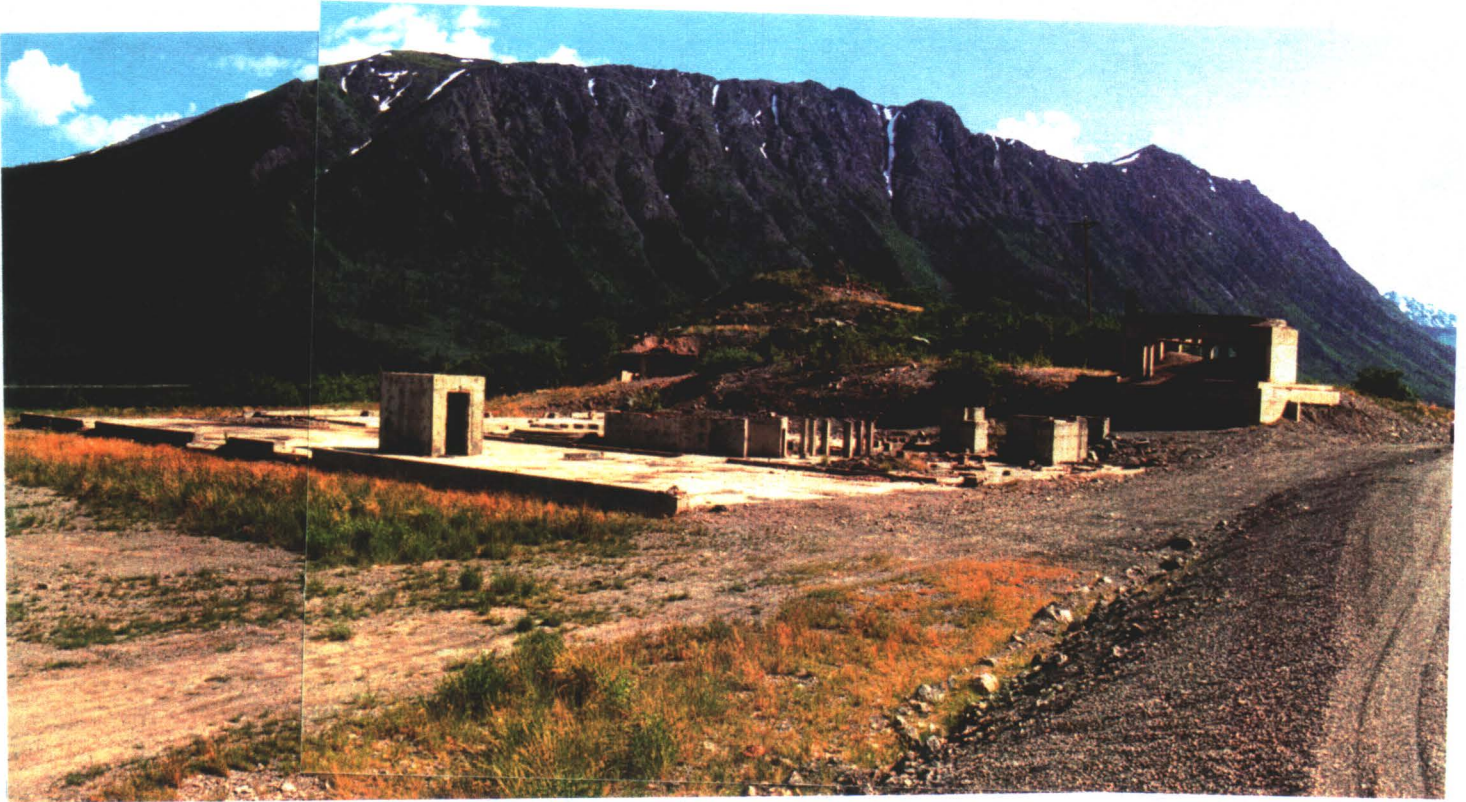
The concrete foundation is the only remains from the mill. All the superstructure has been removed within the past five years from the site. The concrete foundations and floor slab for the mill measures approximately 38x46m, with a separate concrete foundation for the primary crusher remaining behind the mill foundation.

FOUNDATION OF MILL SITE

The mill site has been cleaned up by removing all the buildings from the site. The concrete foundations, floor slab, and some above ground concrete superstructure is the only remaining part of the old mill. The clean up that has been completed appears to have been well done and it is recommended that this part of the site be left in its present condition. Removing the concrete from this site is not considered practical or of any real benefit to the environment.

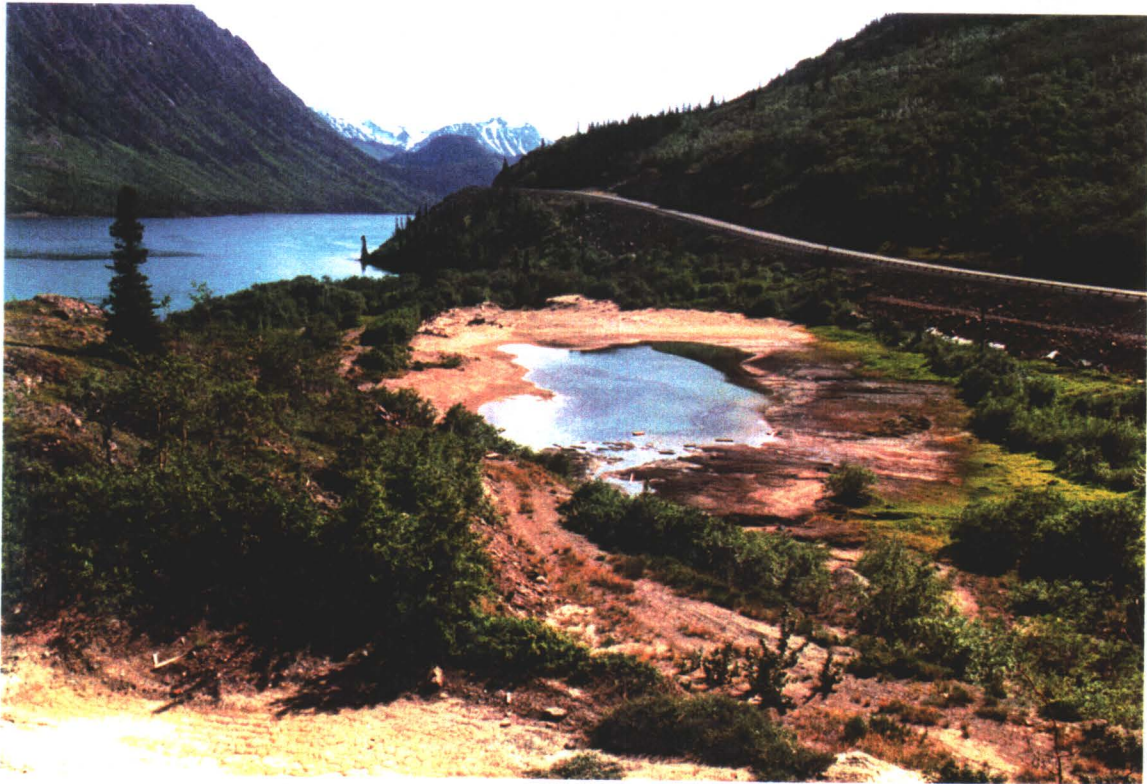
The mill tailings are bounded by Tagish Lake (Windy Arm) to the east, the South Klondike Highway to the west, and by the mill to the north. The tailings pond is in the path of a small creek draining off the slope to the west and appears to have been constructed on the alluvial fan of this creek. Because of the road and mine development in the past, it is difficult to confirm the original topography and ground conditions of the site. An extensively fractured bedrock ridge also partly contains the tailings area to the north and east side of the site. This tailings pond is irregularly shaped but measures approximately 285x115m. As noted, an unnamed creek flows into the tailings pond and is drained through a 600mm pipe with its inlet near the north side of the tailings pond and the outlet onto the shore of Windy Arm. This drainage pipe controls the water level in the tailings pond. The water in the pond covers an area approximately 60m in diameter and appears to be not more than about 0.5m deep.

TAILINGS POND

It is recommended that the first step in developing a site remediation plan will be to review all research completed and recorded for this site. This review will provide the basis in defining what current information needs to be gathered to finalize a site remediation plan. For instance;

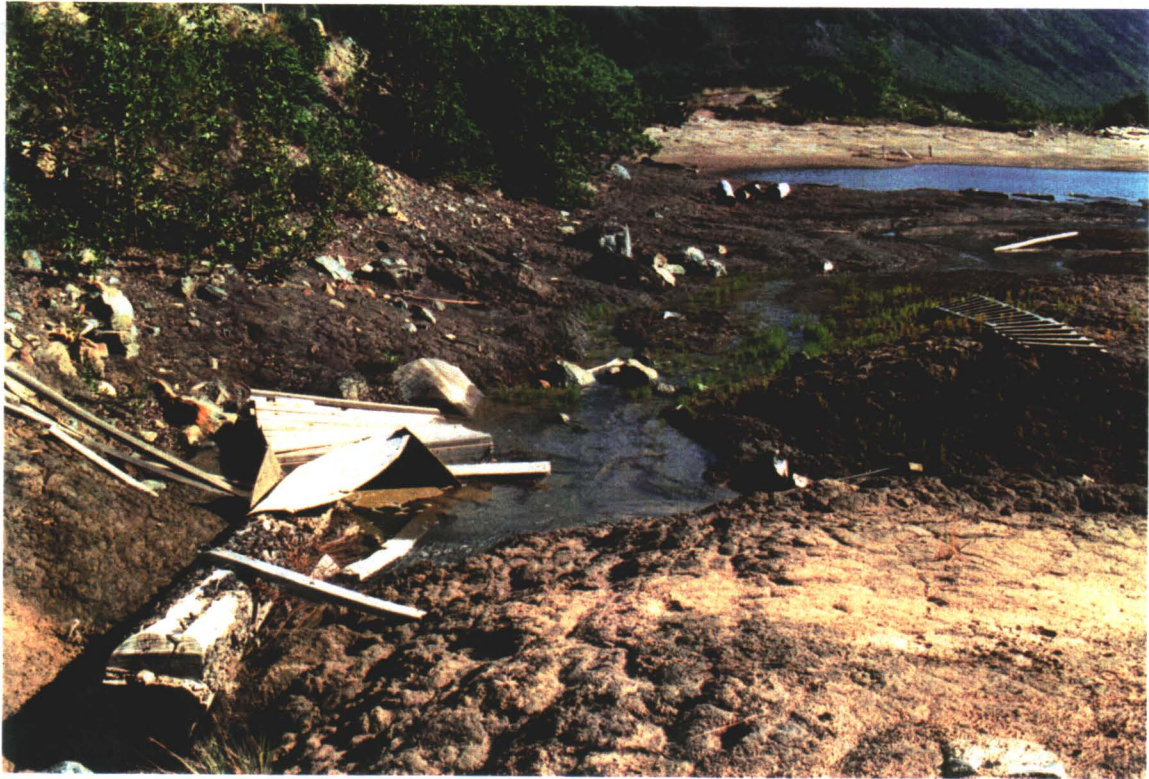
SEEPAGE UPSLOPE OF TAILINGS

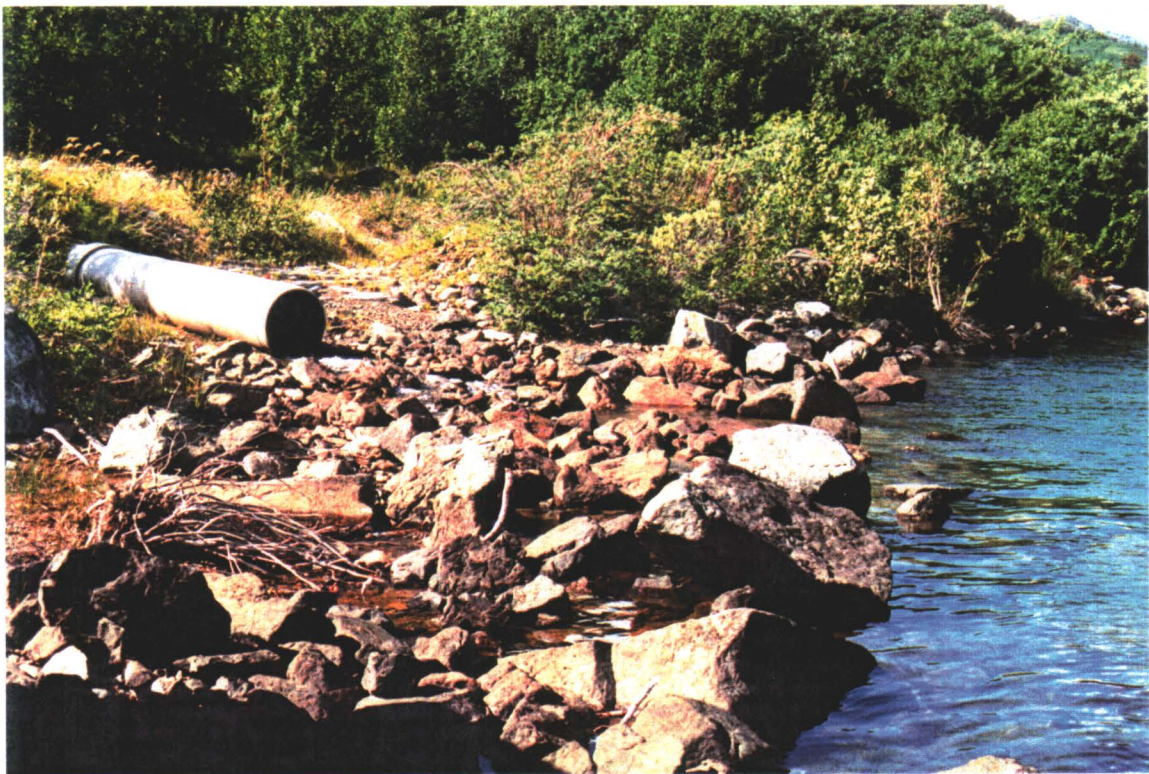
As noted, a drainage pipe was installed in the centre of the tailings area with the outfall on the shore of Windy Arm allowing any fluids in the tailings pond to be drained into the lake. It is apparent that this tailings structure was not constructed to prevent any seepage into the adjacent lake or into the subsurface strata. Significant flushing has been occurring from the relatively large volumes of surface water that is flowing through the tailings pond. Ultimately this water has entered the lake beside the tailings pond. This process has been ongoing for several years.

OUTFALL FROM TAILINGS INTO WINDY ARM

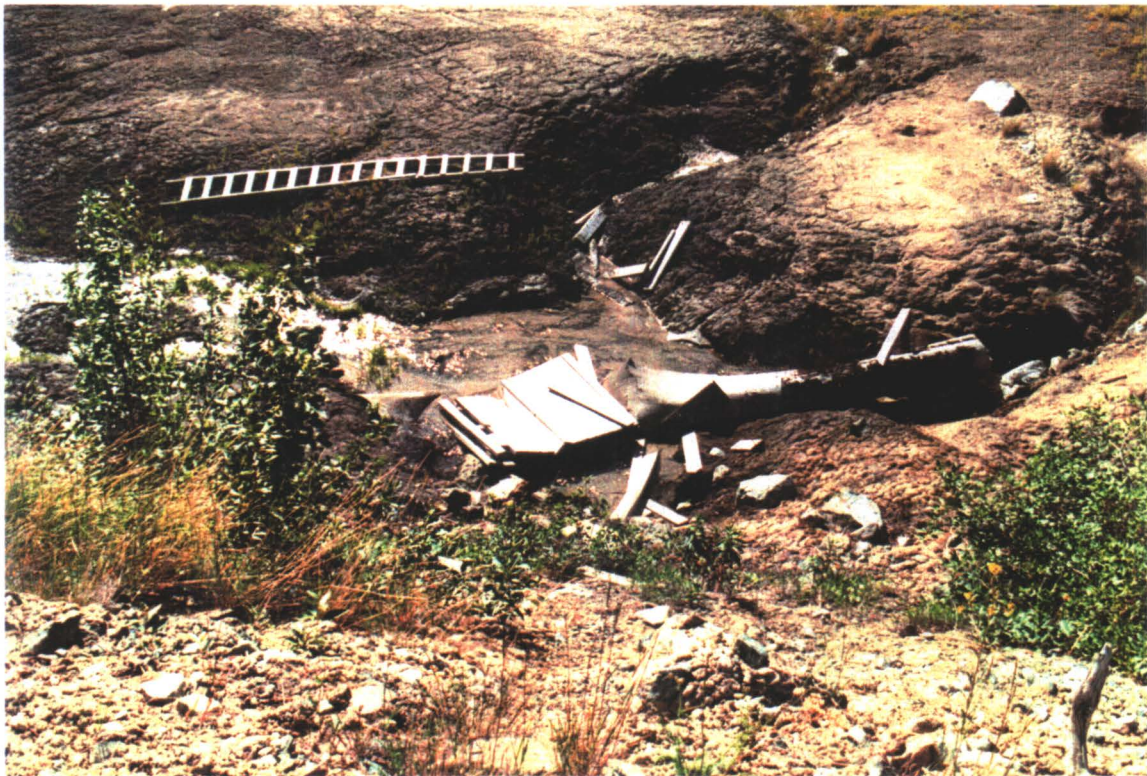
INLET TO DRAINAGE PIPE

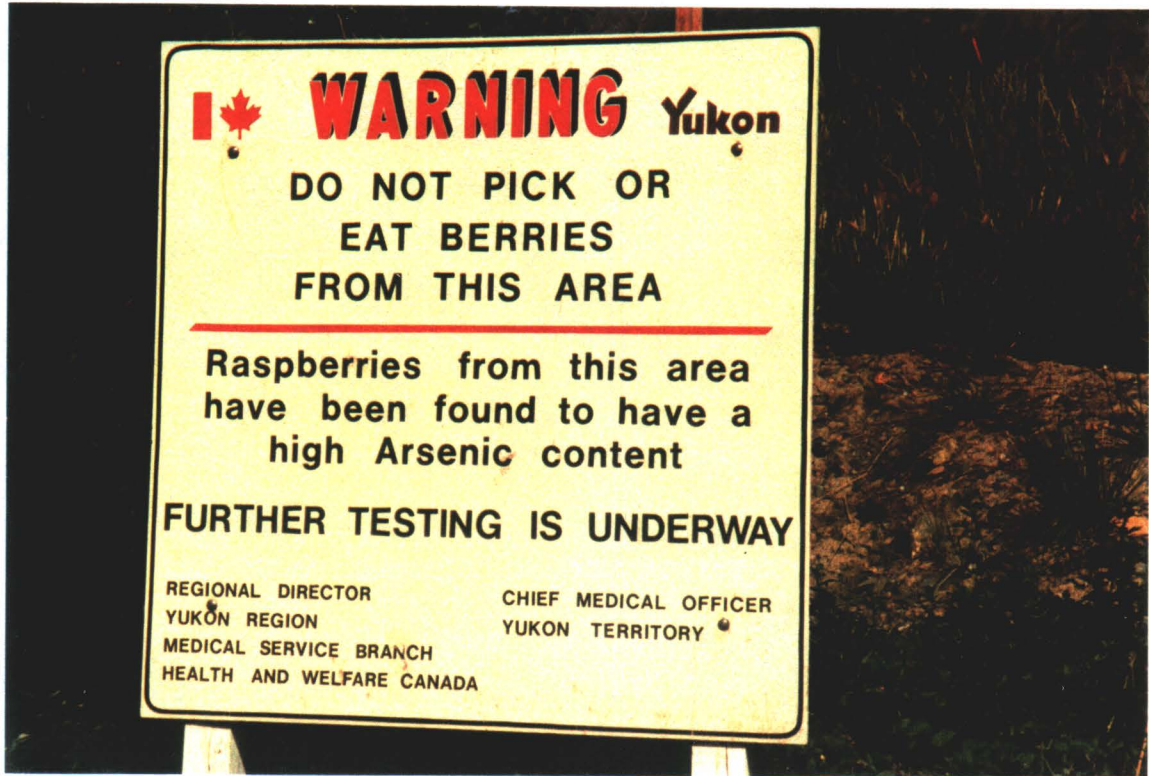
Signs posted around the site indicates the vegetation surrounding this site contains high levels of arsenic.

SIGNAGE POSTED AT SITE
