**ASSESSMENT REPORT**

**105H-07-1**

**CONGLOMERATE CREEK**

**DIAND TECHNICAL SERVICES**

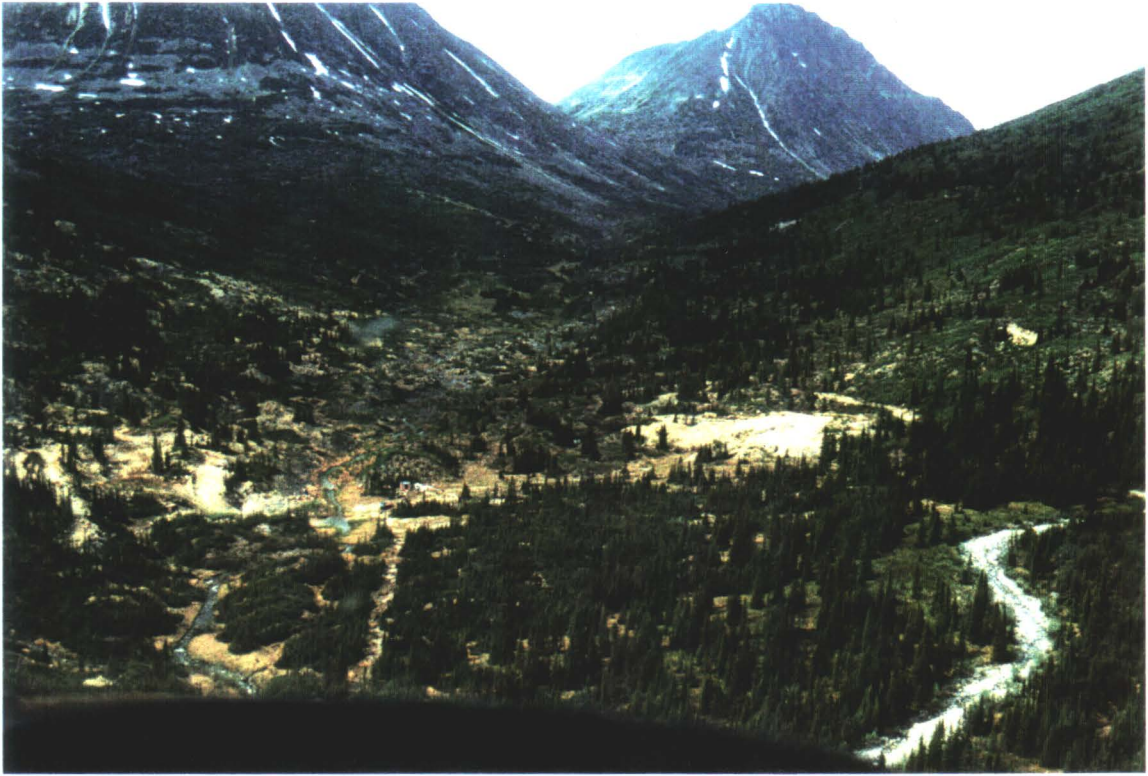
OVERALL VIEW OF SITE

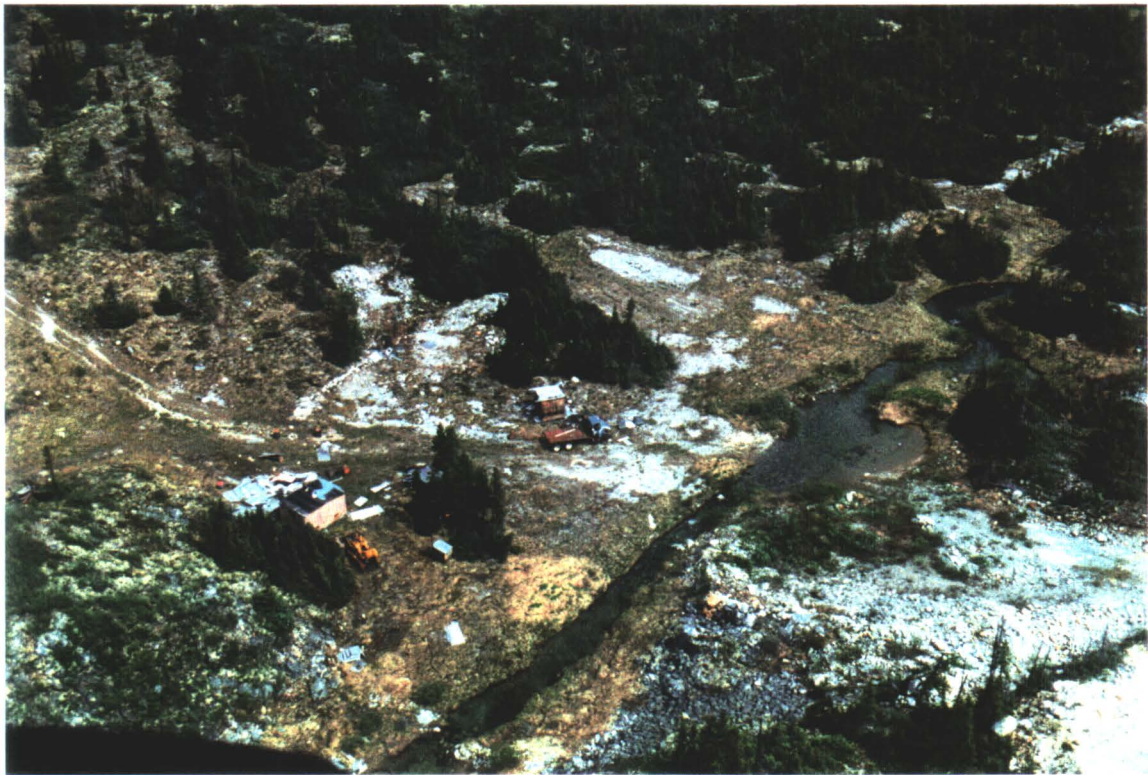
The camp site, covering an area measuring approximately 50x50m, has been abandoned without being cleaned up. Trails around the camp site extend to a number of drill sites, with the main exploration site being above the camp. The vegetation has been removed wherever roads were constructed, drill sites were prepared, or trenching operations took place. No adits were found or recorded in the past.

CAMP SITE AND CONGLOMERATE CREEK

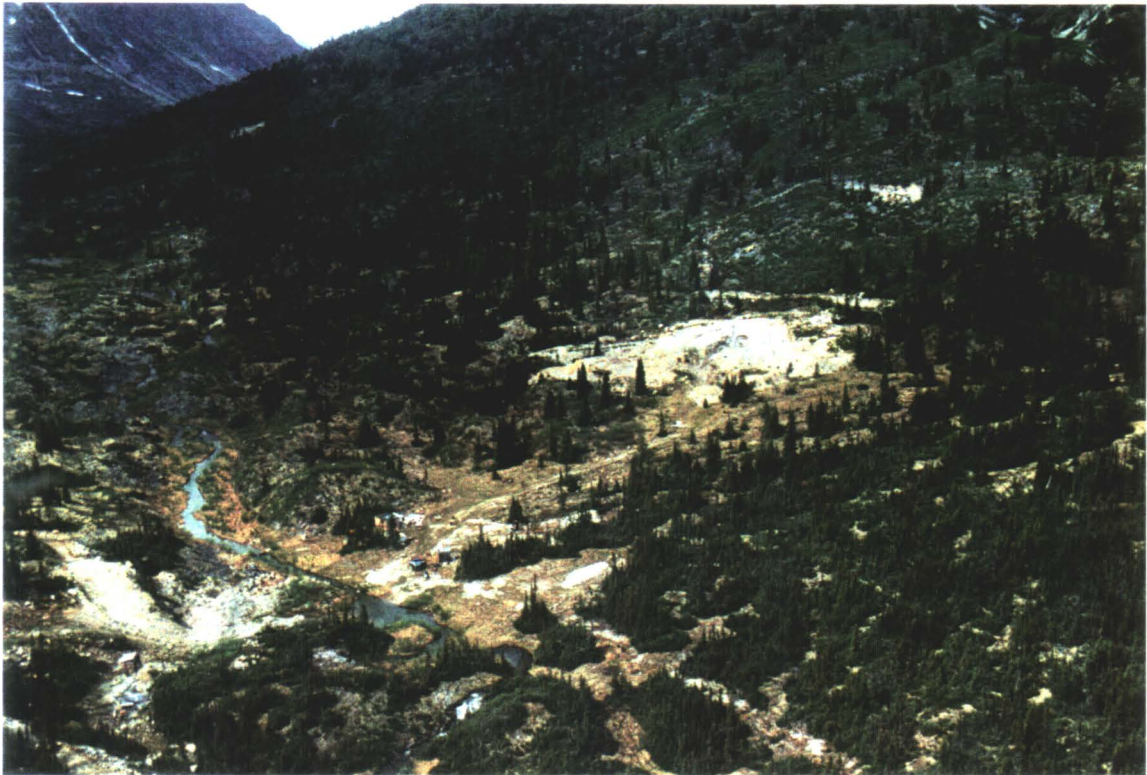
Trenching and stripping across this area has resulted in damage to the surficial soils and vegetation. Generally the soils across this moderately sloped area are very coarse and little surface erosion was evident. The creek flowing through the site was clear with no evidence of any recent siltation.

The roads generally follow the contours of the ground and little material has been cut or filled. The most significant damage from the road construction has been the removal of the vegetation. The only significant excavations have occurred from the trenching where piles of material have been left. Site remediation could include reshaping these excavation piles and attempting to revegetate any cleared areas. It is recommended that neither reshaping or revegetating be considered in this remote, very dry, and very harsh climate. Reshaping would only set back any natural recovery that has started and revegetating this site with very little organics that could not be tended is not likely to be very successful. The disturbed areas will eventually revegetate themselves from the local vegetation encroaching into the disturbed areas. This revegetation process is likely the only practical solution in an area that is extremely remote with a harsh climate.

EXPLORATION SITE

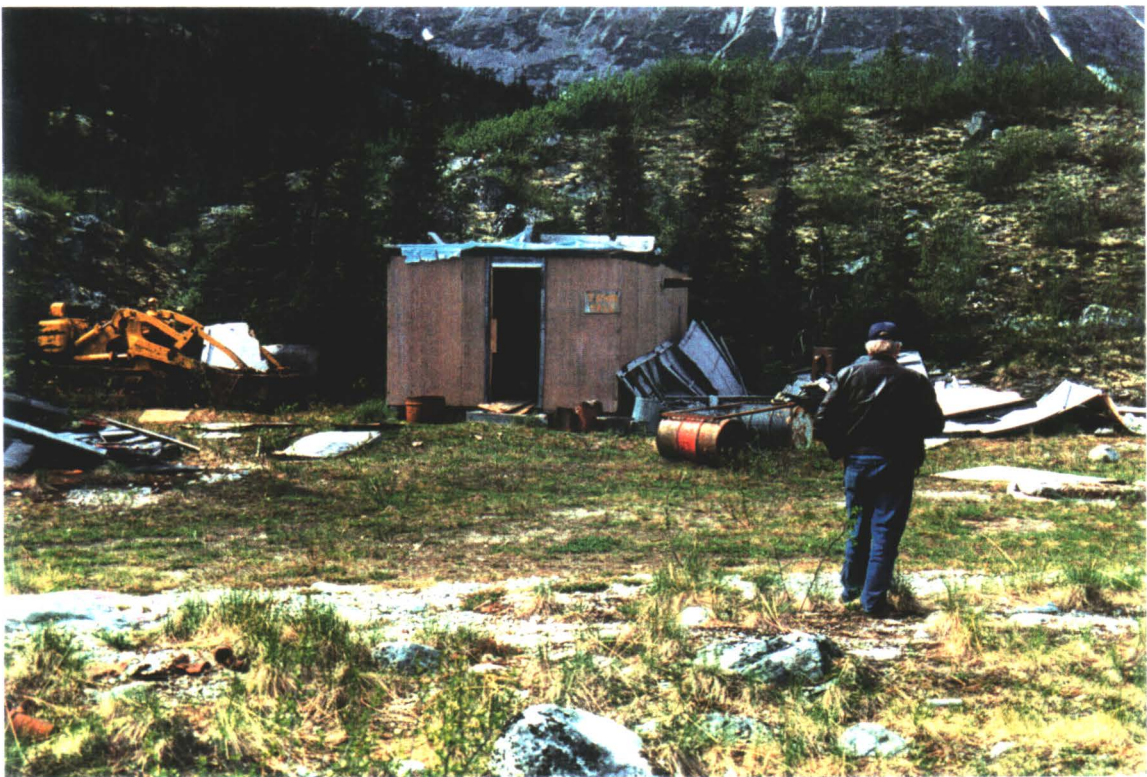
The two large pieces of equipment, the crawler tractor and the truck, are not in running condition and do not appear to be practically repairable. Removing these pieces of equipment would be costly as they would either have to be flown from the site in pieces,

CRAWLER TRACTOR AND CAMP BUILDING

or the road would have to be repaired and equipment mobilized to haul this equipment off the site. Although this equipment is unsightly, it is considered a **LOW** priority for clean-up. The other remaining material left on-site is also considered to be a **LOW** priority for cleaning up the site as they do not appear to be causing any significant ongoing environmental damage.

The buildings left behind are deteriorating and have started collapsing. Although considered a **LOW** priority, it is recommended that these buildings along with any other lumber be stacked and burned in an appropriate manner and location.

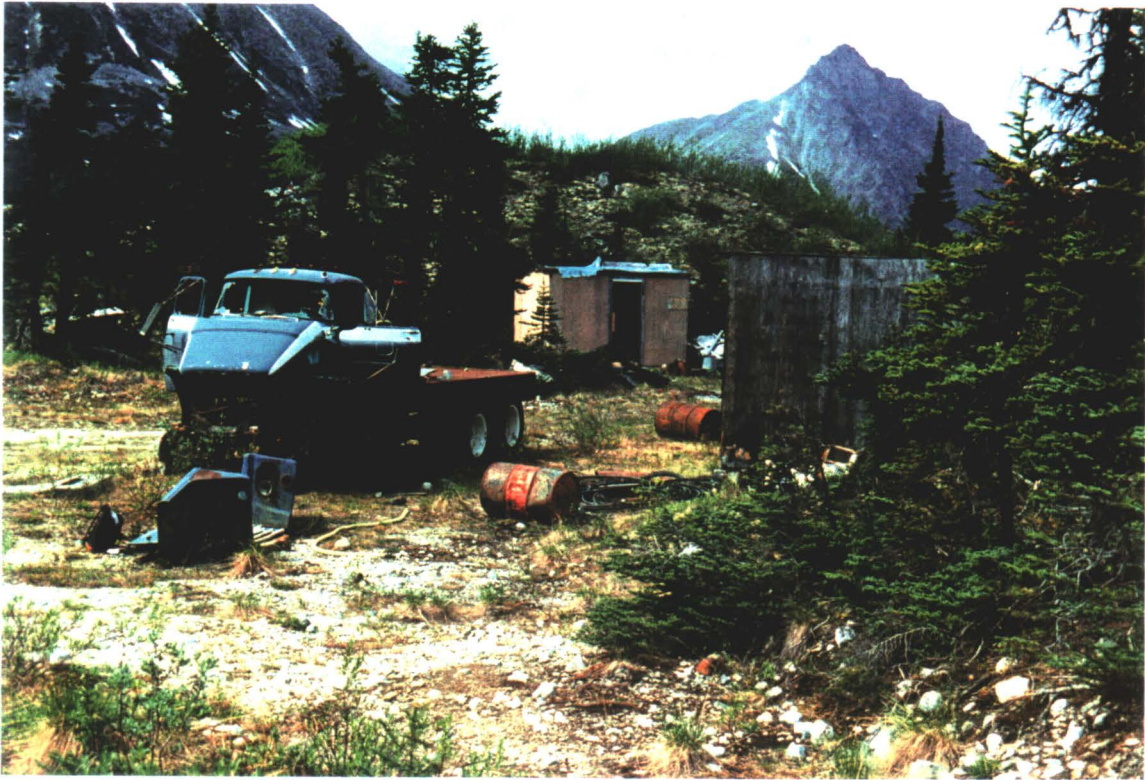
ABANDONED FLAT DECK TRUCK AND MISCELLANEOUS DEBRIS

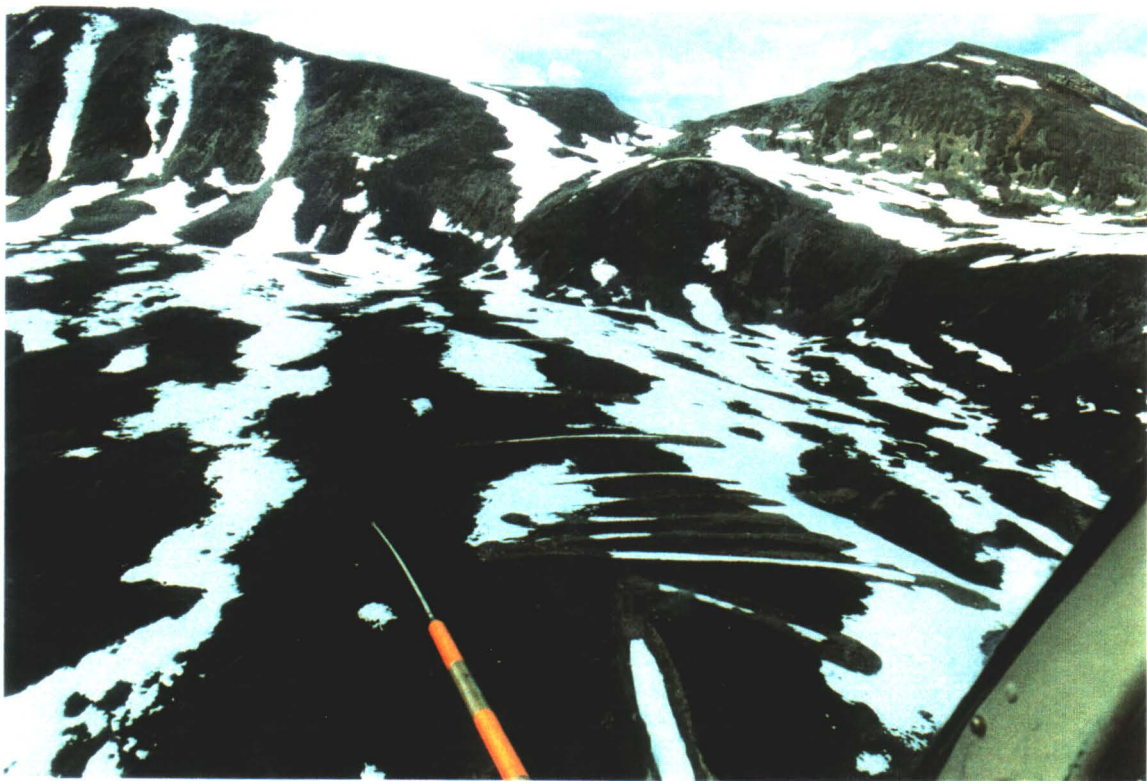
TRENCH SITE ABOVE CAMP
