**ASSESSMENT REPORT**

**105F-09-3**

**HOEY**

**DIAND TECHNICAL SERVICES**

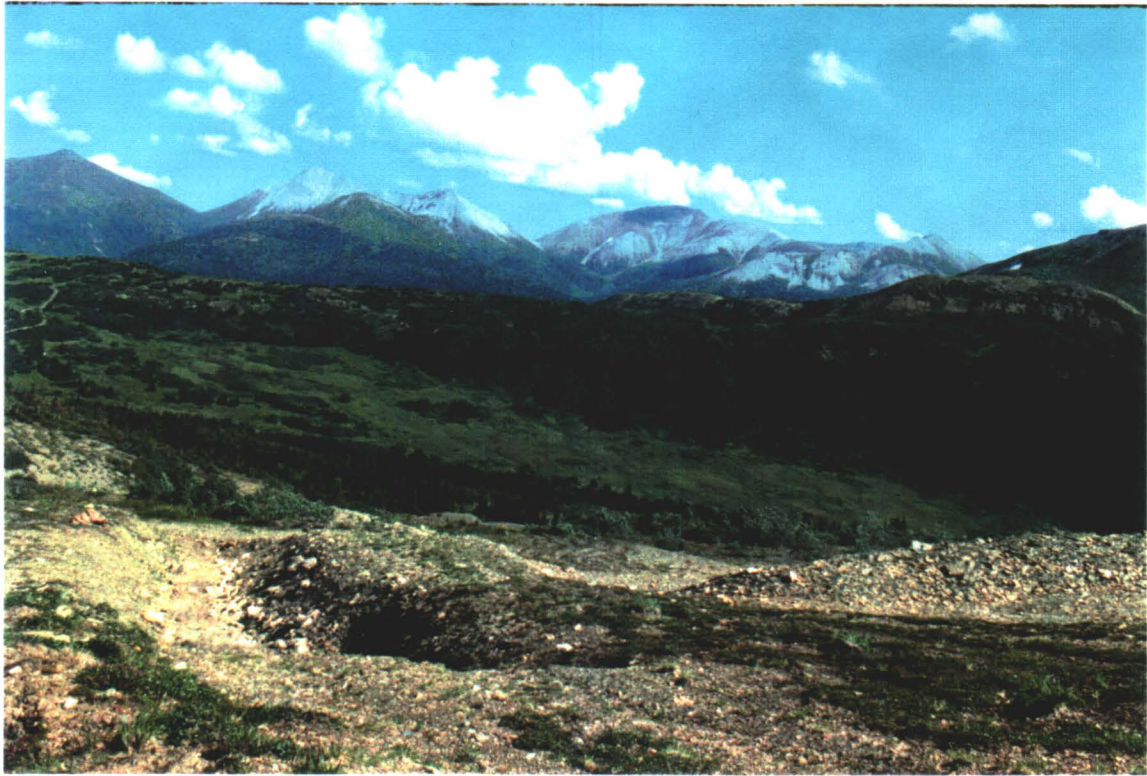
Trenching was conducted in the area approximately 30 years ago and these areas have overgrown with local vegetation. Partially overgrown piles from the trenching activity is the only remaining evidence from this work.

TRENCHING AND LOCAL TOPOGRAPHY

It is recommended that the trench areas not be disturbed, and allowed to continue the slow recovery that is underway.

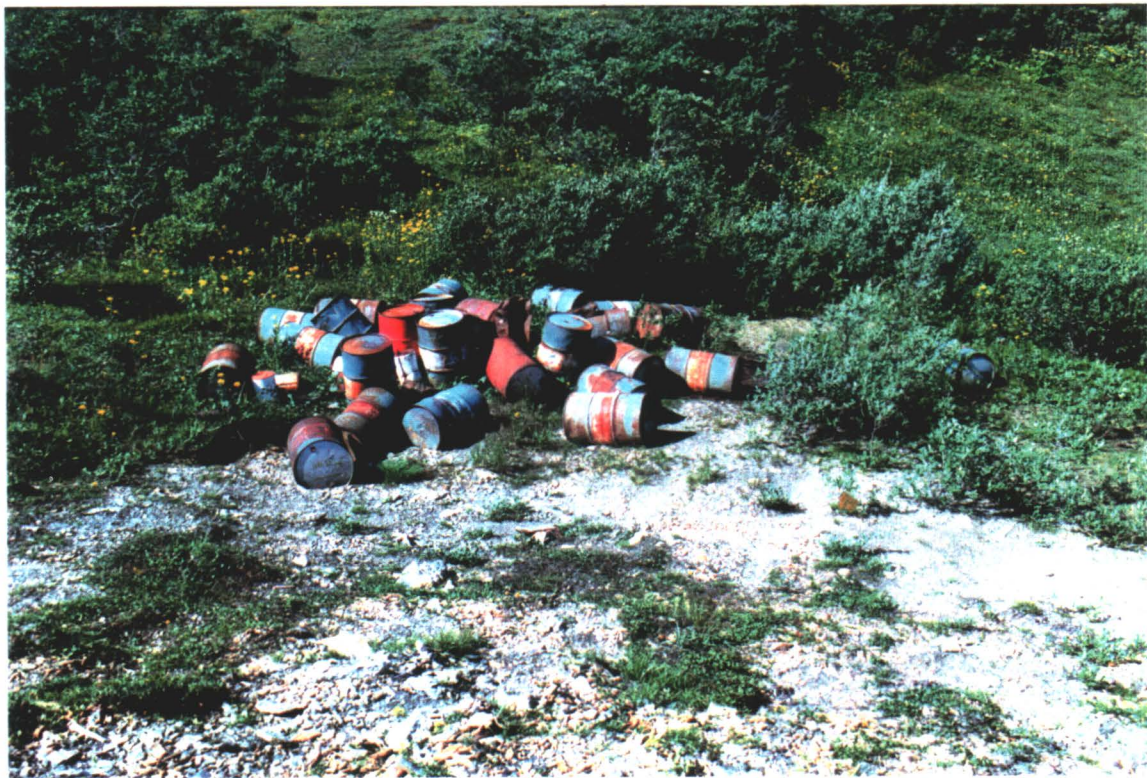
Between 1-2 kilometres south of the adits, remains of a tent camp was found with plywood walls and 27 very old 204 litre barrels. **Seven of these barrels are full of diesel fuel.** As well, a significant amount of trenching has been undertaken in the past. This trenching is not concentrated in one location, but is scattered across a fairly wide area along the network of trails.

The only potential significant impact at the old exploration camp is for the seven remaining barrels of fuel to leak or be punctured and damage the environment. This should be considered a **HIGH** priority for clean-up. All full and empty barrels should be removed from the site as soon as possible.

27 BARRELS (7 FULL) AT CAMP SITE

Overall, very little environmental damage was observed at this site, and it should be allowed to continue its natural recovery. However potential environmental damage could occur if the seven barrels of fuel leaked or was spilled. This fuel should be removed as soon as possible to eliminate the remaining hazard. This should be considered a **HIGH** priority.

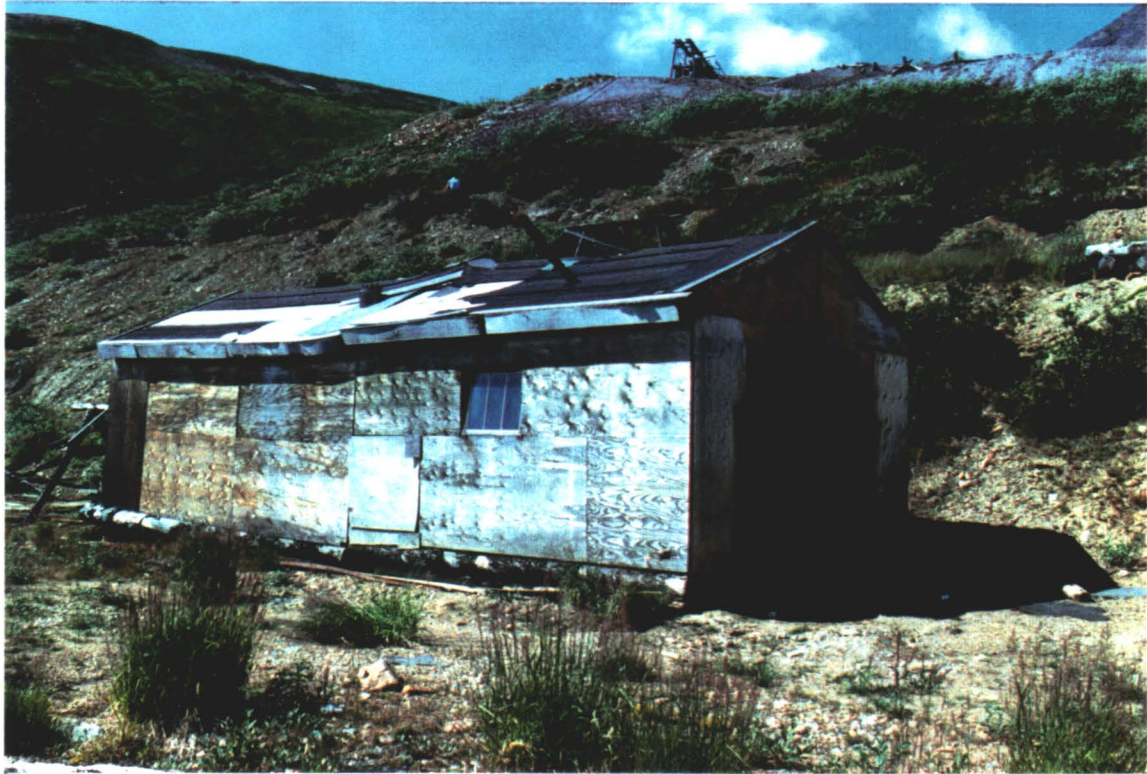
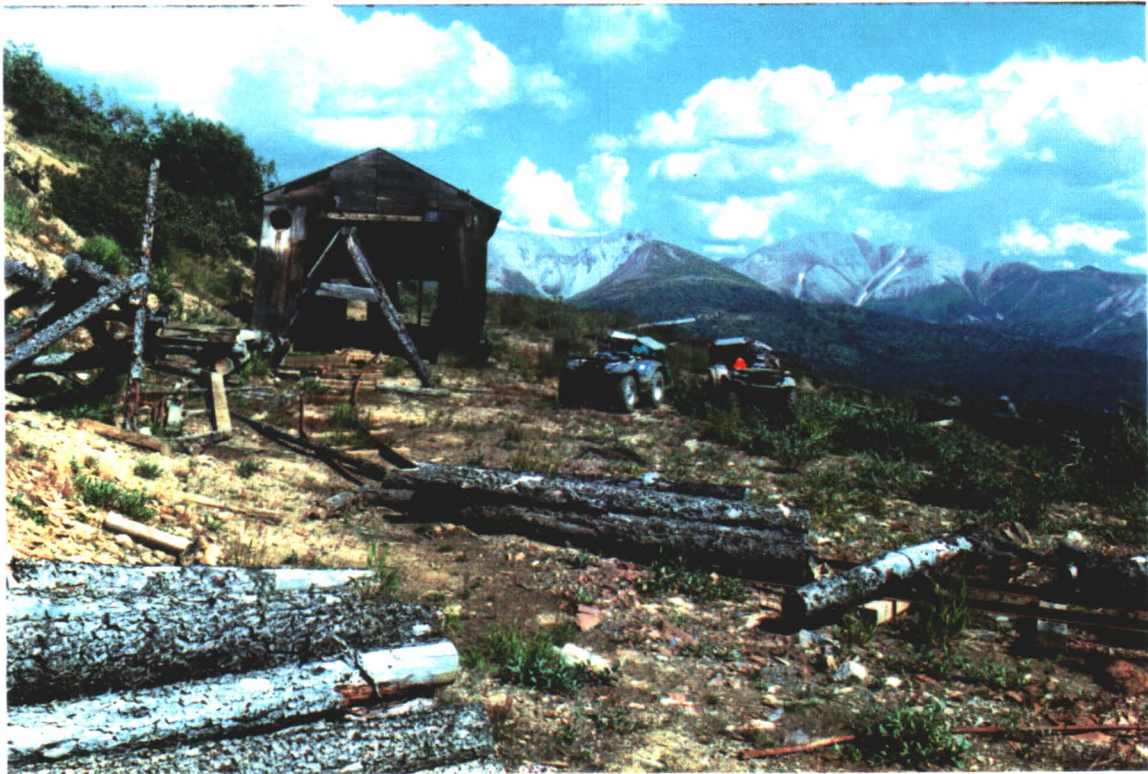
A 5x12m wood frame plywood clad building is located adjacent to the adit and appears to have been used as a workshop and warehouse.

WORKSHOP AT LOWER ADIT

Other surrounding infrastructure such as old rail and other metal waste can be gathered and removed from the site. This is considered a **LOW** priority and could be undertaken only if a general clean-up program is initiated in the area. Similarly, the storage building could be dismantled and removed, however this is considered a **LOW** priority as well.

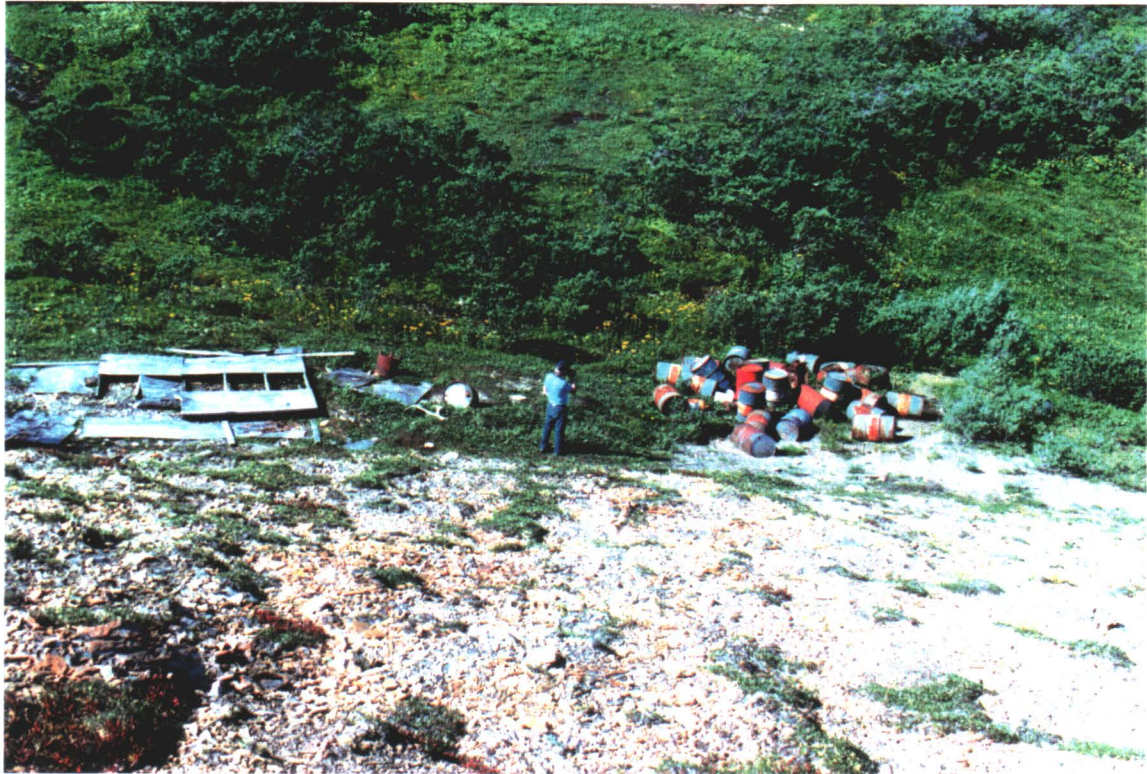
REMAINS OF CAMP AND BARREL SITE

The remaining wood waste could be piled and burned in an appropriate location, however this is considered a low priority.

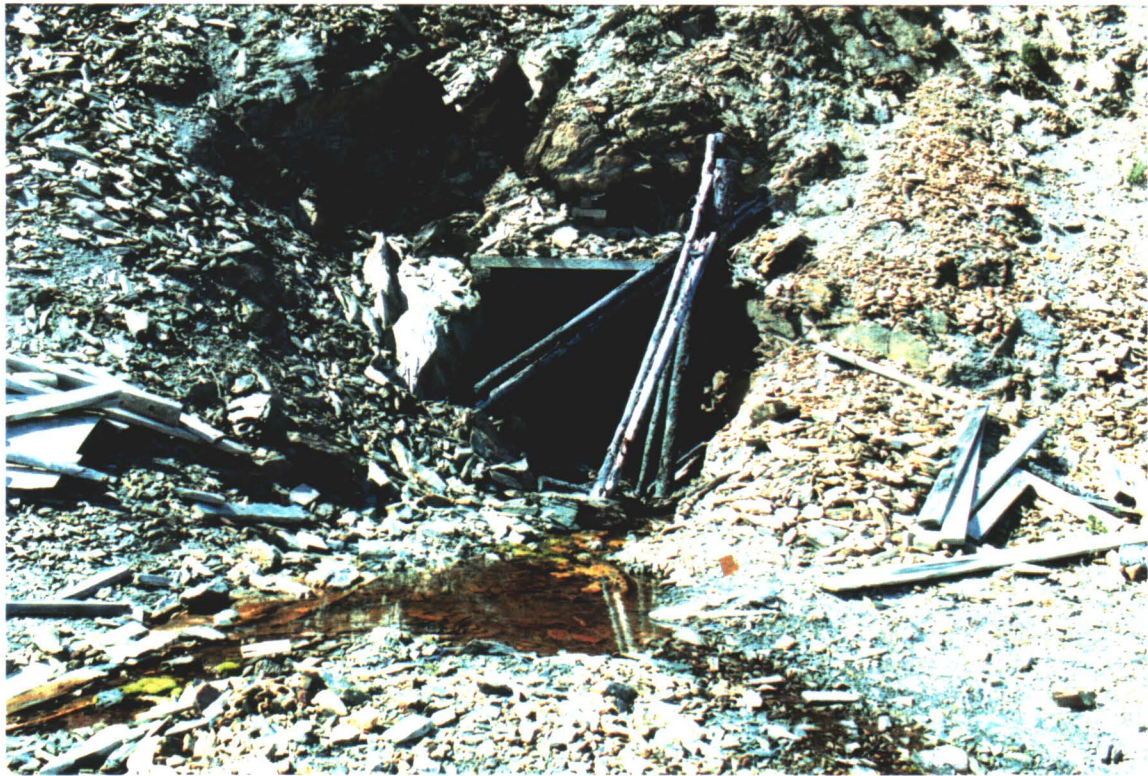
Up to 100 litres/minute of groundwater was flowing out of the adit at the time of inspection on 1993/07/30.

The entrances of the two old adits are unsecured and accessible to the public. These open adits pose a public safety hazard, and the entrances should be closed or sealed against possible entry.

LOWER ADIT

Clean up of buildings and metal waste could be undertaken if considered as part of a regional clean up program. The remainder of the site is considered to be a **LOW** priority for improvement with the exception of the open, collapsing adits which is considered a **HIGH** priority, which should be properly secured as soon as possible.

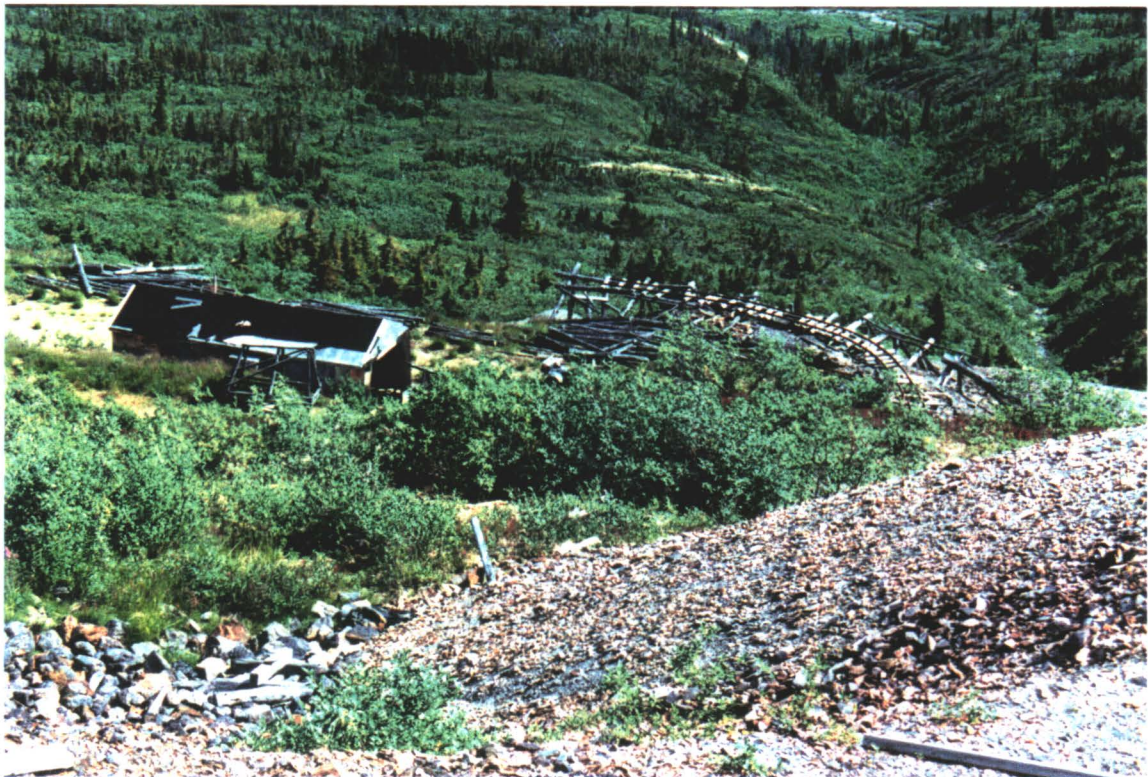
WORKSHOP AND RAIL TO WASTE DUMP AT LOWER ADIT

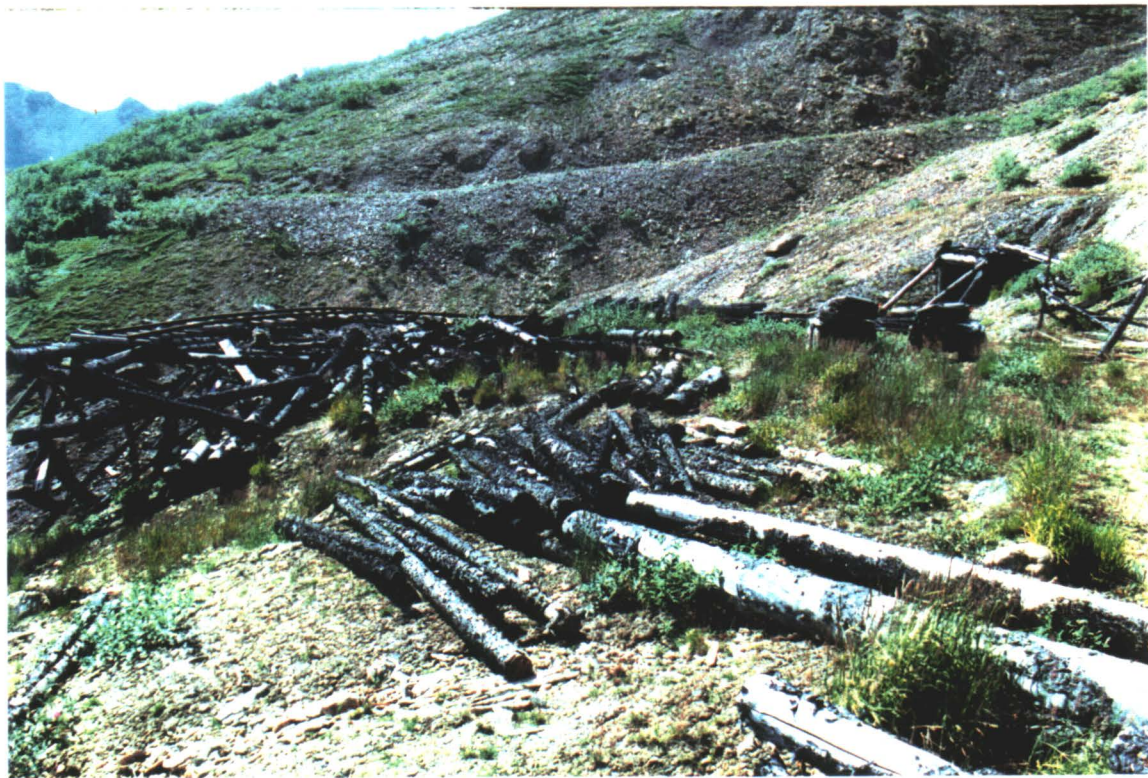
LOWER ADIT, LAGGING, AND RAIL TO WASTE DUMP

Lagging and any other wood waste should be piled and burned in an appropriate location if any clean-up program is undertaken.

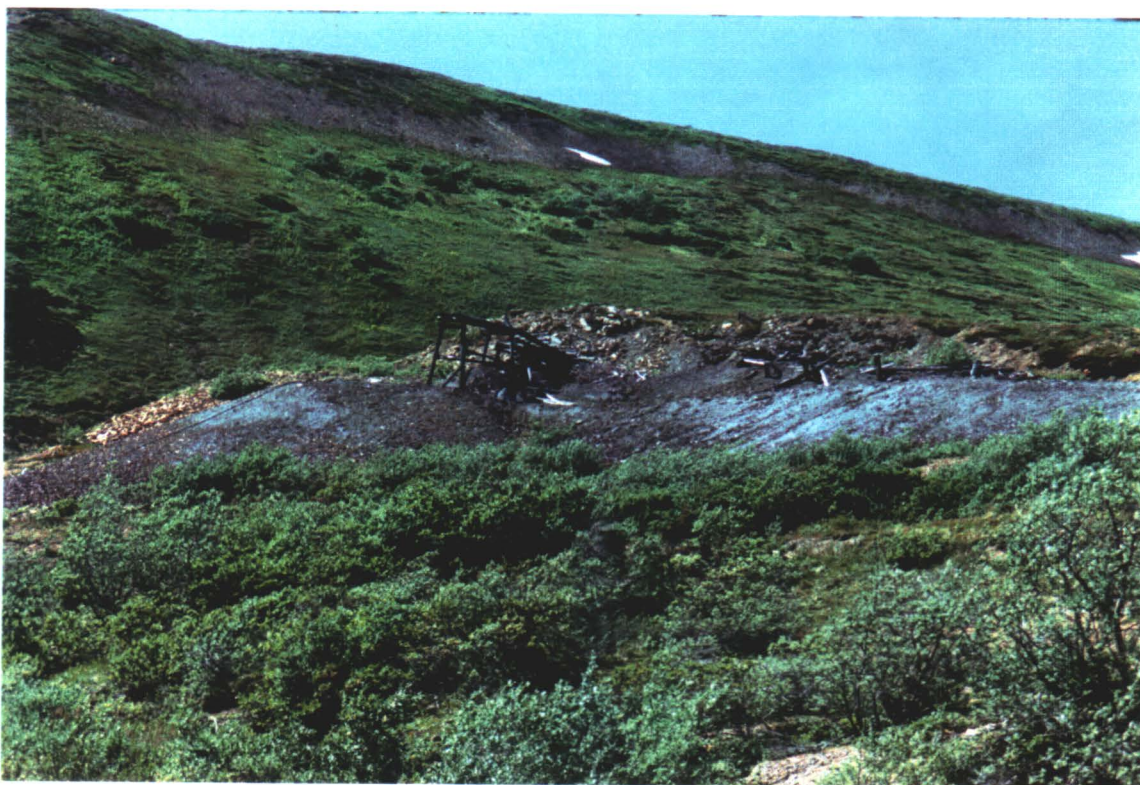
Rock waste has been dumped down the slope in front of the adits. This waste material is visible from quite far away but would be very difficult and costly to conceal or remove. Practically, the waste rock can only be left in place.

WASTE DUMP AT UPPER ADIT

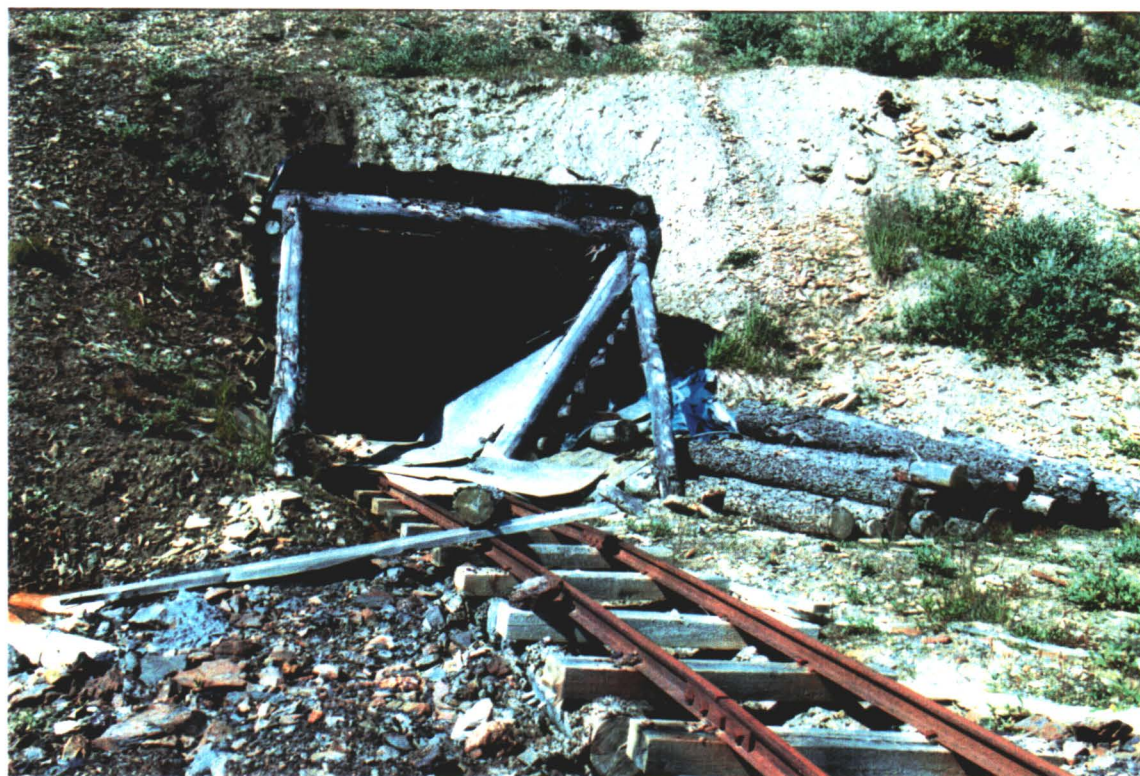
Approximately 25 litres/minute of groundwater was flowing out of the adit.

UPPER ADIT

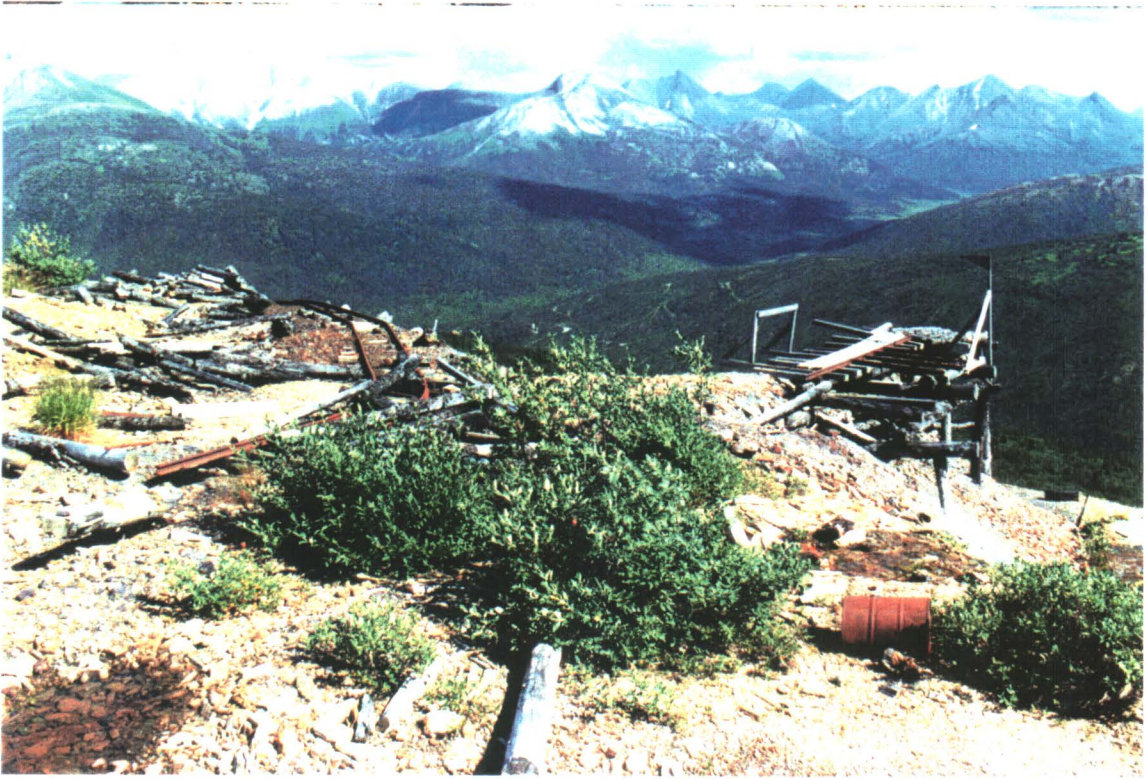
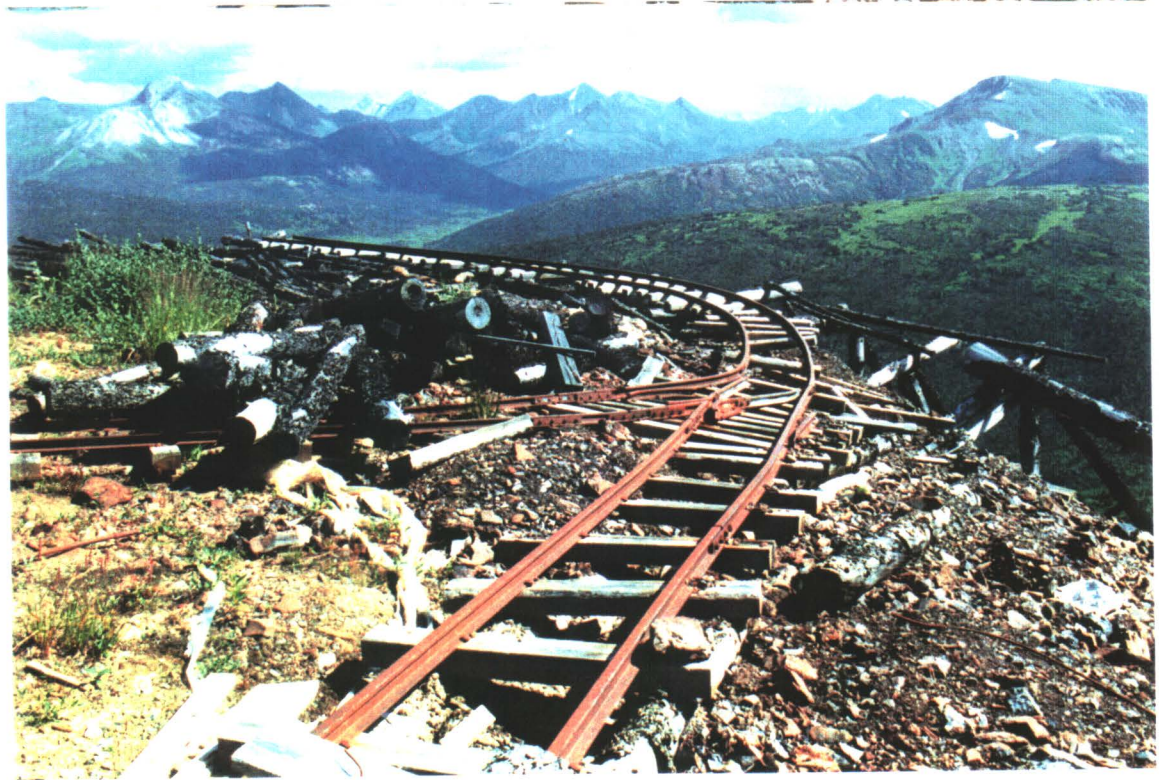
Remaining infrastructure consisted of approximately 60m of rail extending from the adit to a wooden trestle used to dump the waste rock down the slope. A pile of wooden lagging is also piled on-site.

RAIL TO WASTE DUMP FROM UPPER ADIT

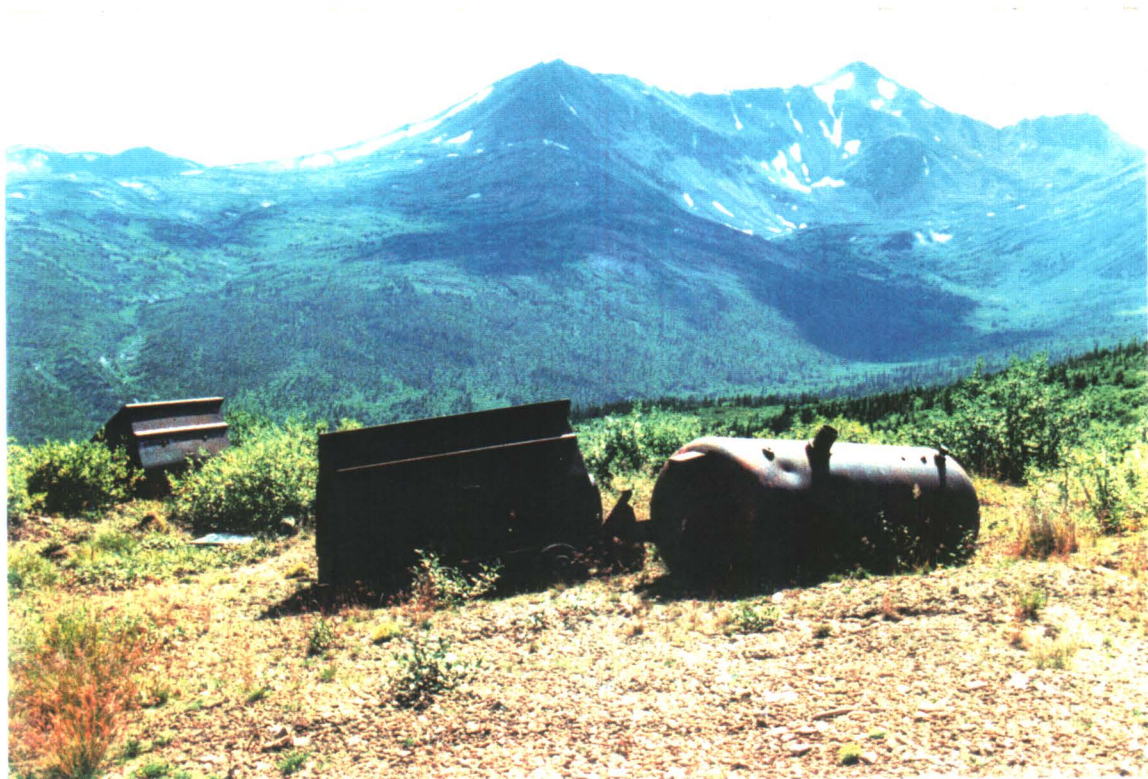
ORE CARS AND PRESSURE VESSEL

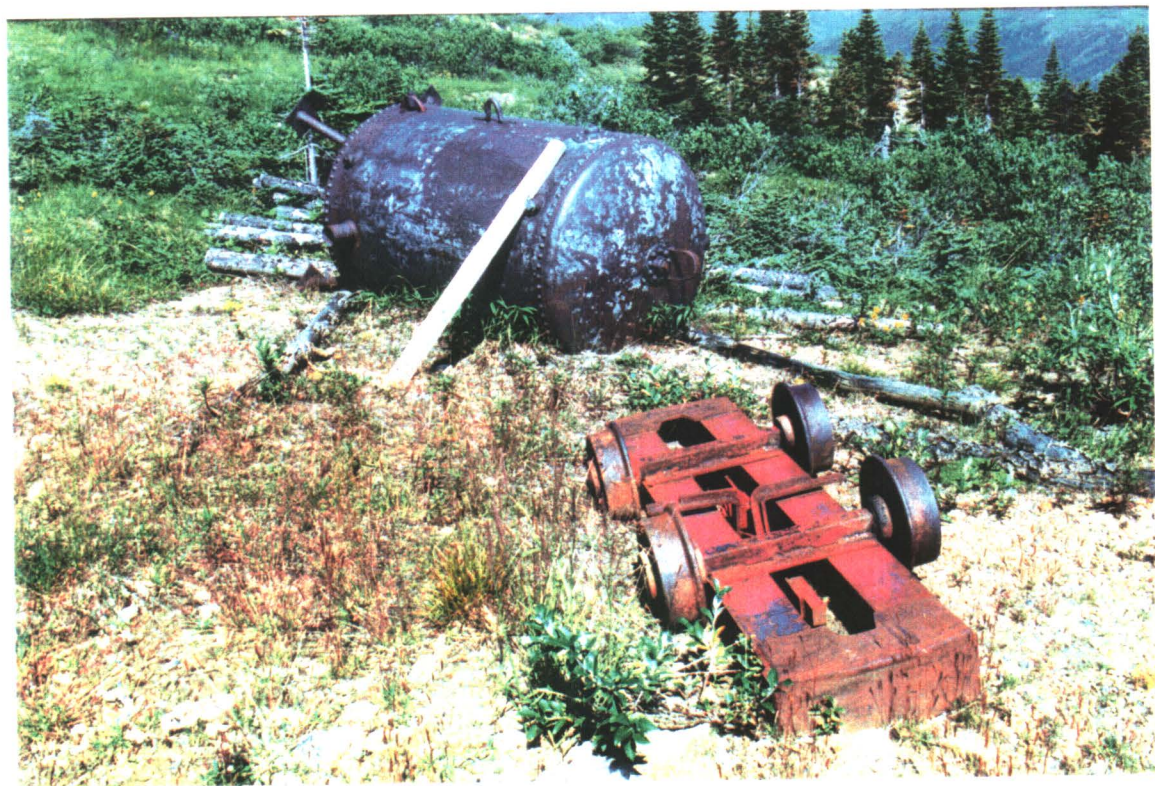
PRESSURE VESSEL AND ORE CAR UNDERCARRIAGE
