ASSESSMENT REPORT

1050-08-1

MACTUNG

DIAND TECHNICAL SERVICES

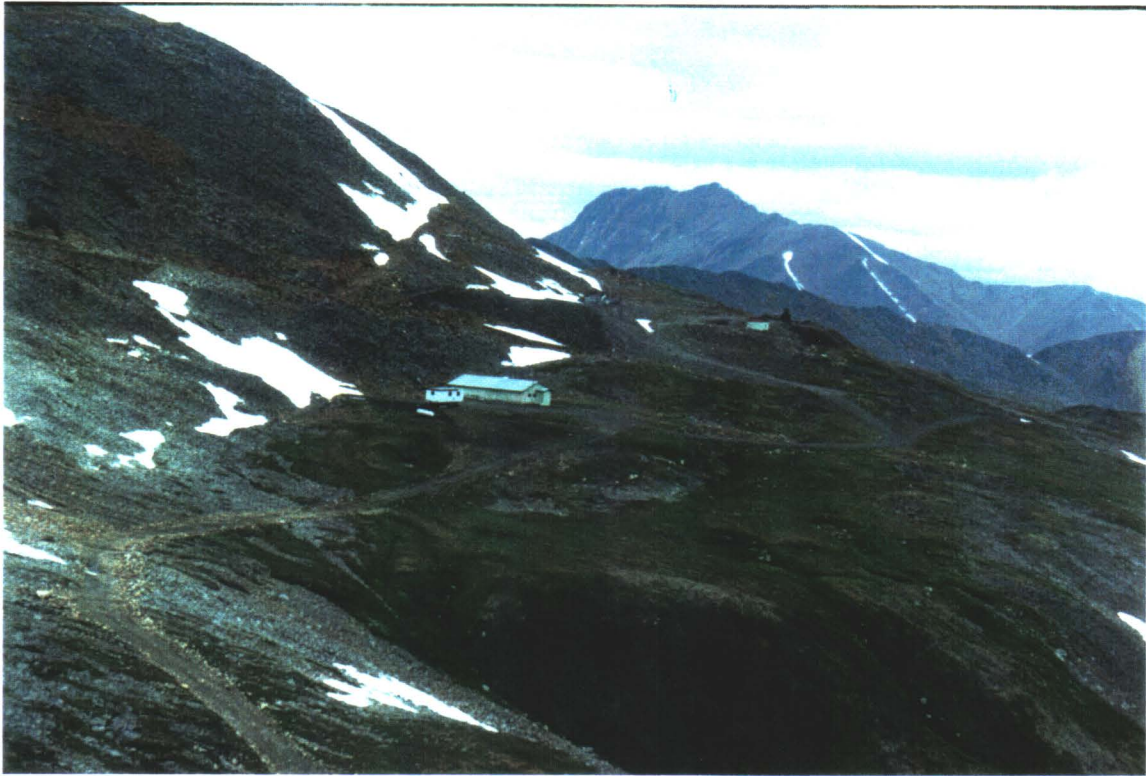
ACCESS TO EXPLORATION SITE

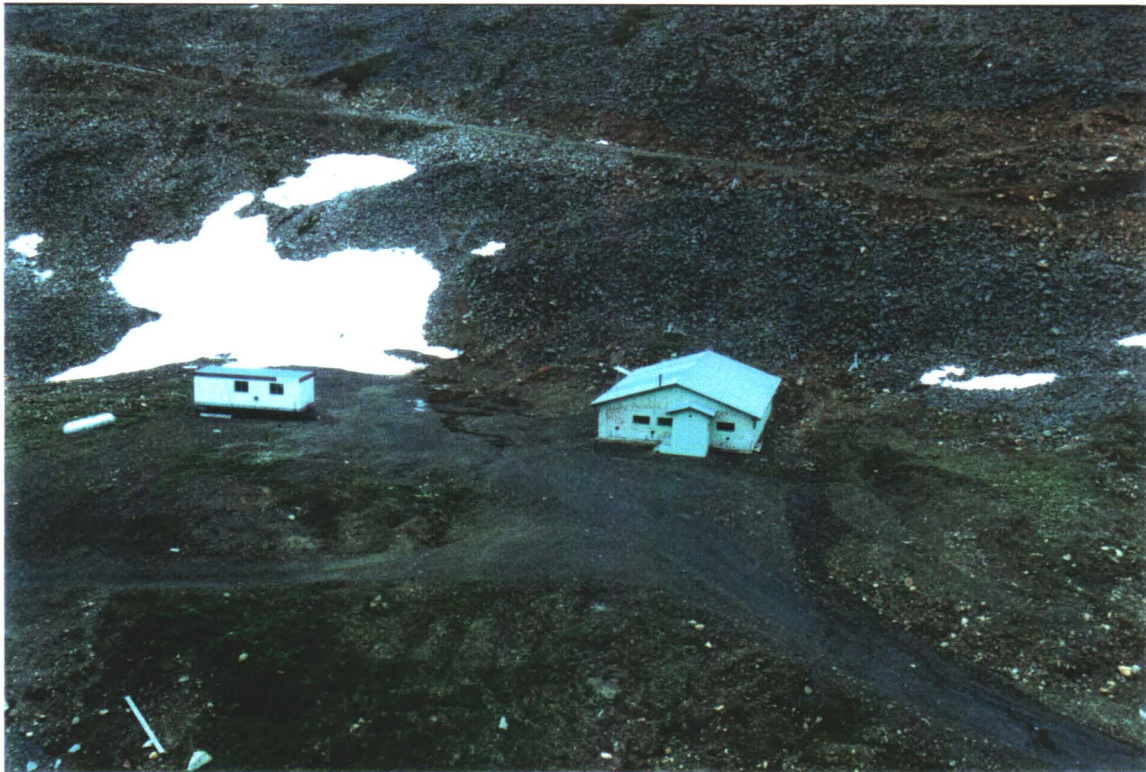
OFFICE TRAILER AND CORE STORAGE BUILDING

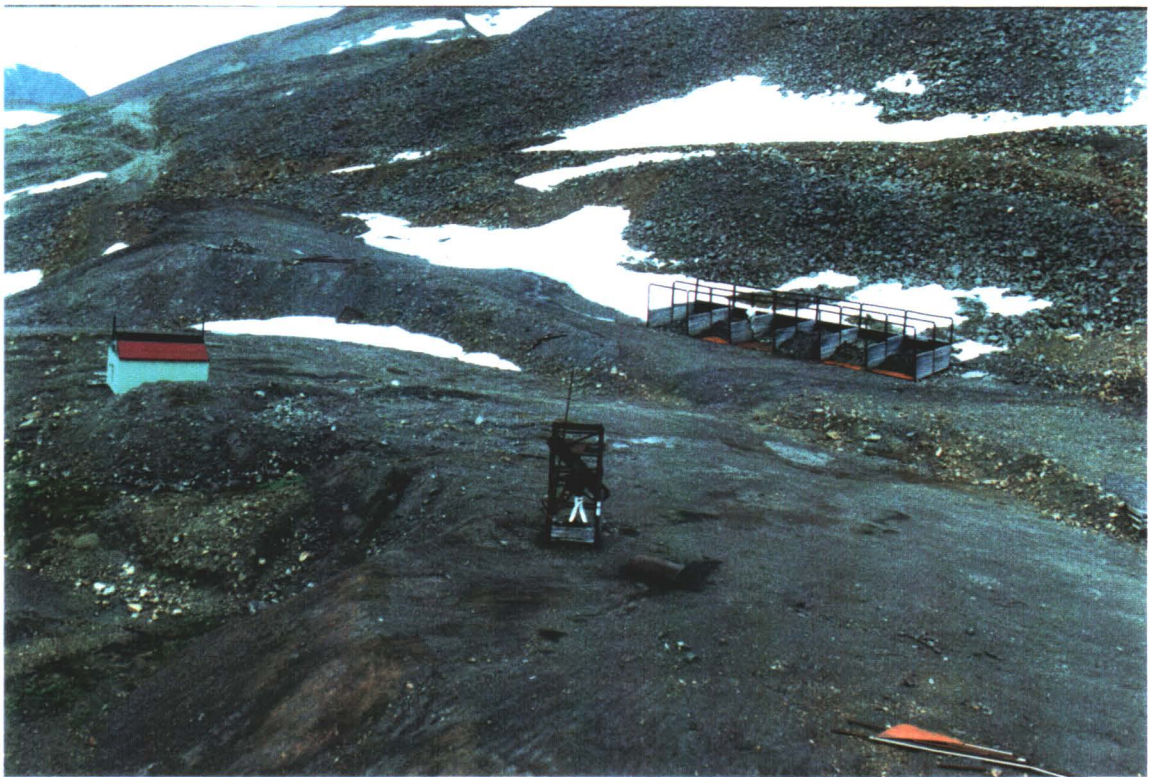
SAMPLING TOWER, ORE BINS, AND GENERATOR BUILDING

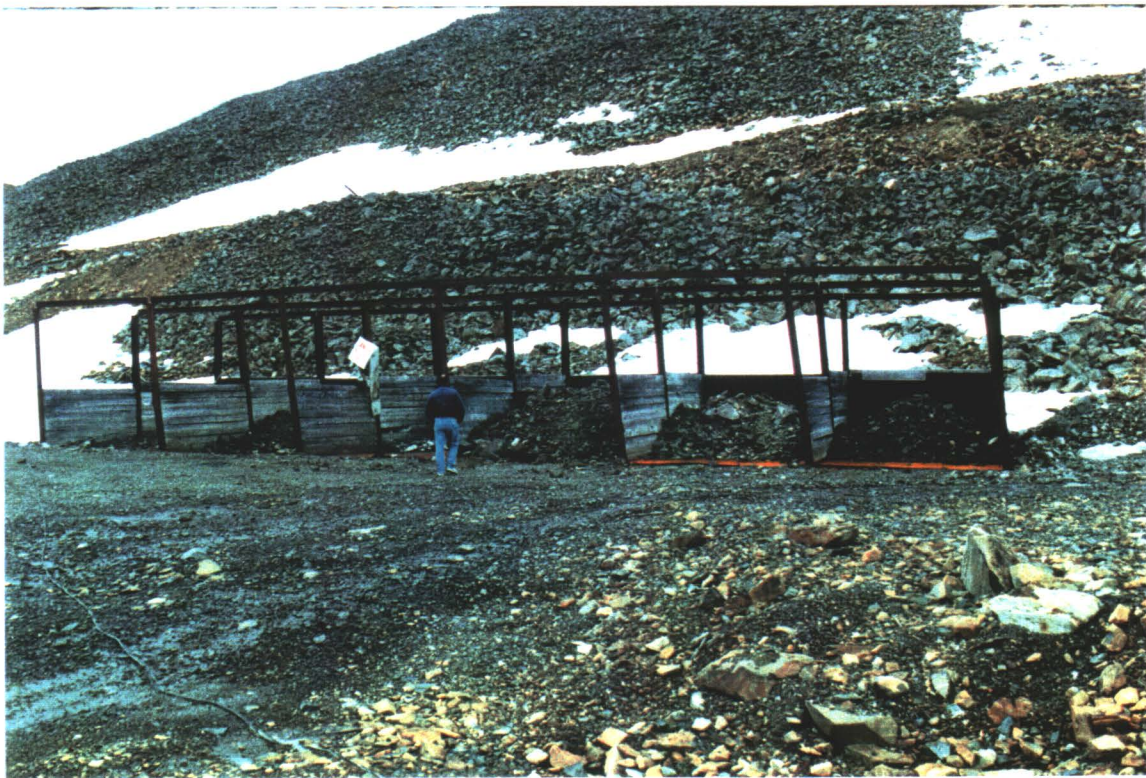
ORE STORAGE BINS

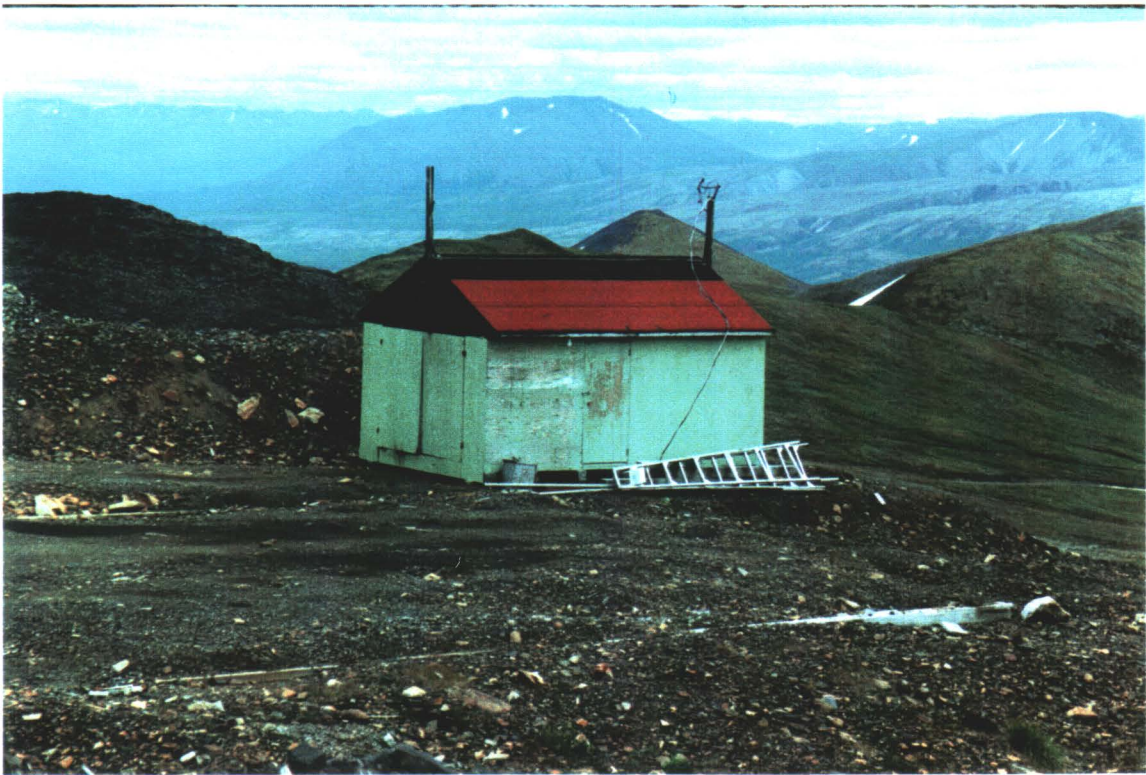
GENERATOR BUILDING

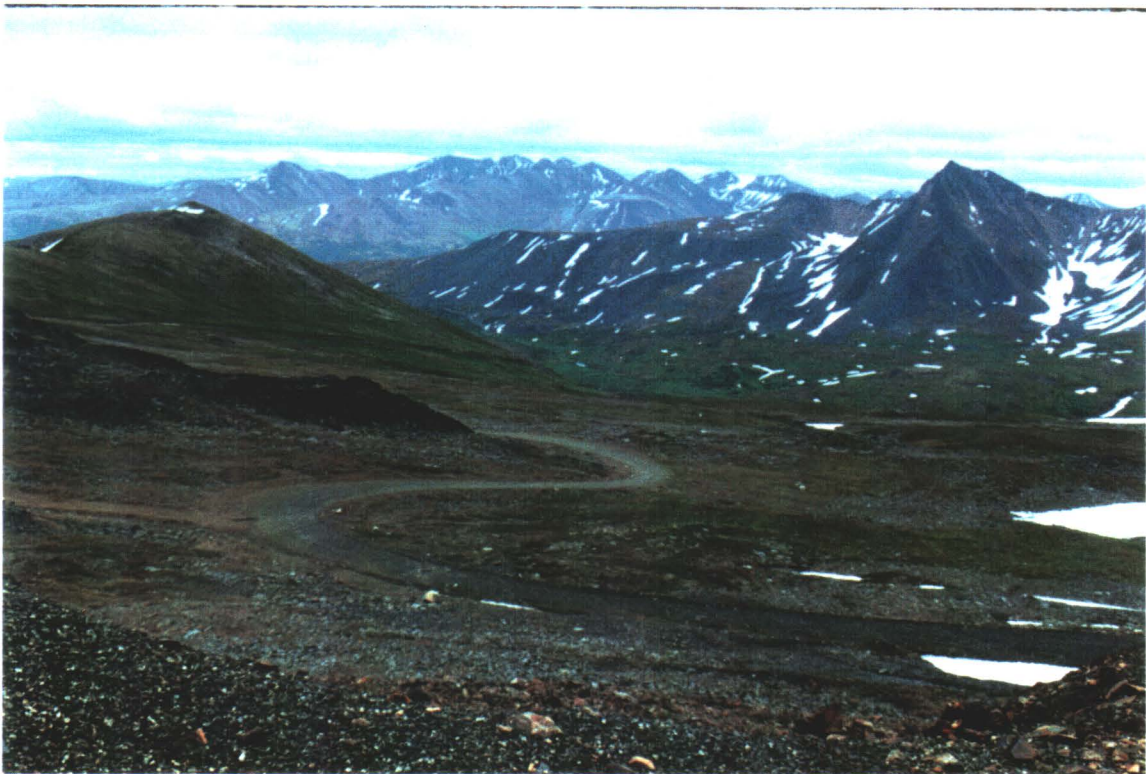
ACCESS ROAD FROM SITE
