ASSESSMENT REPORT

105M-13-1

MOUNT HALDANE

DIAND TECHNICAL SERVICES

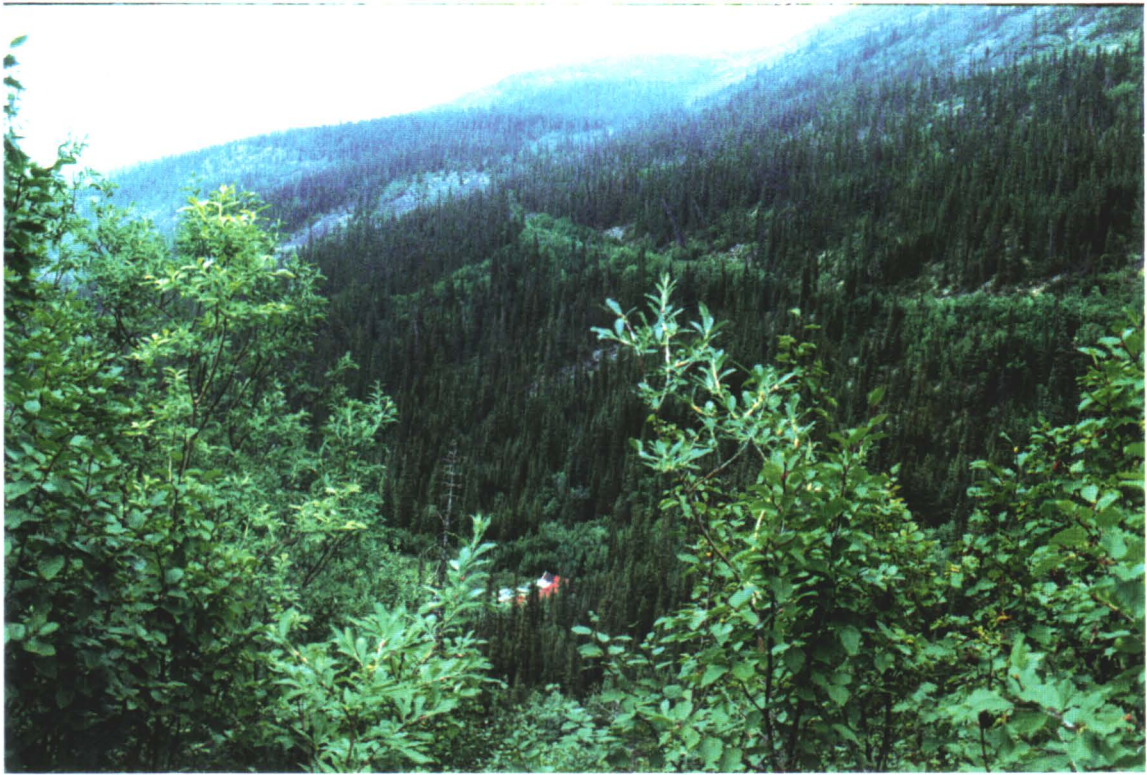
The site is road accessible and can be reached by first travelling north approximately 25km from the village of Mayo on Highway 11. Turning left on a trail just past the Halfway Lakes the site is reached by travelling 20km on a trail circling the north side of Mt. Haldane. The road to the exploration site is accessible using two wheel drive vehicles except for the last two kilometres which can only be travelled with four wheel drive vehicles. The trail crosses several minor intermittent streams and small debris flows.

ACCESS ROAD TO SITE AND SITE BELOW

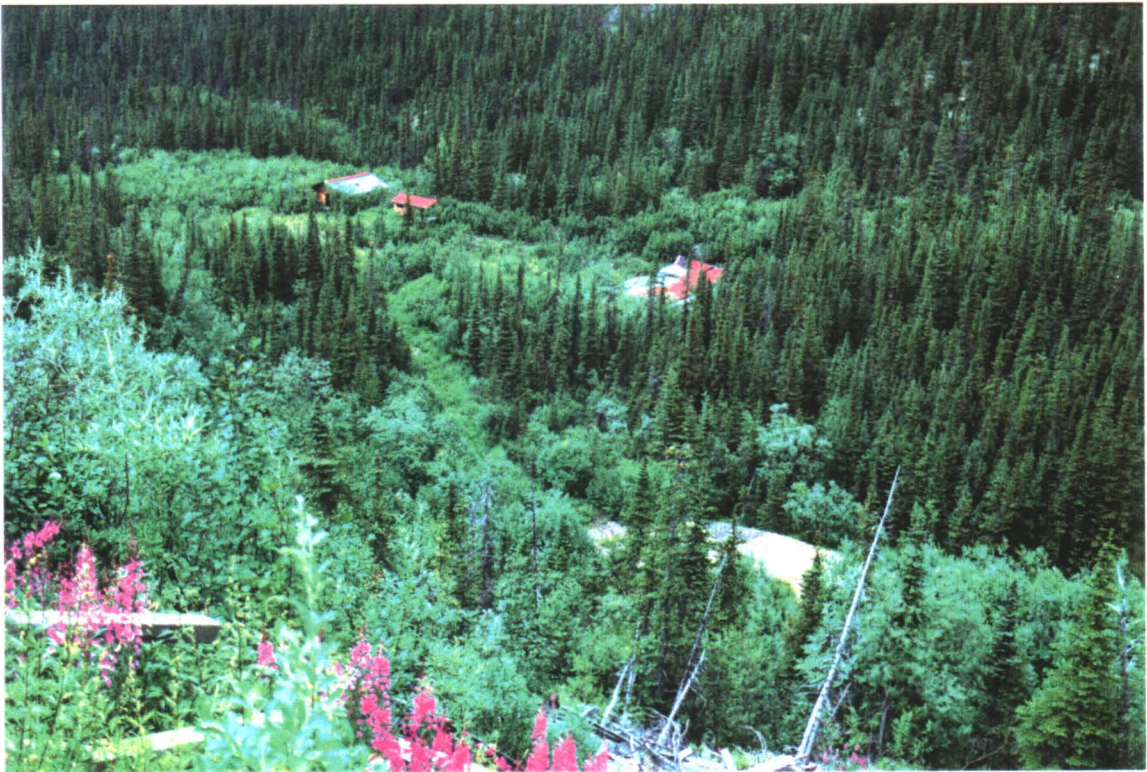
EXPLORATION CAMP SITE

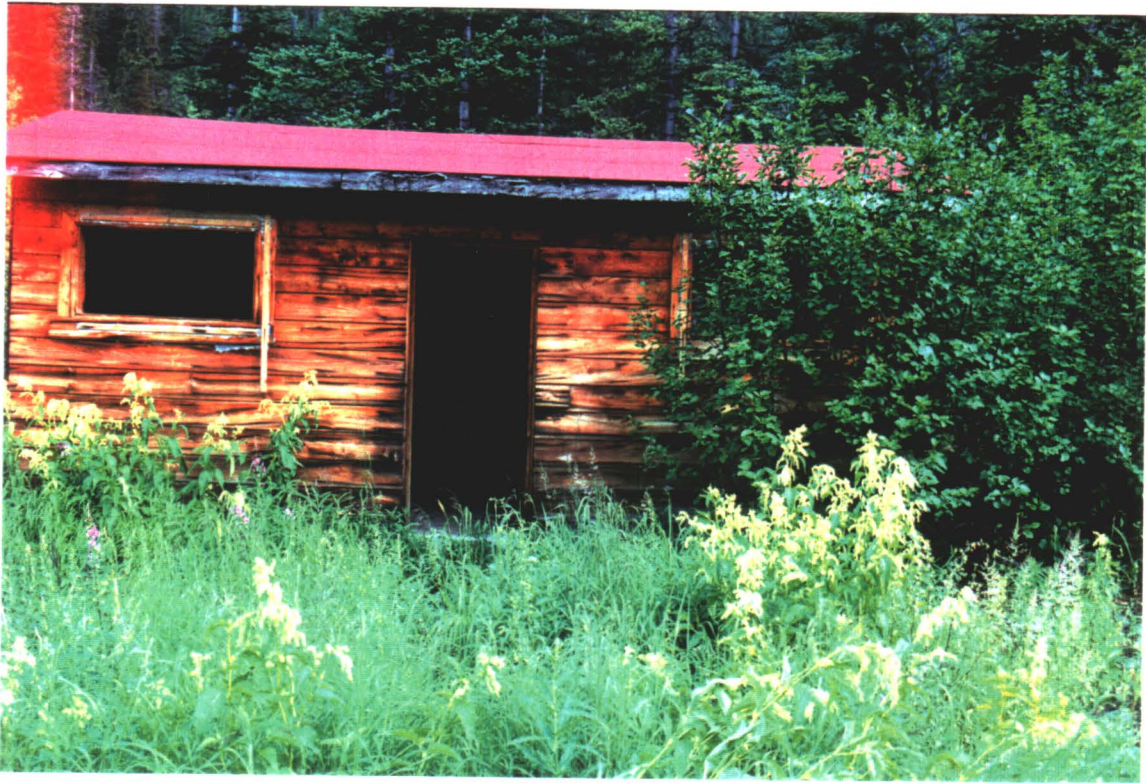
CAMP BUILDING

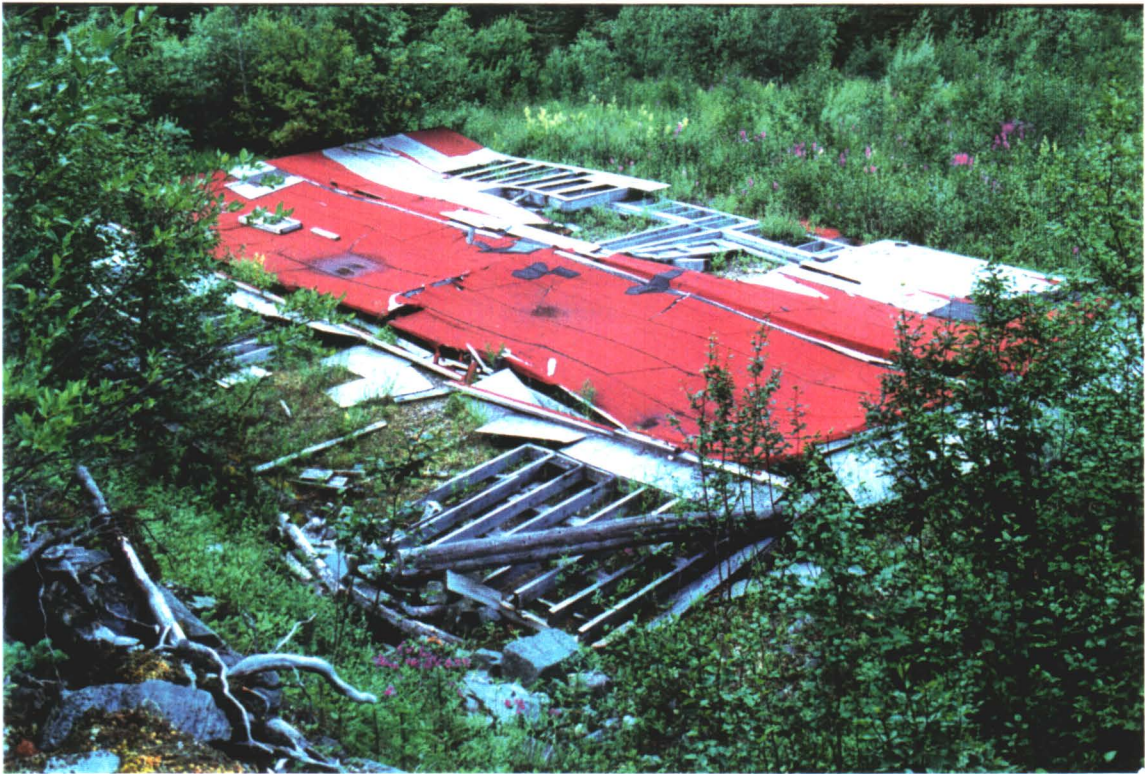
As noted from the historical records, this is a very old site with the main development having taken place during two distinct periods, 1916-1918 and 1964-1966. Any remaining infrastructure that had been put in place is now very old. Remaining structures are deteriorating, collapsing, and rotting. The remaining standing structures are becoming unsafe and will collapse with time. It is recommended that these buildings be posted to advise the public that they are unsafe to enter. If clean up was planned by burning debris on site extreme care needs to be taken at certain times of the year to ensure fires do not spread to the surrounding forest. Vegetation is very thick in this area and the danger of spreading fires must be considered.

COLLAPSED BUILDING

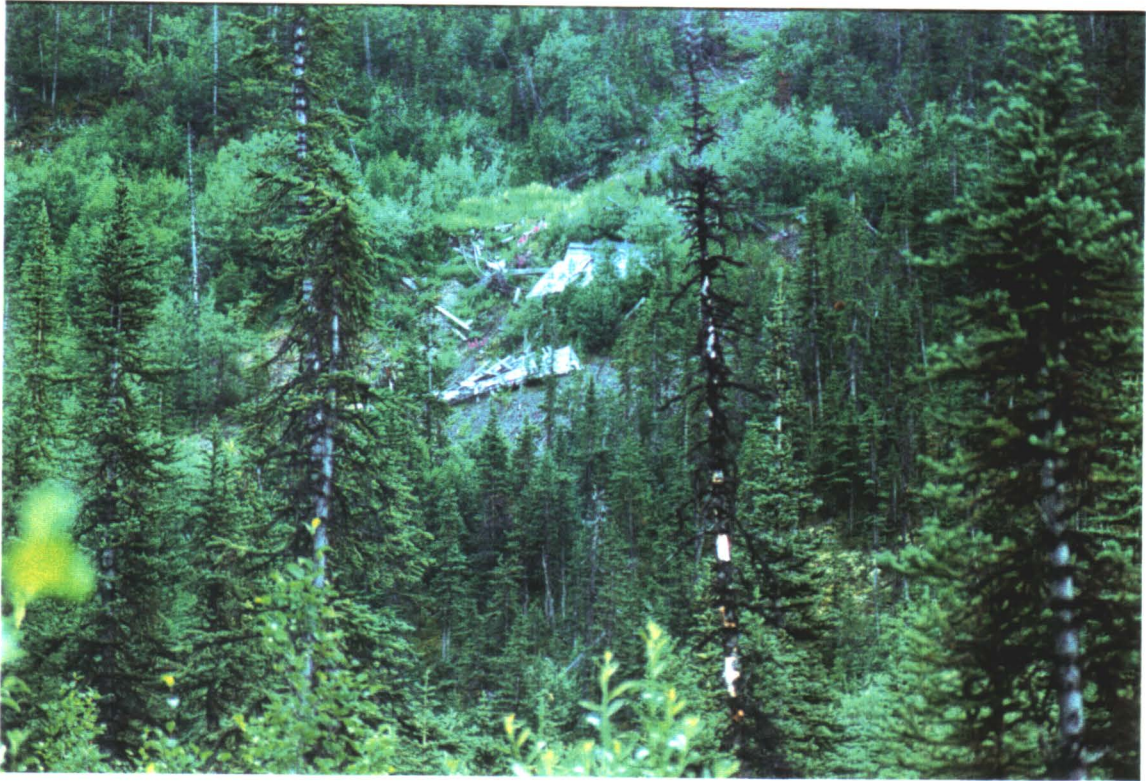
The site is overgrown with alder, black spruce, and willows to 6m high. The vegetation growth is thick due to adequate organic soils and moisture. Debris torrents are present on the steep sections close to the exploration site. These debris flows indicate the soil in this area is susceptible to instability if the vegetation and soil is disturbed.

EXPLORATION DEBRIS AND DEBRIS FLOW

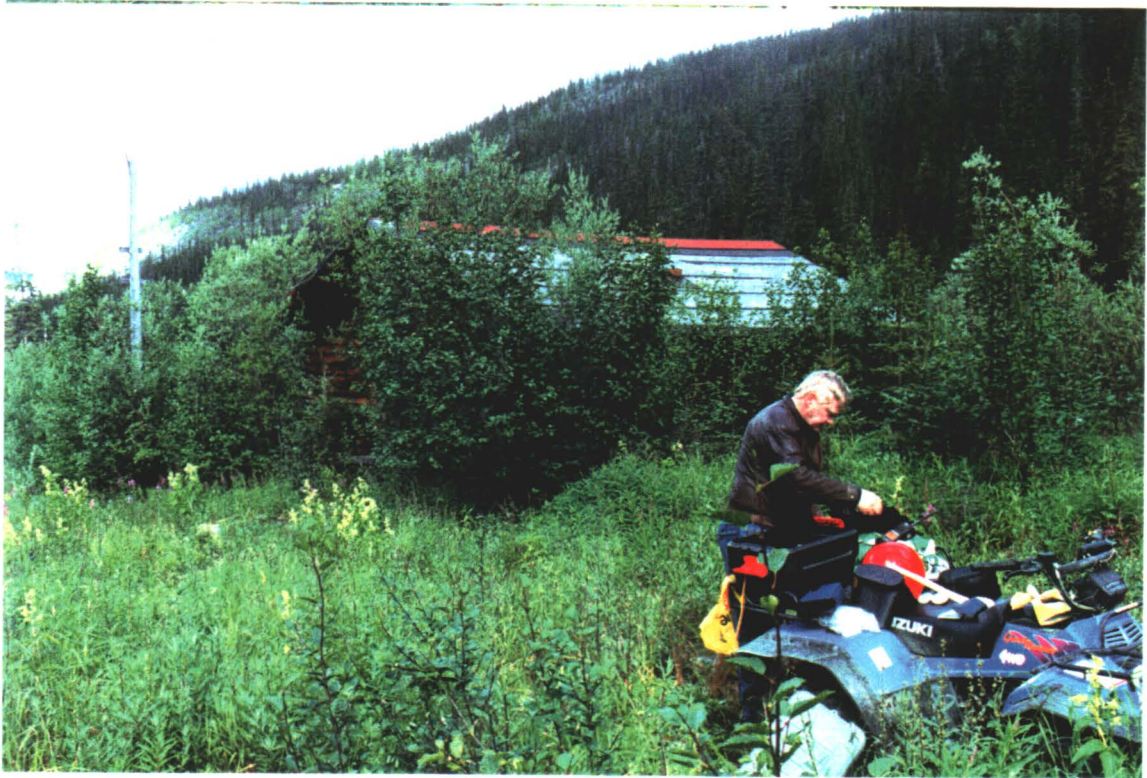
CAMP BUILDING

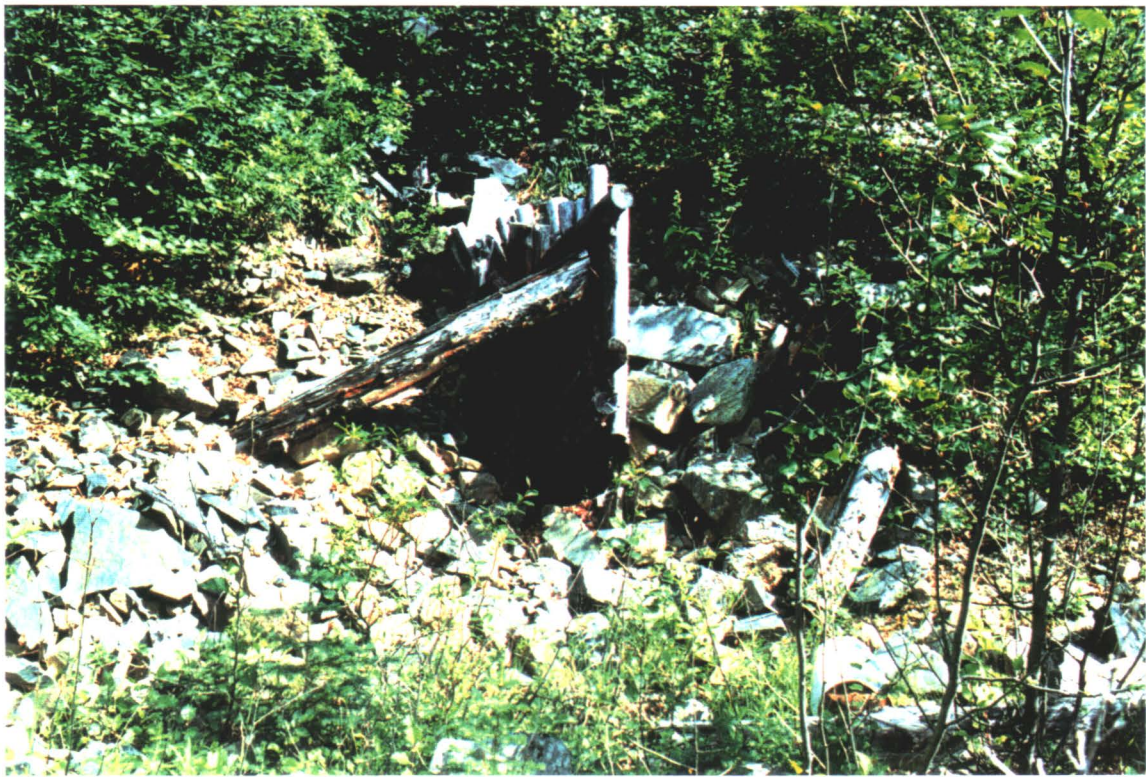
According to historical records, three adits have been excavated. The most recent work on the adits occurred 28-30 years ago from 1964-1966. All adits have collapsed, however one adit entrance is still open but is not easily found (see photograph).

COLLAPSED ADIT

Over time the adits have collapsed and overgrown and are not easily found. The waste piles in front of these adits are also growing over making any past excavations difficult to find. As noted, one adit entrance is still open and is accessible for someone to crawl into. This hole is in such a remote location and so difficult to find that it should be considered only a **small risk** to public safety. However, **it would be prudent to place a warning sign of the potential risk of entering this adit.**

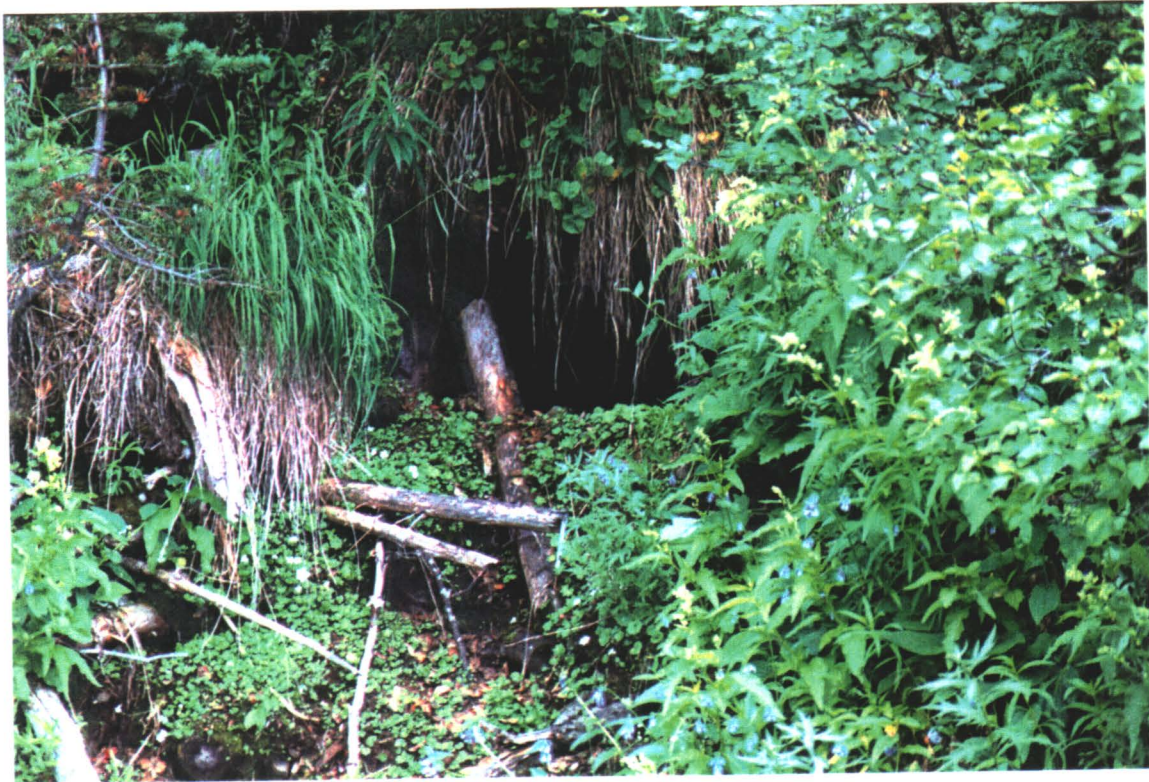
OLD ADIT

The adits have collapsed and only one small opening was found. This is considered a small public safety hazard in this very remote location and it would be prudent to post warning signs of this potential hazard when next in the area.

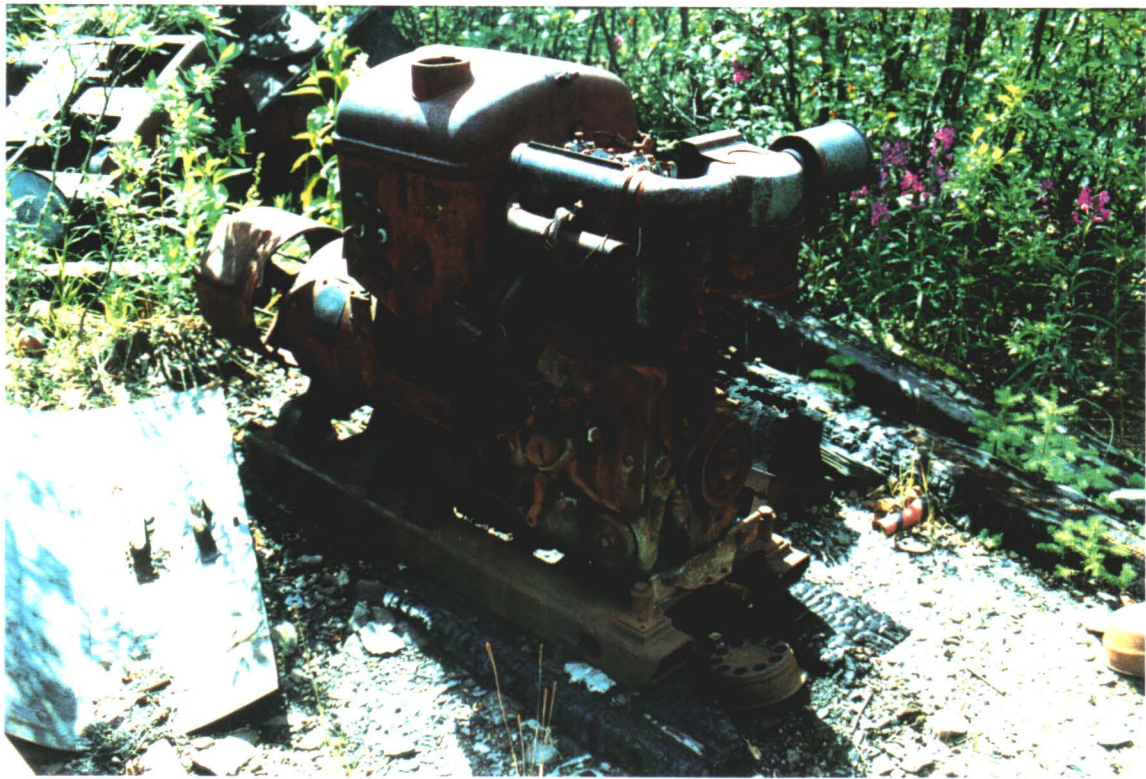
Remaining equipment such as the generators and drill are rusting and being overgrown by surrounding vegetation. This equipment is now hidden by the vegetative growth and would be difficult to gather and remove from the site. This small amount of equipment, although there is no reason for it to be left at this site, does not pose much of an environmental liability. It is recommended that this equipment be left at this site unless there is a program initiated in the area for the clean-up of **LOW** priority sites.

ELECTRICAL GENERATOR AND SURROUNDING DEBRIS

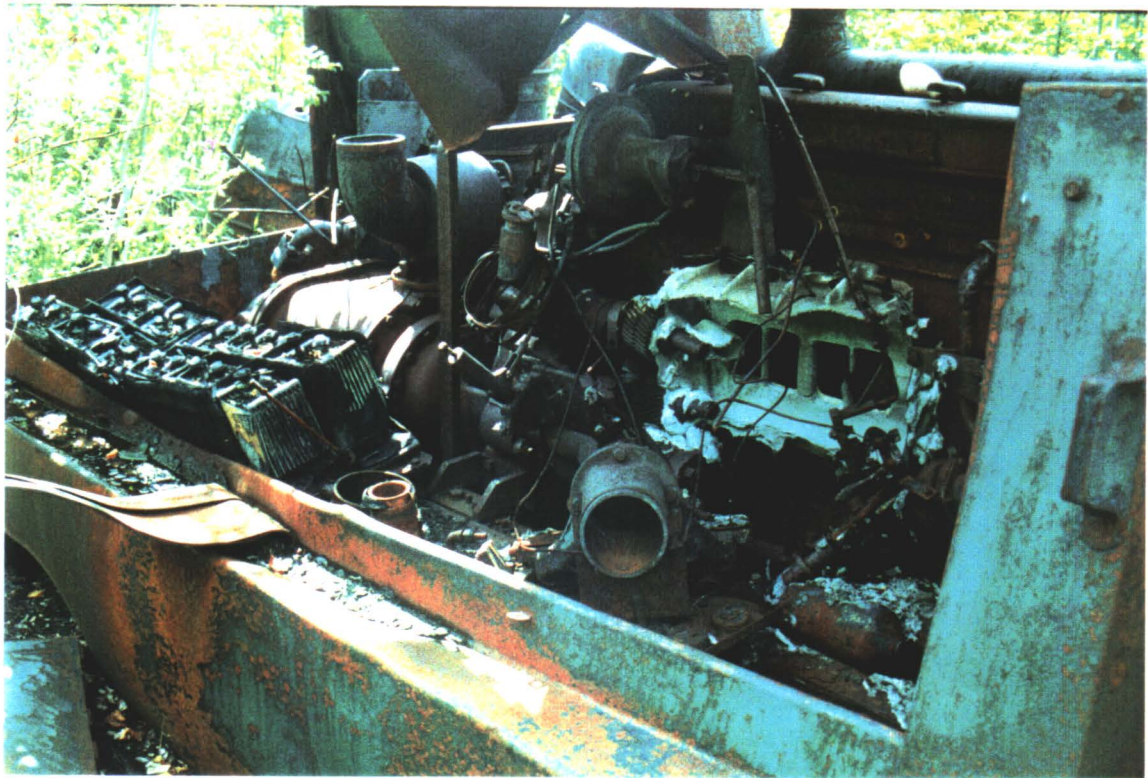
- 1 burned out Gardner Denver drill,
- 2 small generators near adit, and
- remains of an old wooden tramway and some rail.

REMAINS OF DRILL

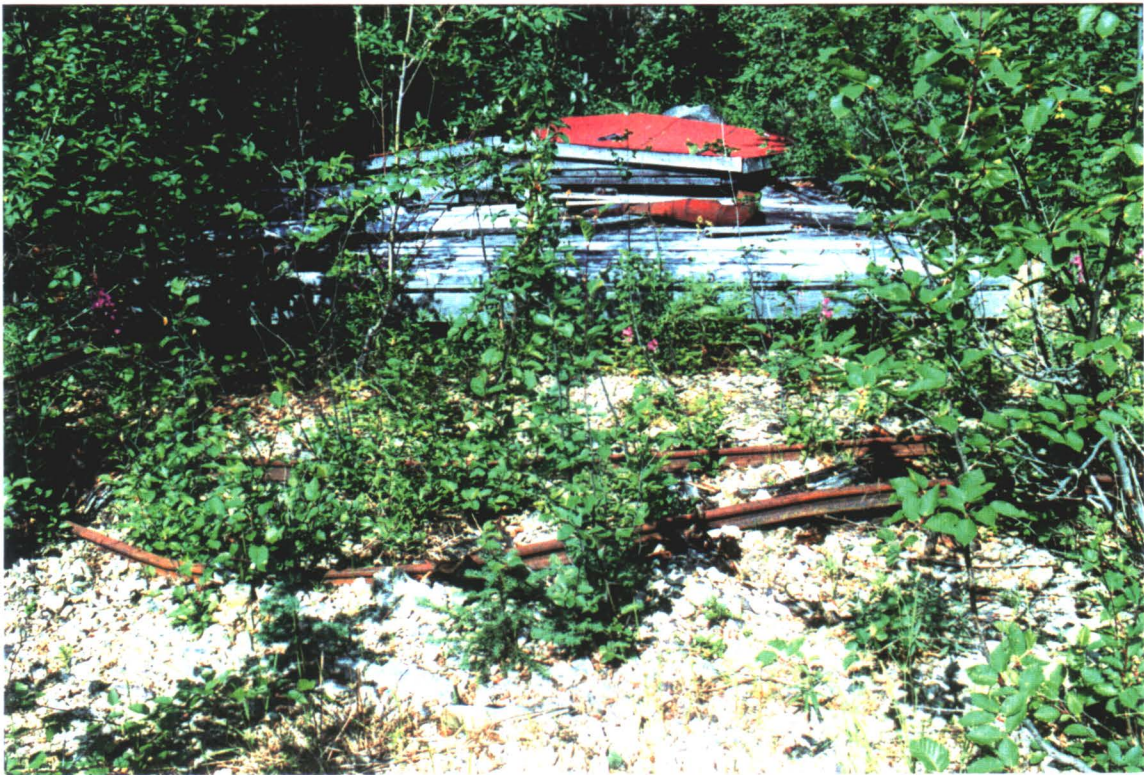
DEBRIS AND RAIL

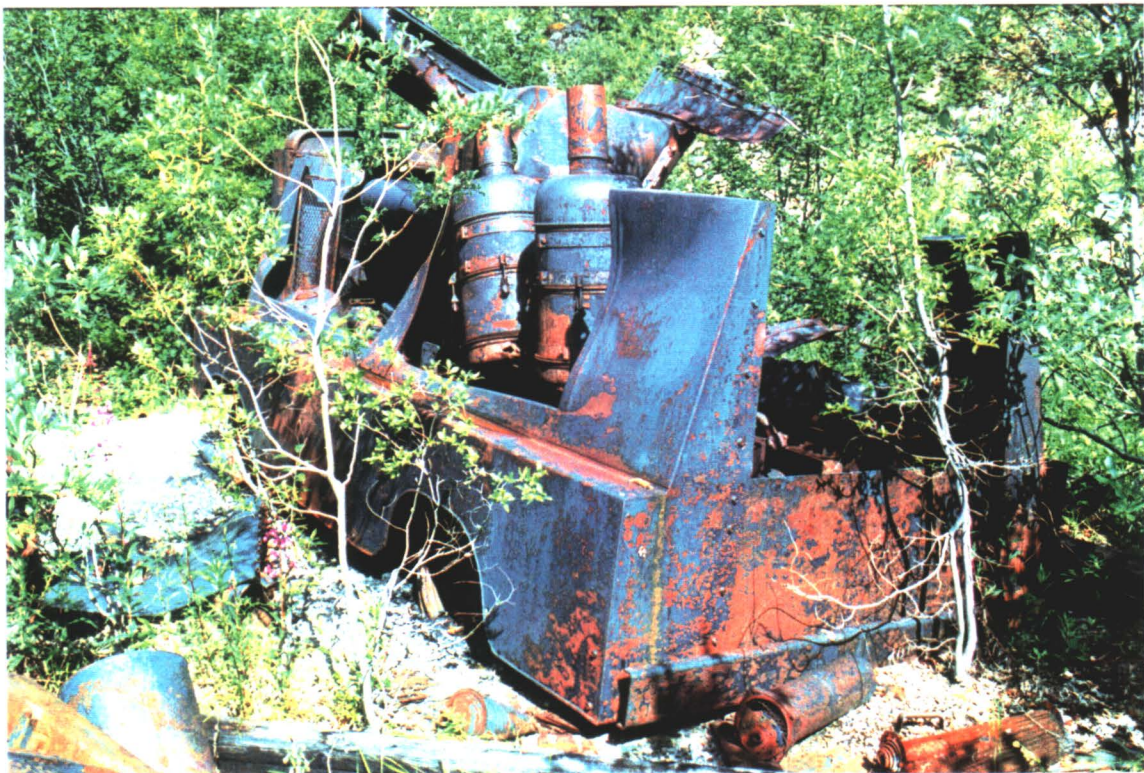
GARDNER DENVER DRILL AND SURROUNDING DEBRIS
