ASSESSMENT REPORT

115I-06-1

LAFORMA

DIAND TECHNICAL SERVICES

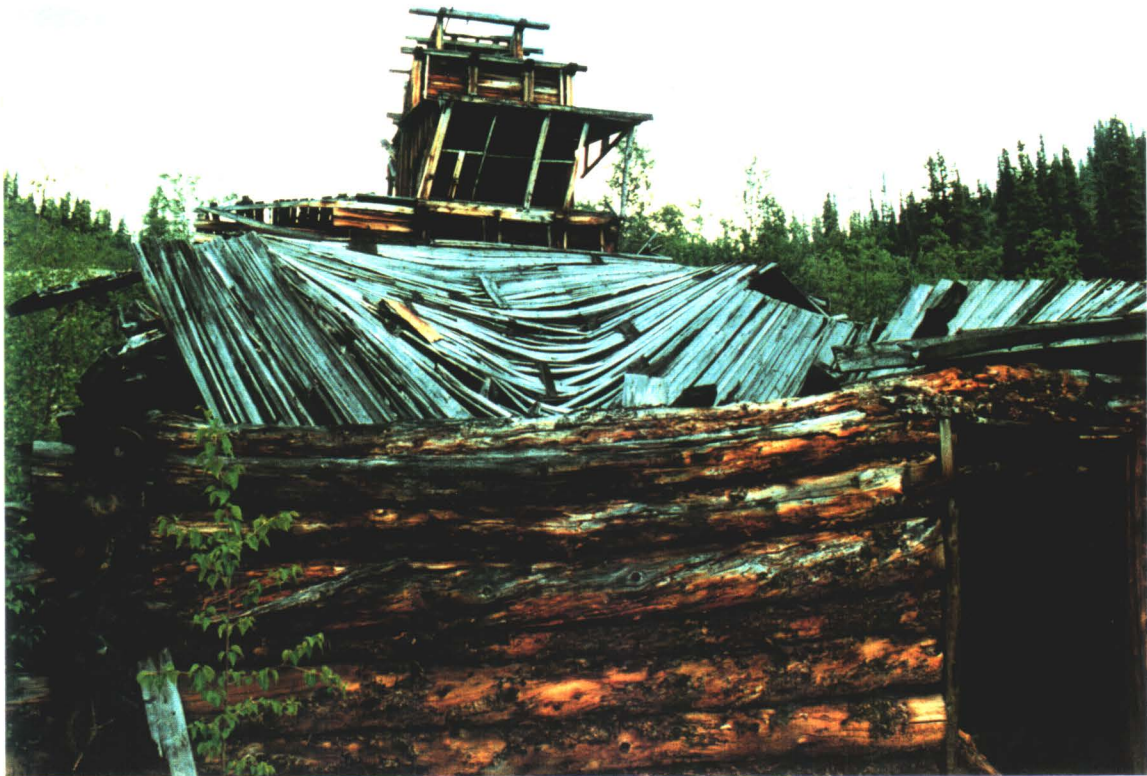
UPPER MILL SITE

Remains of an old 9 tonne mill is located close to 2 adits. The mill is a very old collapsing log and wood frame structure situated on the edge of a gully.

The upper mill site consists of very old collapsing buildings, a waste rock dump, and two open adits. The site is growing over with vegetation and much of the original site is difficult to identify. Generally the site does not appear to be causing any ongoing environmental damage in addition to what has been caused when the site was originally developed. Ongoing concerns related to this site includes potential safety hazards.

The collapsing buildings are considered a small hazard for anyone entering them. It is recommended that these buildings be piled and burned to remove any potential hazard. However this would have to be done with care to avoid starting any fire in the nearby forested area. If this work is undertaken, any of the remaining metal waste should be gathered and removed from the site. This should be considered a **LOW** priority.

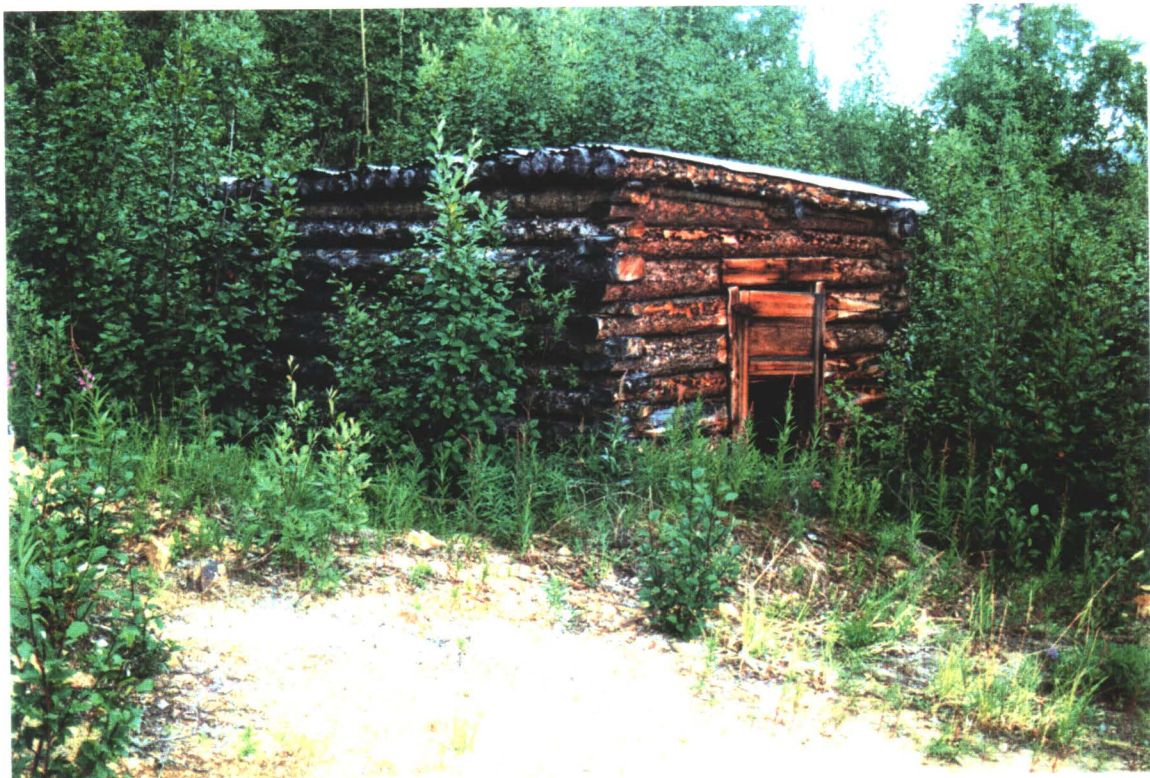
LOG STORAGE SHED

- 6.1x12.2m log garage with collapsed roof,
- roof of a collapsed 3.1x6.1m log structure,
- old Gardner Denver pump,
- approximately 100 pieces of 25-75mm diameter rusted pipe, and
- a few old 204 litre empty barrels and other pieces of metal waste.

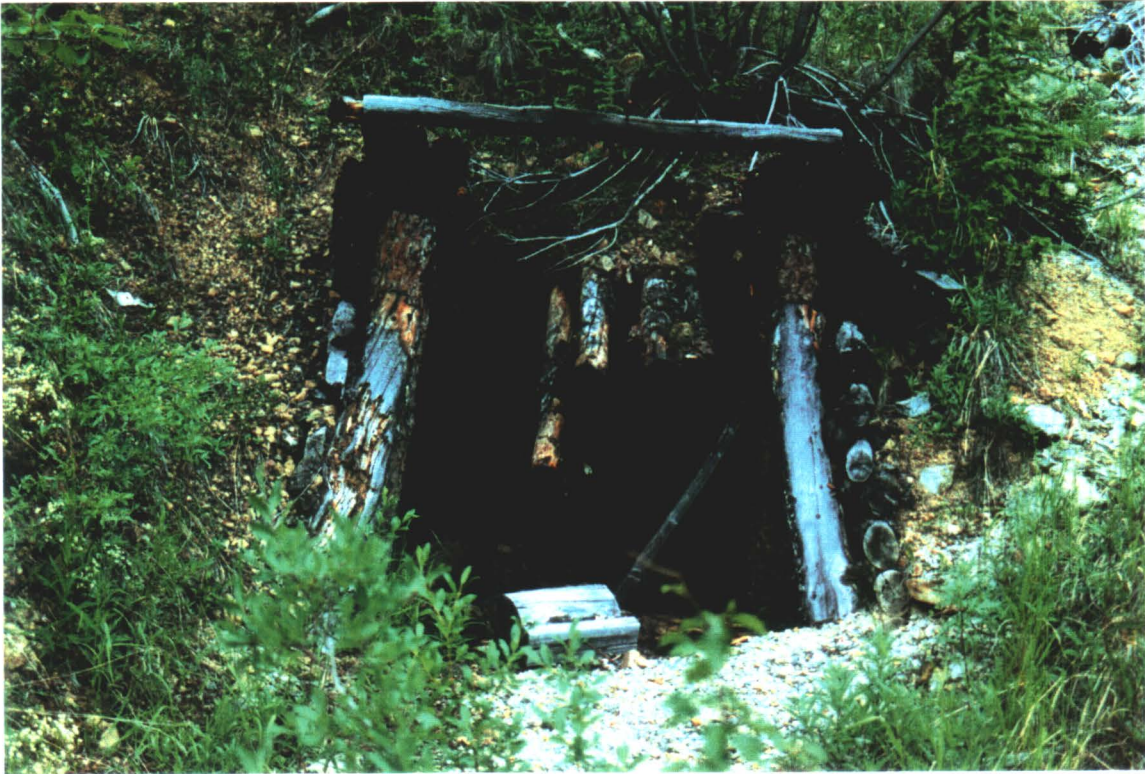
Two open adits were found at this site. Both adits are collapsed but the entrances are still open. Rail extends from the lower adit.

UPPER ADIT

The most significant safety hazard at this location is considered to be the open adits. These two adits should be sealed so that nobody can enter them. This should be considered a **HIGH** priority.

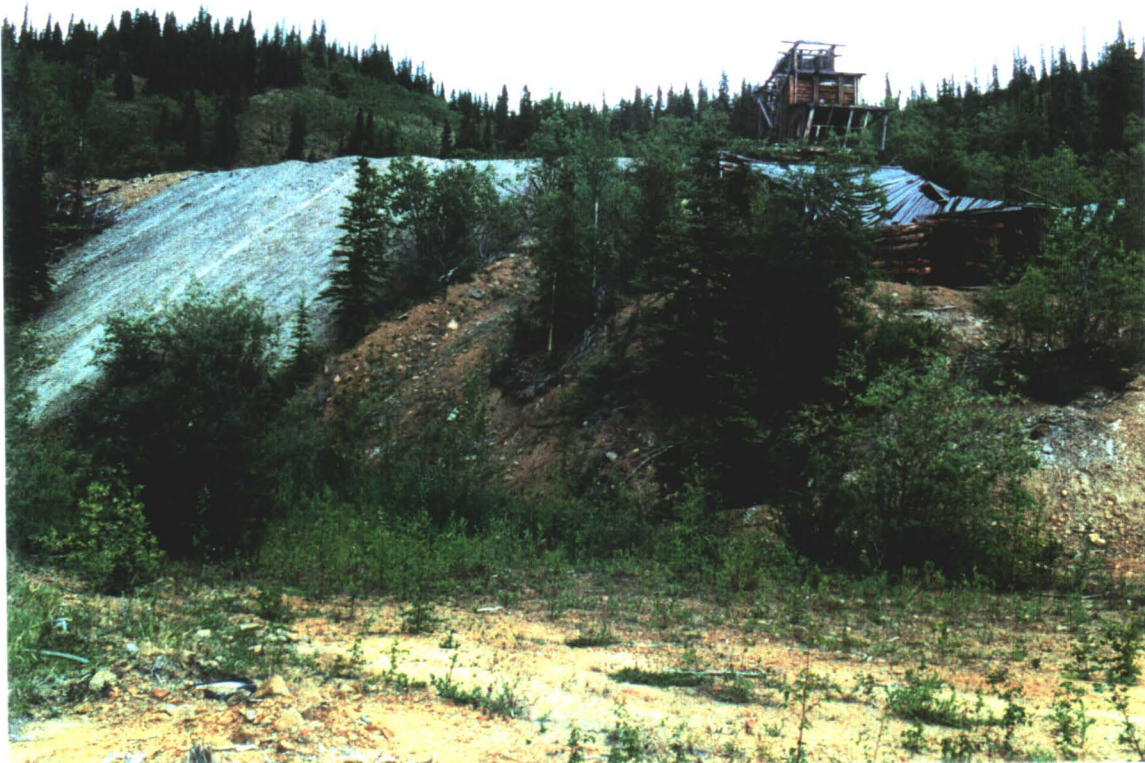
A waste dump measuring approximately 45m wide, 30m long, and approximately 15m deep at the toe is situated to the right side (facing downslope) of the mill and spills into the adjacent gully.

UPPER MILL SITE AND ROCK WASTE ON LEFT

The rock waste pile does not appear to be causing any additional damage to the environment, and it is not feasible to remove or treat the area without causing additional damage to the site. It is recommended that the waste pile be left in its present condition.

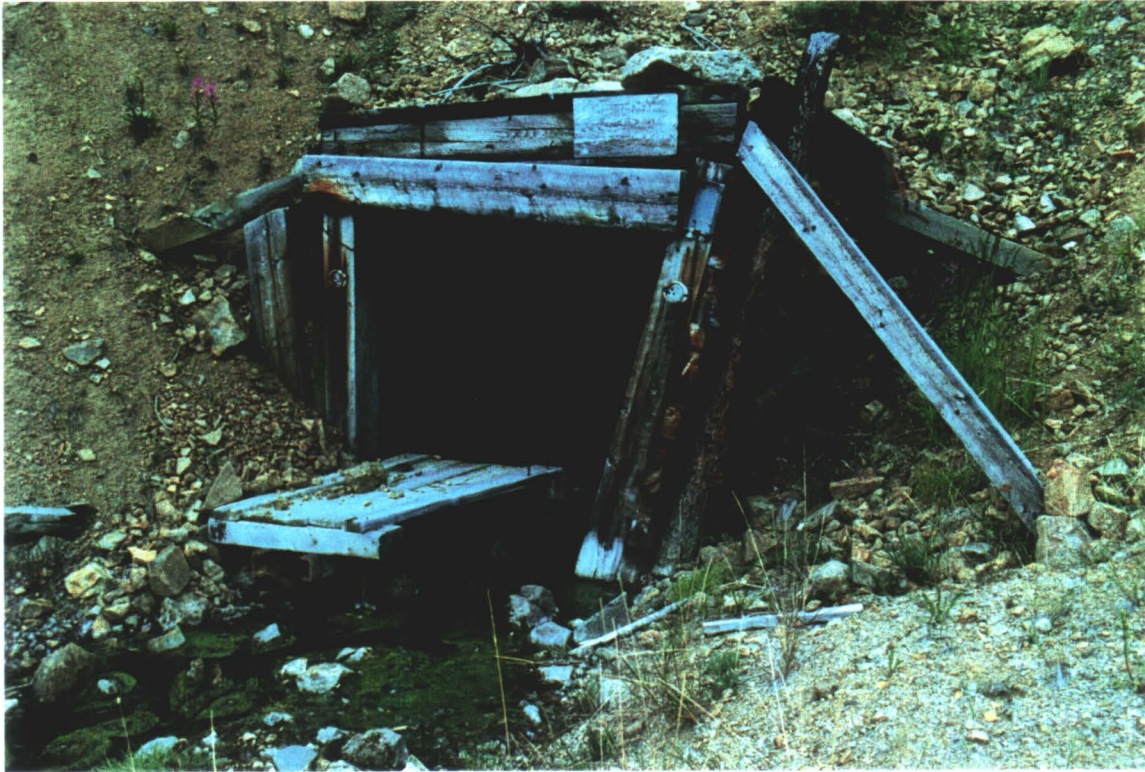
It is estimated that between 40-50 litres/minute of water flows from one of the adits. Rail also extends into this adit.

MIDDLE ADIT AND DRAINAGE FROM ADIT

The adits have not been properly secured and are considered a safety hazard. These adits should be secured against possible entry and posted to warn anyone entering the area of the potential hazard. This should be considered a **HIGH** priority.

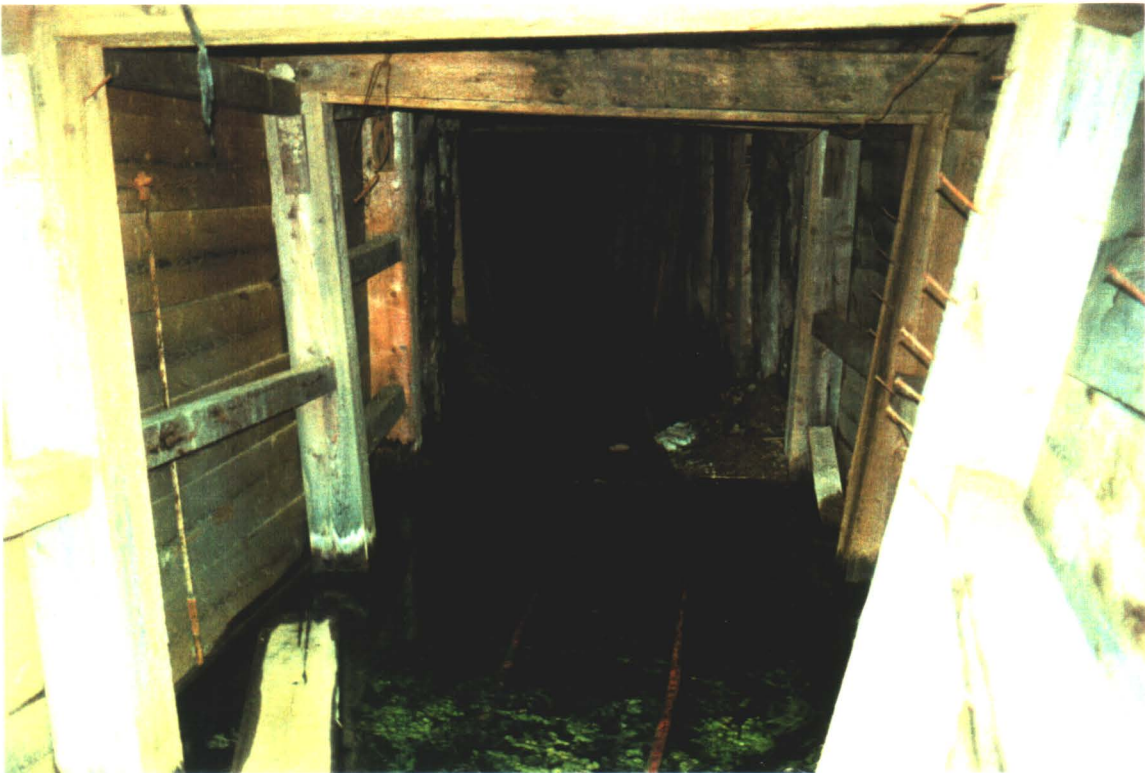
INTERIOR OF MIDDLE ADIT

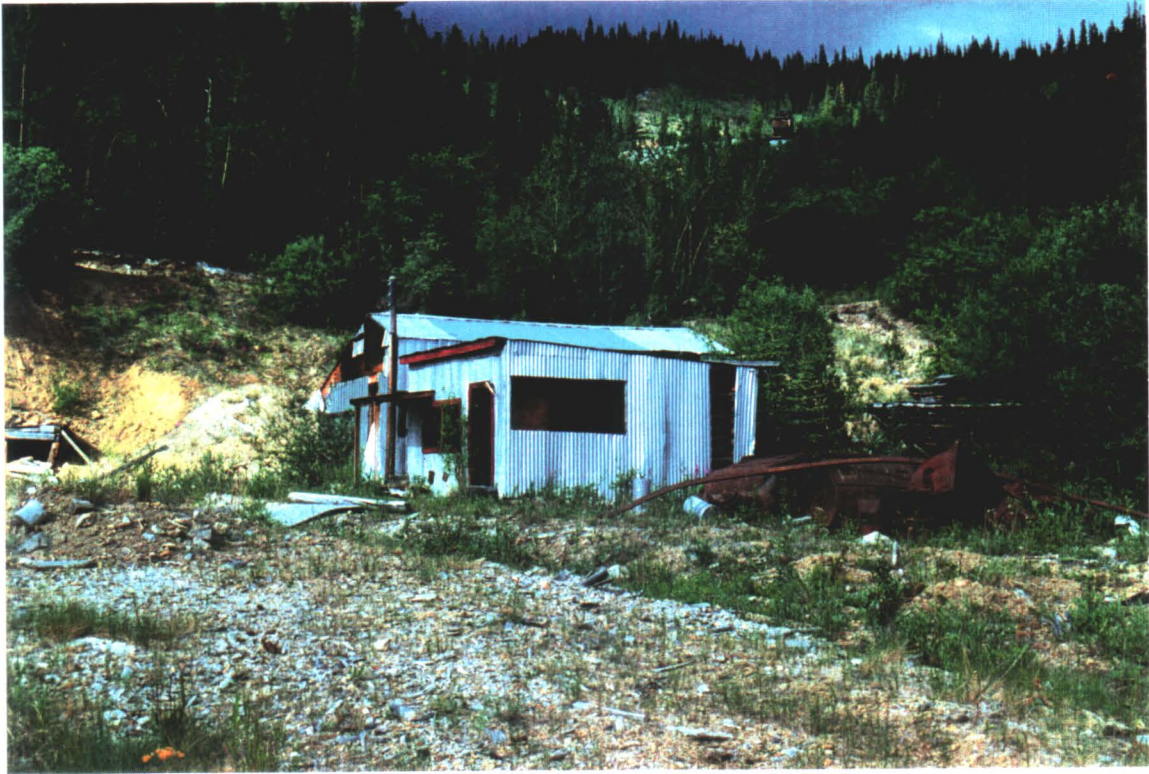
STORAGE SHEDS, ORE CARS, AND ROCK CORE

The remaining core sheds and storage buildings are deteriorating slowly with time, however they do not appear to pose any ongoing environmental hazard. These buildings should be removed from the site only if a general clean-up program is initiated in the area. This is considered a **LOW** priority. The remaining core should be assessed by a qualified geologist if salvage of the core is to be considered.

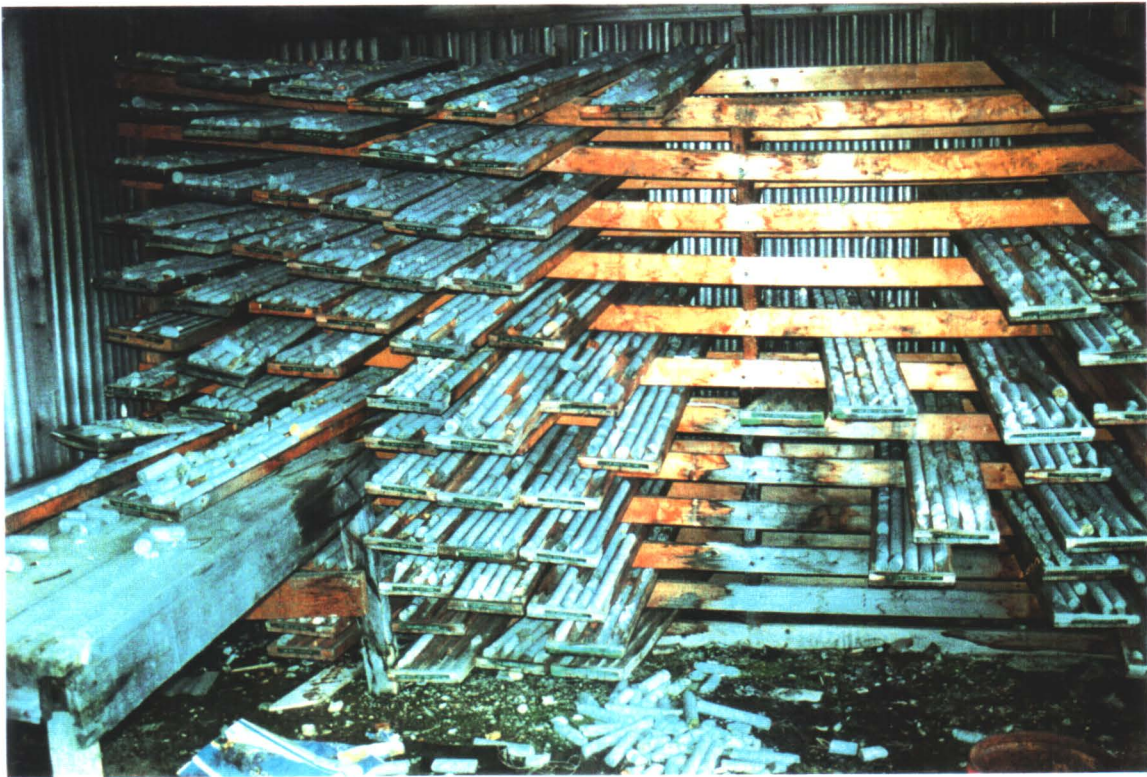
CORE IN STORAGE SHED

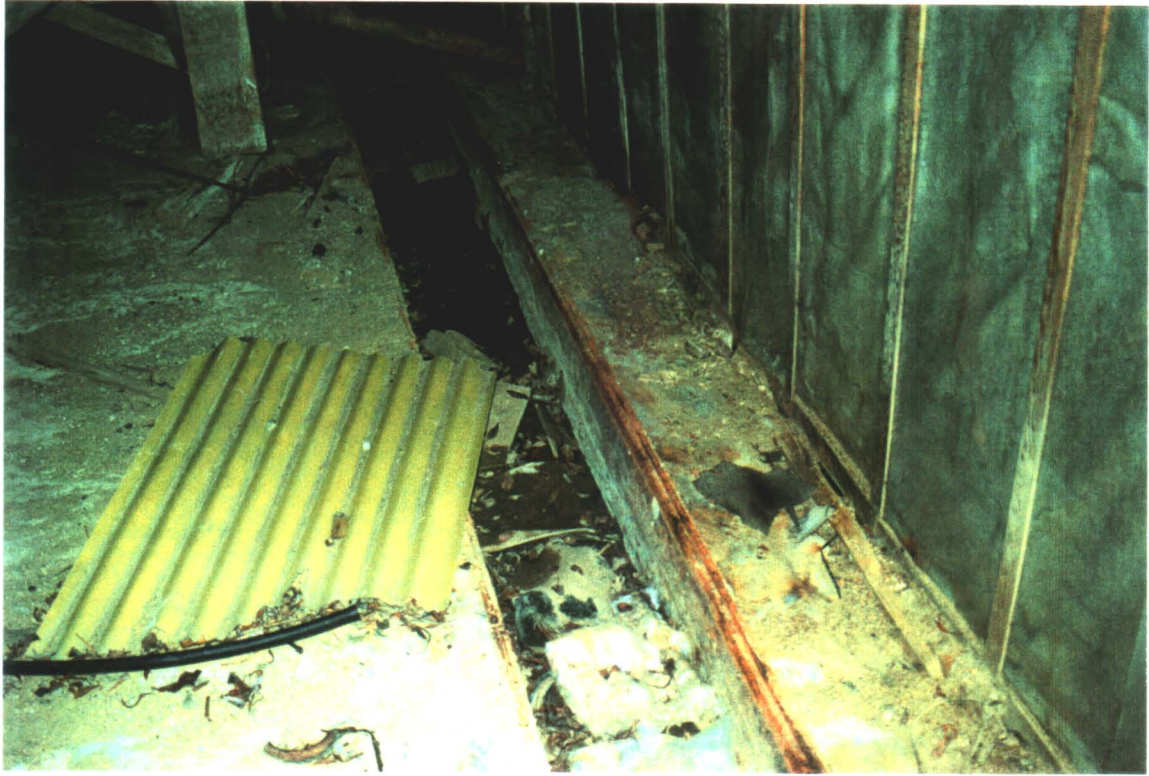
It appears that the tailings may have been drained downslope of the the mill building, however no tailings were found or really suspected as there are no containment dykes. There were no other visible signs of contamination such as vegetation stress.

PROBABLE CATCHMENT CHANNEL FOR TAILINGS

As this was an operating mill tailings would have been produced. Although there is no evidence of any tailings it is recommended that vegetation downslope of the mill be analyzed to verify that there is no lingering contamination in the area.

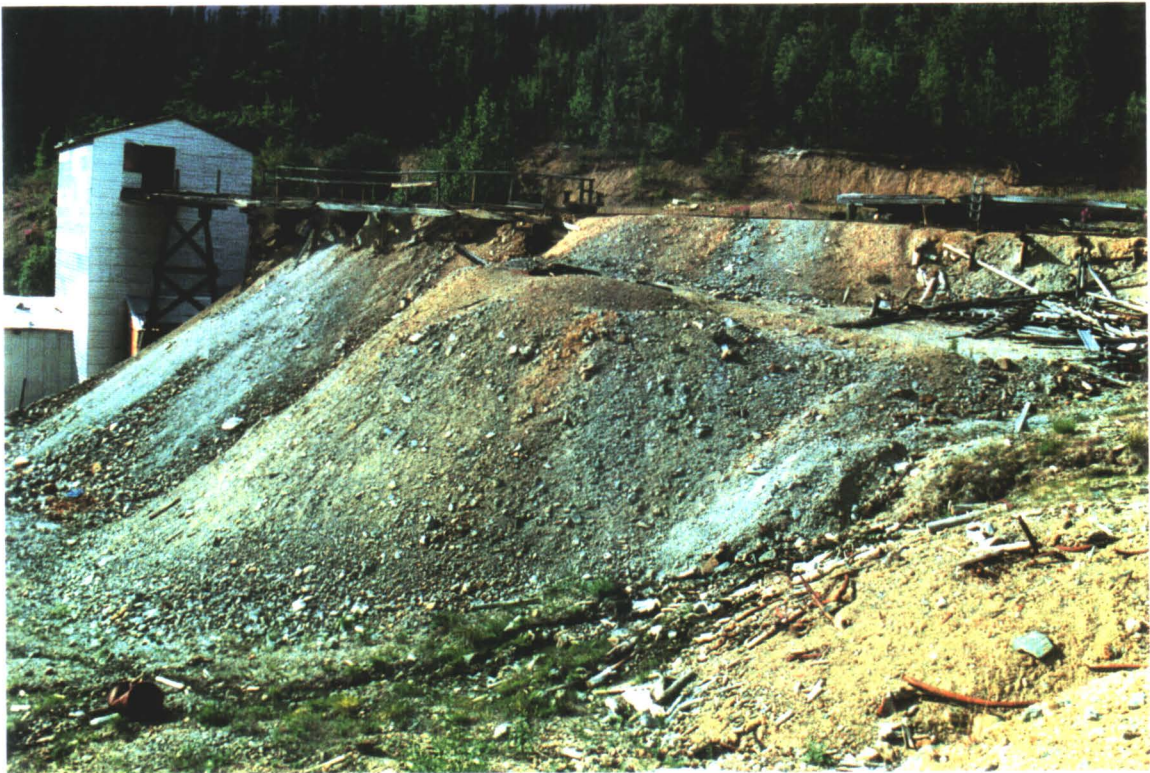
ROCK WASTE DUMP

A large waste rock dump measuring approximately 30m wide, 15m long, and is about 12m deep is situated below the adit and to the left side (facing downslope) of the mill buildings. Other buildings and infrastructure remaining at this site includes;

The large rock waste dump appears stable and appears to be incurring only minor amounts of erosion. It is recommended that this rock waste pile be left untouched as it does not appear to present any major environmental hazard.

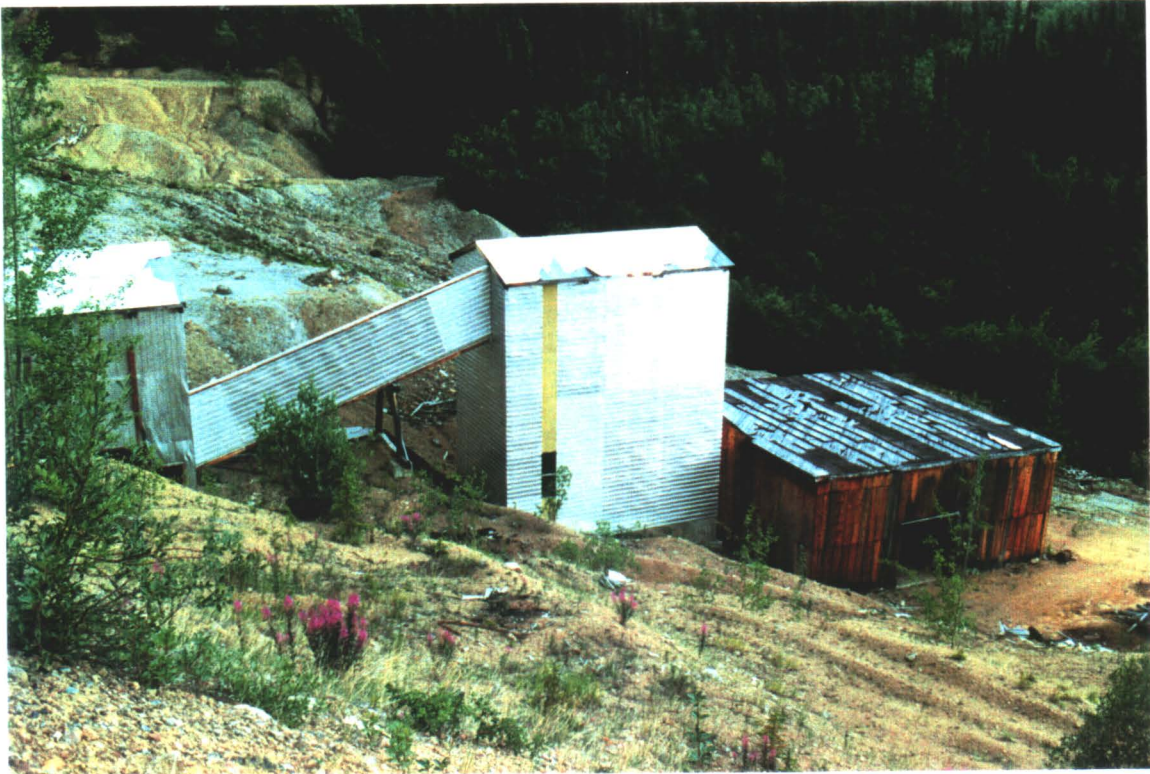
MILL BUILDING

- 12.2x12.8m wood frame plywood clad mill building. This building houses large concrete foundations which once supported the mill. The mill has since been removed. Mill balls and empty pails of Cyanamid AERO Promoter 404 were also found inside.
- 45.7m long and 12.2m wide enclosed metal clad timber frame conveyor and dump structure,
- 5.5x7.3m metal clad core storage shed with sample bags and 12 layers of core stored behind this building (measuring 3x4.5m),
- 3.6x4.6m metal clad core storage shed filled with core,
- 7 ore cars left beside the core storage buildings, and
- 6.1x14.6m wooden loading dock.

The lower mill site contains two large structures namely the mill building and the conveyor and dump structure. These buildings are well constructed and will stand for several years. Salvaging these buildings would require a labour intensive dismantling process and would be quite costly in this remote location. However, salvage of the material from these buildings may offset some of the costs of removal. If clean-up of these buildings is to be considered, then a tender package for removal and site clean-up should be the method considered to reduce costs as much as possible. There are numerous hazards in these structures and entrance should be prohibited and the buildings should be properly secured against entry. If these buildings are left in their present condition then they should at least be posted to warn anyone that they are not safe to enter. Proper notice and security of these buildings should be considered a **HIGH** priority.

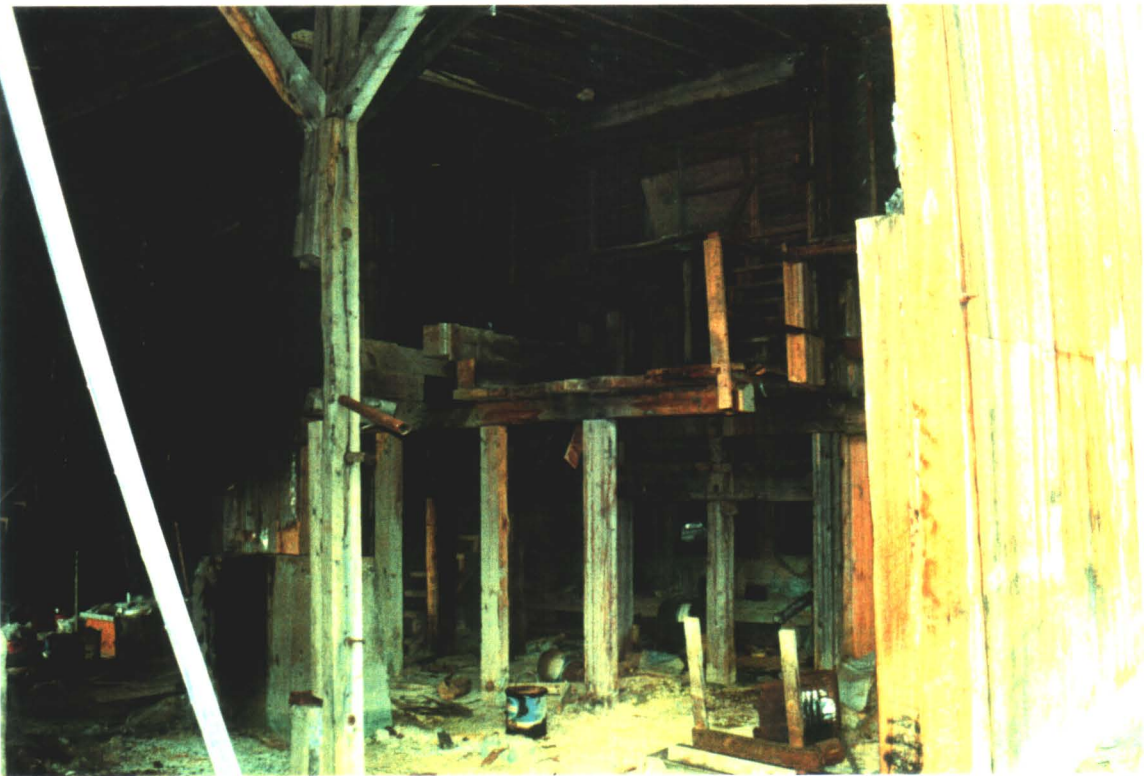
INTERIOR OF MILL BUILDING

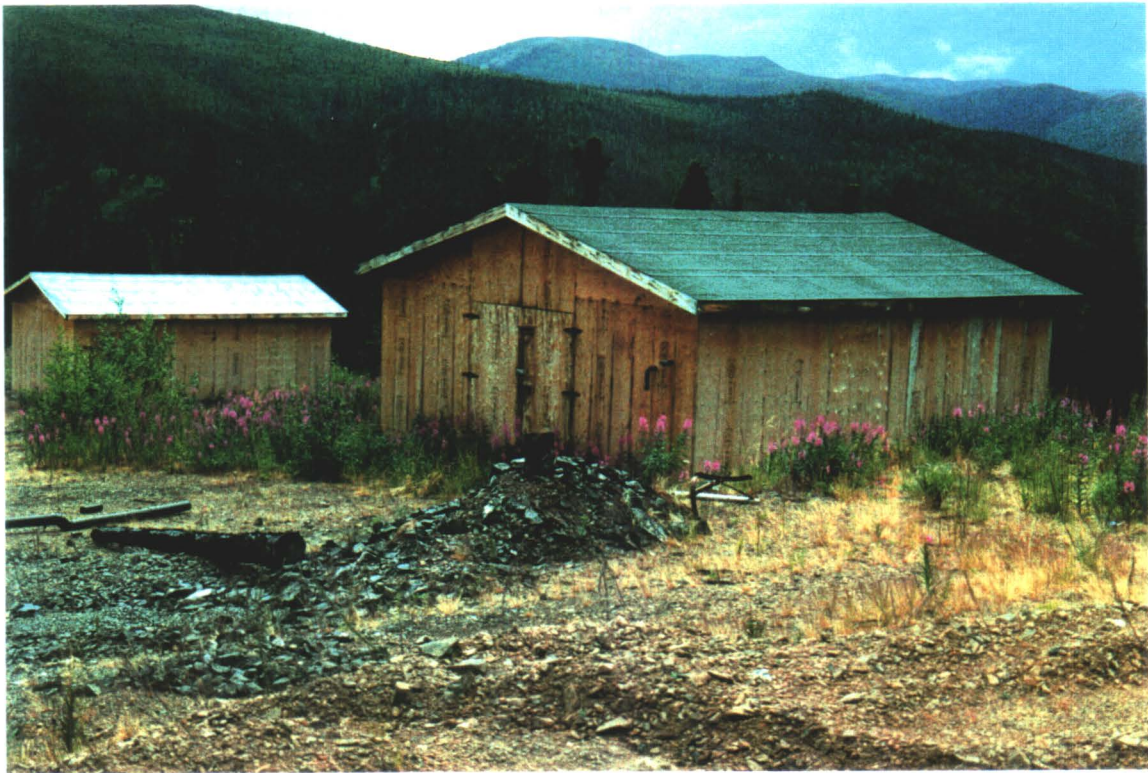
- 7.3x7.3m wood frame plywood clad locked storage shed,
- 4.9x7.3m wood frame plywood clad locked storage shed,
- 9000 litre empty storage tank (may have been used as a water storage tank),
- oil fired electric incinerator.

STORAGE SHEDS AT CAMP SITE

Remaining infrastructure at the camp site is limited to two buildings, an incinerator, and a large tank. This remaining material poses little ongoing environmental liability. The camp site has been cleaned up and the remaining buildings, incinerator, and tank should be removed if a general clean-up program is initiated in the area.

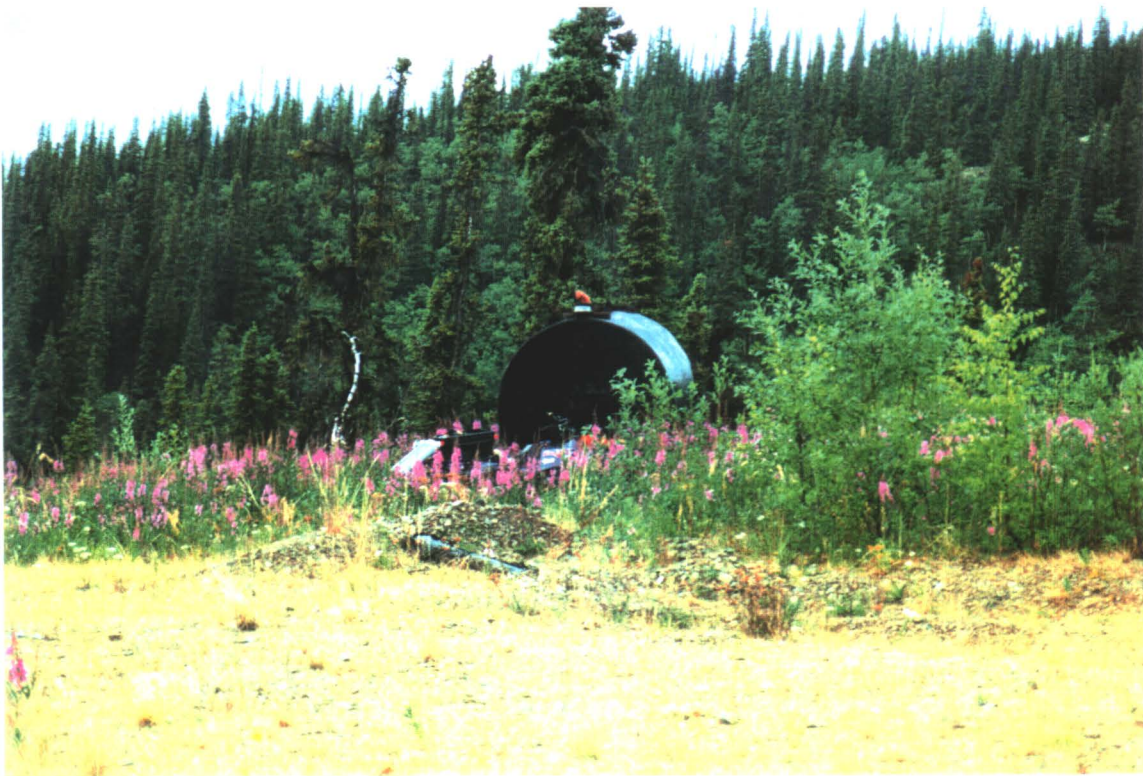
STORAGE TANK AT CAMP SITE
