**ASSESSMENT REPORT**

**105M-14-9**

**PADDY**

**DIAND TECHNICAL SERVICES**

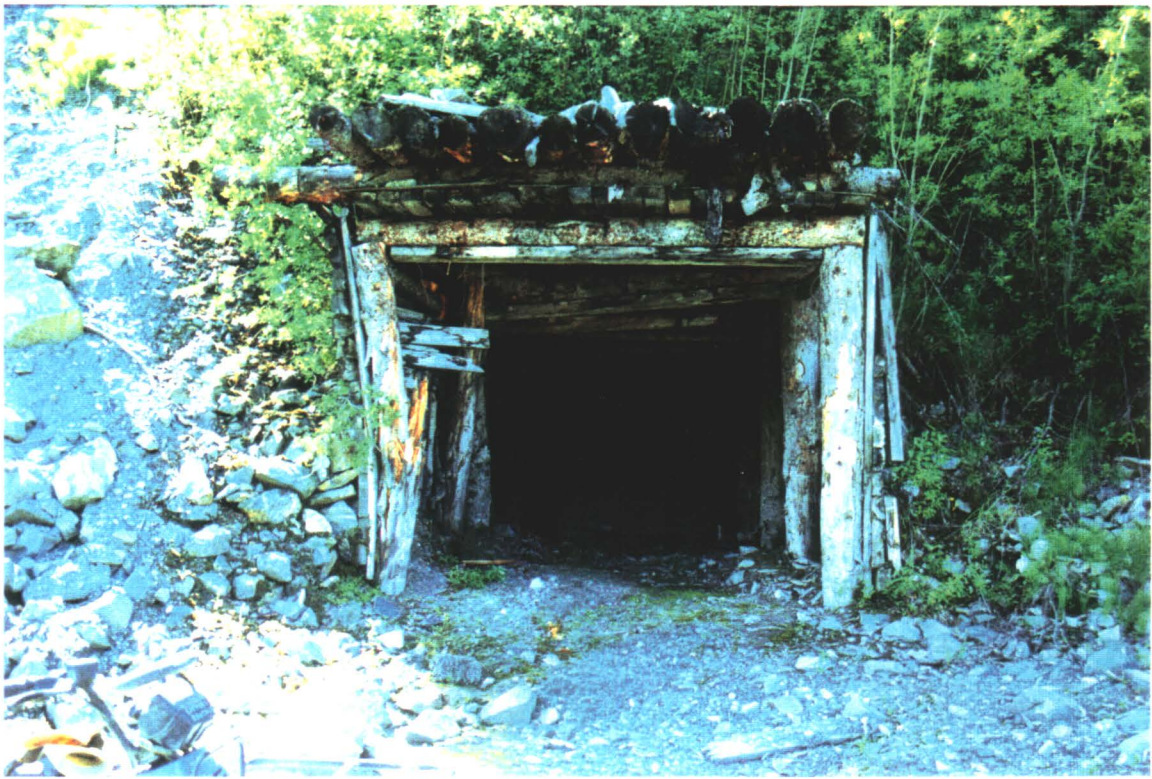
One adit was intact and open, supported at the entrance by locally cut timbers. This open adit is 10-15m above Christal Creek and had a waste area below it sloping to Christal Creek. This waste area measured approximately 40-50m long, was about 4m wide, and 3-5m thick.

The open adit is considered a safety hazard and it is recommended that it be sealed securely so that it cannot be accessed by the public. This is considered a **HIGH** priority and this work should be completed as soon as possible.

OPEN ADIT

The main concern at this site is considered to be the open adit accessible to the public. For safety reasons this adit should be sealed from the public to eliminate any risk of an accident occurring by anyone that could enter it.

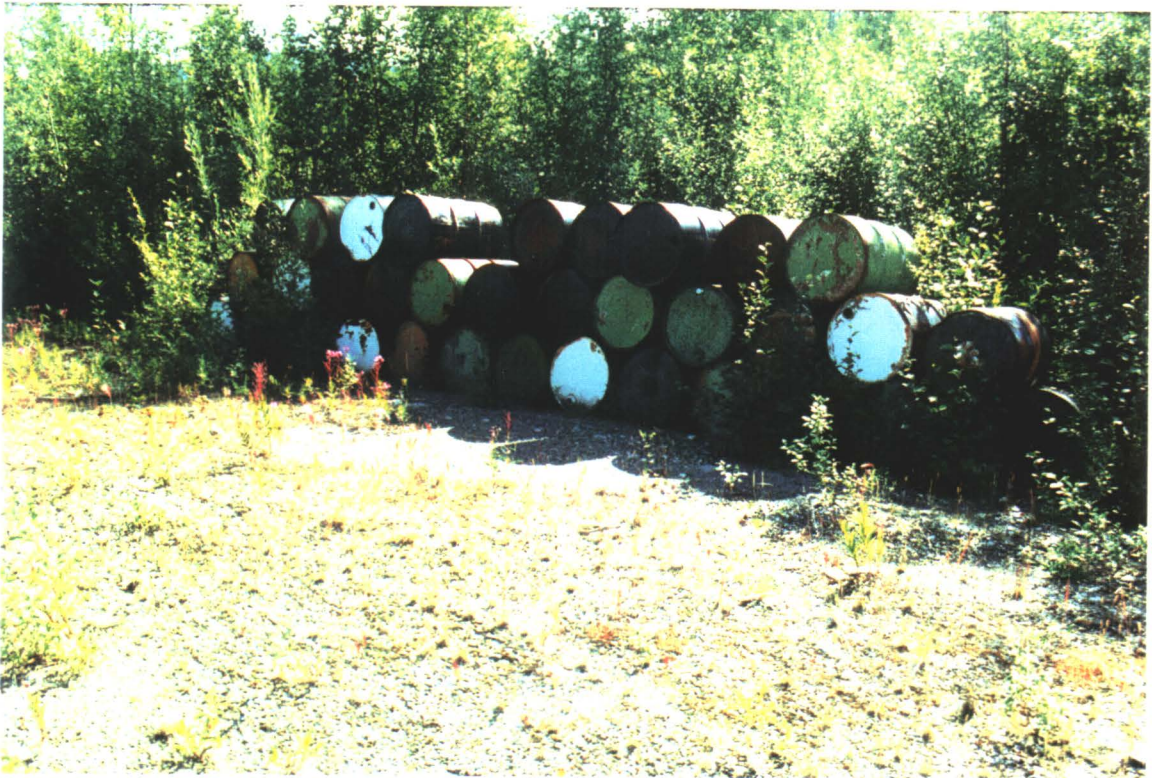
Thirty-five empty 204 litre barrels are stacked on a level area beginning to overgrow with willows. What appears as a hydrocarbon spill measures about 5x5m near the stack of empty barrels.

EMPTY BARRELS

Barrels, pipe, ore cars, and rail left on the site should be removed if a clean-up program is initiated in the area. As roads extend to the site clean-up of this material should be relatively easy to complete. Clean-up of this material is considered a **LOW** priority.

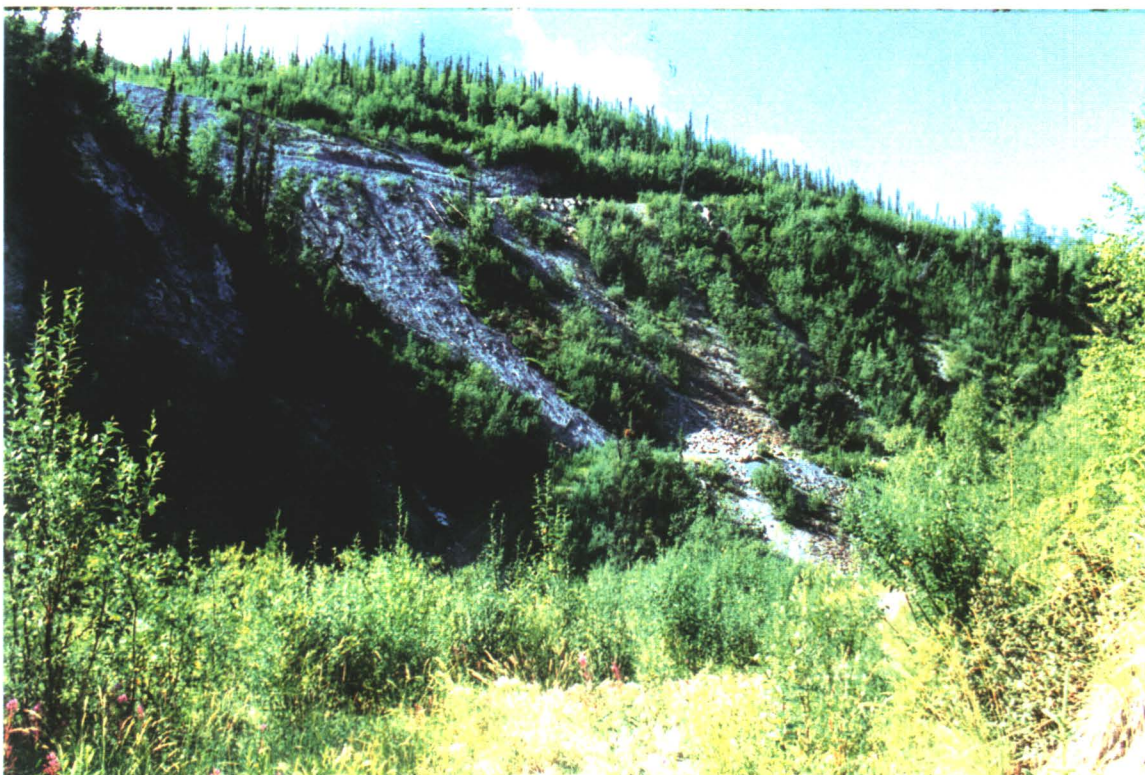
Trenching was completed at a number of places within the area, some of which was quite extensive. Some of the trenching was along the steep slopes above Christal Creek and it is quite likely that at the time this work was ongoing that some material sloughed into the creek. One of the areas of trenching appears to have excavated over an old adit.

WASTE DUMPED DOWN SLOPE (NOTE EROSION)

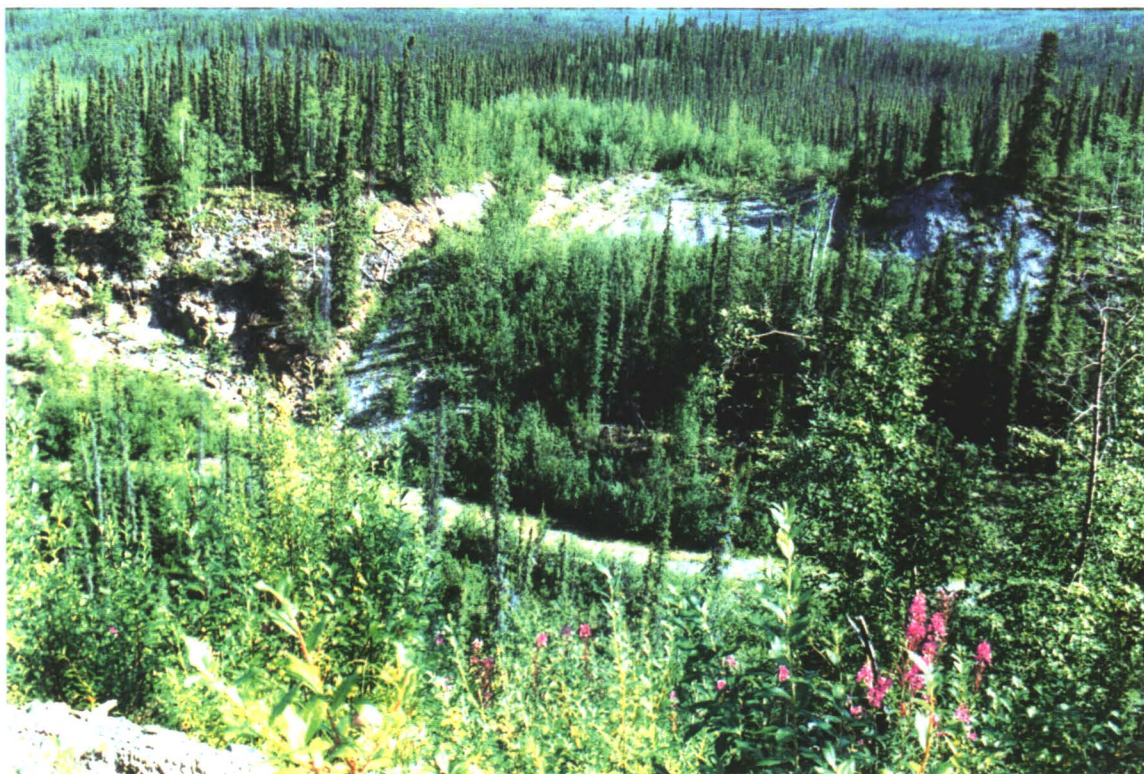
The substantial amount of trenching across this site has caused the most impact on the area. Several sites looking like "borrow pits" have been created, and in some cases material has been pushed down slopes resulting in erosion and some siltation into Christal Creek at some time in the past. However, most of the trenching has taken place a long time ago and is beginning to grow vegetation seeded from the adjacent trees, shrubs, and grasses. Attempting to regrade and reshape the trenched areas will cause additional damage to vegetation that is regrowing in once stripped areas. It is recommended that the trenched areas be left to allow the natural revegetation to continue.

TRENCHED AREAS

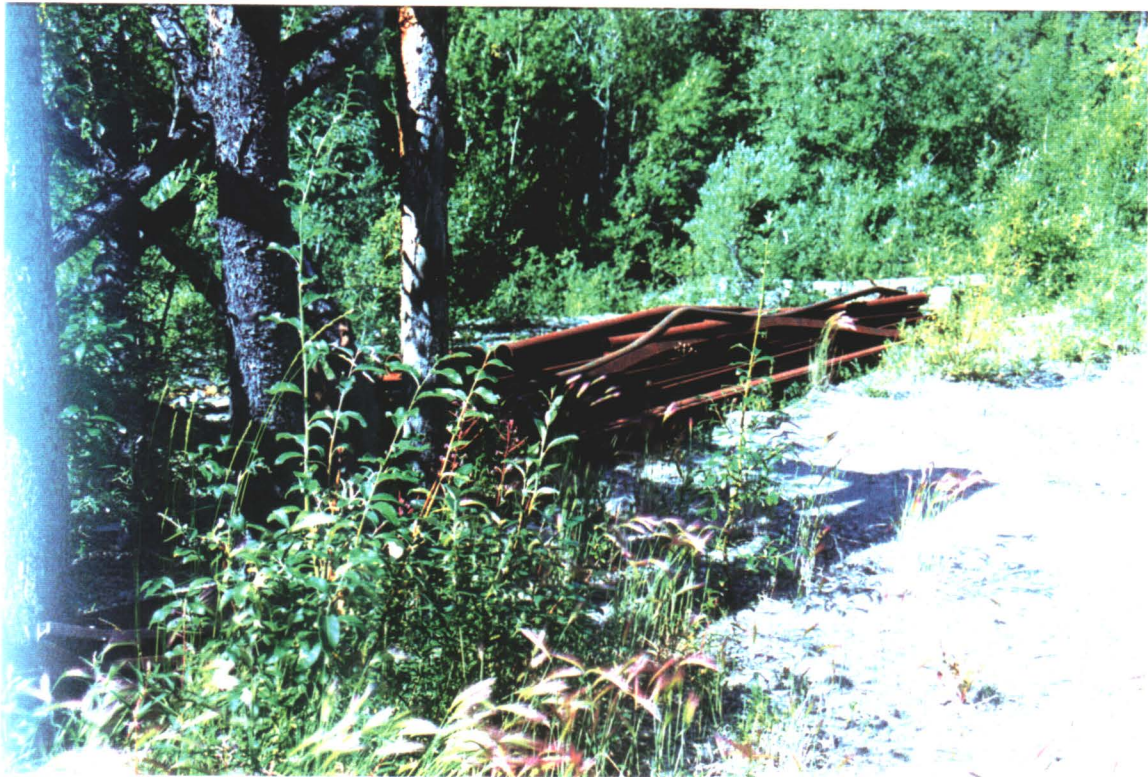
PIPE AND RAIL

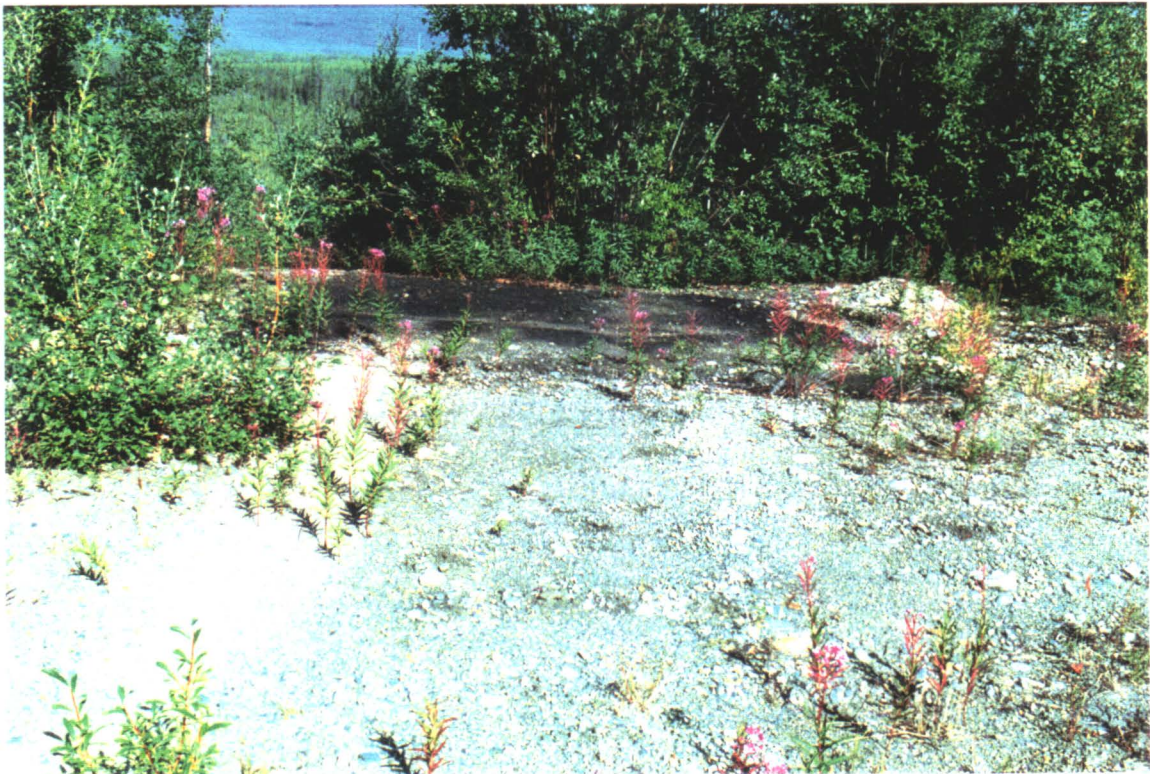
STAINED GROUND

Vegetation is not growing on a small patch of ground that appears stained from a hydrocarbon spill near the barrel site. What appears as an old hydrocarbon spill should be confirmed. This can be completed by sampling and testing the surface soils to determine what is causing the staining. This is a very small area in a remote area and for this reason is not considered a high priority. However if clean-up is undertaken at this site, verifying what is suspected as a hydrocarbon spill should be completed. If this stained area is an ongoing environmental liability, then the extent of the problem can be defined with further testing, and a site remediation plan developed.

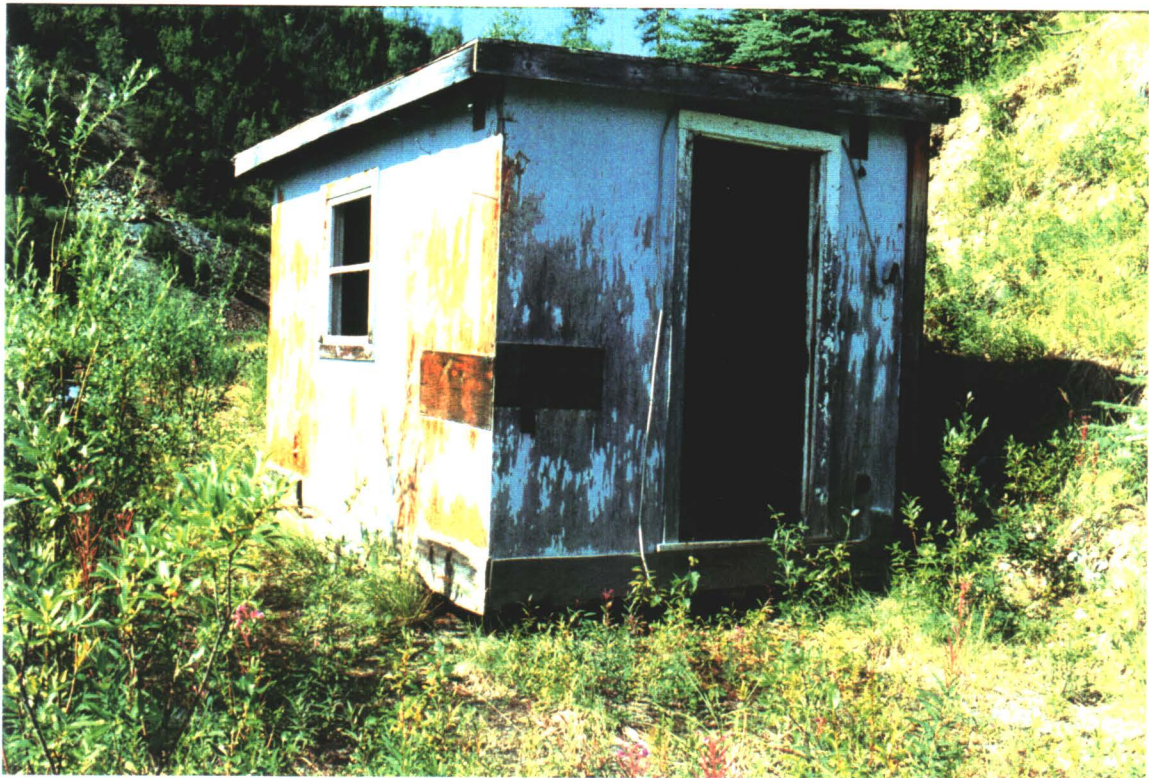
The one small warehouse is very old and deteriorating. This building is portable but is rotting and has very little residual value.

SMALL WAREHOUSE

The building left on-site is in poor condition and of little value. It is recommended that this building be disposed of at some time in the future. This is also considered a **LOW** priority.

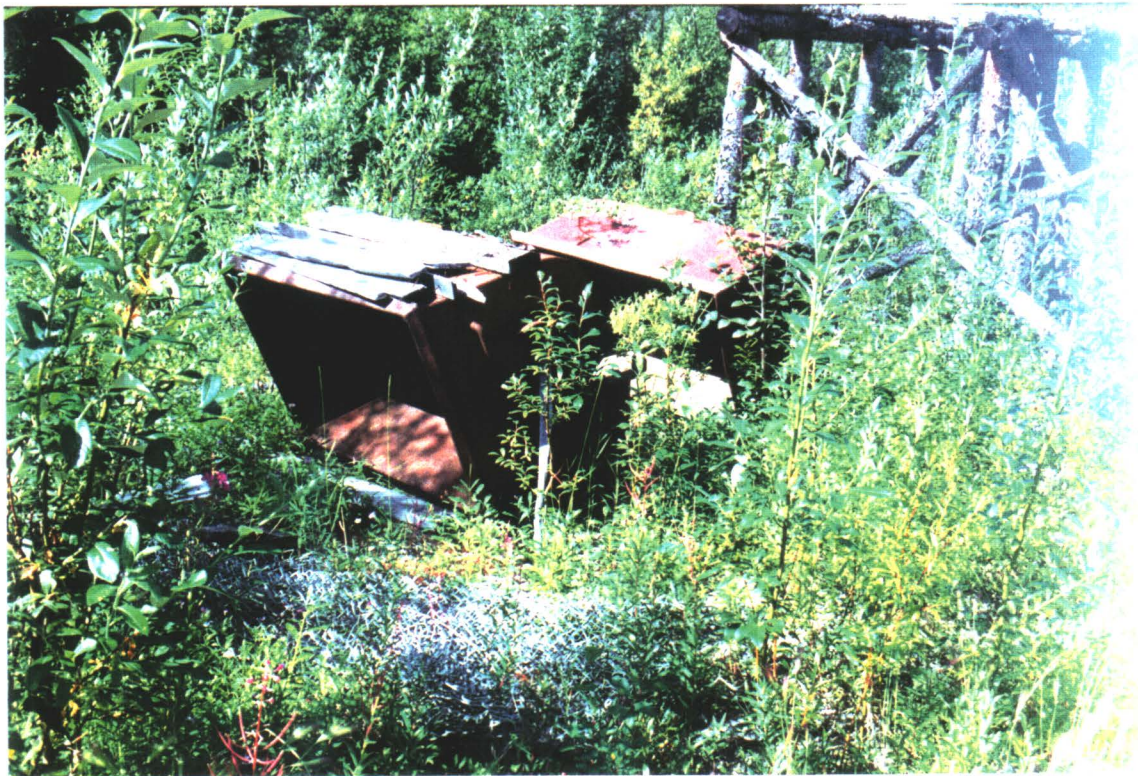
ORE CARS
