**ASSESSMENT REPORT**  
**105M-14-10**  
**PAST WERNECKE**

**PREPARED BY**  
**DIAND TECHNICAL SERVICES**

**FEBRUARY, 1994**

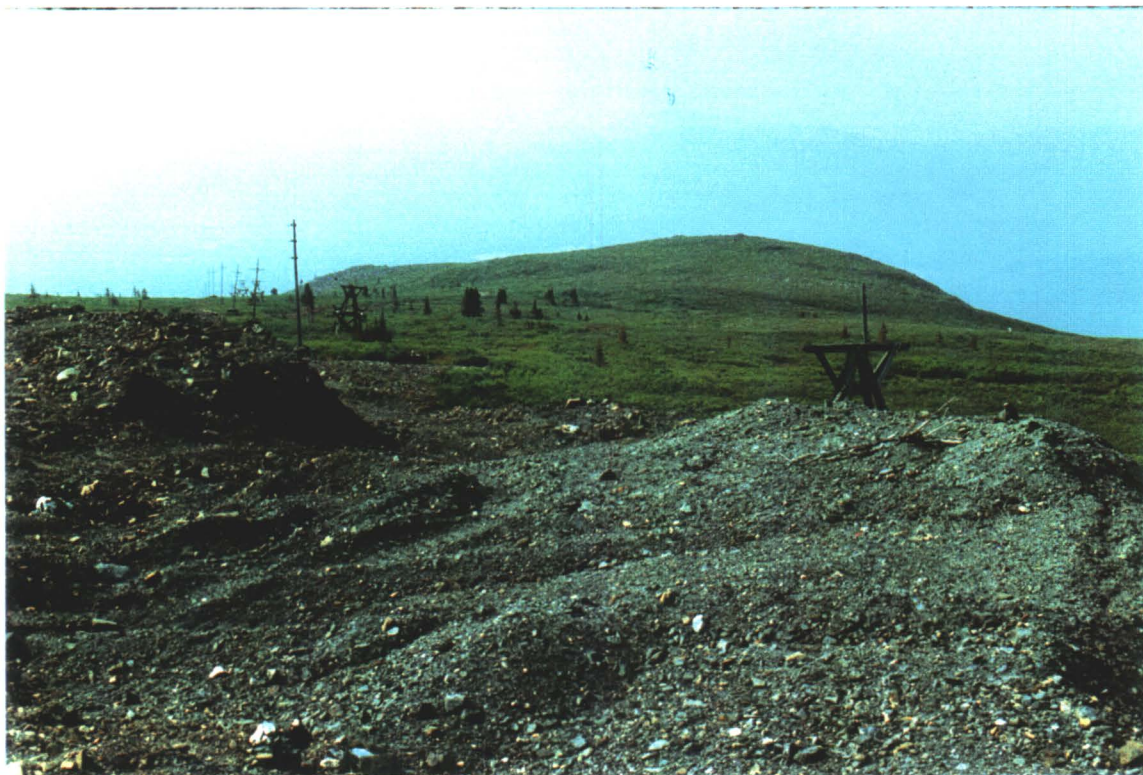
Ore from the exploration shaft was dumped out a chute from the mine shaft building and appears to have been cleared from the chute using a loader. The ore was likely loaded on trucks and hauled off-site for processing. The waste rock was placed approximately 50m downslope from the mineshaft.

WASTE ROCK DUMP, TRAMWAY TOWERS, AND POWER LINE

The powerline poles and the old tramway towers could be removed, however this would likely cause additional damage to the vegetation. It is recommended that these poles, wire, and towers be left to avoid further disturbance of the sensitive vegetation.

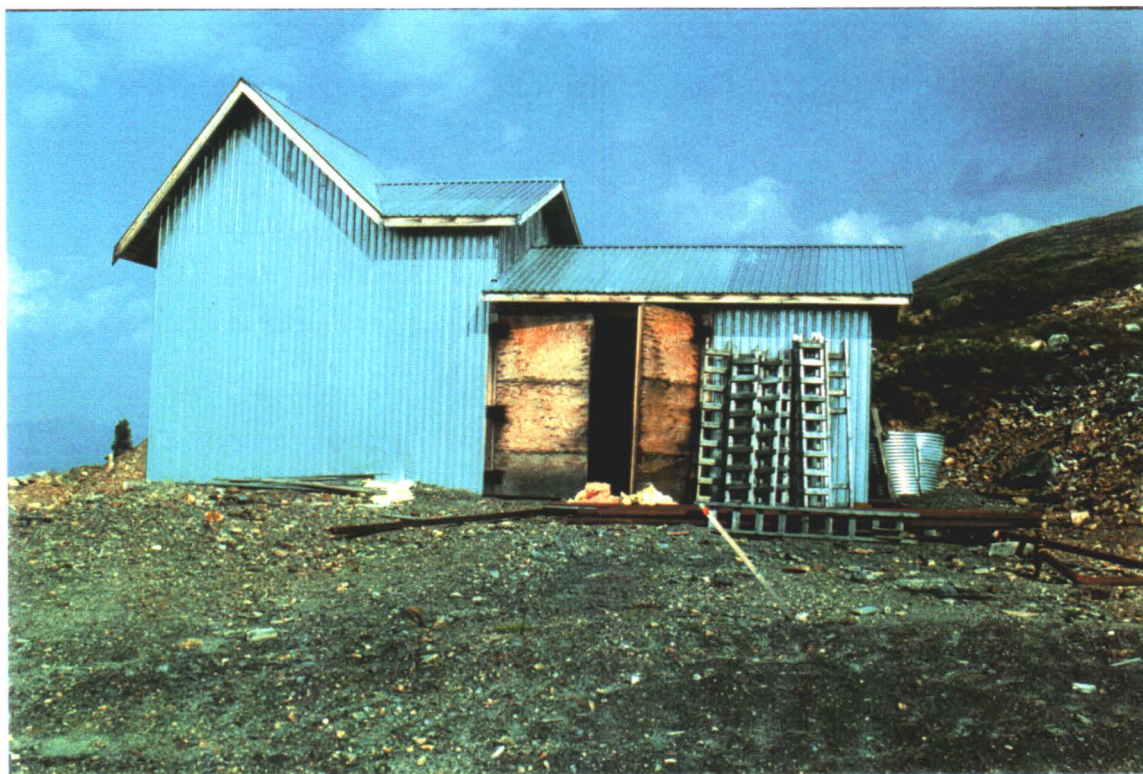
As noted above, the building over the exploration shaft is in good condition. This building appears to have been serviced by electrical power at one time as some electrical wiring is still in the building. Inside the building a large wooden frame has been constructed to support the removal of ore from the shaft.

BUILDING OVER SHAFT

The building covering the shaft is in good condition and should be left in place to protect entry from the shaft. The building should be properly sealed or locked to prevent any unauthorised entry. This is considered a **HIGH** priority and should be completed as soon as possible.

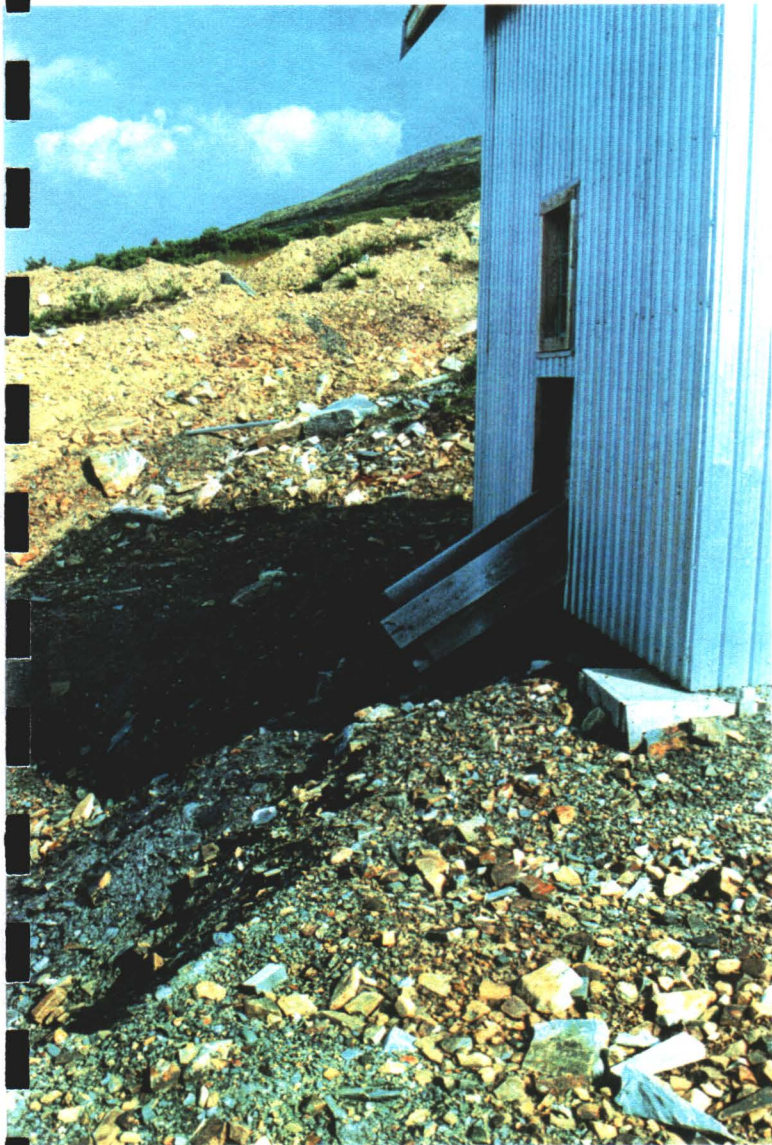
ORE CHUTE FROM BUILDING

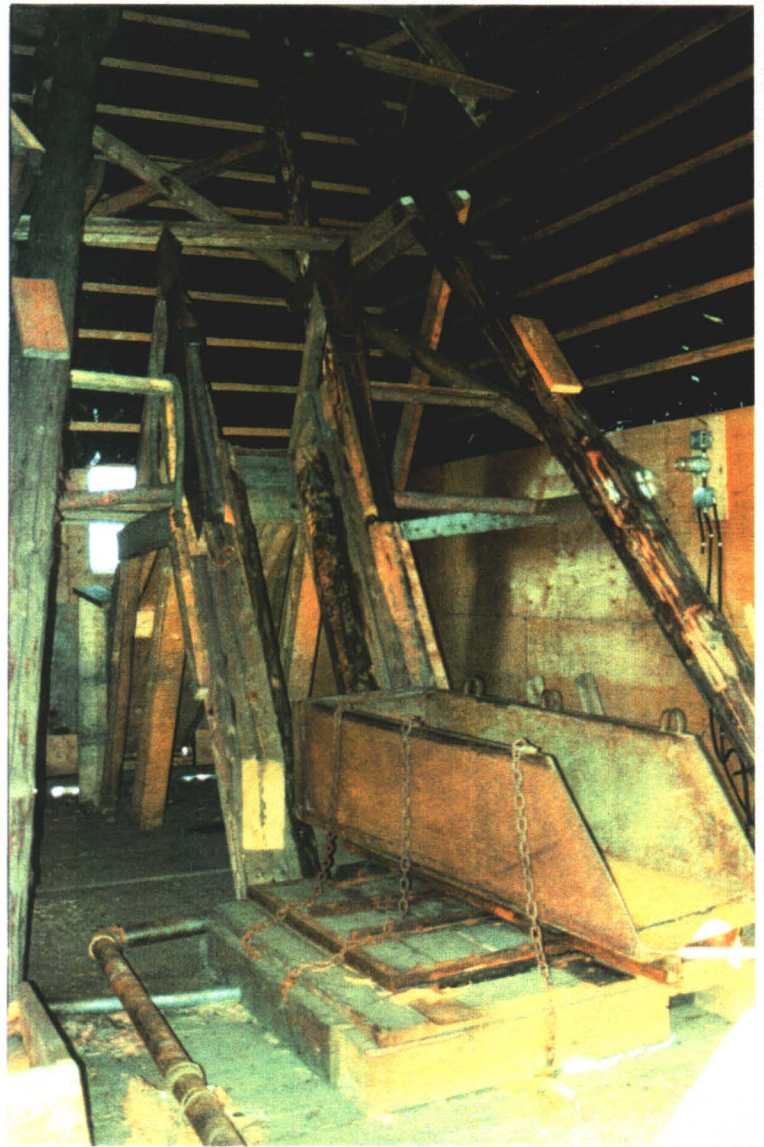
INTERIOR OF BUILDING

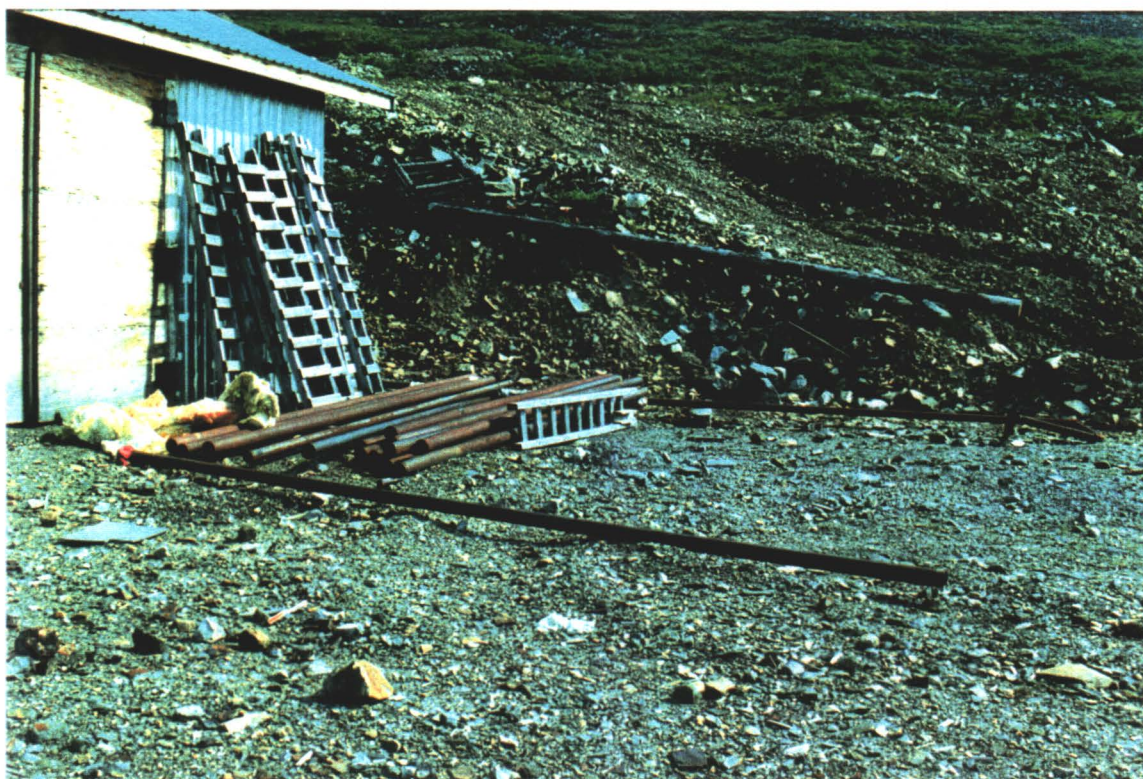
- 16 pieces of variable length pipe up to 6m long and 100mm diameter,
- 1 culvert collar,
- a few pieces of metal cladding,
- approximately 10 wooden ladders, and
- power poles and wooden tramline towers extending from the old community of Wernecke, a distance of approximately 2km.

PIPE AND LADDERS

The pipe, any other metal waste, and wood waste such as the ladders should be removed if a clean-up program is initiated in the area. As roads extend to the site clean-up of this material should be relatively easy to complete. However clean-up of this material is considered a **LOW** priority.
