**ASSESSMENT REPORT**

**105M-14-3**

**RUNER**

**DIAND TECHNICAL SERVICES**

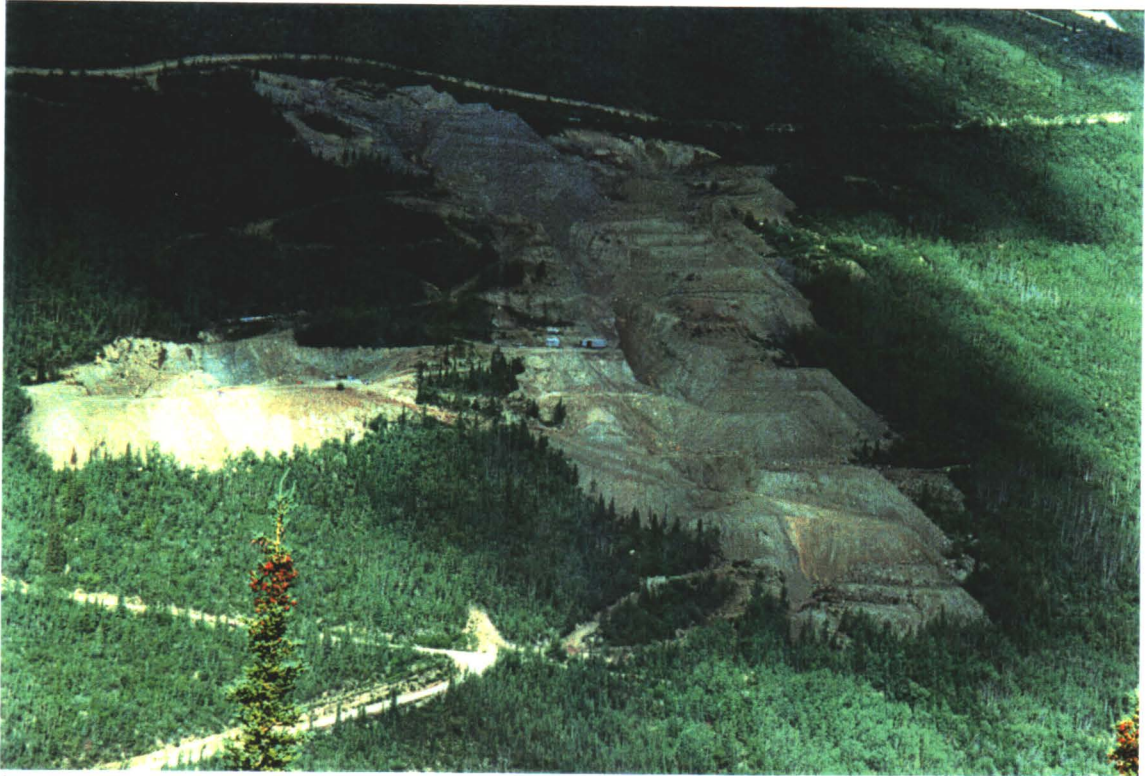
RUNER EXPLORATION SITE

Extensive trenching, stripping, and stockpiling of waste material on this relatively steep slope has caused considerable surface disturbance to the environment. All the vegetation has been removed from the area and the entire site is exposed to wind and water erosion. The material is coarse but contains a high silt content that is susceptible to erosion. Fortunately the site is relatively dry and no surface water features cross this area.

Stockpiling of the waste material in large stockpiles on the steep slope has added a large concentrated mass to the slope. Concentrating load on a slope can increase the risk of triggering instability. Tension cracks were observed in the fill at the time of inspection on 1993/07/23 indicating that movement of the fill was taking place. This movement could be in the form of uneven subsidence of the fill material or movement of the underlying slope. To establish more precisely if and what mechanism of movement is occurring will require a more detailed site assessment. The worst case situation that could occur would result in a massive slope failure downslope into and across Lightning Creek. This would result in the mass movement of soil and vegetation down the slope into Lightning Creek, temporarily blocking any creek flow. If this kind of failure is imminent, it will be very difficult, costly, and risky to even attempt stabilization. It is not considered feasible to

- \* not allowing any work or excavating on the slopes below the fill. For instance, placer mining allowed in the area could increase the risk of causing a failure by excavating material from the toe of the slope. This would also expose any workers in the path of this potential failure.
- \* not adding any more fill on the slope without assessing in more detail the potential for slope instability at this site.
- \* ensuring that surface water is directed away from this area.

It is also recommended that the site be posted to advise of any potential hazards.

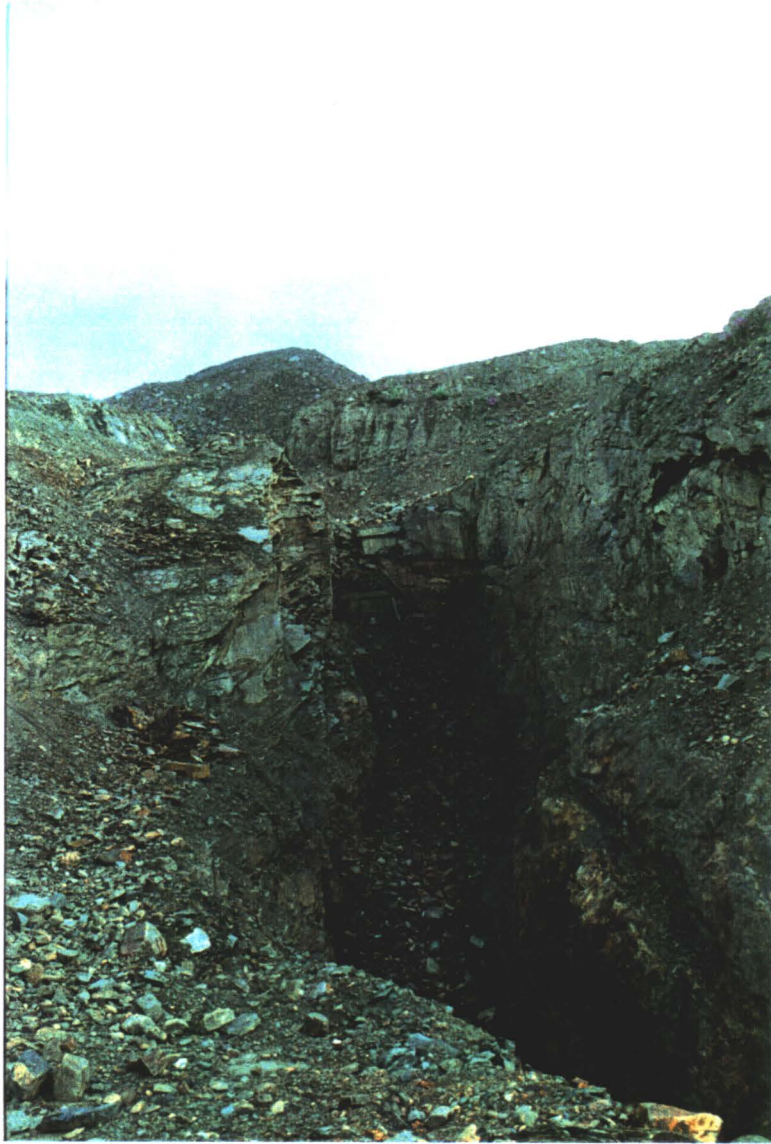
LOWER ADIT

It was not possible to safely get to the adits, however it appeared from a distant inspection that the adits were sealed.

It appears that the adits were sealed with heavy timber planking. Getting to these adits is very difficult and unsafe and it is recommended that these adits can be left without additional safety precautions at this time.

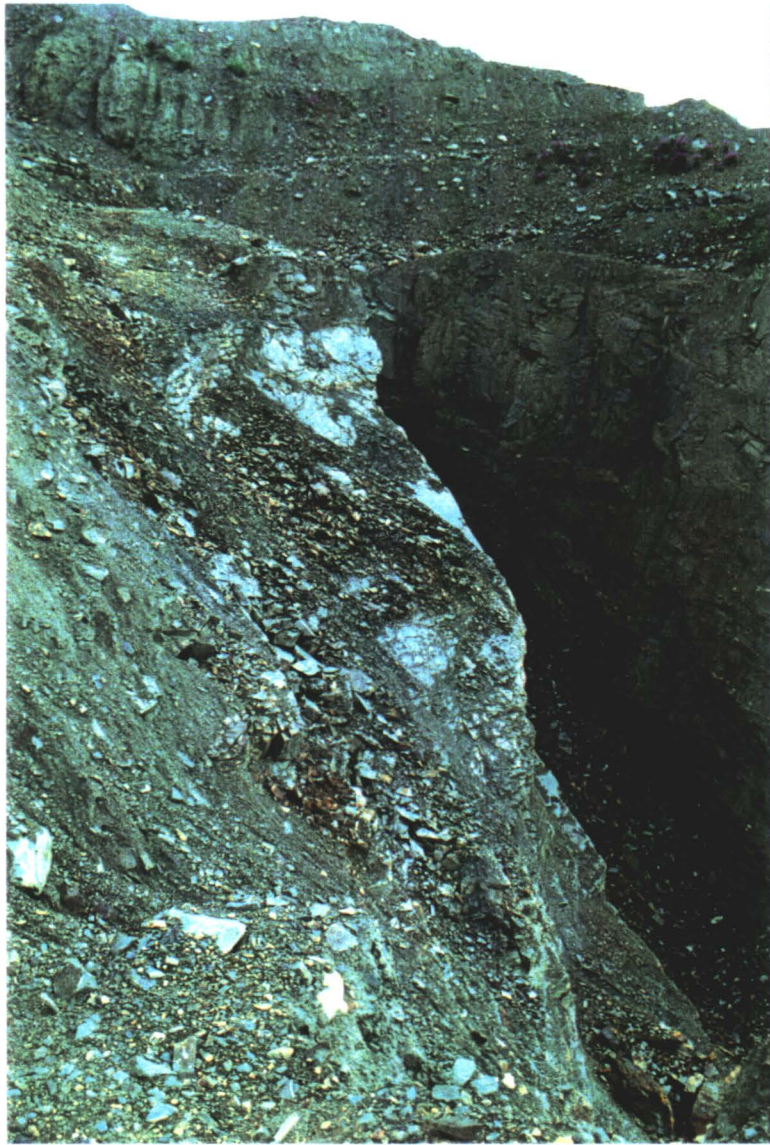
UPPER ADIT

The buildings are located very close to the top of the excavation for the top adit. This excavation is a near vertical face within 10m of the closest part of the building. A wire fence has been constructed near the edge of this escarpment, however there is no signage in place indicating any potential danger or safety hazard.

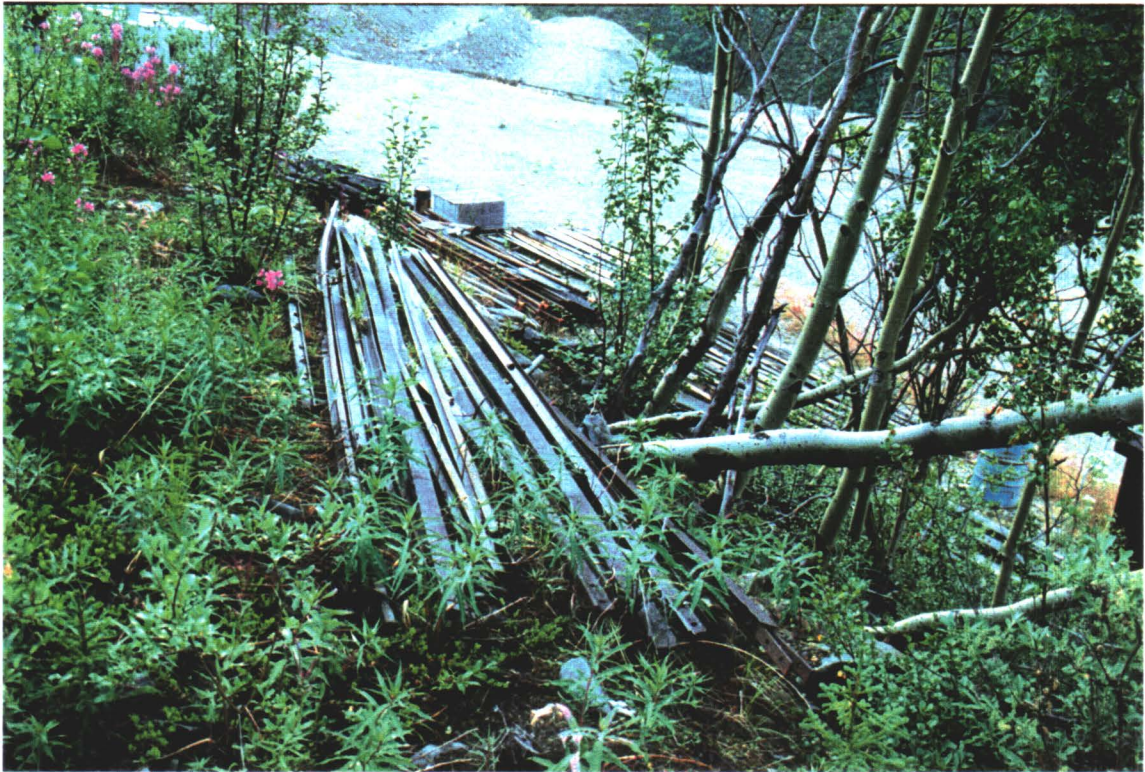
RAIL AND OTHER METAL WASTE

- \* 22 pieces of 100mm diameter pipe up to 6m long below the top adit,
- \* 1 ore car,
- \* 40 pieces of rail up to 6m long, and
- \* miscellaneous pieces of scrap metal.

The site buildings and material in and around them do not appear to be causing any environmental damage, however they are slowly deteriorating with time. The metal cladding is inhibiting deterioration. It is recommended that if a cleanup program is initiated that these buildings and remaining material be removed from the site. The few remaining hydrocarbon products found at the site should be removed as soon as possible to limit any chance of spilling. All fuel tanks should also be removed from the site.

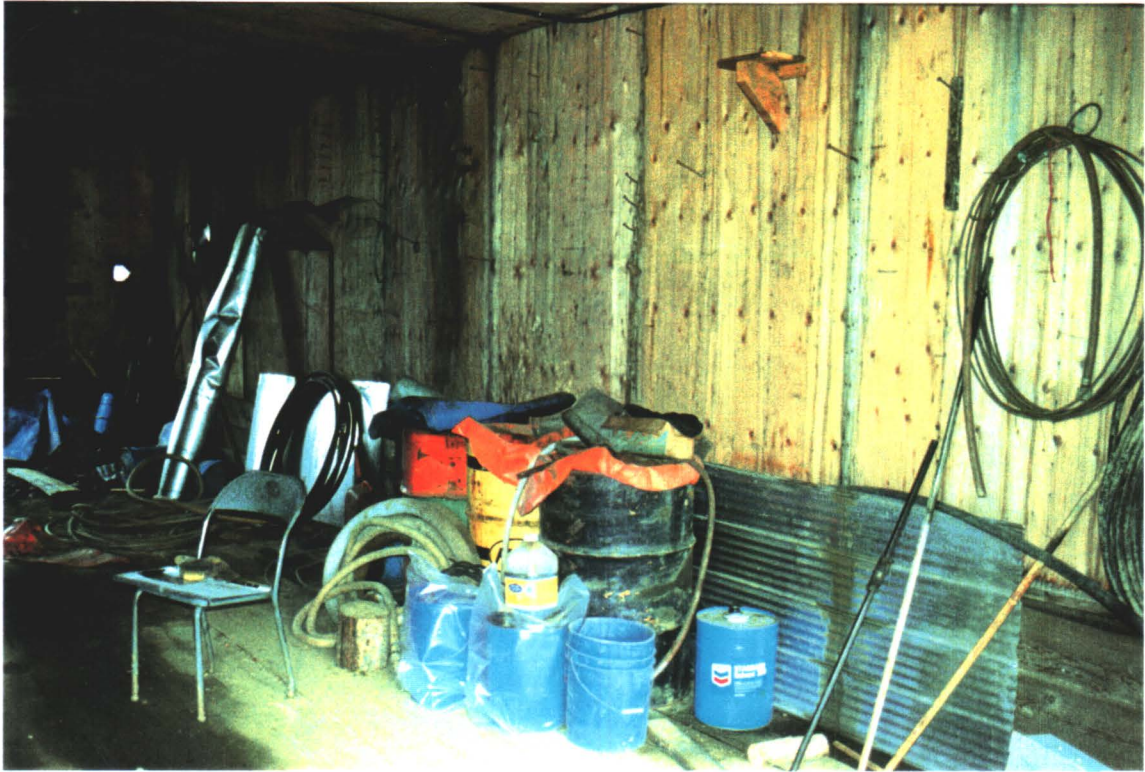
BUILDING INTERIOR

\* 1 - 4.3x11.0m wood frame plywood and metal clad workshop containing;

- old batteries,
- metal ladders,
- chains,
- spool of cable,
- 20-23 litre empty oil pails, and
- drill rods.

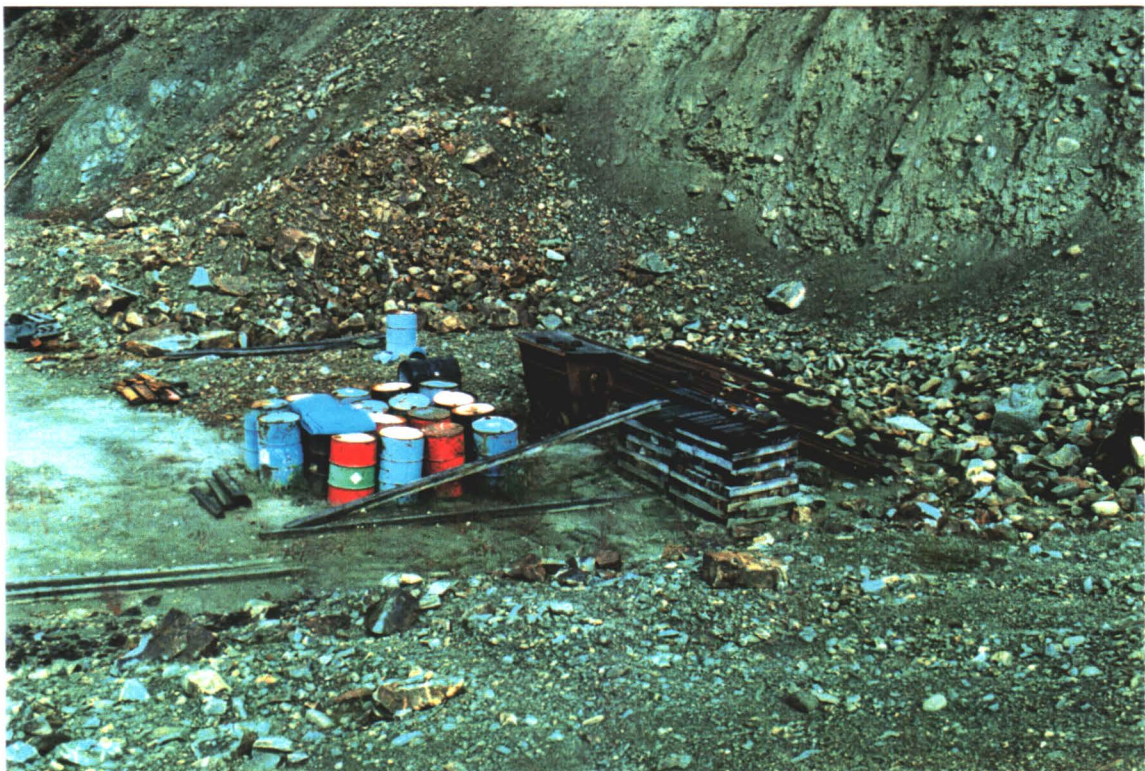
ORE CAR, BARRELS, PIPE, ETC.

\* approximately 320 empty 204 litre barrels stacked near the upper adit, with up to 36 empty barrels scattered below the top adit,

The large cache of empty barrels were marked to once contain JP4 jet fuel, hydraulic oil, methyl isobutyl carbonal, and diesel.

If a clean-up program is initiated all barrels should be removed from the site. This clean-up is considered a **LOW** priority.

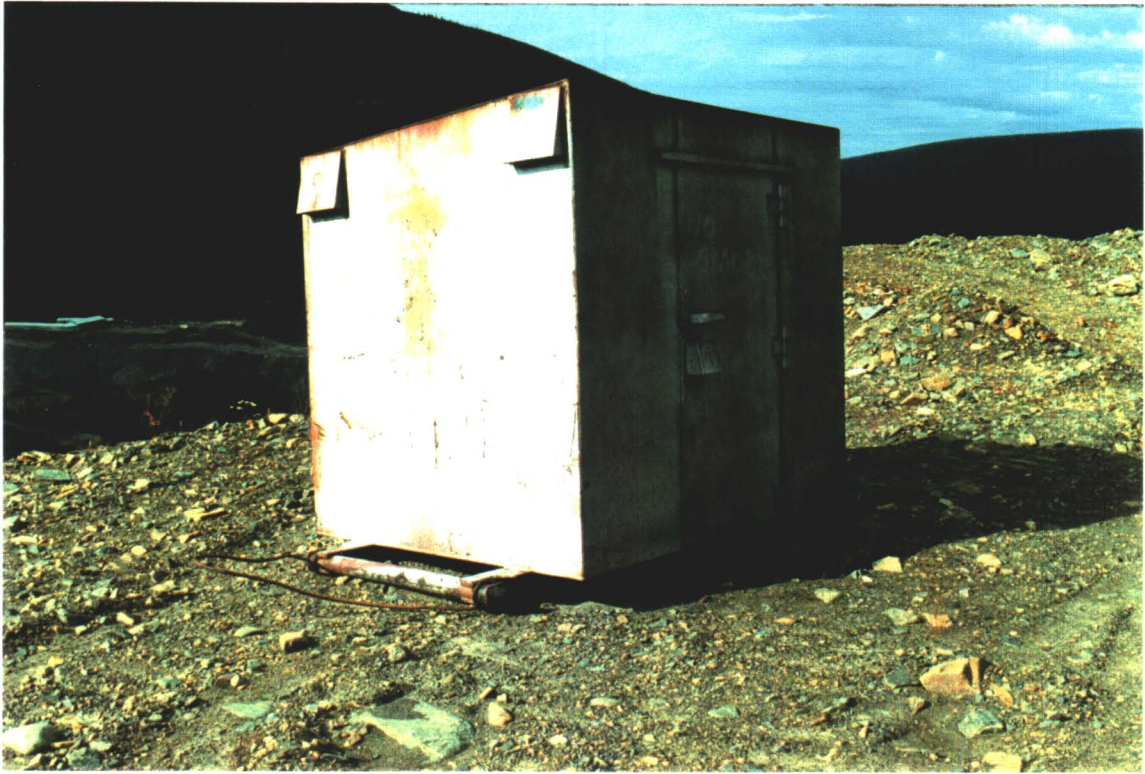
EXPLOSIVES MAGAZINE

\* 3 locked powder magazines (1 at the upper adit, 2 below the upper adit),

It is recommended that additional research be undertaken to confirm the contents of the three explosive magazines found on-site and to determine what degree of risk any remaining explosives pose. The explosive magazines are all locked and secured, however unless any remaining explosives are to be used locally in the near future it is recommended that they should be removed from this unprotected site. This should be considered a **HIGH** priority issue.
