**ASSESSMENT REPORT**

**105O-02-1**

**SAMOVAR**

**DIAND TECHNICAL SERVICES**

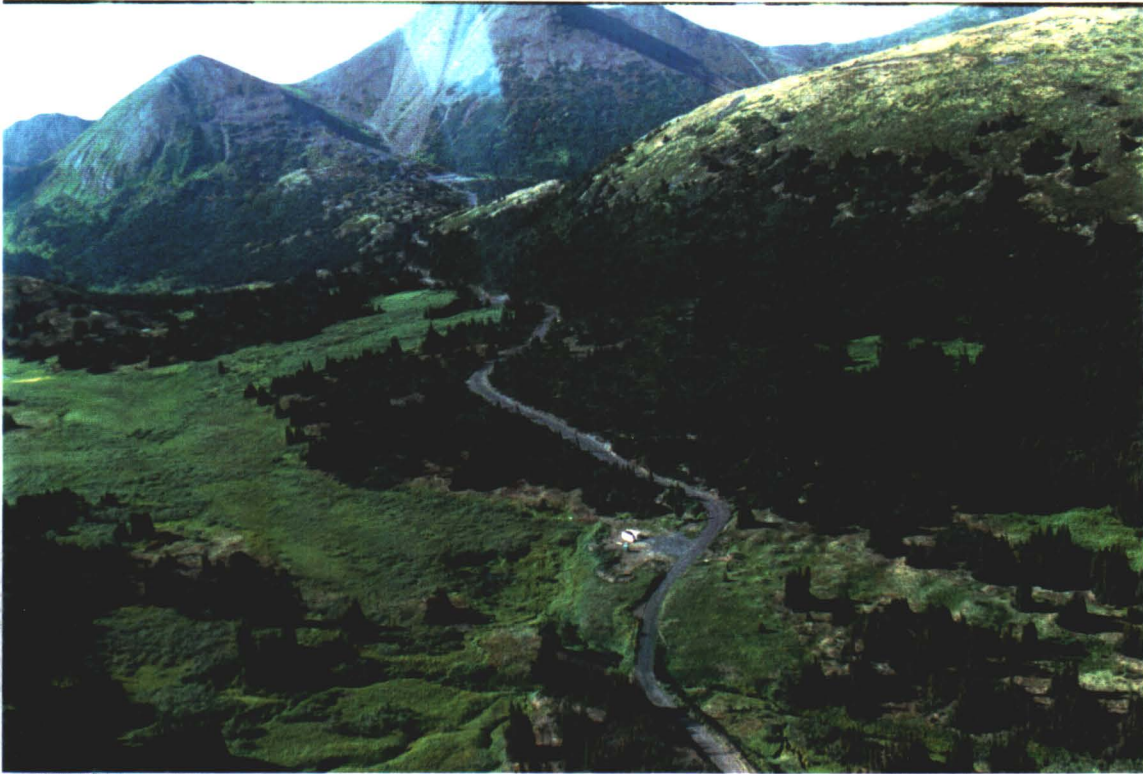
The main access road has been developed in the least damaging way, generally following the bottom of the valley leading to the site. Very little cutting or filling of the slopes resulted and no evidence of any slope instability or erosion was observed or expected. It is recommended that this road not be touched and revegetation left to occur naturally at this remote site.

**ACCESS ROAD AND EXPLORATION SITE ON MOUNTAIN (LEFT)**

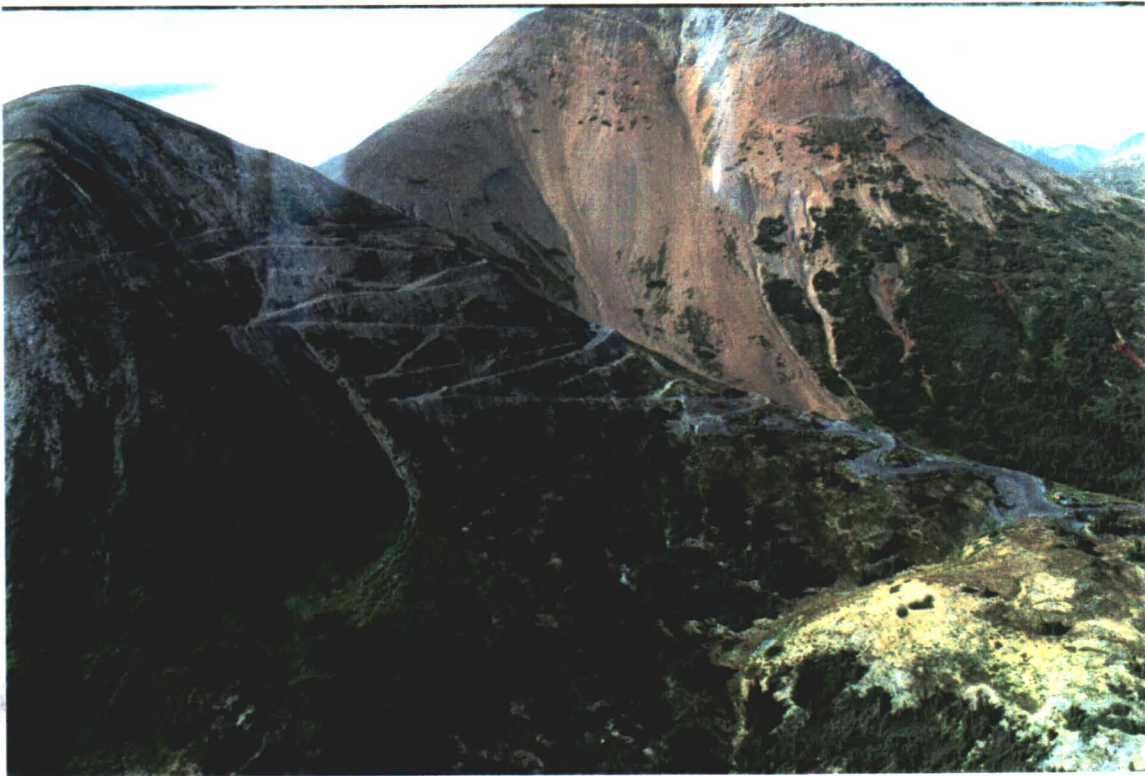
The most impact at this site has been caused by the exploration activity on the mountainside. This exploration activity has caused extensive damage to the vegetative cover as well as causing erosion of the excavated material that had been pushed downslope. Site remediation, if it was undertaken, would consist of reshaping the excavated mountainside. This would likely cause additional damage to vegetation and damage any new vegetation that had started to regrow on these excavated slopes. Because there appears to be little ongoing damage it is recommended that reshaping and revegetation techniques not be considered at this very remote, dry site.

**EXPLORATION AREA**

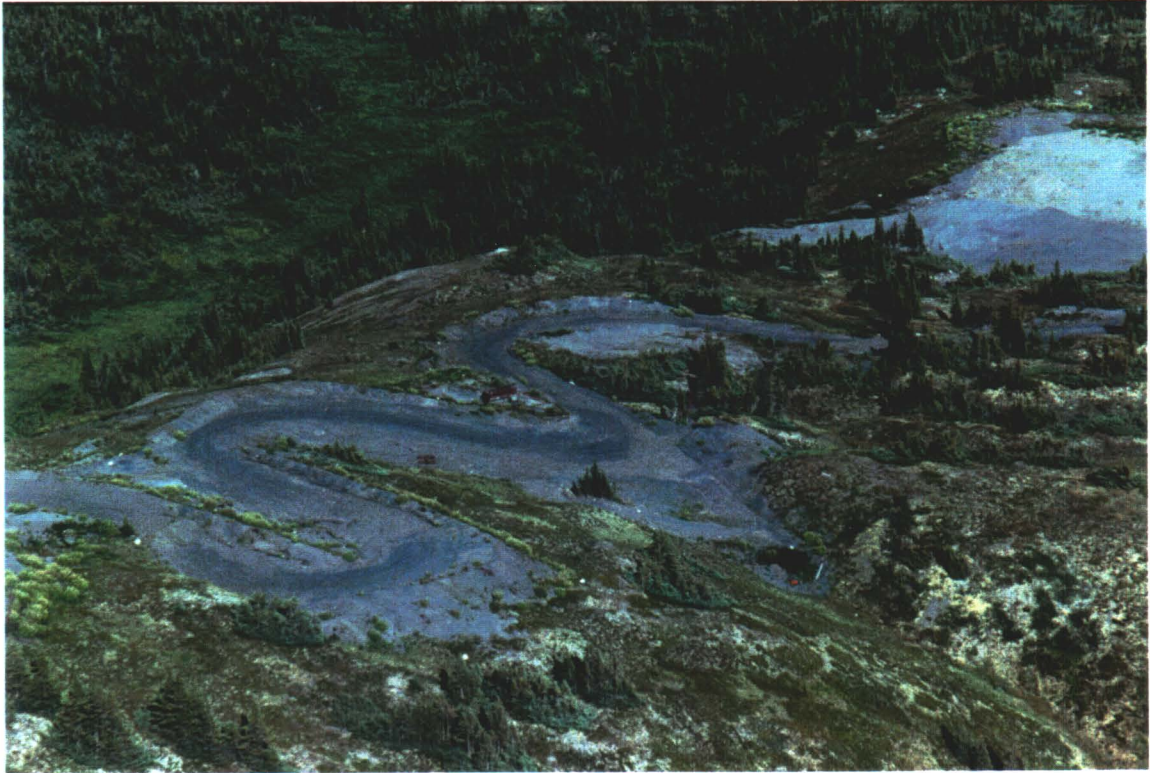
The predominant feature from the development is the road up the valley and the exploration trails on the steep mountain slope. The road to the site was well constructed with minimal disturbance to the surrounding terrain in the valley portion of the road. As the road rises up the mountain to the main exploration area significant mass wasting down the mountain slope has been caused by excavating material out of the mountainside. This method of exploration has buried much of the original vegetation. This disturbed material has also eroded downslope. No terrain instability was apparent at the time of inspection on 1993/07/27.

**ROAD BETWEEN CAMP AND EXPLORATION AREA**

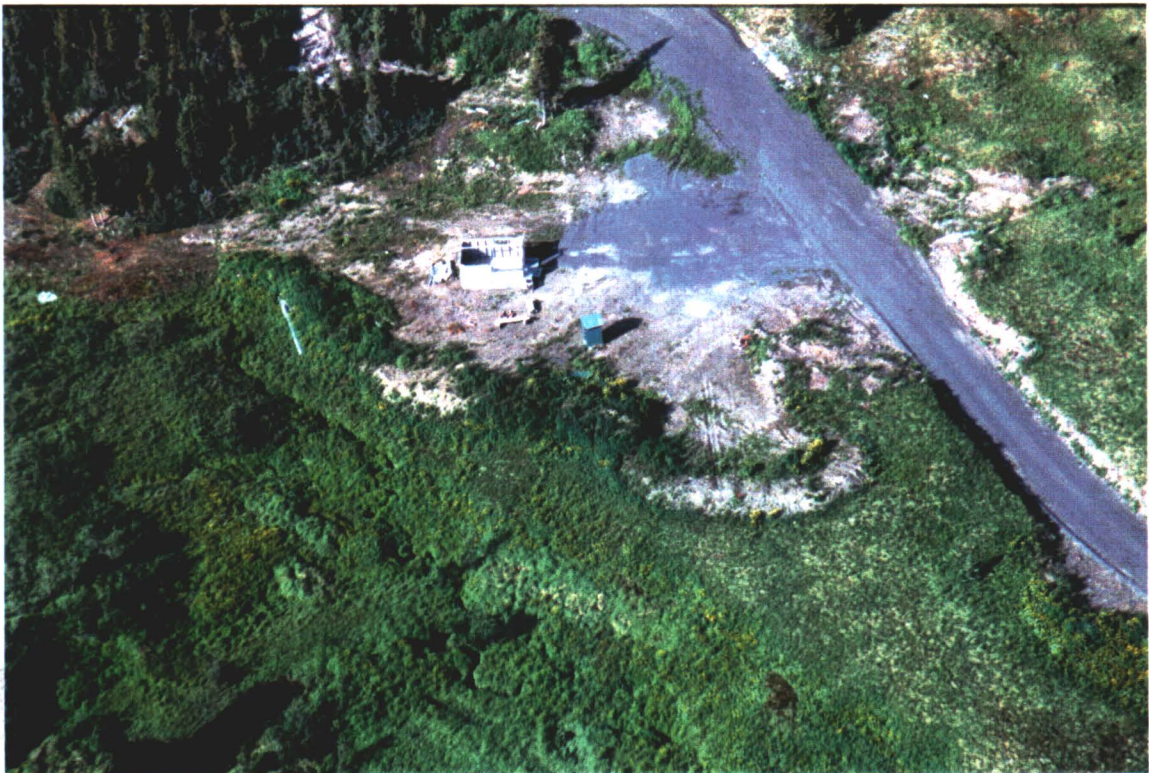
The only other site disturbance is from the remains of an exploration camp. An old wood frame building with plywood walls but no roof, two pieces of metal sheathing (each measuring 2x3m), and a plywood clad outhouse are the only remaining buildings on-site. Some scattered wood lumber appears to be the only other remnants from the exploration activity left around the camp site.

**CAMP SITE**

The only other remaining infrastructure impacting the environment at this site is the remaining building and wood waste. This material has a **VERY LOW** impact on the environment, with the major impact being visual. It is recommended that this material be removed from the site only if a clean-up program has been initiated in the area. The wood waste material, if it was disposed, should be piled and burned in an appropriate area.
