ASSESSMENT REPORT

105M-14-7

SEGSWORTH

DIAND TECHNICAL SERVICES

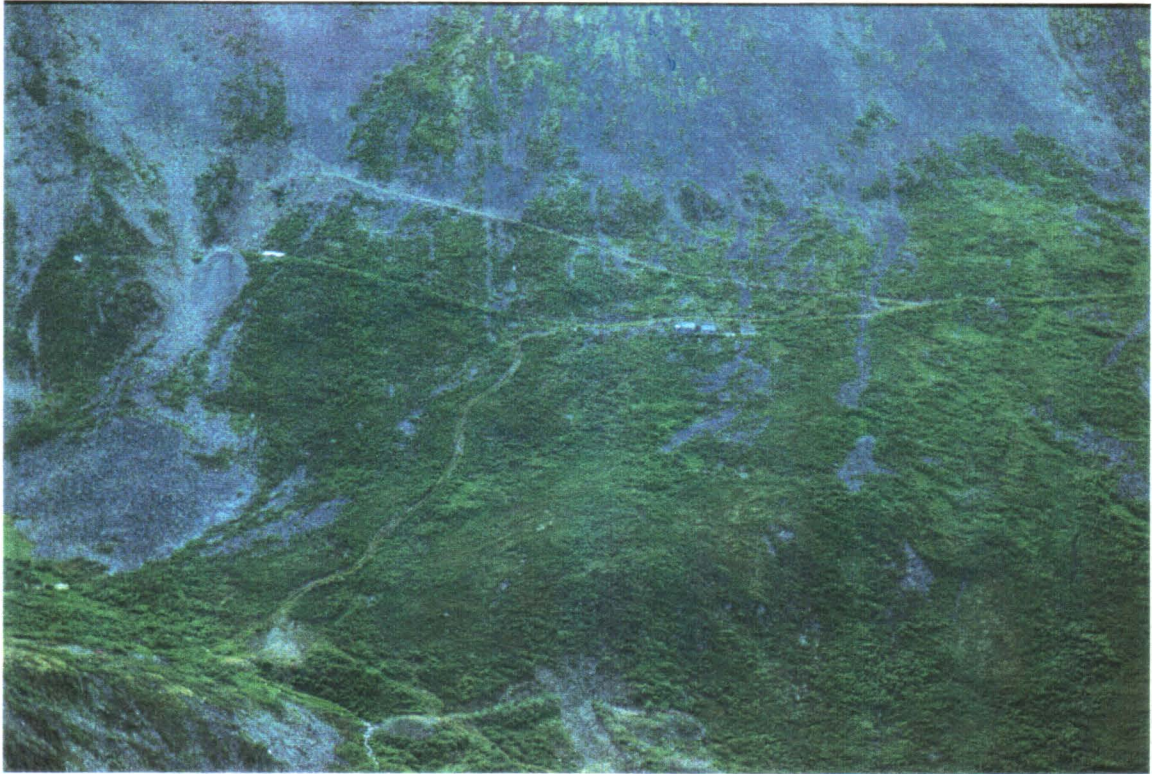
The predominant feature from past activity in the area is the poorly defined access trail down the steep valley. This trail was constructed a long time ago with minimal disturbance to the surrounding terrain, and has grown over with local vegetation. Only small "cut" slopes are evident. No terrain instability was apparent.

ACCESS ROADS TO SITE

The most impact at this site has been caused by the trail development and trenching in the area. Since this work took place many years ago, the roadbed has grown over with local vegetation and has effectively recovered from any disruption in the past. It is recommended that these trails and remnants of trenching be left to allow the revegetation to continue at this remote site.

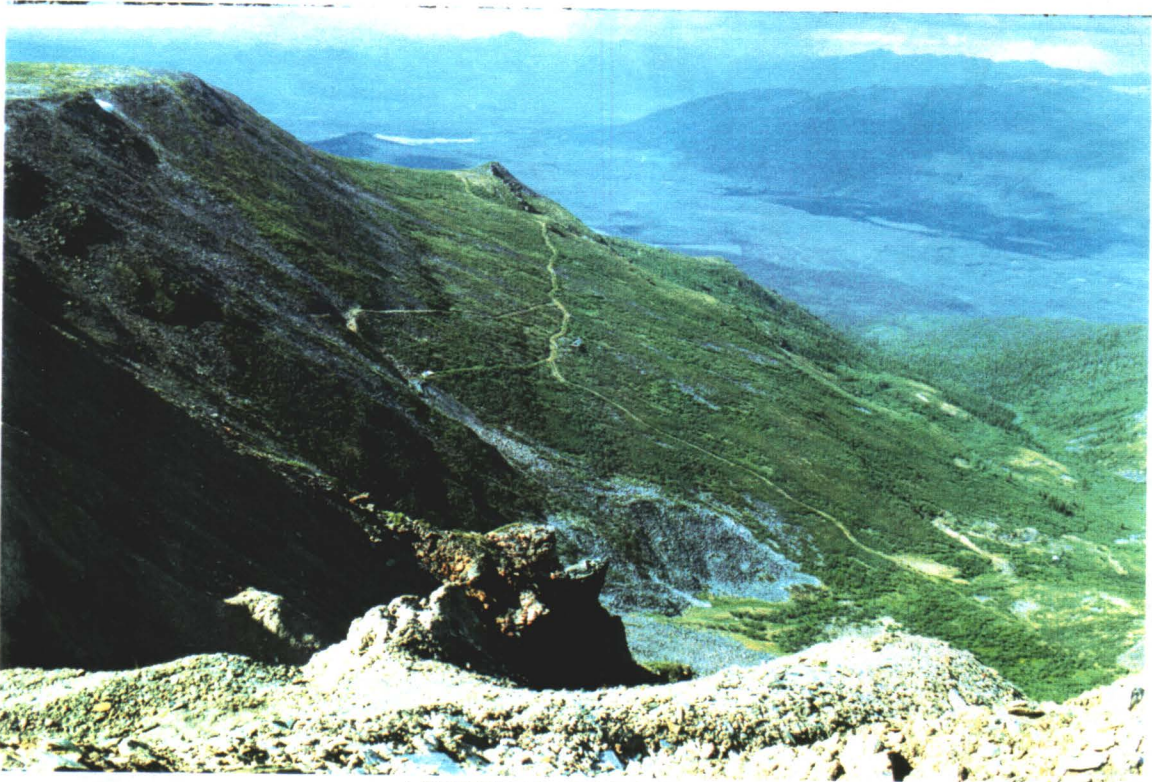
ACCESS ROADS TO SITE

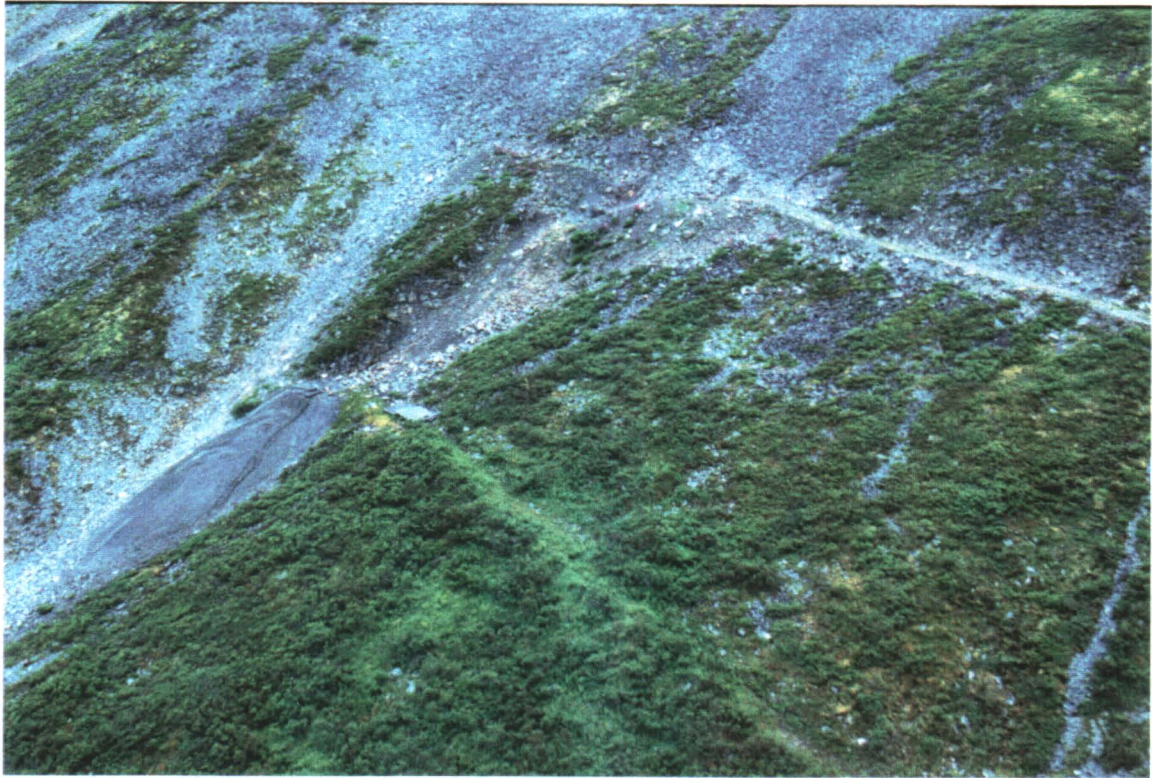
SEGSWORTH EXPLORATION SITE (NOTE SMALL WASTE PILE)

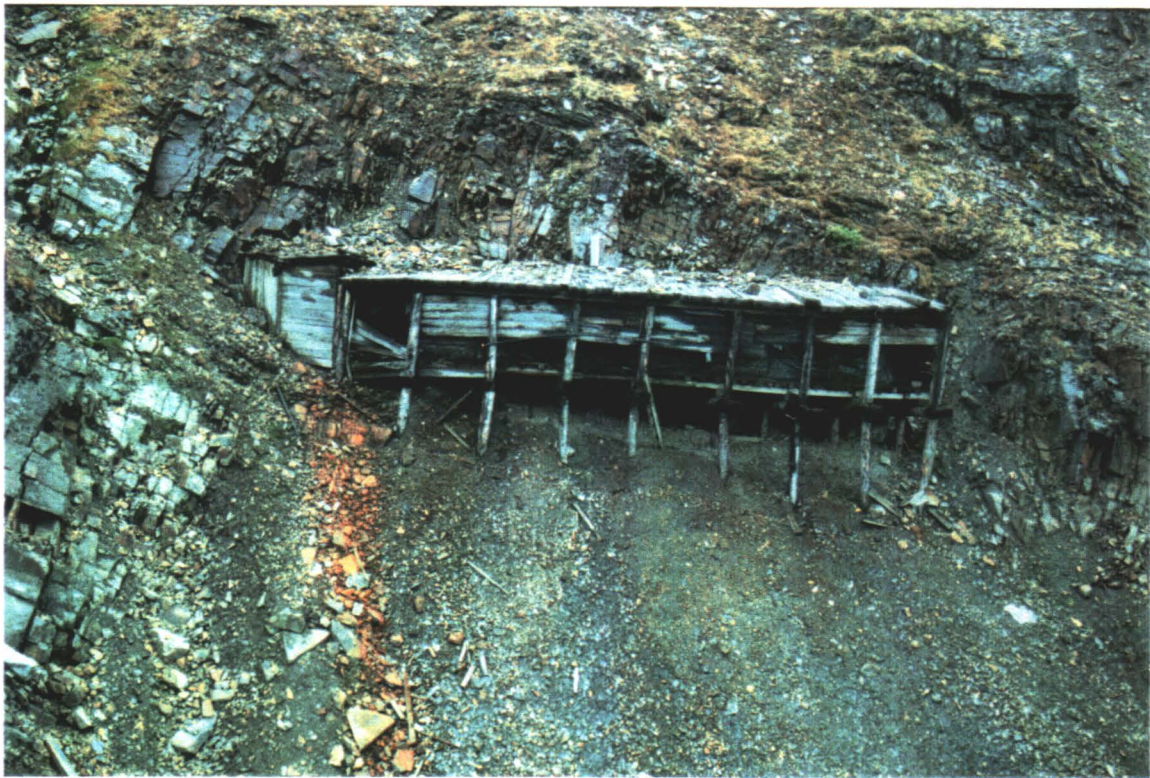
Remnants of two adits were found to be collapsed, with possibly a third adit on the face of the slope. A structure on a near vertical rock face, much higher than the other two adits, appeared to be the entrance and a dump for another adit. The third site was inaccessible and could not be reached safely (see photographs). From an inspection of the area, the only remains of past activity included;

ADIT AND DUMP STRUCTURE ON ROCK FACE

The structure on the face of the slope is inaccessible and cannot be safely reached. It is recommended that this structure be left in place.

Removing the one structure from the rock face is not considered practical and should not even be contemplated.

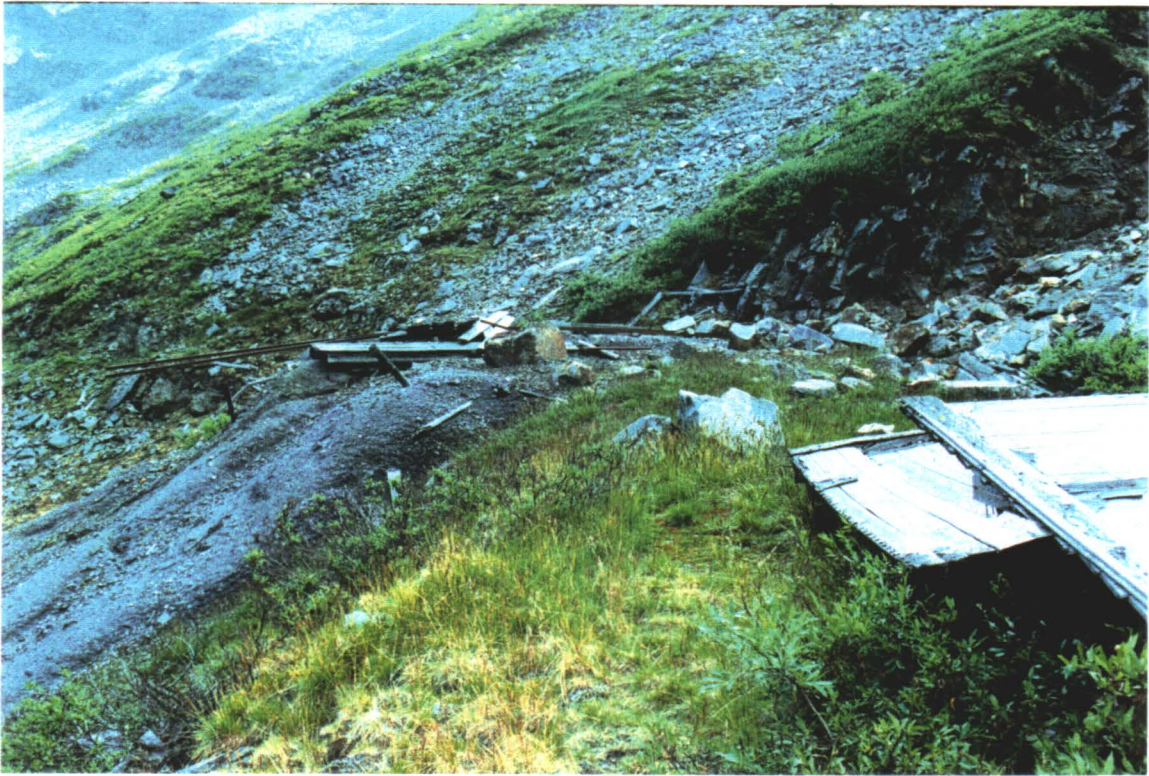
The only other evidence of site disturbance was found at the entrance to the adits. A few pieces of old rail are still at the entrance to one adit, and small piles of waste rock were spilled below these adits. Nothing else was found from any past activity.

ROCK WASTE, RAIL, AND COLLAPSED BUILDING AT ADIT

The only other remaining infrastructure impacting the environment at this site is the remaining rail. This material has a **VERY LOW** impact on the environment and it is recommended that this material be removed from the site only if a general clean-up program has been initiated in the area.

The only remaining material, a few rails left at one of the adits, would be considered a **VERY LOW** priority for clean-up. If this was contemplated, it would be best done using a helicopter to avoid disturbance to the overgrown access trail.

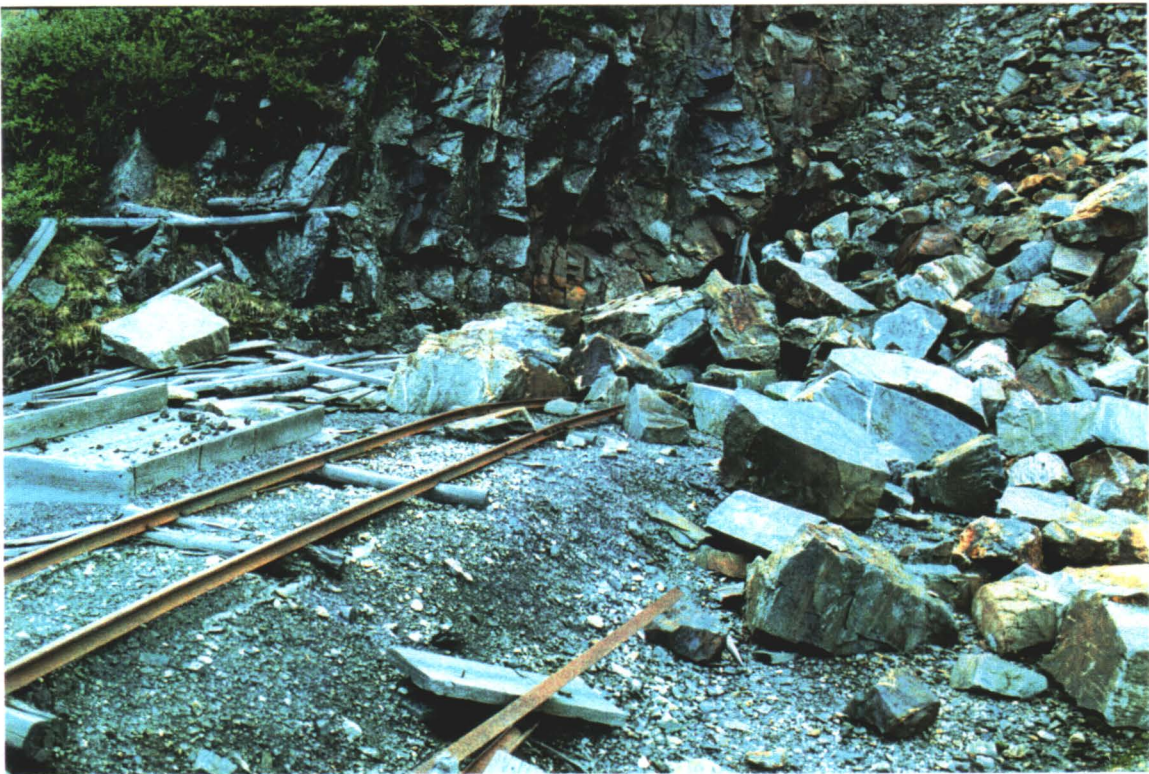
COLLAPSED ADIT
