ASSESSMENT REPORT

105B-01-2

SILVER SEVEN

DIAND TECHNICAL SERVICES

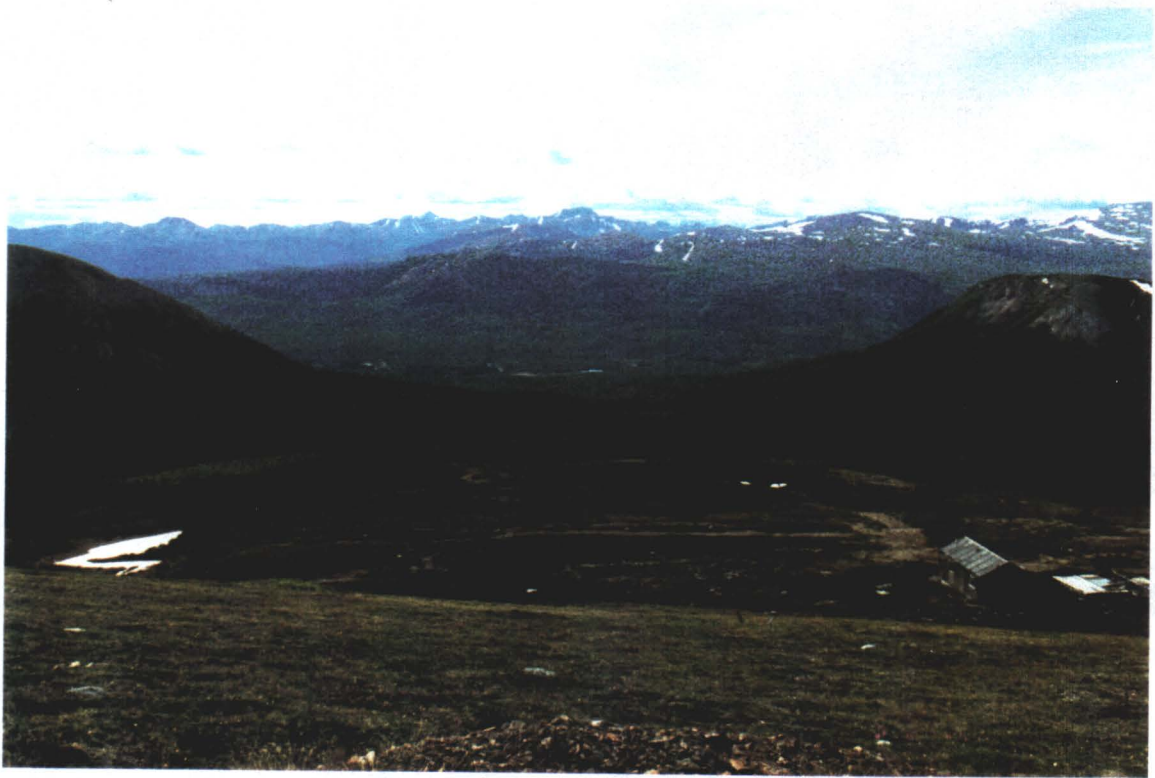
1. OVERLOOKING MINE SITE

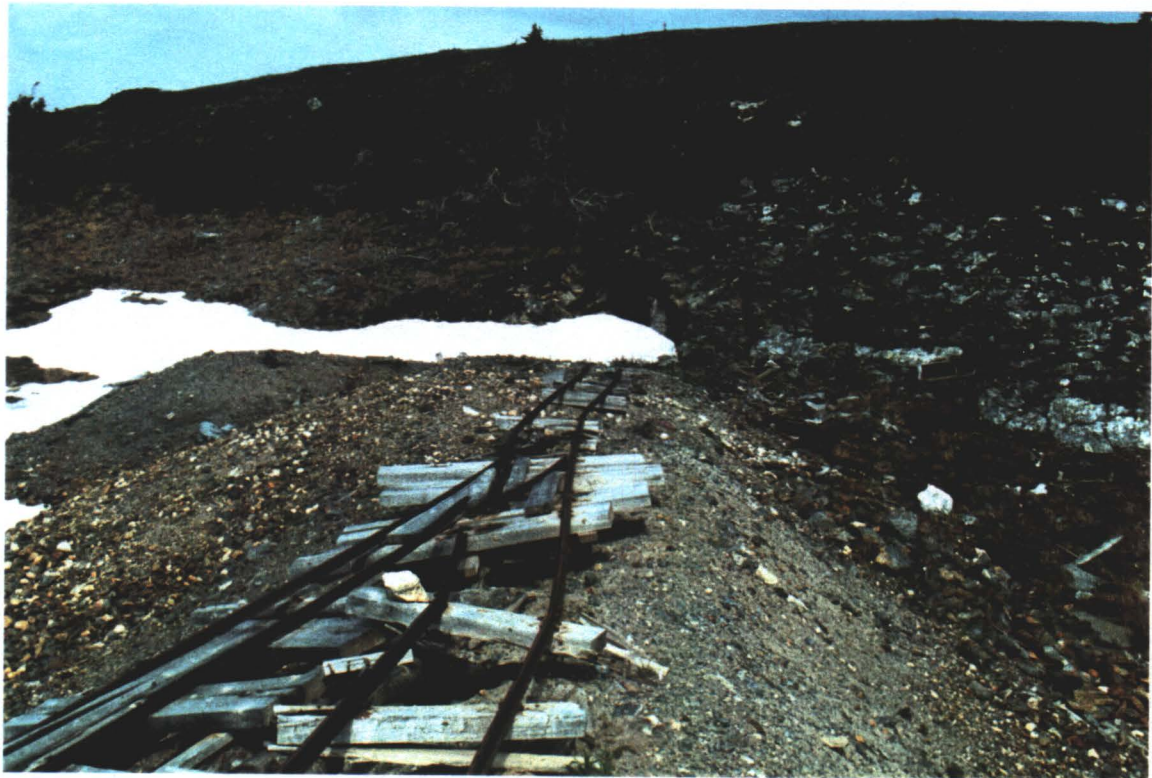
Mine Adit - The mine adit is open, the supporting timbers are old and weakening, and although remote, is accessible to the public. It is recommended that the adit be properly sealed or permanently covered.

2. MINE ADIT AND RAIL

Rock Waste - The waste rock at the entrance to the adit consists of approximately 1000 cubic metres of steeply sloped material. Little can or needs to be done with this pile of rock. If a clean-up program is conducted the rails should be removed between the adit entrance and the end of the waste pile.

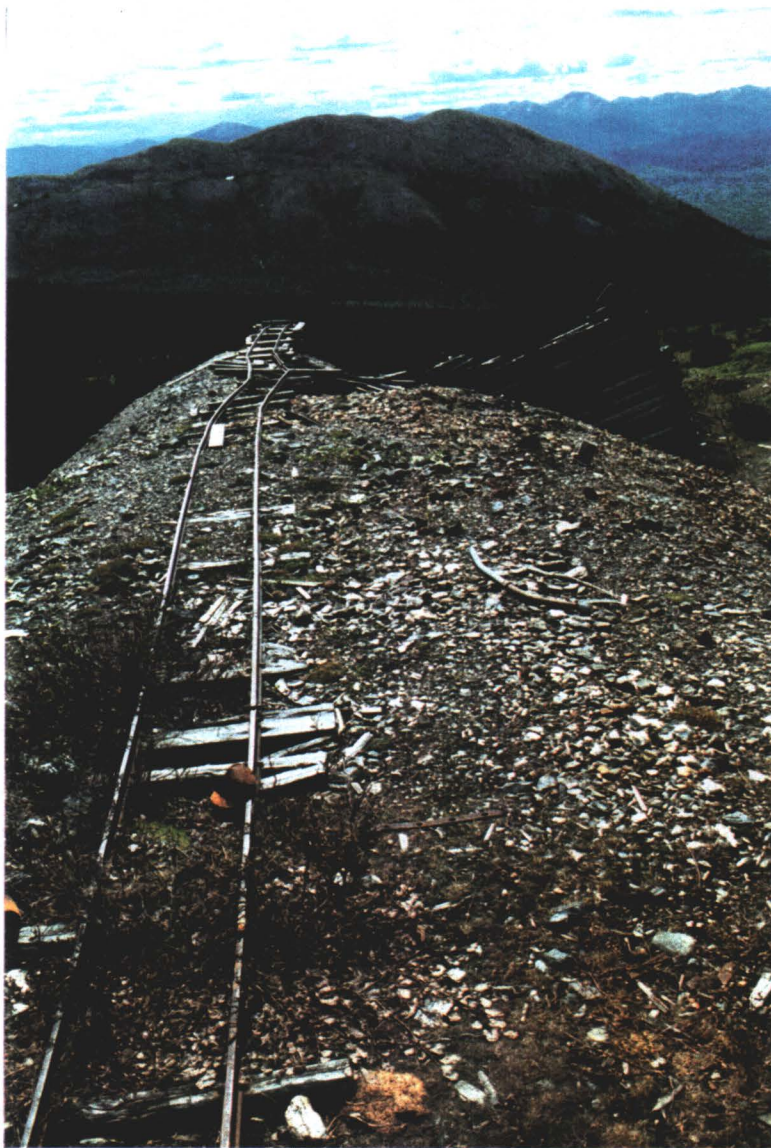
Loadout - The loadout outside the entrance to the adit is constructed of locally cut logs, measures 3x5m and is 3-5m high, is held together with wire cables, and is deteriorating and beginning to collapse. This poses a safety hazard if someone inadvertently climbs this structure causing it to collapse. If a clean-up program is conducted at this site, this structure should be knocked down or dismantled to eliminate any safety hazard.

3. WASTE DUMP AND LOADOUT

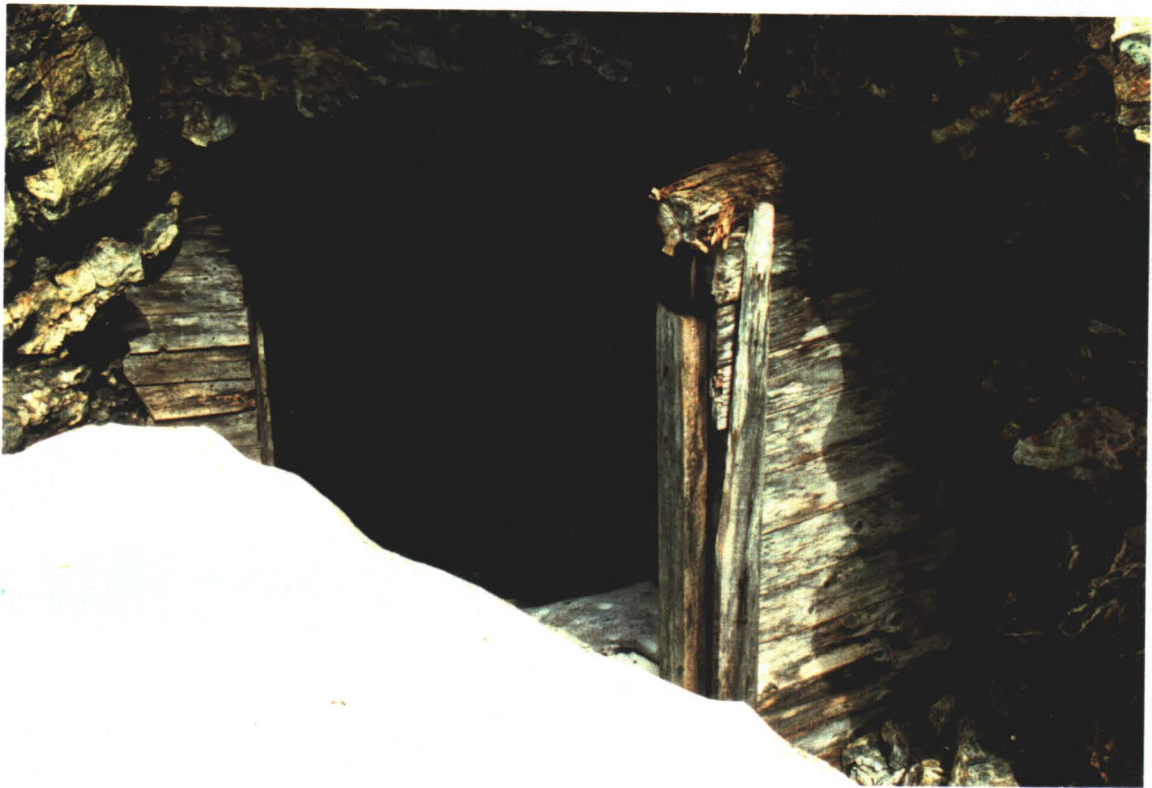
4. OPEN ADIT

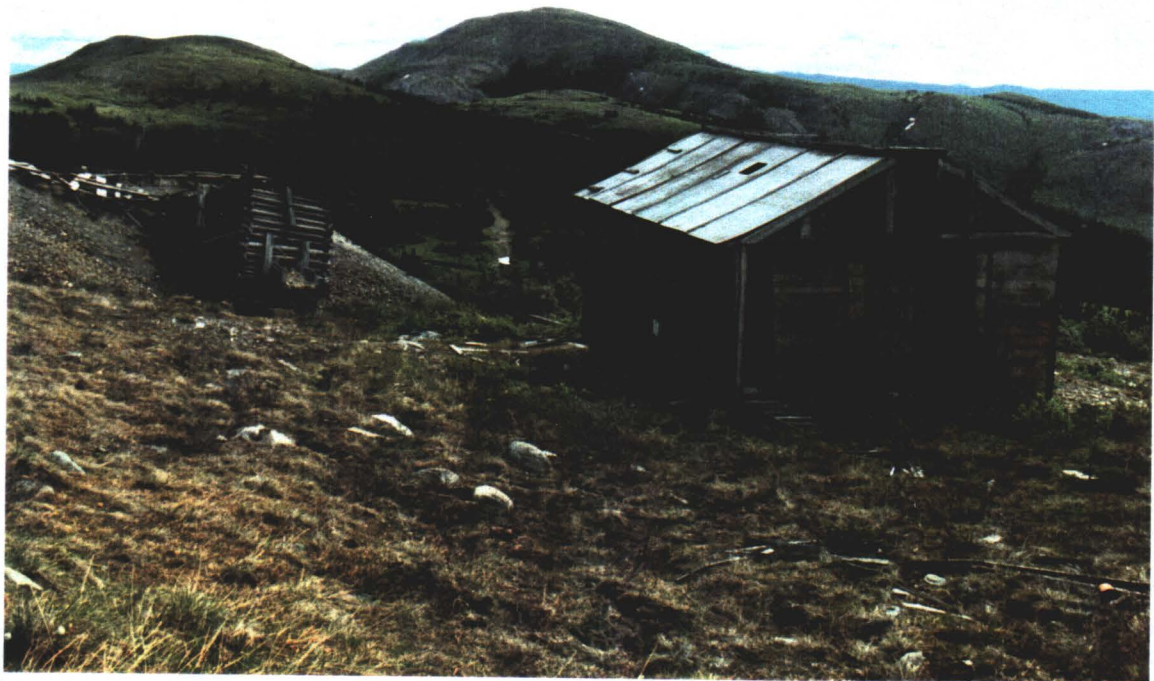
5. TOOL SHED AND LOADOUT

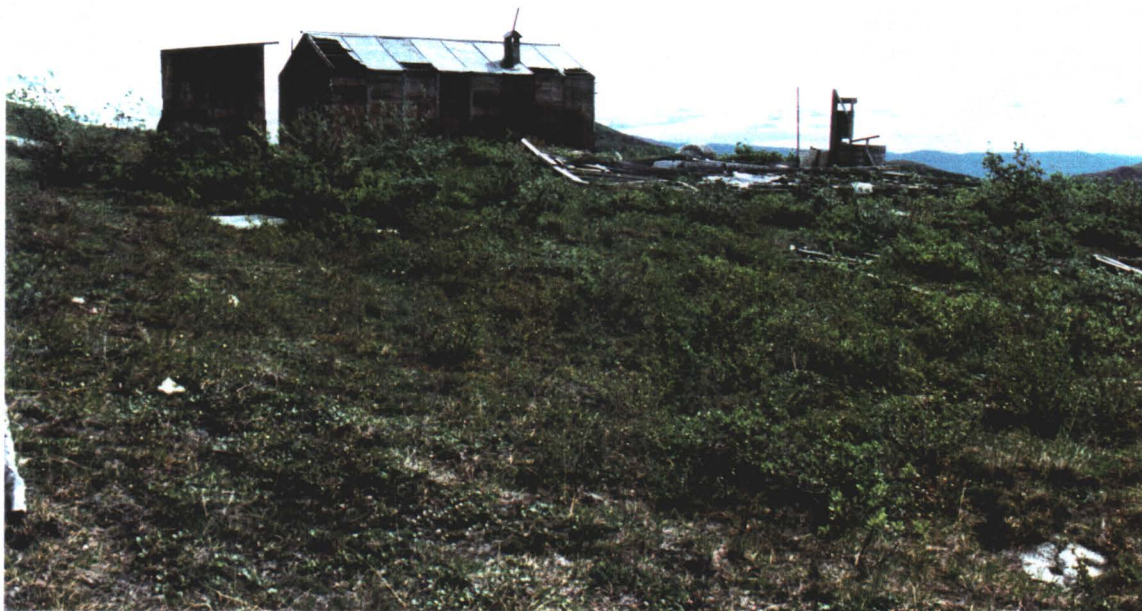
Mine Buildings - Three old plywood clad buildings, one that has already collapsed, remain at the site. These buildings are continuing to deteriorate from the weather and will eventually collapse. These structures are small and not expected to cause any environmental problem. It is recommended that if a site clean-up program is conducted at this site, the buildings should be piled and burned. However this is considered a low priority. No spilled or stored hydrocarbon products were found around the mine site.

6. COLLAPSED STORAGE BUILDING AND PLYWOOD CLAD BUILDING

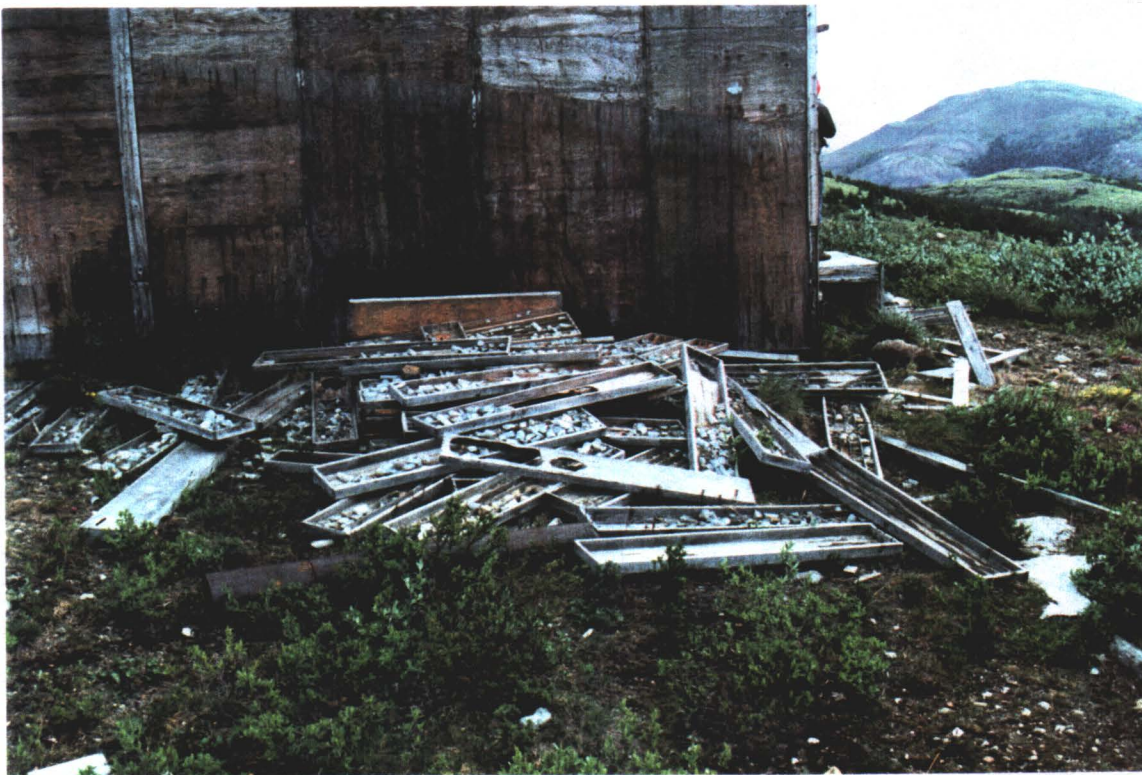
7. SPILLED ROCK CORE

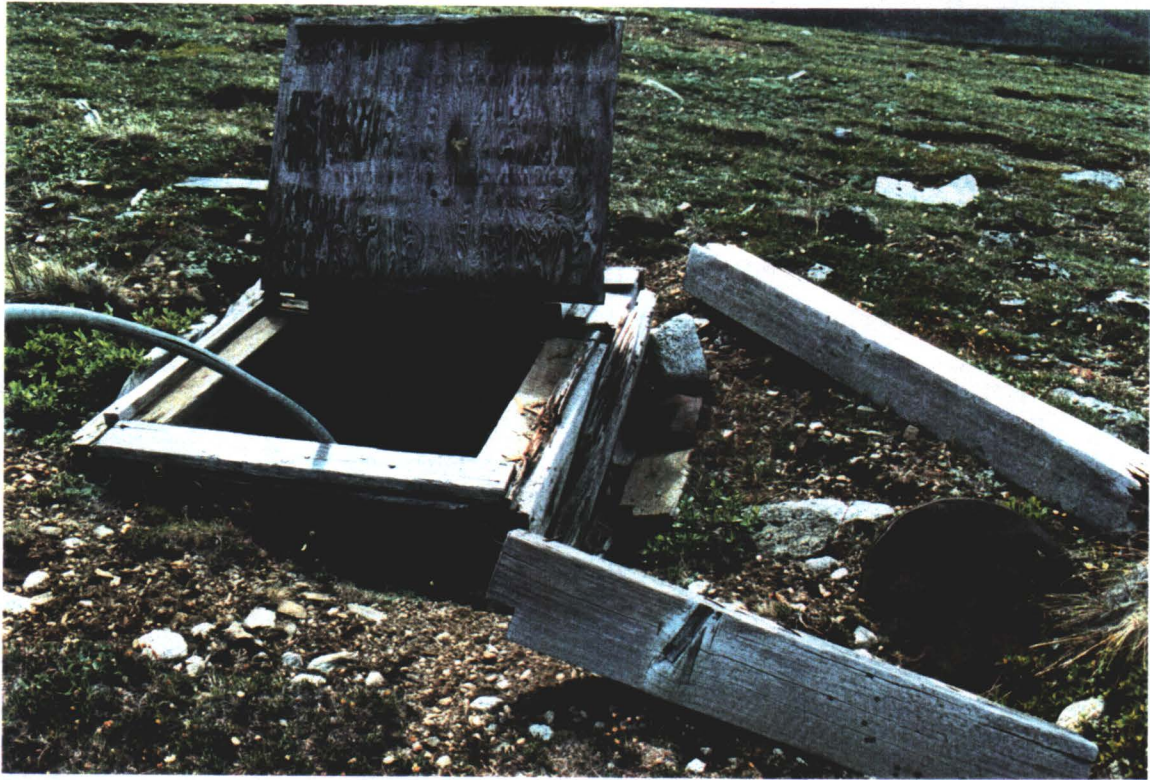
Raises and Vertical Shafts - Two unmarked shafts (raises) above the adit are still in place. One of the shafts is covered with an unlocked plywood door and the other shaft is open. As a precaution, the two shafts should be properly sealed to prevent anybody from entering them and possibly injuring themselves.

8. OPEN SHAFT WITH PLYWOOD COVER

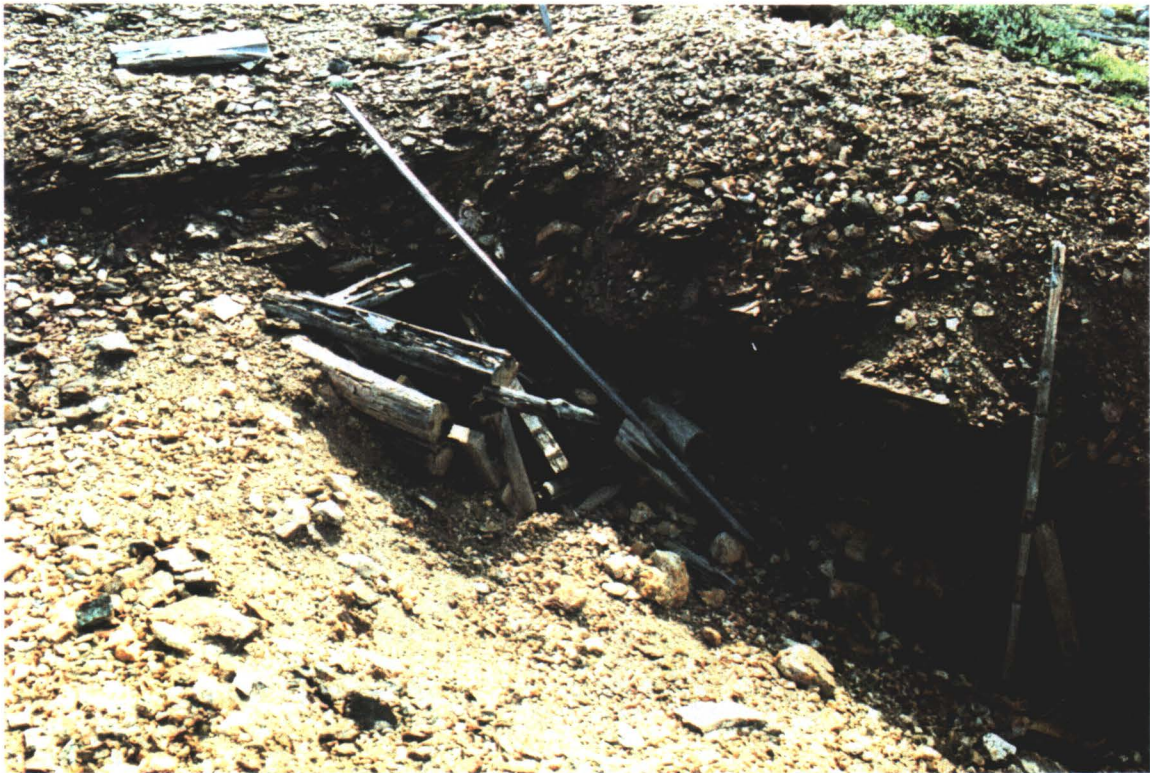
9. OPEN RAISE ABOVE ADIT

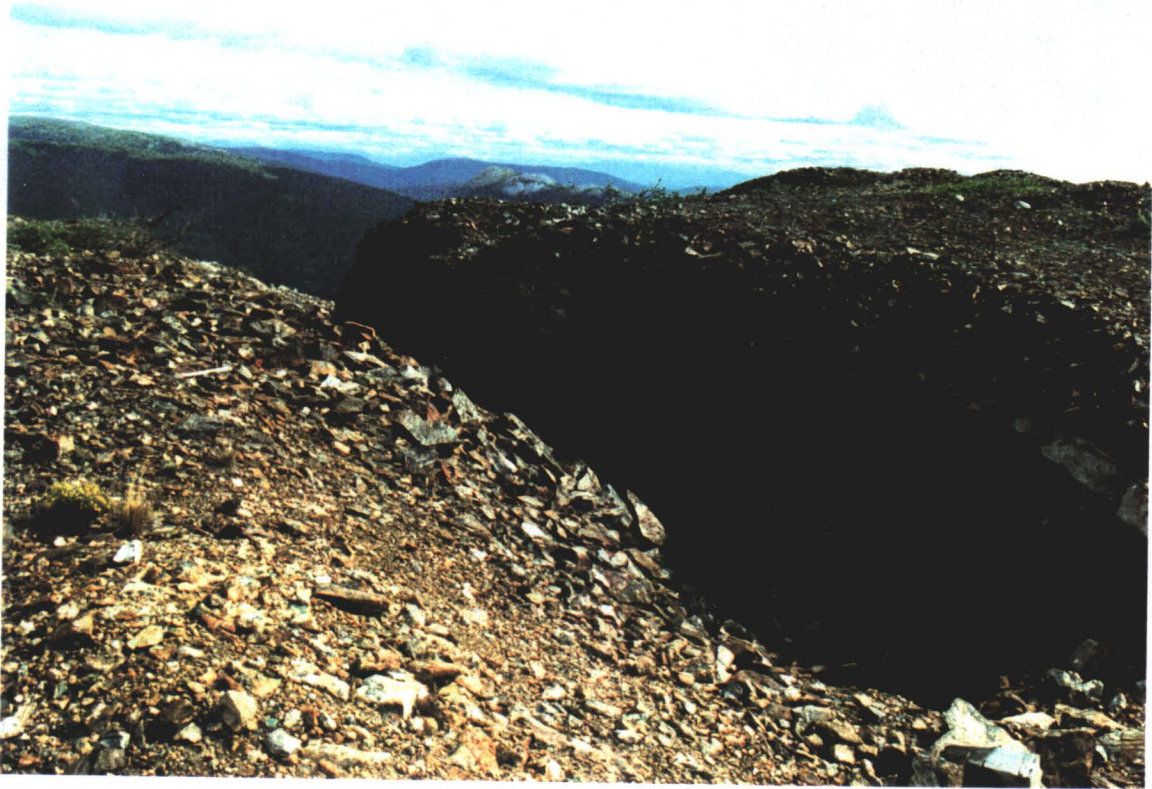
Trenching - The damage caused by the trenching conducted across this site is mainly aesthetic with damage to the vegetation and surface disturbance. The native material is weathered rock with few nutrients and is very slow to naturally revegetate. As the site is very remote with a harsh climate, natural revegetation is really the only practical solution. Because the material is naturally coarse the trenched areas are not showing any evidence of erosion. There are no streams in the area to be impacted from the mine site.

10. TRENCHING

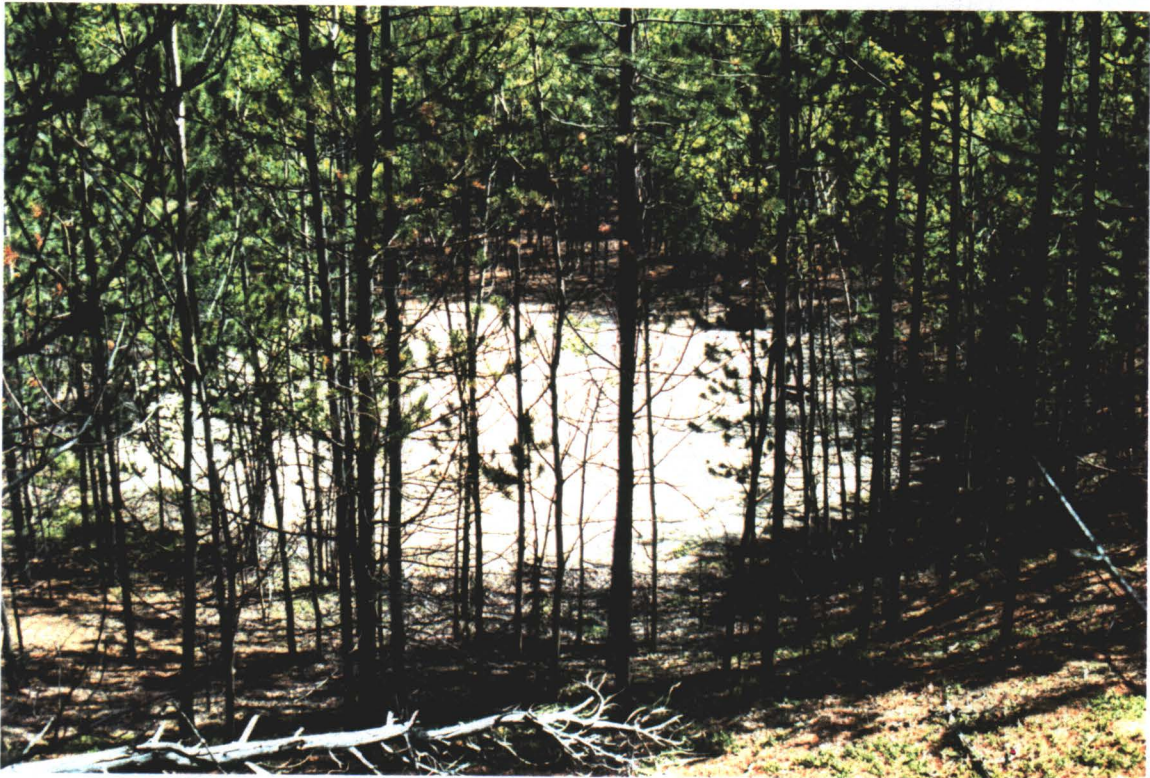
There is no remaining evidence, with the exception of an open trench close to the mill site, of how the tailings was moved from the mill to the tailings area downslope of the mill. However, one can speculate that tailings was deposited by gravity through either a pipe or flume. There is no evidence that any proper tailings structure was constructed. It appears that the tailings was simply dumped into the natural depression and any liquids either seeped into the soil or evaporated. The tailings, consisting of sand sized particles and covering an area 25-30m in diameter, is void of any vegetation after 40 years. Animal droppings were evident across the site indicating the tailings might be used as a "salt lick". The surrounding vegetation did not exhibit any obvious signs of distress at the time of inspection.

11. TAILINGS POND AND SURROUNDING VEGETATION

It is recommended that the tailings and surrounding vegetation be sampled and analyzed for contaminants. Soil sampling at and below the surface should be completed to determine if any contaminants leached into the surrounding soil. Although the site is not likely to be used by local or passing population, it is close to the Alaska Highway and also appears to be frequently used by animals which could be ingesting any residual contamination. Any testing should determine whether or not the tailings could have any adverse effects on the animal population in the area.

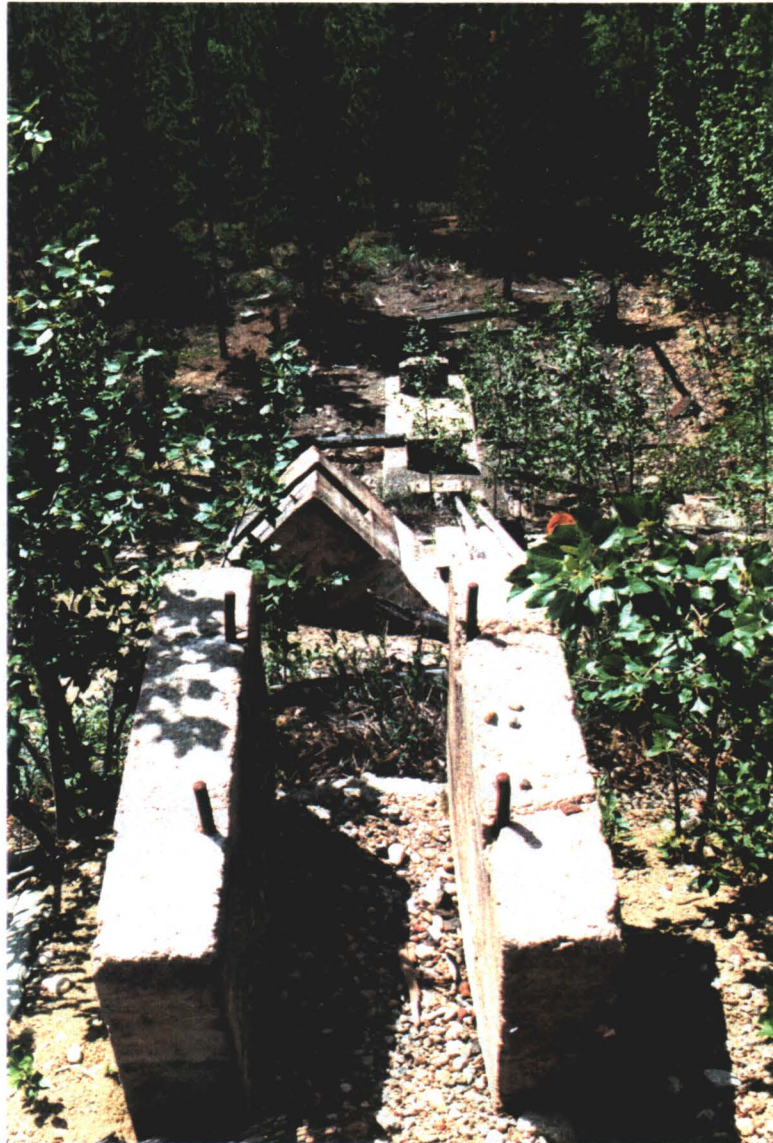
The only remains of the mill site are the concrete foundations and a few metal scraps. The mill appears to have burned down as some charred timbers were found near the concrete foundations. It is recommended that these foundations simply be left as they are. The vegetation has regrown around the mill site and little remains to be cleaned up.

12. MILL FOUNDATIONS

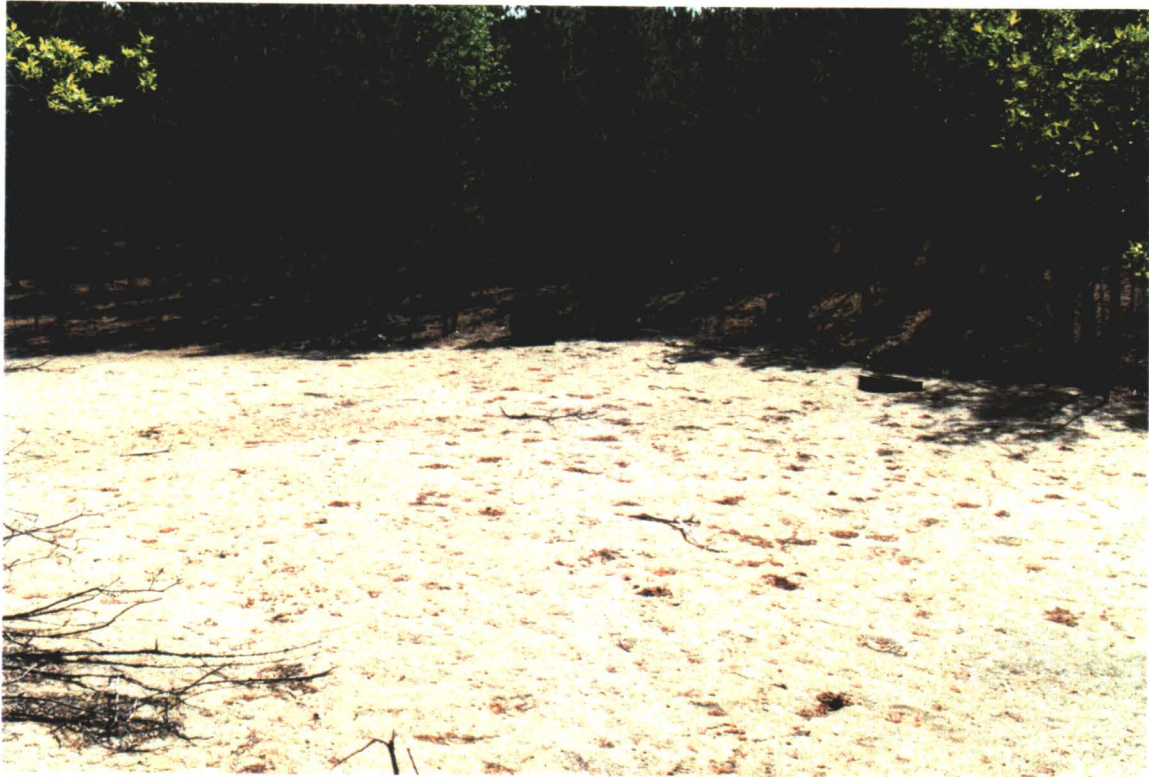
Ore from the underground mining was hauled over the rough, steep trail 8.2km from the mine to the mill. There is no remaining evidence that there was a proper (culvert or bridge) crossing of Boulder Creek. Remnants of infrastructure at the mill site includes concrete foundations from the mill and tailings contained in a natural depression below the mill site. According to the historical records milling took place between 1951-1953. **It is important to note that the tailings area is void of any vegetation after 40 years.**

13. TAILINGS POND

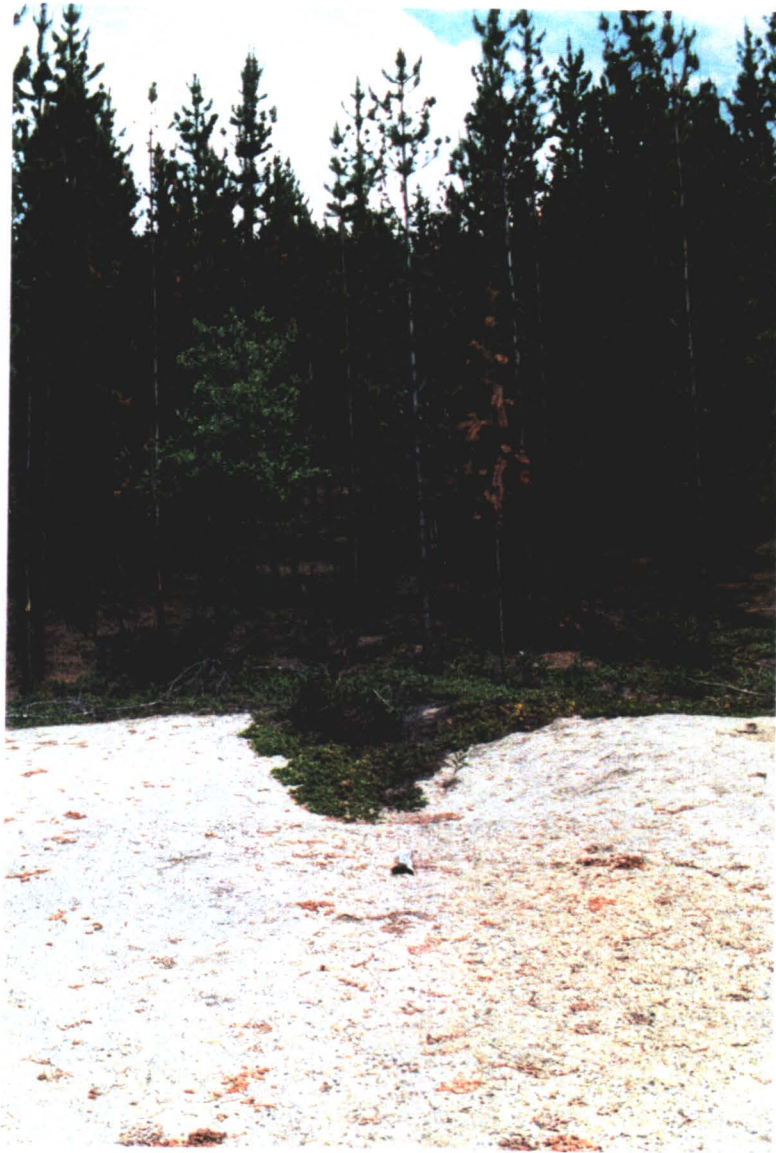
14. INLET TO TAILINGS POND
