**ASSESSMENT REPORT**

**116C-08-2**

**SOURDOUGH**

**DIAND TECHNICAL SERVICES**

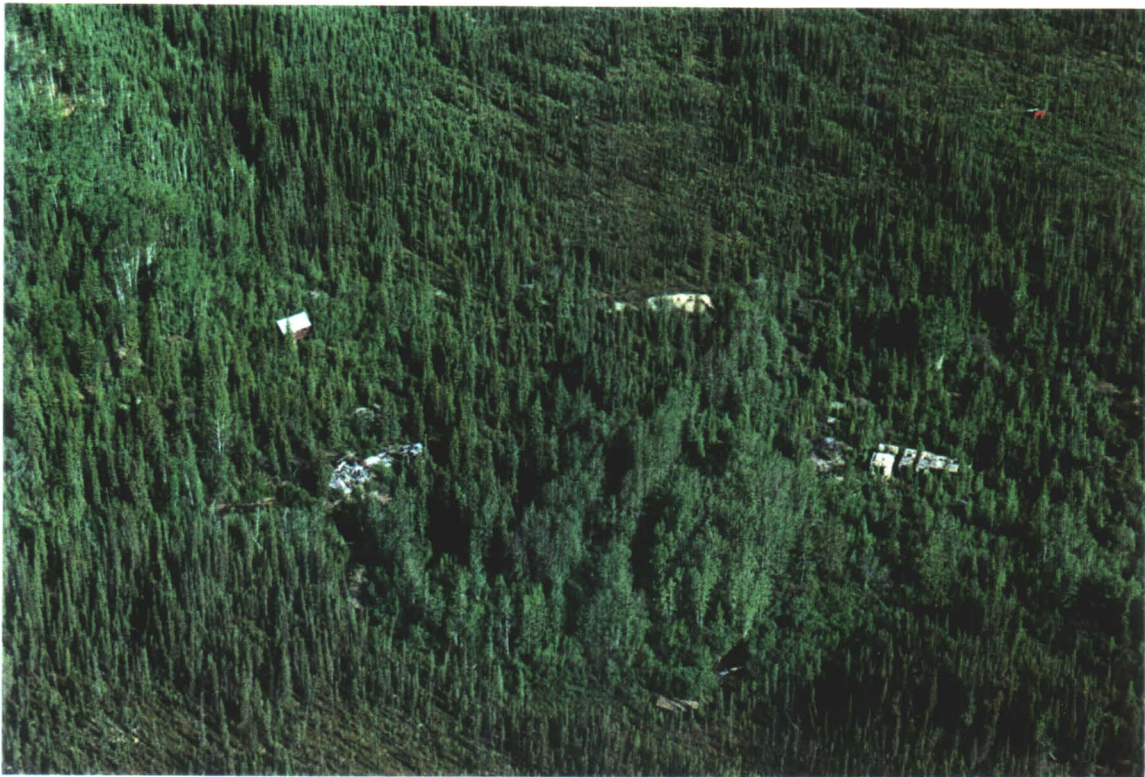
OVERVIEW OF SITE

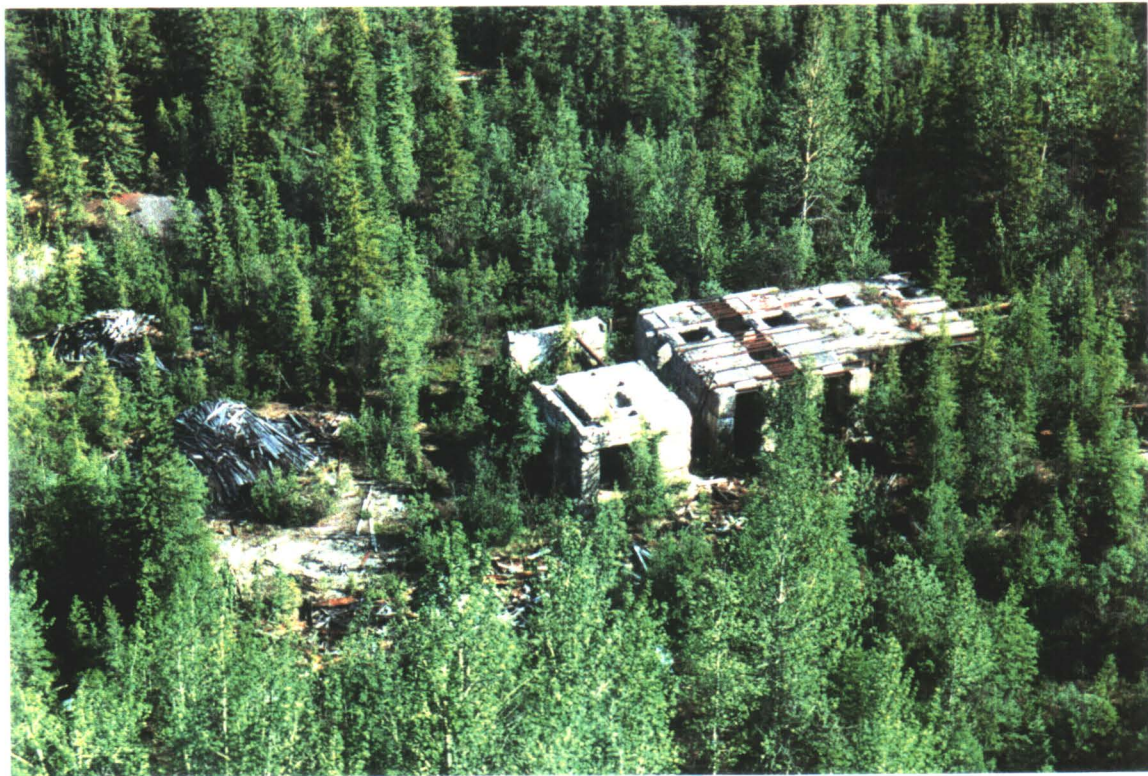
- 1) The old powerhouse is a concrete structure that is still standing but crumbling and is in an advanced state of decay.
- 2) Three wood frame wood clad structures including a warehouse, cookhouse, and one other building on the opposite side of the creek, have all collapsed.
- 3) The only standing wood structure is a two storey log residence that is leaning and is expected to collapse in the near future.

CONCRETE STRUCTURE

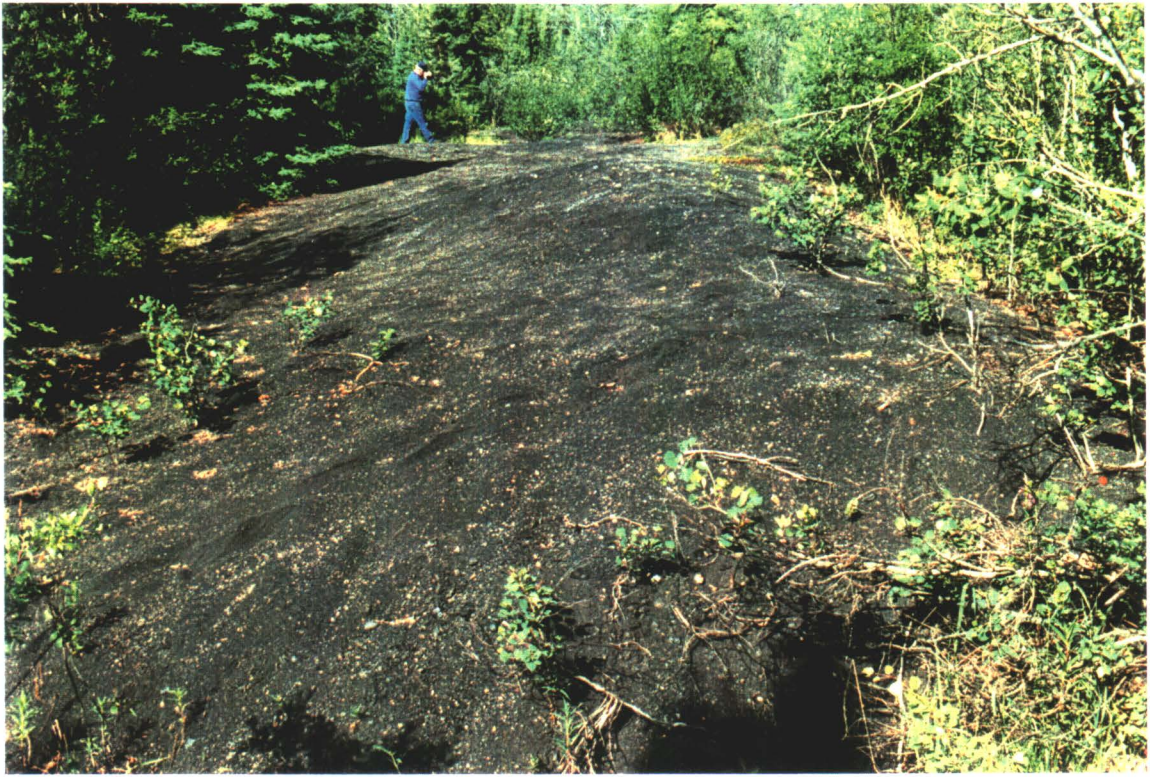
No open adits were found at the site at the time of inspection on 1993/06/29, however locations suspected of being adits were located. These adits have all collapsed. Small piles of coal 3-4m high along with a pile of ash are located near the old powerhouse.

PILES OF COAL

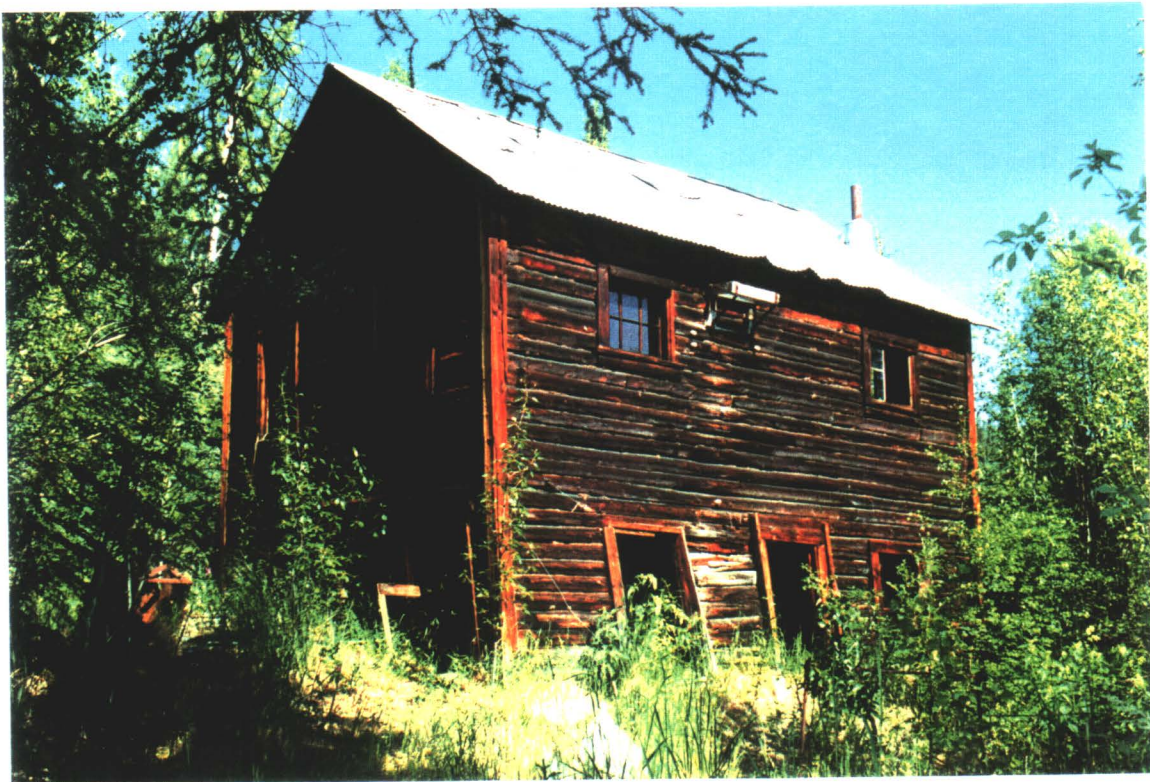
LOG RESIDENCE

The standing log structure represents a public safety hazard because it is collapsing. It is recommended that the building be posted to warn anyone in the area that this building is unsafe to enter.

Posting the one remaining log structure that it is now unsafe should be completed as soon as possible.

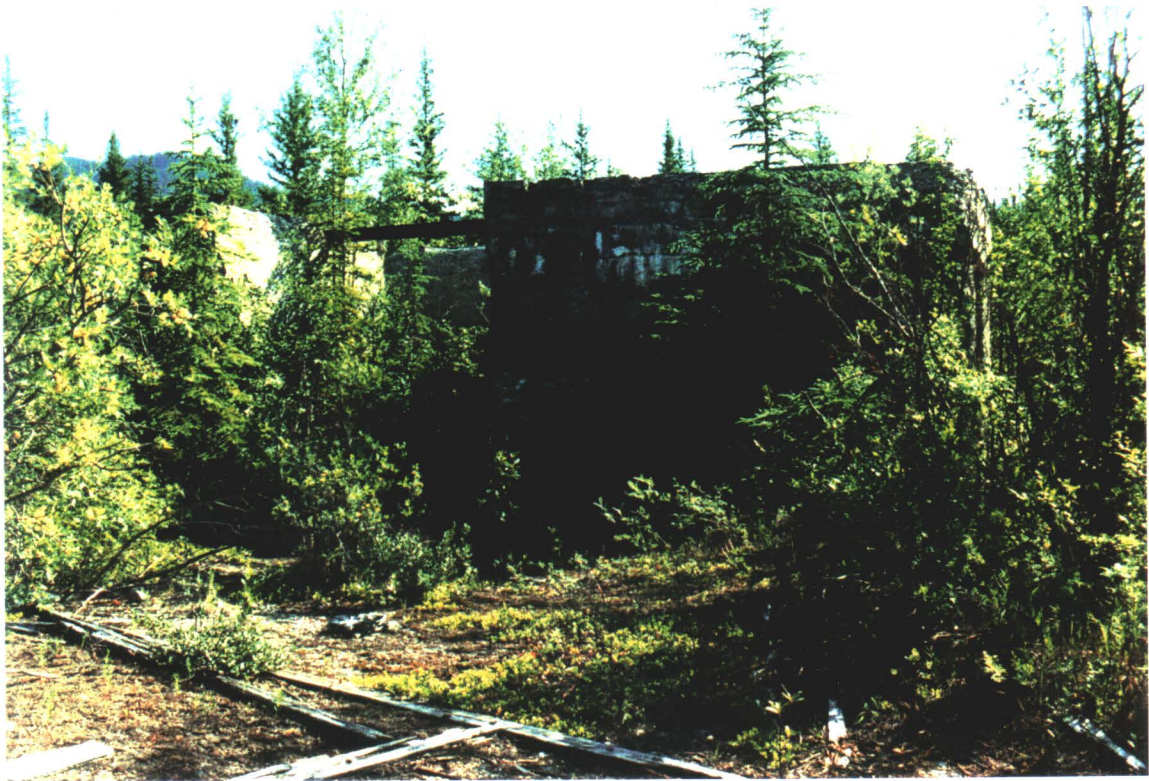
CONCRETE STRUCTURE

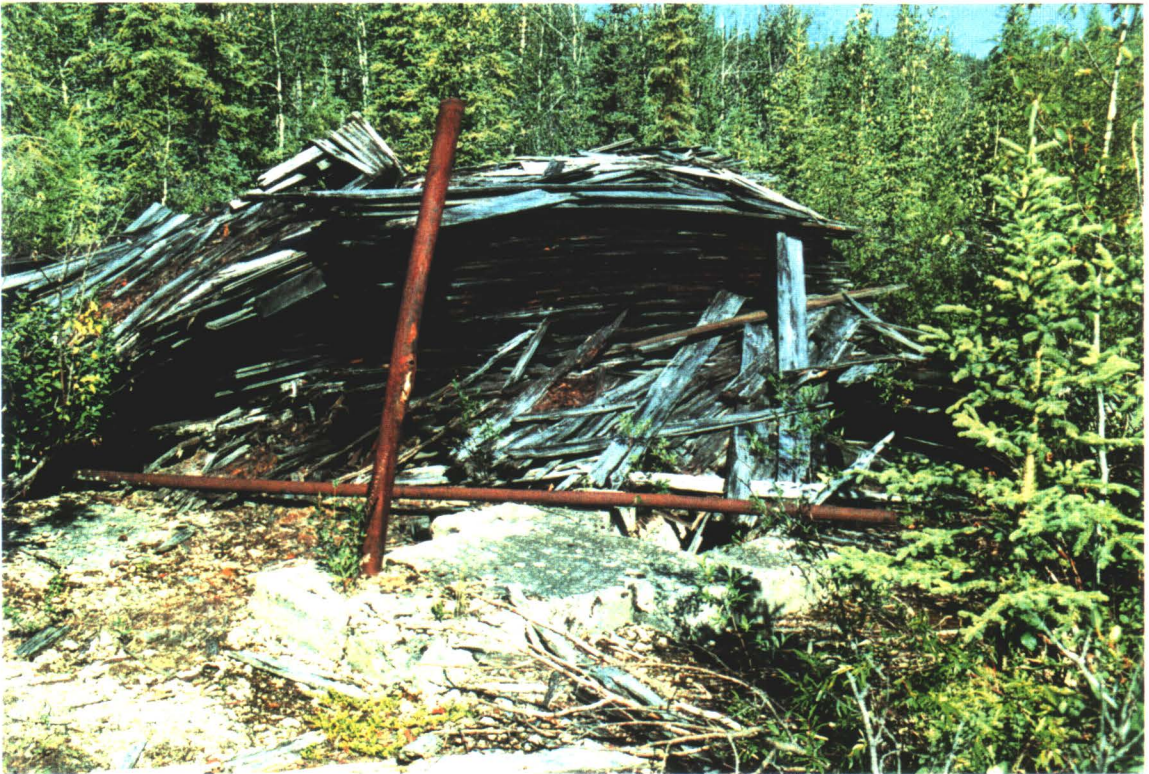
WOOD AND METAL WASTE

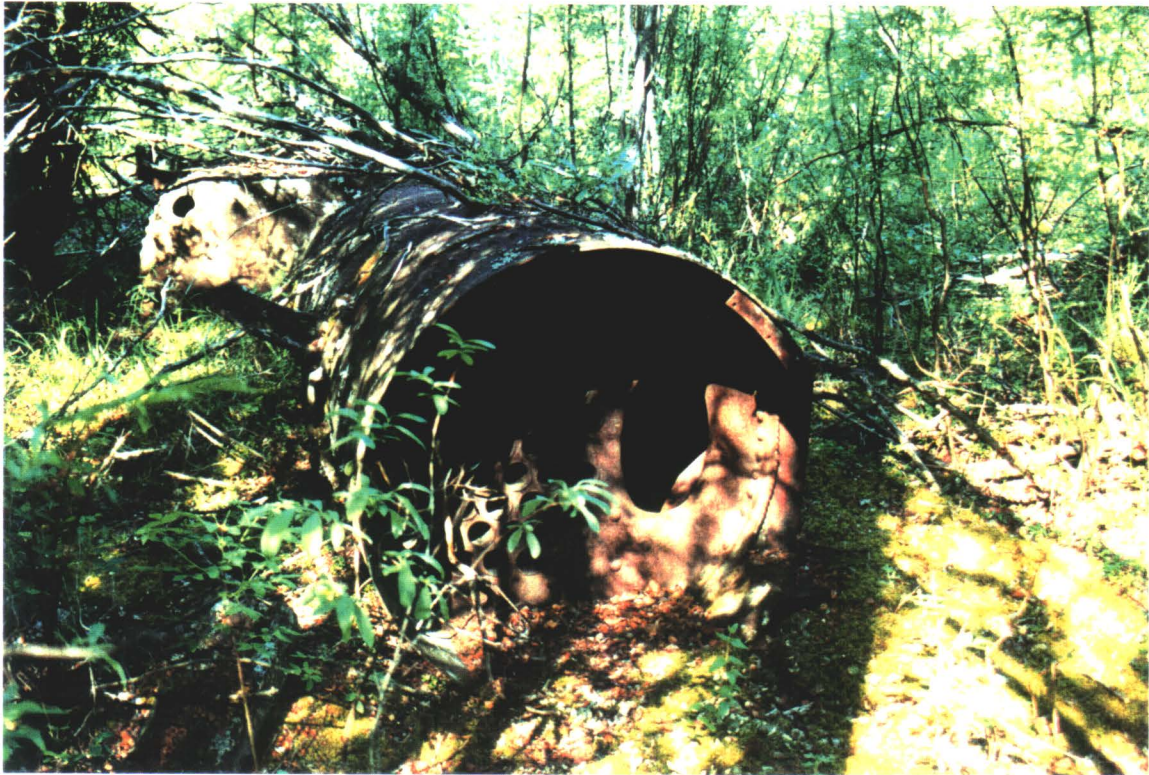
REMNANTS OF OLD BOILER

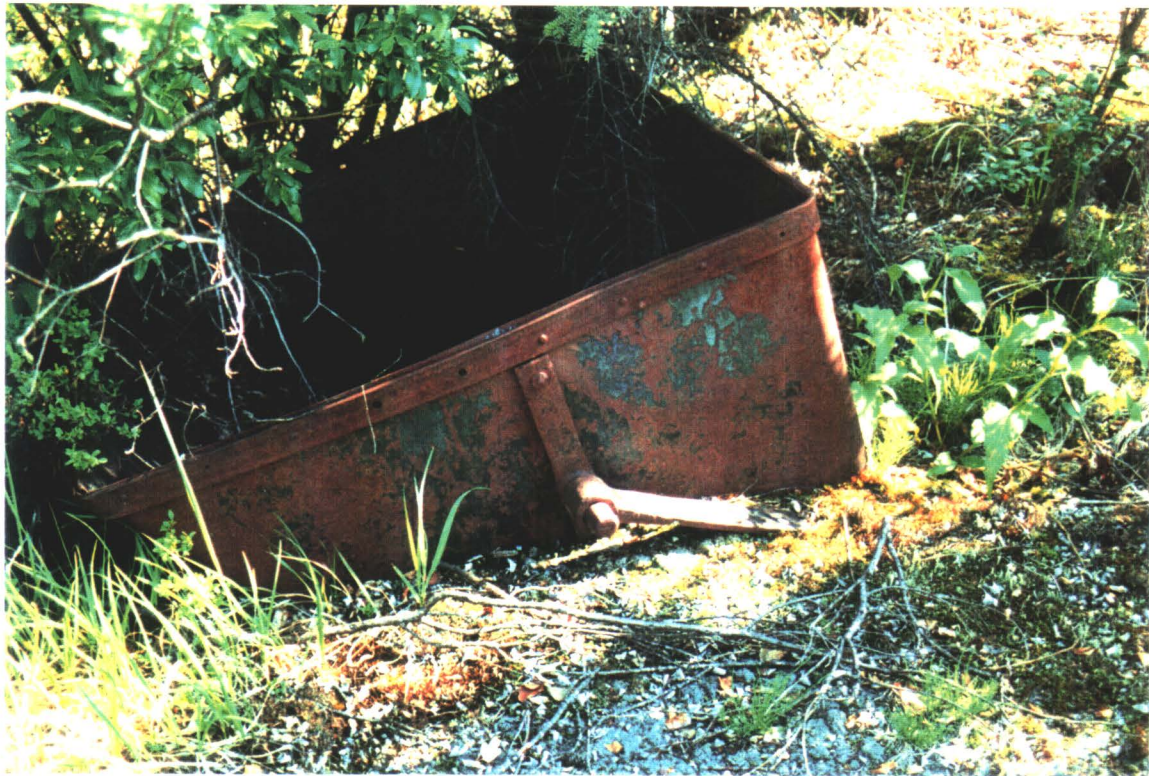
METAL BOX

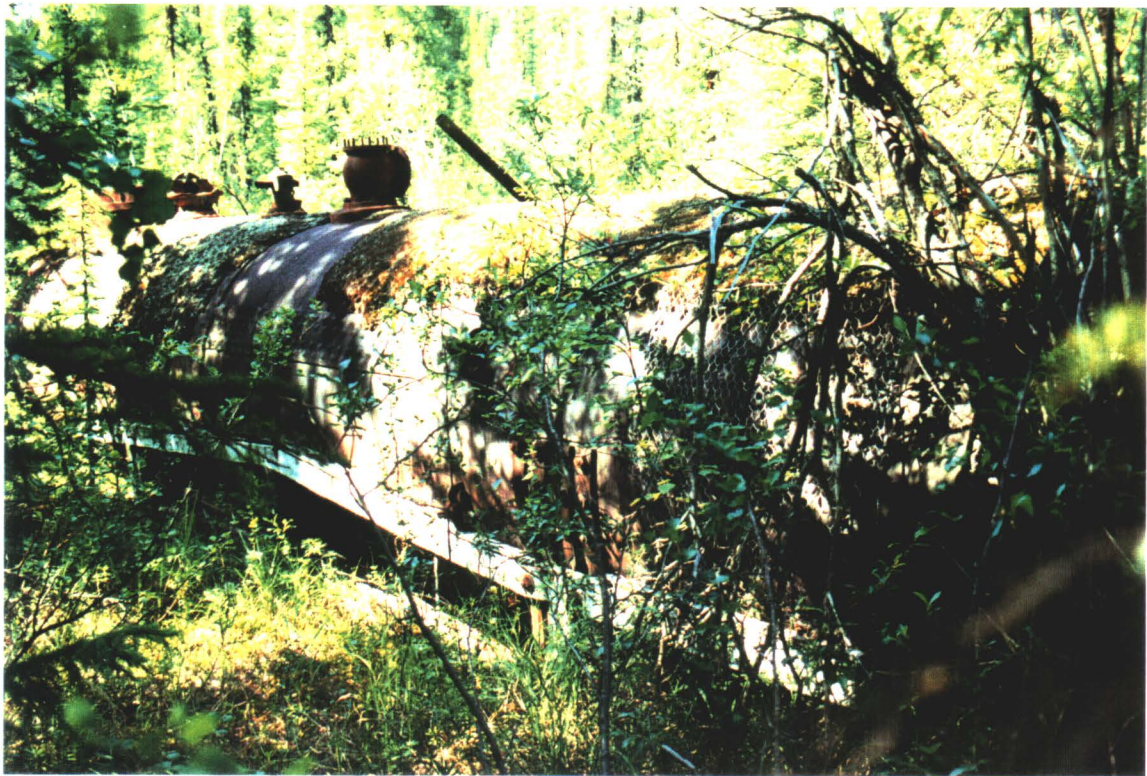
BOILERS

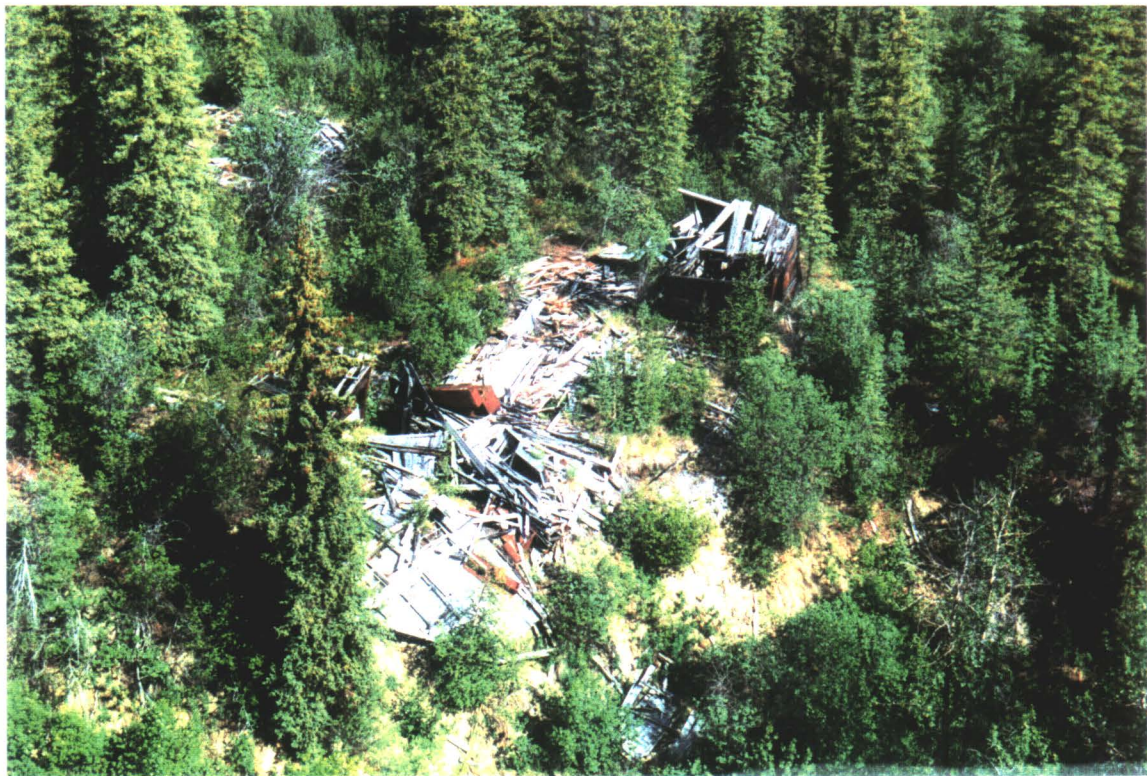
WOOD AND METAL WASTE
