ASSESSMENT REPORT

105M-14-12

SOUTH OF GAMBLER LAKE

DIAND TECHNICAL SERVICES

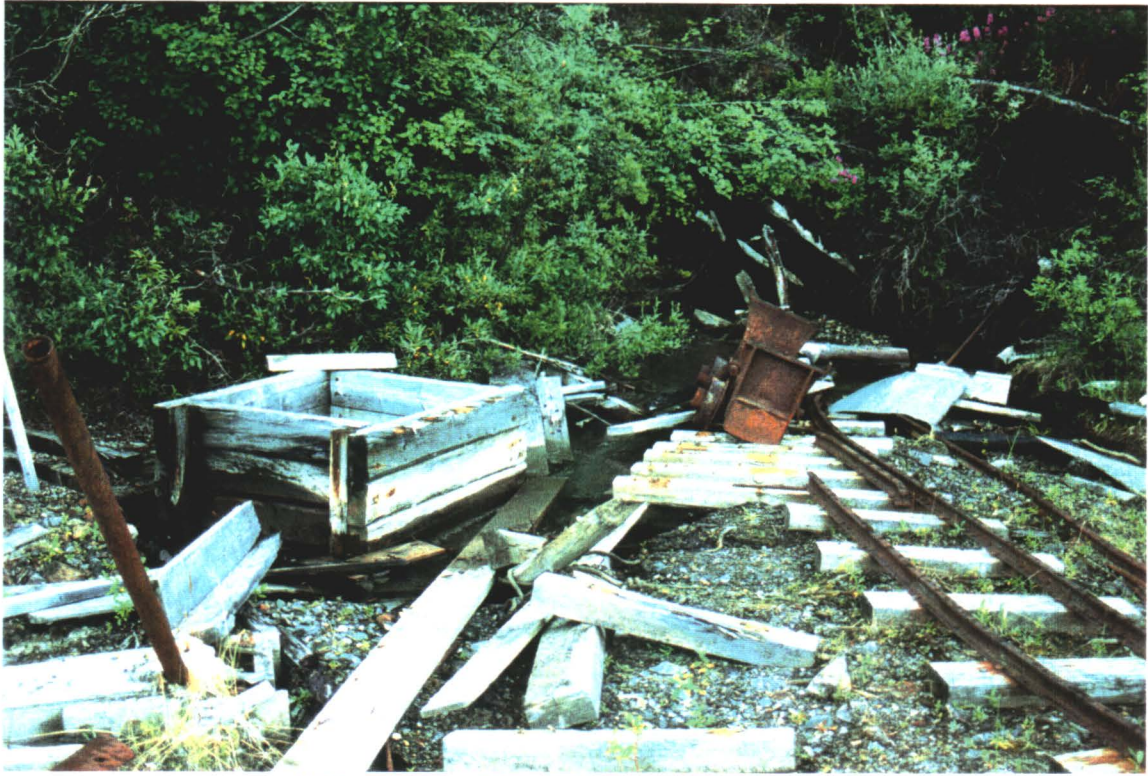
It was estimated that between 600-800 litres/minute of water was flowing from the one adit found on-site at the time of inspection on 1993/07/24. This water was flowing from the adit into a vertical shaft beside the adit. This shaft may have been constructed specifically as a drainage feature for the mine. The other surface water is channeled from a poorly defined gully upslope of the site which channels snowmelt and water from seasonal subsurface thawing across the site past the waste rock dump, continuing downslope into a gully below the site. It appeared that there may be some vegetation stress in the gully above and below the site.

The collapsed adit is essentially closed off. Railway track extends out of the adit to a loadout and waste rock dump, a total distance of not more than 100m. The loadout structure was constructed as a wood retaining structure that is now collapsing. In addition to this infrastructure, the following material was found on-site;

The open unmarked vertical shaft in front of the adit is quite dangerous as someone entering the area could fall into it. It is recommended that the site be posted to warn anyone entering the area of the potential hazards, or alternatively the shaft should be securely covered so nobody could fall into it. It is also recommended that the high volume of water flow into this shaft not be blocked as this appears to be an effective way of draining the water from the site. Blocking this flow will require rechanneling water across the site potentially causing erosion and/or increasing the potential of a slope failure. Securing this shaft properly is considered a **HIGH** priority.

COLLAPSED ADIT AND ADJACENT SHAFT

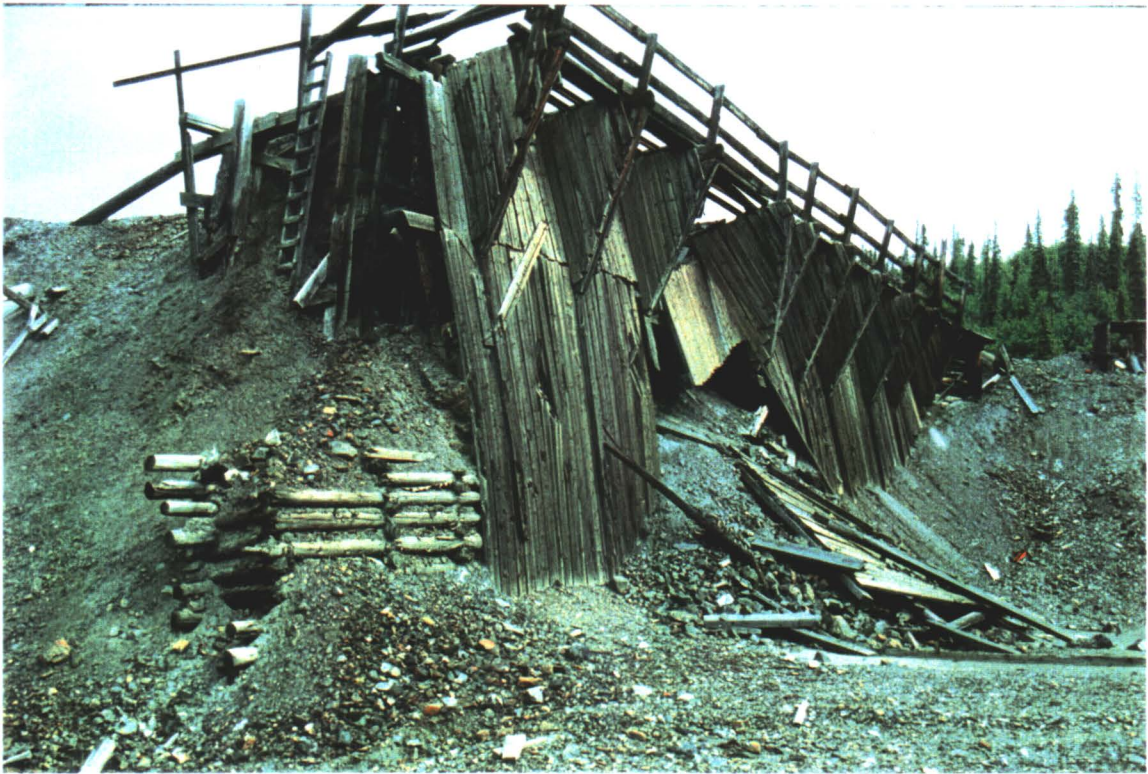
Another safety hazard is the collapsing loadout structure. The wood retaining structure has rotted and is now starting to collapse. It is possible that this structure could fail suddenly and it should not be relied upon to support any loads. It is recommended that this structure be posted to warn anyone that it is potentially unsafe, or alternatively it could be dismantled. It would be more costly to dismantle this structure than to post warning signs in this very remote location. This is considered a **MEDIUM** priority.

COLLAPSING LOADOUT

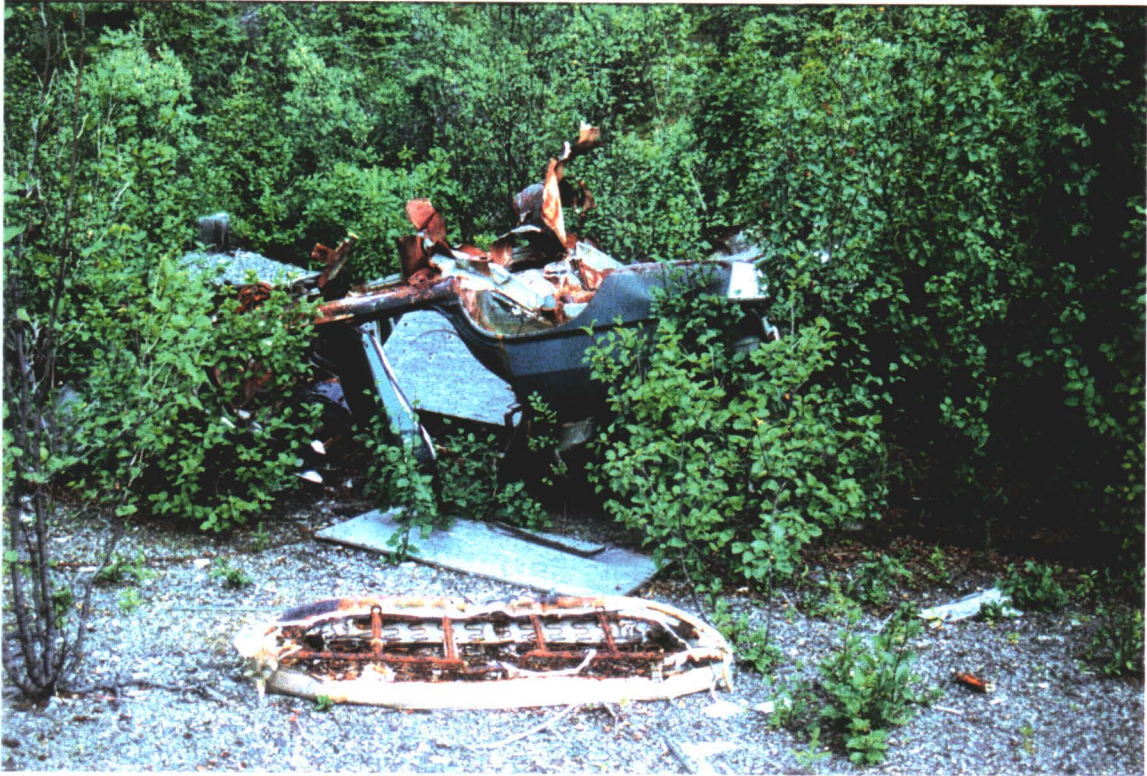
ABANDONED CAR BODY

Other work that could be completed at this site would be to clean-up any metal or wood debris. The metal debris could be gathered and hauled from the site, and the wood debris could be piled and burned on-site. This is considered a **LOW** priority and should be completed only if a general clean-up program is initiated in the area.

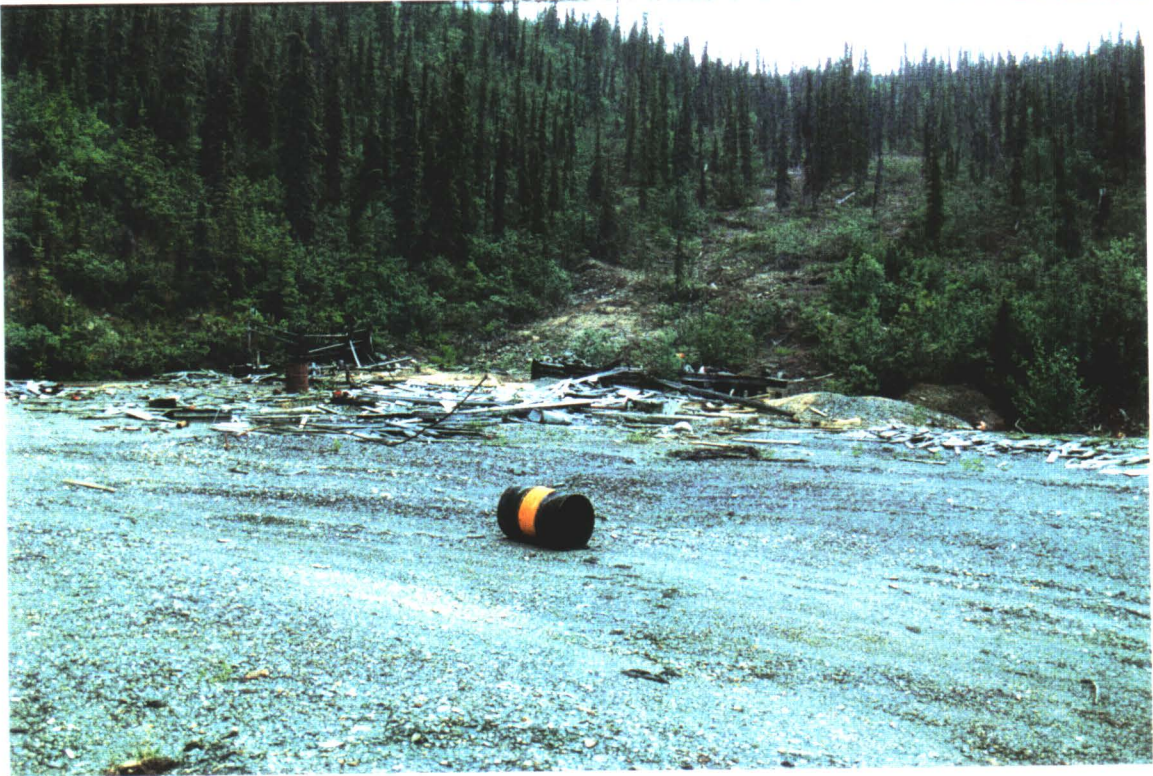
It appeared that the vegetation in the gully above and below the mine site was coloured differently than the surrounding vegetation out of this gully. This minor discolouration was limited to a small area, less than one hectare in size. It was not obvious whether this discolouration is a natural occurrence or whether it is caused from environmental disturbance to the area such as leachate from the mine waste rock at this site or the Wernecke site above.. If this is of concern in this remote area, then vegetation sampling and analysis should be conducted. From the inspection this would appear to be a **LOW** priority.

GULLY ABOVE SITE

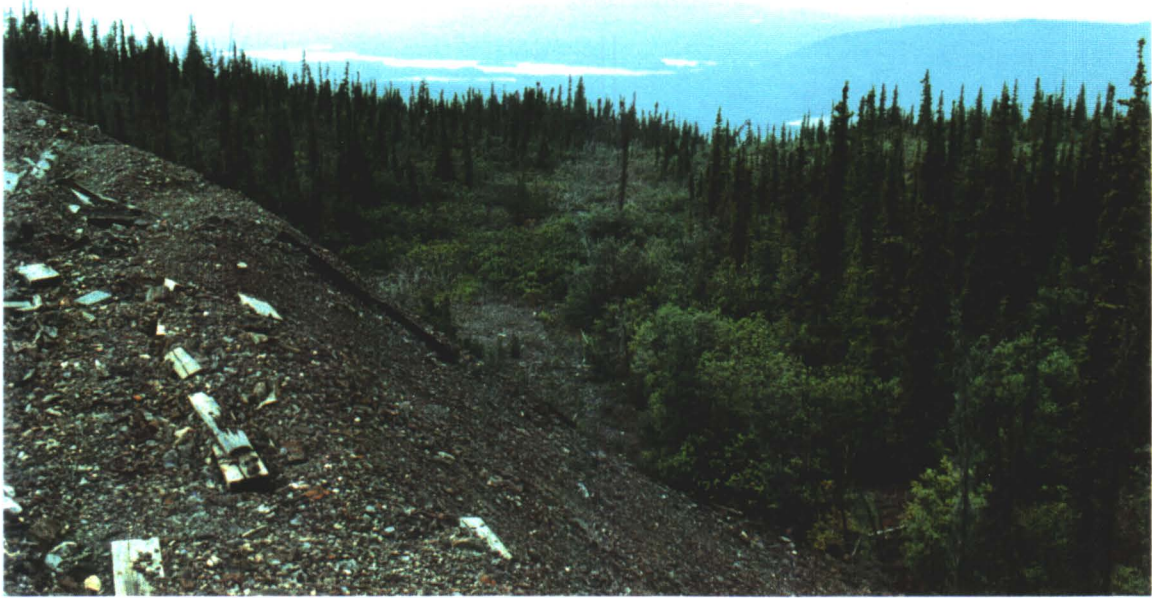
WASTE ROCK AND GULLY DOWNSLOPE
