**ASSESSMENT REPORT**

**1050-01-1**

**TOM**

**DIAND TECHNICAL SERVICES**

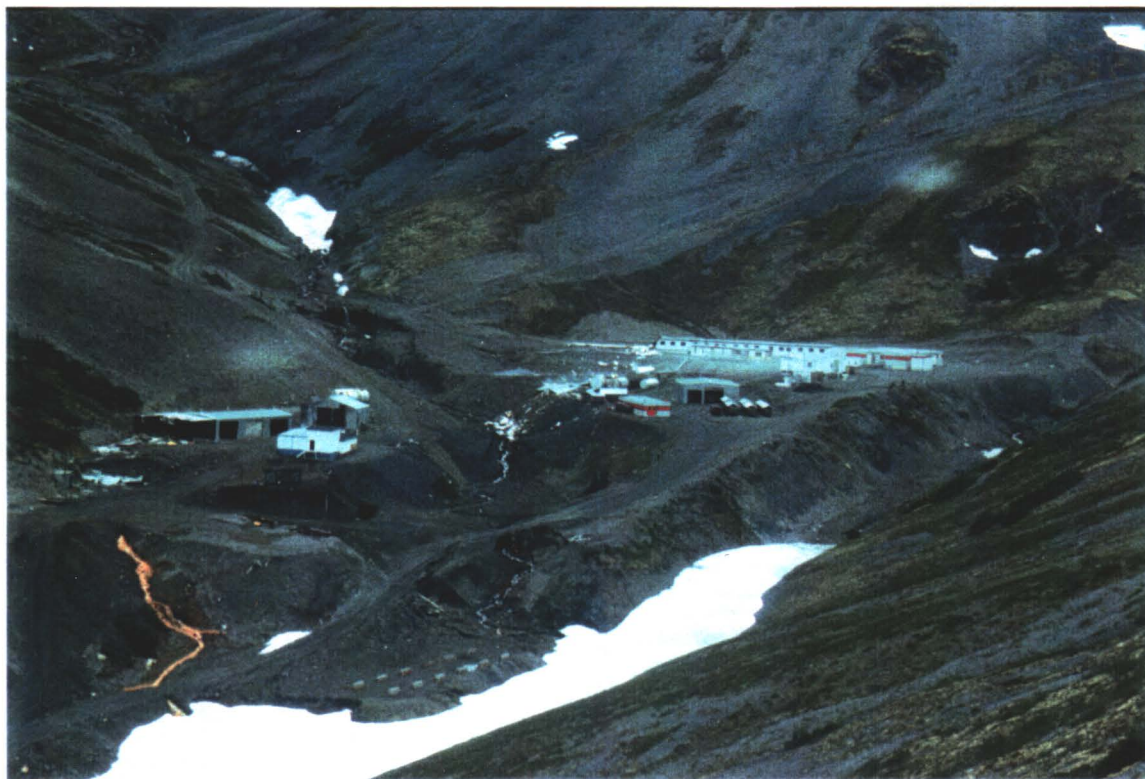
CAMP AND ADIT LOCATION

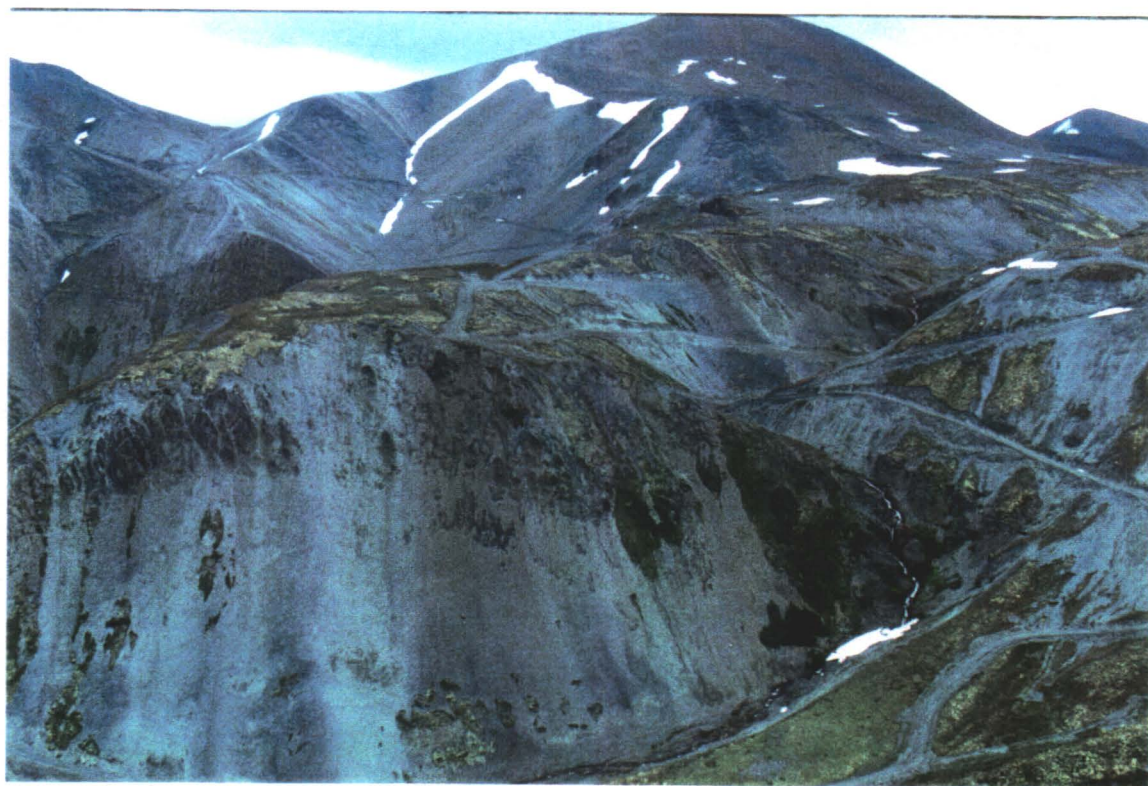
An extensive network of exploration trails and trenched areas cross the site above the camp location. The installation of the trails and trenching has caused a significant amount of surface disturbance over an area covering several square kilometers. This disturbance is in the form of large cut and fill slopes which eliminated any natural vegetation cover over much of this area. These exposed slopes are now much more susceptible to erosion from wind and water.

Extensive road construction and stripping across this area has resulted in damage to the vegetation and surficial soils. The roads and stripping is extensive on very steep slopes and some erosion has been obviously caused from this development. Vegetation over the trenched areas is sparse so destruction of vegetation does not appear to have been significant. Site remediation, if it was undertaken, would consist of reshaping cut slopes to blend with the natural slopes and revegetating the site. This method of remediation would be very costly and also result in additional disturbance to the site setting back any revegetation that may have started. Instead, it is recommended that leaving the site to recover naturally is the most suitable solution for this site. However, it must be understood that recovery of the site will be slow in this area that is extremely remote, dry, and sensitive to disturbance. Revegetation of the site is likely best left to natural reseeding due to its remoteness, and the difficulty of promoting growth in an extremely dry environment with very poor soil.

TRENCHING AND DRILL AREA

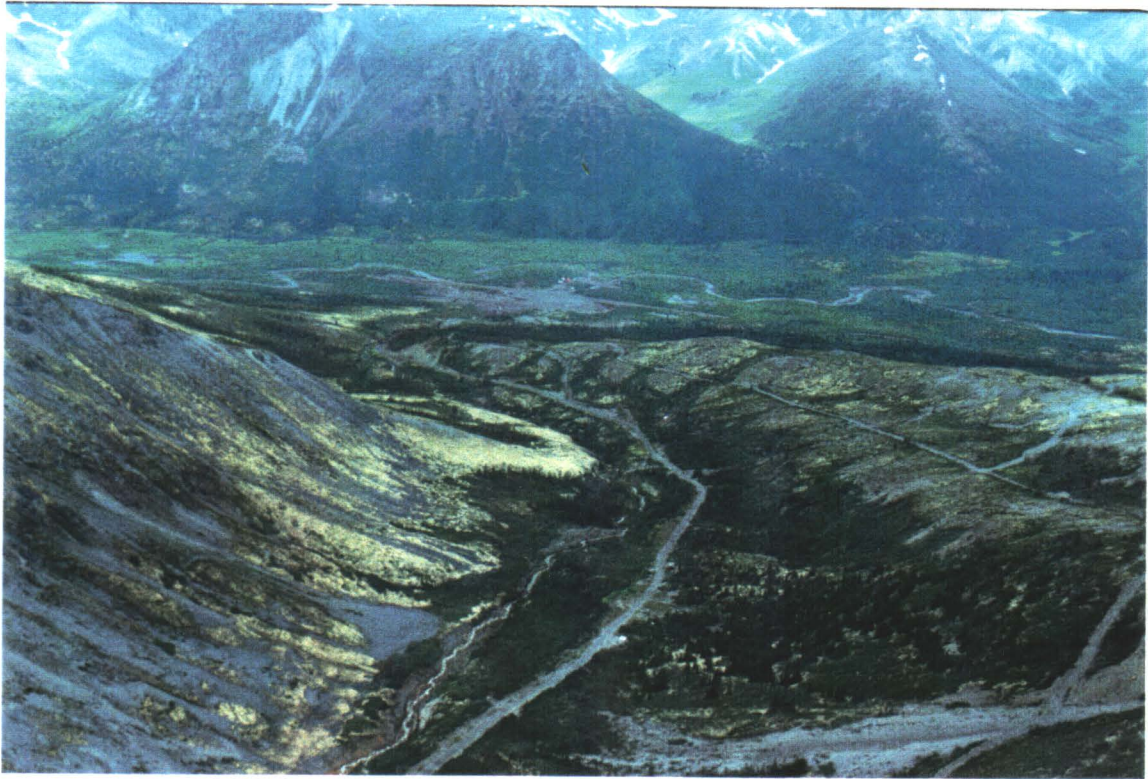
ACCESS ROAD BETWEEN NORTH CANOL ROAD AND SITE

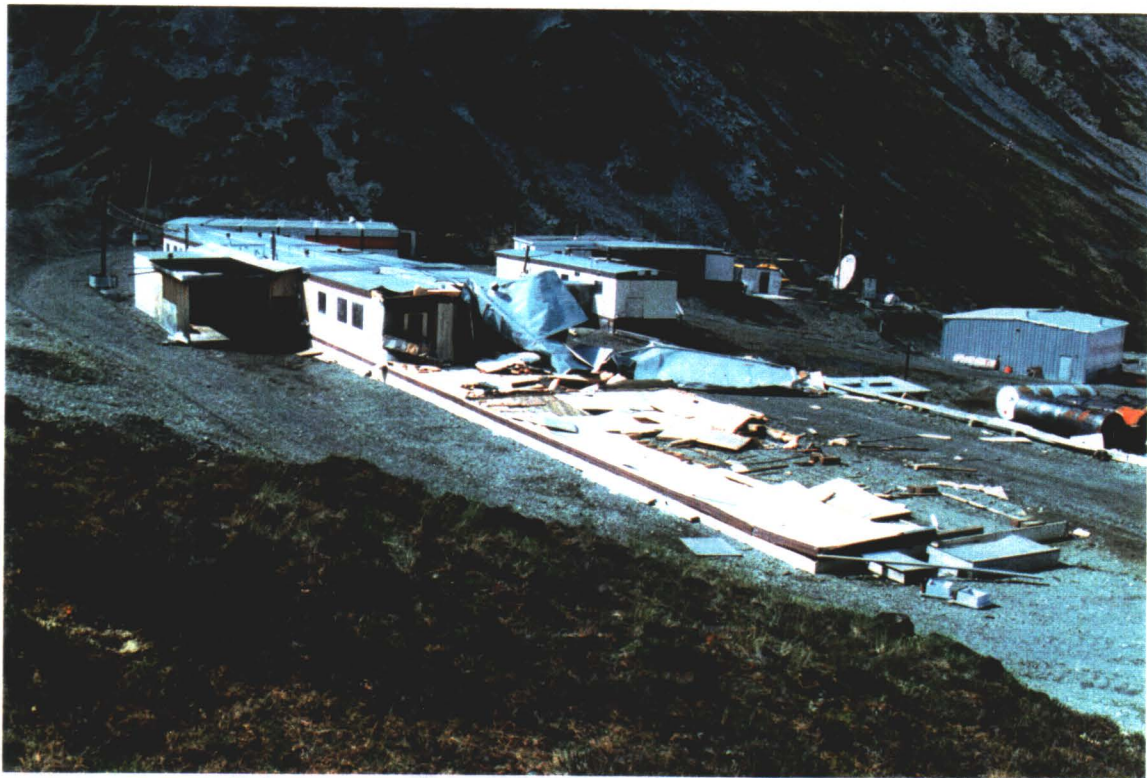
As noted the camp and adits are located near the headwaters of a confined mountain creek. This location is confined in a narrow valley that is susceptible to avalanches. A recent avalanche through the camp has eliminated four trailers and scattered debris from these trailers downslope into the tank farm area. This avalanche also dislocated large empty fuel storage tanks from their cradles in a dyked containment area..

CAMP SITE AND DEMOLISHED TRAILERS FROM AVALANCHE

It is also recommended that all the infrastructure be removed from the site. Failure to remove the trailers, tanks, and core from the site will result in further deterioration of this infrastructure and materials. This should be considered a **MEDIUM** priority because of the potential damage from future avalanches. Clean-up could be accomplished by removing all material by road during the summer.

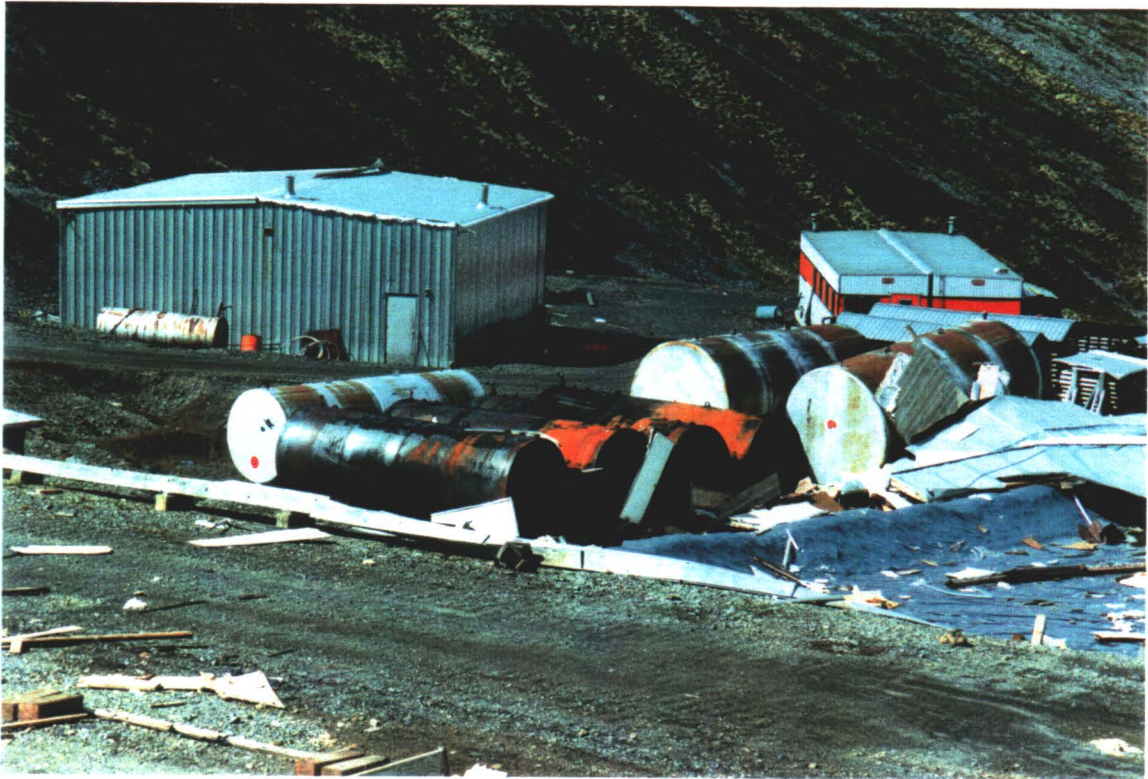
FUEL STORAGE TANKS, WORKSHOP, AND DEBRIS FROM TRAILERS

It is recommended that the hydrocarbon products be removed from the site. This should be considered a **HIGH** priority.

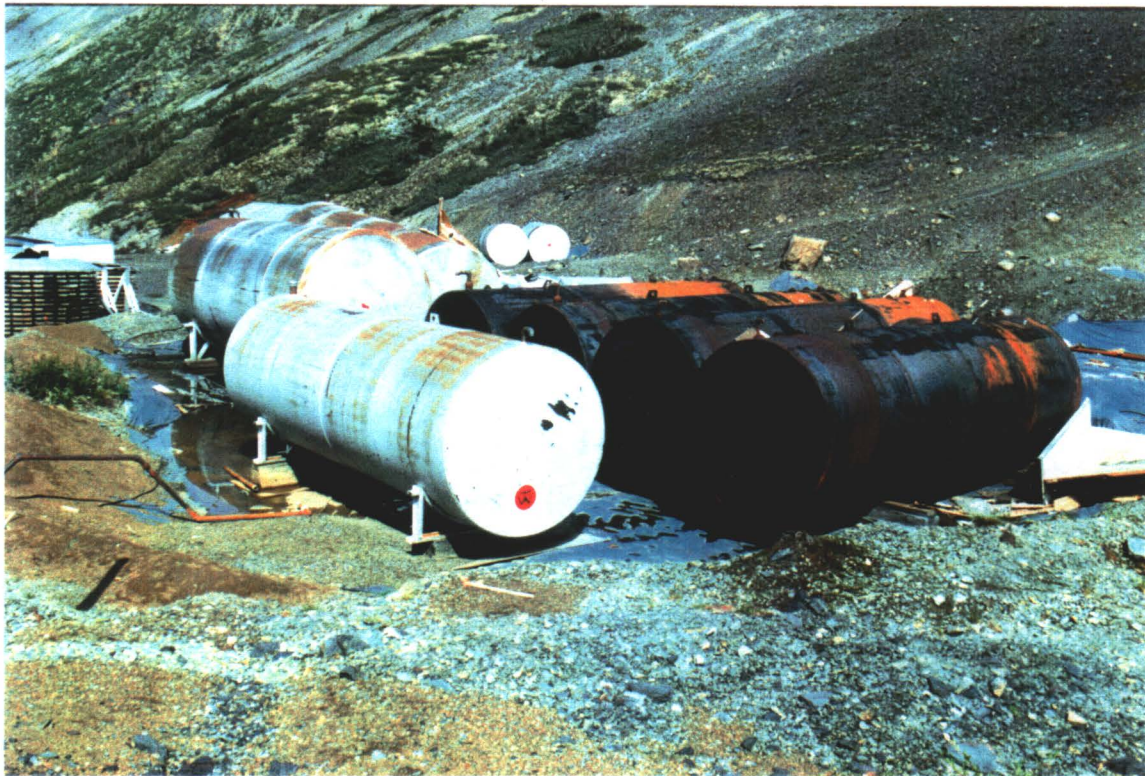
FUEL STORAGE TANKS

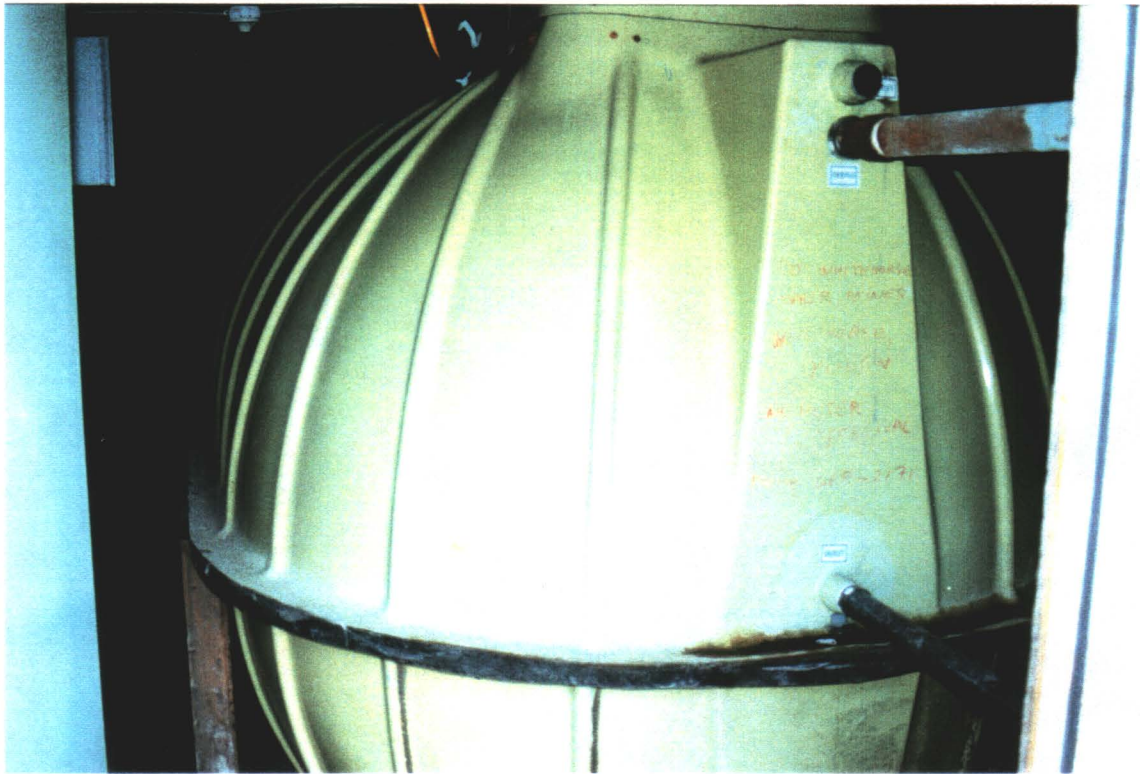
WATER STORAGE TANK

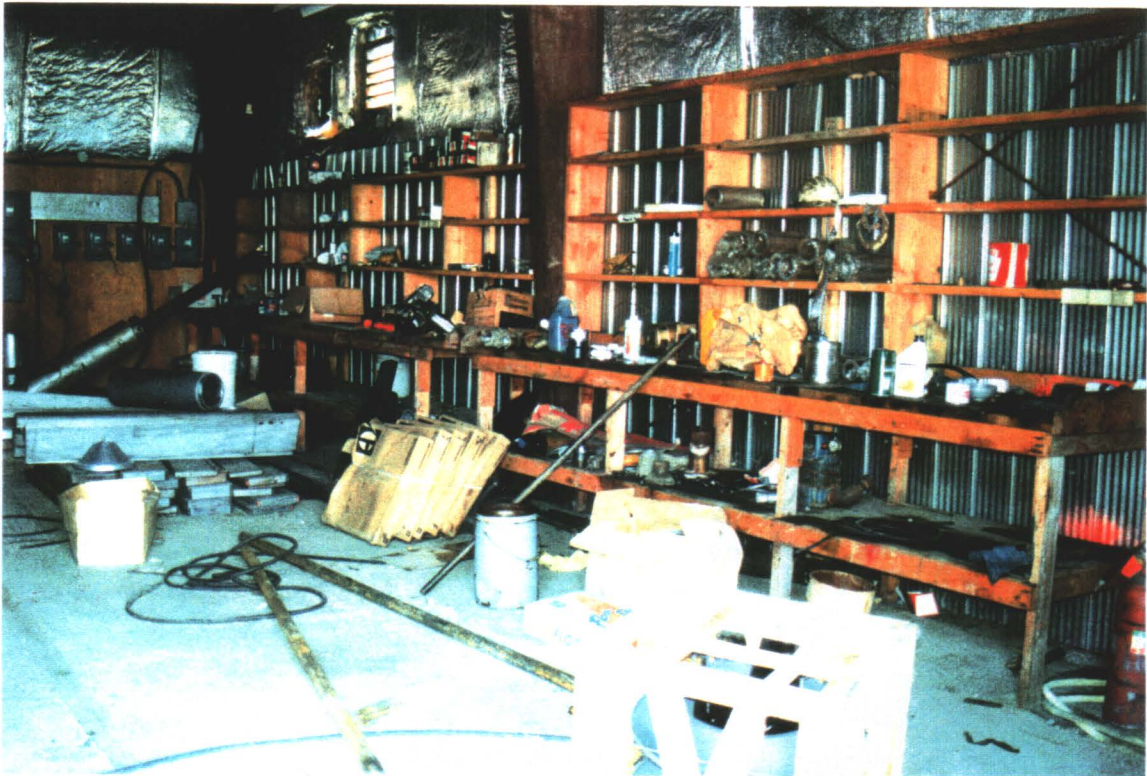
- 1 - 12x13m Stran metal clad workshop with concrete floor. Core, equipment parts, lead-acid batteries, fire extinguishers, electrical switching equipment, etc. is scattered throughout this workshop.

INTERIOR OF WORKSHOP

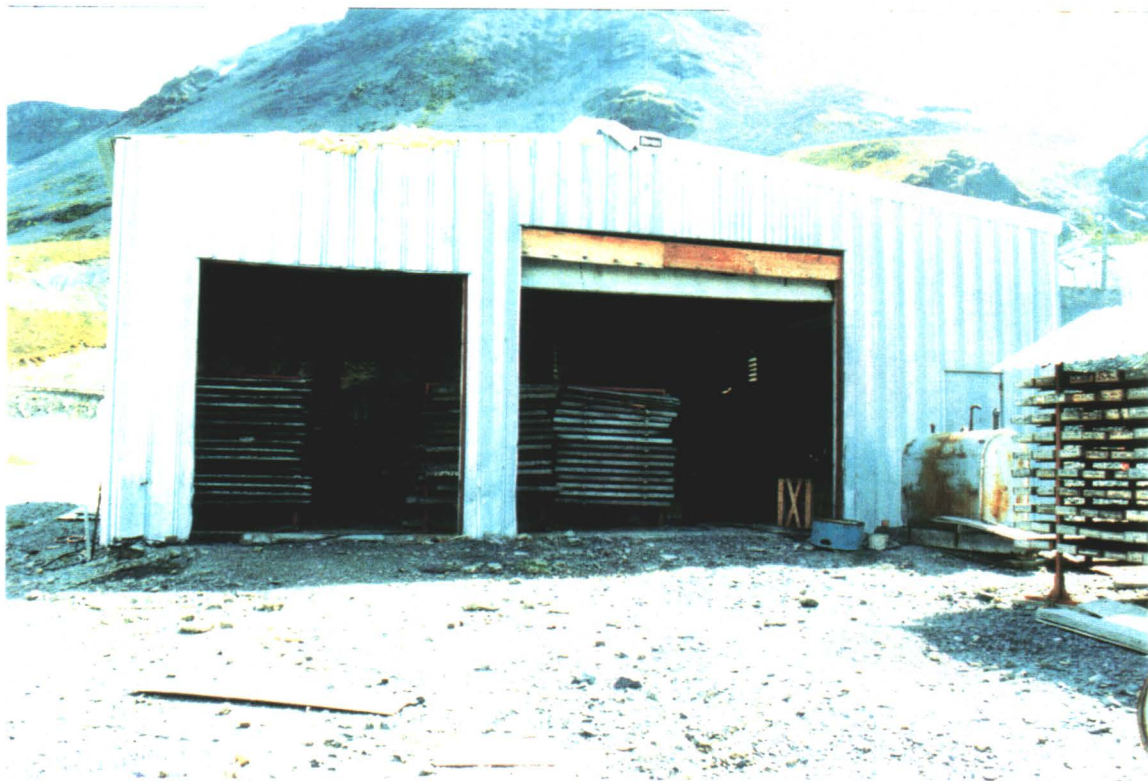
WORKSHOP AND CORE STORAGE

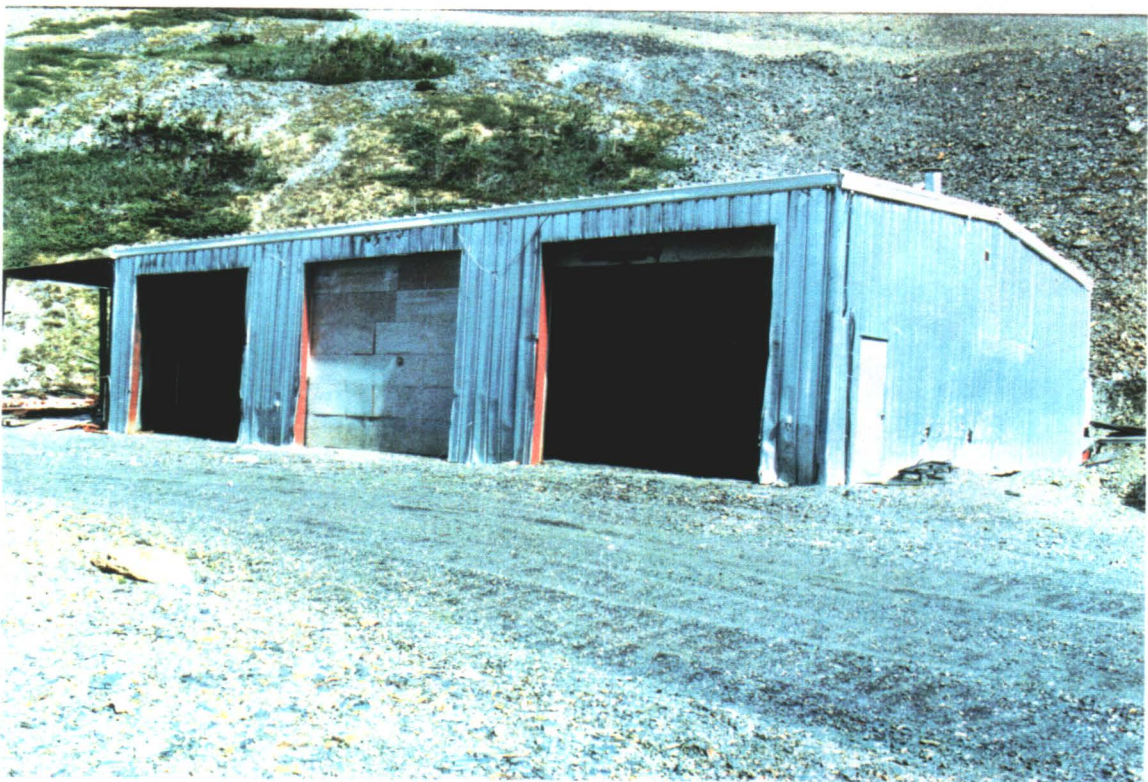
3 BAY GARAGE

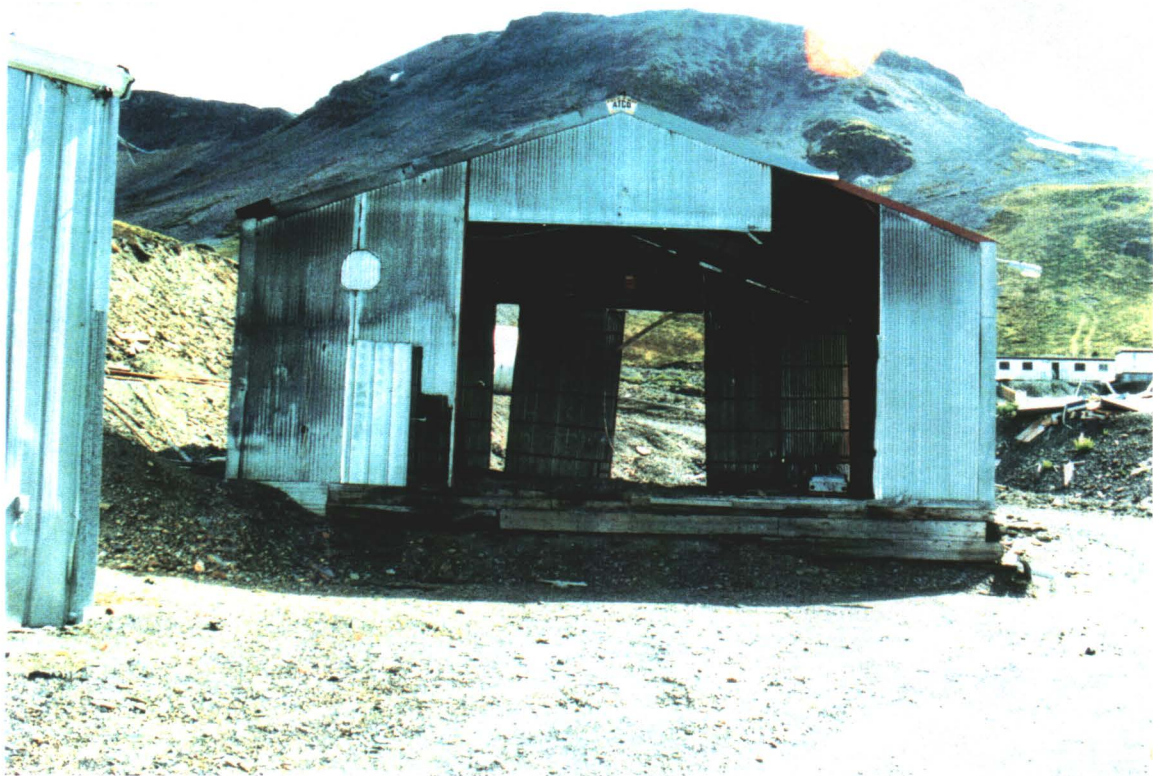
WORKSHOP

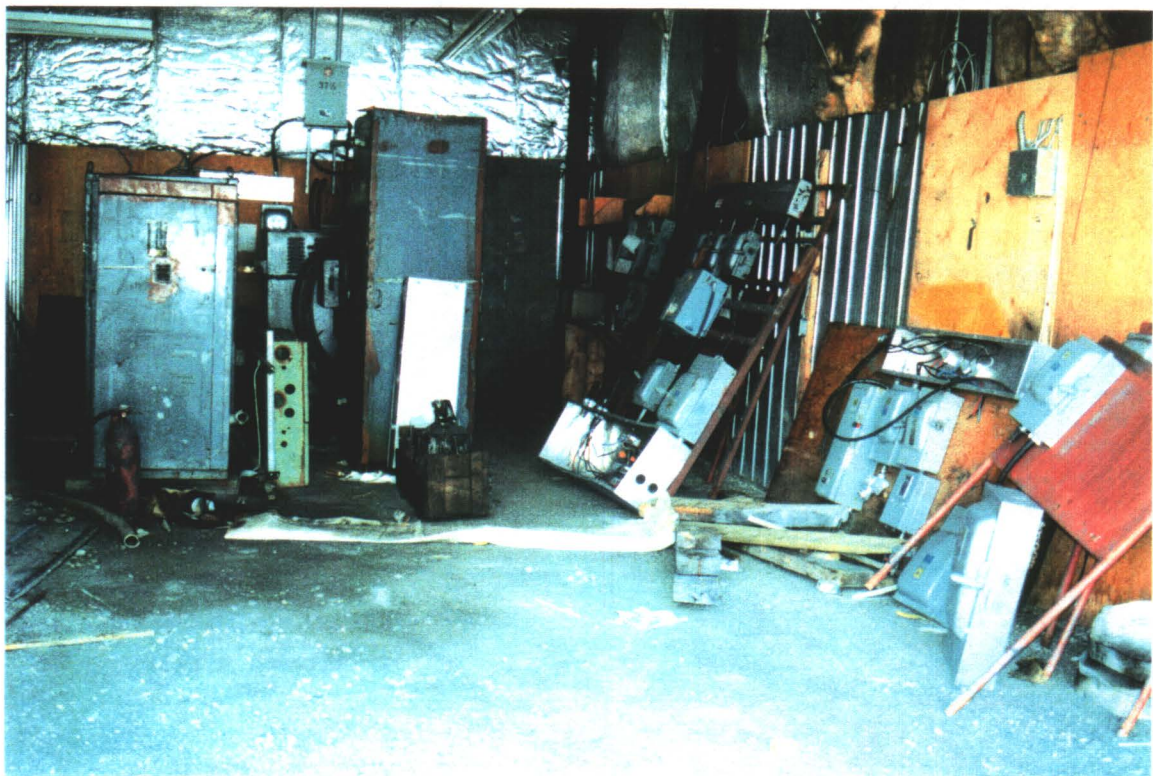
INTERIOR OF 3 BAY GARAGE

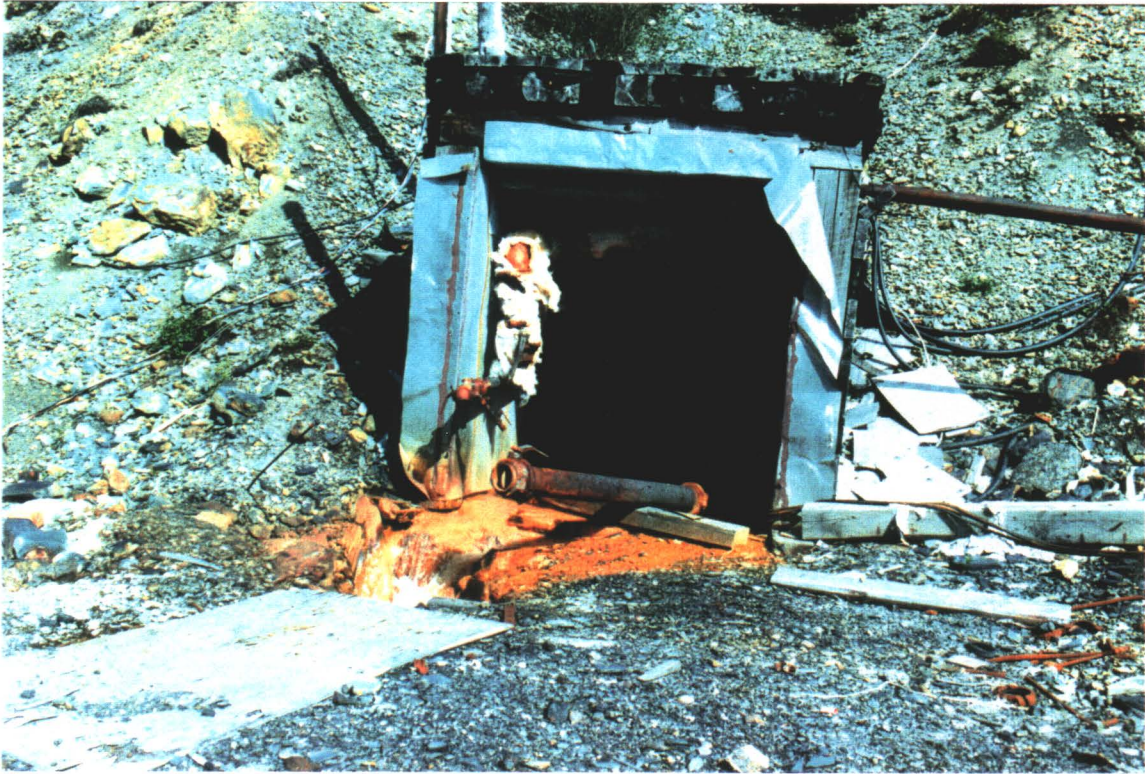
Two open adits remain at the site. A large volume of water (estimated to be between 100-200litres/minute) is flowing from one adit and draining in a channel it cut to the creek below. This water appears to have a high iron content due to orange staining. Piping extends into this same adit. The other adit was dry and appeared to be the adit used for exploration. Snow from the previous winter was still not melted at the entrance at the time of inspection on 1993/07/27.

ADIT (NOTE WATER DRAINING AND VENTILATION AND WATER PIPES)

Two adits are located beside the camp site and accessible by road. These adits are open and accessible to the public. Even though these adits are located in a remote location they still pose a safety hazard and it is recommended that they should be properly sealed to prevent anyone from entering them. This should be considered a **HIGH** priority.

The large volumes of water draining from one adit should not be blocked.

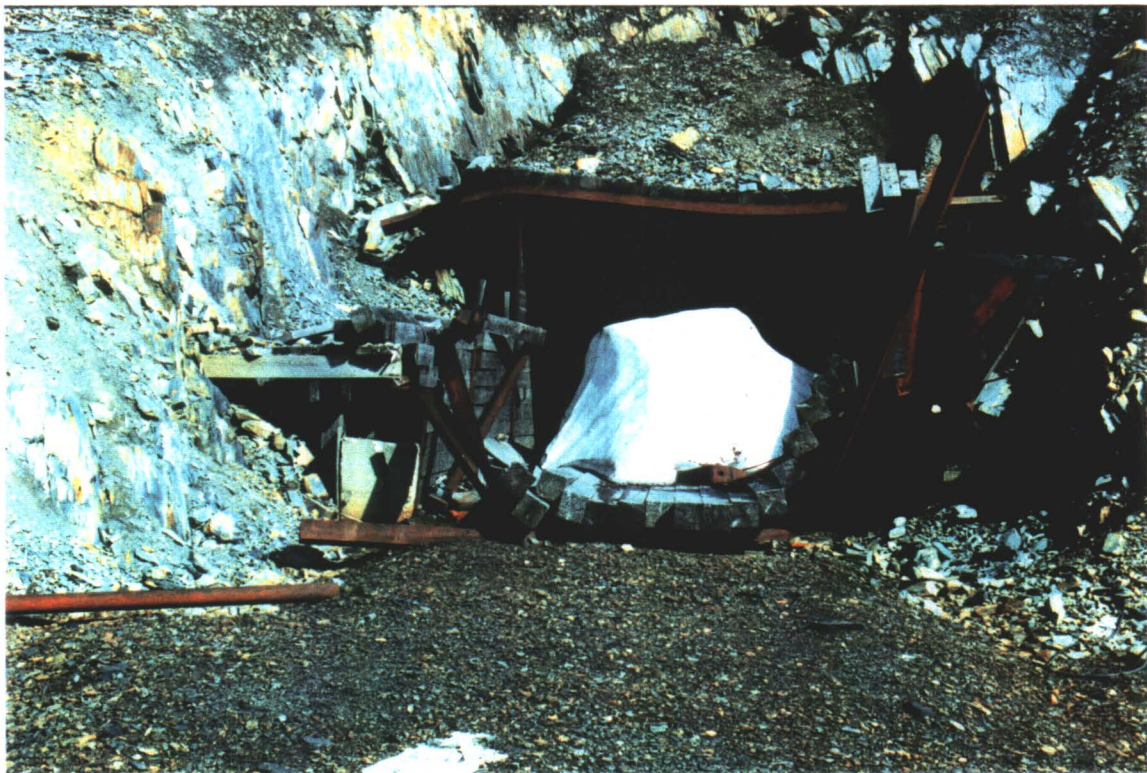
MAIN COLLAPSING ADIT WITH SNOW AT ENTRANCE

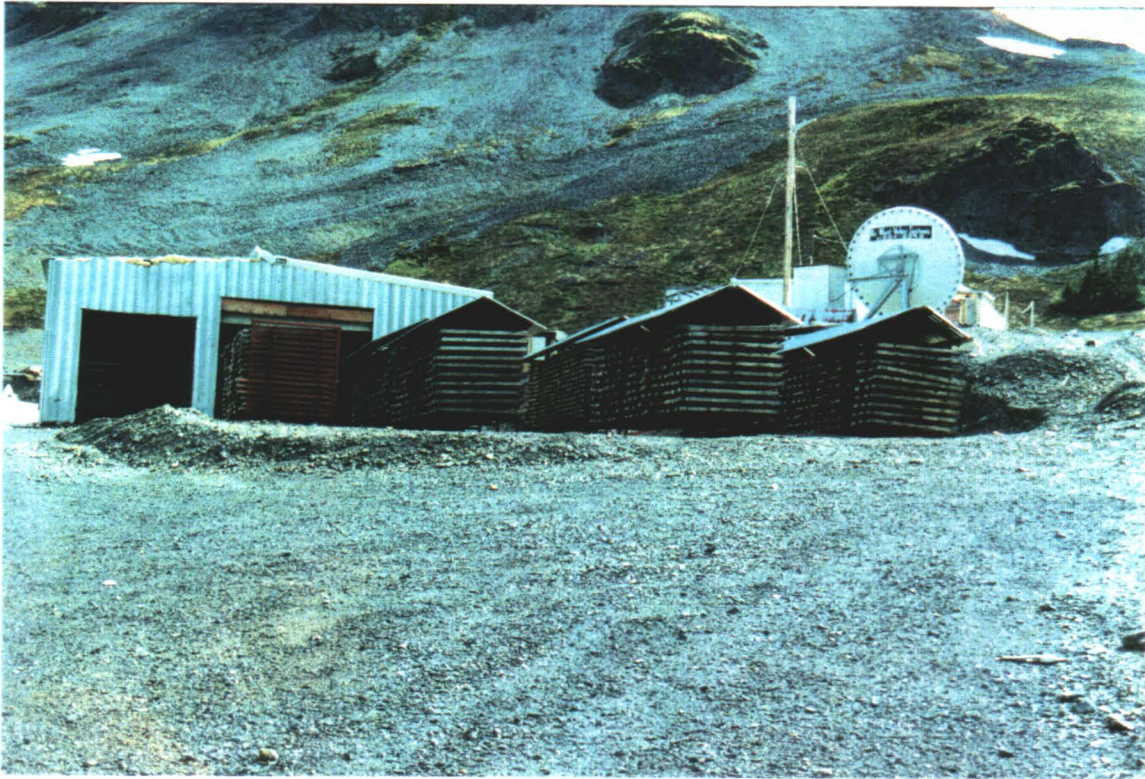
CORE STORAGE AND SATELLITE RECEIVING SYSTEM

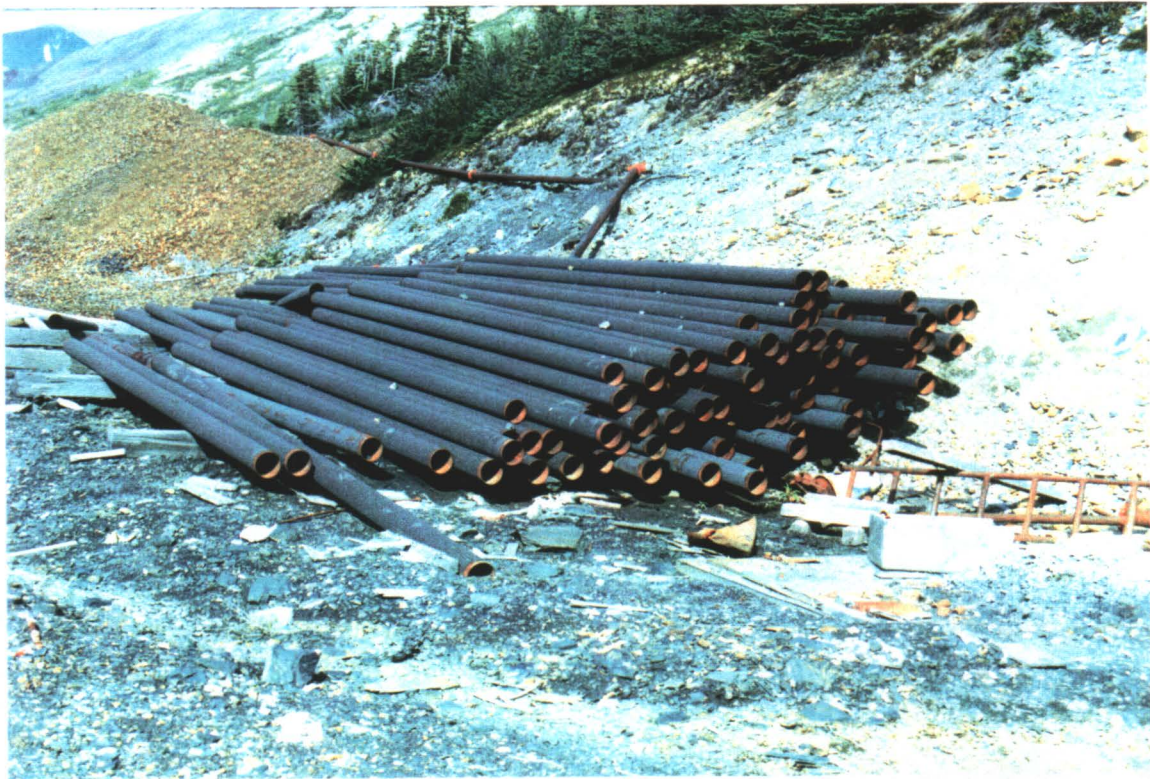
VICTAULIC PIPE
