ASSESSMENT REPORT

105M-14-1

TUNDRA

DIAND TECHNICAL SERVICES

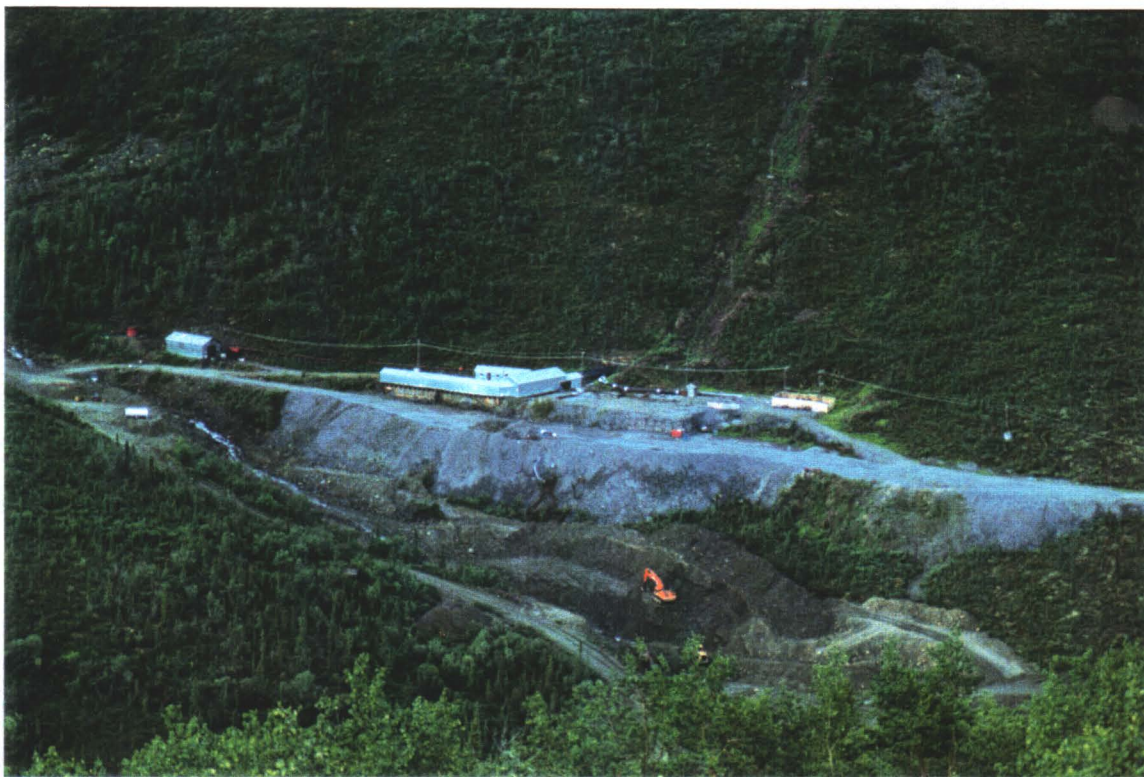
BELLEKENO MINE SITE

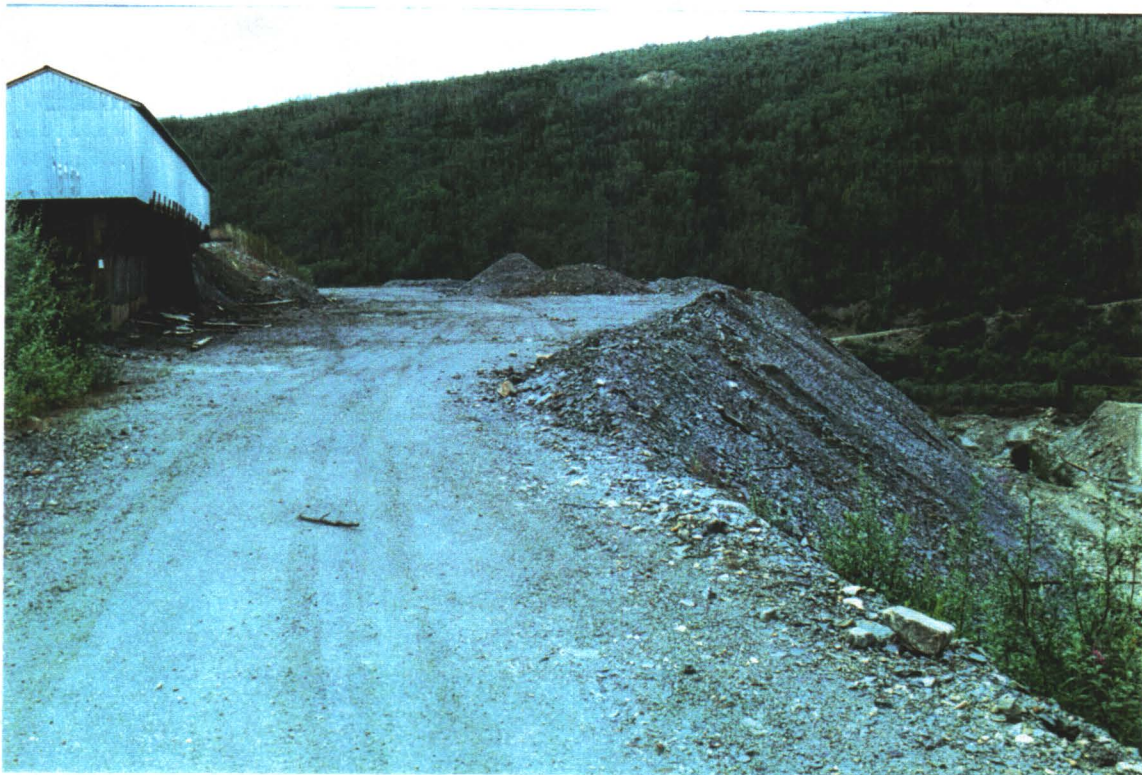
Waste rock has been dumped downslope of the adit and loadout structure. This waste rock has been spread over a length of at least 300m between the mine and Thunder Creek. The toe of the rock waste approaches the top of the bank of Thunder Creek at the upstream side of the site. The waste rock has been flattened and is used as a driving surface to get around the mine.

MINE LOADOUT AND WASTE DUMP

The large rock waste dump consisting of resident rock has been placed between the adit and the creek. No chemical treatment of this rock is evident as there is no mill present or any tailings pond. It appears that this rock is stable and is not causing any environmental problems. Site remediation of this waste rock, such as revegetation, is not considered practical. It is recommended that this waste rock be left in its present condition.

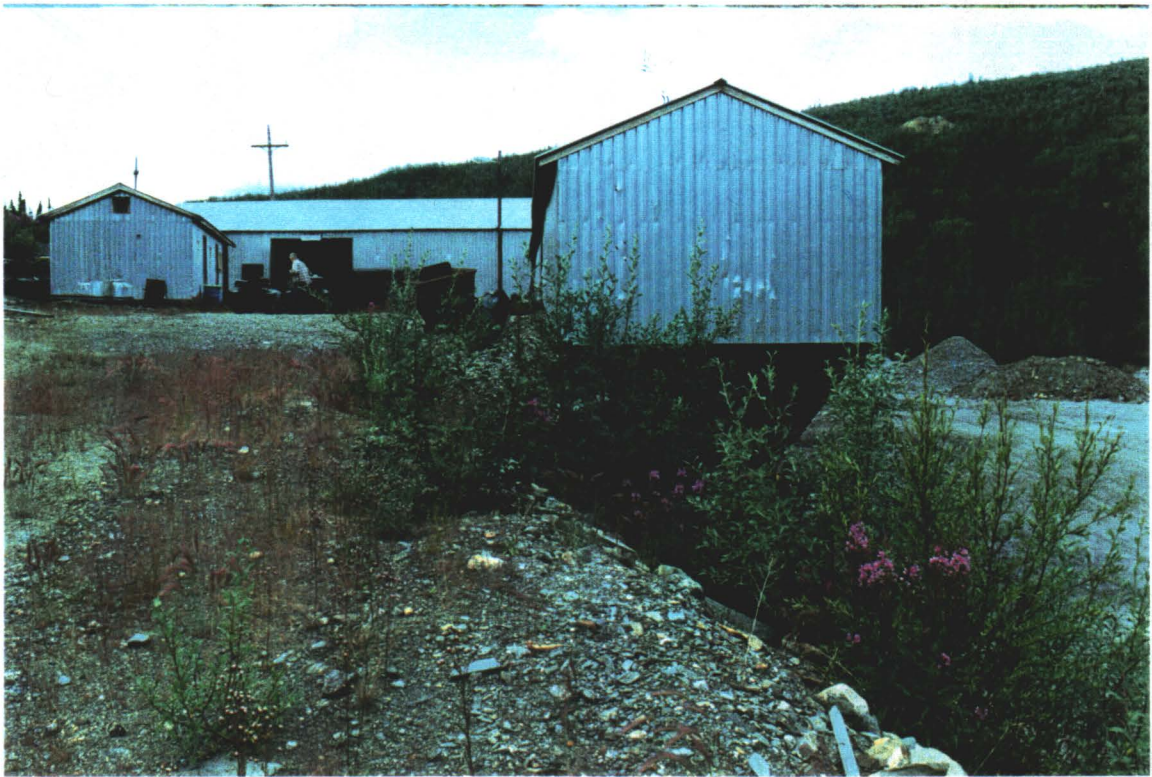
LOADOUT, ENTRANCE TO ADIT, AND STAFF BUILDING

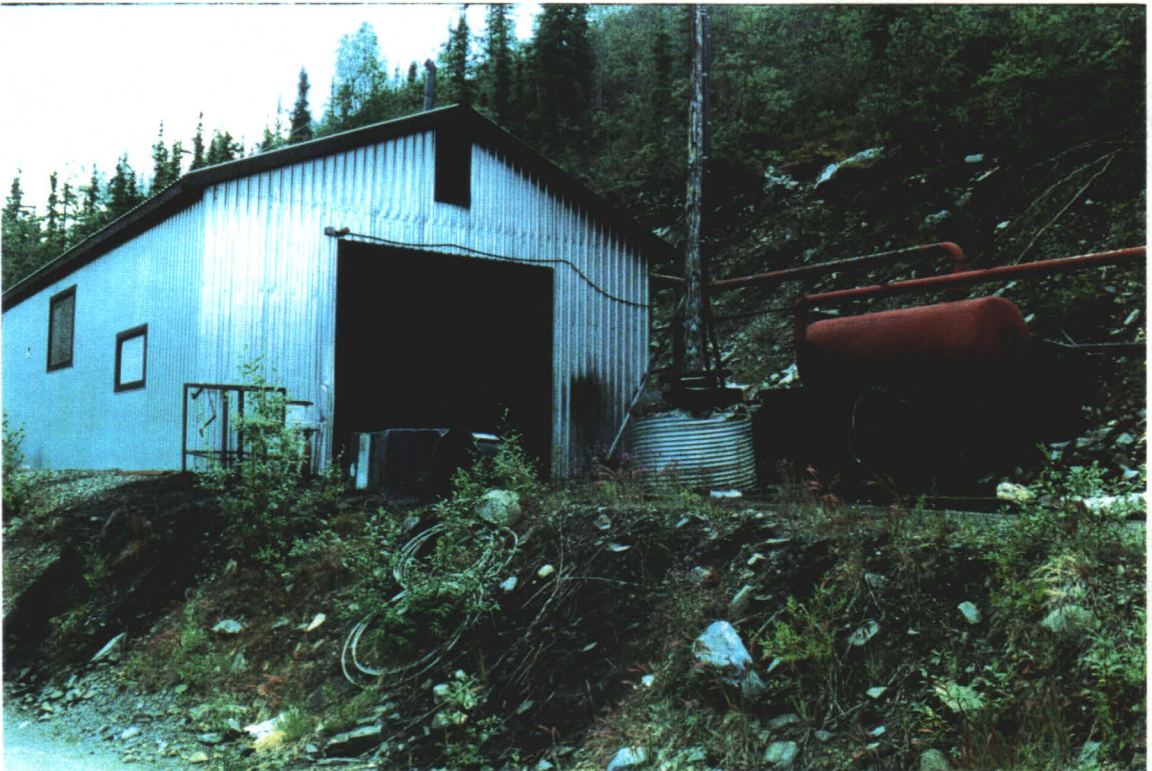
GENERATOR BUILDING (NOTE FUEL SPILL)

Very little hydrocarbon products were found on-site and any spillage that could occur would cause minimal damage to the environment, however it is recommended that any hydrocarbon products be removed. All barrels and tanks, once empty, should be removed. A **MEDIUM** priority should be placed on removing these products and tanks. It was observed that hydrocarbon products had been spilled around the generator building. The ground was stained all around the area of this building. This spillage likely took place when the mine was in operation and there is no evidence to indicate that any recent spilling has taken place. It appears that this area of ground contamination is quite small, however the extent of this contamination could only be confirmed by completing a soil sampling and analysis program. This type of program should be considered if it is suspected that the environment and/or people are being impacted downstream of the site, and there are negative consequences from this damage. A site remediation plan can only be established once the sampling program and analysis is complete.

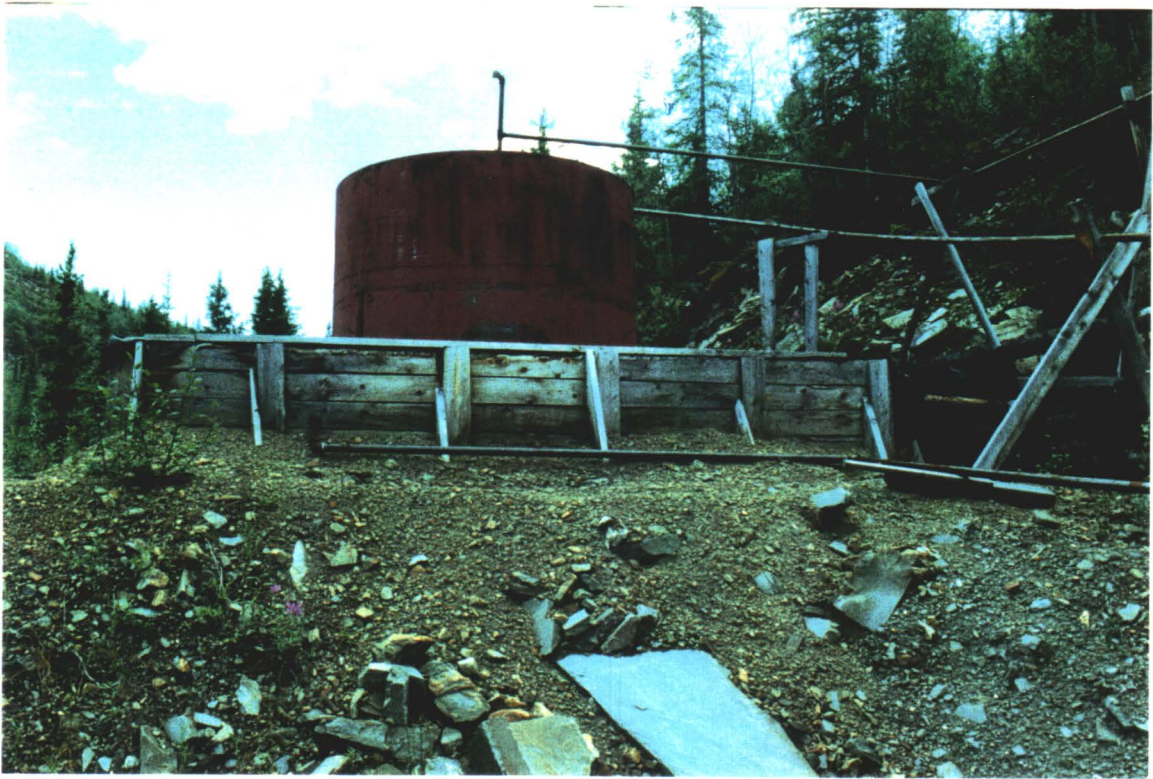
FUEL TANK

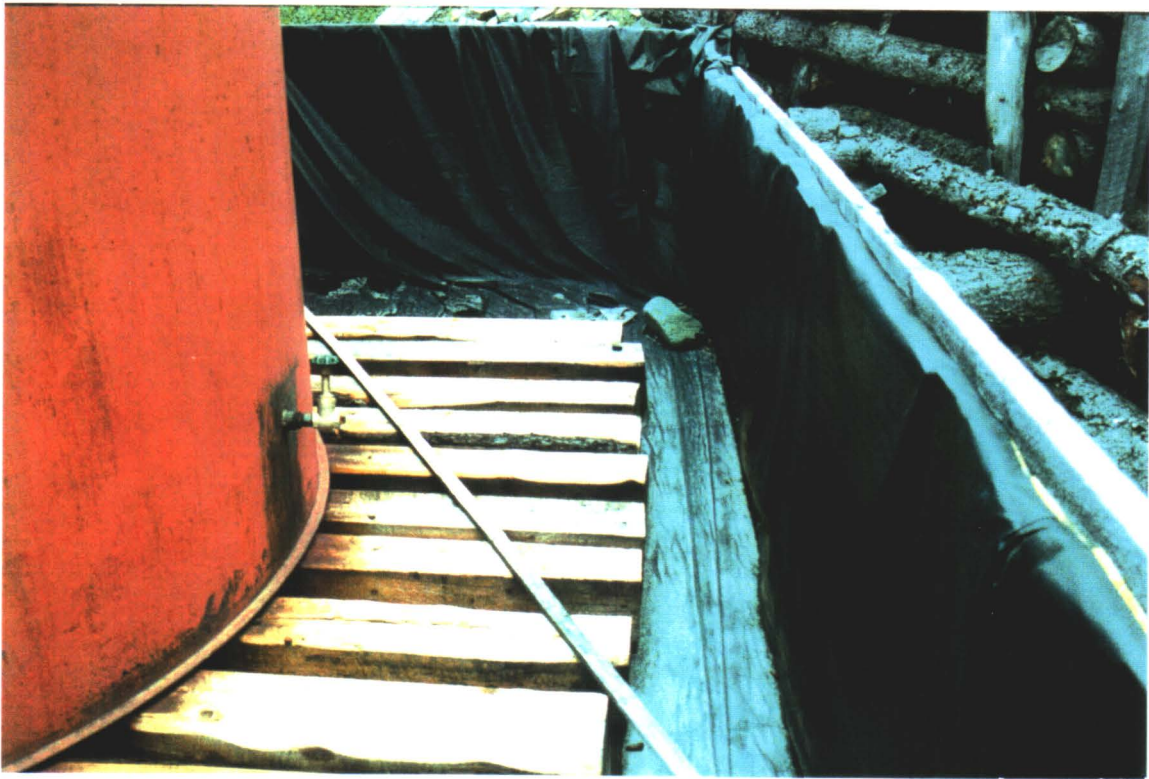
- 2.8m diameter x 3.05m high fuel storage tank. Tank appeared empty at time of inspection. This tank was contained in a wood frame dyke and lined with a plastic liner. This liner is quite brittle and may leak. The tank is supported on levelled wood timbers beneath the liner.
- 1.2m diameter x 1.5m long fuel tank inside workshop/generator building.
- 2-204 litre barrels of hydraulic oil inside workshop/generator building.
- 681 litre Tidy Tank on an ore car with an estimated 450 litres of diesel fuel remaining.

BASE OF FUEL TANK AND DYKE LINER

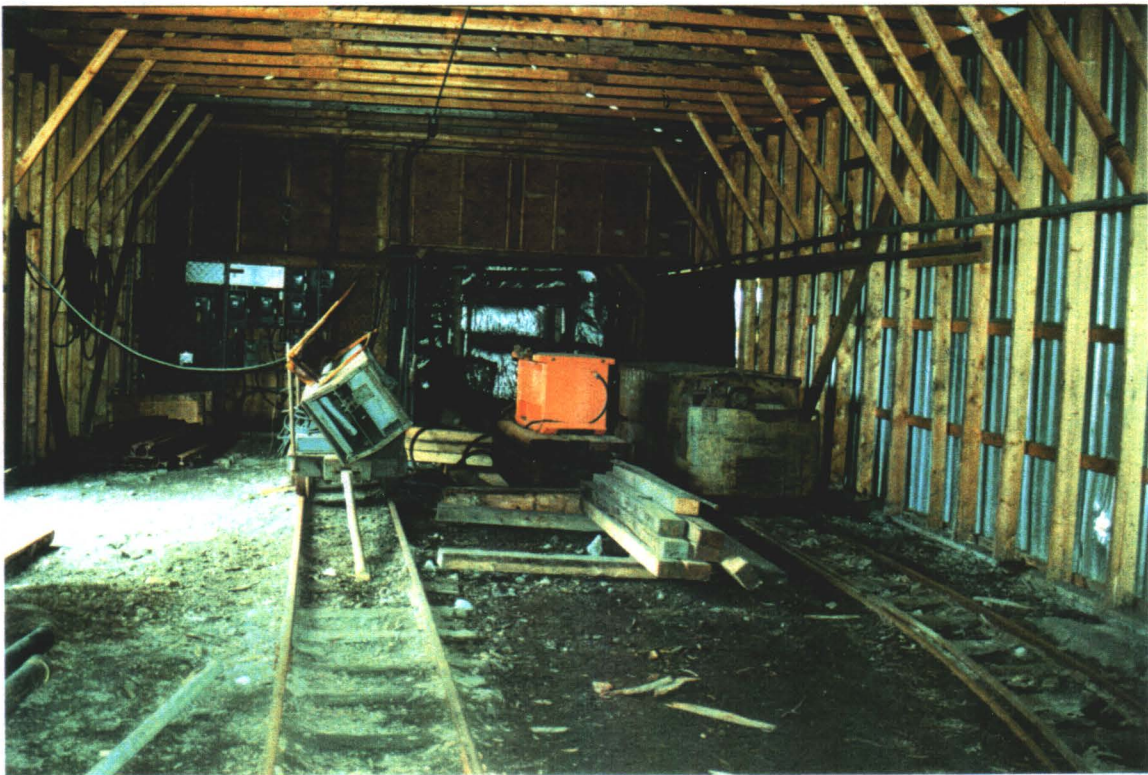
**ENTRANCE TO ADIT, ELECTRICAL SWITCHING GEAR, AND LOCOMOTIVE
INSIDE MINE ENTRANCE BUILDING**

Overhead electrical services extended across the site from a base of transformers located at the north side of the site. It is recommended that these transformers be tested to verify whether or not any polychlorinated biphenols are present in the oil. The necessity to remove these from the site can be determined once this testing is completed. This testing is considered a **HIGH** priority.

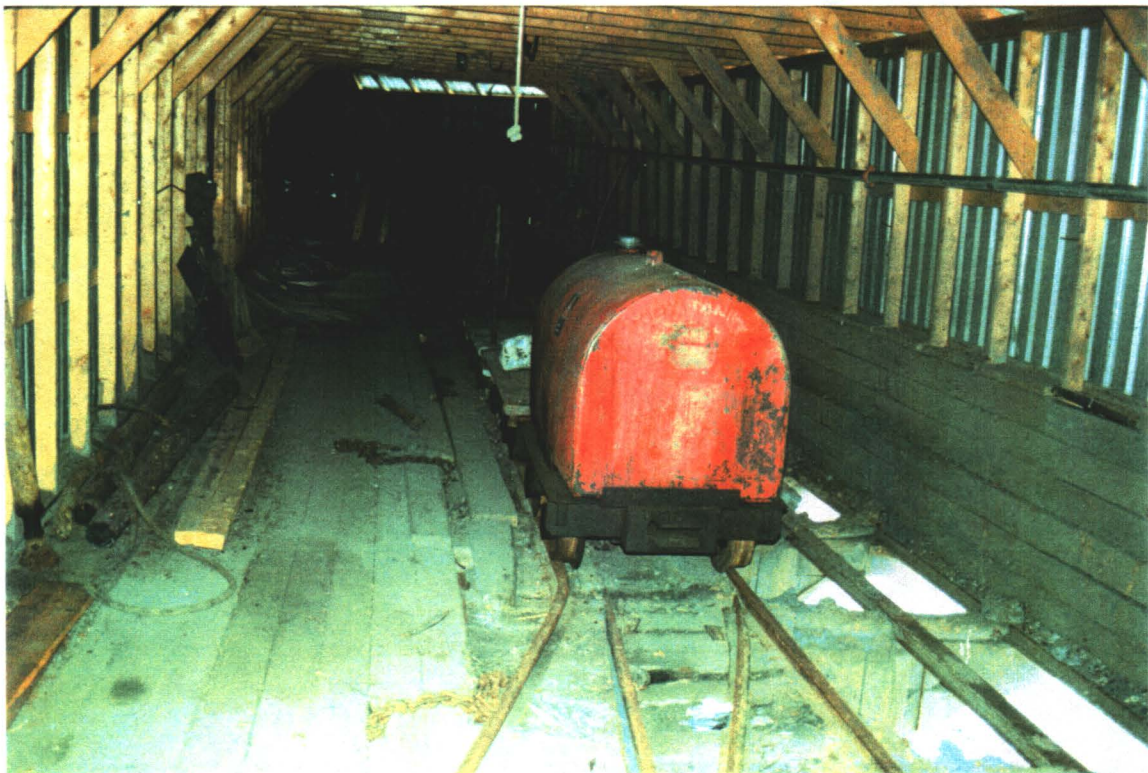
- 10 ore cars (8 are on the tracks inside close to the ore dump, 2 are outside the ore dump). One ore car is equipped with a loading bucket. **One ore car is fitted with a 681 litre "Tidy Tank" that contains an estimated 450 litres of diesel fuel.**
- Caterpillar generator complete with air handling equipment located in the workshop/generator building,
- wheeled Gardner Denver air compressor located in the workshop/generator building,
- electrical poles and service to the buildings and extending up the slope above the mine **as well as a number of transformers** located in a separate fenced area,
- approximately 60m of 900mm diameter air ducting along with a small fan building,

INTERIOR OF LOADOUT WITH ORE CARS AND FUEL TANK

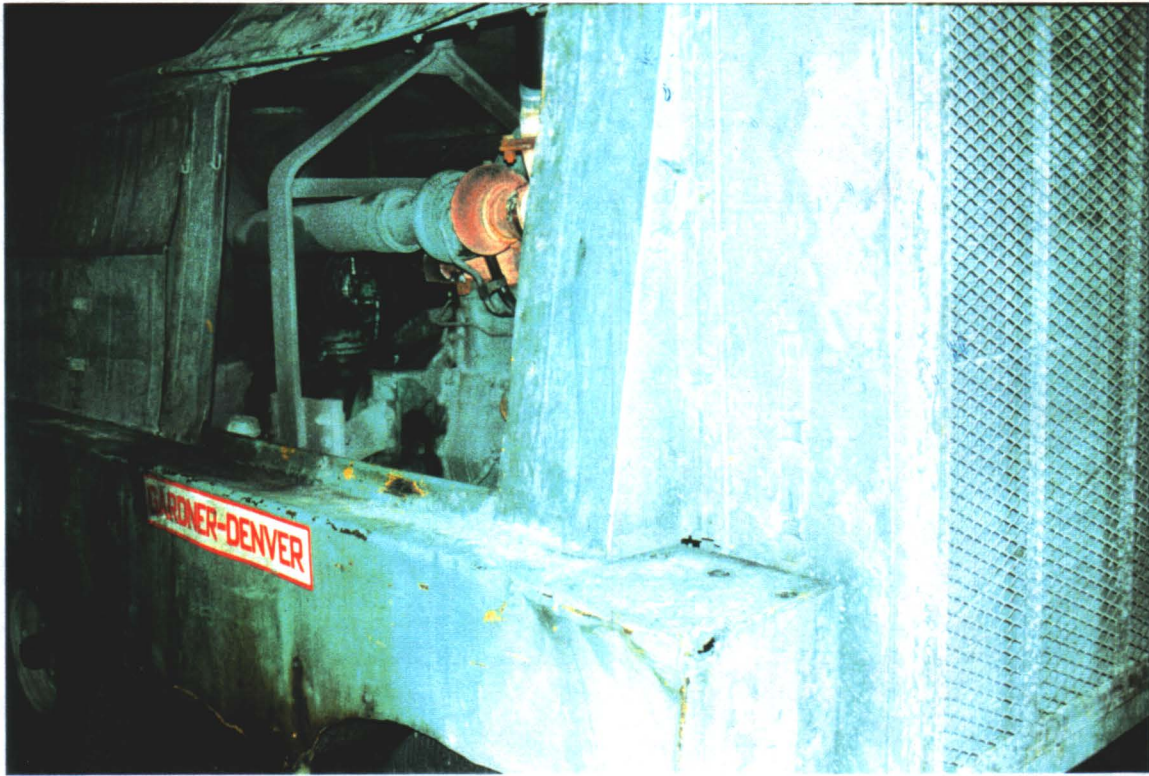
GARDNER DENVER DRILL LEFT ON-SITE

All equipment would need to be loaded and hauled from the site. Some equipment such as compressors, electrical generators, ore cars, and locomotives may have some residual value. Leaving the equipment on-site should not cause any environmental hazard and is considered a **LOW** priority.

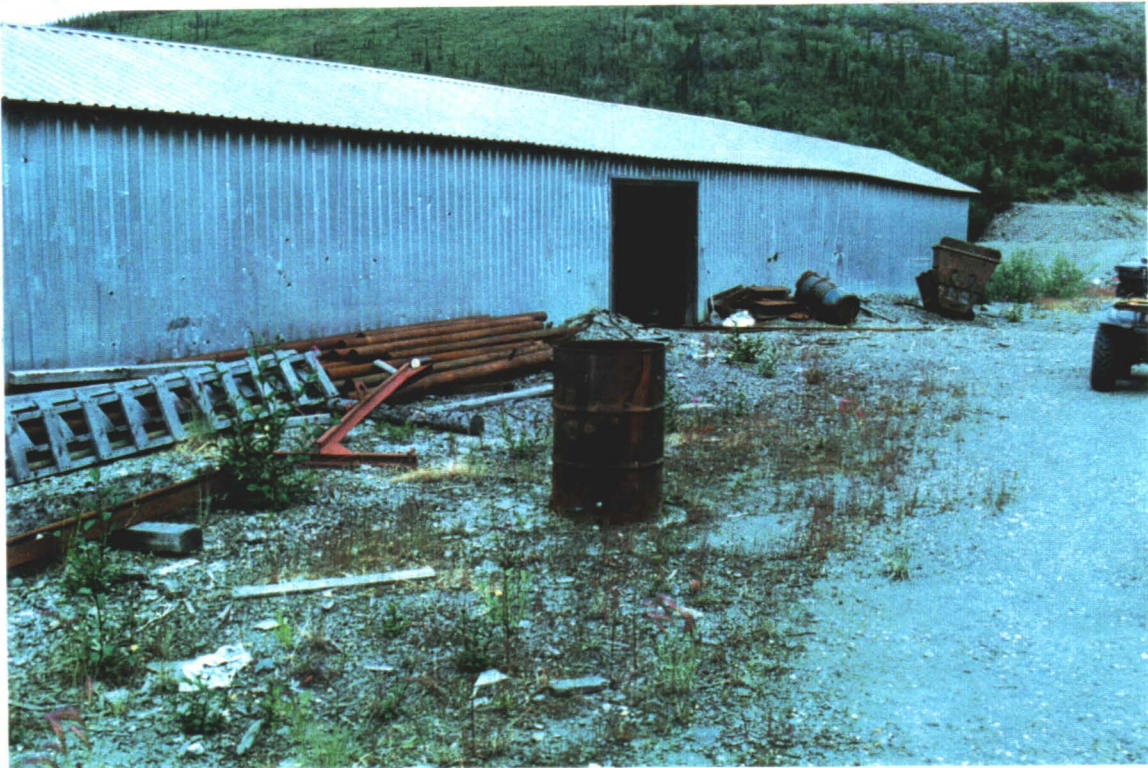
WASTE MATERIAL OUTSIDE LOADOUT BUILDING

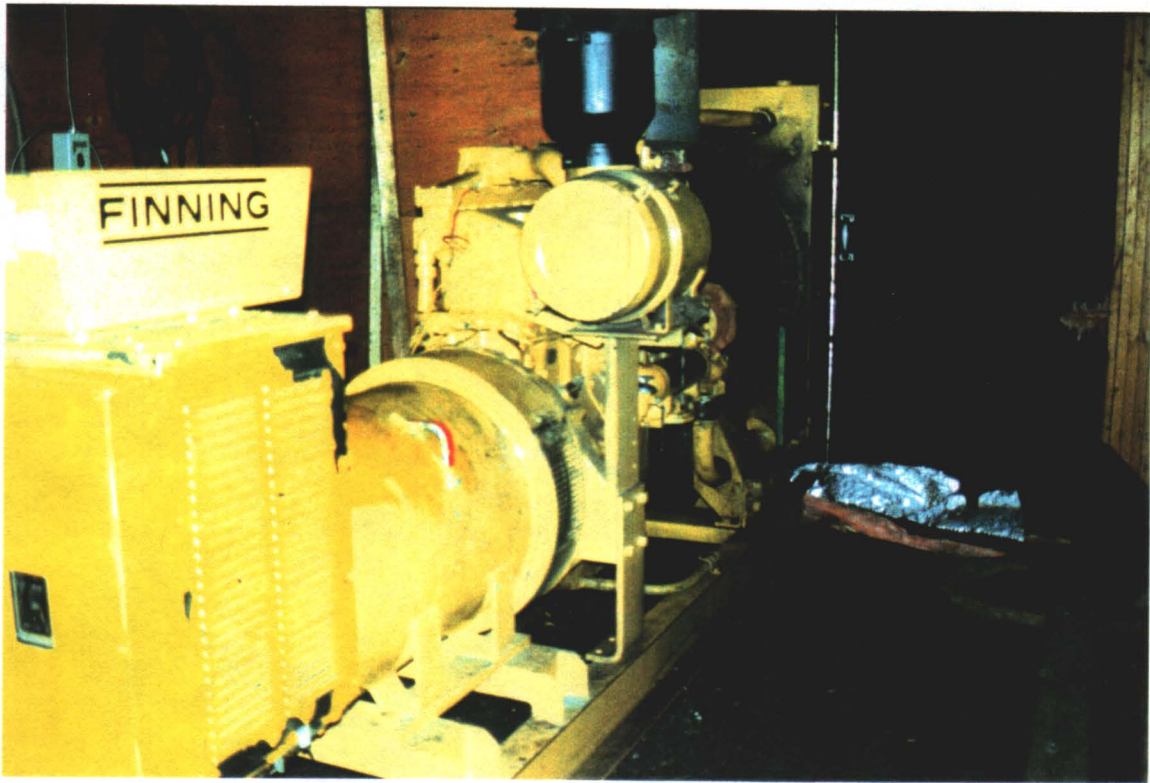
CATERPILLAR GENERATOR INSIDE GENERATOR BUILDING

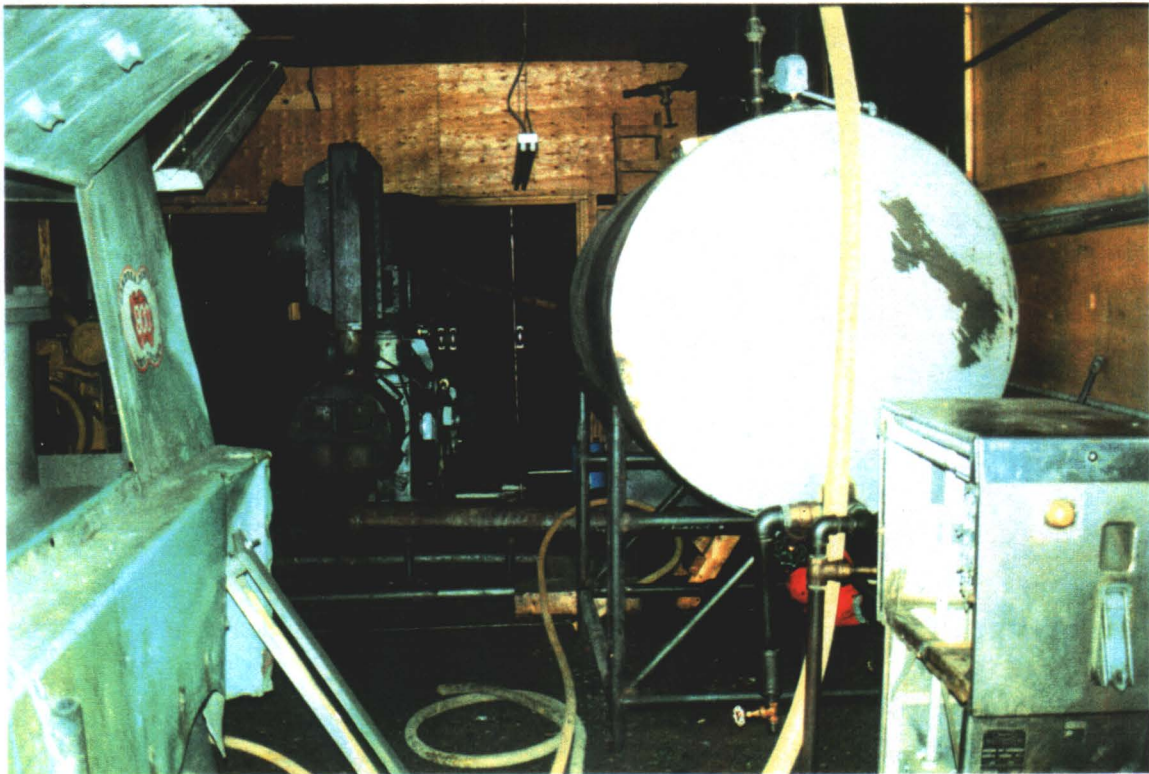
FUEL TANK, FUEL PUMP, AND AIR HANDLING EQUIPMENT

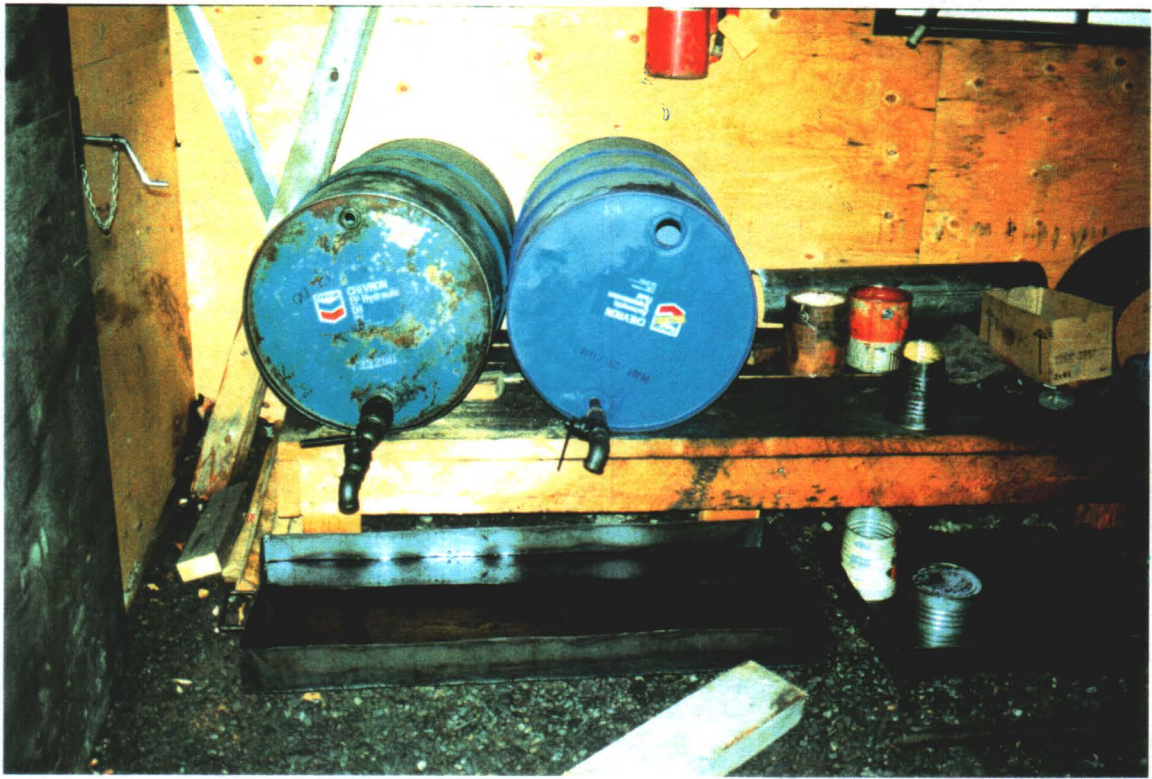
OPEN OIL BARRELS CONTAINING HYDRAULIC OIL INSIDE GENERATOR BUILDING

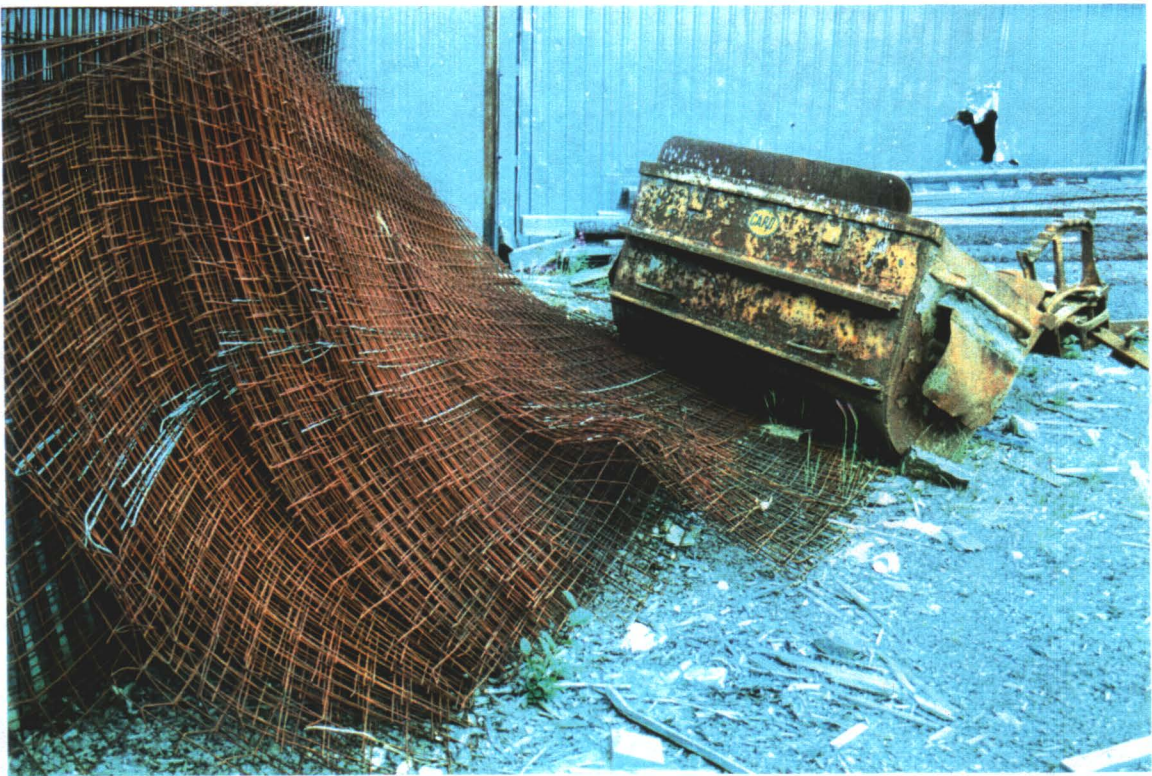
WIRE MESH AND ORE CAR

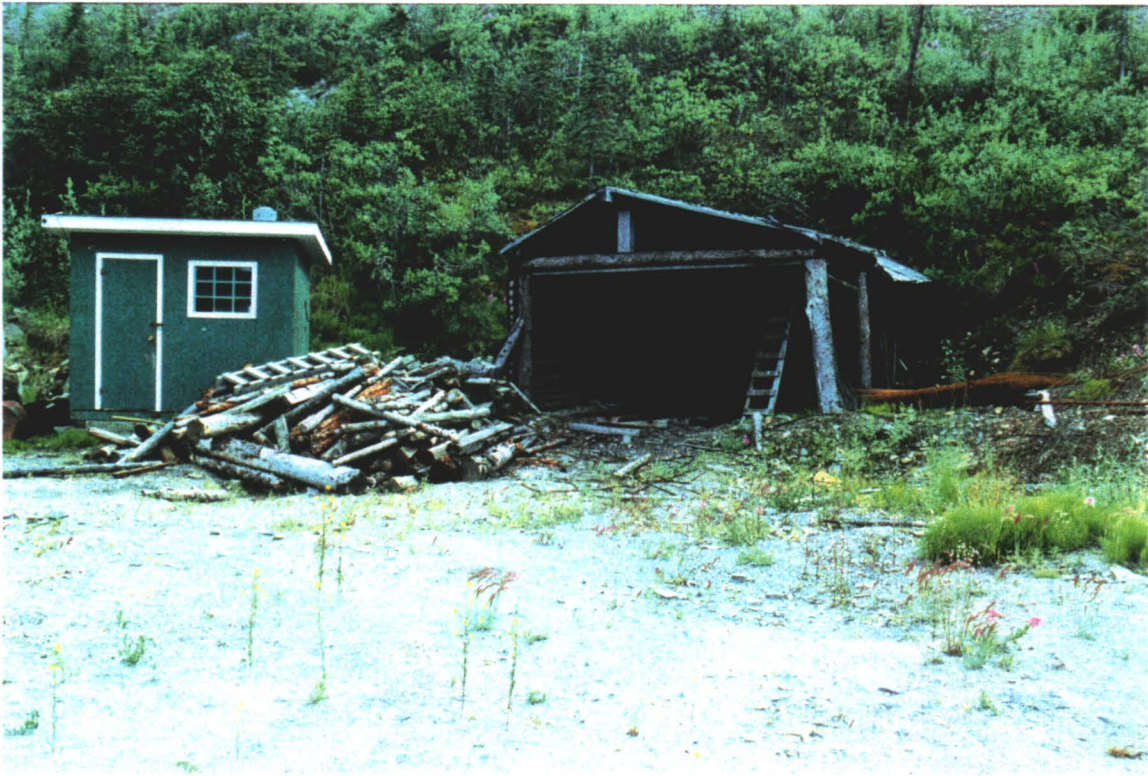
- a 1.8x2.4m plywood clad building. This building was locked and contained what appeared to be an explosives magazine.
- a 2.4x4.8m board clad building. This building is very old and deteriorated.
- a 4.9x7.3m board clad building once used as a dry building. It contains five 204 litre barrels supported in the roof structure, which were used for water storage. A barrel in the middle of the floor remains connected to the overhead barrels.

ADIT TO EXTENSION MINE AND WAREHOUSE WITH EXPLOSIVES MAGAZINE

The owners of the explosives magazine should be contacted to confirm any contents and remove it from site as soon as possible. This should be considered a **HIGH** priority.

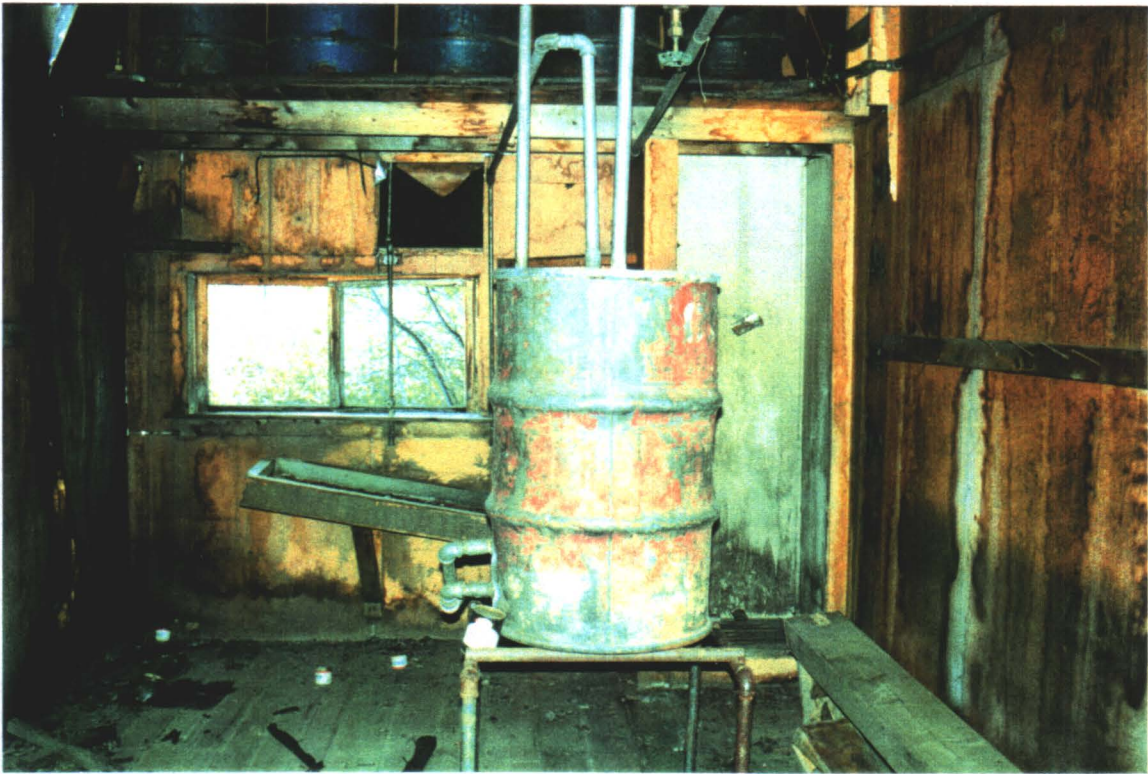
INTERIOR OF DRY BUILDING

All buildings are old, constructed of wood, and deteriorating. These buildings could be burned to eliminate any future hazard. Any metal, such as the barrels, etc. inside these

buildings should be removed and hauled from the site prior to any demolition of these buildings. Removal of these buildings is considered a **LOW** priority.

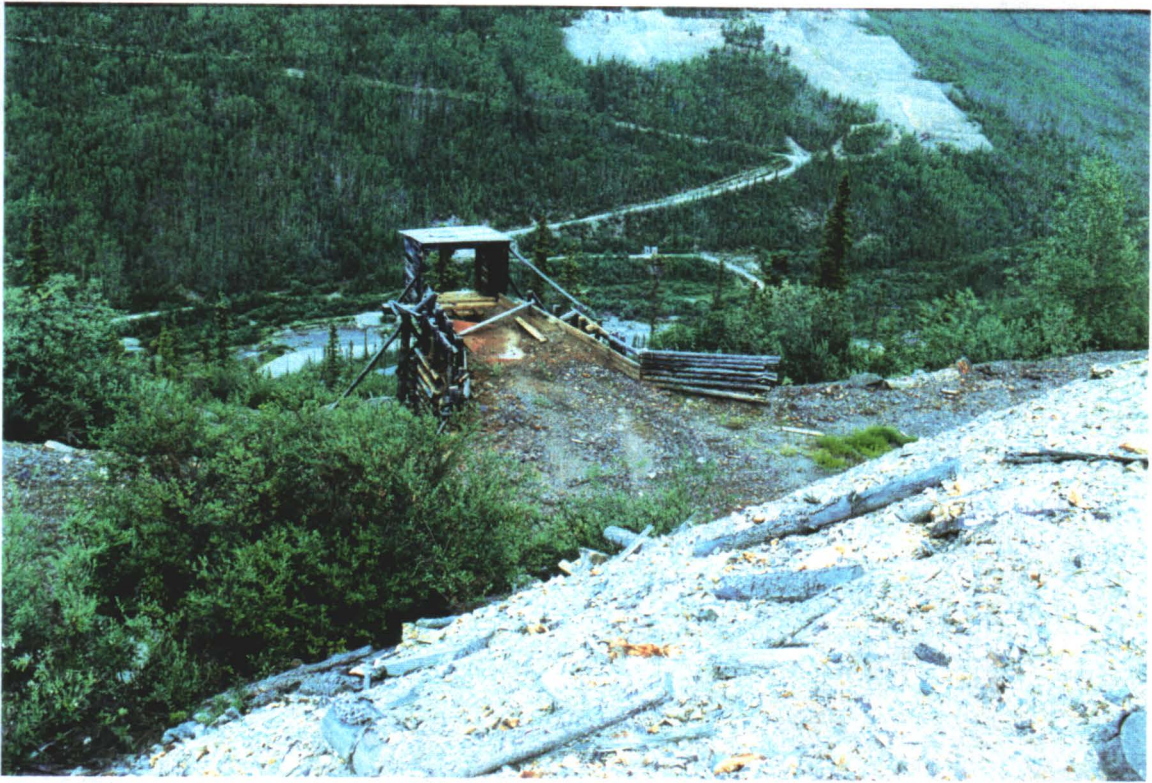
Waste rock was typically dumped downslope and extends between 50-100m downslope of the adit. Within the waste rock area a timber loadout was constructed for loading ore.

LOADOUT ON WASTE ROCK

The rock waste placed downslope of the adit appears to be stable. It is recommended that this rock waste be left in its present condition.

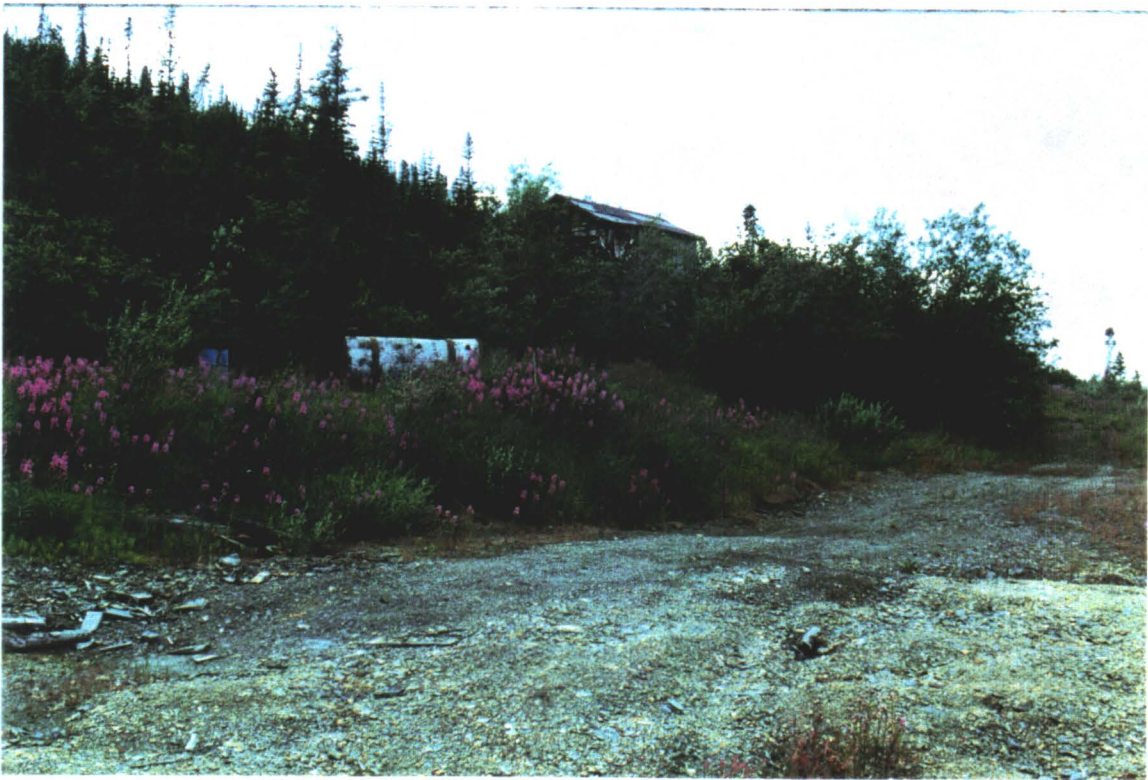
FUEL TANK AND DRY BUILDING

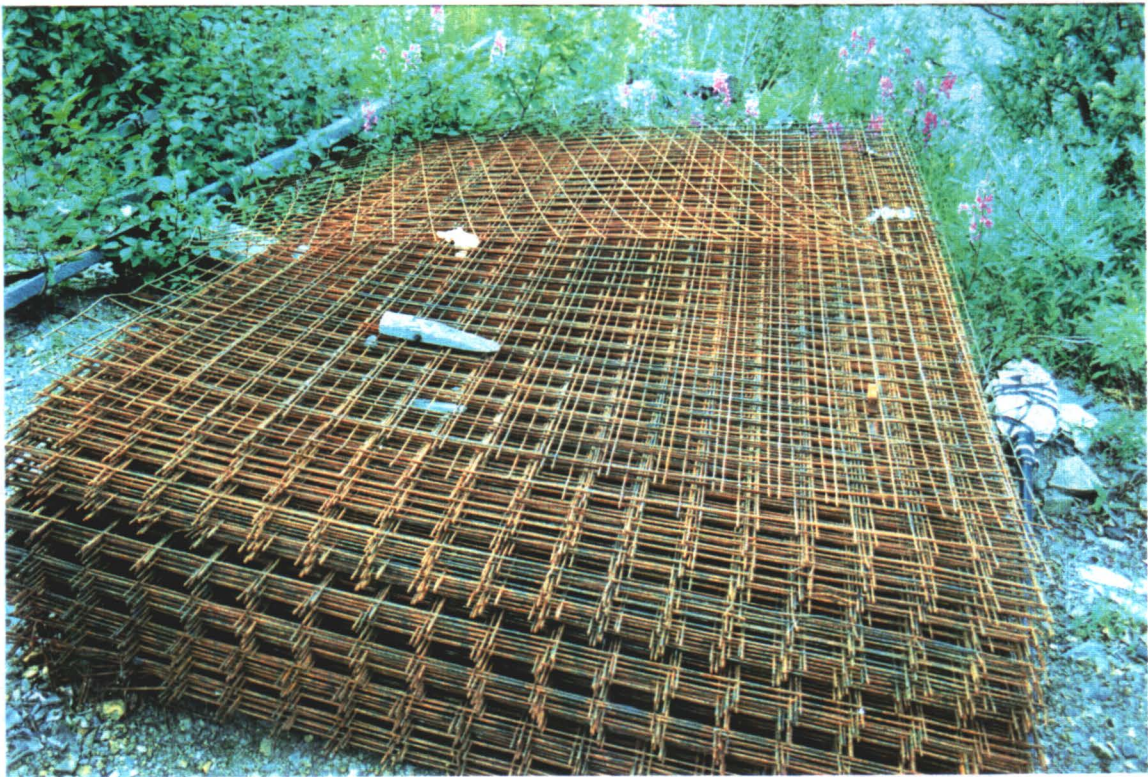
STACK OF WIRE MESH

Removal of the metal waste should be completed if a general clean-up program is initiated in the area, however this is considered a **LOW** priority. Similarly, the one barrel of oil remaining on-site should be removed, however because of the very small volume present, this is also considered a relatively **LOW** priority.

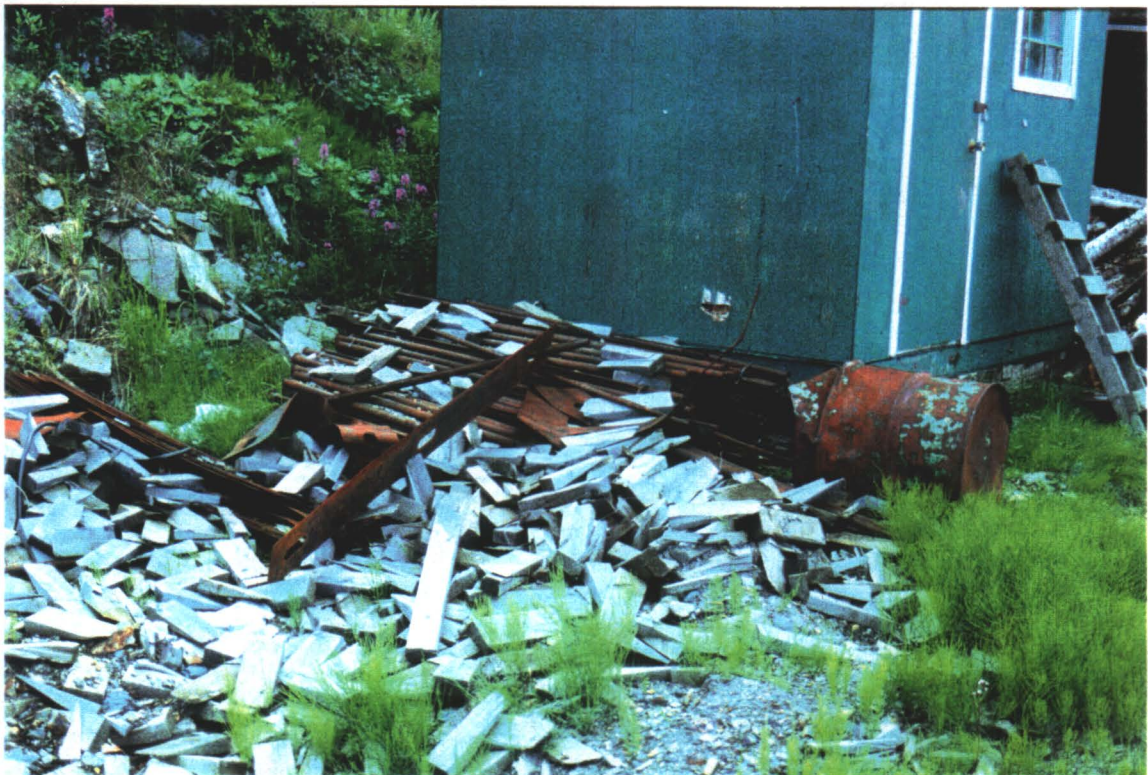
PIPE AND OTHER METAL WASTE NEAR ADIT
