ASSESSMENT REPORT

106C-05-1

VAL

DIAND TECHNICAL SERVICES

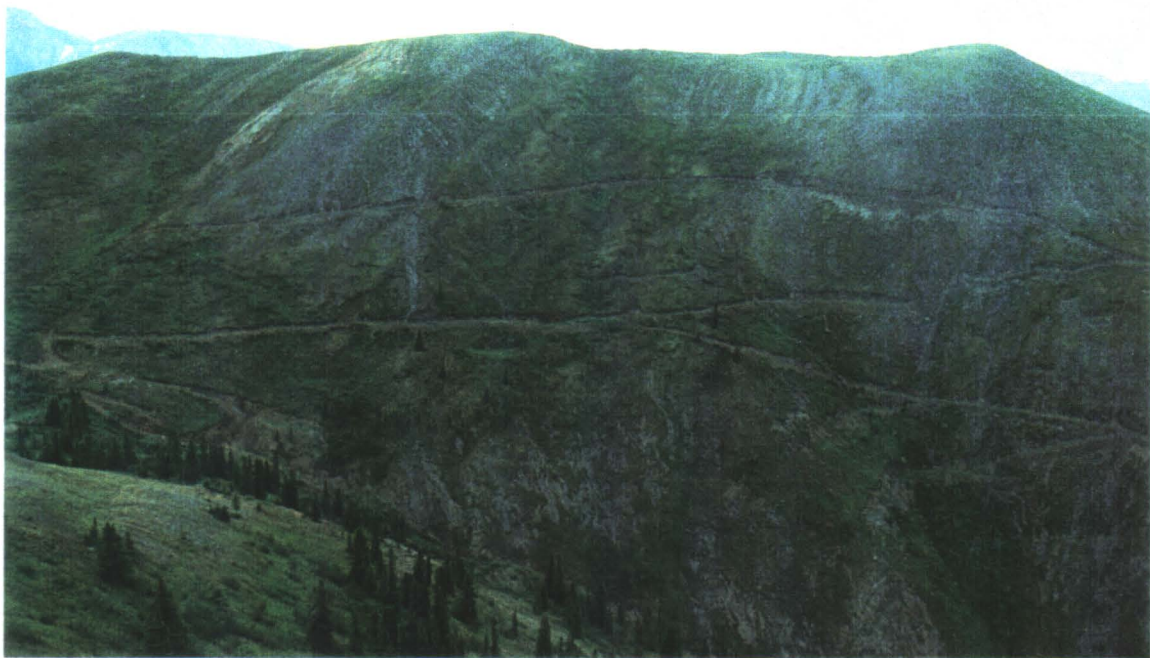
OVERVIEW OF EXPLORATION SITE

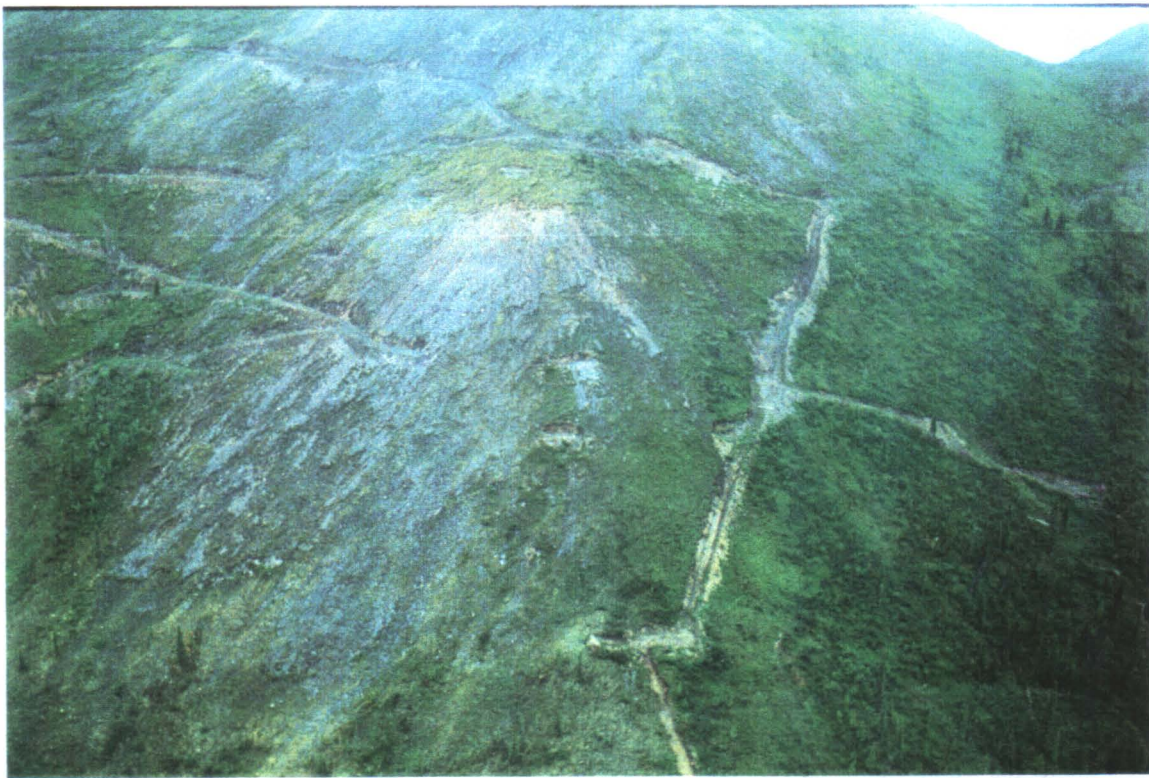
OVERVIEW OF EXPLORATION SITE

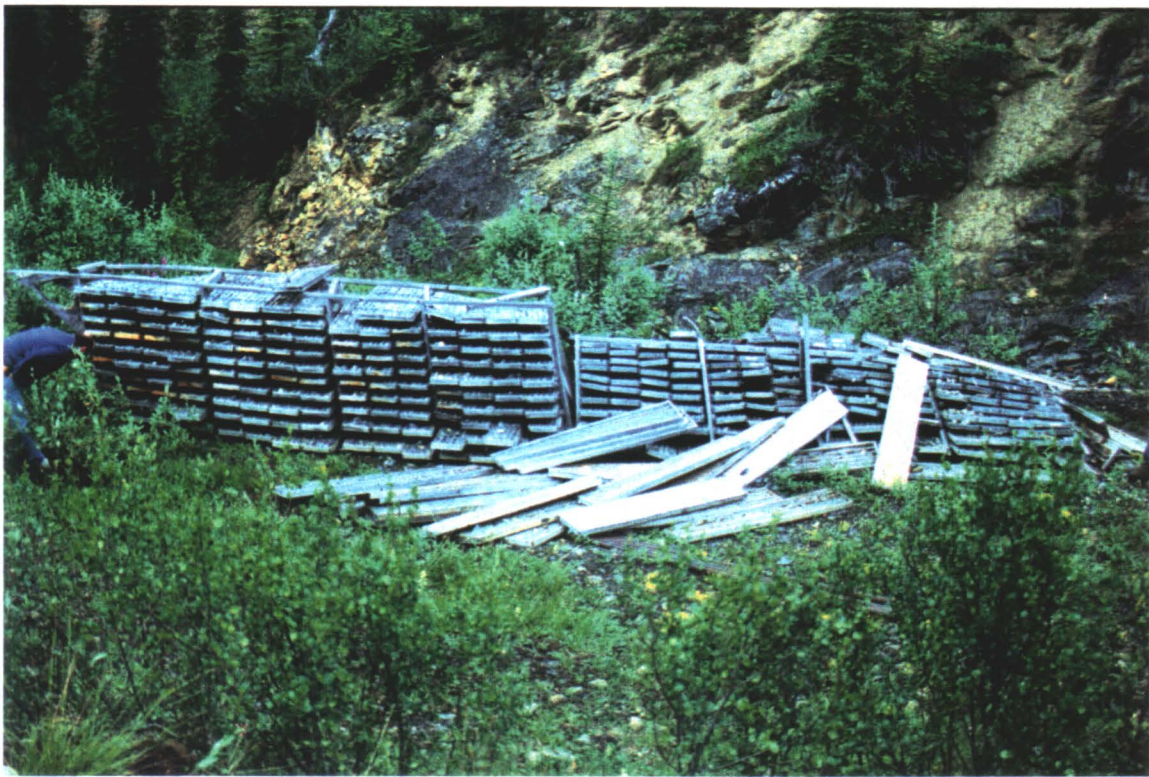
The boxes of core have been stacked beside a creek. It was observed that three of these core boxes appear to have been washed down this creek. These core boxes are poorly stored and are collapsing and being scattered around the site. This core is exposed to the weather. If this core has any value it will need to be better protected to retain any value.

CORE BOXES LEFT AT SITE NEAR BOTTOM OF CREEK

The remaining core left near the creek does not appear to be causing any ongoing problems. Eventually the core boxes will rot and collapse making recovery of any of this core more difficult. If this core is of any value it should be removed as soon as practical. This is considered a **VERY LOW** priority for clean-up.

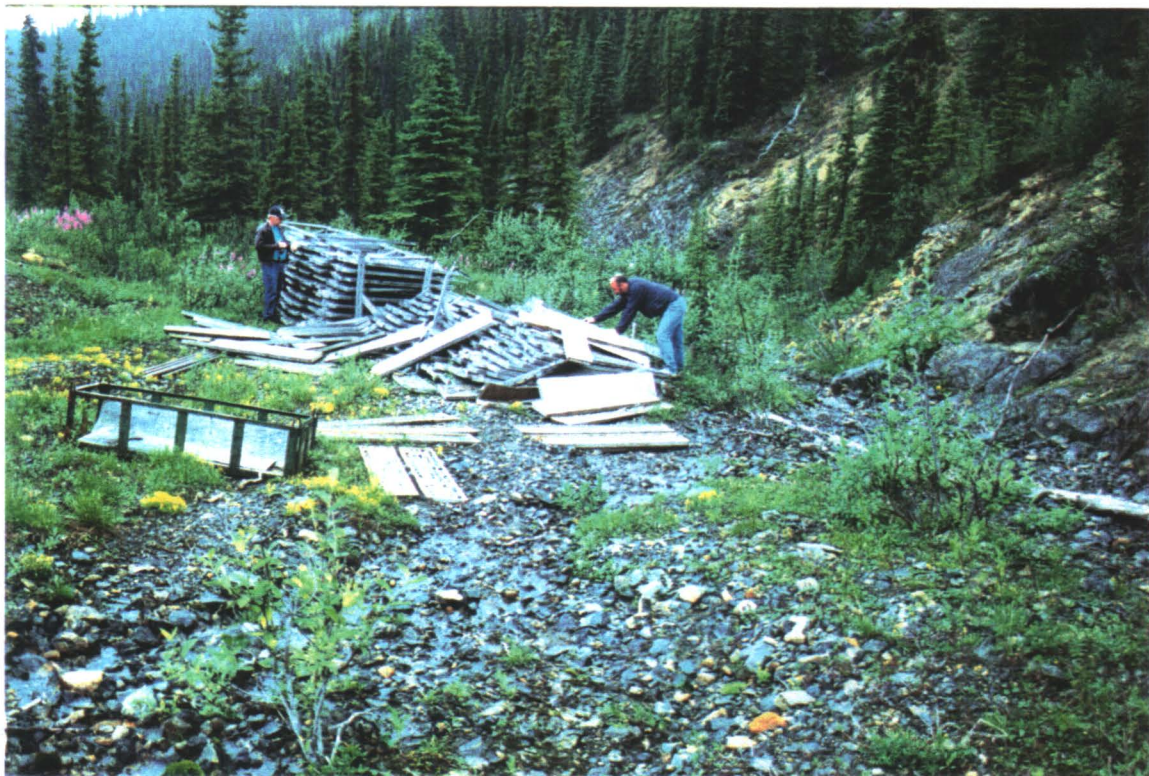
The only other equipment found on-site was a metal framed sled and five pieces of drill rod left near the core boxes. One barrel of Jet B fuel was also spotted in the area.

CORE BOXES AND METAL FRAME
