ASSESSMENT REPORT

105M-14-11

WERNECKE

DIAND TECHNICAL SERVICES

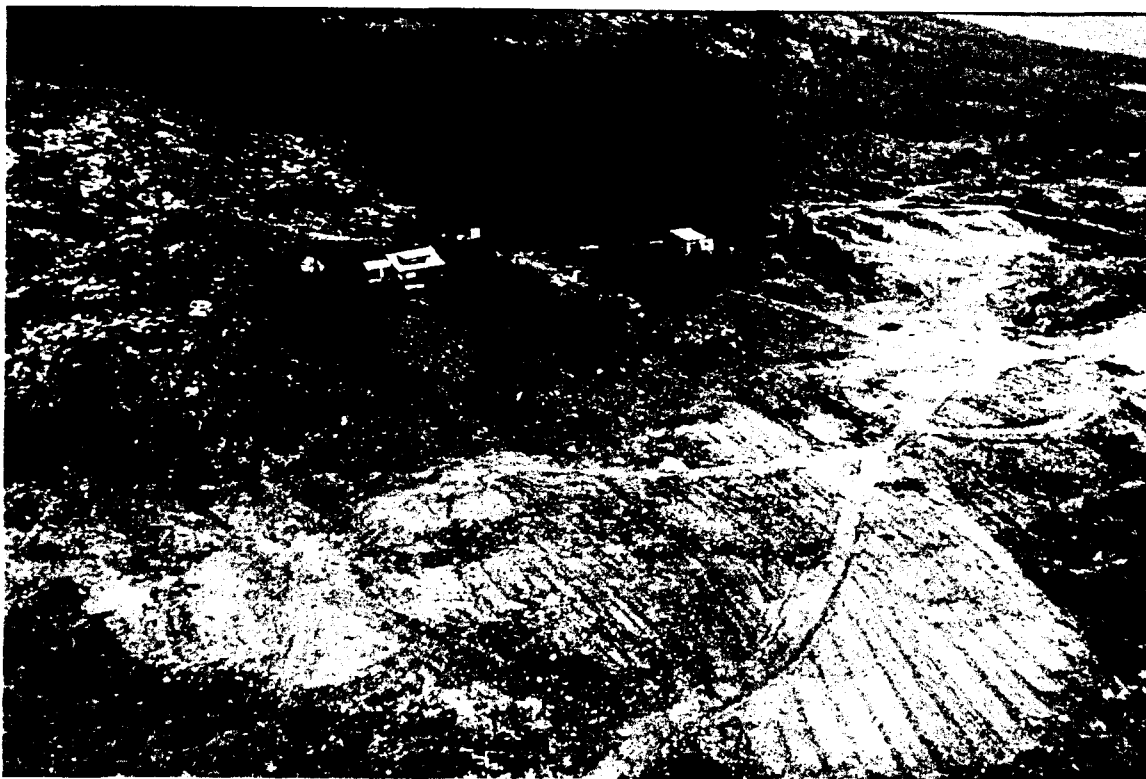
OVERALL VIEW OF WERNECKE TOWN SITE AND MINE SITE

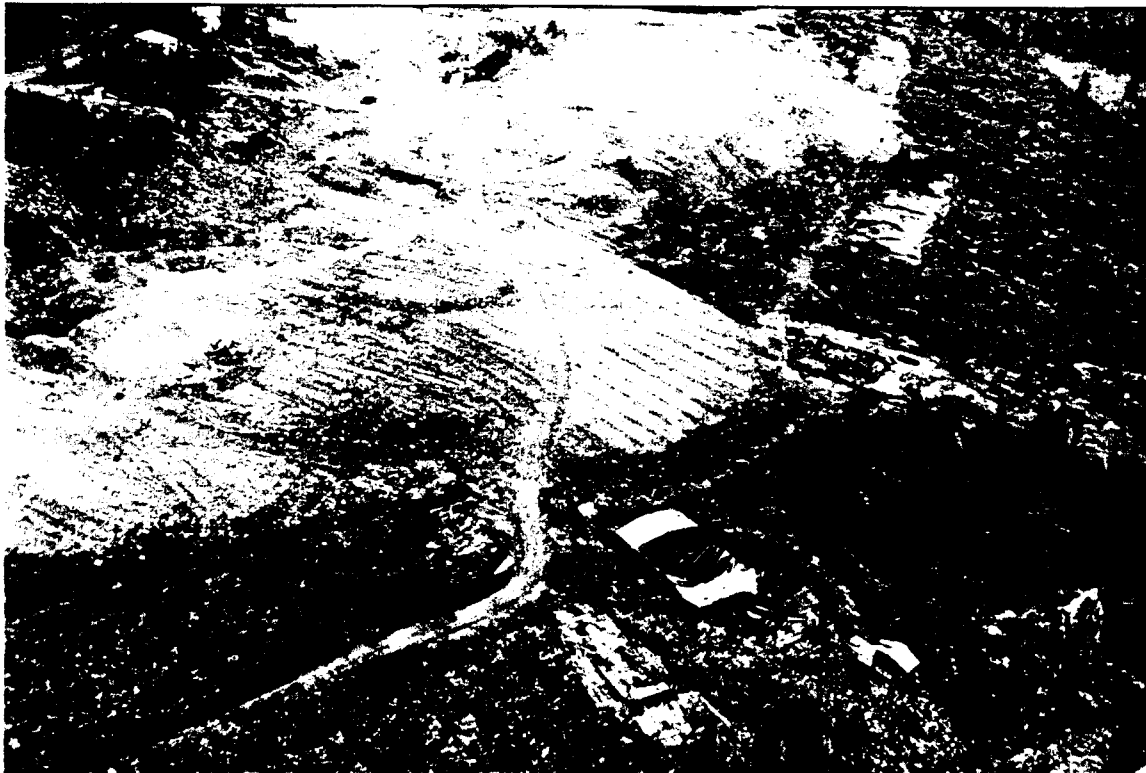
The waste piles surrounding the site appear to have been flattened and pushed downslope. Most of the lower part of the site is void of much vegetation.

OVERALL VIEW OF LOWER PART OF MINE SITE

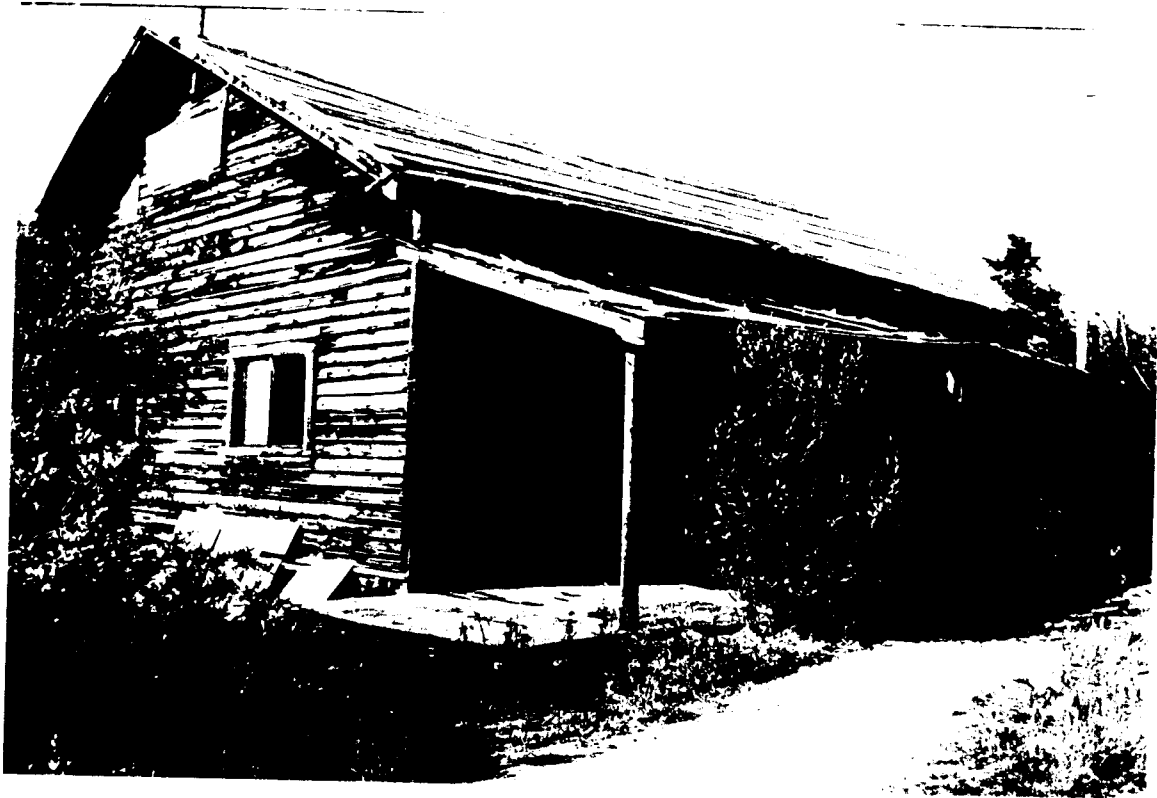
The buildings at this site are all old, decaying, and many are collapsed. The least deteriorated building was a wood frame one and one half storey house that appears to have been occupied in recent years by geological exploration crews or campers. The building measures 15x16m and contains a few wood bedframes and tables.

HOUSE

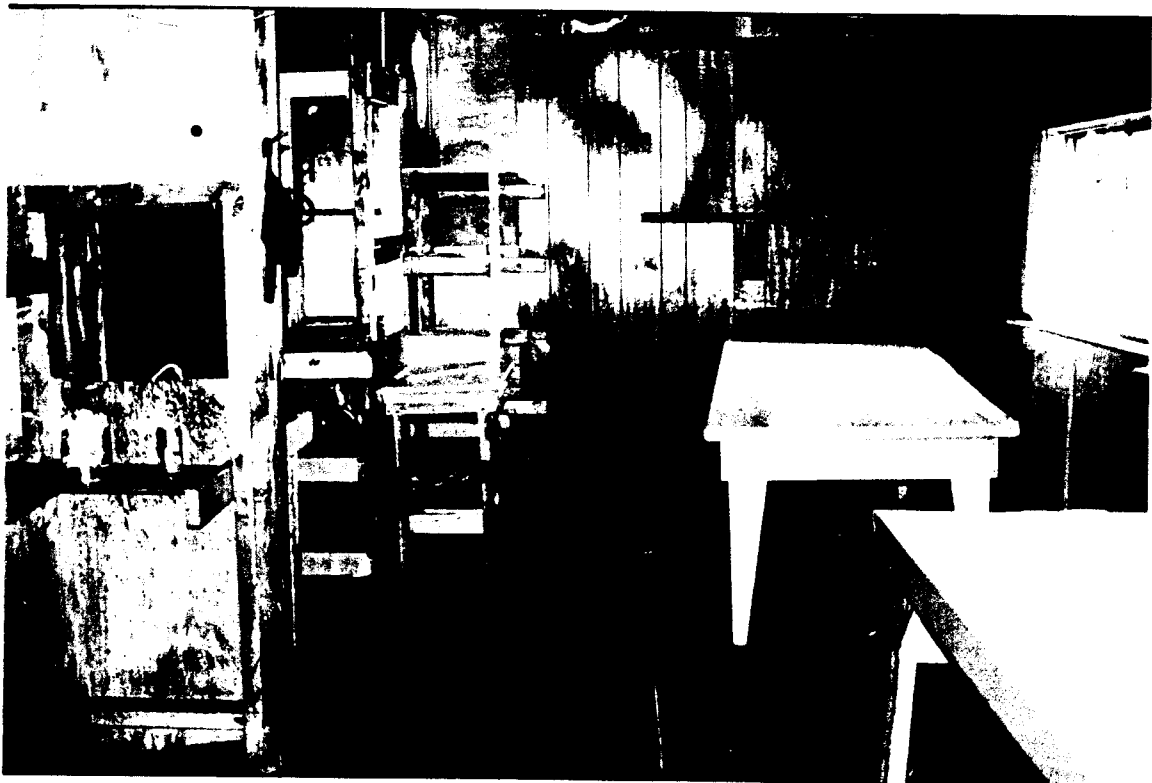
INTERIOR OF HOUSE

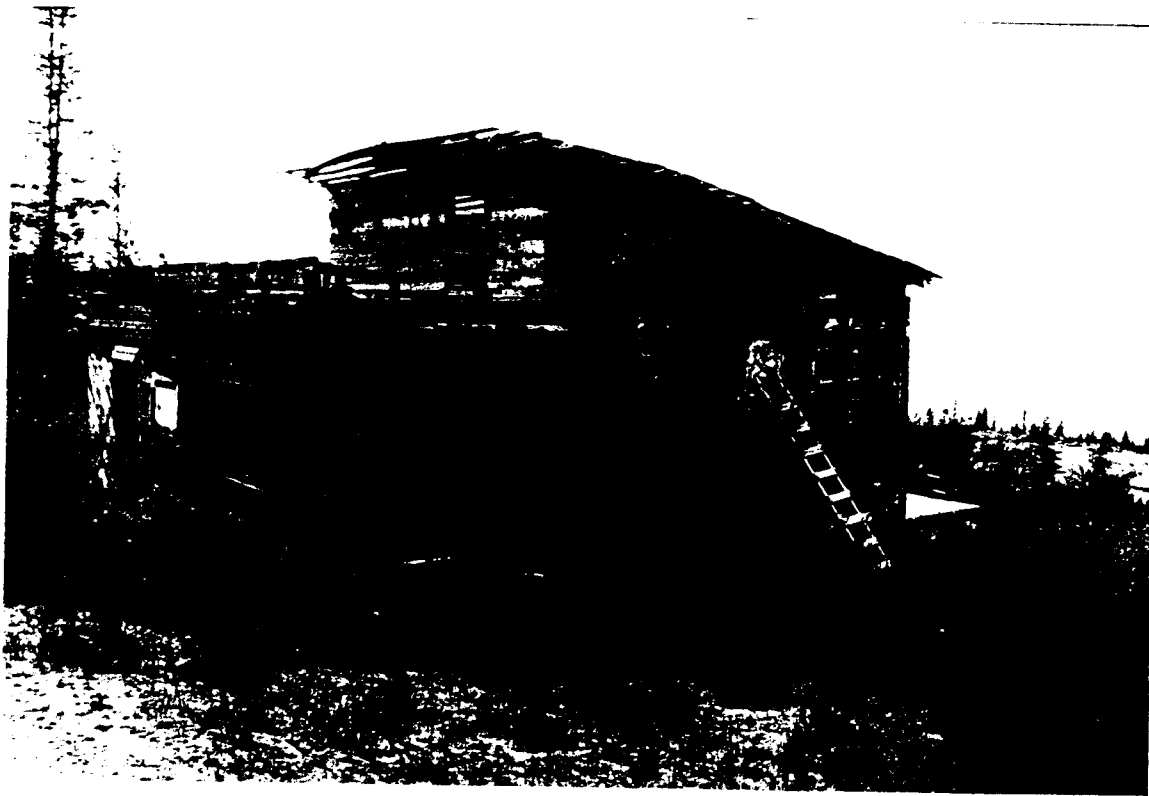
- 3x4m wood frame used for a sauna,
- 4x5m wood frame shed containing a large amount of stove pipe,
- an outhouse,
- 6x10m wood frame building used as a residence. This building is in very poor condition and is beginning to collapse,
- 11x24m collapsed log and wood frame structure with an arch roof.

BUILDING ADJACENT TO HOUSE

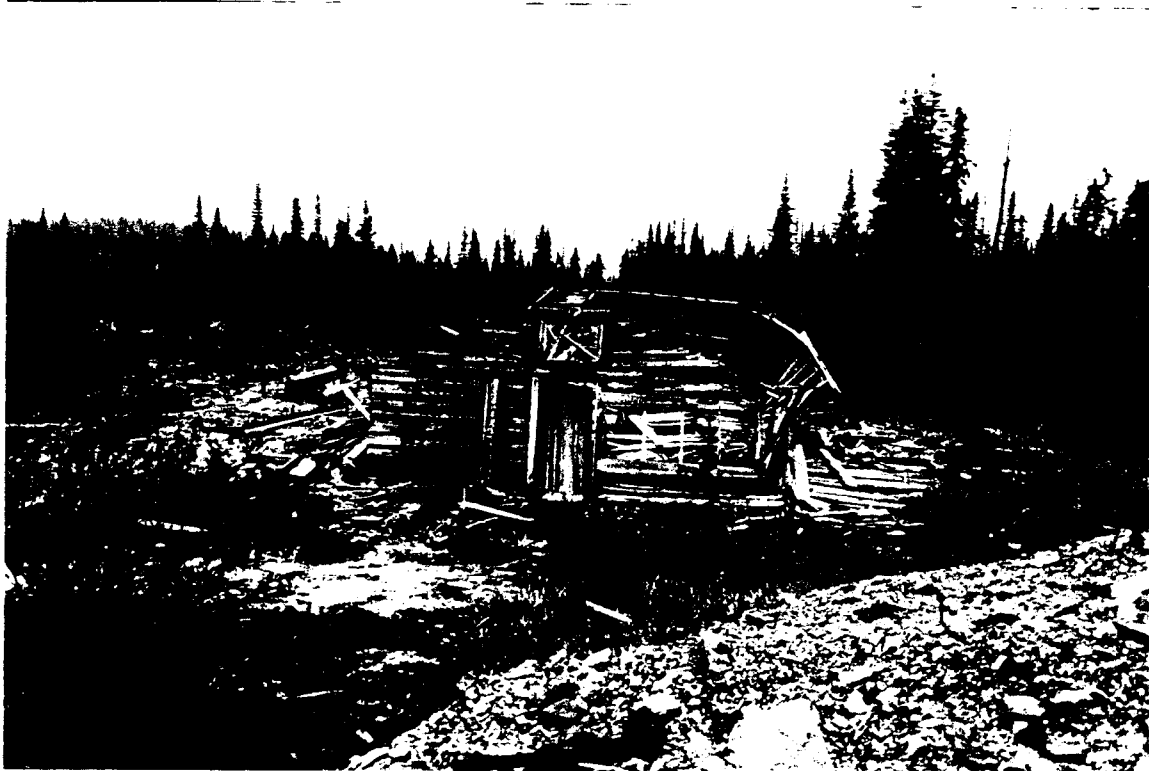
COLLAPSED WAREHOUSE

If the buildings or remains are considered to be of historical significance then they should be left to serve that purpose. It should be understood that these buildings will continue to deteriorate and become unsafe (or may already be unsafe) and a safety hazard. If at some time in the future protecting these structures no longer is considered essential then the site could be cleaned up by removing any remaining structures and collecting all metal and other material and removing it from the site. However, this would be considered a **LOW** priority.

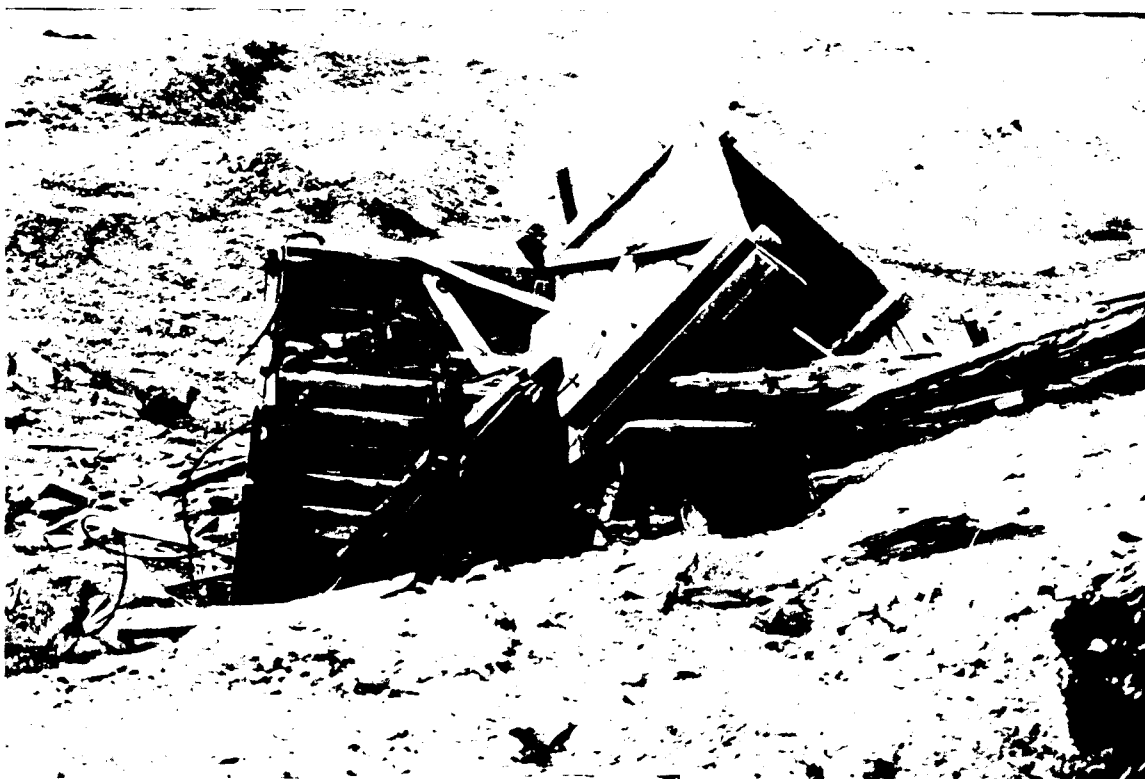
Foundations for other buildings were still evident , however no structures were completely standing. Some other material was found on-site, most notably the remains of a boiler with metal exhaust stack. A variety of pieces of metal junk were found inside the remains of the arch building. Little else was found on-site.

WASTE ON SITE
