**PHASE II ENVIRONMENTAL ASSESSMENT  
OF THE  
CANALASK  
ABANDONED MINE SITE**  
prepared for:

**PHASE II ENVIRONMENTAL ASSESSMENT  
of the  
CANALASK MINE SITE**

**Environmental Services  
Public Works and Government Services Canada**

**March 1997**

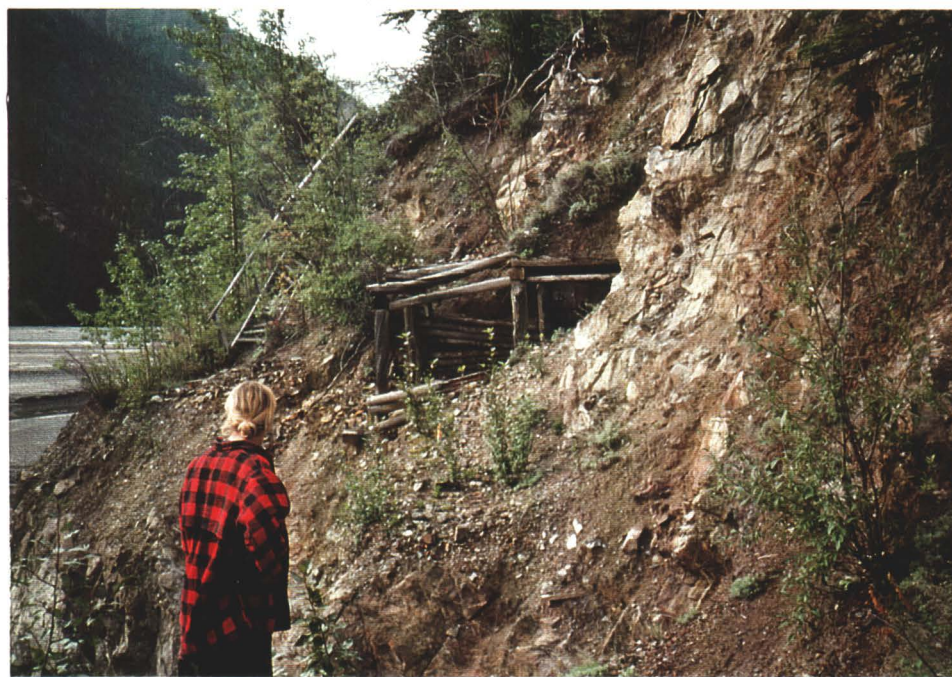
The portal opening or mine adit measures 2 m high by 1.5 m wide and is located on the face of the eastern bank of the White River. The adit is constructed of wood beams and 2 inch by 4 inch lumber. Some of the beams that had provided a roof over the adit entrance have fallen away, possibly due to rock slides, and others are missing. A wire mesh screen was installed over the entrance of the adit to restrict access, but the screen has been cut. A sign reading "danger keep out" has also been installed at the entrance. The bank above and beside the adit entrance appears to be unstable, consisting of loose shale and rock outcropping. The adit entrance is only accessible by traversing the cliff face. The stairs that provided access in the past are no longer safe.

Photo 4. Adit opening located on the bank of the White River. Staircase leading to the adit is visible behind shrubs to the left of the adit.

**Recommendation 1.** Assuming no further site development, the mine portal or adit opening should be sealed by blasting. Charges can be placed by drilling from above. Experienced blasters should be retained to minimize potentially land slides entering the White River and endangering workers above the adit.

Prior to closing the adit, the potential for the presence of hazardous materials should be evaluated only if the adit can be entered into safely.

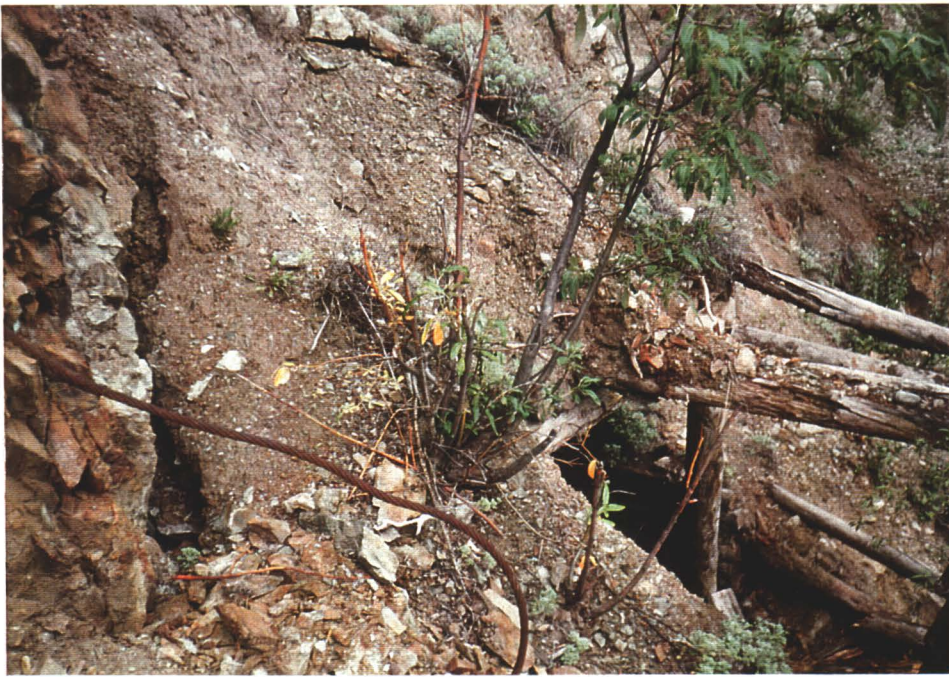
Photo 5. Bank area above adit opening. Note loose shale material on bank.

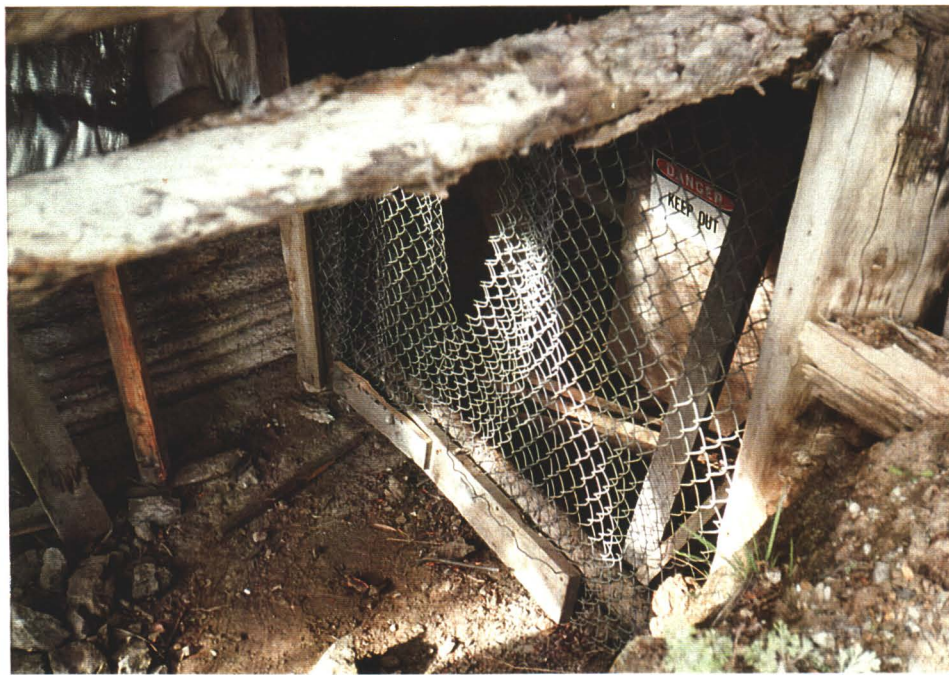
Access to the underground workings is still possible but highly dangerous, and therefore may pose a hazard to human safety. The small shed that has not collapsed is highly unstable and therefore is of concern from a health and safety point of view.

Photo 6. Adit entrance has been screened off and sign posted warning of danger, keep out. Note screen has been cut to allow access.

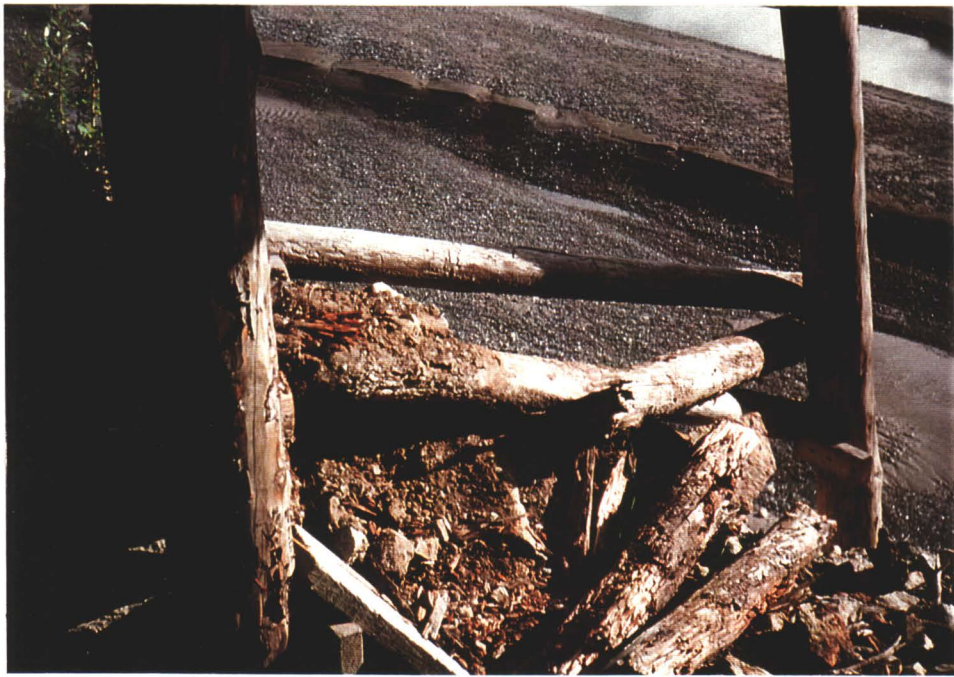
Photo 7. Timbers supporting the adit are in poor condition.

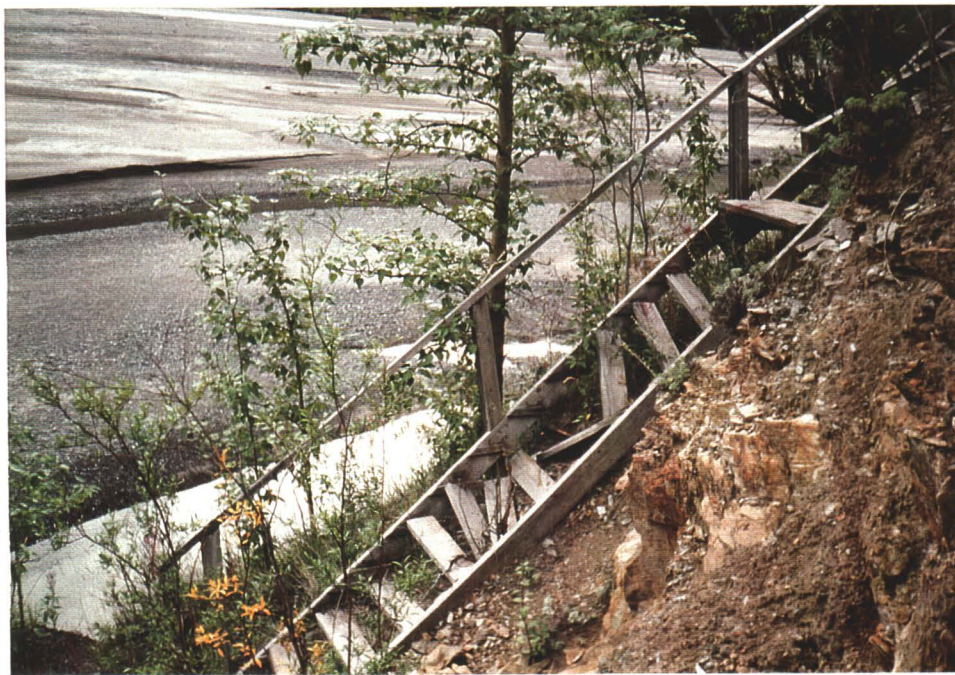
There is also a wooden staircase on the bank leading to the mouth of the adit. The staircase is in extremely poor condition with several of the stairs, as well as portions of the railing, missing. The remnants of a wooden trellis is located on the bank above the adit opening. Like the stairs, this structure is in extremely poor condition and has been overgrown with

Site Assessment Component	Hazard or Concern
Buildings, Infrastructure, and Equipment	Minor hazard of people exploring through rubble and stepping on nails, etc. Attempting to use unstable stairs could result in a 7 m fall to a side channel of the White River. Small unstable building could collapse with someone inside.
Non-Hazardous Waste Materials	Minor hazard of people exploring through rubble of old demolished building could result in stepping on nails and other sharp objects. Piles of rubble are a minor aesthetic concern.
Waste Rock Disposal Areas	Waste rock is potentially acid-generating
Mine Openings	The entrance to the mine adit is extremely hazardous to approach and timber cribbing is unstable. Adit opening presents a significant safety concern.

Photo 8. The staircase leading to the adit is in disrepair and is very unsafe.

**Recommendation 2.** Piles of wood debris should be sorted and all hazardous objects such as nails and sharp objects should be removed and properly disposed of off site. All combustible material including the wooden staircase leading to the entrance to the adit and the wood frame building should be dismantled and/or demolished, stockpiled and burnt under controlled conditions.

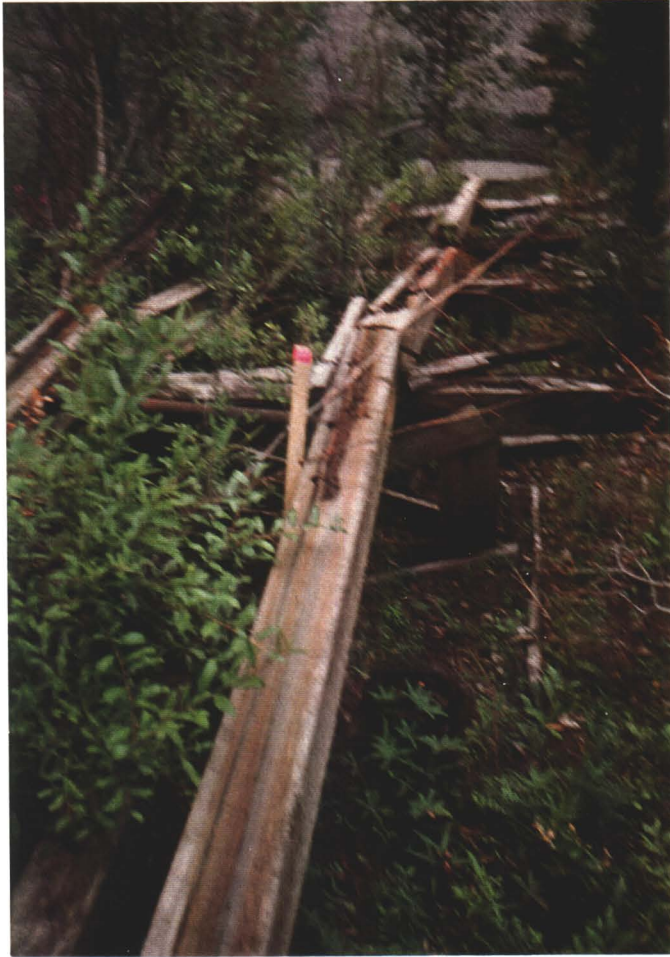
Photo 9. Wooden trestle running up bank above the adit.

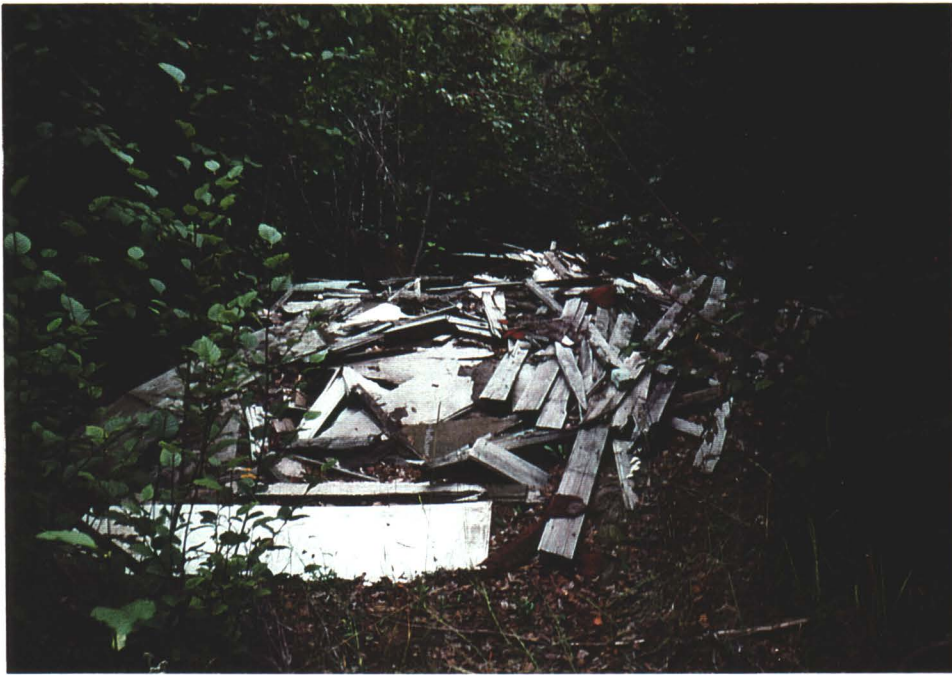
All building structures with the exception of one small wooden shed have been demolished. Two debris piles, from the demolition of these structures, have been left in a wooded area adjacent to an open area beside the access road. This area where the mine site buildings were located is higher up off the bank of the White river and above the adit or working area of the mine. The shed has been significantly damaged and is in very poor structural condition.

Photo 10. Demolished building in the wooden area on bank above the adit area.

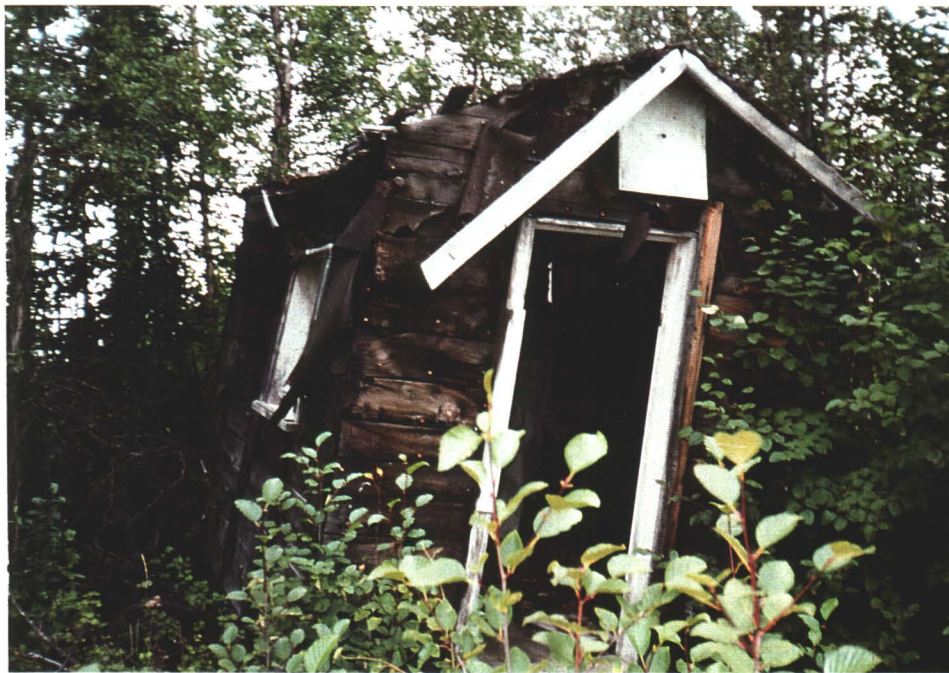
Photo 11. Damaged building at fringe of open area along side access road. In same general area as building debris shown in photo 10.

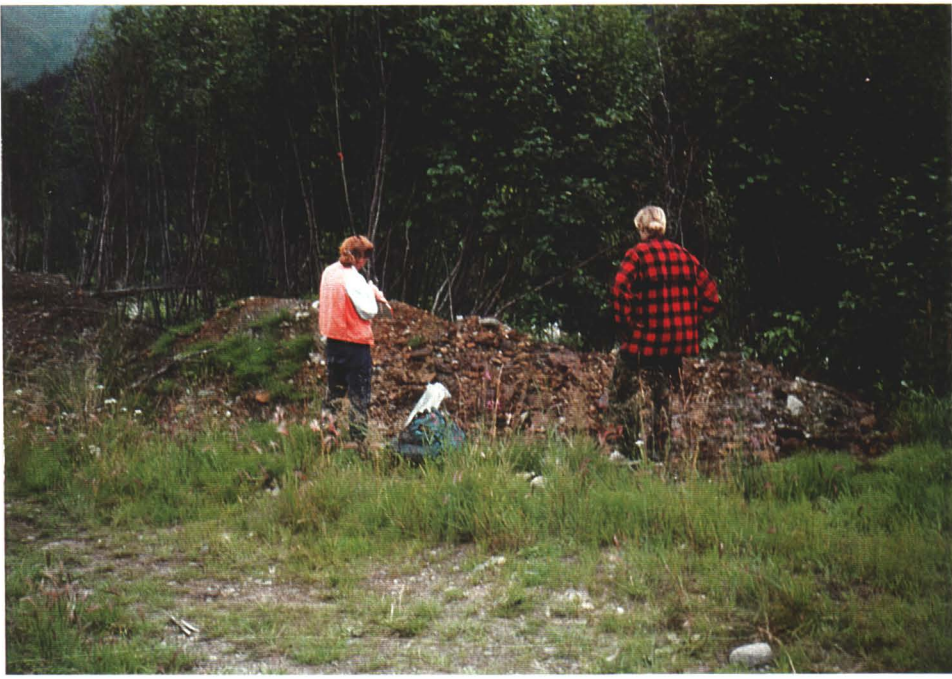
Results of ABA tests suggest that the waste rock at the Canalask property is potentially acid-producing and contains high concentrations of soluble oxidation products. However, no seeps or evidence of seepage were observed from the piles, and since they are so small, the potential for significant environmental effects is unlikely.

Photo 12. Waste Rock pile along side mine access road.

**Recommendation 3.** Should further development occur on the site, regulatory agencies should ensure that an acid drainage prevention plan is developed which includes detailed measures for handling and disposal/management of mineralized waste rock.

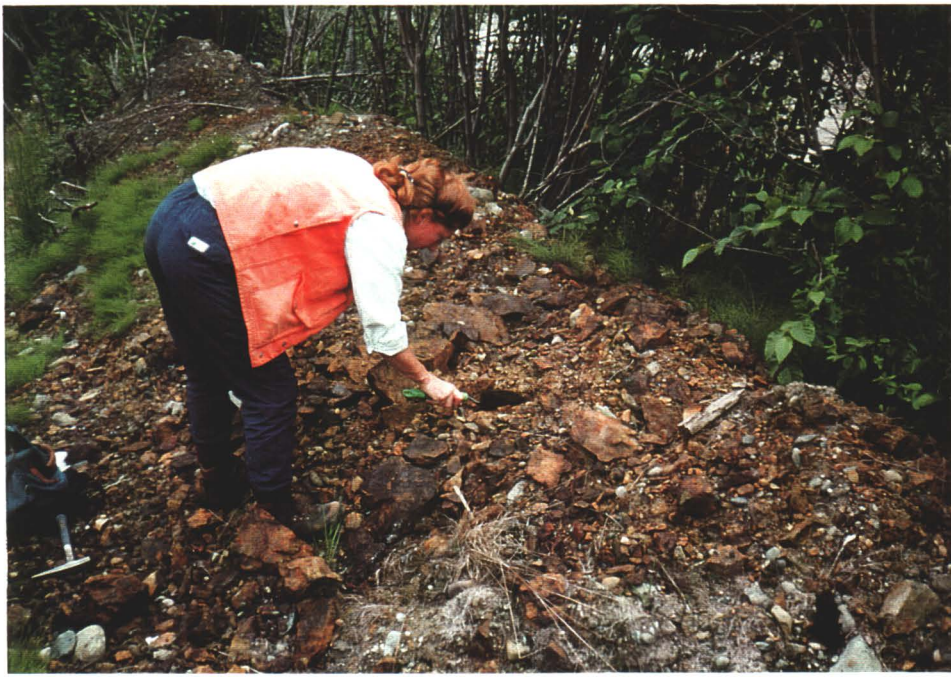
Photo 13. Sampling waste rock pile.
