**P118401**

**PHASE II ENVIRONMENTAL ASSESSMENT  
OF THE  
COBALT ABANDONED MINE SITE**

**FEBRUARY, 1997**

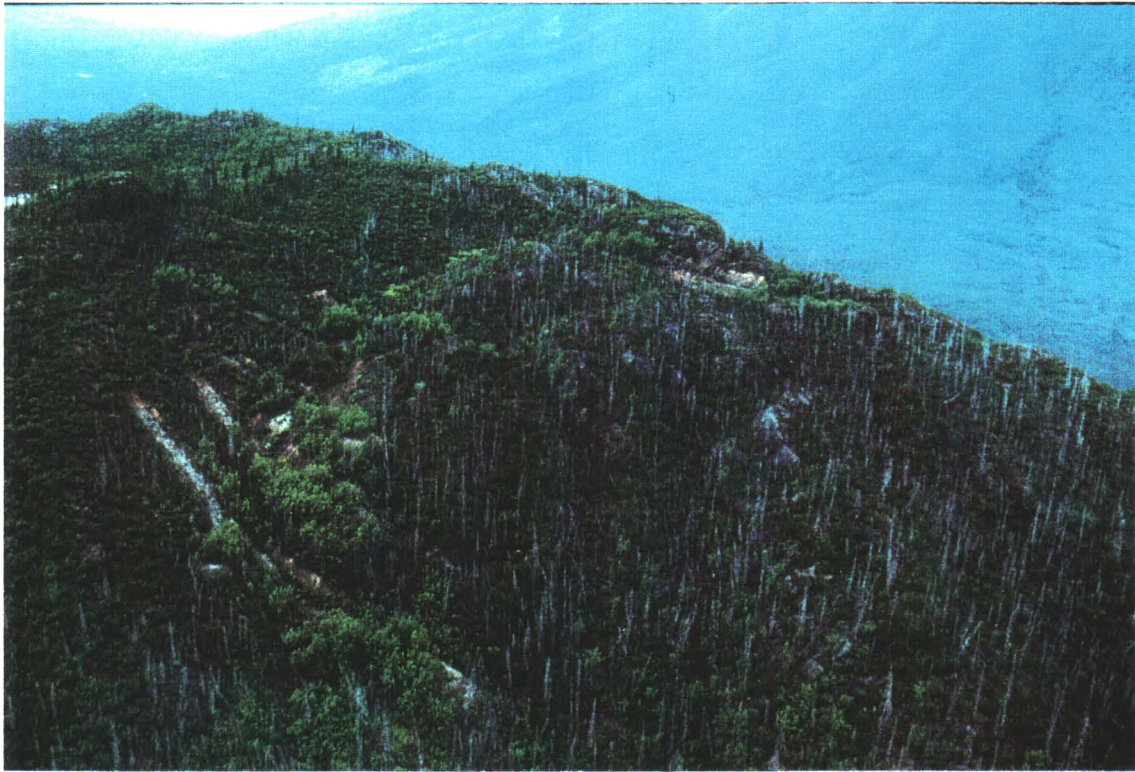
The Cobalt mine site occurs within the Yukon Plateau North ecoregion. Vegetation at 1000 metres above sea level on the terraced slopes in the Gustavus Range is typical of warmer Western Boreal areas. Black spruce white spruce, alpine fir, and willows are abundant; aspen poplar, balsam poplar, white birch, and alder are less common (GSC Memoir 364, p.4). The Cobalt site appears to have typical vegetation for the area, based on photographs provided by DIAND (1994). The area has been burnt, probably sometime in the last 20 years given the height of the new growth (DIAND, 1994, Photos 1 and 2).

Photo 1: Cobalt abandoned exploration site, in an old burn area. Looking south. (Photo reproduced, with permission, from DIAND, 1994)

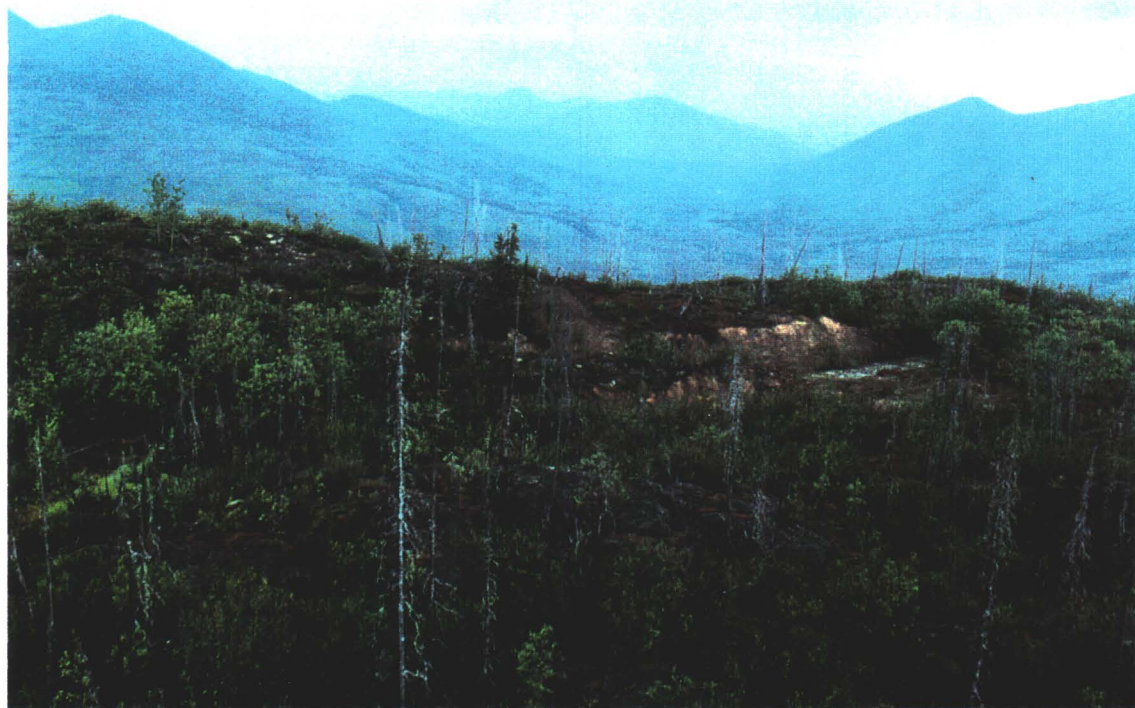
Photo 2: Trench at Cobalt. Adit is in the centre of the photo, at the upper left side of the trench. Looking west. (Photo reproduced, with permission, from DIAND, 1994).

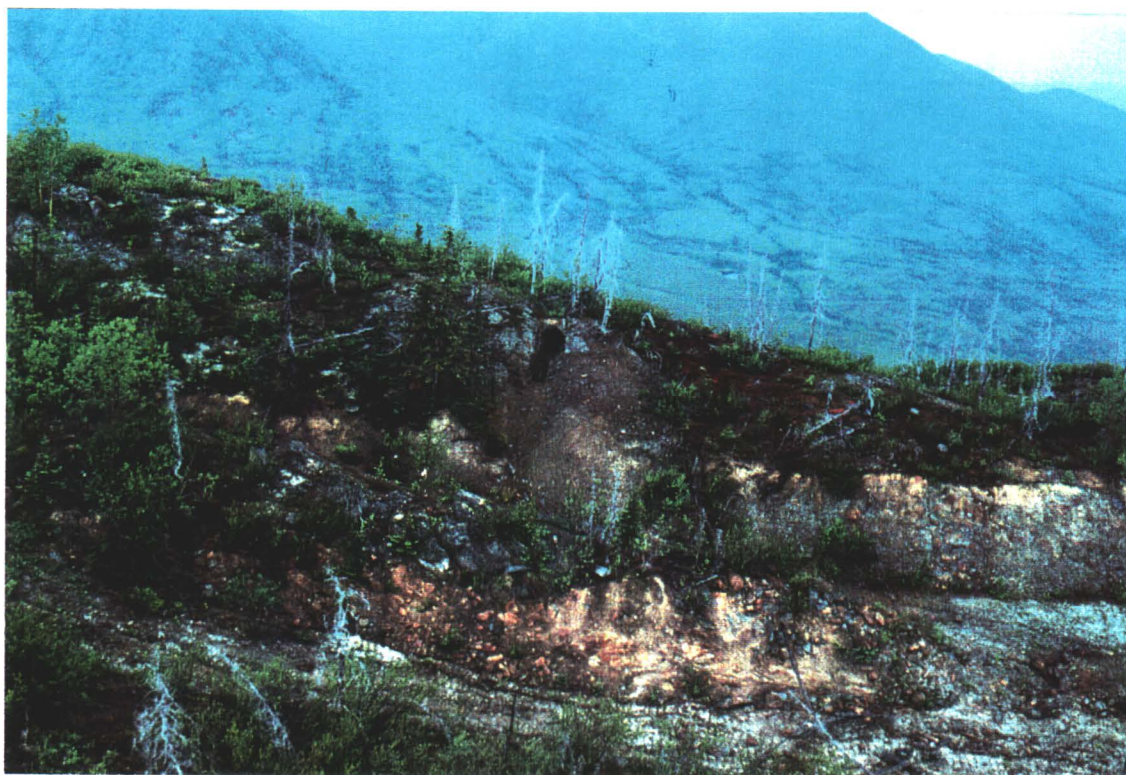
A small pile of waste rock is located above the trenching and on the west side of the adit (Photos 3 and 4). The volume of waste rock produced from the underground exploration program is in the order of 300 tonnes. The assumptions made to derive this estimate are:

The trenching and the adit have exposed iron stained rocks (GSC Memoir 357, p. 61). The mineral occurrence contains the occasional erratic 5 to 8 cm wide veinlets of galena,

which is a potential source of metal leachate, and the waste rock on site contains pieces with massive galena (GSC Memoir 357, p.61). The volume of waste present at the site is very small, as is the overall extent of disturbance by trenching.

An adit, 12.2 metres long, is located at the southeast end of the trenching (Photos 3 and 4). It is open and the ground conditions around the entrance appear stable. The total area disturbed by trenching is probably 125 metres by 50 metres (DIAND, 1994, GSC Memoir 357, p.61).

Chemical stability issues were identified, since it is possible that the underground workings, waste rock and the trenches are sources of acid generation and metal leaching. The mineral occurrence at the Cobalt site is reported to contain the occasional veinlet of massive galena, a lead sulphide which, when allowed to oxidize, can generate acidity and metal leachate. The host rock is phyllite and phyllitic quartzite which typically have a low capacity to neutralize acidity generated by oxidation of sulfides. It is reported that much of the vein material has been heavily oxidized and that the surface of the exposed rock is iron stained, therefore acid generation and metal leaching have probably occurred.

Photo 3: Adit and waste rock or 'upper dump', above trenching that shows iron staining. Looking southwest. (Photo reproduced, with permission, from DIAND, 1994)

The open adit, as it was photographed in 1993, appears to be narrow and in solid rock. Due to the short length of the underground workings and the remote location of the site no mitigation measures are recommended at this time. However, if access to the area is improved in the future consideration should be given to sealing the adit to prevent entry.

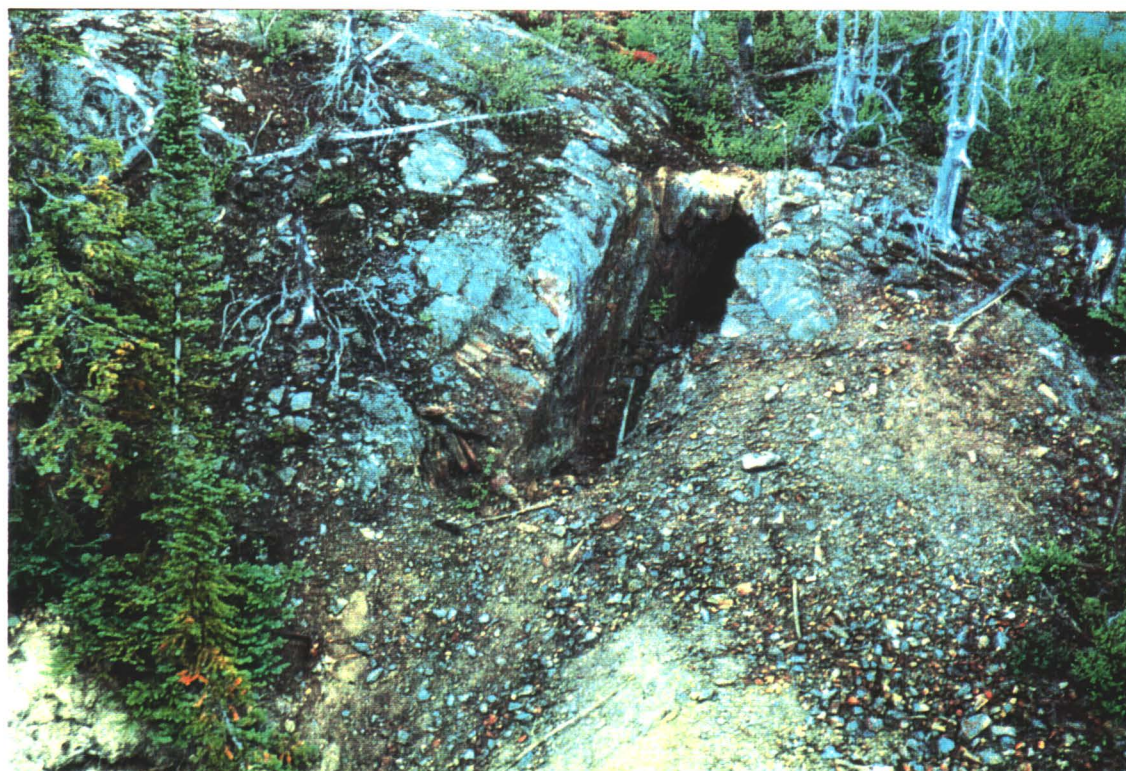
The adit on the site has not been sealed to prevent entry and, as such, poses a health and safety hazard. Access to this remote site is difficult and no work is ongoing in the area; however, so the potential for exposure to the hazard, and therefore the safety risk, is low. The area has not seen any exploration activity for several years and the adjacent mineral claims have been allowed to lapse (as of April 9, 1994); therefore, it is unlikely that access to the site will soon be improved.

Photo 4: Adit and oxidized waste rock pile. Looking south. (Photo reproduced, with permission, from DIAND, 1994)
