**PHASE II
ENVIRONMENTAL ASSESSMENT
of the
FAITH (DUNCAN)
ABANDONED MINE SITE**

**Action on Waste Program
Indian and Northern Affairs Canada**

**Environmental Services
Public Works and Government Services Canada**

March, 1997

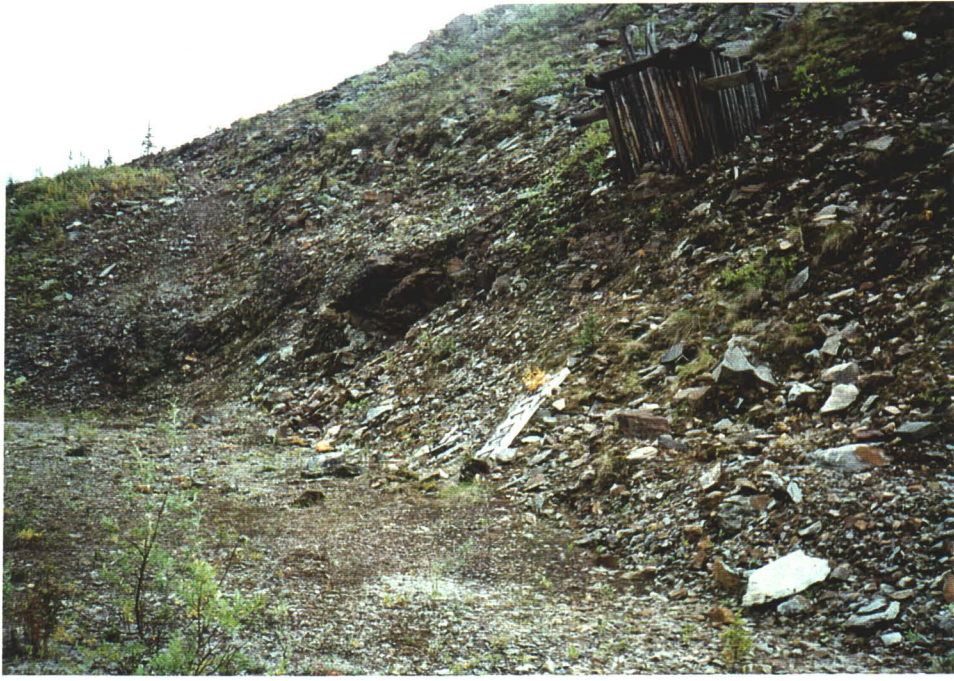
Photo 1. View of open shaft from cat trail looking east.

It is recommended that the mine opening be secured from human and animal access for health and safety reasons by covering the opening with existing waste rock. Should the mine need to be reopened, access to workings is achievable with heavy equipment.

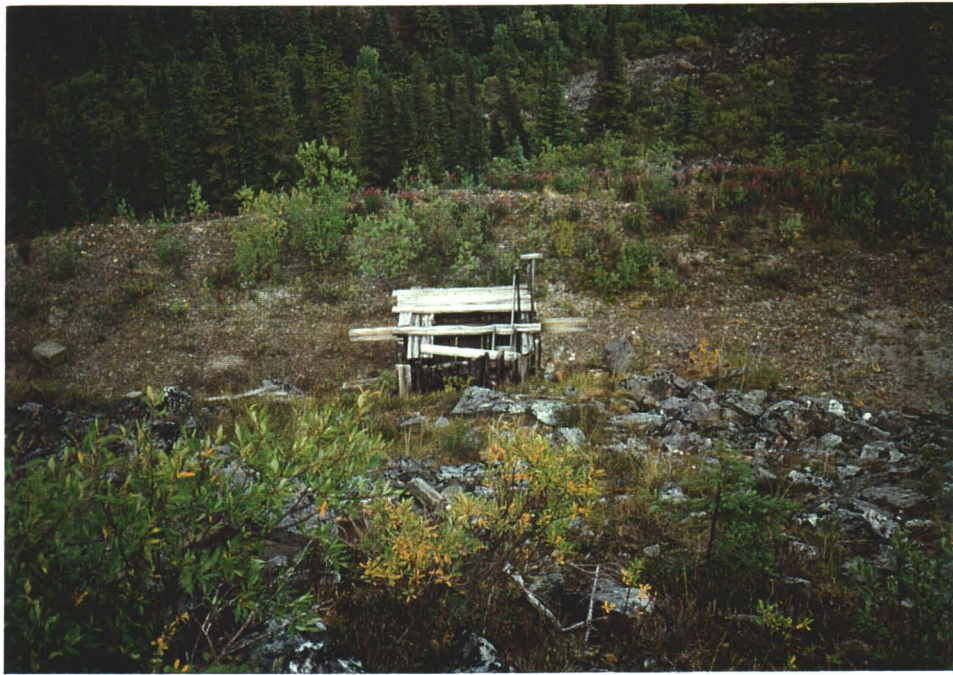
Photo 2. Top of shaft enclosure (looking north downslope) will not prevent entry to shaft.

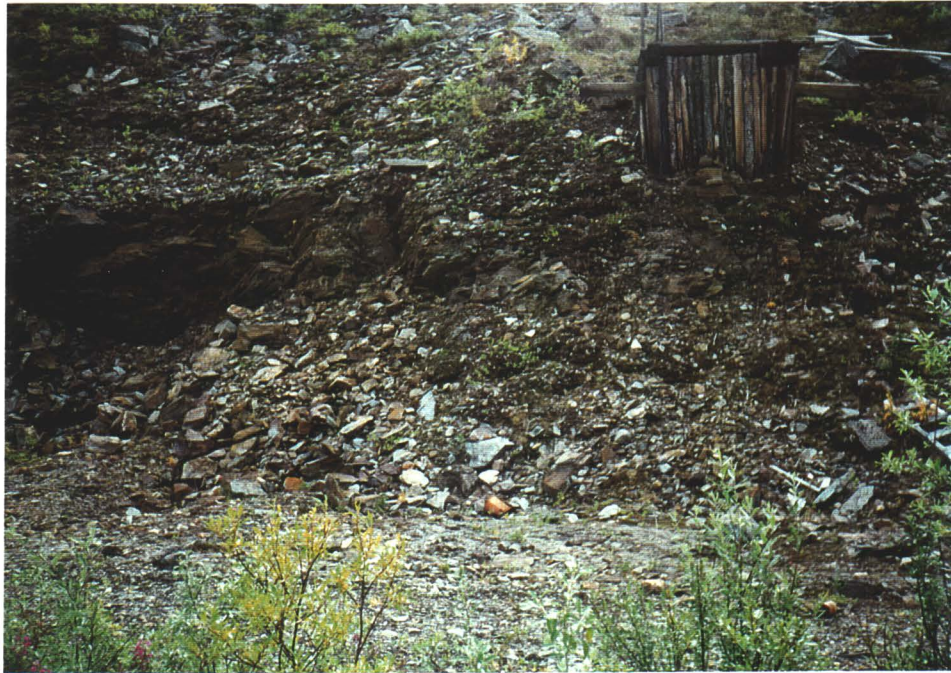
Photo 3. Wood waste upslope and downslope of shaft enclosure and excavation material below shaft entrance.

It is recommended that site debris be collected and buried on-site for aesthetic reasons. Structural timbers, and miscellaneous glass and metal debris, surrounding the site can be collected using locally available labour and resources.

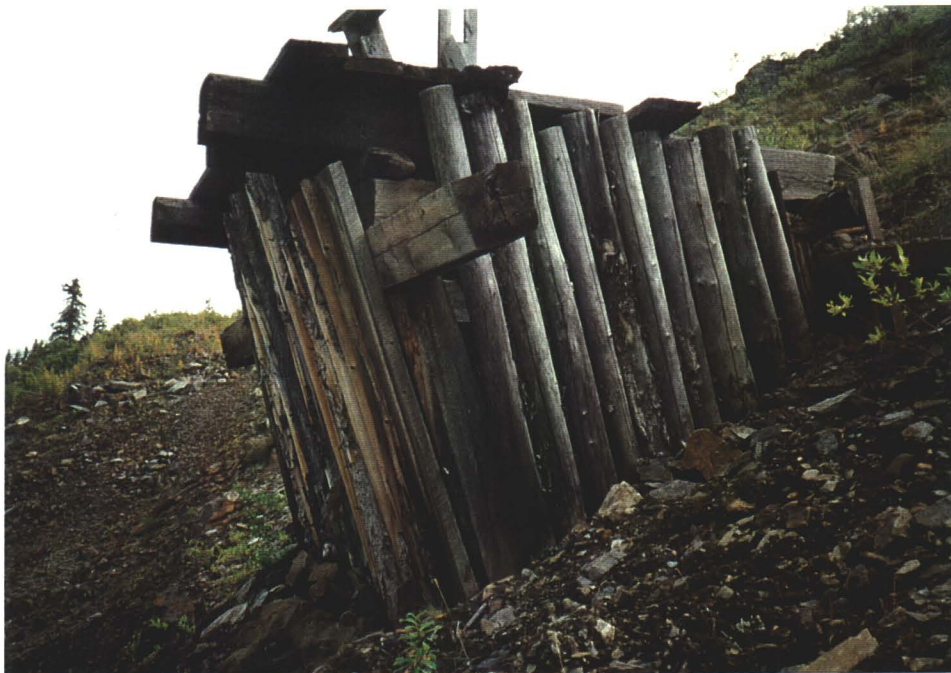
The remains of a vertical shaft that was excavated between 1919 and 1923 was found on the site. The top of this shaft is open which poses a human safety risk. Wood cribbing made out of vertical posts supports the top of the shaft and an old wooden ladder extends into the shaft. Also observed was the remains of a wooden frame which was likely used to support a windlass above the shaft. A metal pail, likely used to lift ore from the shaft, was found near the adit (See Photos 4, 5, & 6).

Photo 4. Timber shaft enclosure.

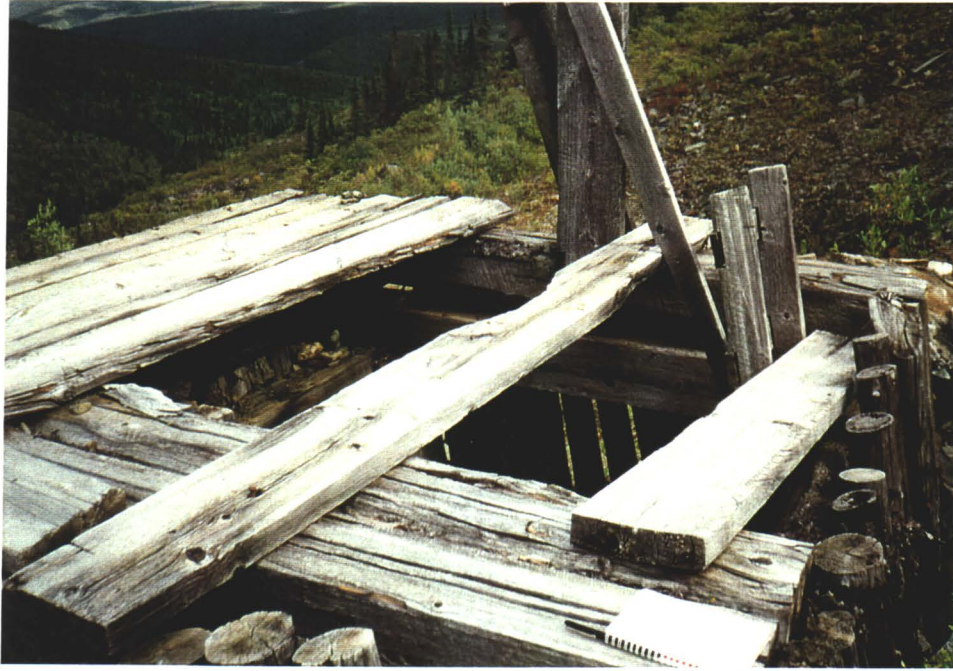
Photo 5. Top of timber shaft enclosure with access ladder at right.

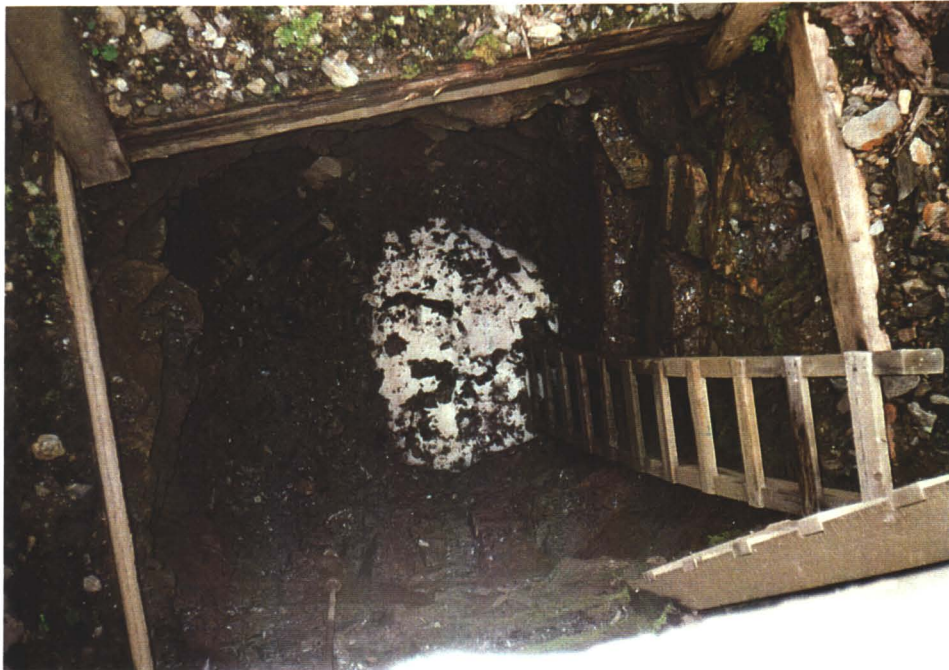
The shaft does not represent a significant health and safety risk because it is plugged with ice a few metres below the surface. Erosion of the waste rock pile is controlled by the vegetation which has taken root on the slopes; therefore, the risk of slope failure is low.

Photo 6. Interior of shaft enclosure with frozen water 3 m below.

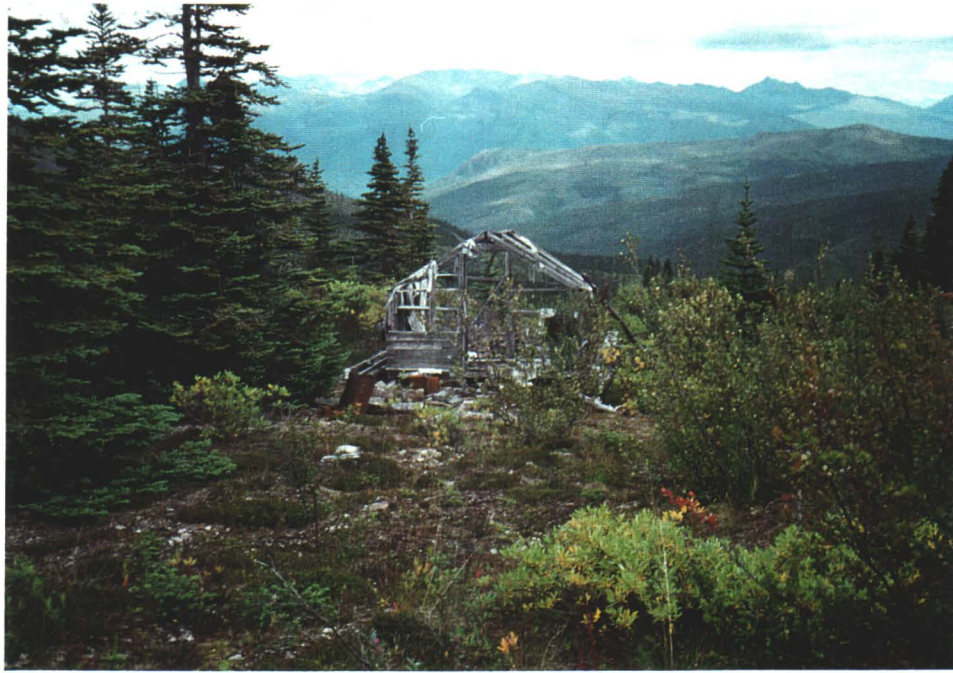
Remnants of a building were also found on site, located 125 m southeast of the remnant roadway and adit (See Table 1). This structure has deteriorated since the site was abandoned - only the frame and a portion of the walls and floor remain intact (See Photo 7).

Photo 7. Dilapidated wood tent frame upslope from shaft entrance.

It is recommended that the cabin demolished, burned and the debris buried on site for aesthetic, health and safety reasons. This can be accomplished using locally available resources and labour and can be buried on-site together with other site debris. Burial can occur by covering waste material with surrounding rock and soil on a clearing adjacent to a rock slope.

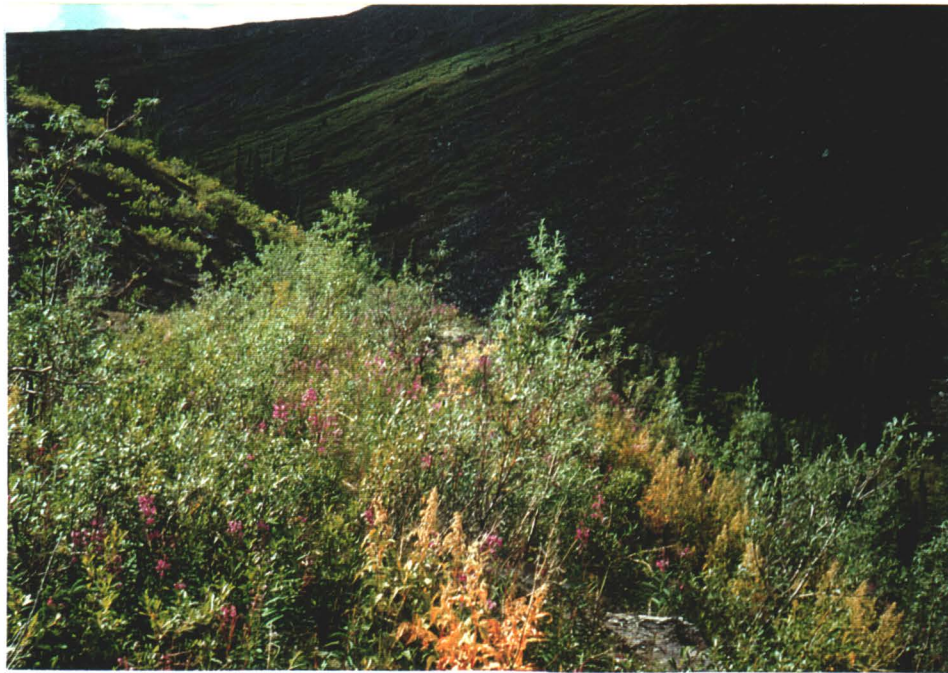
Photo 8. View west from revegetated waste rock pile north downslope from shaft.

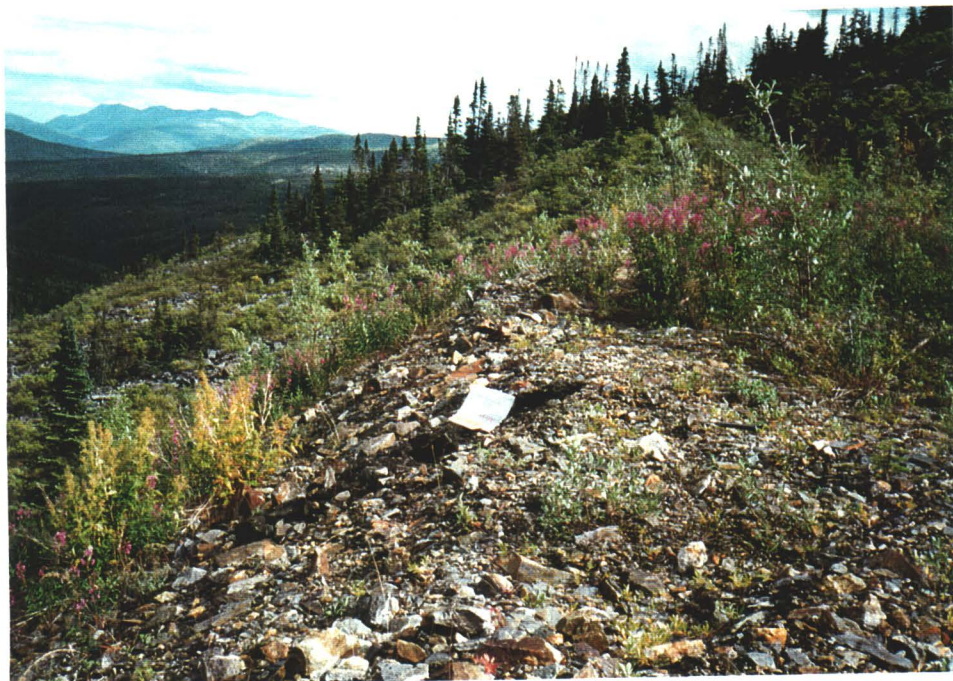
Photo 9. View east from sample DU-WR-P/301 collected approximately 100 m upstream from waste rock pile in Faith Gulch.

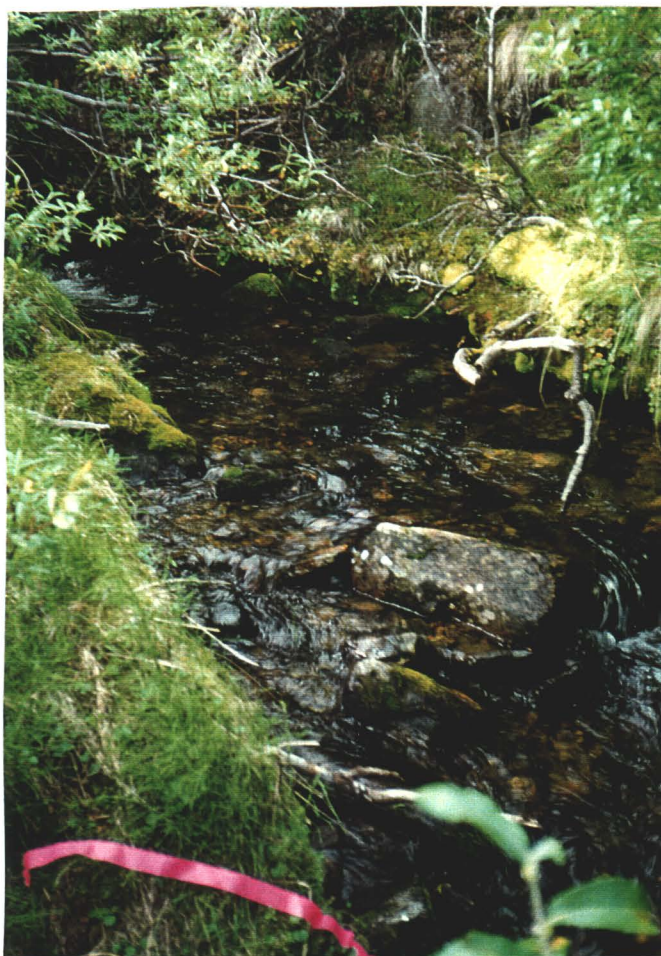
Photo 10. Faith Gulch looking west upstream of sampling location DU-WQ-P-302.
