**P118401**

**PHASE II ENVIRONMENTAL ASSESSMENT  
OF THE  
GAMBLER ABANDONED MINE SITE**

**PUBLIC WORKS AND GOVERNMENT SERVICES CANADA  
ENVIRONMENTAL SERVICES**

**STEFFEN ROBERTSON AND KIRSTEN (CANADA) INC.**

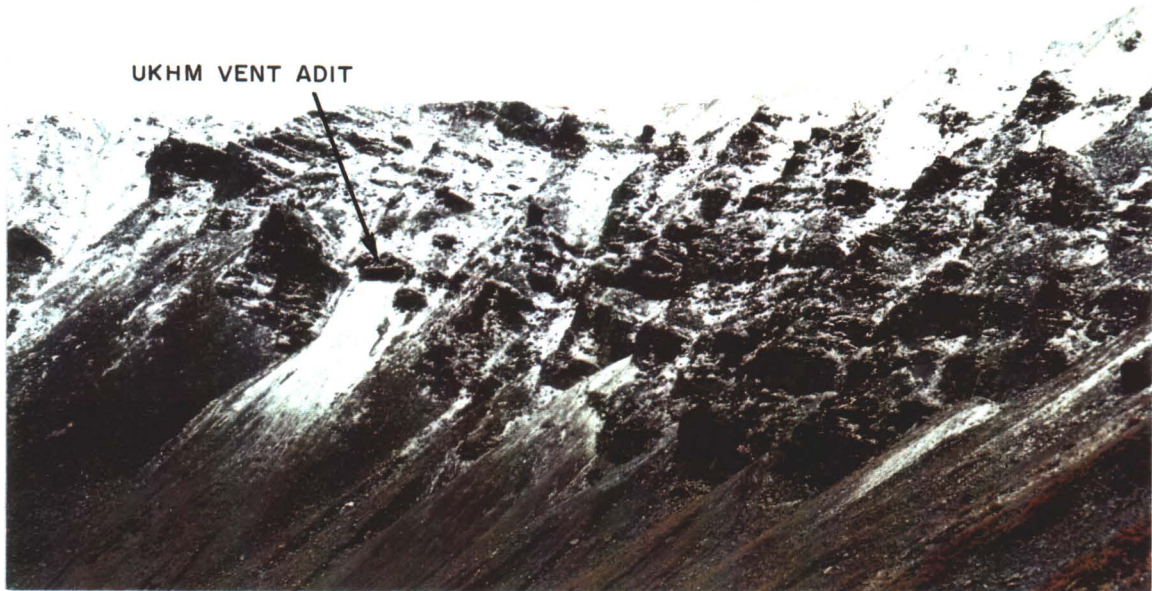
The Phase I assessment identified another adit to the southeast of the Gambler mine site. The adit, located on the face of a cliff at the head wall of Faro Gulch (Photo 1), is not part of the Gambler mine site, but, rather part of the United Keno Hill Mines (UKHM) workings (pers. comm., J.B. O'Neill). GSC Bulletin 111, Figure 9, shows a number of adit openings developed into the head wall of Faro Gulch. Most of these presumably have caved or been buried under talus. The adit identified in the Phase I assessment is probably a crosscut driven to Faro Gulch from the 200 level drift on UKHM's No. 3 vein "to serve as a waste haulageway and ventilation" (GSC Paper 68-68, p.22).

Photo 1: Head wall of Faro Gulch. Platform from UKHM underground workings breakthrough at left of centre, looking southeast. September 18, 1996

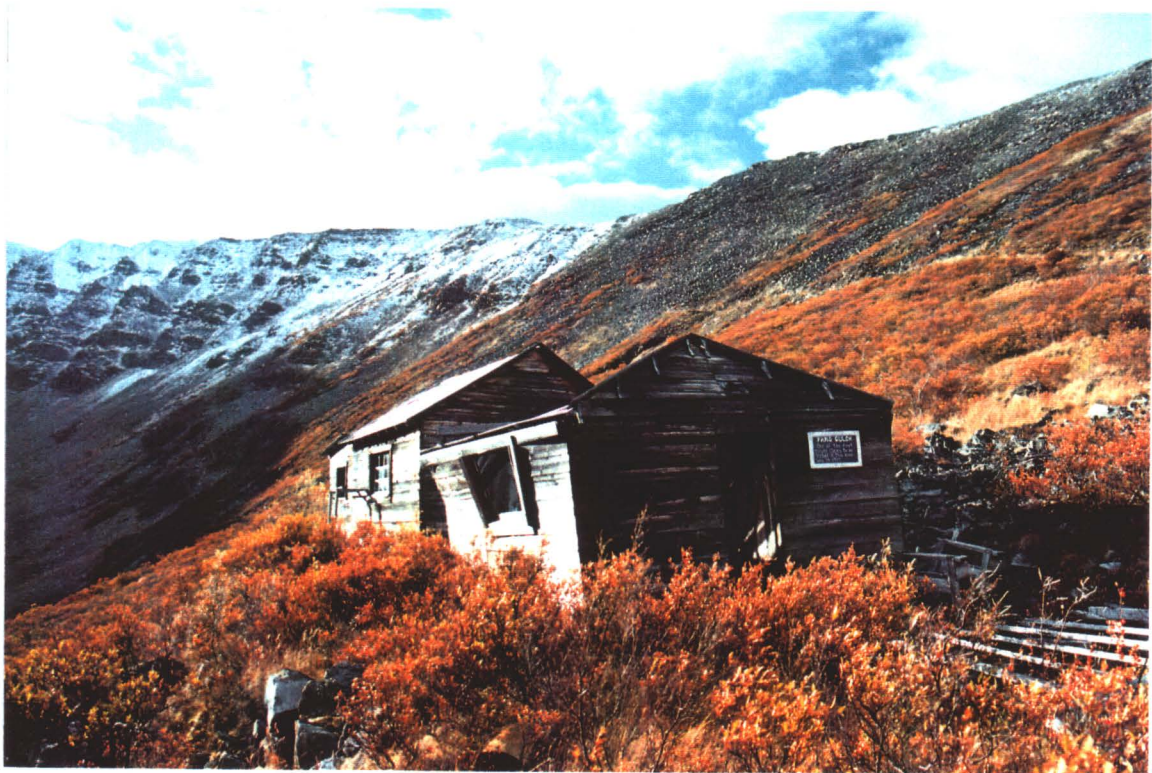
- A: A 6 x 5 metre, wooden framed, clapboard structure with a small addition (wood storage) on the southwest corner. The building consists of a main section with a large table, various shelves and kitchen sink, and a later addition (south end) containing a wooden frame bed. The floor, roof, and ceiling joists (2"x 4" construction on 3 foot centre) of the building are in reasonable condition (Photos 2, 3, and 5).

- B: A 5 x 4.5 metre, wooden framed, clapboard building with a partially collapsed roof. The roof timbers are unstable in the present condition. The floor is in fair to poor condition (Photos 2 and 3).

Photo 2: Gambler Mine Site, Main Cabin and partially collapsed cabin looking southwest. September 18, 1996.

- Demolishing four of the five wooden buildings, at the camp site, by burning.
- Collecting all other wood debris at the camp and adit and burning.
- Collecting metal and other non-wood debris and transporting to landfill (offsite).
- Refurbishing the main living quarters.
- Repairing the mine rock seal at upper adit.

Four of the five buildings should be demolished and burned as they are in various states of collapse. The fifth building (main living quarters) requires repairs to the roof and floor to both preserve and make the building safe. If refurbished, the cabin will require periodic care and maintenance. However, the local residents and tourism association show a keen interest in maintaining historic sites and artifacts, and would likely be willing to take responsibility of its long-term maintenance. The local tourism association may also be interested in organizing and carrying out the reclamation work.

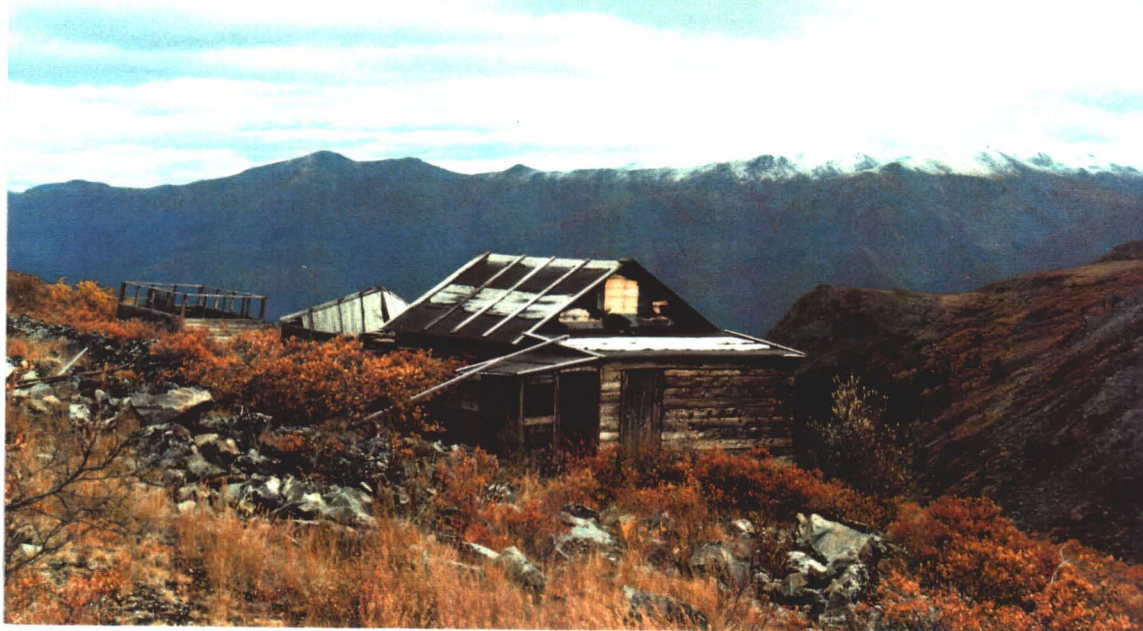
- C: A 3 x 3 metre, open topped, wooden structure that was designed to be covered by a canvas roof. The walls and floor are in reasonable condition (Photos 3 and 4).

Photo 3: Camp at Gambler Mine Site, buildings looking northeast. September 18, 1996

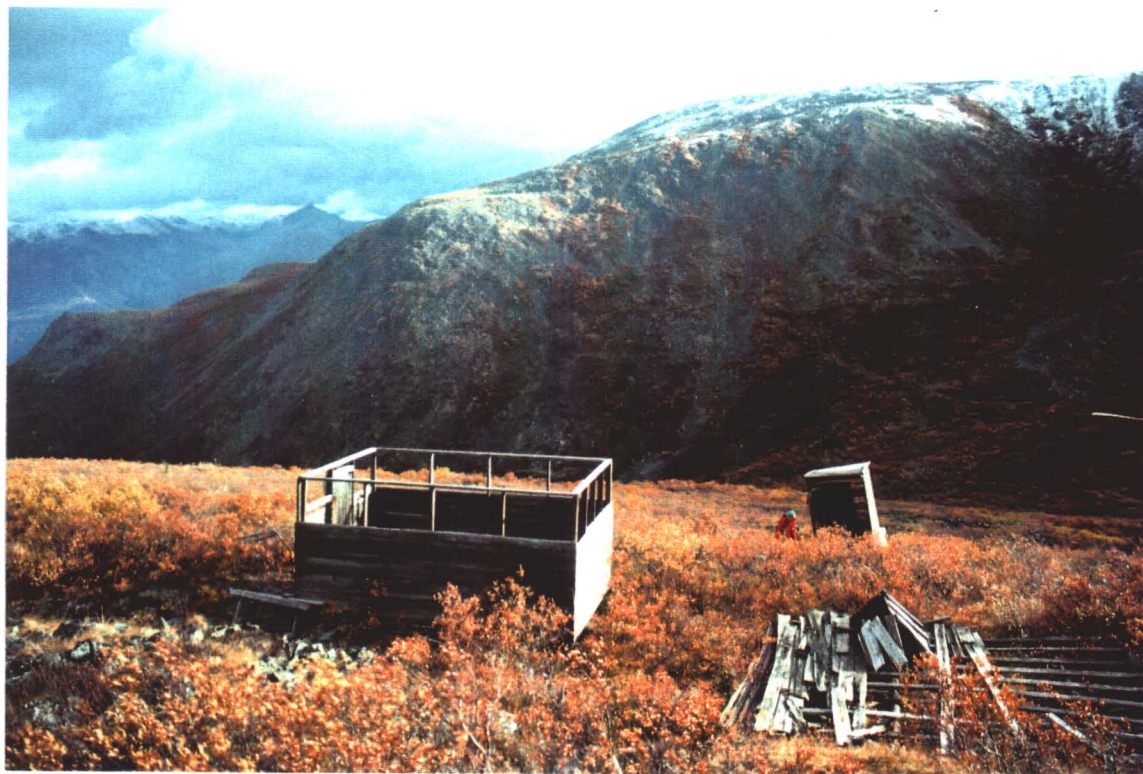
- D: A 3 x 3 metre wooden tent platform. Floor is in fair to poor condition (Photo 4).
- E: Wooden outhouse; about to fall over (Photo 4).

Photo 4: Remnants of wooden buildings and outhouse, looking east. September 18, 1996.

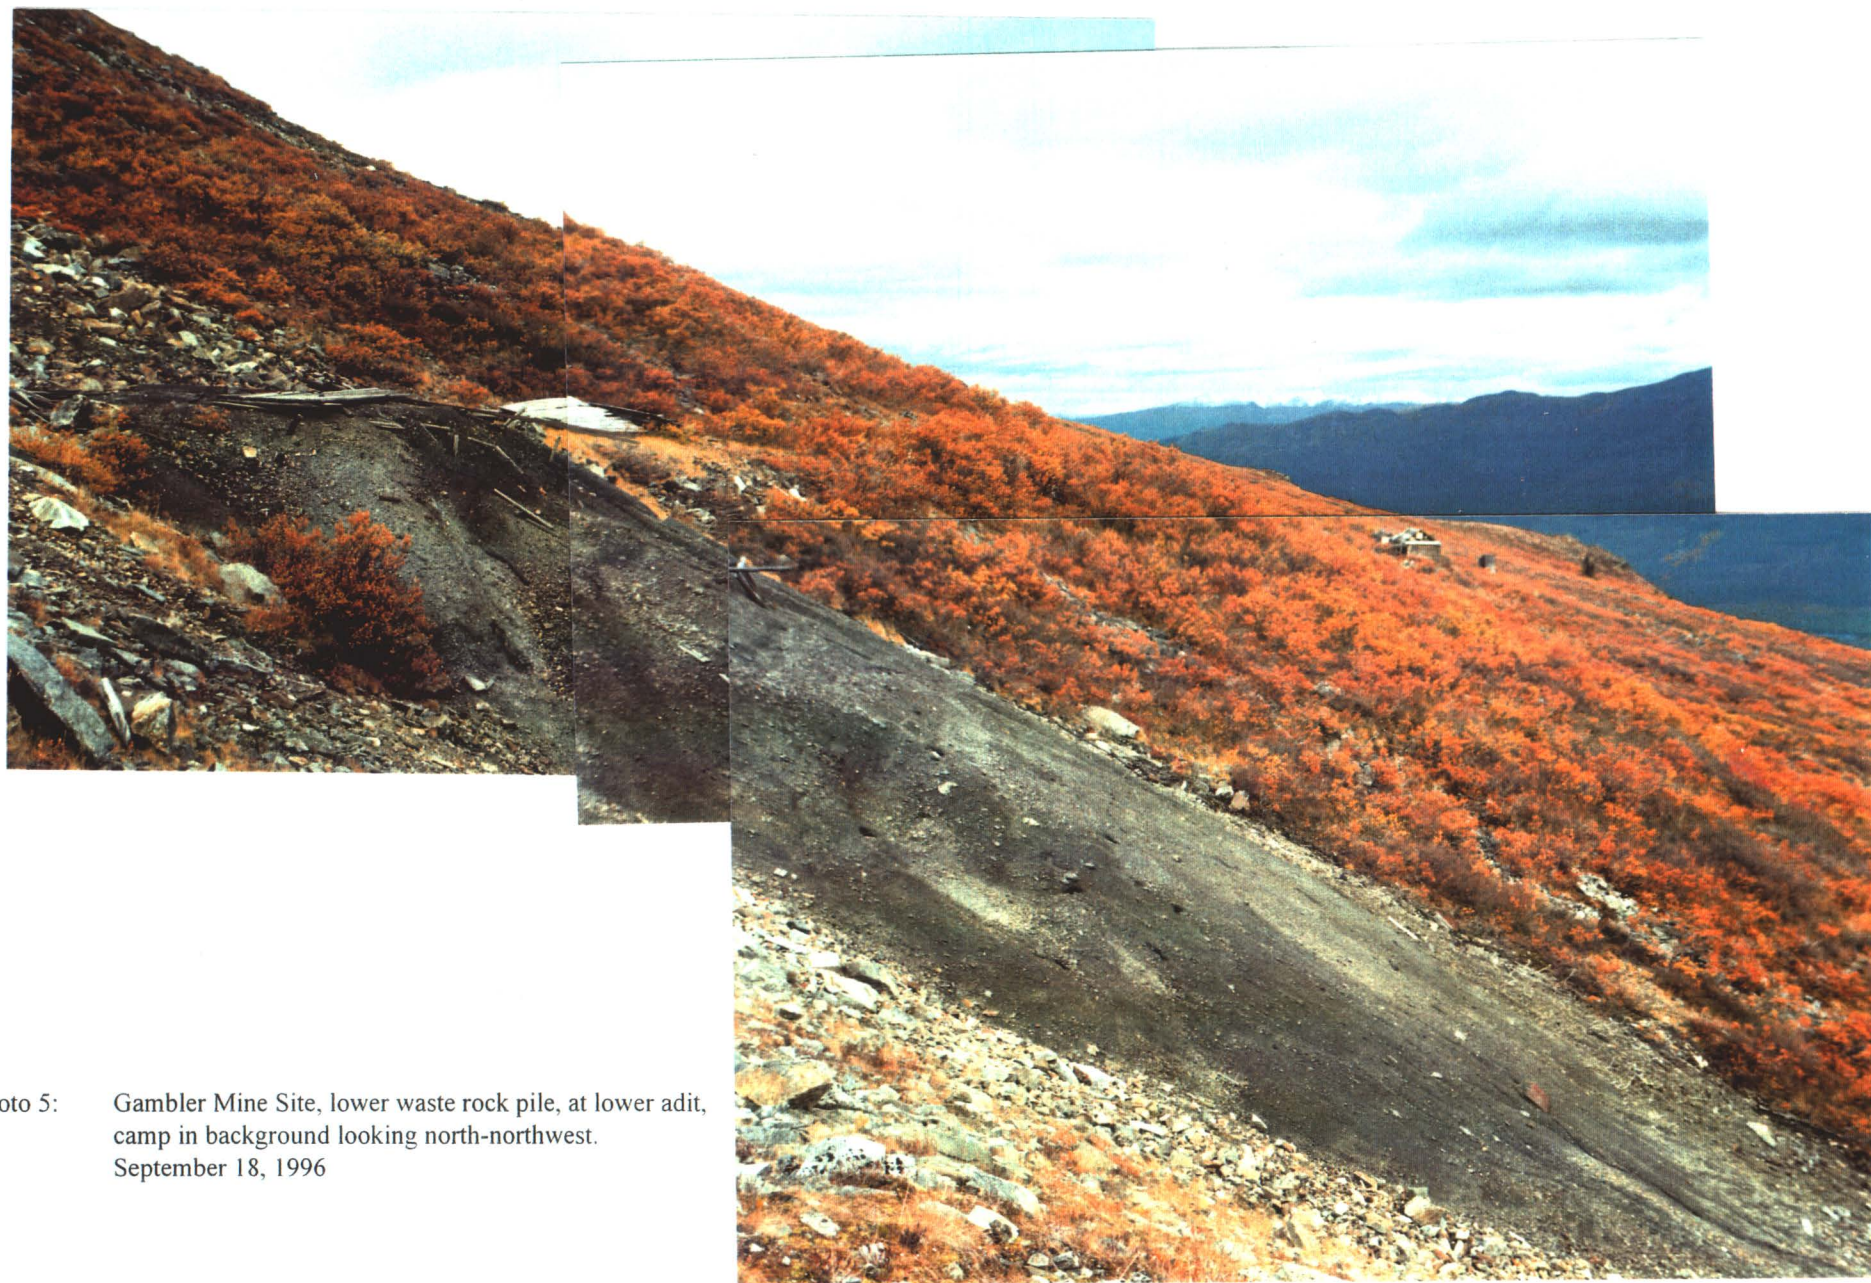
The infrastructure remaining at the mine workings consists of two buried adits and related track and waste dump facilities. Tracks at the lower adit extend from the underground workings out over the waste pile by approximately 2 metres and, although twisted, are in reasonable condition (surface corrosion only). A wooden platform covers part of the tracks at the edge of the waste rock pile (Photos 5 and 6).

The material forming the lower waste rock pile is finer than that in the upper pile, and contains significant quantities of sand and silt. The slope of the material is similar to the underlying talus slope and varies from 40° at the crest to 30° near the toe. Slump features were observed on the face of the pile near the crest, indicating that the face of the dump is marginally stable and may be undergoing active creep deformation (possibly related to poor drainage and frost action). Such shallow surface deformation is likely to continue in the future, and may result in a gradual extension of the toe. Rapid, large-scale failure does not appear likely, however.

The physical stability issue associated with the shallow slumping or creep evident in the face of the lower dump. Further deformation is likely to occur, but is not expected to result in rapid, large-scale failure, and the risk therefore considered to be low.

Photo 5: Gambler Mine Site, lower waste rock pile, at lower adit, camp in background looking north-northwest. September 18, 1996

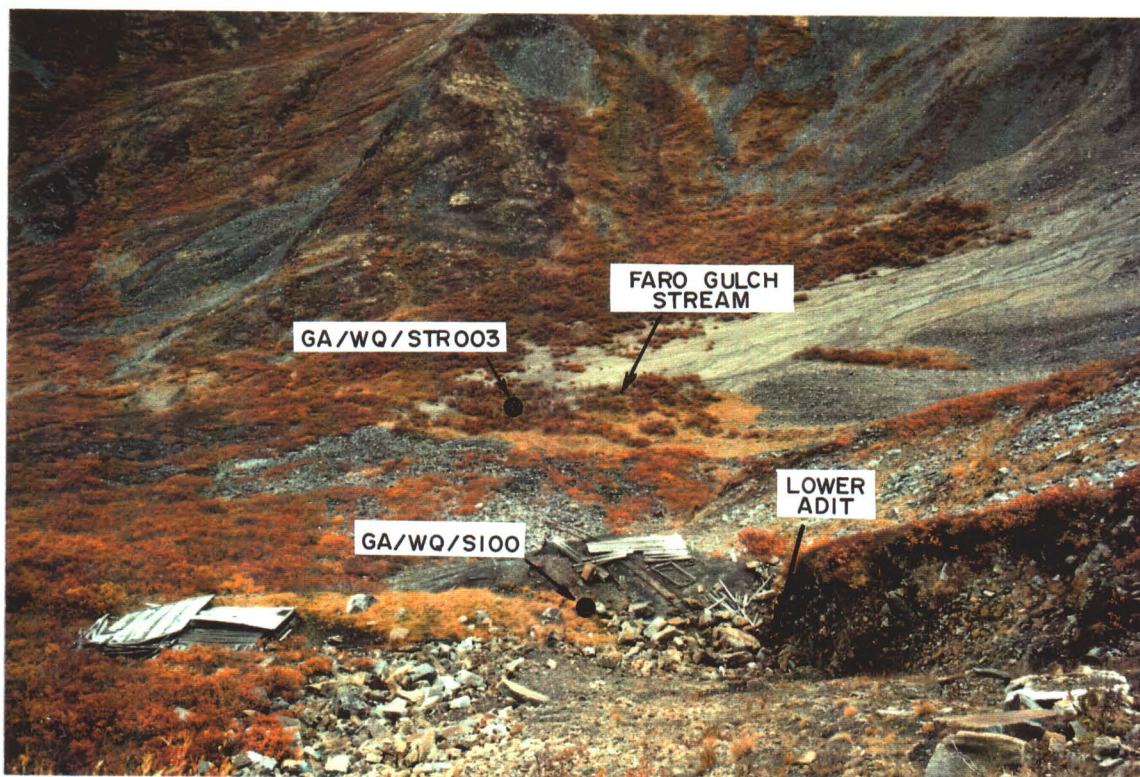
Photo 6: Lower adit and Faro Gulch Stream as seen from upper adit looking east. September 18, 1996.

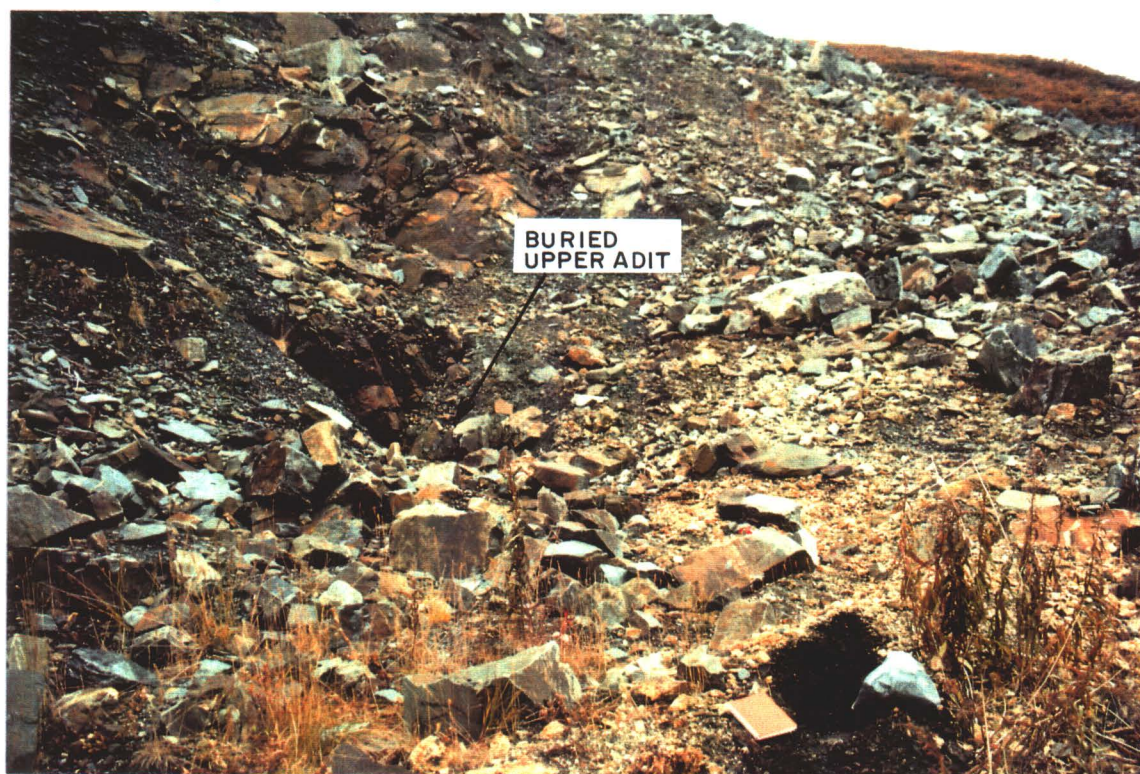
The upper adit (Photo 7) is located approximately 15 metres in elevation above the lower adit. There is a shallow depression, 0.3 to 0.4 m across, in the ground at this location which may have been caused by the settling of fines within the material use to block the adit. The opening created appears to be 2 metres deep. While the adit does not currently pose a safety hazard, there is some concern that the seal may not be adequate over the longer term.

The lower adit is securely sealed and does not pose a health and safety hazard. The fill used to seal the upper adit shows signs of settlement. While the closure of the upper adit is adequate at the moment, there is concern that it may deteriorate with time and may require additional work to insure it performs adequately over the long term.

Photo 7: GA/WR/P201 sample site, at buried upper adit looking west. September 18, 1996.

The opening observed in the mine rock seal on the upper adit should be filled in to block any access. This can be accomplished with hand tools and using loose rock near the opening.

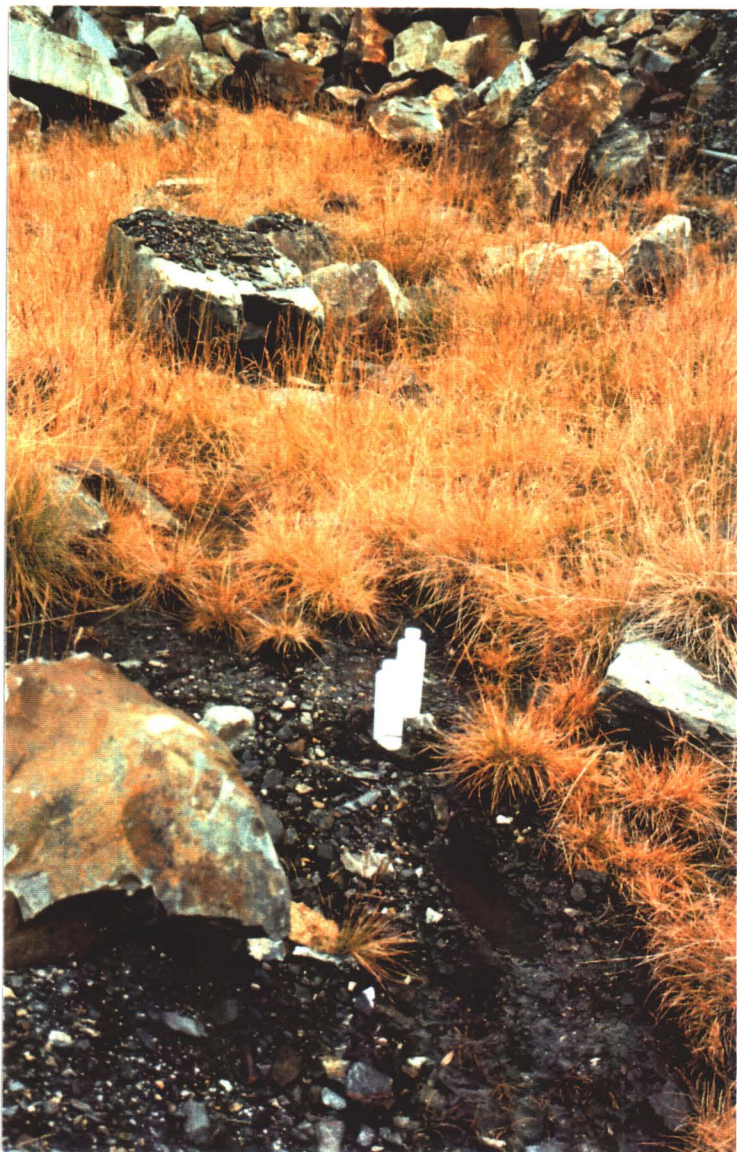
No seepage was observed from the upper adits. Groundwater was observed to be flowing out of the lower adit at less than one litre per second (visual estimate). The water flowed across the surface for less than 10 metres before disappearing into the ground at the northern edge of the waste rock pile. A sample (GA/WQ/S100) of this water was collected (Figure 3) and submitted for analysis. The catchment area above the waste rock piles is small and most surface runoff is naturally directed to the seep channel at the lower adit. No seepage, or signs thereof, were observed emanating from the lower pile.

Photo 8: Seep from lower adit, Water Sample Site, FA/WQ/S100. September 18, 1996

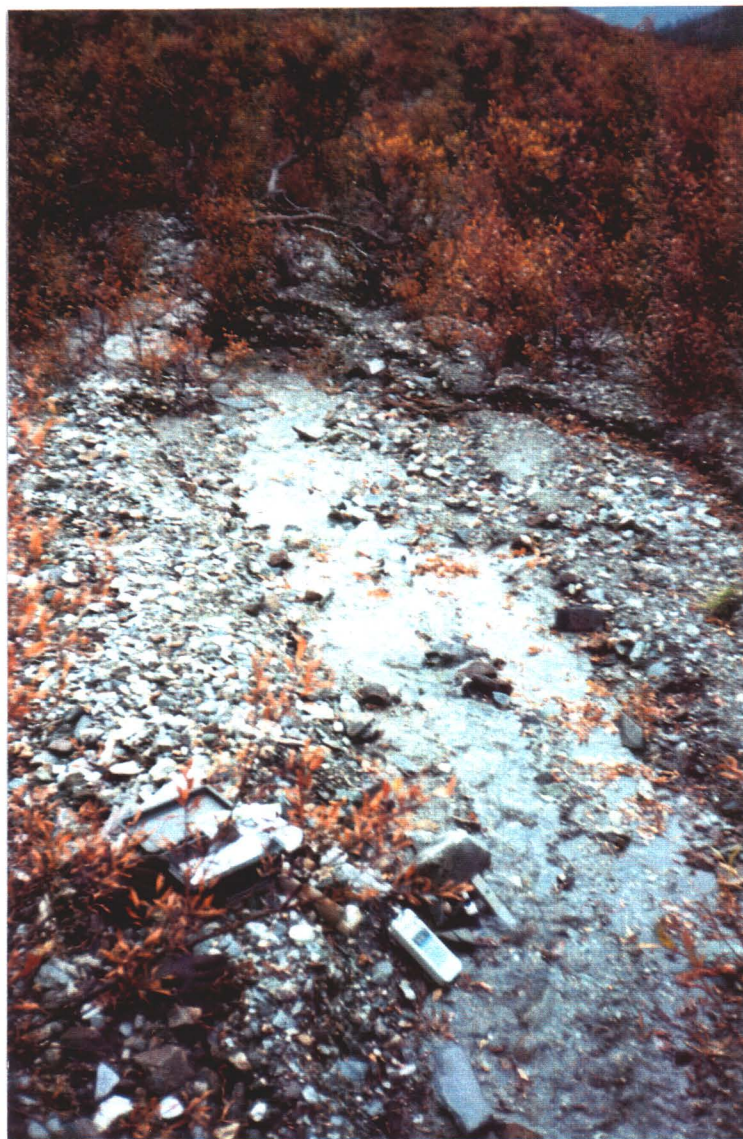
Photo 9: Water sample site GA/WQ/Str002, tributary of Faro Gulch below cabins. September 18, 1996.
