**PHASE II ENVIRONMENTAL ASSESSMENT
OF THE
GOLD HILL**

ABANDONED MINE SITE

Action on Waste Program
Indian and Northern Affairs Canada

March, 1997

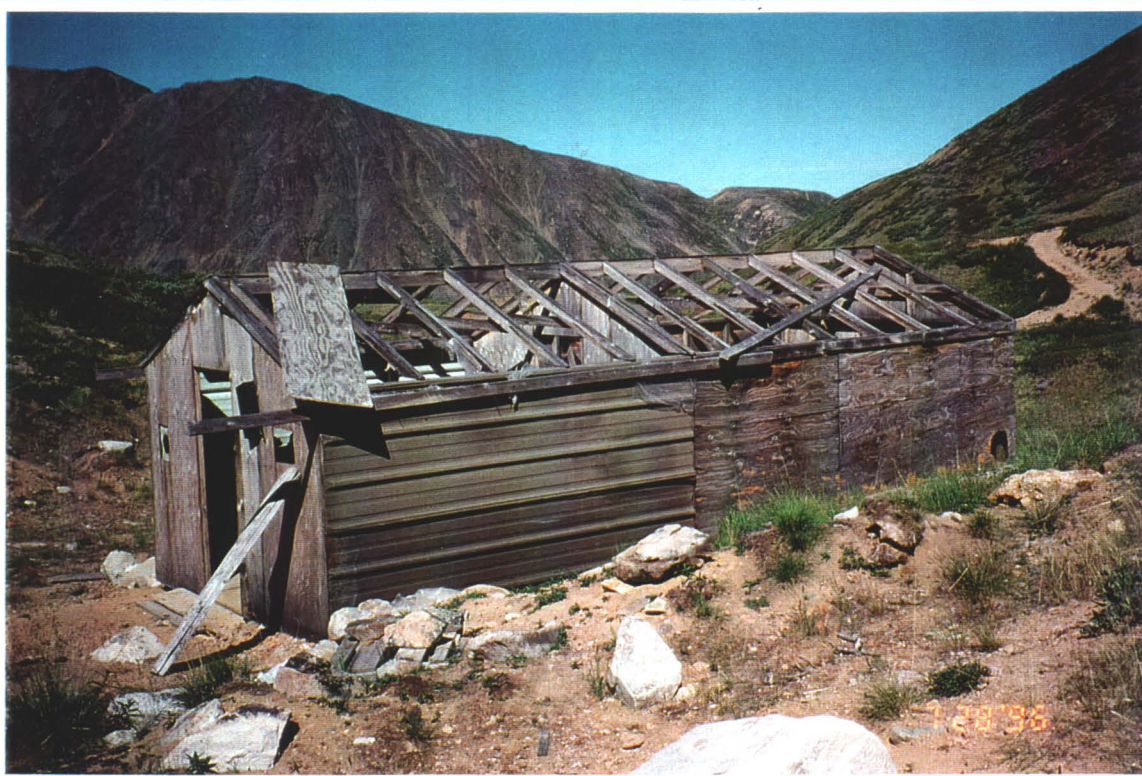
Inventoried Material	Location	Comments
~10 m x 3 m bldg.	bottom of northwest valley	wood frame with some aluminum siding; poor condition
wood outhouse	bottom of northwest valley	plywood construction; destroyed

Photo # 1 - Deteriorating Shack on Site

It is recommended that the buildings be demolished and burned and the ashes buried on site for aesthetic reasons.

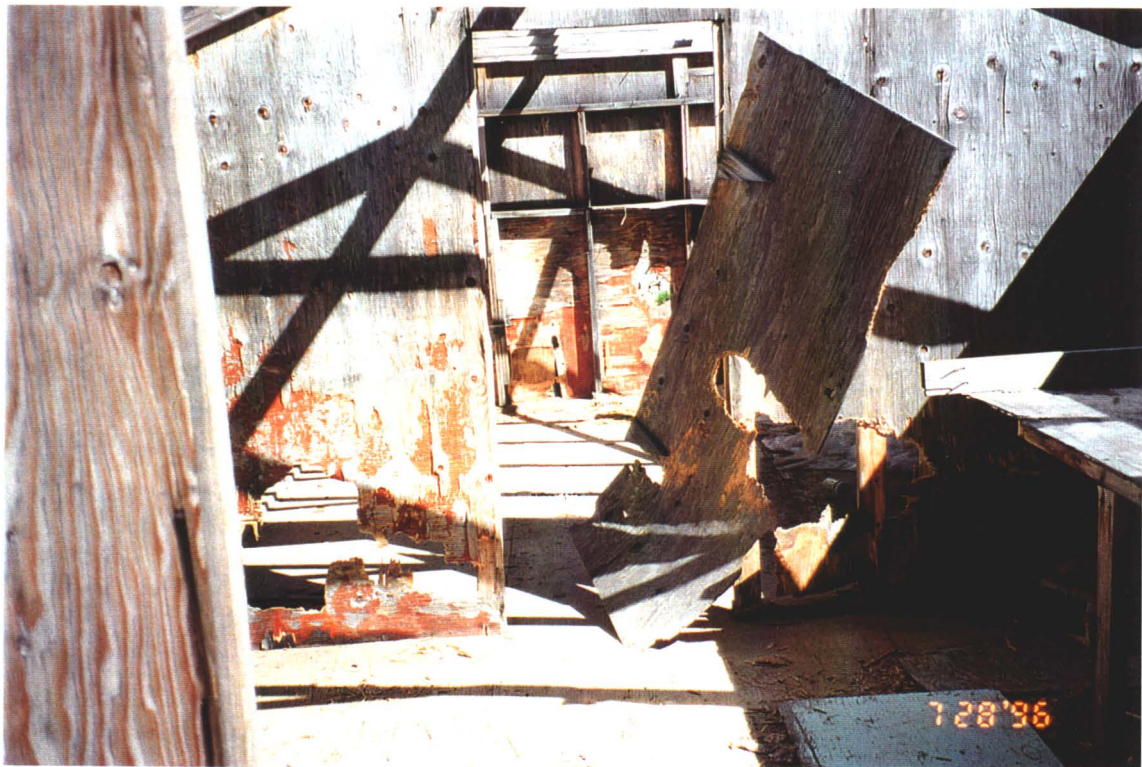
Photo # 2 - Interior of Shack

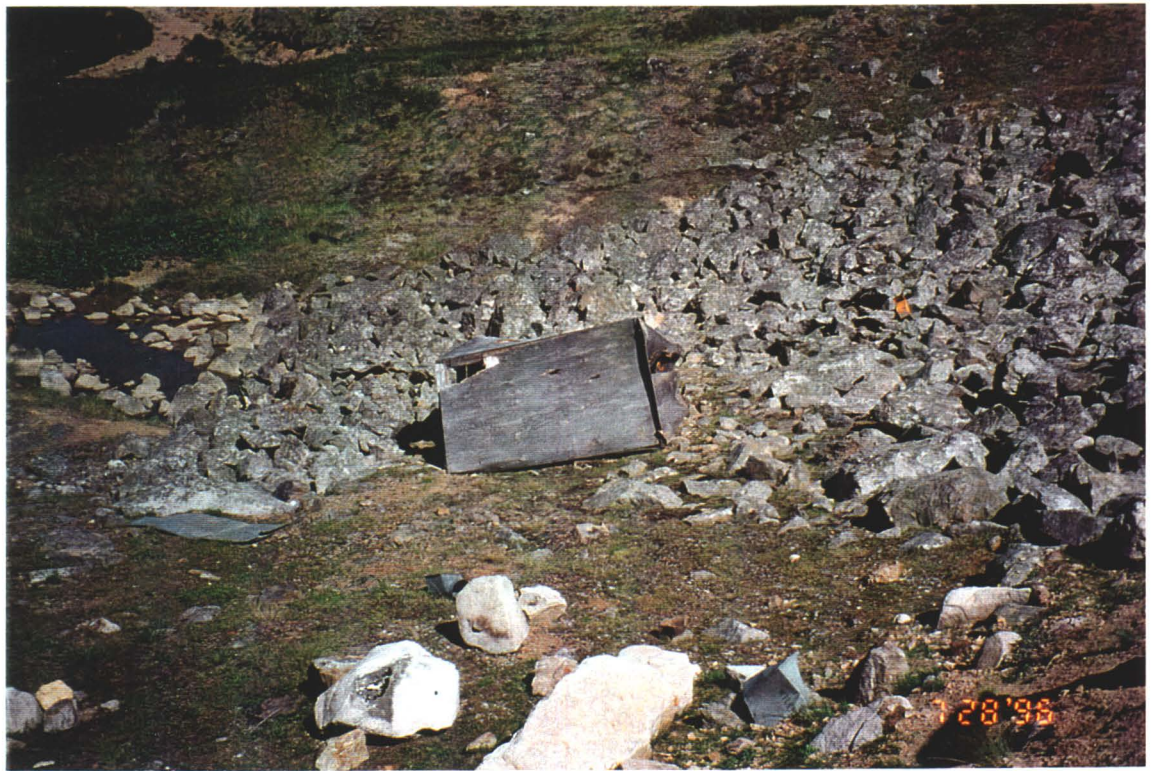
Photo # 3 - Miscellaneous Wood Debris

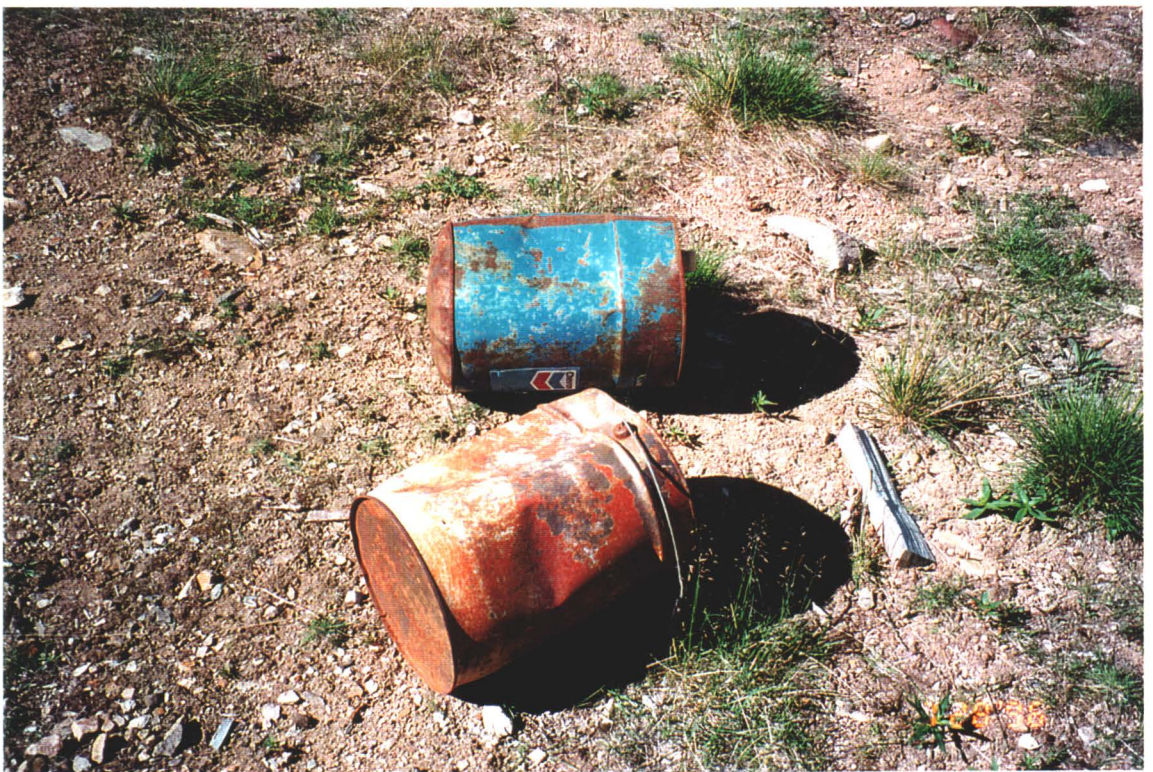
Waste Material	Number/Volume	Location
2 empty pails	23¢ each	adjacent to buildings
miscellaneous domestic waste	< 5 m ³	adjacent to buildings

Photo # 4 - Barrels to be Collected

It is recommended that metal site debris, including portions of the building and domestic waste, be collected and transported off site for aesthetic reasons. The debris can be collected using locally available labour.

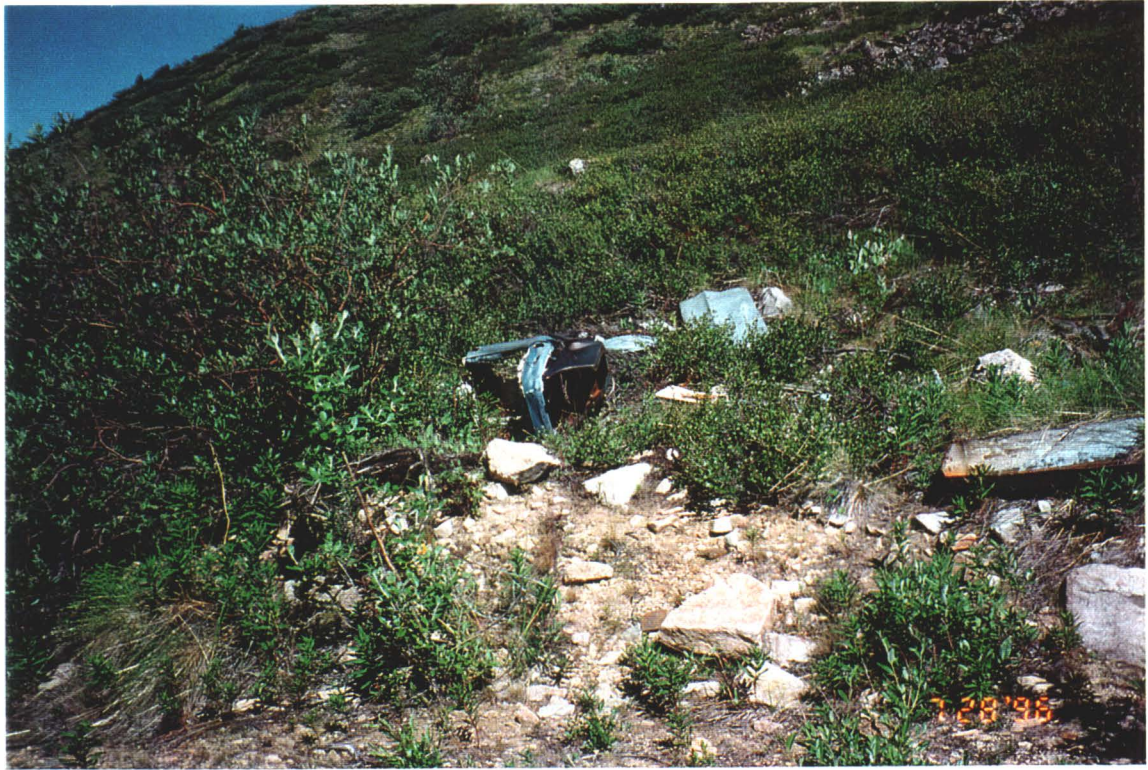
Photo # 5 - Miscellaneous Metal Debris

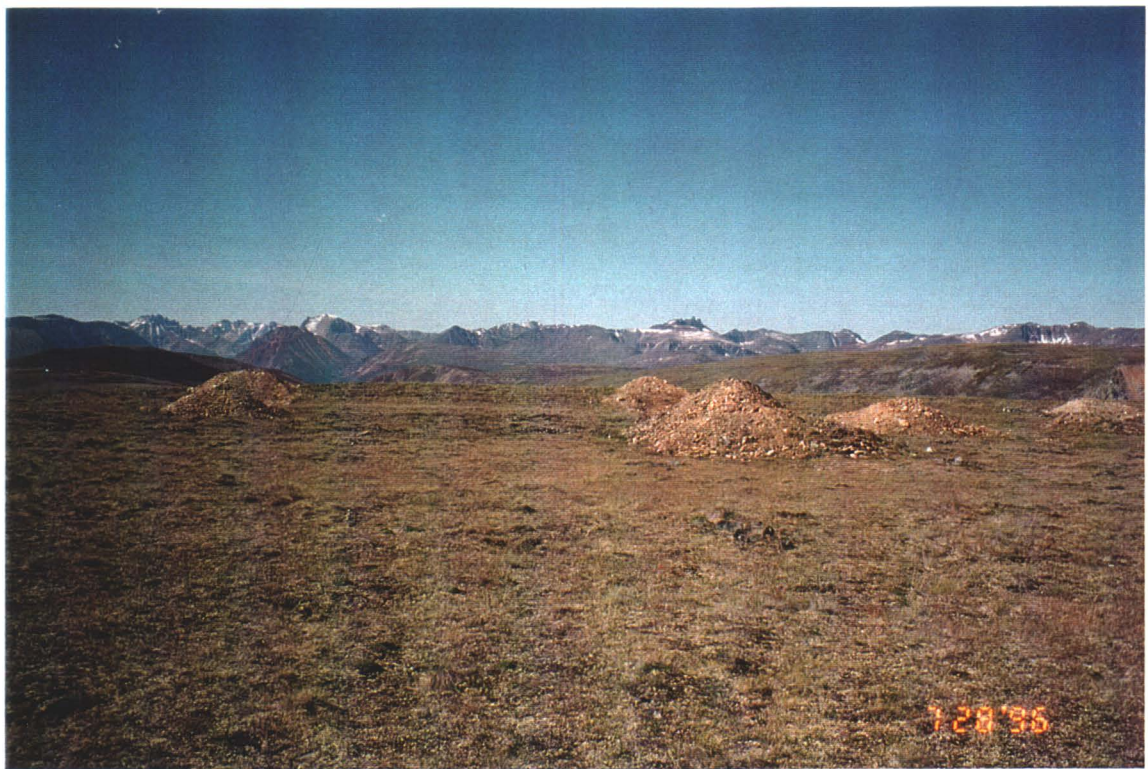
No indication of underground development work was found during the site assessment. Evidence of extensive surface trenching, circa 1910, was observed on the north side of Gold Hill. These trenches have sloughed in since that time and approximately 50% of the disturbed area is now fully revegetated. The site resembled a reclaimed alluvial mining area more than a hard rock mine site. The more recent trenching is located a short distance to the west of the old workings.

It is apparent from the site observations that the recent disturbances caused by trenching on the site will be non-detectable to the general public within 80 years if no reclamation work is undertaken on the site.

Photo # 7 - Trenching on top of Mountain
