Assessment of Abandoned Yukon Mine Sites

Mount Haldane #37

Prepared for
Public Works and Government
Services Canada

February 1997
GV206.01

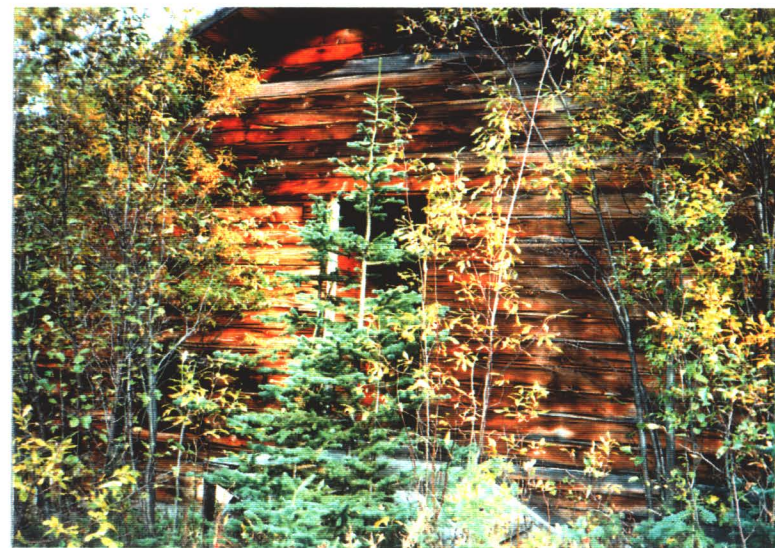
2

The main building is located at the base of the gulch and appear either much newer than the other buildings or of much better construction (Photos 1 and 2, Appendix A). This building is in good condition except some of the floor boards are weakening. The building is constructed of wood with dimensions of 8.5 x 7.4 m. The building was virtually empty of debris with the exception of a wood burning stove. In its current condition, this building would be suitable as a resting area or emergency shelter, however, may pose a small hazard with additional deterioration.

Buildings - Several buildings on-site are in various states of deterioration. The main and bunk buildings are standing and in fair condition. The other buildings noted are collapsed and present a hazard to people that may walk on or near the structures. The floor boards on the standing buildings are slightly deteriorating and in the future may pose a health and safety hazard to people entering the buildings. All buildings should be demolished to prevent a future health and safety issues. If the buildings are to remain in place, signs should be posted to possibly reduce the liability to the property owner.

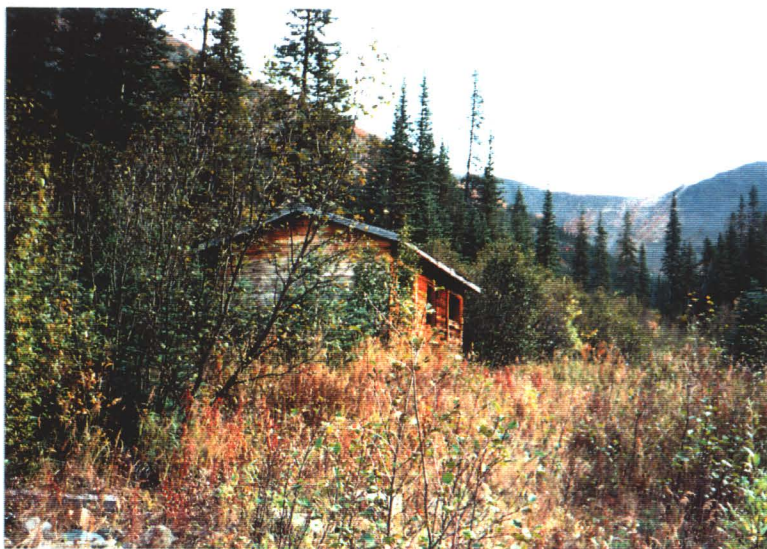
3

The bunk house (Photos 1 and 3, Appendix A) is located 12 m east of the main building. The 6.2 x 3.7 m wood building contains fibreglass insulation. Debris found in the building consists of three bunks and one gas stove. The building is in fair condition; however, floor boards are deteriorating. A wooden outhouse is located near the northeast corner of this building.

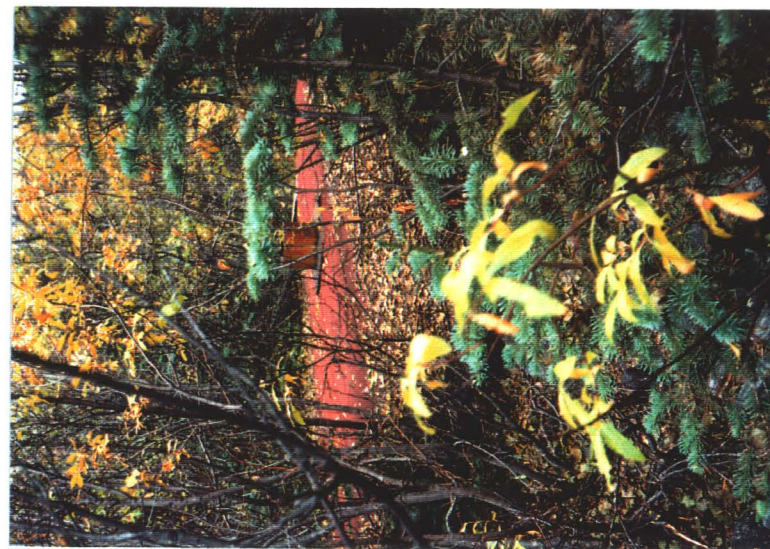
Two collapsed wood buildings (Photos 1, 4 and 5, Appendix A) are located on either side of the roadway approximately 40 m west of the main building. The building on the south side of the roadway is constructed of wood and has dimensions of 4.6 x 4 m. The building on the north side of the road is also constructed of wood with asphalt roof shingles and is 5 x 3.7 m. There was no evidence of any building materials other than wood and asphalt shingles.

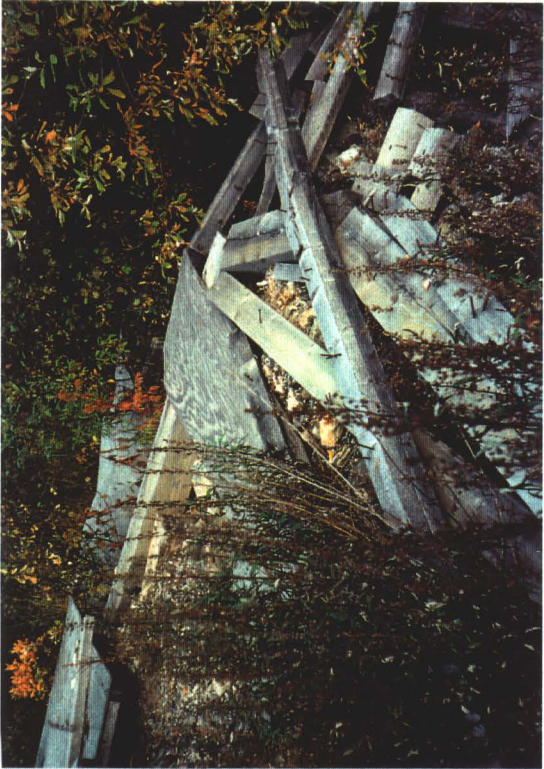
7

Upper South Adit - The collapsed wood structure (Photos 1 and 7, Appendix A) is located approximately 30 m west of this adit. Most debris is spread out over an area of 10 x 10 m and some is spread out down the slope to the north. A landslide has occurred above this former building and may account for the debris torrent below the building. An estimated 10 to 20 m³ of non-hazardous debris is present in this area. Galvanised sheet metal and nails sticking out of wood debris make this area a minor safety hazard.

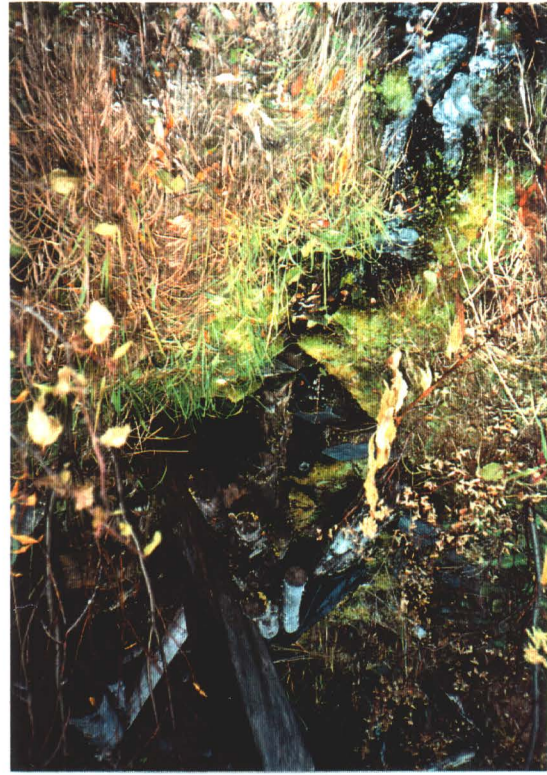
12

The lower south adit (Photos 12, Appendix A) is mostly collapsed and supported by timber extending horizontally into the slope face. The adit is up to 1 m wide but would be difficult to access. The depth of the adit could not be determined. This adit may present a minor safety hazard.

Lower South and North Adits - A few cubic metres of fill from nearby both these openings can be used to block the entrances and eliminate any safety hazard.

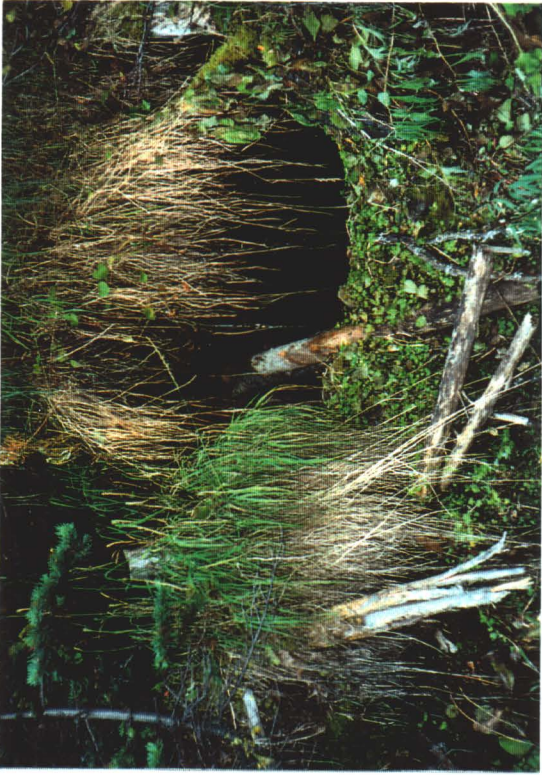
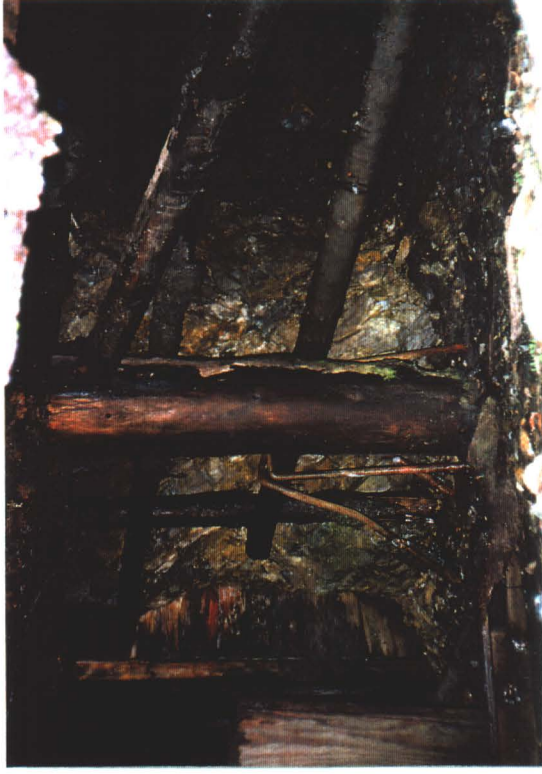
The upper south adit (Photos 13 and 14, Appendix A) entrance is about 2 m wide at the base, approximately 0.75 m high, and is supported by wood cribbing. Once inside the entrance, the adit opens into a larger area where there is another doorway approximately 3 m into the hill. The adit likely leads further into the hill from the doorway. The ease of access to this adit is identified as being a safety hazard.

Upper South Adit - To reduce the safety hazard, the portal entrance should be closed. If earth moving equipment is mobilised to the site, the portal can be buried with benign rock or soil. If no earth moving equipment is mobilised on-site, a rock drill can be brought in with a light truck to drill blast holes in the rock around the portal. A qualified blaster could then charge the holes and collapse the entrance to the adit.

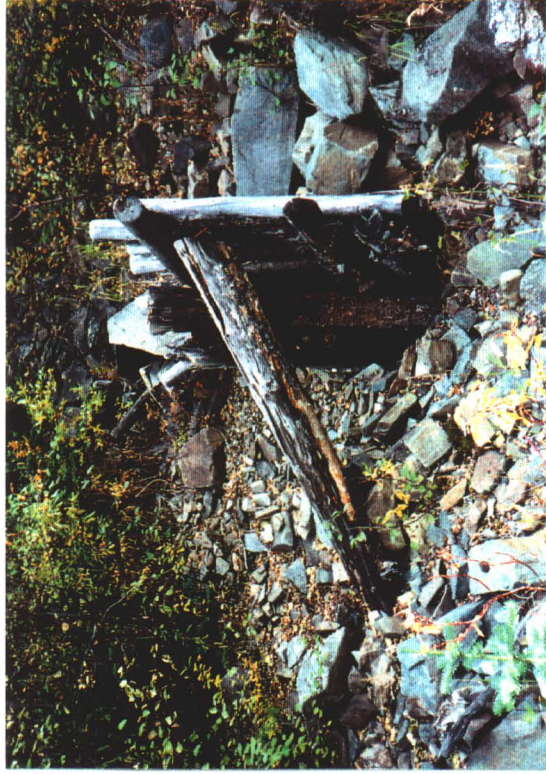
15

The north adit (Photo 15, Appendix A) entrance is collapsed and, therefore, presents a very minor safety hazard.
