PHASE II ENVIRONMENTAL ASSESSMENT OF THE RUNER MINE SITE

Prepared for:
Action on Waste Program
Indian and Northern Affairs Canada

March 1997

Environmental Services
Public Works and Government Services Canada

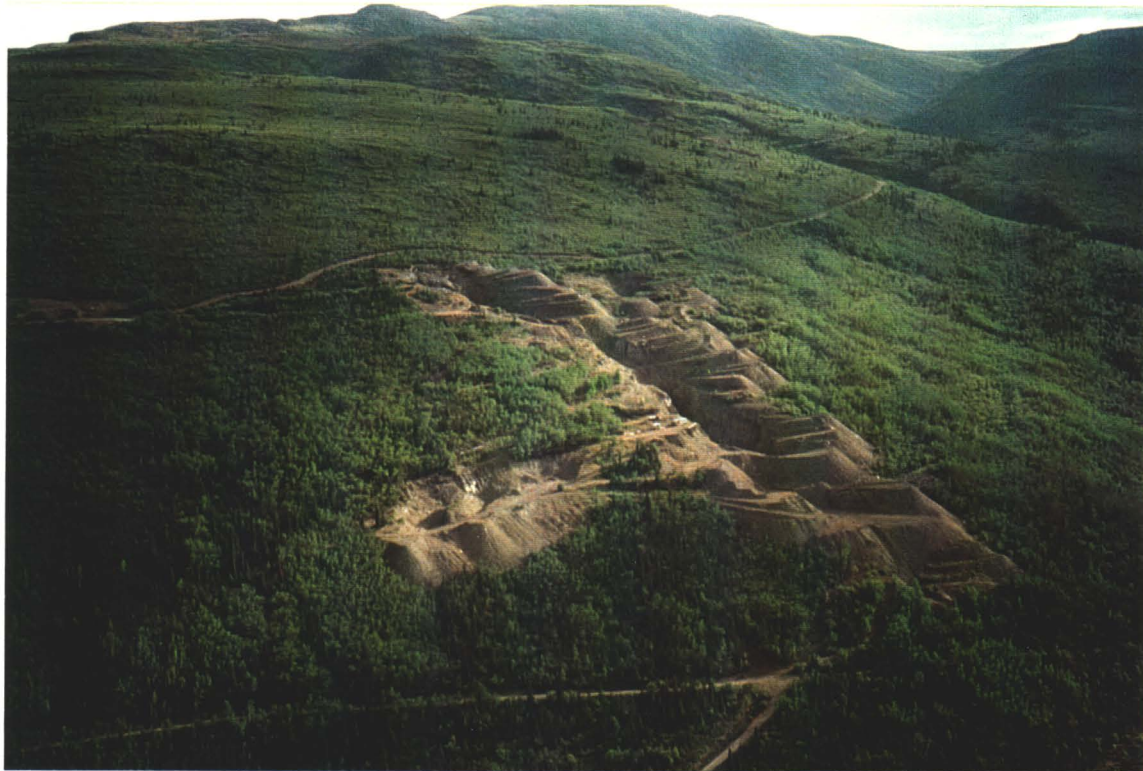
The current claim holder, M. Swyzinski of Keno, YT, leased the property in 1982. In 1983 a new 35.4 metre adit was drive near the 3820 level. In 1986 a new exploration adit was collared, although its depth is unknown. 534 tonnes of ore were shipped from the site during this period. The last reported work on the property was a trenching program in 1987 (Yukon Minfile 105M 016). Approximately 500 metres of lateral underground development and 25 metres of shaft sinking is reported as occurring at the Runer mine site. Conditions observed at the site indicate that additional trenching may have occurred more recently (Photos 1 and 2).

Photo 1. Runer mine site viewed from the west.

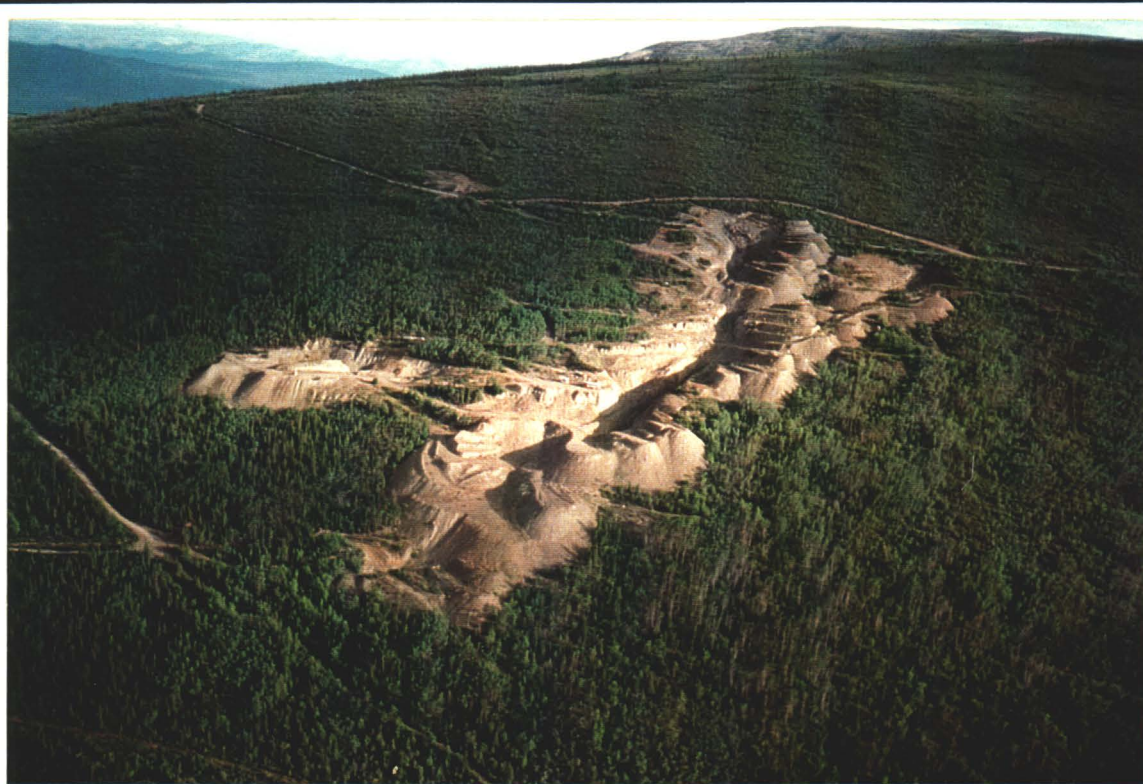
Photo 2. Runer mine site viewed from the east.

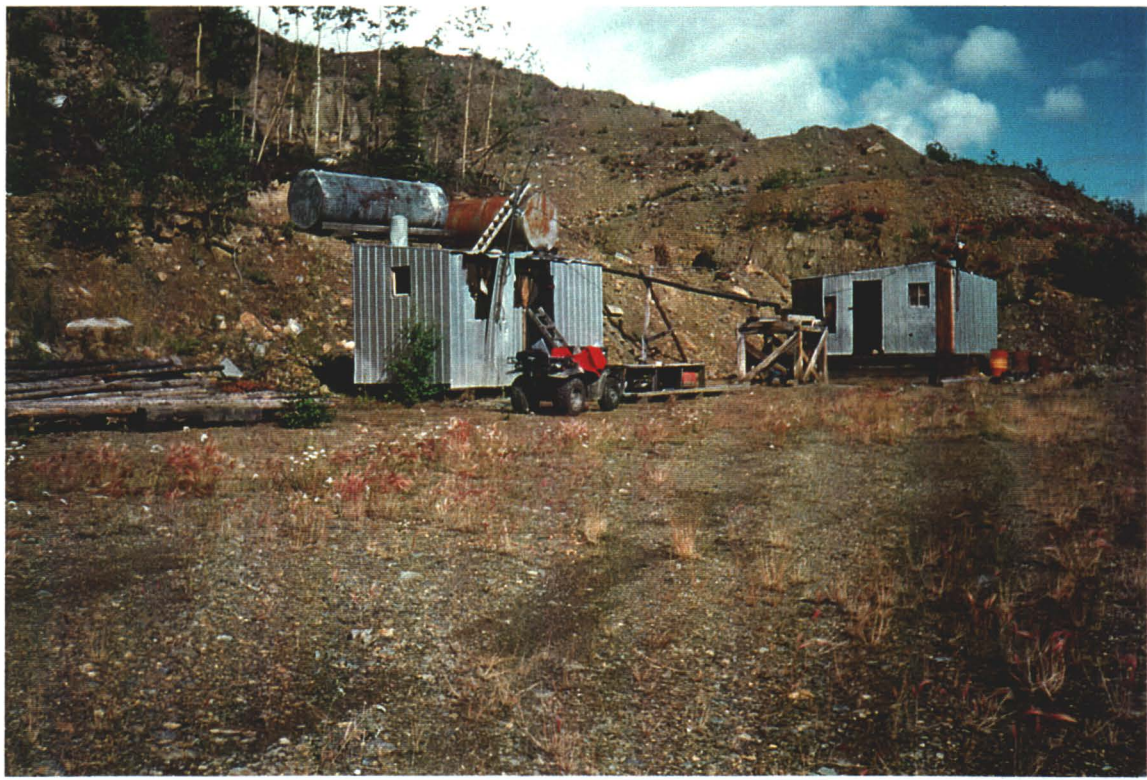
Two 22,750-litre welded steel above-ground storage tanks (ASTs) are located on an embankment behind the garage and storage shed buildings. A wooden support for a refuelling line joins the easternmost tank with a wood beam loading dock, which at one time supported a smaller-volume refuelling tank. A visual inspection of the tanks' interiors found the easternmost AST to be empty with a minimal sludge residue; the westernmost tank was tilted slightly downward at its western end, and approximately 1.5 cm of oily water was measured at the lowest point.

Photo 3. Storage shed (middle of photo) and garage (right) looking to northeast. Two 22,750 litre (5000 gal) ASTs visible on bench above buildings.

Recommendation 7. Empty drums should be consolidated, rinsed, crushed and buried on site. Similarly, the two ASTs should be cleaned, cut apart, and buried on site. Oily residues should be separated from wash water should be recovered with sorbent material. Tank sludge and the contaminated sorbents can be burned on site.

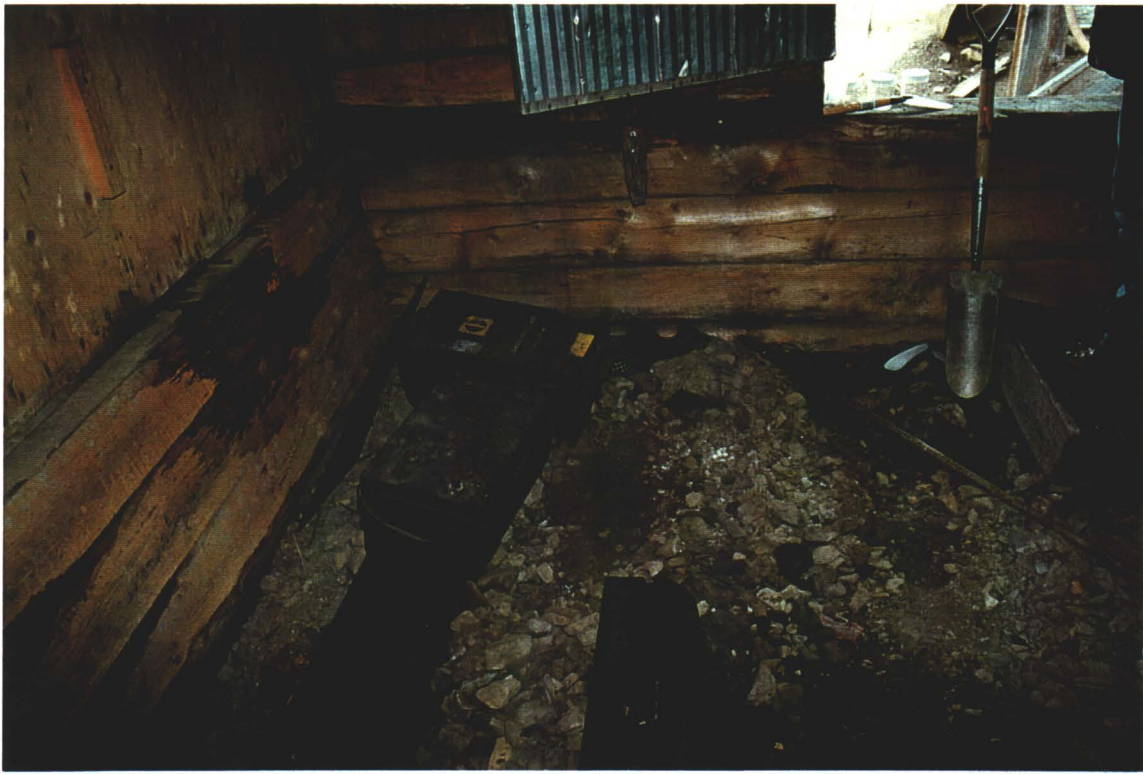
Sample RU-SL-201 was collected in the garage interior from the surface of discolored gravel and sandy silt next to two Caterpillar batteries (one of which had a broken casing and no remaining electrolyte). The area of discoloration was about 0.5 m² (Photo 5). Analytical results showed antimony, arsenic, cadmium, lead and zinc above CCME Commercial/Industrial criteria, while PAH compounds were within C/I limits.

Photo 5. Interior of garage (looking toward doorway) with 2 Caterpillar tractor batteries and areas of soil staining visible.

Recommendation 9. The battery located in the garage should be removed to Keno Hill for transport to an approved disposal facility.

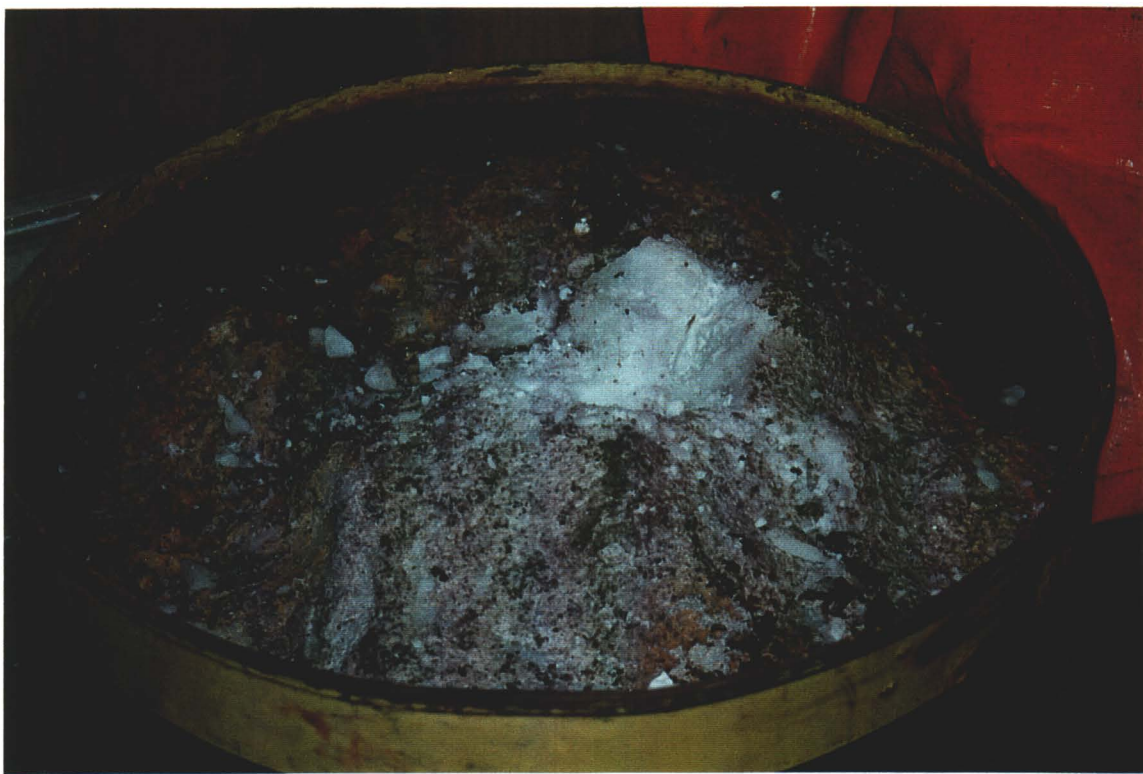
Photo 6. Salt-like substance in one of 3 drums inside garage.

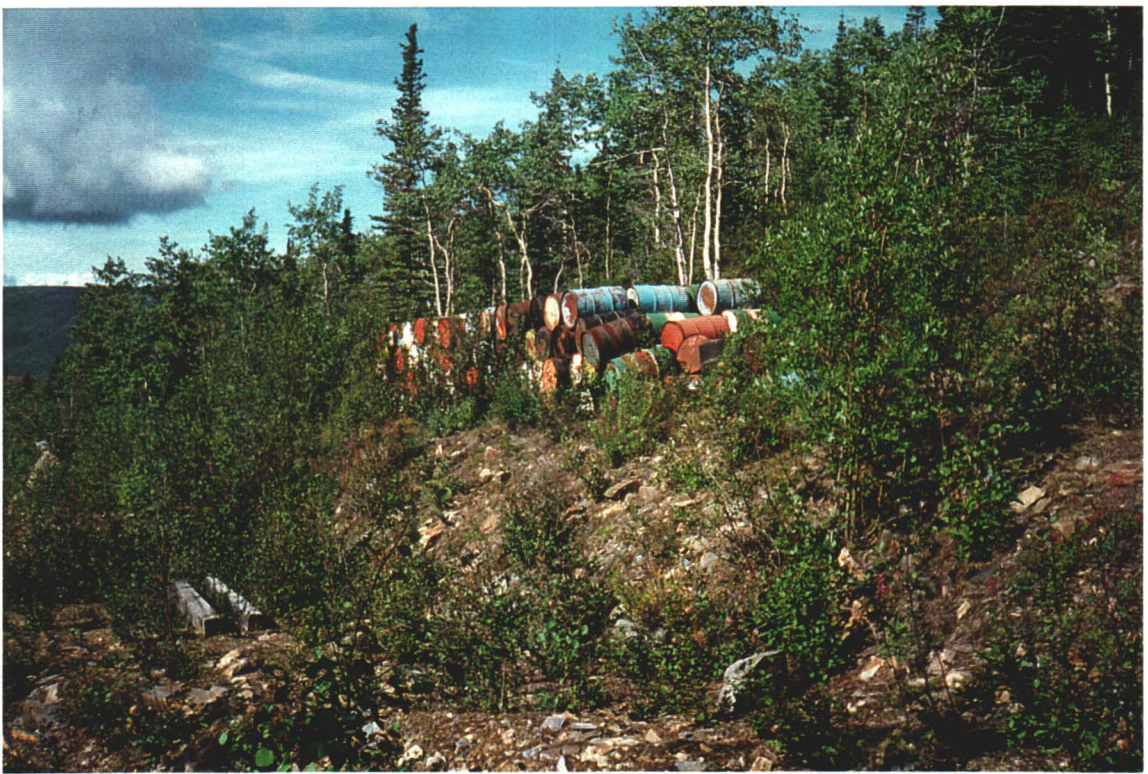
Photo 10. Drum disposal area on slope above material storage area, viewed toward northwest. About 320 empty 205 litre drums stacked or in vicinity.

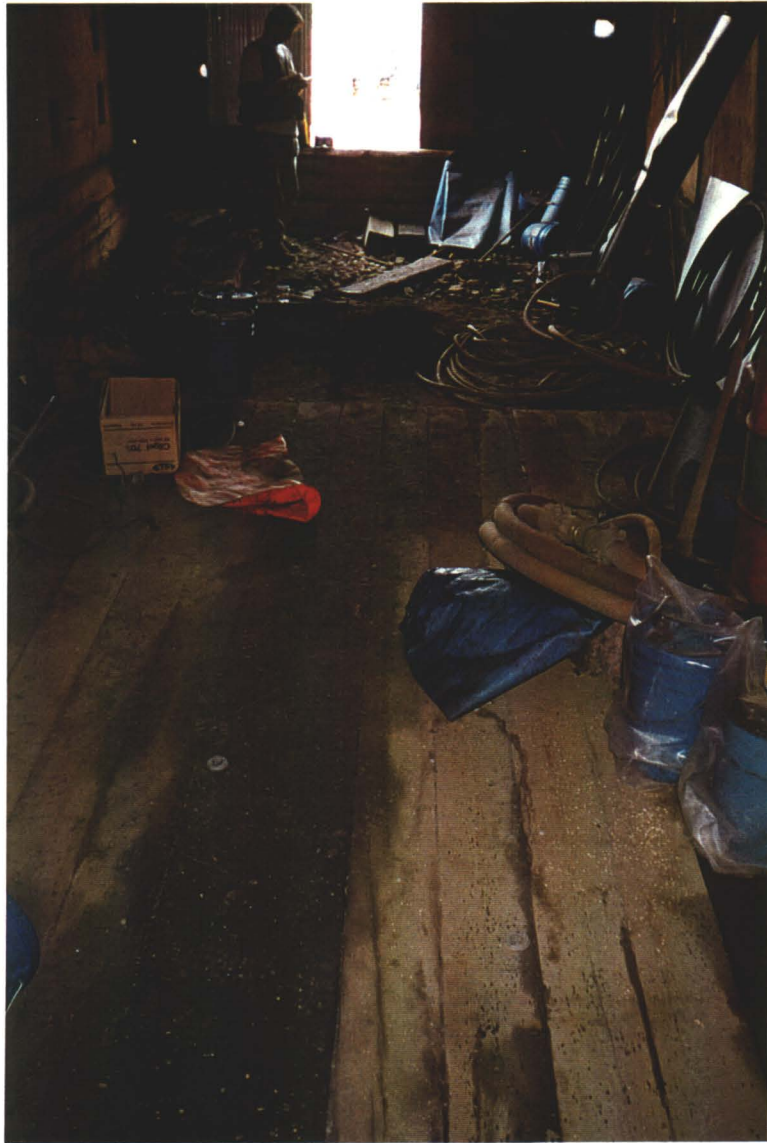
Almost all of the untimbered portion and about one-quarter of the timbered section of the garage floor exhibited moderate to heavy hydrocarbon staining (Photo 11). The waste rock/soil portion was most heavily stained, and appeared to have been used as a disposal area for waste motor and transmission oil.

Photo 11. Interior of garage; note extensive hydrocarbon staining of timbered floorboards.

Recommendation 5. Stained soil areas within and adjacent to the garage and storage shed should not be actively remediated. As described above, the integrity of the waste rock pad supporting these buildings is at risk from an undermining slope failure, and for that reason no mechanical scarification with heavy equipment is advised. Overall, the environmental risk of the stained soils in their present condition is minor, while a safety risk could be incurred by personnel and equipment while actively remediating those areas.

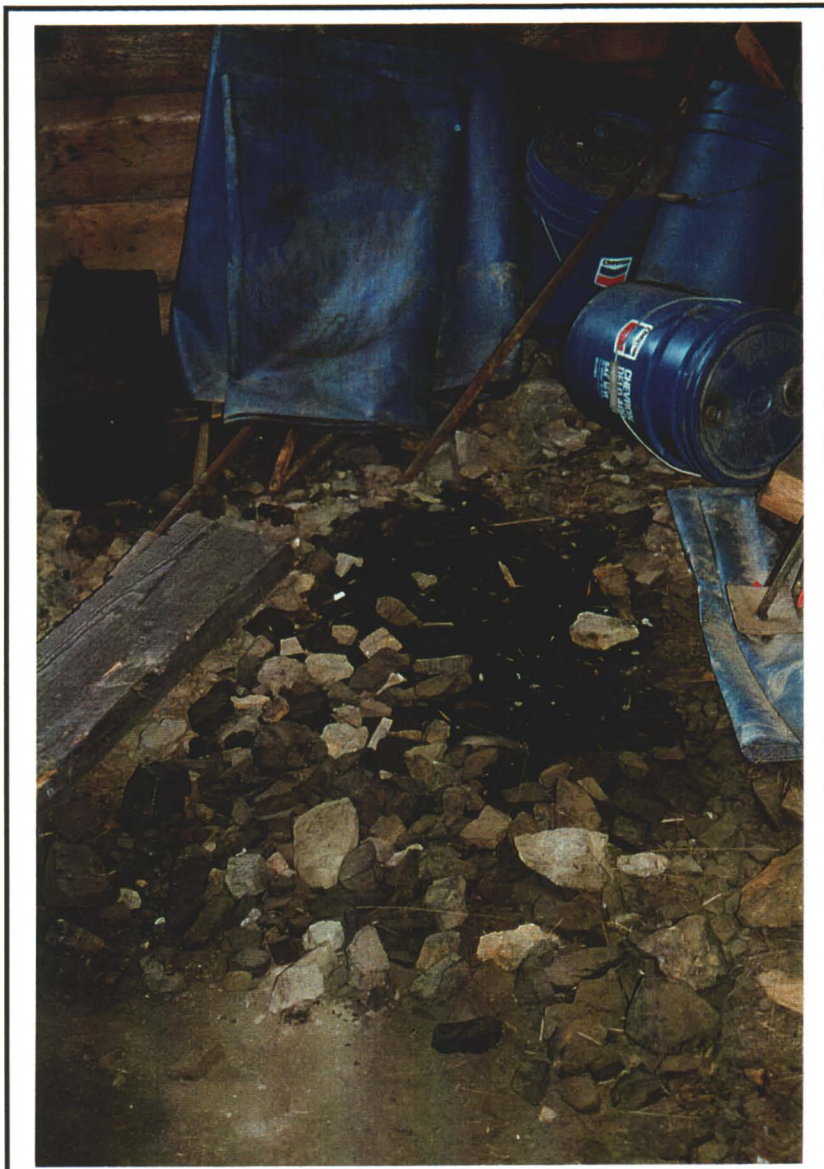
Sample RU-SL-202 was collected from the surface of a heavily-stained area of near the northwest corner of the garage (Photo 12). Approximately 1 m² was heavily stained, and the surrounding 3.5 - 4 m² was moderately stained. A pick and shovel were used to excavate the area of heaviest staining to a depth of 40 cm. The soil profile consisted of mixed, compacted waste rock (50% >50 mm) and sandy silt to 40 cm; similar materials appeared to extend past that depth. A layer of oily soil was evident to 30 cm depth, and significant staining continued from 30 cm to the excavation bottom at 40 cm. The coarse granular nature of the garage floor base suggests hydrocarbons have penetrated well beyond 40 cm depth. A very strong oily smell was noted in soil from all levels of the excavation. Analytical results showed antimony, lead and zinc above CCME Commercial/Industrial criteria, while PAH compounds were within C/I limits.

Photo 12. Sample location RU-SL-202 near NW corner of garage.

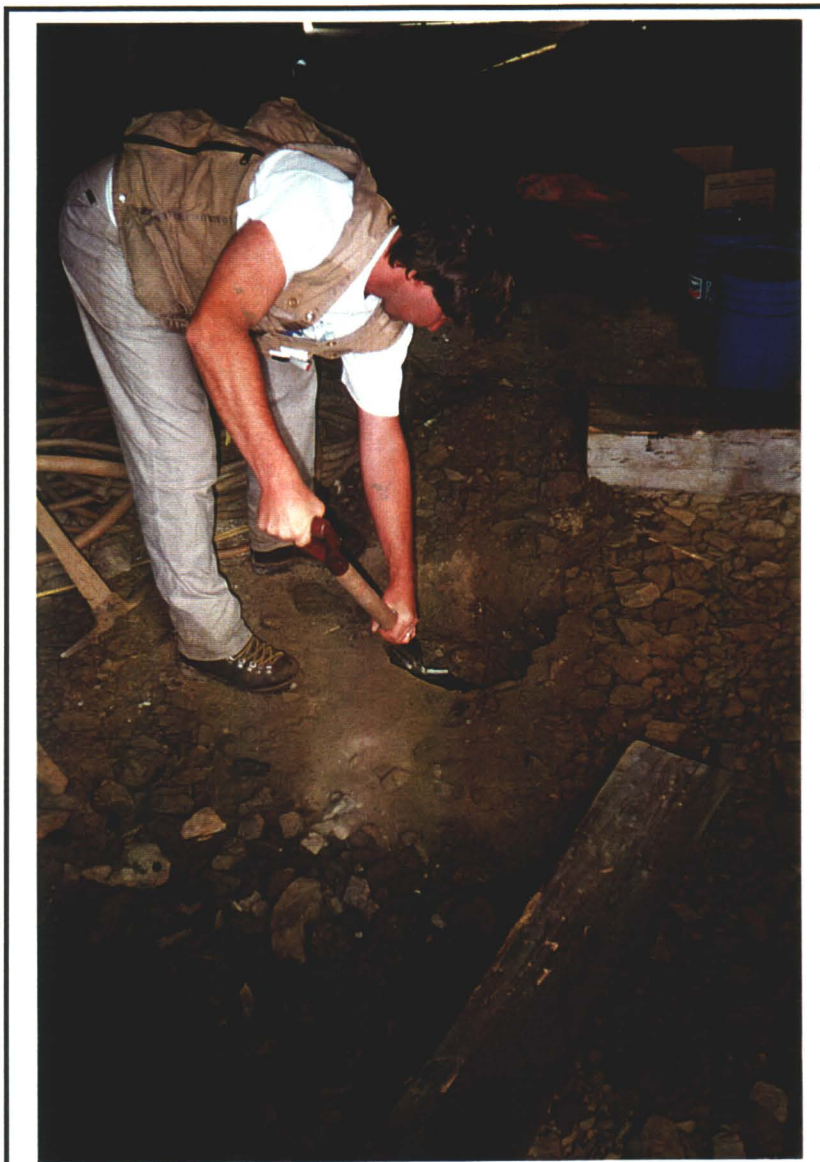
A second excavation to 40 cm depth was completed 1.5 m from RU-SL-202 in another area of heavy staining (Photo 13). Soil composition in the area of this excavation was similar to sample location RU-SL-202. Stained soil with a strong oily smell was evident from the surface to 40 cm, and the coarse waste rock and sandy silt present in the excavation profile suggests contamination below 40 cm depth. Sample RU-SL-203 was collected from the side wall of this excavation at 30 cm depth. Analytical results showed antimony, arsenic, and lead above CCME Commercial/Industrial criteria, while PAH compounds were within C/I limits.

Photo 13. Sample location RU-SL-203 in garage near timbered floorboards.

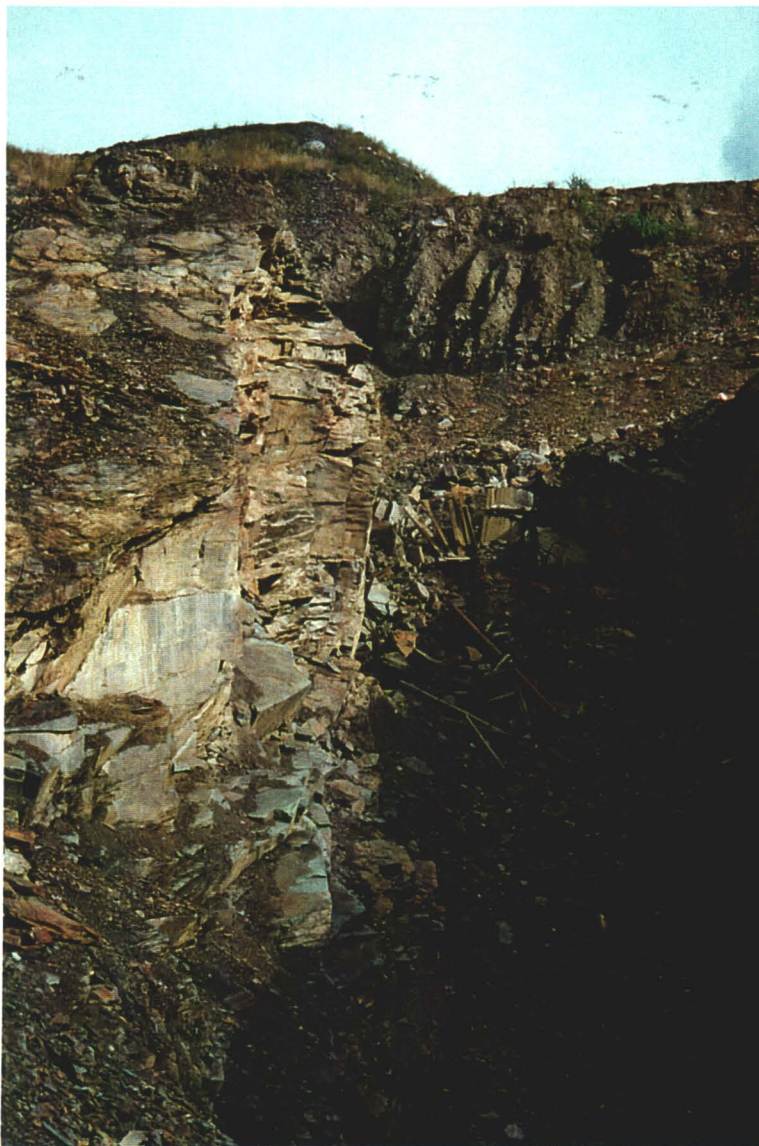
The remains of an adit (possibly the 3800-level adit) were observed high in the wall of the lower trench (Photo 14); a timber retaining wall above the adit and the adit entrance have been crushed by slumping overburden and bedrock.

Photo 14. Collapsed adit entrance in lower trench (centre of photo). Note steep, unstable overburden above at top of trench.

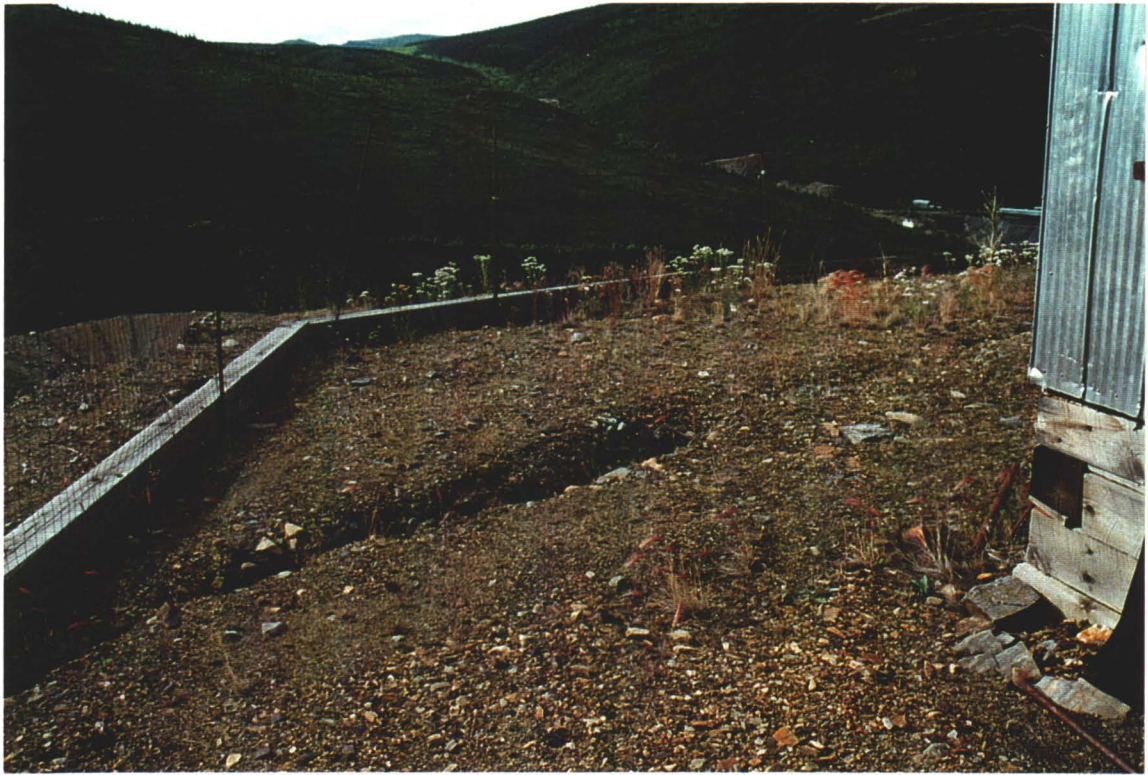
The slopes of the trench walls are steep and unstable. The slopes of the bulldozer-worked piles of overburden and rock appeared to be at the angle of repose and are considered relatively stable, with one critical exception. A near-vertical fracture in the weathered bedrock below the machine shop has caused the ground to cave within 10 metres of the building. Extension cracks are present within 2 metres of the building (Photos 15 and 16).

Very serious safety risks are posed by slope instability and the potential for linked failures of adjoining waste rock piles. The imminent failure of the garage waste rock pad and roadway threatens those buildings and the safety of any persons present on the downhill road bed.

Photo 15. Slope failure crack within 3 metres of SE corner of garage.

Recommendation 2. The garage and storage shed are at risk from incremental slumping or an acute slope failure at the edge of the buildings' waste rock pad. Heavy equipment movement on the pad may trigger a major slump; therefore, mechanical removal of either building is not recommended. Both buildings should be demolished by burning in situ. Metal cladding and other metal parts and components should be removed by hand before burning. After the buildings are burned, the west and south edges of the waste rock pad should be brought to a stable angle of repose by blasting.

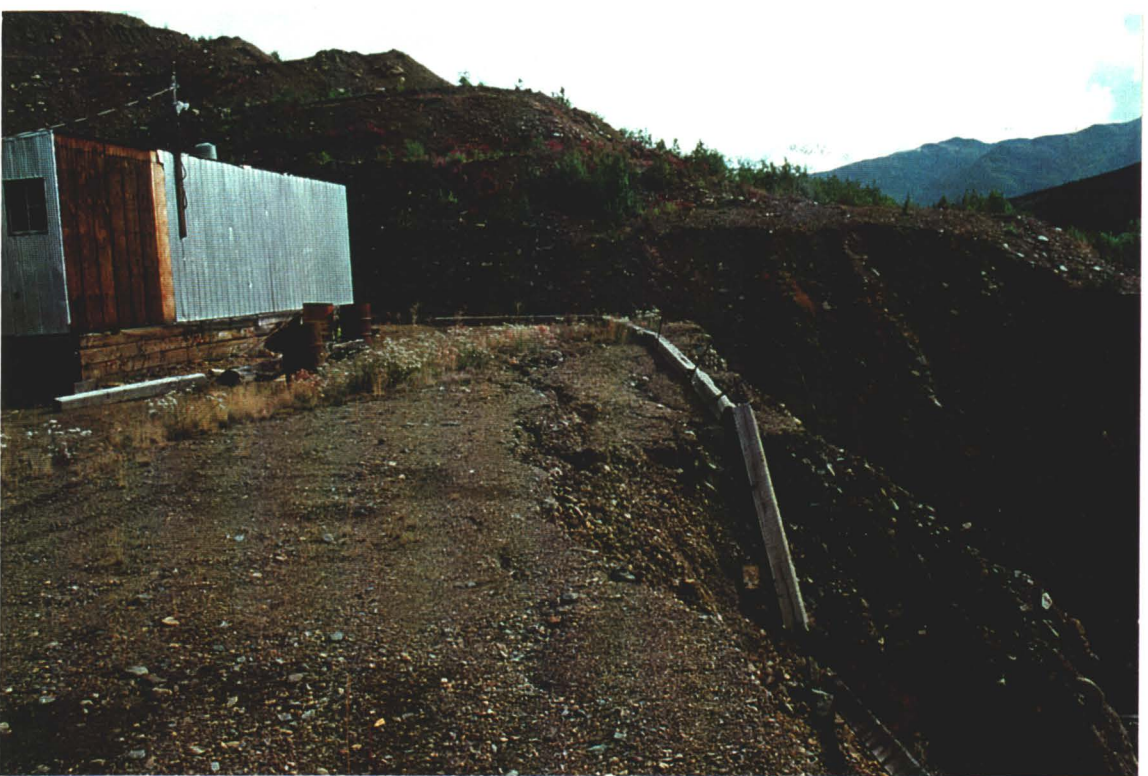
A garage and small storage shed are the only significant buildings at the Runer site. Both buildings have been moved onto a levelled waste rock pad. A "hanging fence" near the garage and slope failure cracks evident beside the garage (Photos 15 - 17) are indicative of ongoing wasting of the pad along the south and west edges. Details of construction features and interior contents are summarized in Table 5.1.

Photo 16. Slope failure cracks and "hanging fence" near garage, looking northeast.

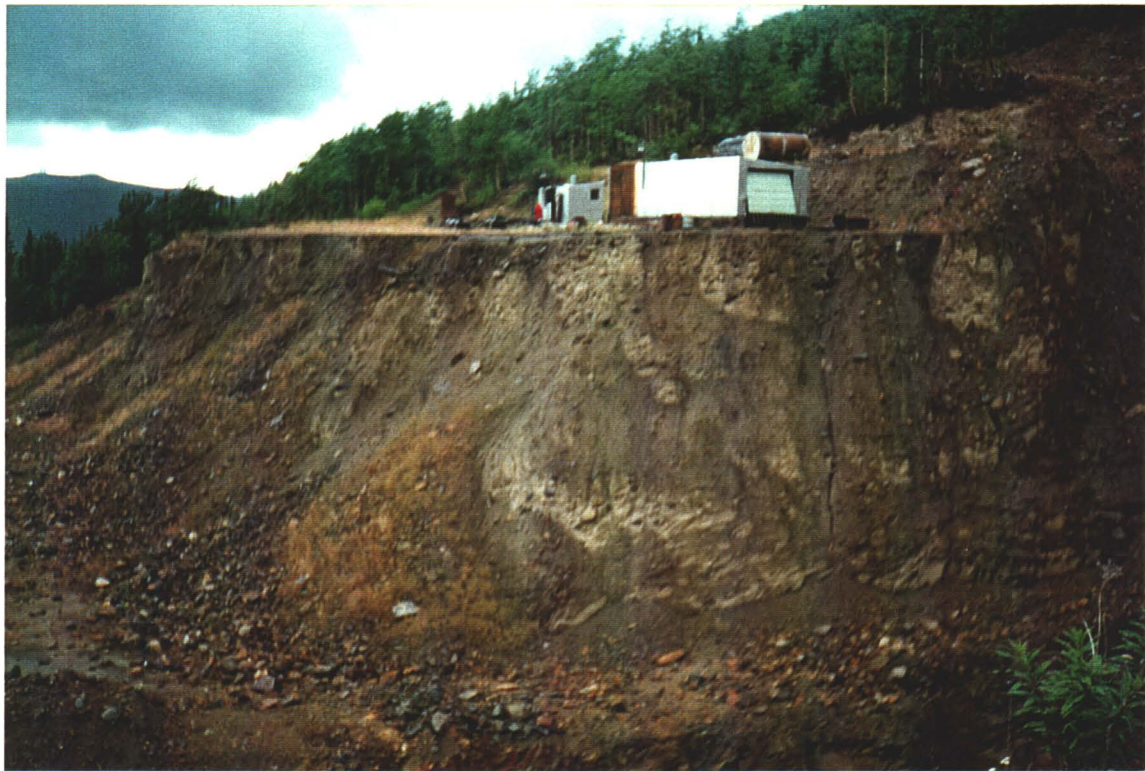
Photo 17. View of garage and sheer wall of waste rock pad, looking northwest.

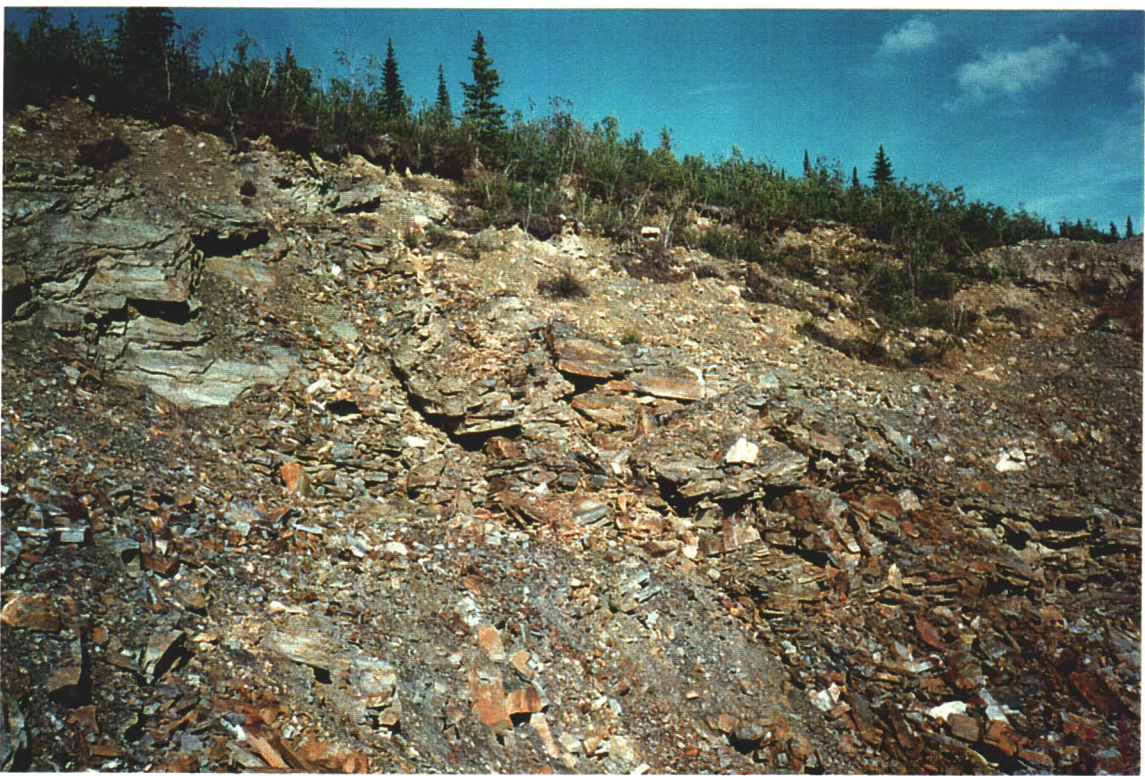
Photo 18. View of upper workings looking northeast. Note evidence of undercut (left side of photo) and rotational slumping (right side) along vegetated edge of workings.

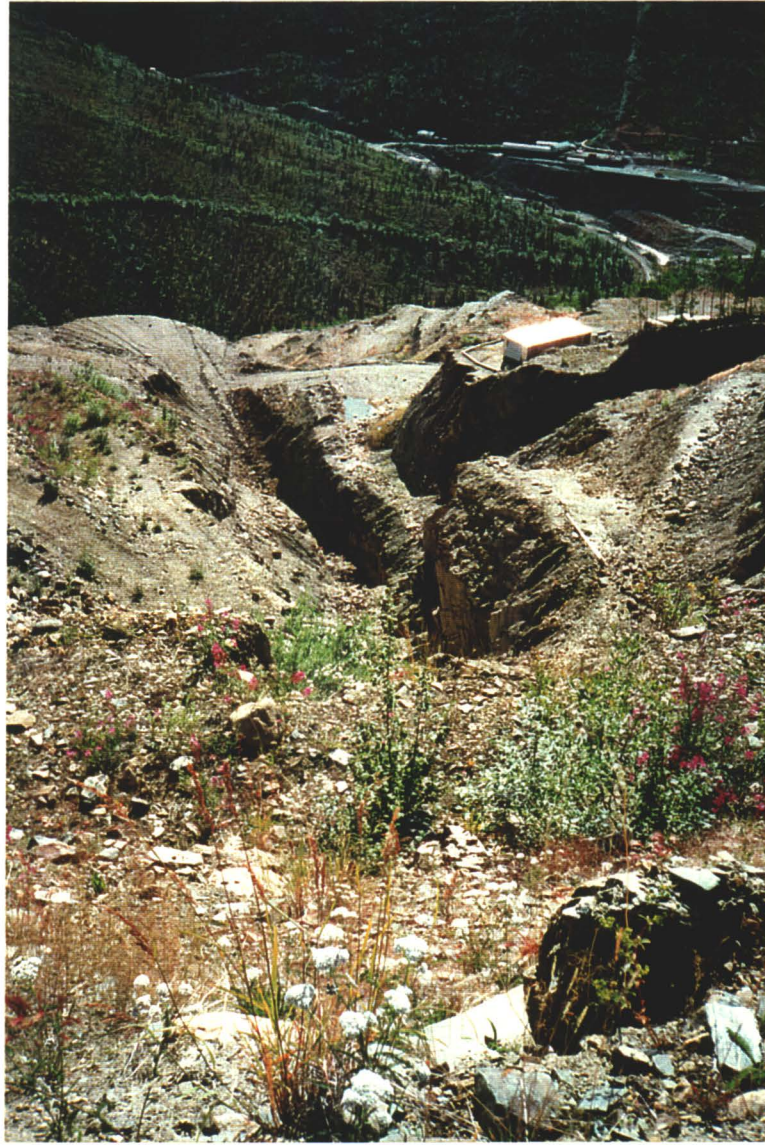
Because both trenches have been cut into rock, the trench wall slopes range from 40° to near-vertical (Photo 19). Loose waste rock or overburden piles are "perched" atop the trench walls at the trench edges. The margins of both trenches are not fenced, and no warning signs have been posted to alert site visitors of danger areas.

The upper and lower trenches are deep, have steep walls, and are surmounted by loose waste rock or overburden piles at the edges of the trench walls. The margins of the trenches are not fenced, and no warning signs have been posted to alert site visitors of danger areas. These features pose a safety risk to persons walking toward the edges of the trenches and persons within the trenches.

Photo 19. Lower trench looking south from upper trench area. Note waste rock piled to trench edge at left centre of photo.

Recommendation 1. Assuming no further mine development work at Runer, it is strongly recommended that the site be fenced to prevent casual access to the upper and lower trenches and the waste rock pad supporting the two site buildings. Approximately 1400m of wire fencing is required to surround the danger areas; high-visibility warning signs should be attached to the fencing at intervals of 50m.
