**PHASE II ENVIRONMENTAL ASSESSMENT  
OF THE  
SILVER SEVEN  
ABANDONED MINE SITE**

Action on Waste Program  
Indian and Northern Affairs Canada

Environmental Services  
Public Works and Government Services Canada

February 1997

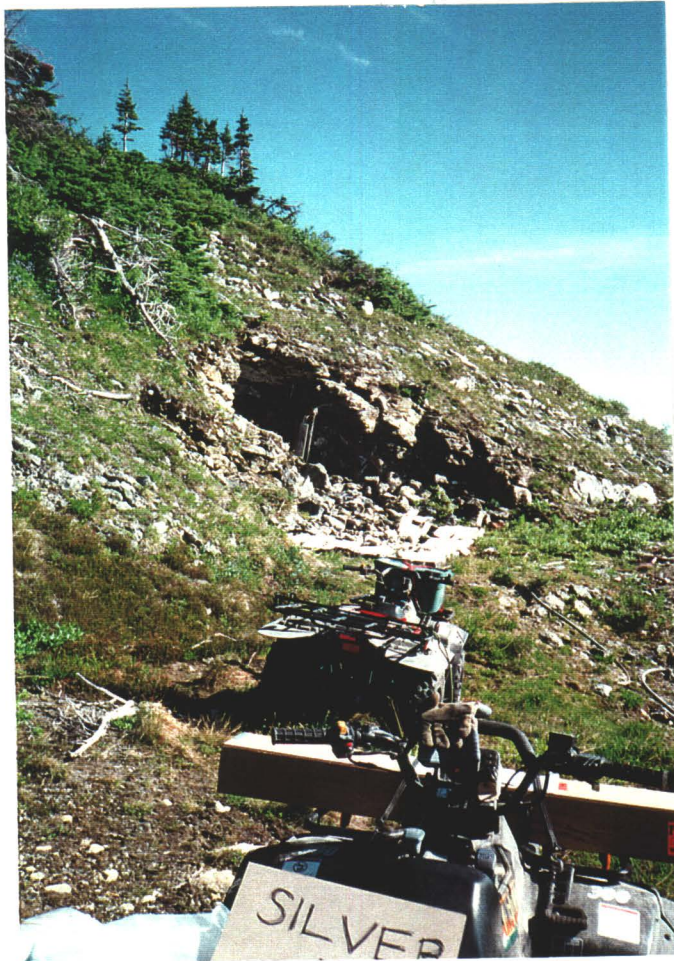
The primary health and safety risk at this site is the risk to humans and animals from the open adit at the main mine level and the unsecured raise at the upper level. Another significant concern is the condition of the ore bin and the stability of the waste rock pile supporting the trestle and rails leading into the adit. Secondary health and safety concerns arose from the dilapidated condition of the buildings on site and the possibility of collapse.

Photo 1. Main level adit view from access road looking northeast.

It is recommended that both the mine opening and upper raise opening be secured from human and animal access for health and safety reasons by covering the opening with existing waste rock. Should the mine need to be reopened, access to workings is achievable with heavy equipment.

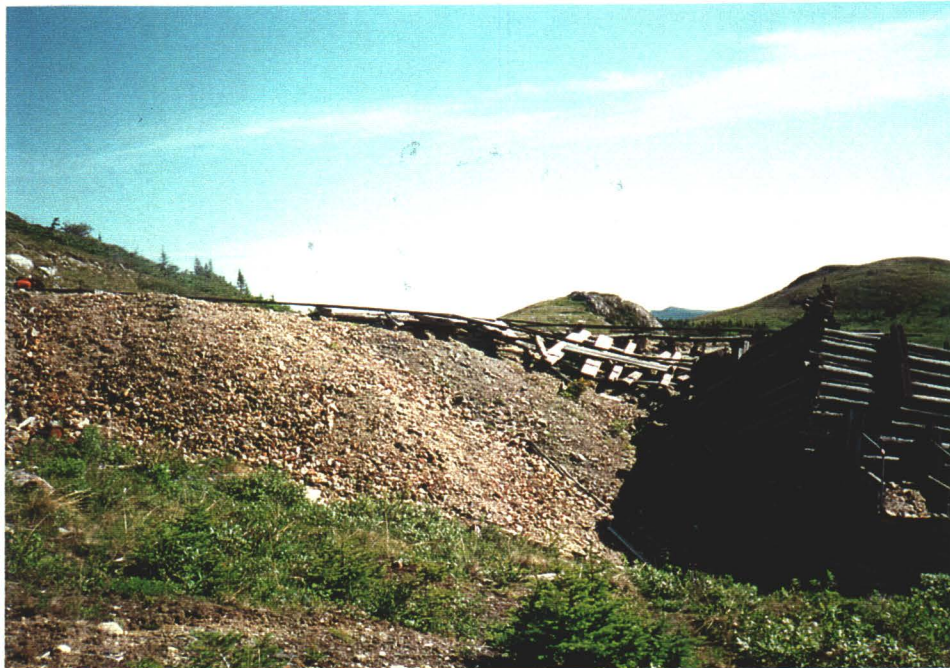
In the vicinity of the Silver Seven mine site adit area, 60 m of metal rail and trestle were found together with the wooden ore bin structure located at the end of the trestle (see Photo 3). Four rusting 205 l. barrels were identified below the adit and wood and miscellaneous metal waste were scatted on either wide of the waste rock pile leading out from the adit (see Photos 4 & 6).

Photo 2. Trestle on top of waste rock leading to log framed ore bin at right.

It is recommended that the wood trestle and ore bin configuration be demolished and burned or buried as appropriate to minimize risk to humans and animals. Further all remaining wood structures on site should be demolished and burned on site for aesthetic, health and safety reasons. Any remaining metal waste on site (including rails, empty barrels, and associated waste) should be buried on site using available rock material.

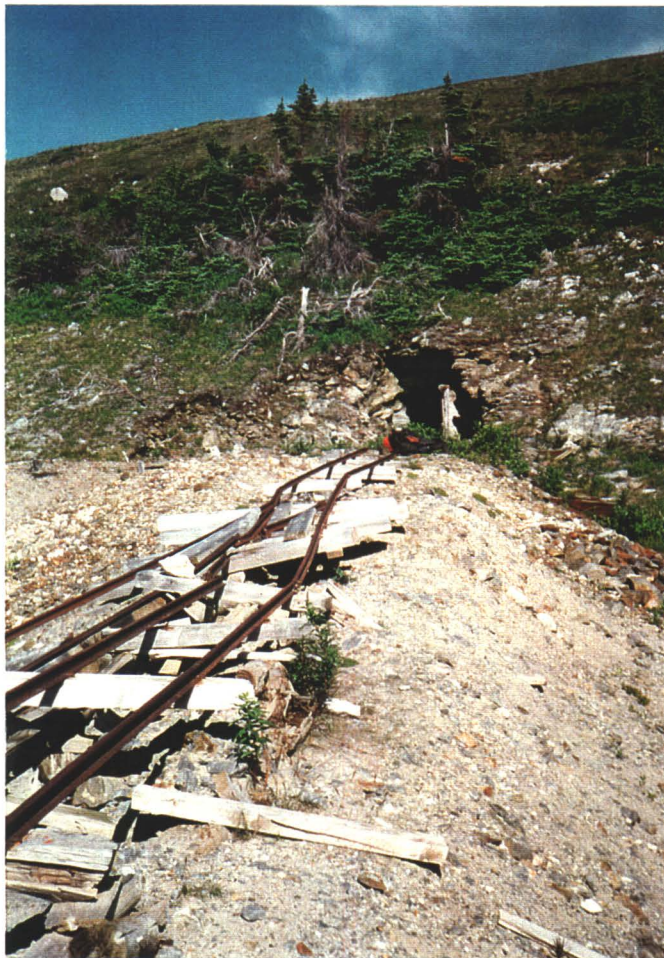
Photo 3. Rusted metal track running from adit entrance along waste rock escarpment.

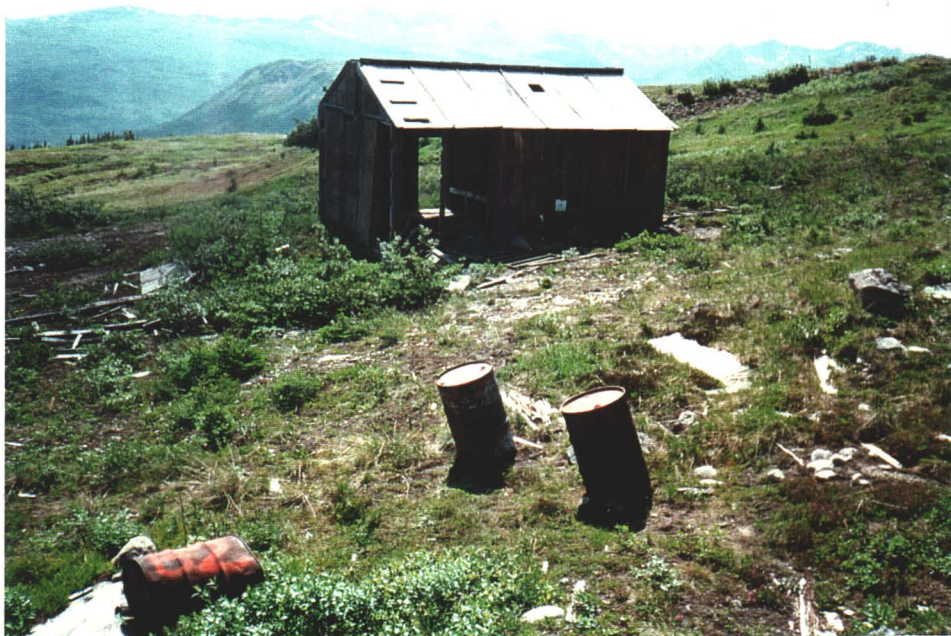
No signs of stained soils were observed during the course of the site inspection at the Silver Seven mine site and consequently no soil samples were taken at this location. However, a total of 3 X 205 litre steel barrels were scattered about the main site with several more scattered within 200 m of the main adit. Samples of petroleum product were taken from 2 partially full 205 litre metal barrels in tact in an upright position (Barrels S7BL-3 and S7BL-4) located

Photo 4. Machine shop/maintenance/equipment shed adjacent to ore bin with partially full 205 litre barrels in foreground and wood waste in background.

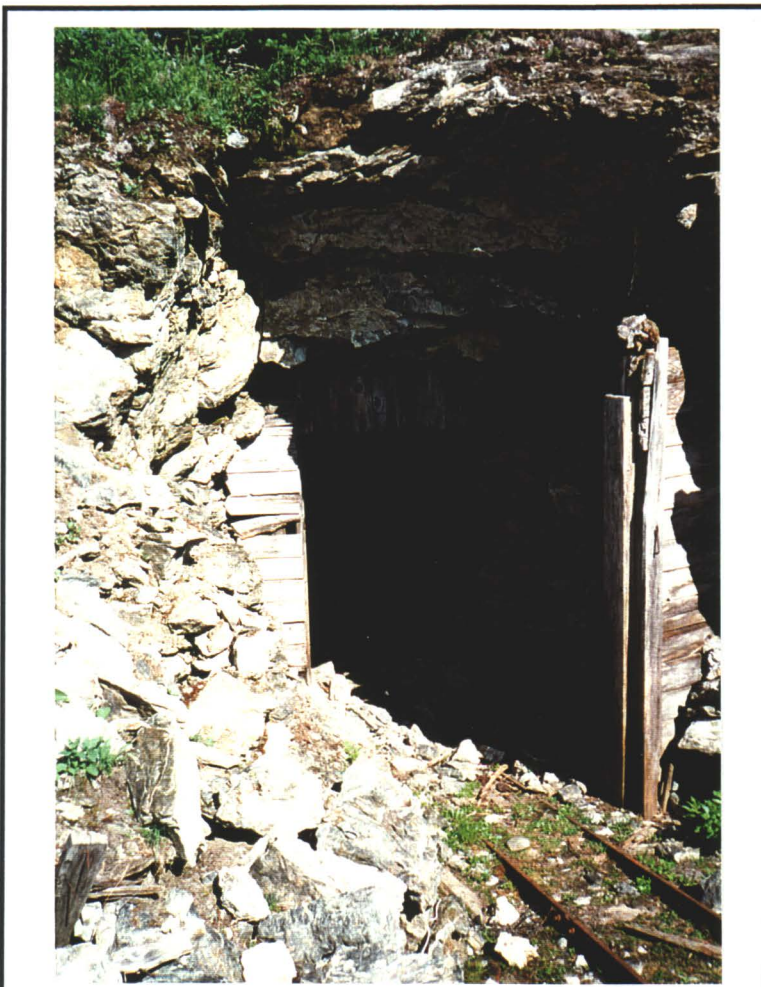
The adit has not been timbered, even around the portal, but is in sound condition with only very minor failures of the backs noted. The raise, which comes to surface approximately 175 m to the northwest of the portal at an elevation of approximately 1570 m, was blocked 3 m down from surface by ice and rock. Evidence of second raise to surface, possibly from a sublevel, or a glory hole is collapsed approximately 26 m further to the northwest.

Photo 5. Uncovered adit entrance with wood frame, overburden and track. Note risk of collapse of overhead rock.

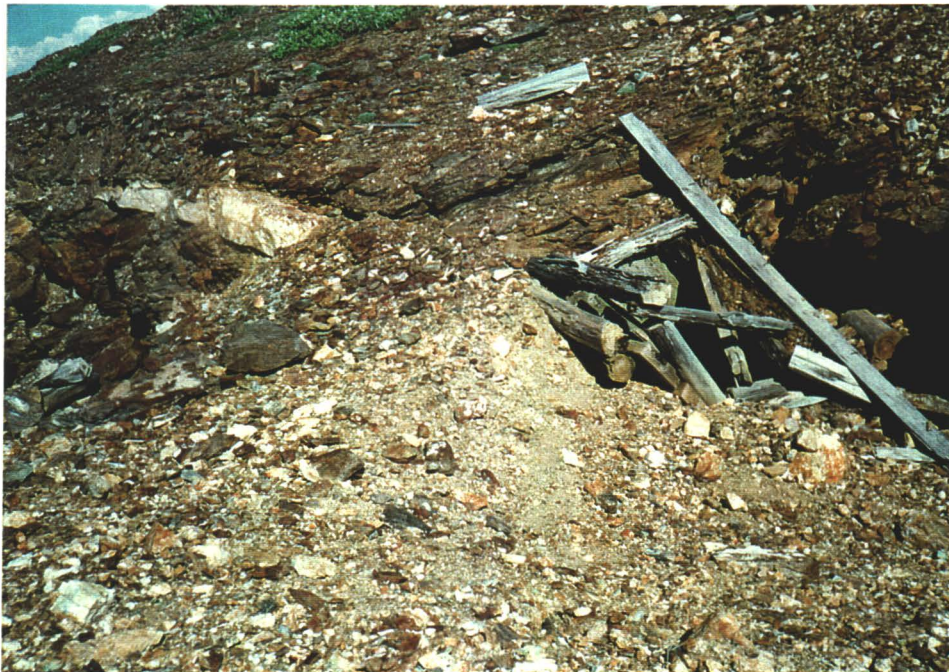
Wood and metal debris could also be found in the vicinity of the upper raise and trenching areas (see Photos 9, 10, & 11). At the Silver Seven mill site, wood and concrete waste from the old milling operation were found. Findings are summarized in Table 2 below.

Photo 10. Collapsed shaft found in upper trenching area.

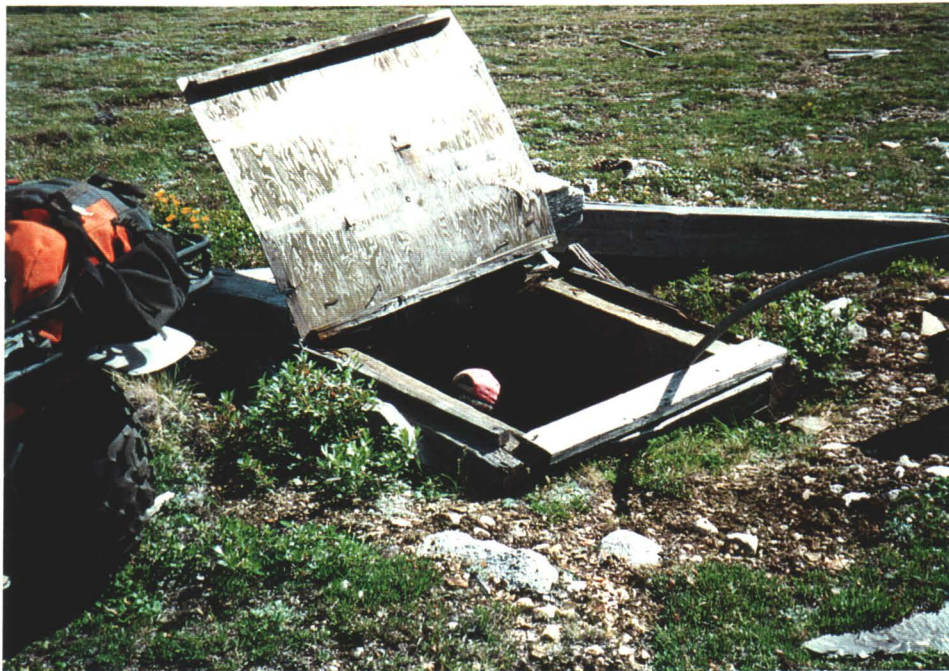
Photo 11. Entrance to upper level raise with plywood cover attached.

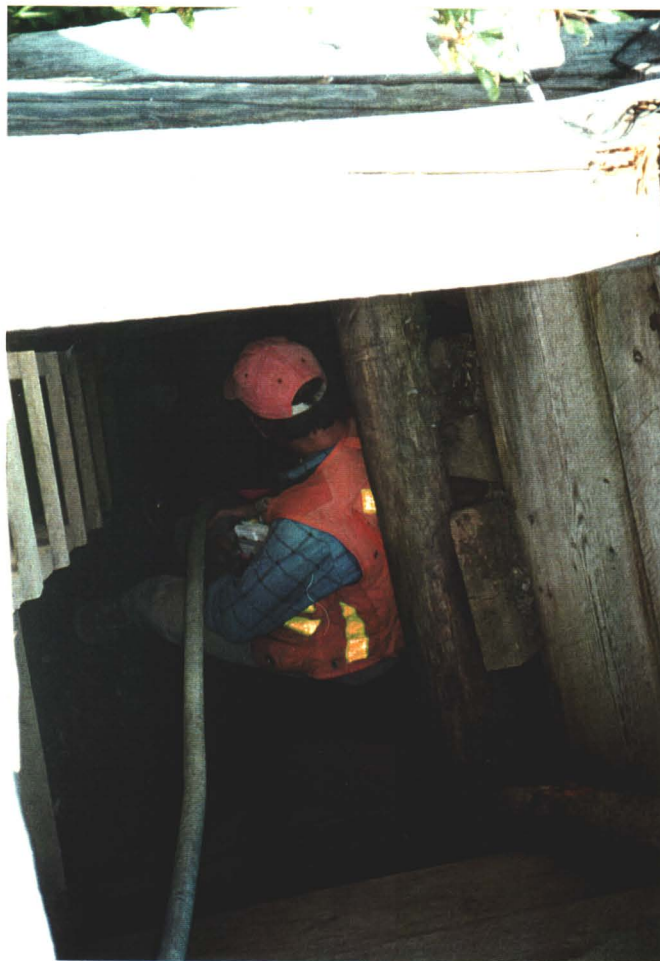
Photo 12. Inspecting interior of upper level raise.

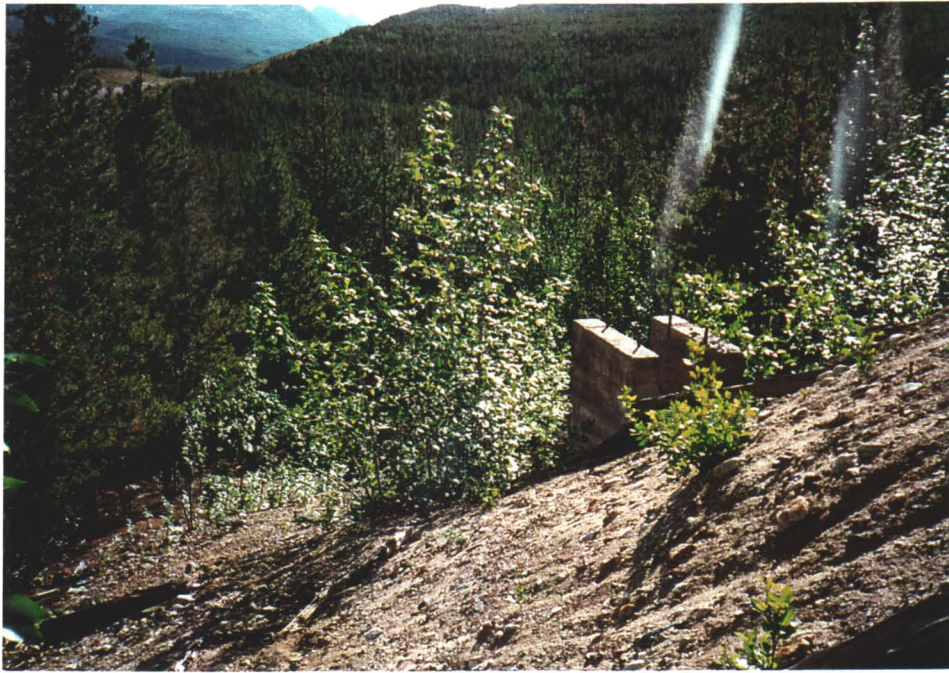
A small unspecified volume of ore was processed through the Silver Seven mill. Today, concrete foundations and metal scraps are all that remain of the mill. There is a small ore stockpile of rusty weathered vein material above the mill site of approximately less than 20 m<sup>3</sup> which was not sampled.

Photo 13. View down slope from access road to foundations of former Silver Seven mill site.

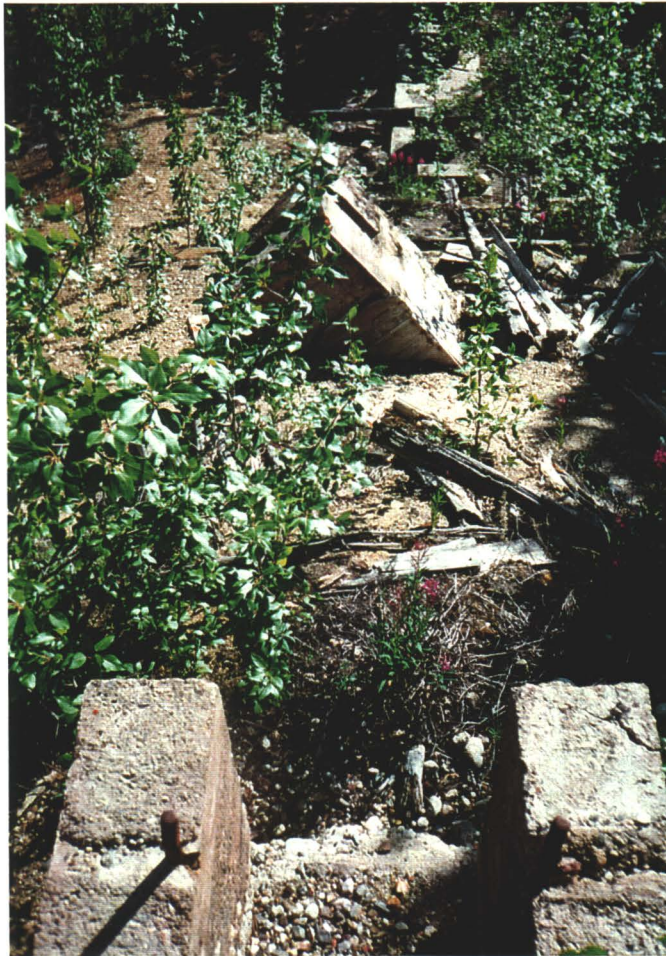
Photo 14. View down slope from access road to foundations of former Silver Seven mill site..

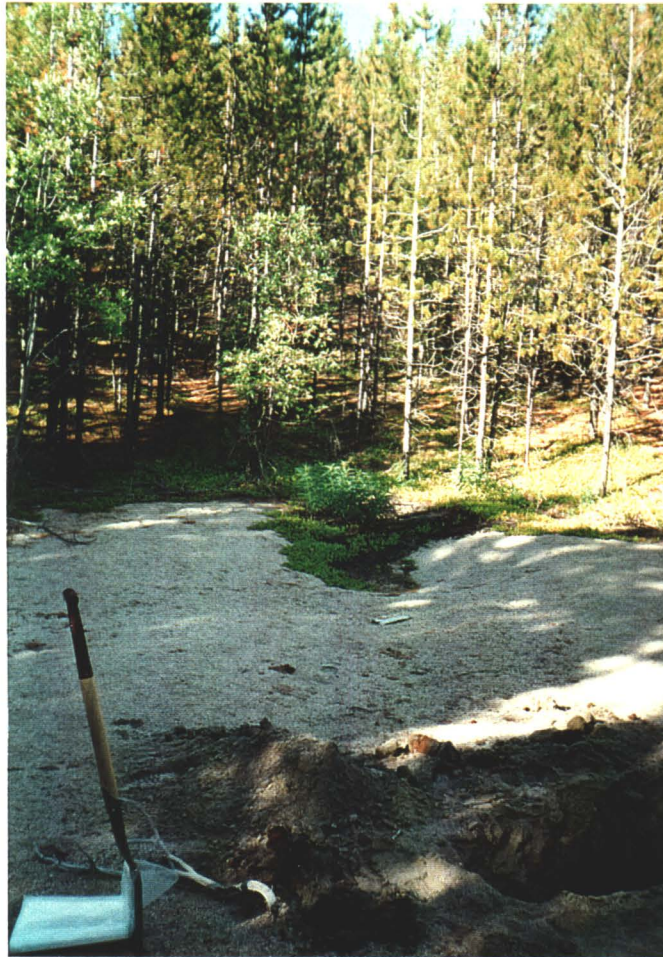
Minor environmental risks exist relating to the tailings at the mill site based on contained values exceeding CCME guidelines for lead, zinc, and silver. However, since the volume is small contained and chemically unavailable over the long term annual monitoring for a period of 5 years should be sufficient.

Photo 15. Silver 7 mill site tailing pond which appears as small lake on NTS map 105/B1

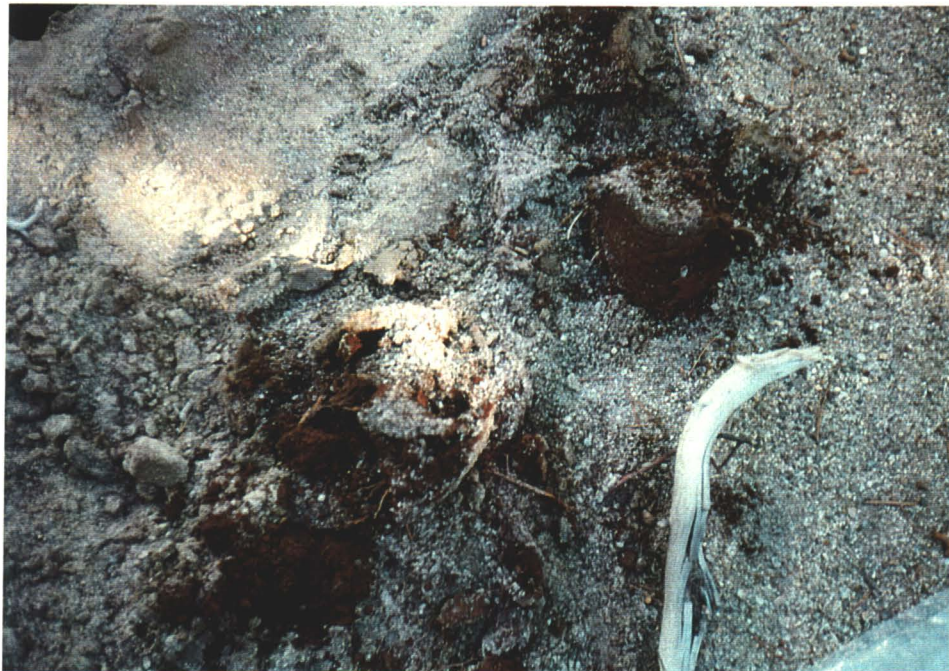
Photo 16. Close up of material excavated from mill tailing pond.
