Assessment of Abandoned Yukon Mine Sites

Tinta Hill #82

Prepared for
Public Works and Government
Services Canada

February 1997
GV206.01

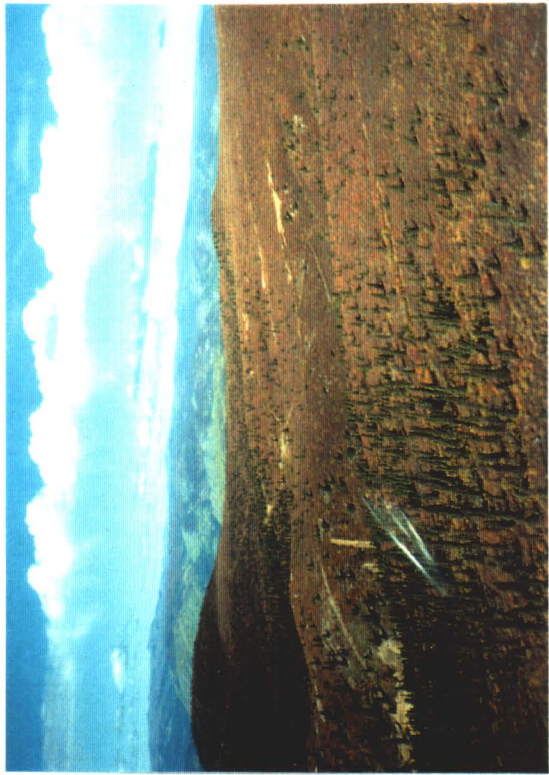
The site is located near the tree line. Black spruce are sparse (Photo 1 and 2, Appendix A) and willow shrubs are abundant. Little or no vegetation is being re-established in trenches and excavations (Photo 3, Appendix A). The site is mantled by a very thin layer of topsoil that is underlain by granular rocky material with no organic content; therefore, disturbed areas will not re-vegetate easily.

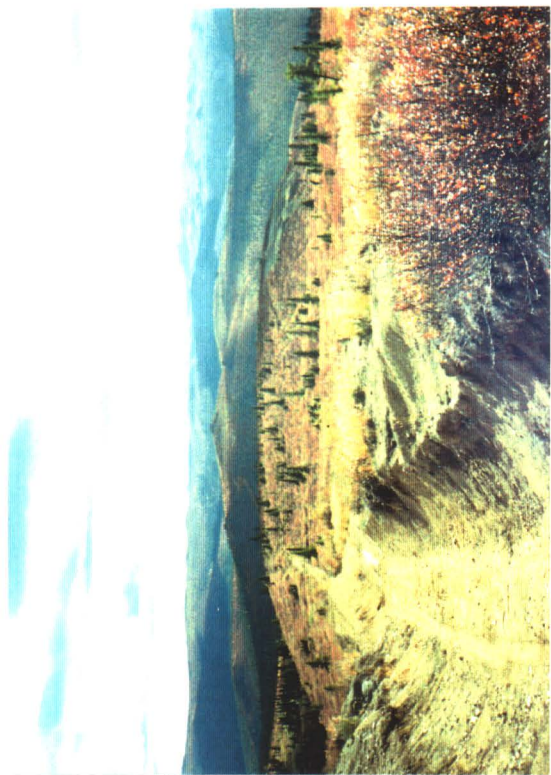
Trenches and excavations are located in the exploration area. Some of these are shown in Photos 1, 2 and 3, Appendix A. Photo 3 is typical of the trenches along the northern portion of the site. The excavated material is very sandy to rocky in nature, and the excavations are generally shallow. The slopes do not show signs of deep-seated instability, nor do they appear to present a significant health and safety issue.

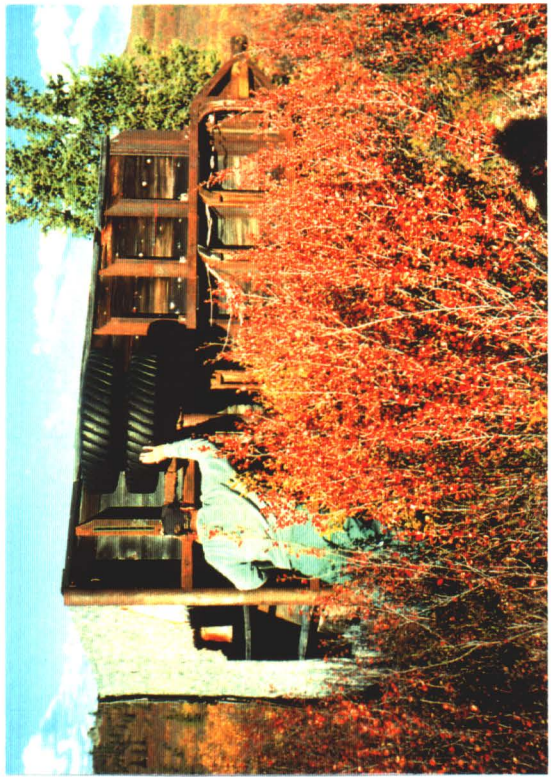
4

The abandoned trailer is lying on its side and is located west of the site. The trailer has a steel base, wood frame and chip board walls (Photo 4, Appendix A). Most of the roof was covered with asphalt shingle material. The trailer is approximately 2.4 m wide and 3.5 m long. The trailer contained approximately 1 m³ of wood waste.

A fibrous insulation was present in the walls. A sample of the insulation (GV206THINS) was collected and analysed for asbestos content. The results of the analysis (Table C1, Appendix C) indicate that the insulation does not contain asbestos.

A contractor can collect the debris and trailer and haul it off-site for disposal in a proper landfill at Carmacks.

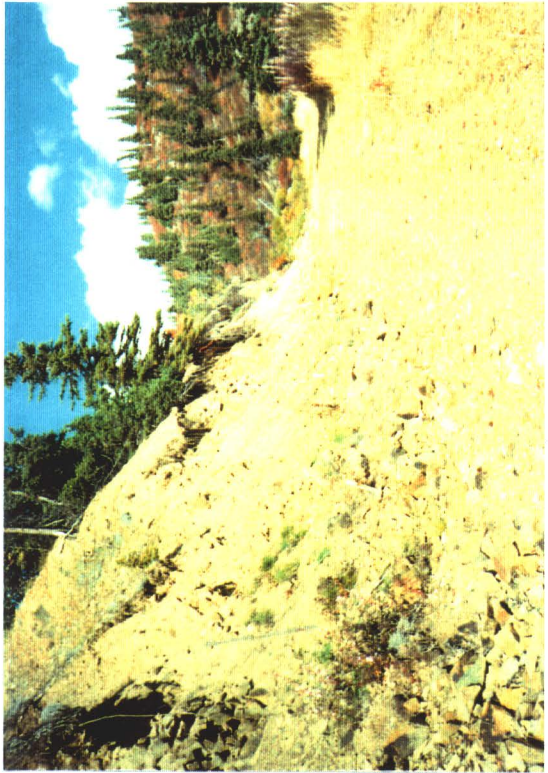
7

Erosion and slope instability was noted along the road cut along the steep bank on the south side of the site. Photo 7, Appendix A, shows a section of the road where erosion has occurred.
