PHASE III ENVIRONMENTAL ASSESSMENT
OF THE
ARCTIC GOLD & SILVER

MILL AND TAILINGS IMPOUNDMENT

**PHASE III ENVIRONMENTAL ASSESSMENT
OF THE
ARCTIC GOLD & SILVER
MILL and TAILINGS IMPOUNDMENT**

March, 1998

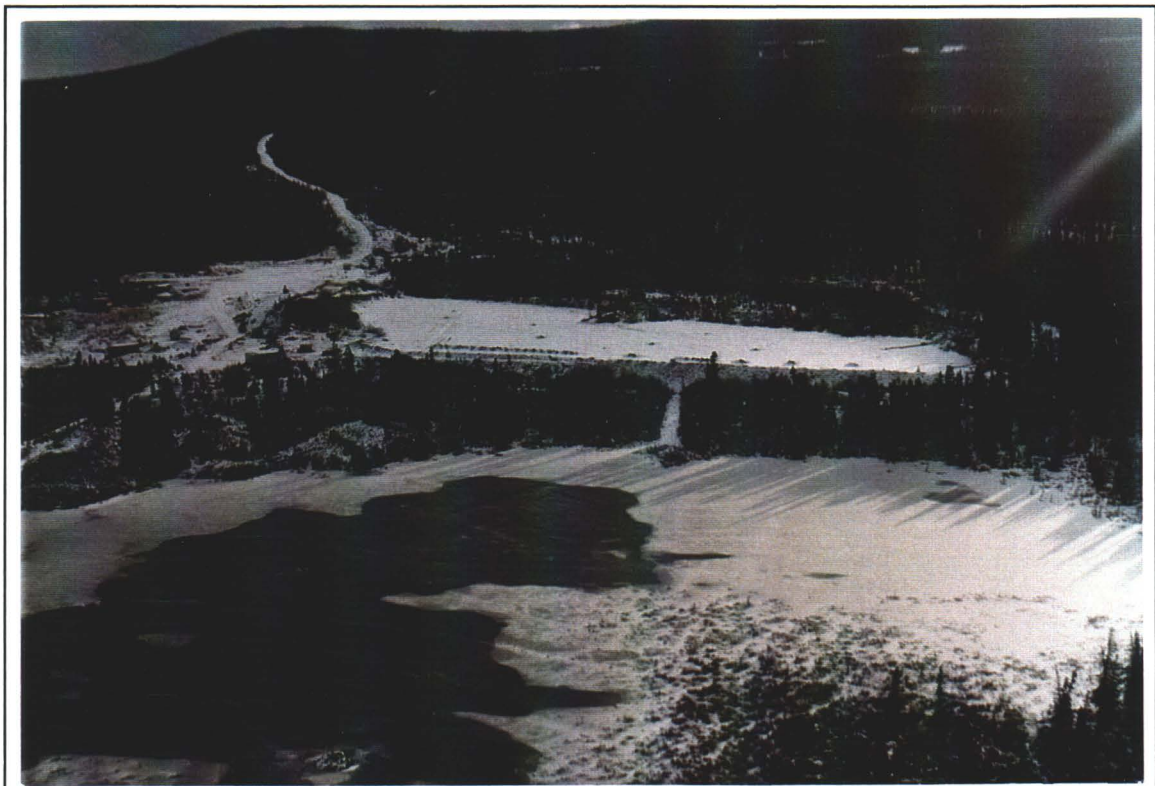
Iron oxide staining resulting from oxidation of iron sulphides was visible in places on the tailings surface. In addition, the bed along which the tailings solutions drain between the tailings embankment and the lake is coated with dark red iron oxide precipitates. Seepage from the tailings impoundment was not seen at any other location.

Photo# 1: Aerial View of the Tailings Impoundment and Drainage to Lake

Action should be taken to reduce or eliminate drainage from the tailings. A low permeability cover should be placed on the pile to reduce infiltration. The cover should be contoured to shed water and ensure that precipitation does not pond on the pile surface. Although there was no evidence of seepage or impact to the surrounding soil from the small ore piles, these piles should be removed. If the tailings are to be reclaimed, the simplest solution would be to dispose of the waste on the tailings before the tailings are covered. Metal rich sediment deposited in the small lake, as well as material deposited along the seepage drainage path between the impoundment and the lake, should be excavated and placed on the impoundment before covering.

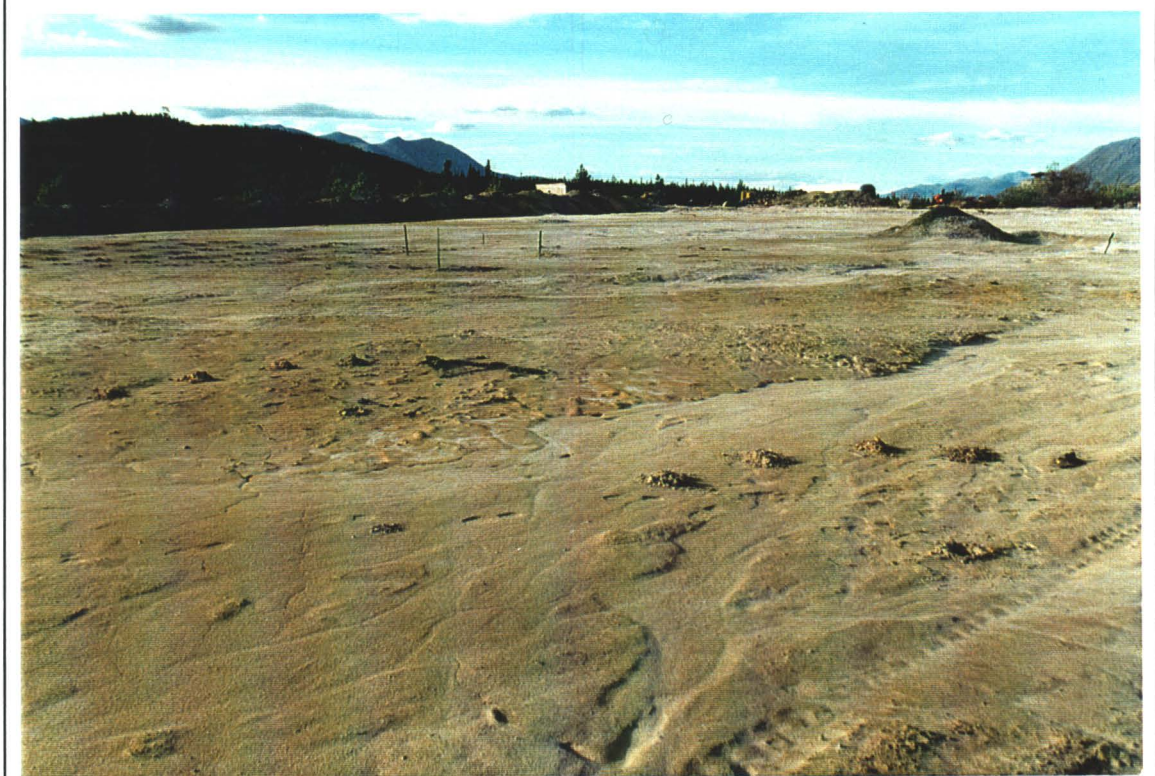
Photo# 2: Tailings Surface looking North West (note oxidation)

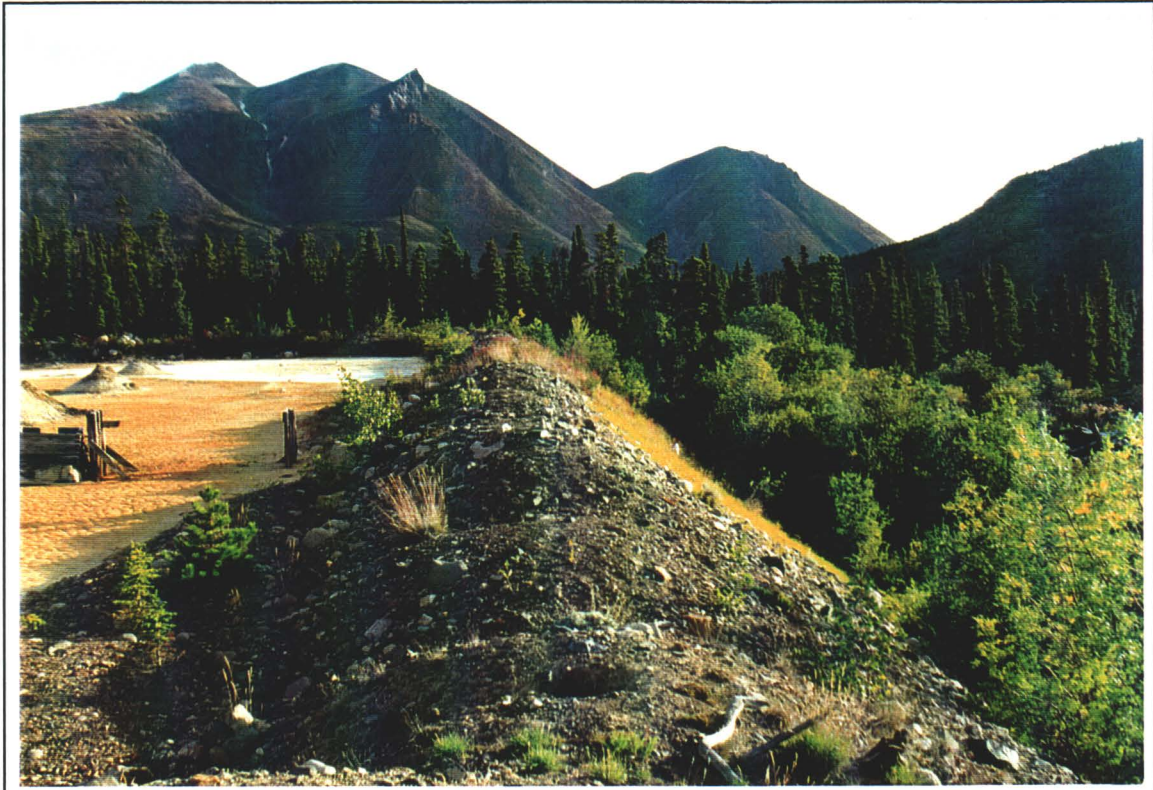
Photo# 3: Berm - West End

It is recommended that berm repairs be made to restrict further lateral migration of the tailings from the breached section of the berm and to provide enhanced stability to the west section of the berm. The load-out ramp should be leveled and used as berm/cover material. This can be done in conjunction with the reclamation work done on the tailings.

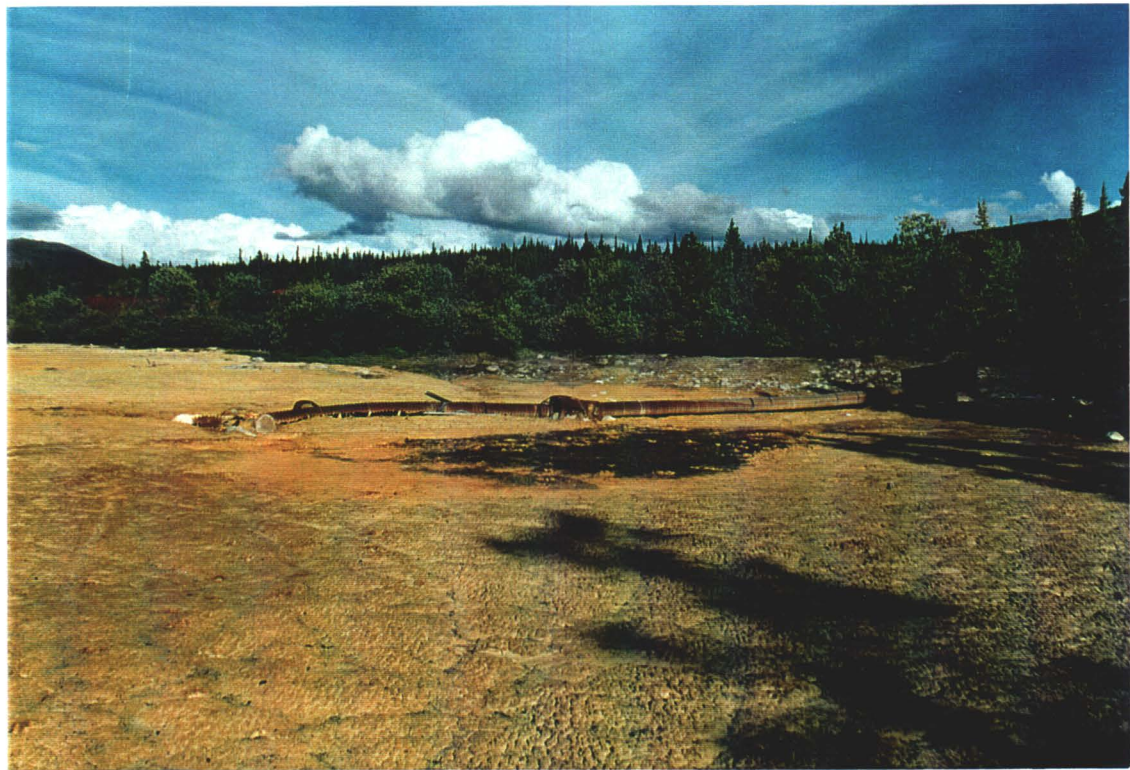
A portion of the pipe exiting the smaller water collection box was left exposed to the air and has corroded and, in some places, completely dissolved. Drainage collected in the deeper structure is piped through the tailings dam and released on the face of the tailings embankment. This seepage travels along the ground surface for approximately 20 metres before entering the adjacent small lake. See Drawing 1 for site details.

Photo# 4: Decant Pipe (note low lying wet area)

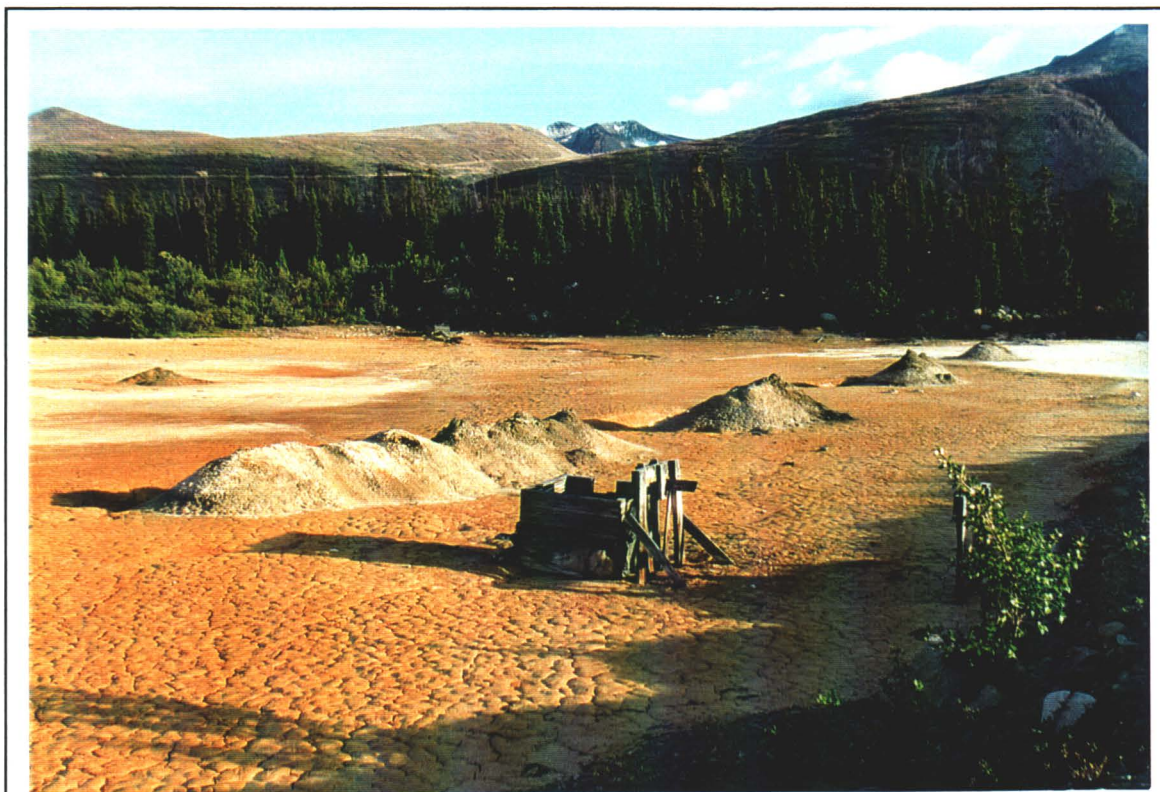
Photo# 5: Drainage Decant Box

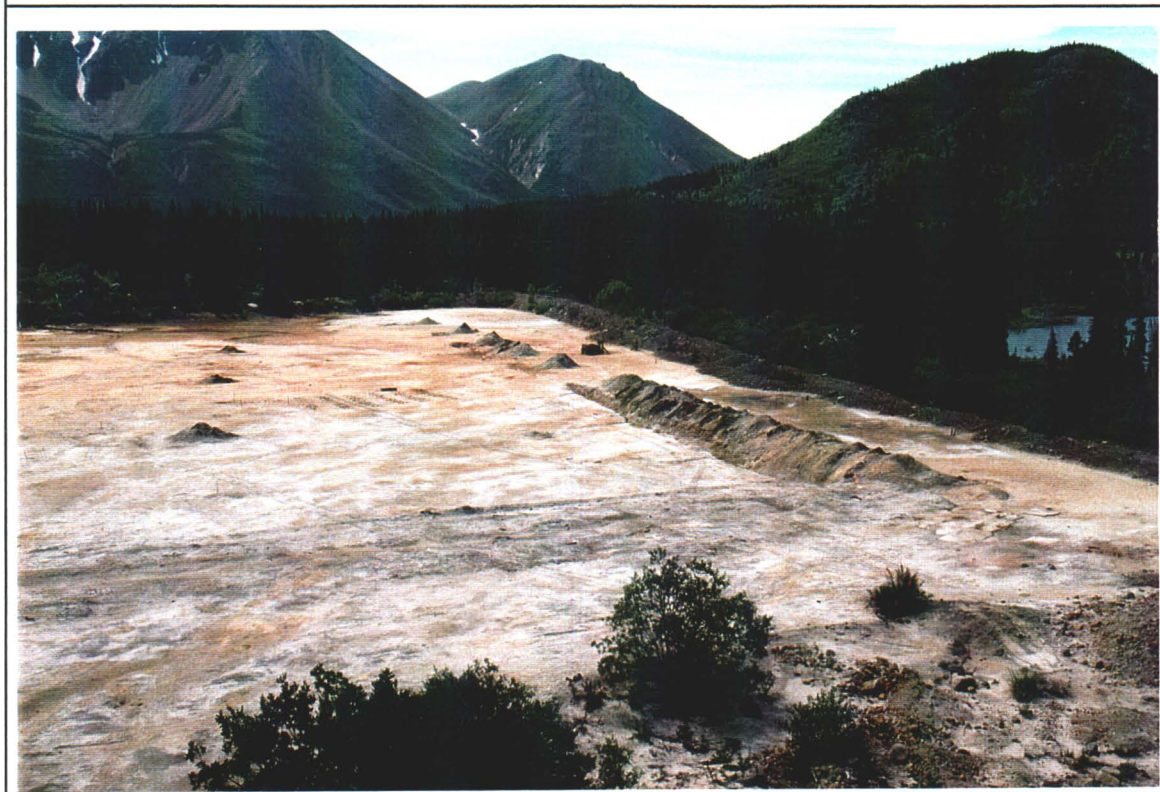
Photo# 6: West End of Tailings Impoundment

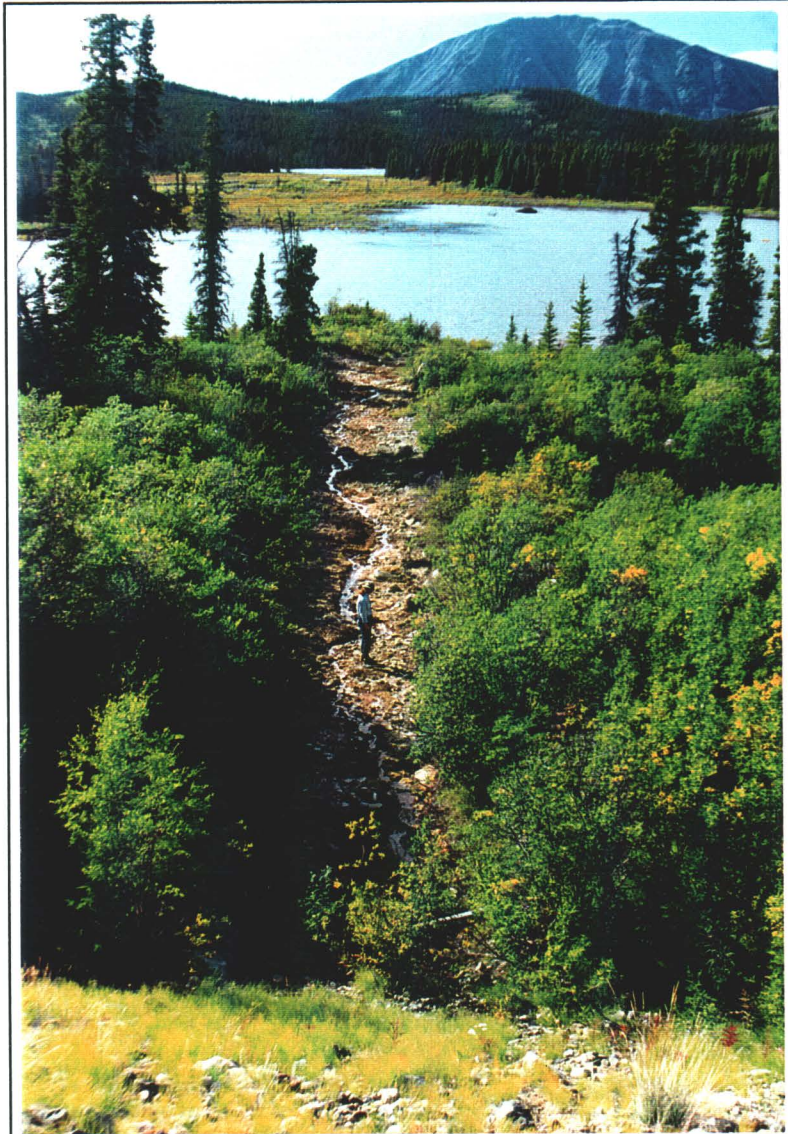
Drainage from a corroded pipe directed through the tailings dam flows westwards downstream along the ground surface for about 20 metres before entering the unnamed lake. The source of this seepage is unknown but is believed to be primarily precipitation which infiltrates through the tailings. It is possible that upstream groundwater is contributing to this seepage.

Photo# 7: Drainage Trench to Lake

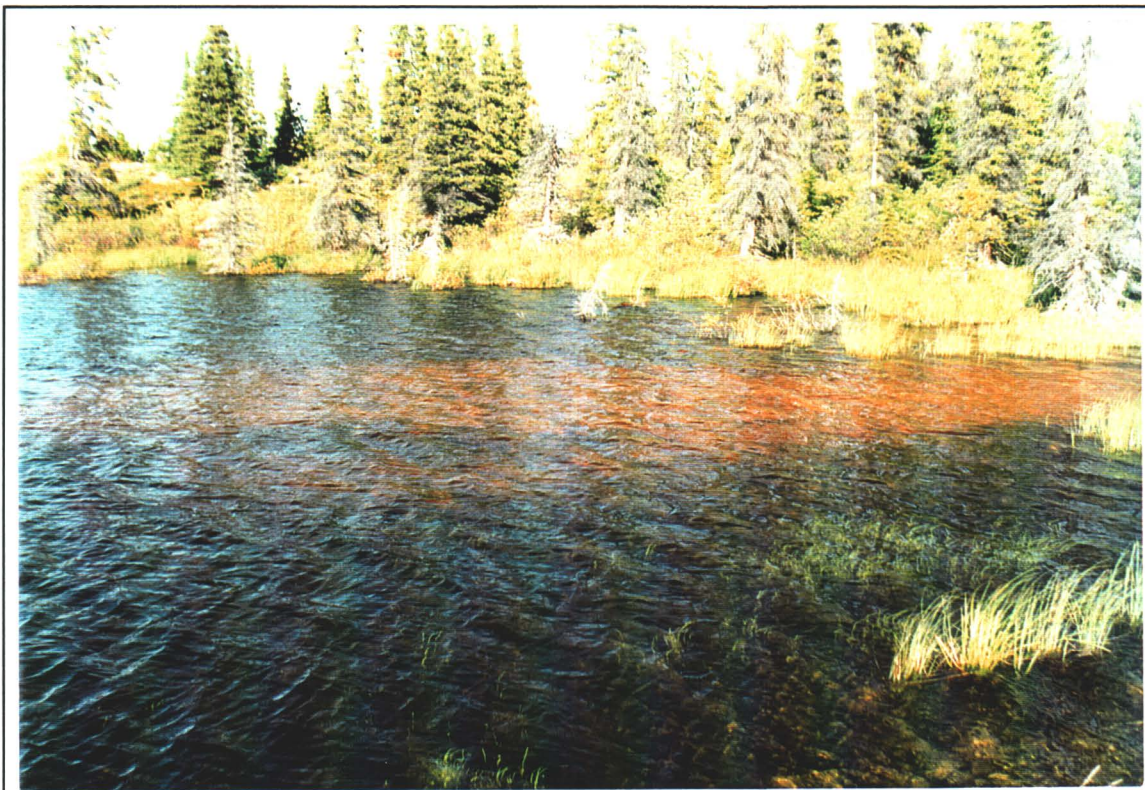
Photo# 8: Tailings in Lake

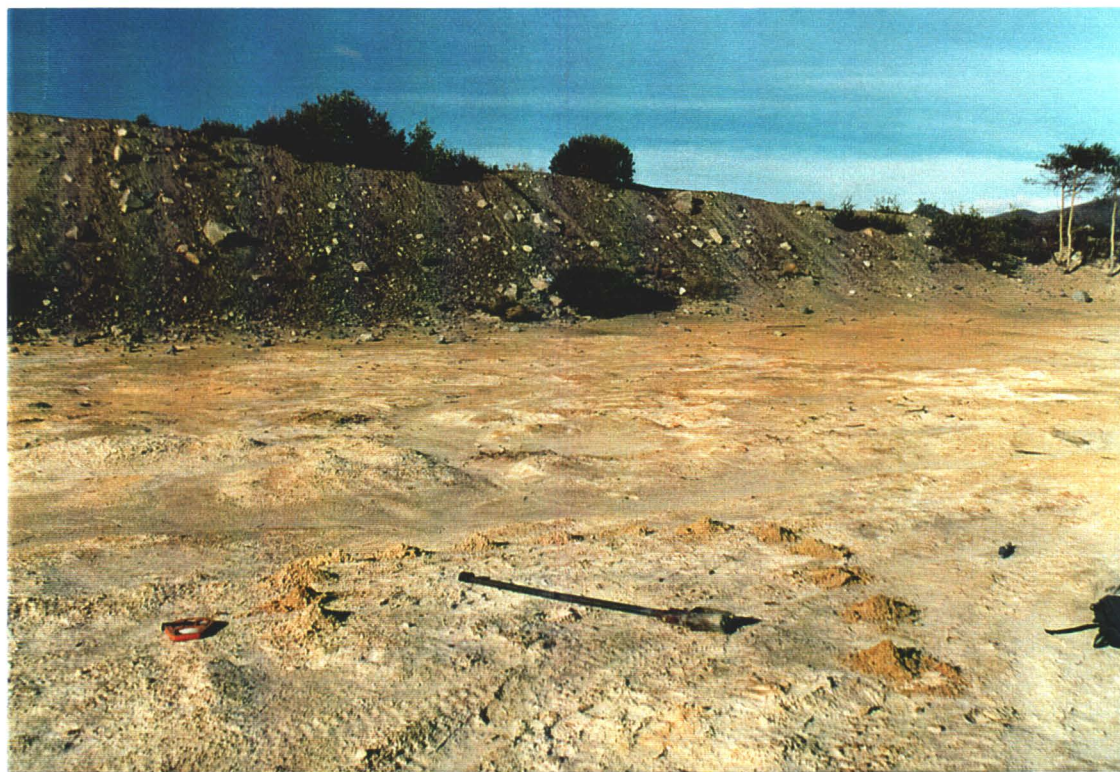
Photo# 9: Tailings Sampling Profile; South End of Loadout Ramp

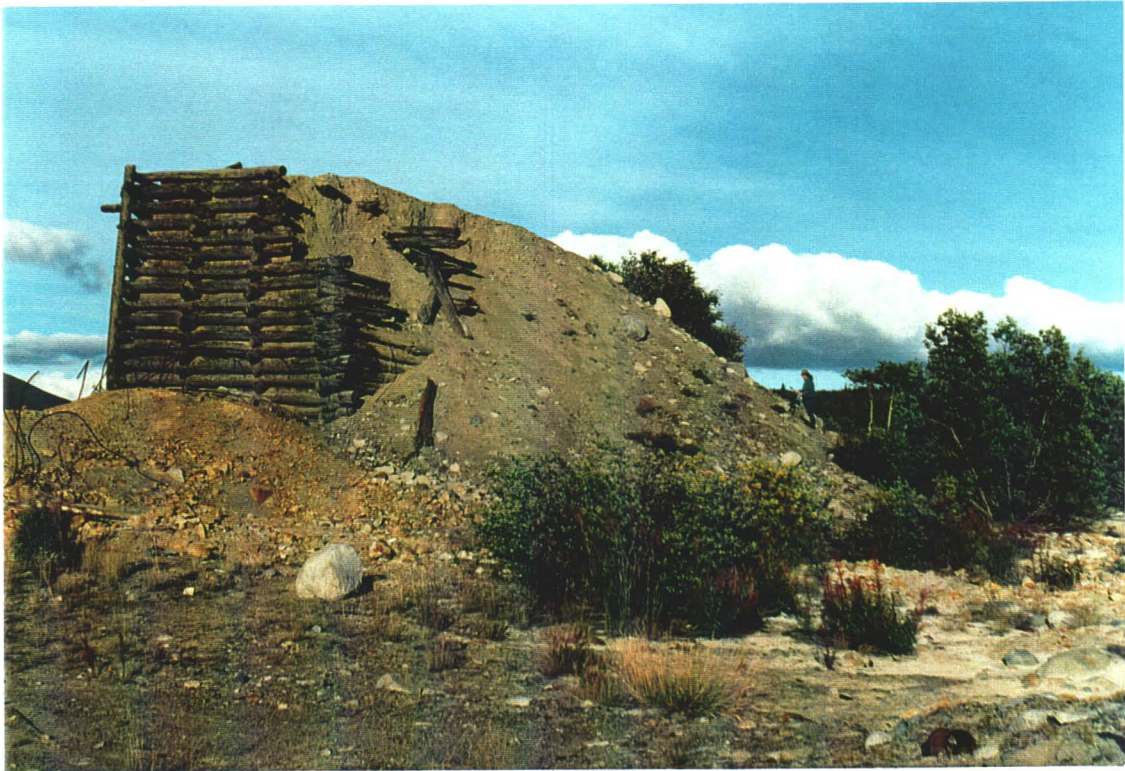
The load-out ramp at the north end of the impoundment shows signs of decay in the log cribbing supporting the west face.

Photo# 10: Log Cribbing at West End of Loadout Ramp

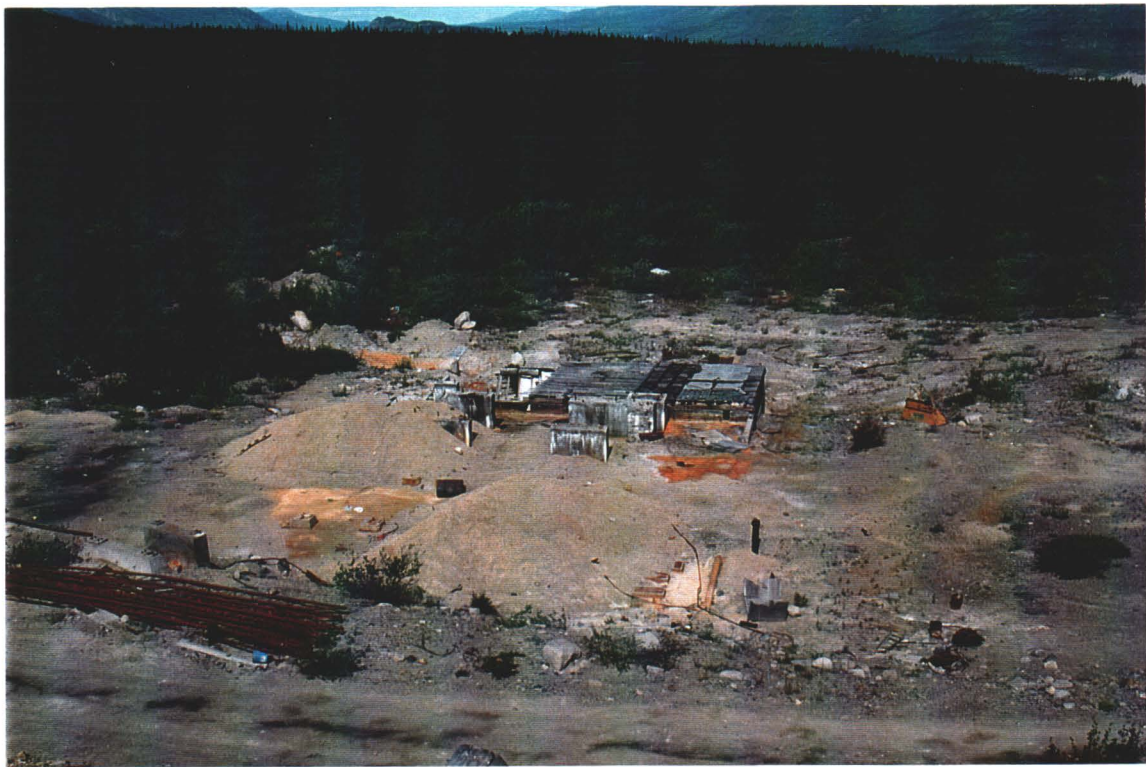
Aesthetic concerns arise from the range of infrastructure, equipment and debris, both metal and wood, noted throughout the site, particularly the mill foundations, concrete pillars, heavy equipment, trailer and wooden structures.

Photo# 11: Mill Site Foundation and Ore Piles

It is recommended that the mill foundations and pillars be demolished to grade and possibly buried on-site. The building be demolished and burned on site. The wood waste can be burned and metal should be collected and disposed at a suitable nearby landfill. The loadout facilities should be dozed and the areas restored to the original slopes by dozing. The trailer should be relocated and salvaged by a local interested party. These activities can be accomplished using locally available resources and labour.

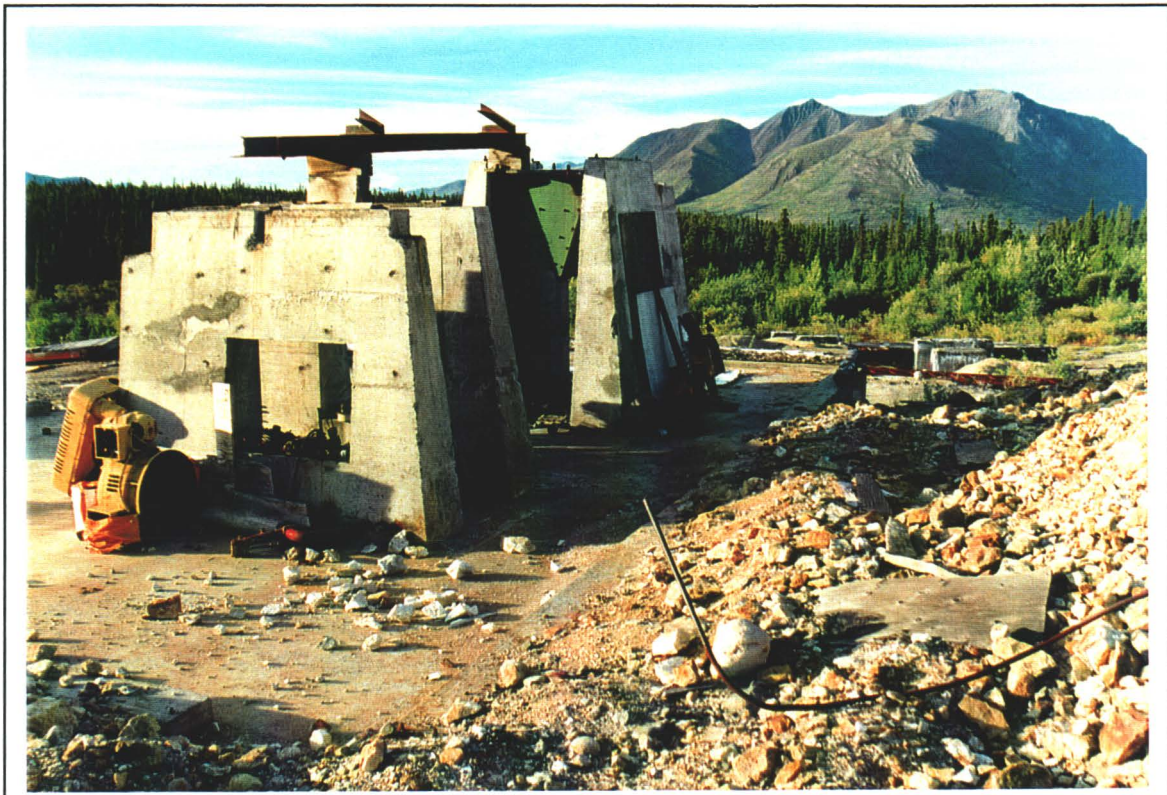
Photo# 12: Concrete Pillars on Foundation

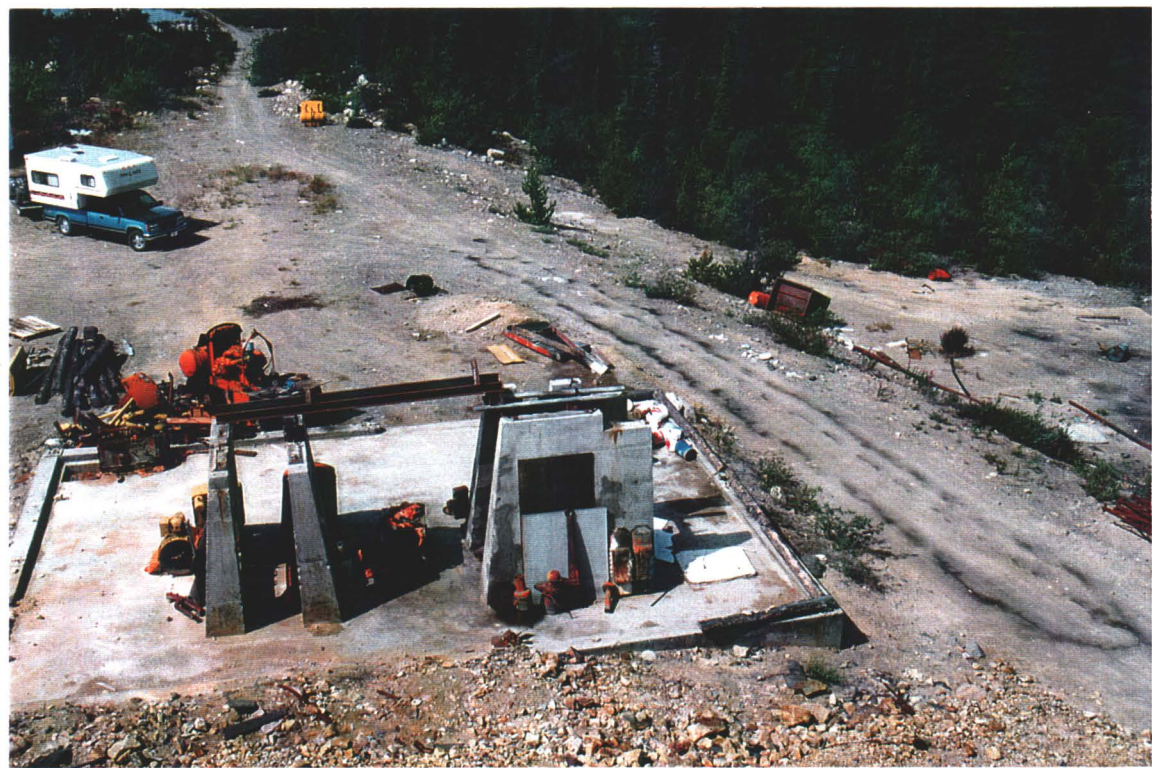
Numerous pieces of abandoned equipment lay scattered throughout the site. As well, foundations, wooden structures and concrete pillars lie exposed.

Photo# 13: Mill Foundation and Debris

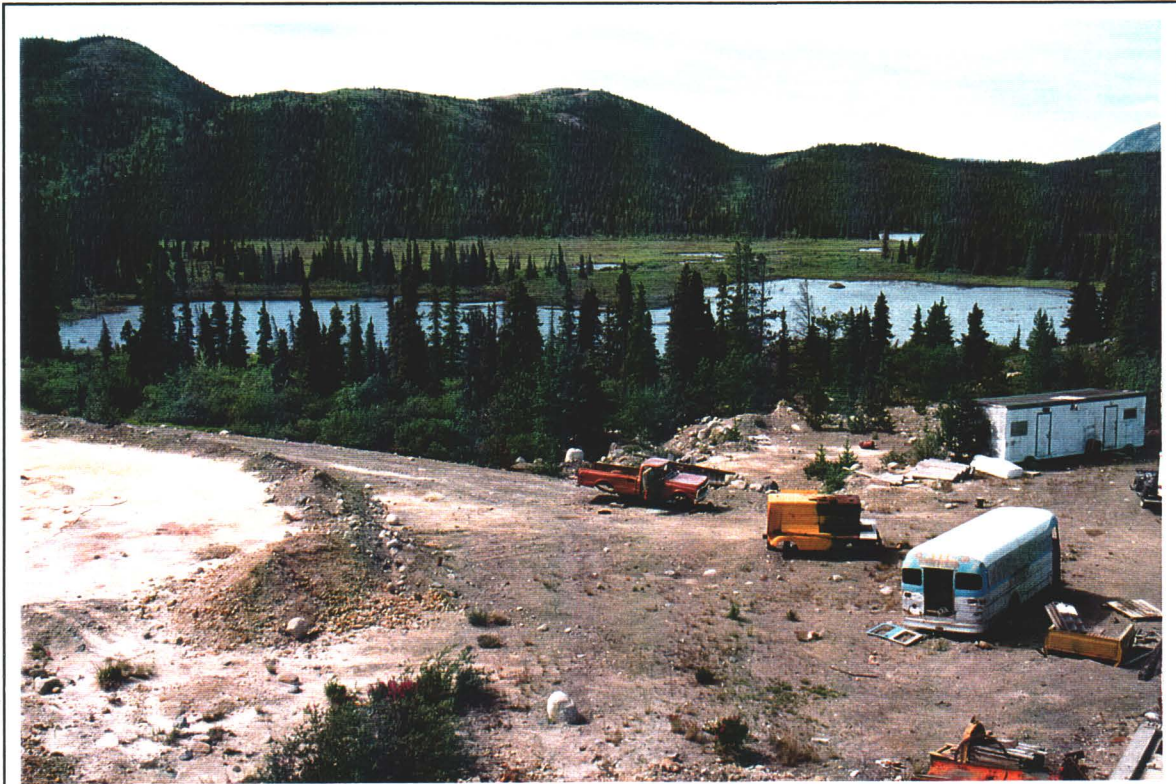
Photo# 14: Derelict Vehicles, Equipment and Trailer
