Phase III Environmental Assessment

Formo Mine Site

Final Report

Action on Waste Program
Indian and Northern Affairs Canada

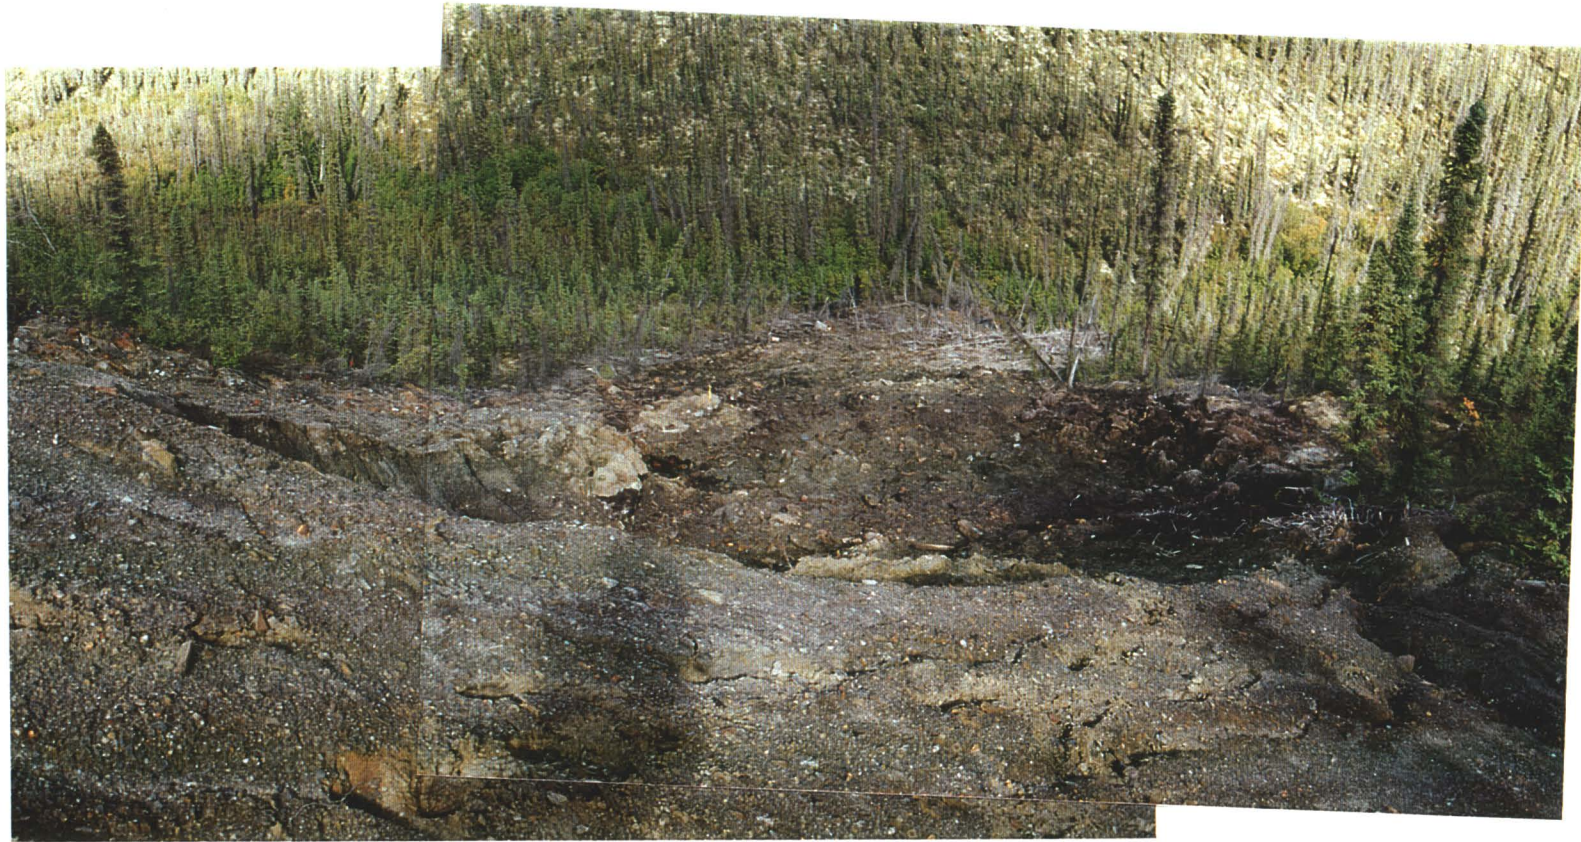
Photo 1. View from top of lower/eastern waste rock slope, looking downslope towards area of slumped overburden and dead vegetation above Christal Creek.

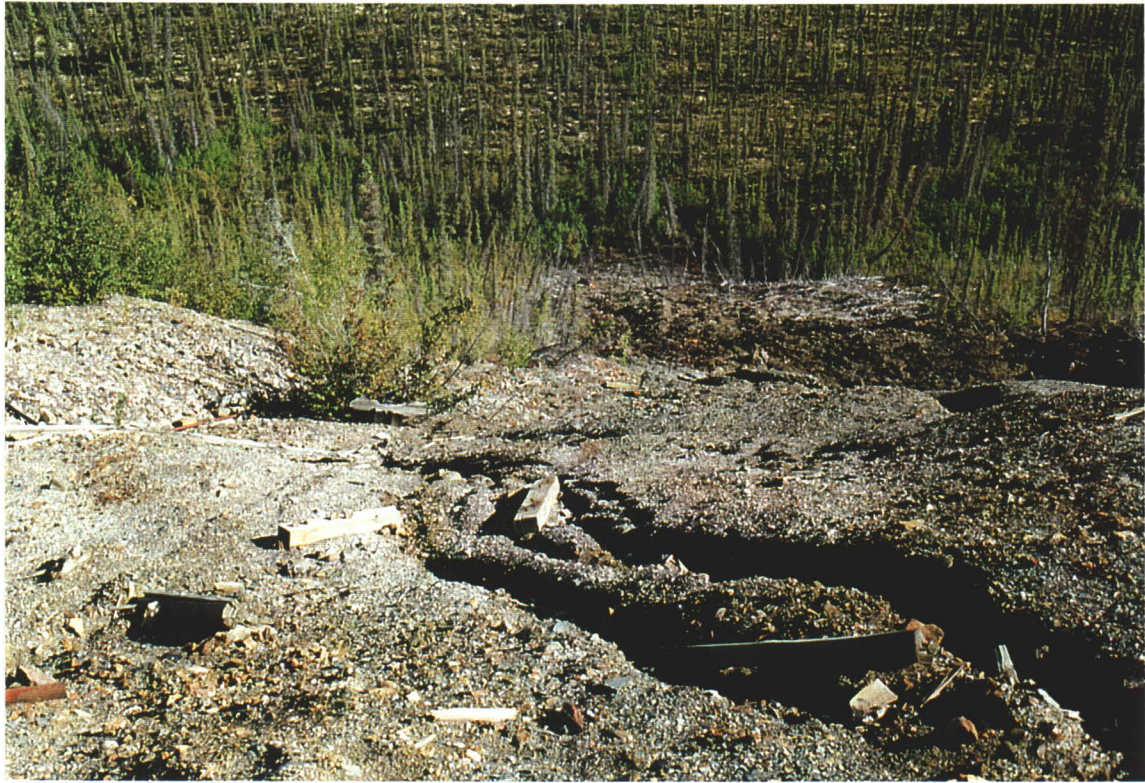
The presence of numerous tension cracks above the existing slide area and in the area of the west lobe is evidence of probable future slope failures. There is also significant downslope movement of waste rock material resulting from erosion by surface runoff. Mass wasting is occurring in the form of both active creep and surface erosion.

Photo 2. Tension cracks at crest of lower/eastern waste rock slope.

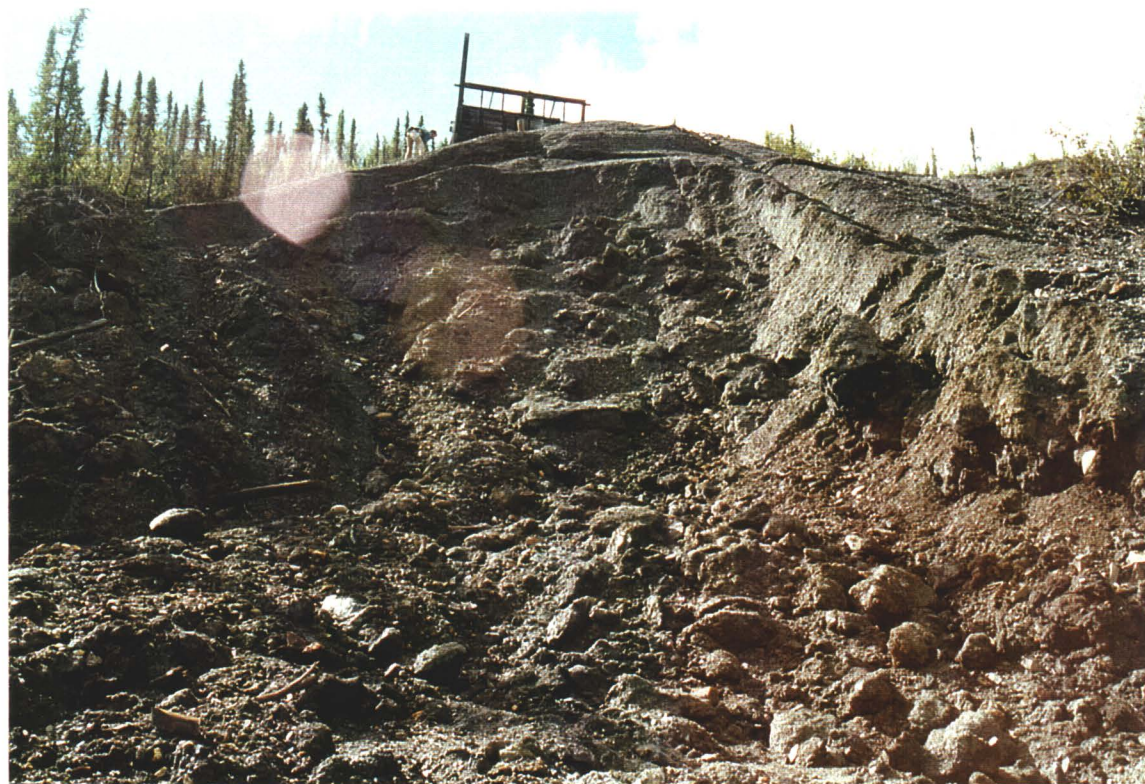
Photo 3. Slumped overburden and waste rock below crest of waste rock slope.

Recommendation 1. Physically stabilize the toe of the slope to prevent future slumping into Christal Creek. The proposed slope stabilization method would involve building a toe berm to provide lateral support and to act as a physical barrier to migration of surficial soils into Christal Creek.

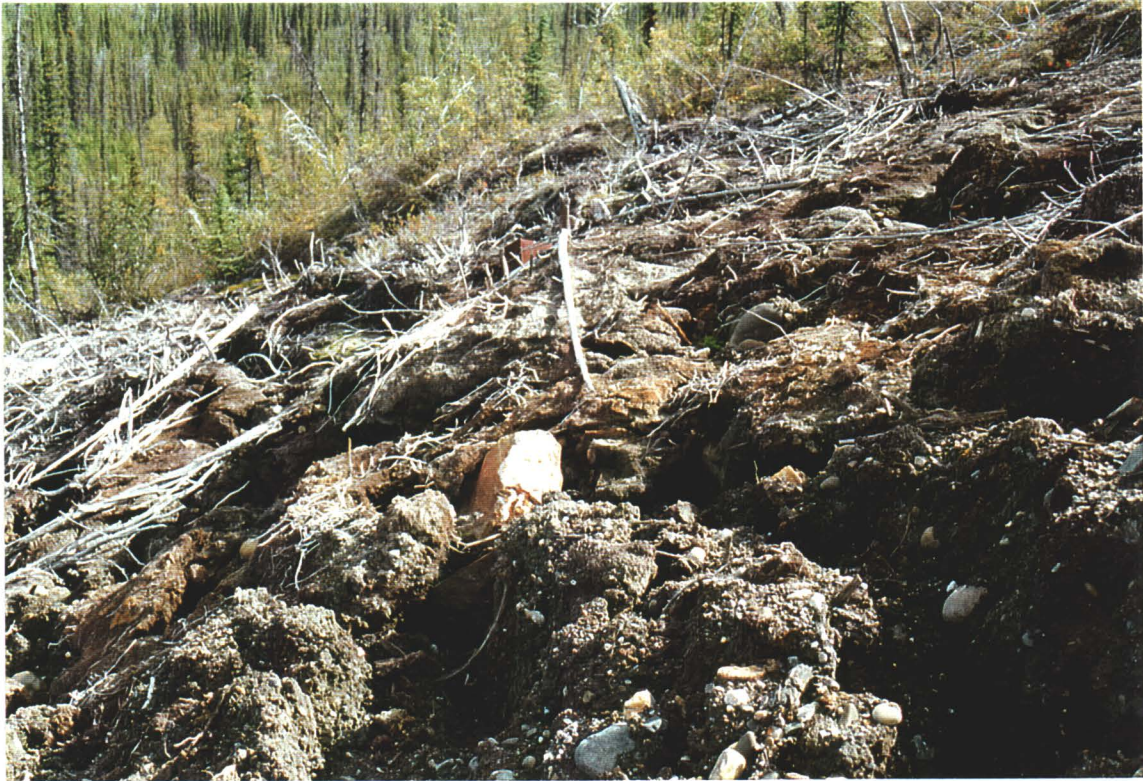
Photo 4. Slumped, eroded peaty overburden; note vegetation mortality caused by the disturbance of root systems.

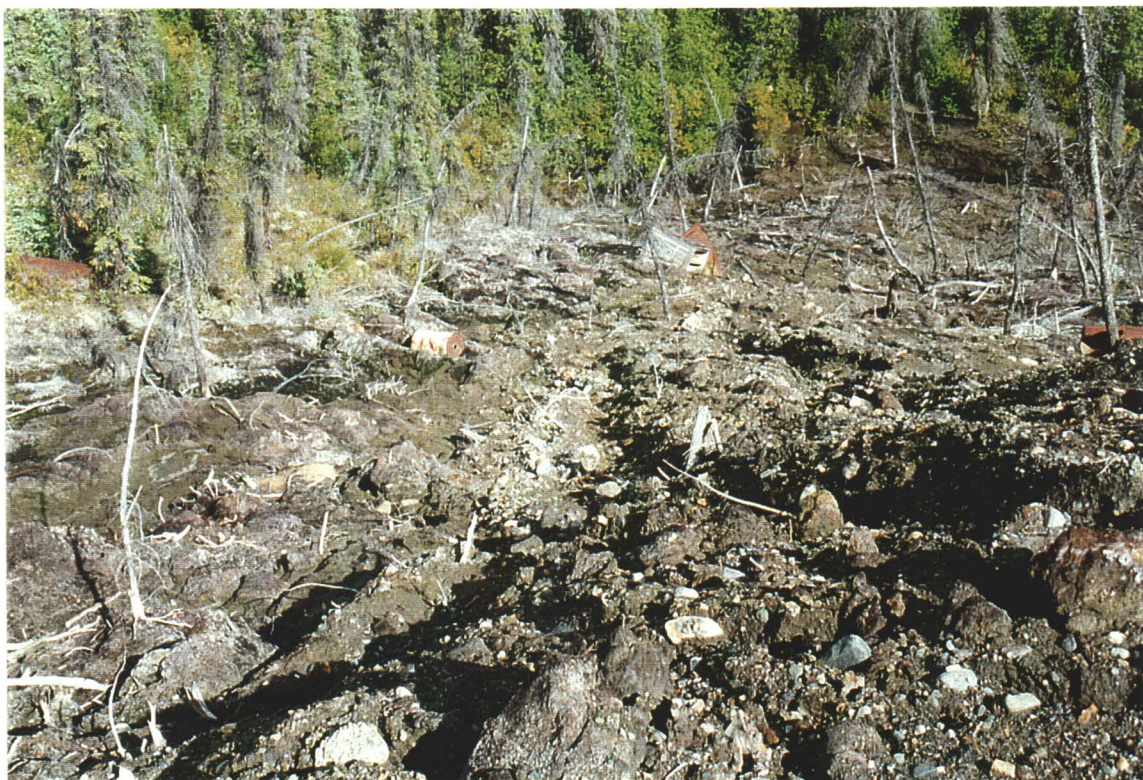
Photo 5. West edge of slumped overburden and waste rock, viewed from approximate midpoint of waste rock dump slope.

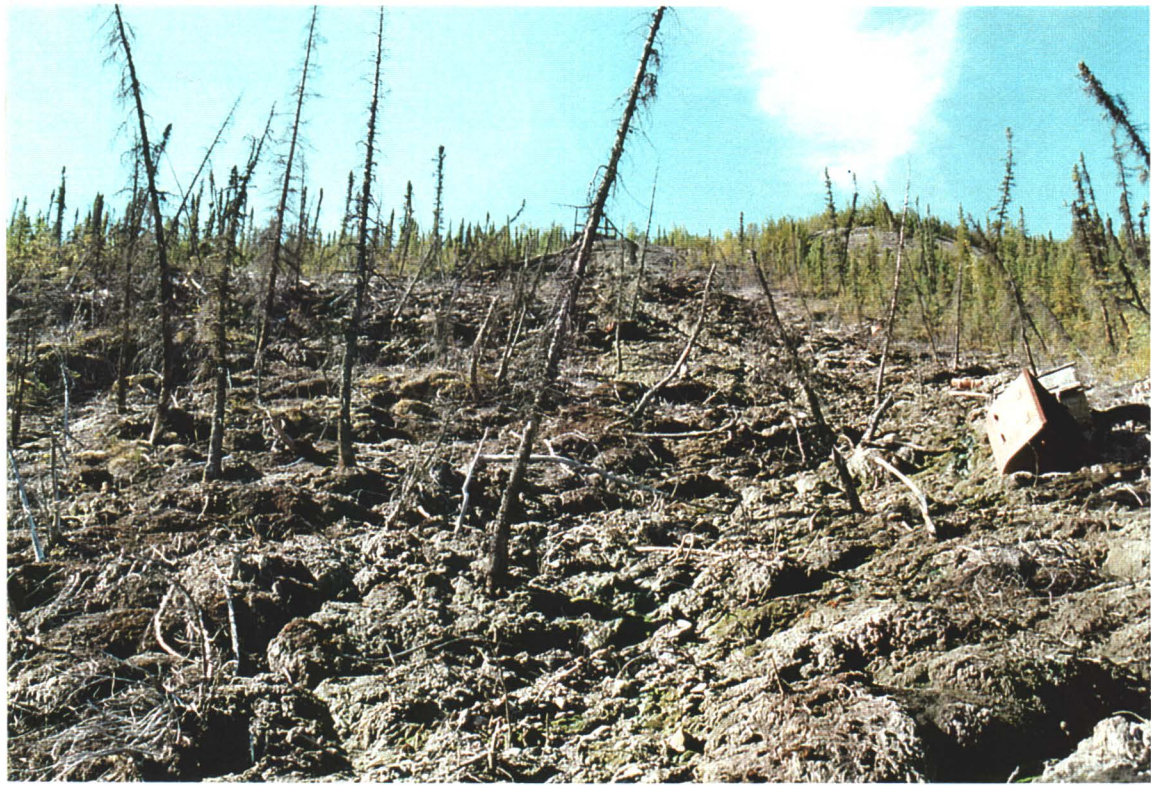
Photo 6. Lower region of slumped, peaty overburden looking towards crest of waste rock dump.

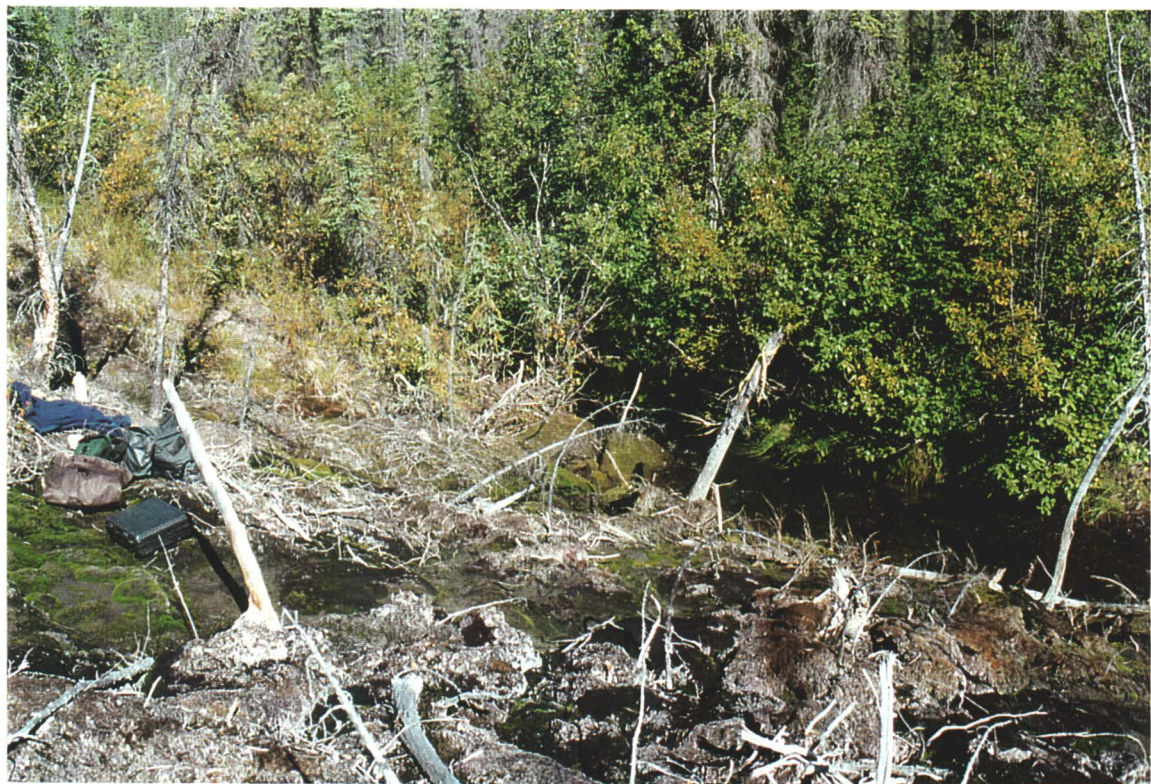
Photo 7. Christal Creek surface water sampling station FO-WQ-ST1-2, with disturbed peaty overburden and vegetation mortality visible down to Creek's edge.

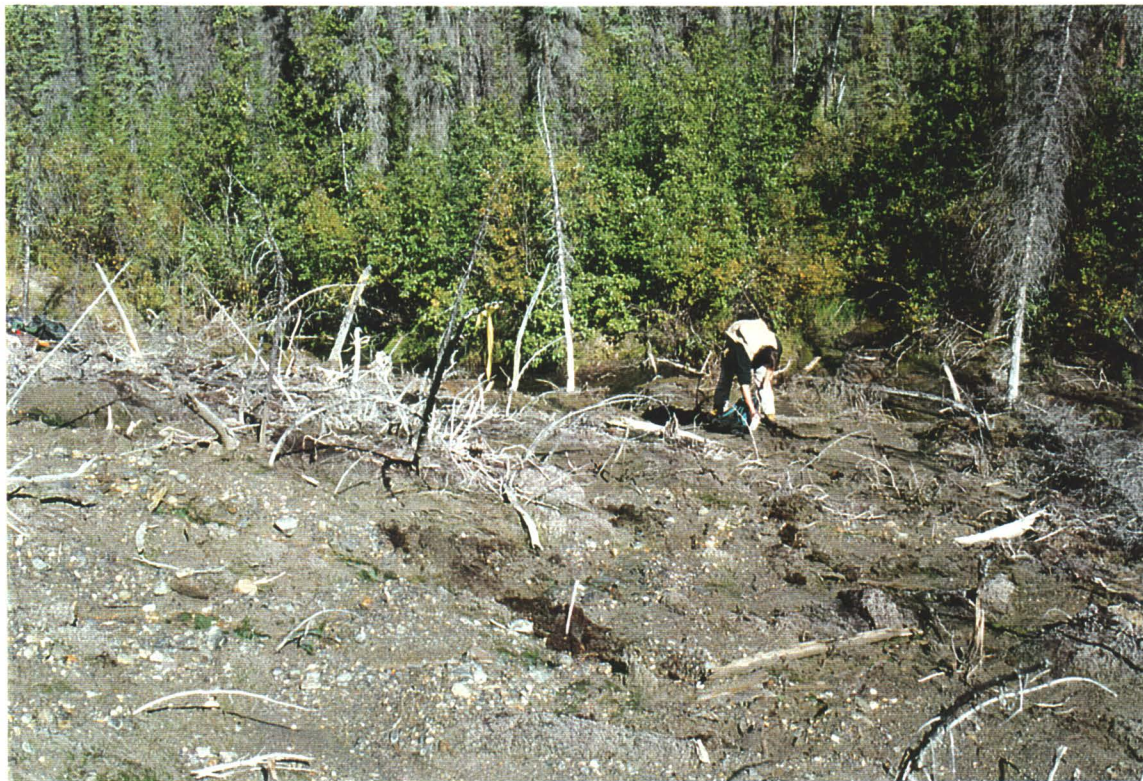
Photo 8. Seep sample station FO-WQ-SE-1, visible as a small brown patch at lower centre of photo.

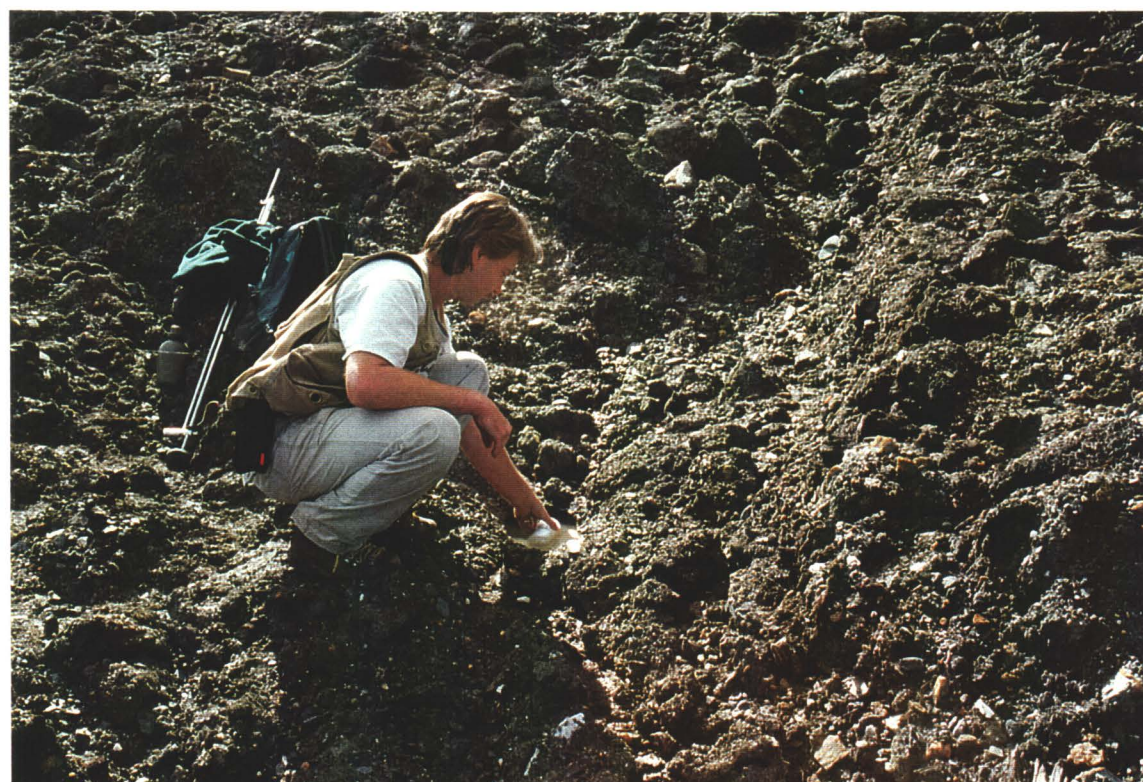
Two active seeps were discovered at the lower/eastern waste rock dump during the August 19, 1997 site visit: the first seep was found about 35m below the crest of the dump slope, and the second seep was near the toe of the slope about 8m above Christal Creek. Neither seep was active during the August 1996, October 18, 1997, or April 23, 1998 site visits.

Photo 9. Seep sample location FO-WQ-SE2-1, approximately 35m below crest of waste rock slope.

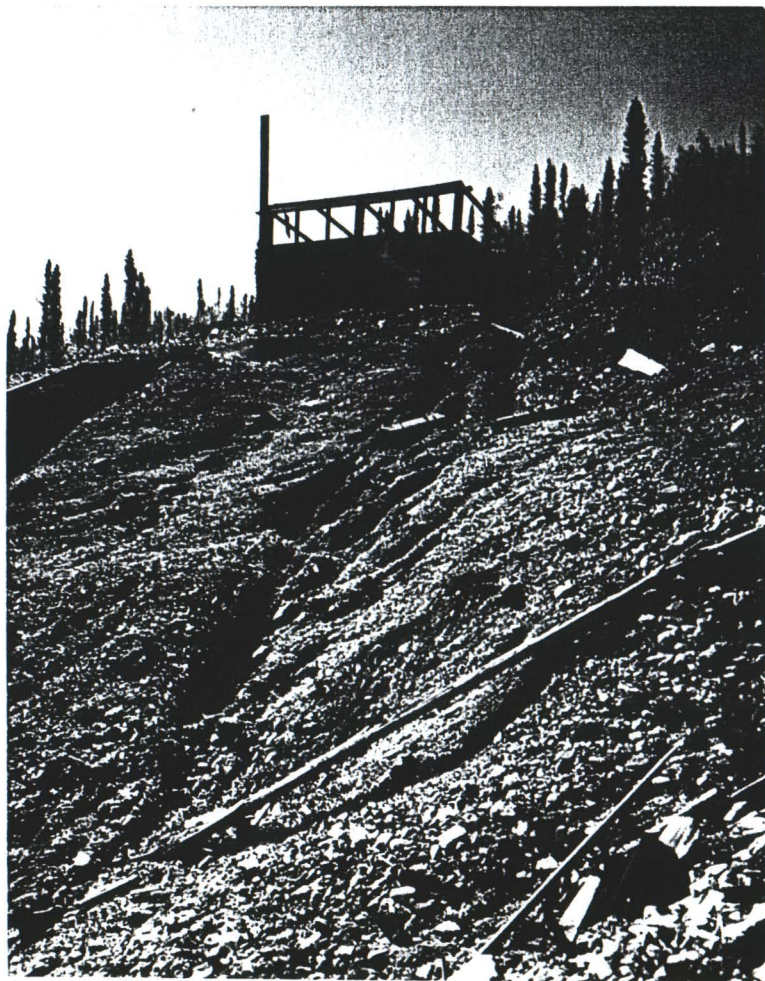
Photo #F1: Looking up the lower waste rock pile slope at the old garage. Note rivuleting due to surface runoff.

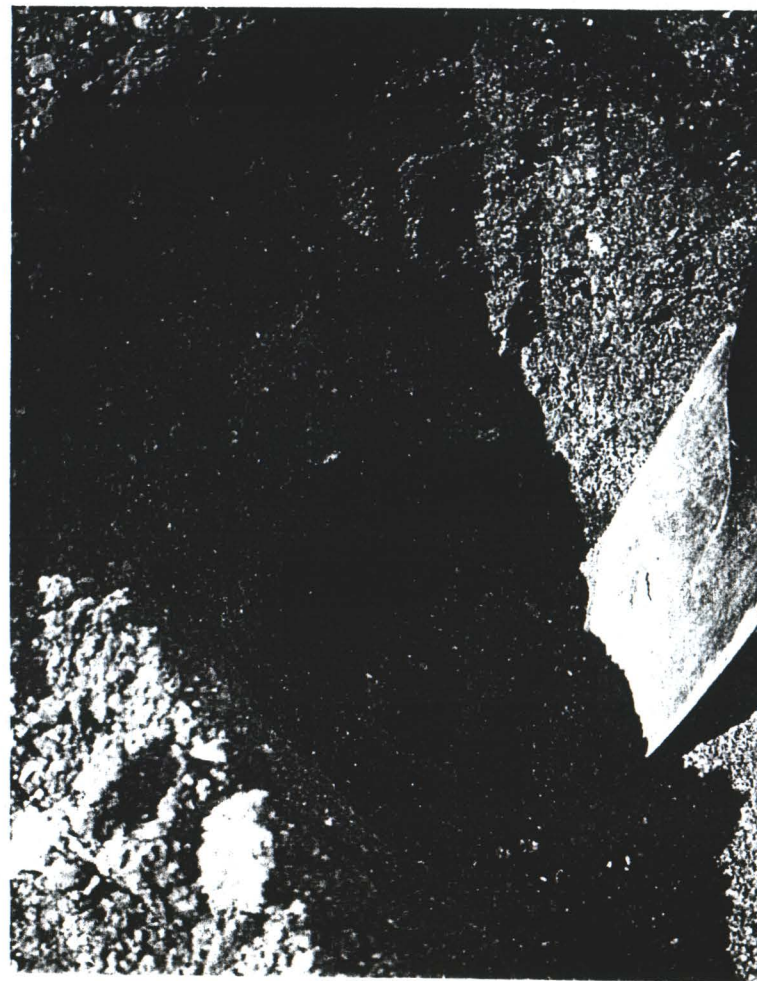
Photo #F2: Looking at hand dug test pit in waste rock pile (sample Formo 4) Note fine grained schist over heavily oxidized sulfide rich rock.

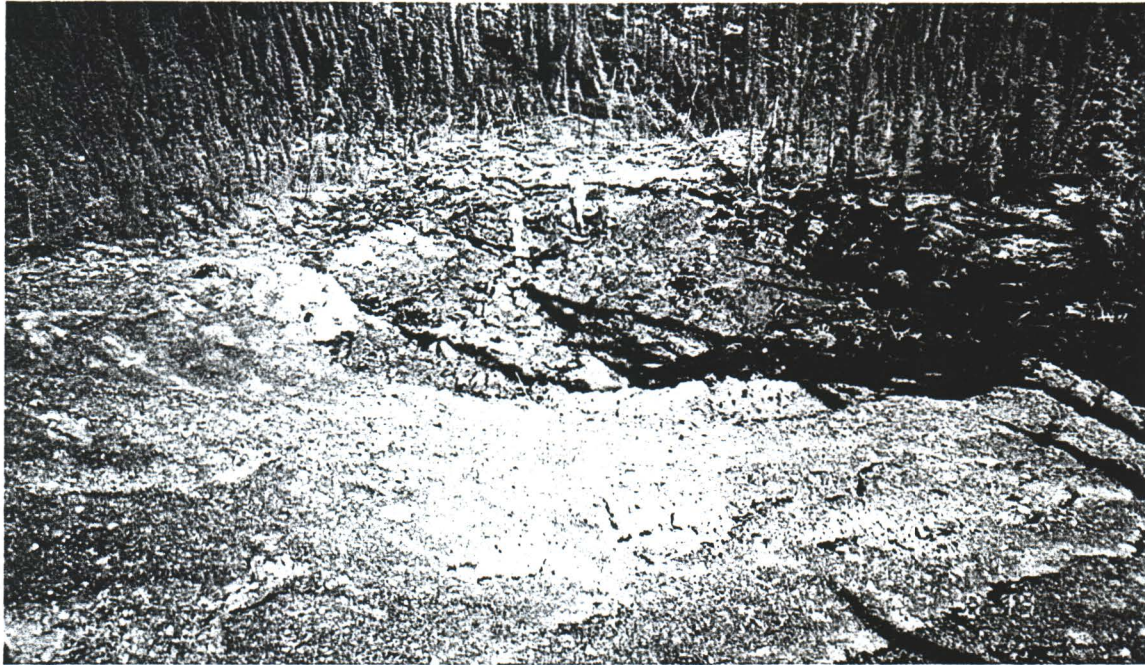
The lower workings consisted of a waste rock pile covering an area of approximately 80 m by 60 m as described in Drawing 12953-7. The waste rock pile area was slightly vegetated with young poplar and willow and the slope angle ranged from 28° to 34°. The primary area of waste rock material is located immediately below the adit and level pad where the two old structures are located. The most notable feature of this area was the presence of a large slide failure within the waste rock pile at the location shown in Drawing 12953-7 and as depicted in Photo #F3. The slide appeared to be caused by a translational slip which involves a failure surface developing at the interface of an adjacent stratum with significantly different strength. This stratum is typically at a relatively shallow depth and the failure surface tends to be planar and roughly parallel to the slope¹. The failure surface appeared to occur between the native gravel and sand till material and the overlying peat layer. The peat layer, which represented the original ground surface prior to the deposition of the waste rock, was noted as being up to 0.5 m thick as seen in Photo# F4. The instability of this weak layer was compounded by the excessive surcharge load which had accumulated on a slight bench formation along the slope near the bottom of the waste rock area. The natural bench along the slope can be seen on the right hand side of Photo# F3. The peat layer would have virtually no resistance to shear failure induced by surcharge loads from the overlying waste rock. Further, the compression of the peat would decrease its insulating capabilities causing an increase in the active layer and a corresponding decrease in the shear strength of the previously frozen underlying soil. It is believed that the waste rock had accumulated at the bench along the slope until the increase in surcharge load on the unstable peat layer had eventually caused a translational slip failure along the peat and underlying till interface.

Photo #F3: Looking down slope at area of slump failure at lower workings waste rock dump. Note slight bench formation on right side of photo and extensive peat material.

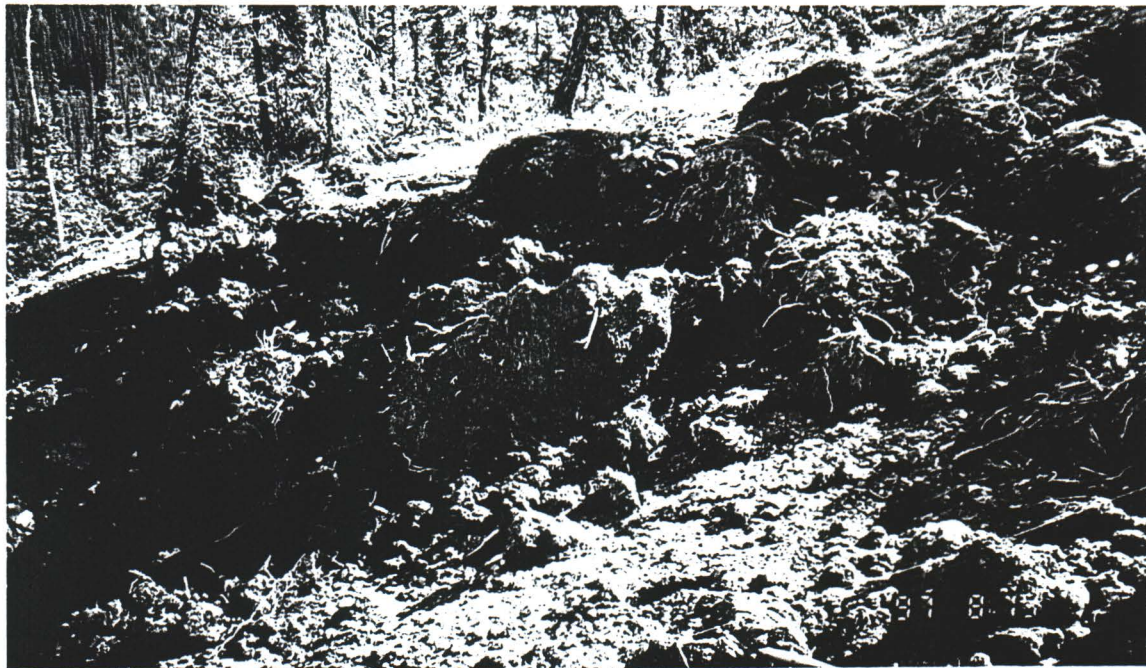
Photo #F4: Looking east from within slump failure area at natural ground surface. Note extensive peat material (up to 0.5 m thick) underlain by gravelly silt till material.

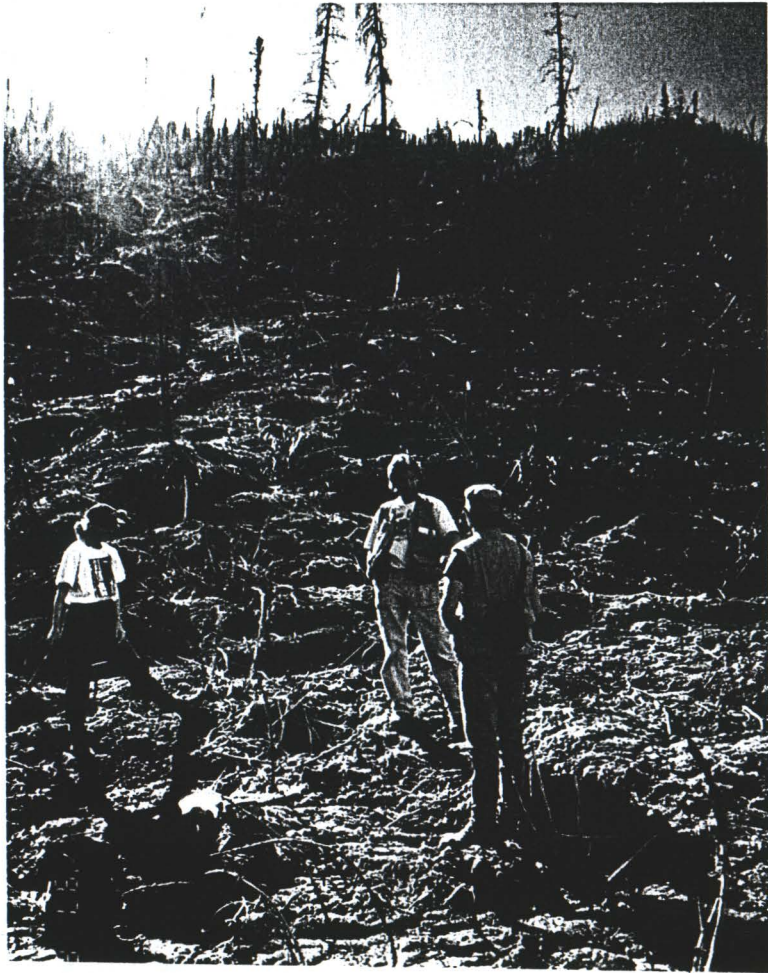
to the slide. As seen on Photo# F5, the disturbed peat formed terraces along the approximately 24° slope and also undermined the existing vegetation as evidenced by the leaning trees. Although it was reported by SRK that the waste rock had extended to the creek, this was not apparent during the site visit. Rather, the run out apron of the slide appeared to extend approximately 60 metres below the previous lower extent of the pile and approximately 150 metres from the creek. Exception to this was in the area of the drainage course shown on Drawing 12953-7 where some surface erosion of the waste rock had occurred which resulted in some further down slope movement.

Photo #F5: Looking up at end of flow slide area near Christal Creek.
Note terraced disturbed near surface peat and leaning trees.

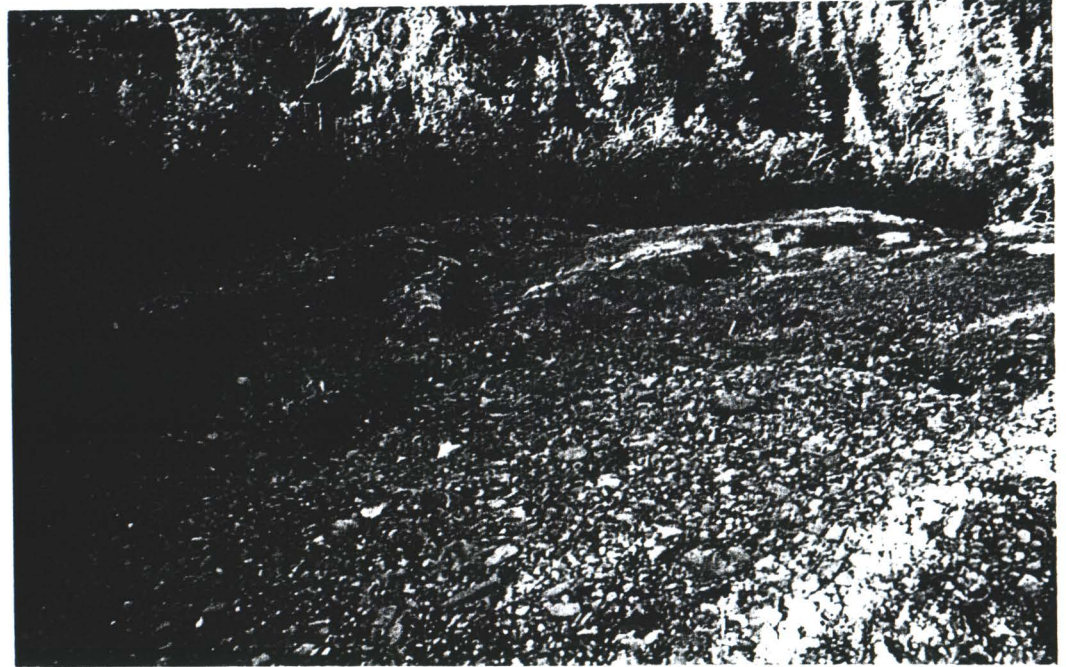
In regards to the stability of the existing waste rock material at the lower workings, there is evidence that future failures could occur. This is due to the presence of numerous tension cracks located above the existing slide area and in the area of the west lobe as shown on Photos #F3 and #F6, respectively. There is also a significant amount of down slope movement of the dump material occurring as a result of erosion from surface runoff. Rivuletting is apparent at the areas described in Photo# F1 and in Drawing 12953-7. From these visual observations, it is apparent that mass wasting is occurring in the form of active creep and surface erosion and that future slide failures are possible at the lower workings waste rock pile.

Photo #F6: Looking down slope at west lobe of lower workings; note evidence of slump failures along top of slope.
