**Phase III ENVIRONMENTAL ASSESSMENT**

**PADDY MINE SITE**

**Final Report**

Environmental Services  
Public Works and Government Services Canada

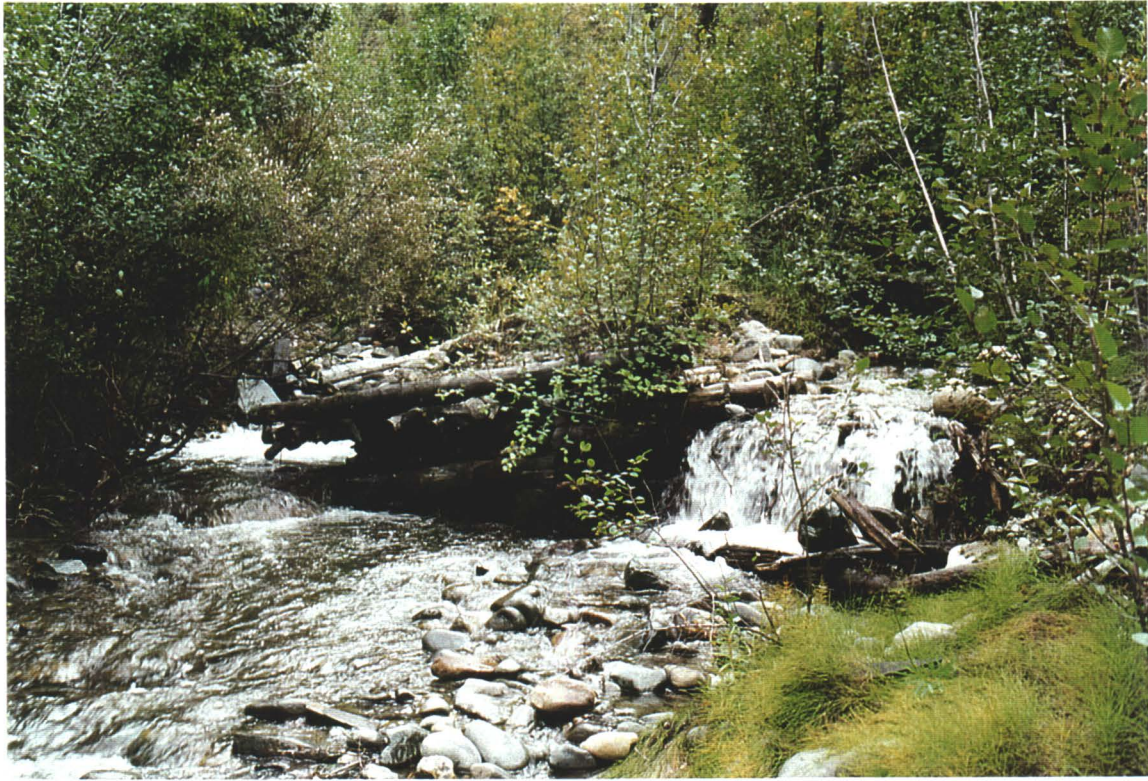
Photo 1. Collapsed bridge approximately 600 m downstream from adit.

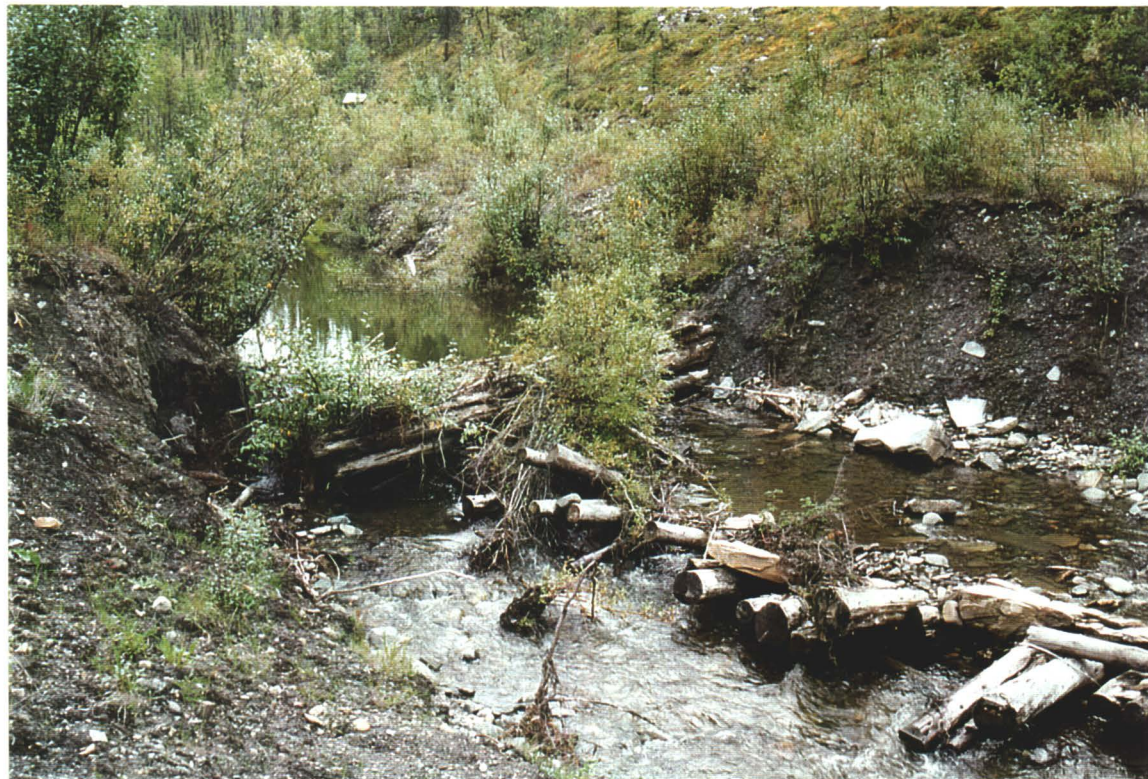
Photo 2. Collapsed bridge upstream from adit. Note ponded water behind cross-stream beams indicating partial flow blockage.

The collapsed bridge #2 closer to the adit is more seriously impeding the flow of Christal Creek. The bridge appeared to dam the creek, causing a change in water elevation of approximately 0.6 m and creating a log jam at the upstream end. There was seepage through the collapsed bridge at various locations which allowed the creek to maintain flow downstream. Based on visual observation, the collapsed bridge #2 could represent a hindrance to the fisheries resource of Christal Creek. However, with little fisheries information available for this particular creek, the extent of this impact cannot be reasonably assessed. With this in mind, it is considered to be more effective to actually remove the obstruction in order to alleviate the problem rather than to engage in an assessment of the impact to the fisheries resource.

The collapsed bridge #2, which is the further east of the two, has severely impeded the flow of the creek and caused log jams and similar disturbances to the creek. This bridge should be demolished and the debris should be removed from the creek and buried in the immediate area. This work could be accomplished with a Caterpillar 225 backhoe or similar with a thumb attachment on the bucket to facilitate debris removal from the creek. Access to the collapsed bridge could be accomplished via the road leading from the gravel pit on the Hanson Lakes Road as shown on Drawing 12953-1.

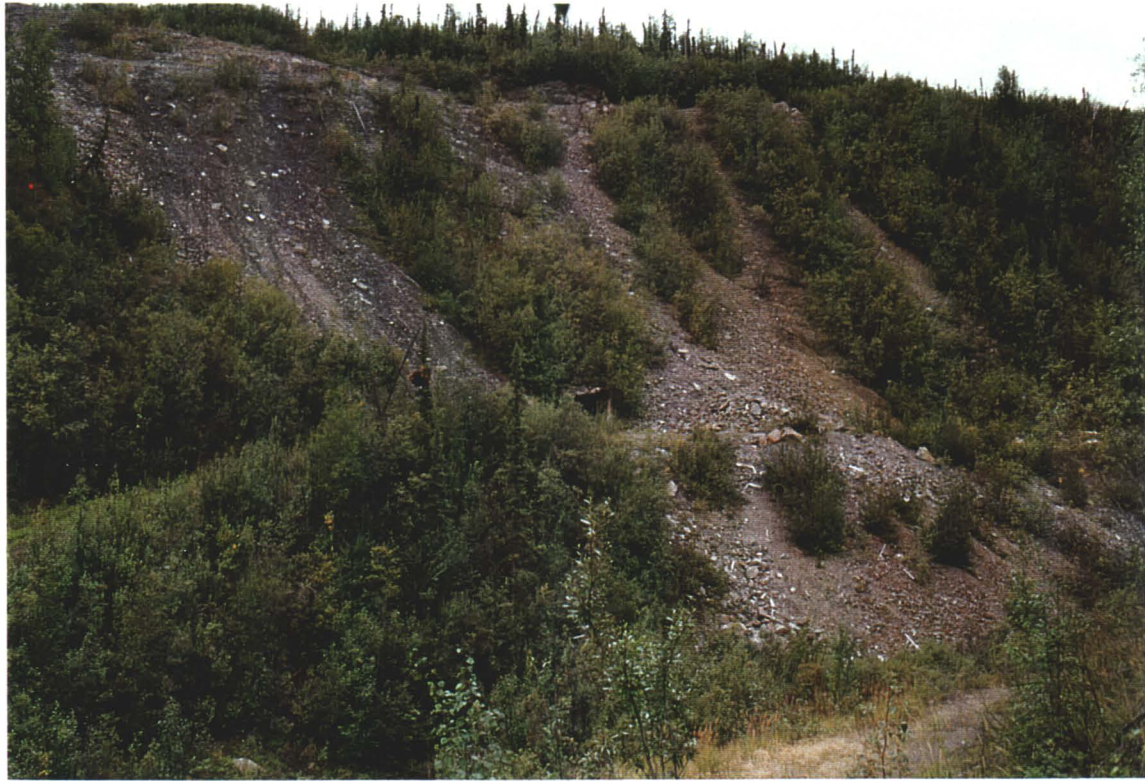
Waste rock along the south canyon slope near the adit consisted of alternating lobes of fine grained, slightly pulverized schist rock and course grained quartzite rock. The slope angles of the waste rock material approached 38° due to the naturally steep slope of the canyon wall. During the site visit, it appeared that mass wasting at this site was restricted to gradual surface movement as there was no evidence of translational slip failure or more extensive slides of this nature. There were signs of slumping and creep at the upper road and western most waste rock lobe. In the

upper road area, some slumping has occurred at the top of the waste rock slope. There was no visual evidence of past deep seated failures along the waste rock slope. At the westernmost waste rock lobe, some slump failure appears to have occurred within the schist-based waste rock mass.

Photo 3. Paddy waste rock slope. Upper Road is visible at top left of photo; adit is visible at center of photo.

- Recommendation 1.** To prevent further movement of waste rock material into Christal Creek, gabion baskets or other physical barrier should be placed at the toe of the waste rock slope.
- Recommendation 2.** The collapsed bridge upstream from the adit should be demolished. Bridge materials and jammed logs should be removed to improve fish passage through the canyon area.

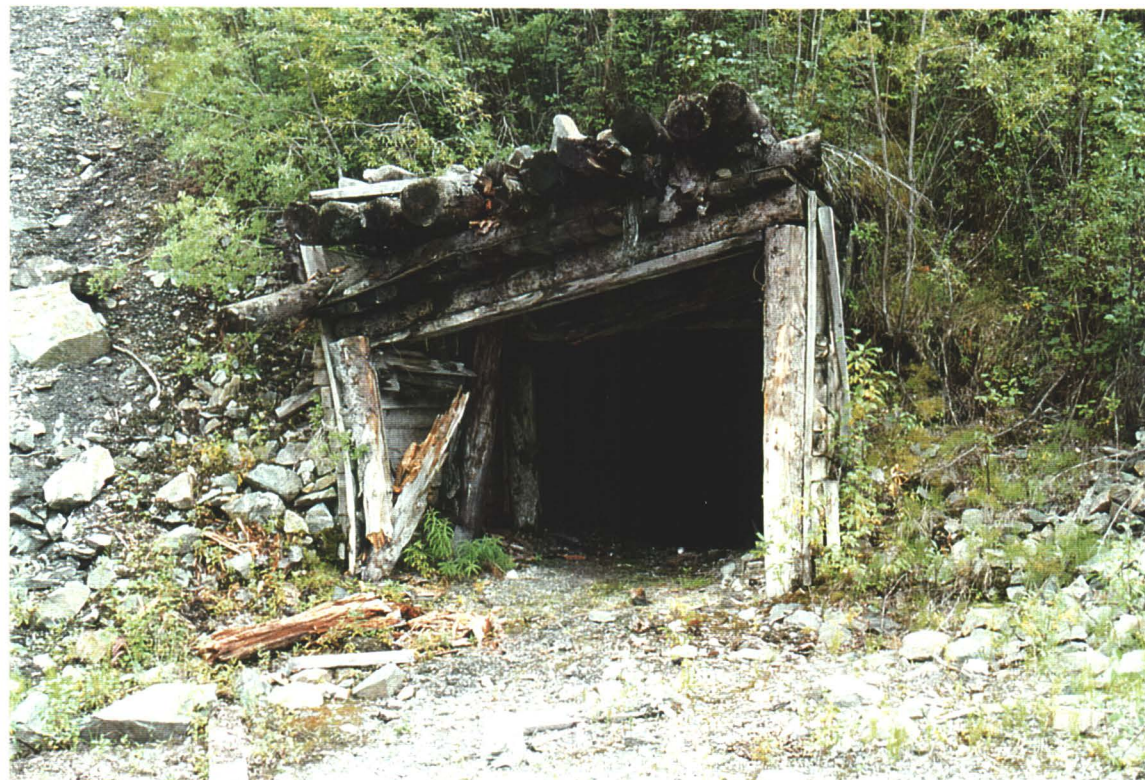
Photo 4. Paddy mine adit.

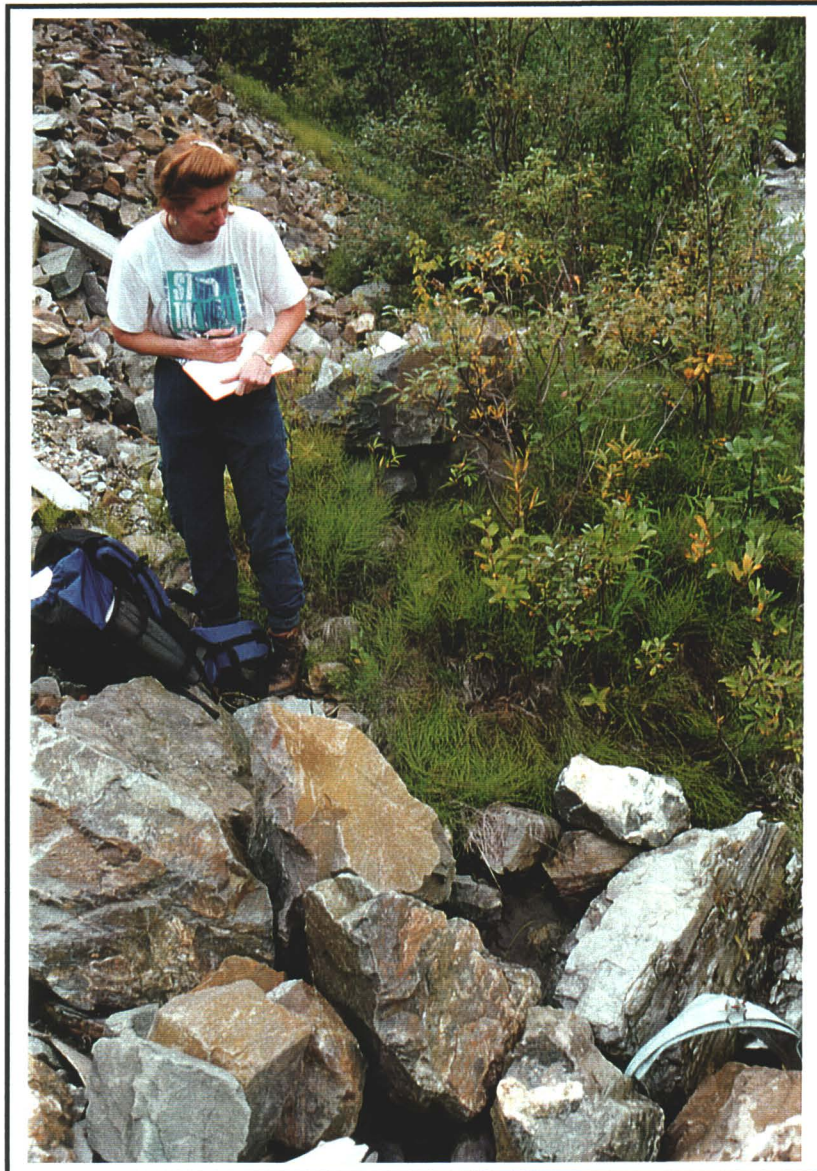
In August 1997, seepage from the main waste rock pile was less than 1 L/min. On both the August 1996 and August 1997 sampling dates, the seep had a pH of approximately 7.7 and sulphate concentration between 459 mg/L and 502 mg/L. Zinc was above the CCME criterion for freshwater aquatic life in August 1996, while cadmium, copper, and zinc concentrations were above the criterion during August 1997. Concentrations of copper and zinc probably reflect the presence of freibergite and sphalerite in local rock; however, the cadmium source is unknown. No seepage was observed during October 1997 or April 1998.

Photo 5. Toe of waste rock slope near Christal Creek. Waste rock seep is visible at lower center of photo.

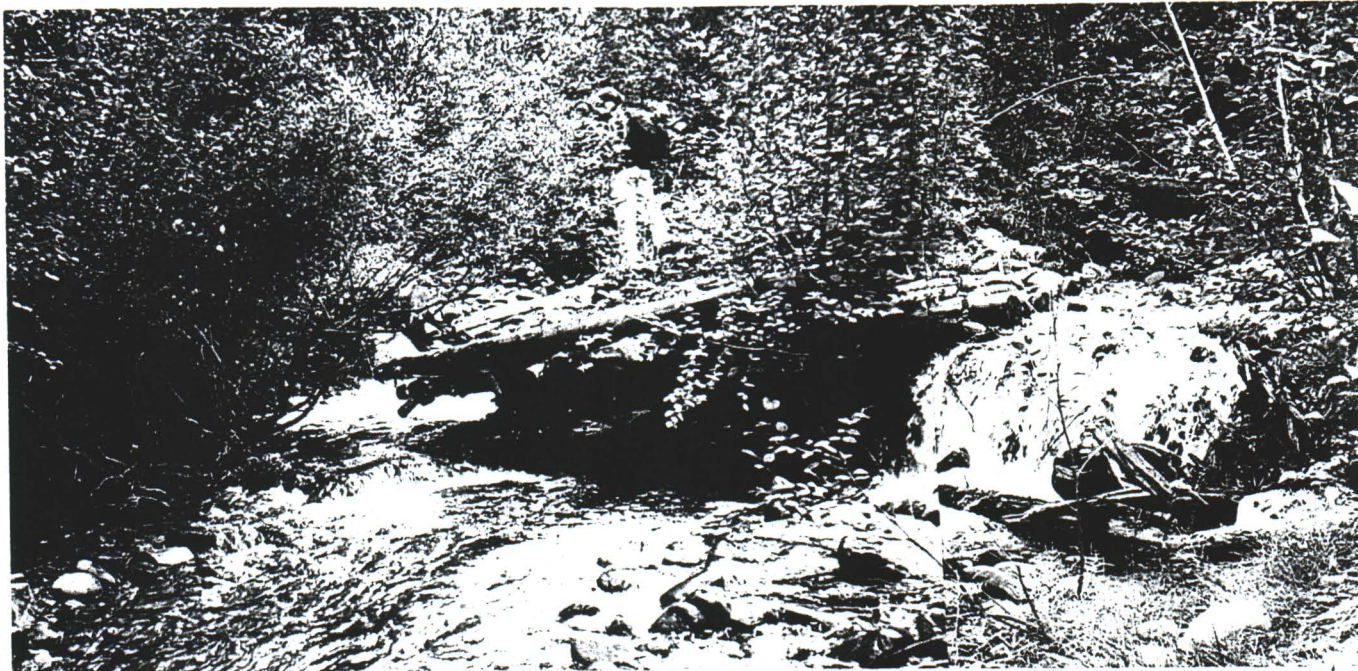
Photo #PA1: Bridge#1 collapsed into creek. Note log crib construction with earthen fill; note approximately 0.5 m drop in water level at right side of creek.

In the areas of the two bridges, it appears that the failure has resulted from the erosion of the bridge abutments over time, causing each bridge to collapse into the creek. The abutments and bridges themselves were constructed of log cribbing with earthen fill and were clearly not capable of withstanding large fluctuations in the creek flow or water elevations. As a result, the supports at either side of the bridge were eroded away, eventually causing the bridge to collapse into the creek. As seen in Photo PA1, the collapsed bridge #1 does not seriously impede the flow of Christal Creek since channels have been developed on either side of the bridge. There is an approximately 0.5 m drop in elevation of water level at the right side (west) and an approximately 0.3 m drop at the left side. Based on visual observation, it does not appear that the collapsed bridge #1 would pose a threat to the fisheries resource of Christal Creek.

Since the restoration work will involve a significant amount of machinery crossing the creek at failed bridges #1 and #2, these areas will have to be rehabilitated with corrugated steel pipe culverts covered with earth fill. This will serve as a temporary bridge during the construction and could be subsequently removed to restrict other users from the area. Site access will also require some grading of the road approximately 175 m west of failed bridge #1 where a short length of the road was intentionally destroyed to prevent vehicular passage.

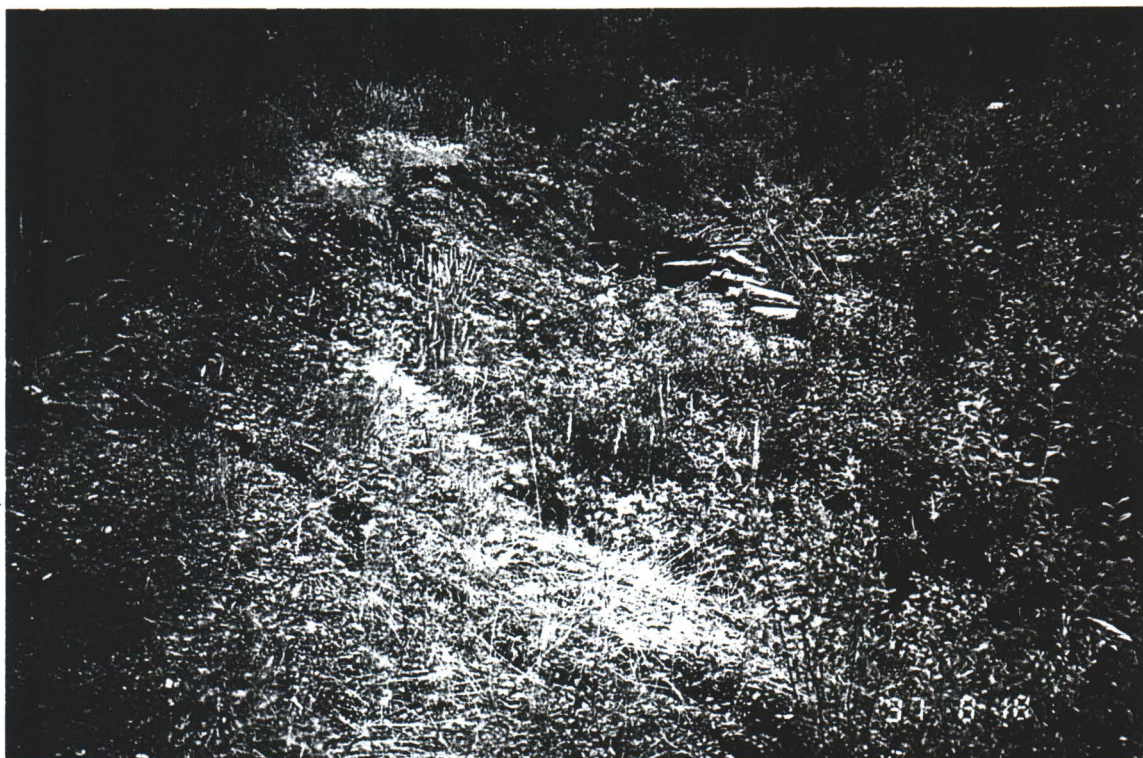
In regards to the lower access road, there appeared to be slight mass wasting either due to erosional effects of Christal Creek or due to an excessive slope gradient leading toward the creek. The tension cracks and evidence of slump failures seen in Photos PA2 and PA3 have occurred at those locations along the south edge of the lower road which are directly adjacent to the creek and which have a steep slope angle (in excess of 35°) leading from the edge of road to the creek. These areas also correspond to locations where fill was placed for the construction of the road. Based on these observations, it appears that the failures have been primarily due to slope angles which are in excess of the maximum angle of repose for such a fine grained, schistose-based silty sand soil. To a lesser extent, it is likely that the fill for the road construction was not placed with adequate compaction, further reducing the shear strength of the soil mass.

Photo #PA2: Note slump failures along north bank of creek just down stream of collapsed bridge #2.

1. In regards to the lower road, it appears that the failures have been primarily due to slope angles which are in excess of the maximum angle of repose for such a fine grained, schistose-based silty sand soil. In order to prevent further slumping of the soil along the lower road into Christal Creek, some grading work will be necessary at various locations along the road to achieve a final slope of 2.5H:1V.

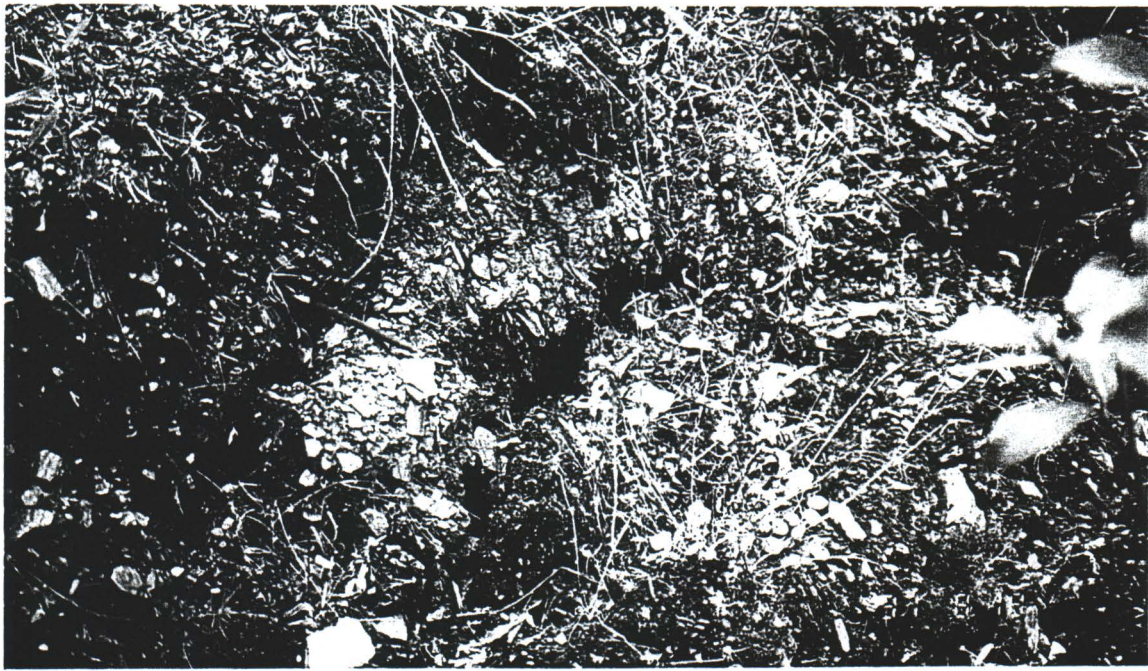
From this, it is envisioned that future slope failures along the lower road would involve a series of slumping events of soil into and subsequent erosion by the creek. The erosion of the slumped material undermines the toe of the newly formed slope which in turn causes further slumping. This cycle is typically repeated until sufficient slumping has occurred such that a natural slope angle for the fine grained material is realized. Based on the height of the road above the creek, it does not appear that the volume of material at each particular slumping event would greatly impede the flow of the creek. Rather, the slumping and subsequent erosion will affect the creek by slightly increasing the sediment loading over a period of several years. It cannot be estimated with reasonable accuracy whether this increase in sediment loading would adversely impact the fisheries resource of this creek.

Photo #PA3: Evidence of slump failure along lower road. Movement due to eventual stabilization of loose fill material placed at excessive slope angles and without compactive effort.

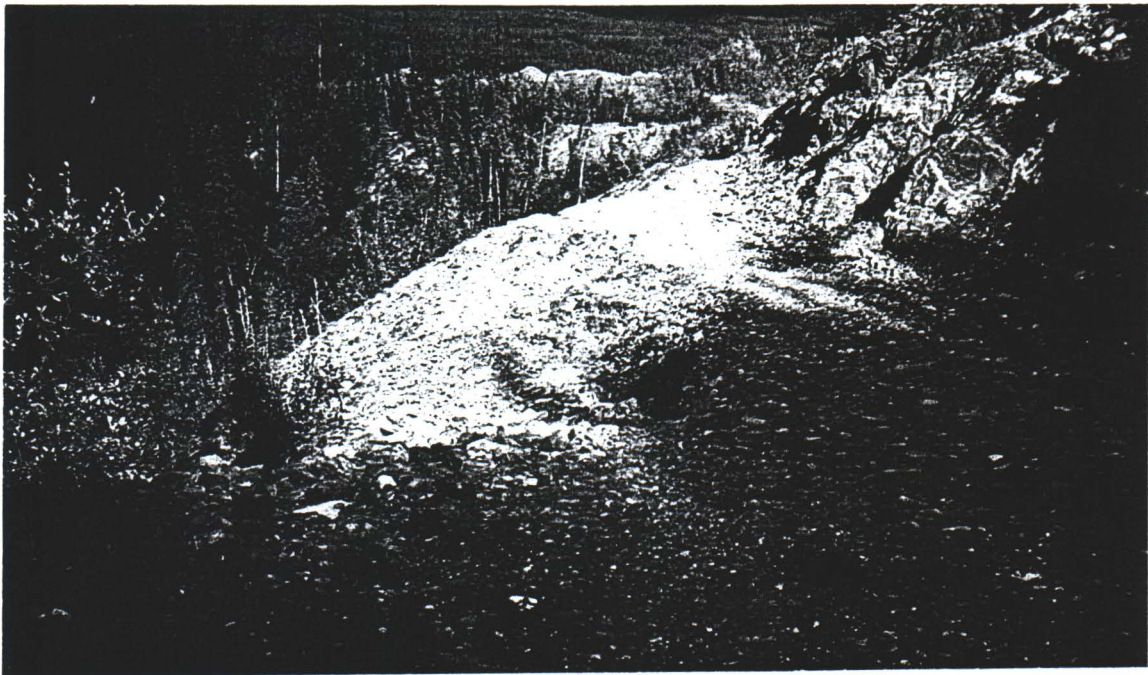
Photo #PA4: Looking east along upper road near waste rock dump. Note slumping of road, extension cracks due to natural slope stabilization.

There were signs of slumping and creep at the upper road and western most waste rock lobe as indicated on Drawing 12953-3 and in Photo PA4. In the case of the upper road area, some slumping has occurred at the top of the waste rock slope. As seen on the particle size analysis of Sample Paddy 1 which was retrieved from this area, the sample was composed of sand and gravel sizes, with some silt. The material was schist based, with a fines content of close to 20%, and appeared to be placed in a relatively loose state. These collective factors are most likely the cause of the slump in this area. Namely, the relatively high fines content and platy, graphitic schist nature translates to relatively low shear strength characteristics of the waste rock material. The loose nature of the material also has lead to slumping due to the decrease in void spaces and corresponding consolidation of the waste rock mass. There was no visual evidence of past deep seated failures along the waste rock slope. Such a failure would most definitely adversely impact Christal Creek.
