Phase III Environmental Assessment

Venus Mine Site

Interim Report

Environmental Services
Public Works and Government Services Canada
Pacific & Western Regions

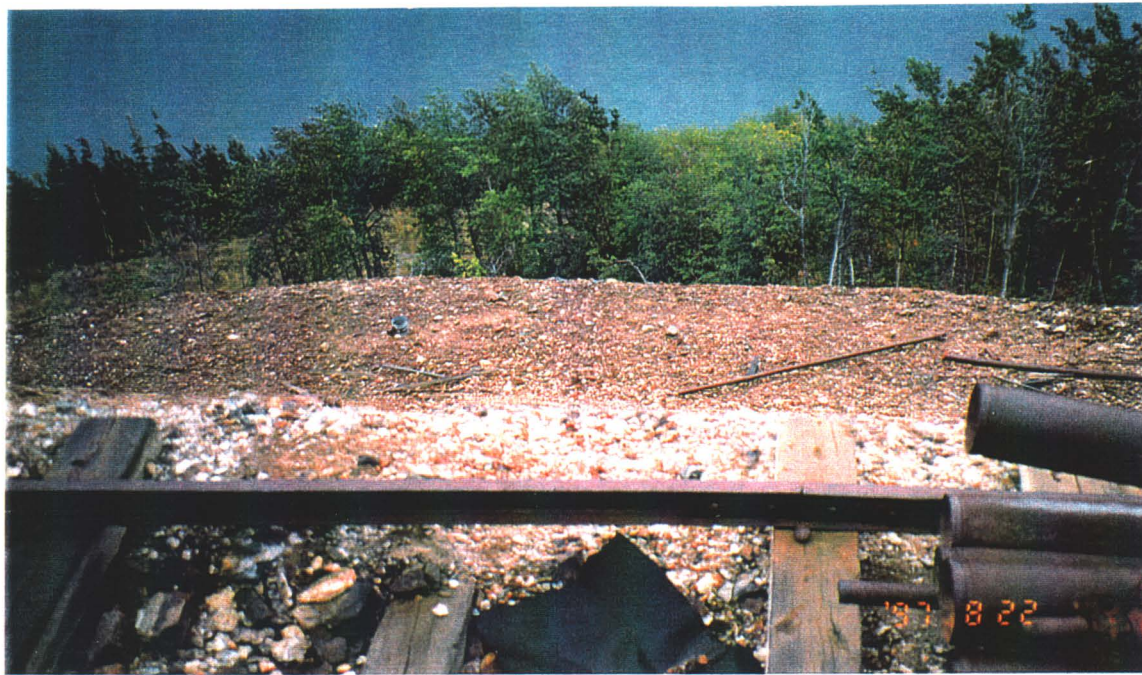
The slope was thoroughly inspected for signs of previous slope failures or of active mass wasting. There were no signs of tension cracks near the top of the slope or bulging at the toe which would suggest slope movements. Rather, the extent of downslope movements has been restricted to near surface sloughing from disturbances such as avalanches and other slides. This is particularly evident at the south portion of the waste rock pile where surface sloughage has undermined the tracks leading from Adit 1 as seen in Drawing 12953-11. The presence of two horizontal benches downslope of the waste rock has restrained the surface sloughing from extending further down the slope. It does not appear that significant mass wasting has occurred in the area of Adit 1 as there were no observed failures related to the waste rock pile in this area.

Photo #V1: Looking east down slope from adjacent to shack at north portion of area near adit 1. Note lower benches of waste rock and of access road. Note fallen pipes.

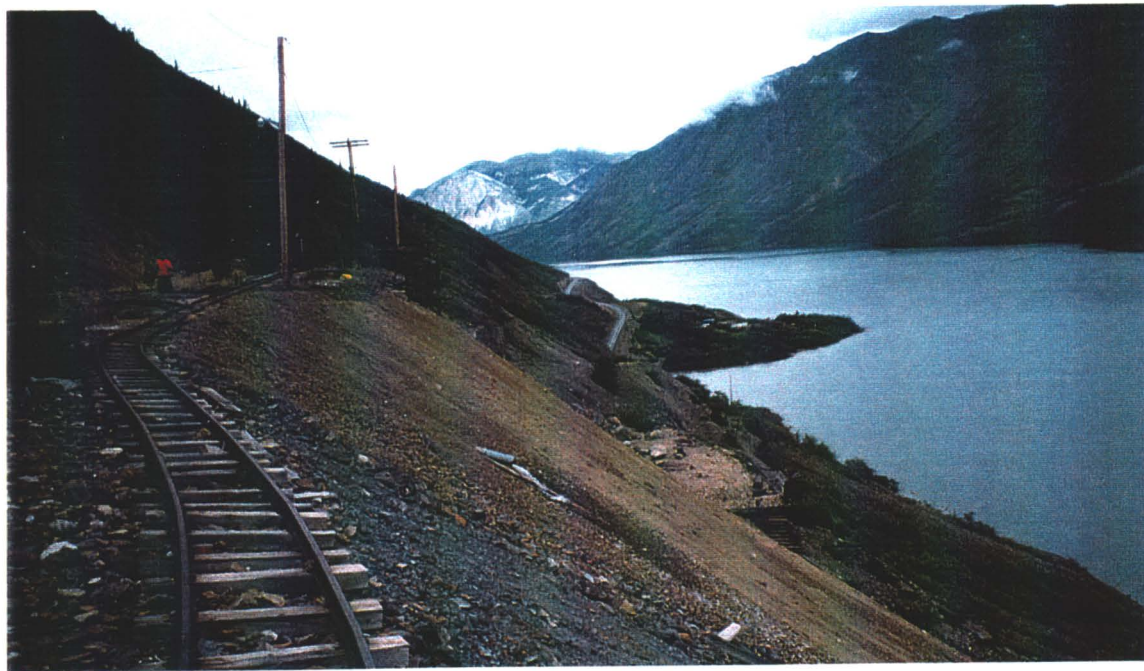
Photo #V2: Looking north along tracks at area of adit 2. Note culvert along waste rock pile slope; note lower retaining wall built of log cribbing.

The most significant feature in the area of Adit 2 was the presence of relatively unstable retaining walls along the waste rock slope. These are illustrated in plan drawing 12953-12 and profile 12953-13 as well as in photos #V3 and #V4. Of particular note were the two retaining walls built in series along the waste rock pile slope shown as section B-B on drawings 12953-12 and 12953-13. These have been constructed with log cribbing and have shown natural degradation over their 25 or more year existence. With respect to the lower wall, the log cribbing itself showed some natural decay and there were some failures noted at the joints along the edges. There was also extensive sloughing of the waste rock behind the wall and tension cracks parallel to the wall. As the integrity of the wall and waste rock mass is undermined by natural decay and slight movements, a sudden failure may eventually occur leading to a large mass of waste rock mobilizing downslope. This could occur if the joints along the cribbing continue to fail to the point where the waste rock begins to deform and the strength within the remaining cribbing support is insufficient to restrain the waste rock mass from

However, the risk of slope failure is considered more probable in the area of the two retaining walls as previously discussed in Section 2.3. To avoid the sudden failure of these retaining walls in the future and the associated risk of downslope movement of waste rock to the South Klondike Highway, it is recommended to intentionally fail these structures and to grade the waste rock to a slope which is naturally stable for this type of material. The method of destroying the wall would have to be sensitive to the possibility of disturbing the surrounding waste rock material. For example, blasting of the walls may cause a massive failure of the extensive waste rock material adjacent to the retaining structures. With this in mind, it is recommended to construct a catchment area downslope of the retaining walls, demolish the walls gradually with the use of various heavy machinery such as a dozer and a backhoe, and then dispose the fallen rock material to a suitable waste dump location. The proposed reclamation program is described in detail below.

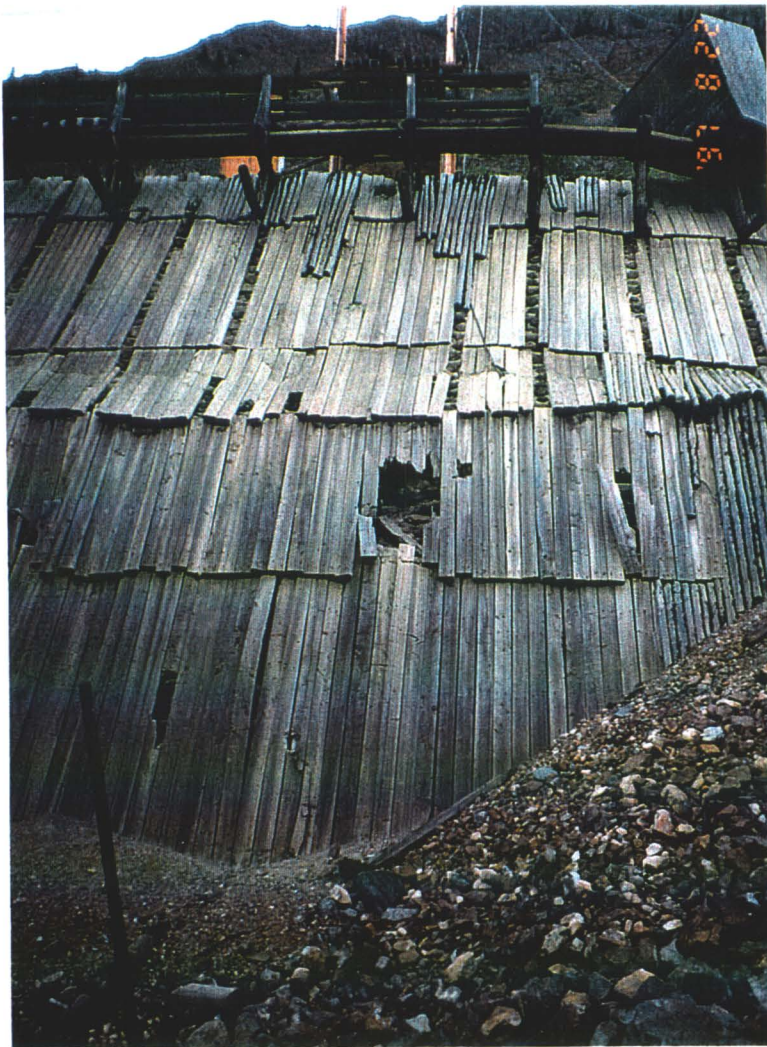
Photo #V3: Looking west at log cribbing retaining structure. Note log cribbing construction; note shack fallen over at top right;

With respect to the upper retaining wall, the log cribbing did not appear to have decayed nearly as much as the lower wall. This is most likely due to the apparently coarse, free draining nature of the waste rock which was retained by this wall as compared to the finer grained material of the lower wall. This free draining nature of the waste rock has ensured a dry environment immediately surrounding the log cribbing which has retarded natural biological decay. There were no noticeable failures of the cribbing joints or evidence of movement within the material behind the wall. Although this retaining wall is subject to natural decay and would eventually exhibit more active failure in the future, the affect of the lower wall on the instability of the upper wall is considered to be more significant. If such a failure of the lower wall was to occur, this could undermine the toe support of the upper wall which may result in failure and downslope mobilization of waste rock from the upper wall. However, the rate of this failure is uncertain. The maximum volume of waste rock restrained by the upper wall is estimated at between 1300 m³ and 1500 m³. The mobilization of this amount of rock would likely impact the South Klondike Highway below since the slope angle remains in excess of 28° to 30° along the run-out path and there is not sufficient retention capabilities of the lower benches to restrain such a volume of rock from mobilizing down to the highway.

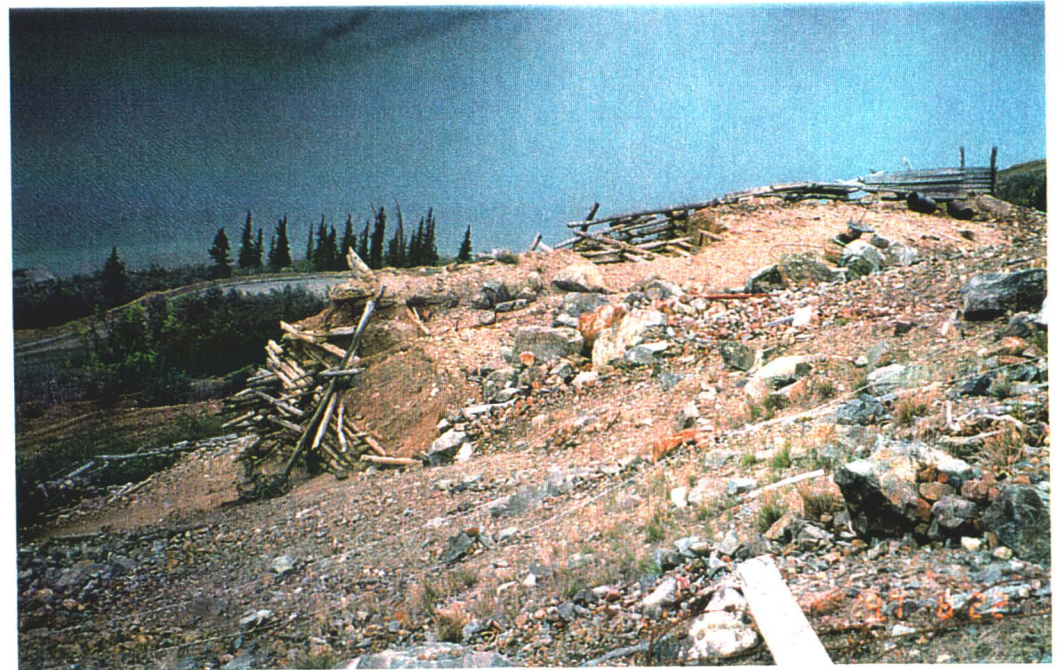
The more significant feature is the presence of unstable retaining walls along the waste rock slope. The walls are constructed with log cribbing and have shown natural degradation over the approximately 25 years of existence. The lower wall showed decay of the log cribbing and some failure at the joints along the edges. There was also extensive sloughing of the waste rock behind the wall, as well as tension cracks parallel to the wall. If the joints along the cribbing continue to fail to a point where the waste rock begins to deform and the strength within the remaining cribbing support is insufficient to restrain the waste rock from mobilizing downslope, it is uncertain that the benches below would prevent this materials from impacting the highway. The rate of failure is uncertain. This material is estimated to be approximately 500 m³.

Photo #V4: Looking south east at lower retaining wall. Note sloughing of waste rock material; note poor condition of log cribbing supports.

Recommendation 1. The two retaining walls below Adits 1 and 2 should be intentionally failed to reduce the risk to the South Klondike Highway below the site. It is recommended that the material behind the retaining walls be relocated to the bench area near Adit 2.

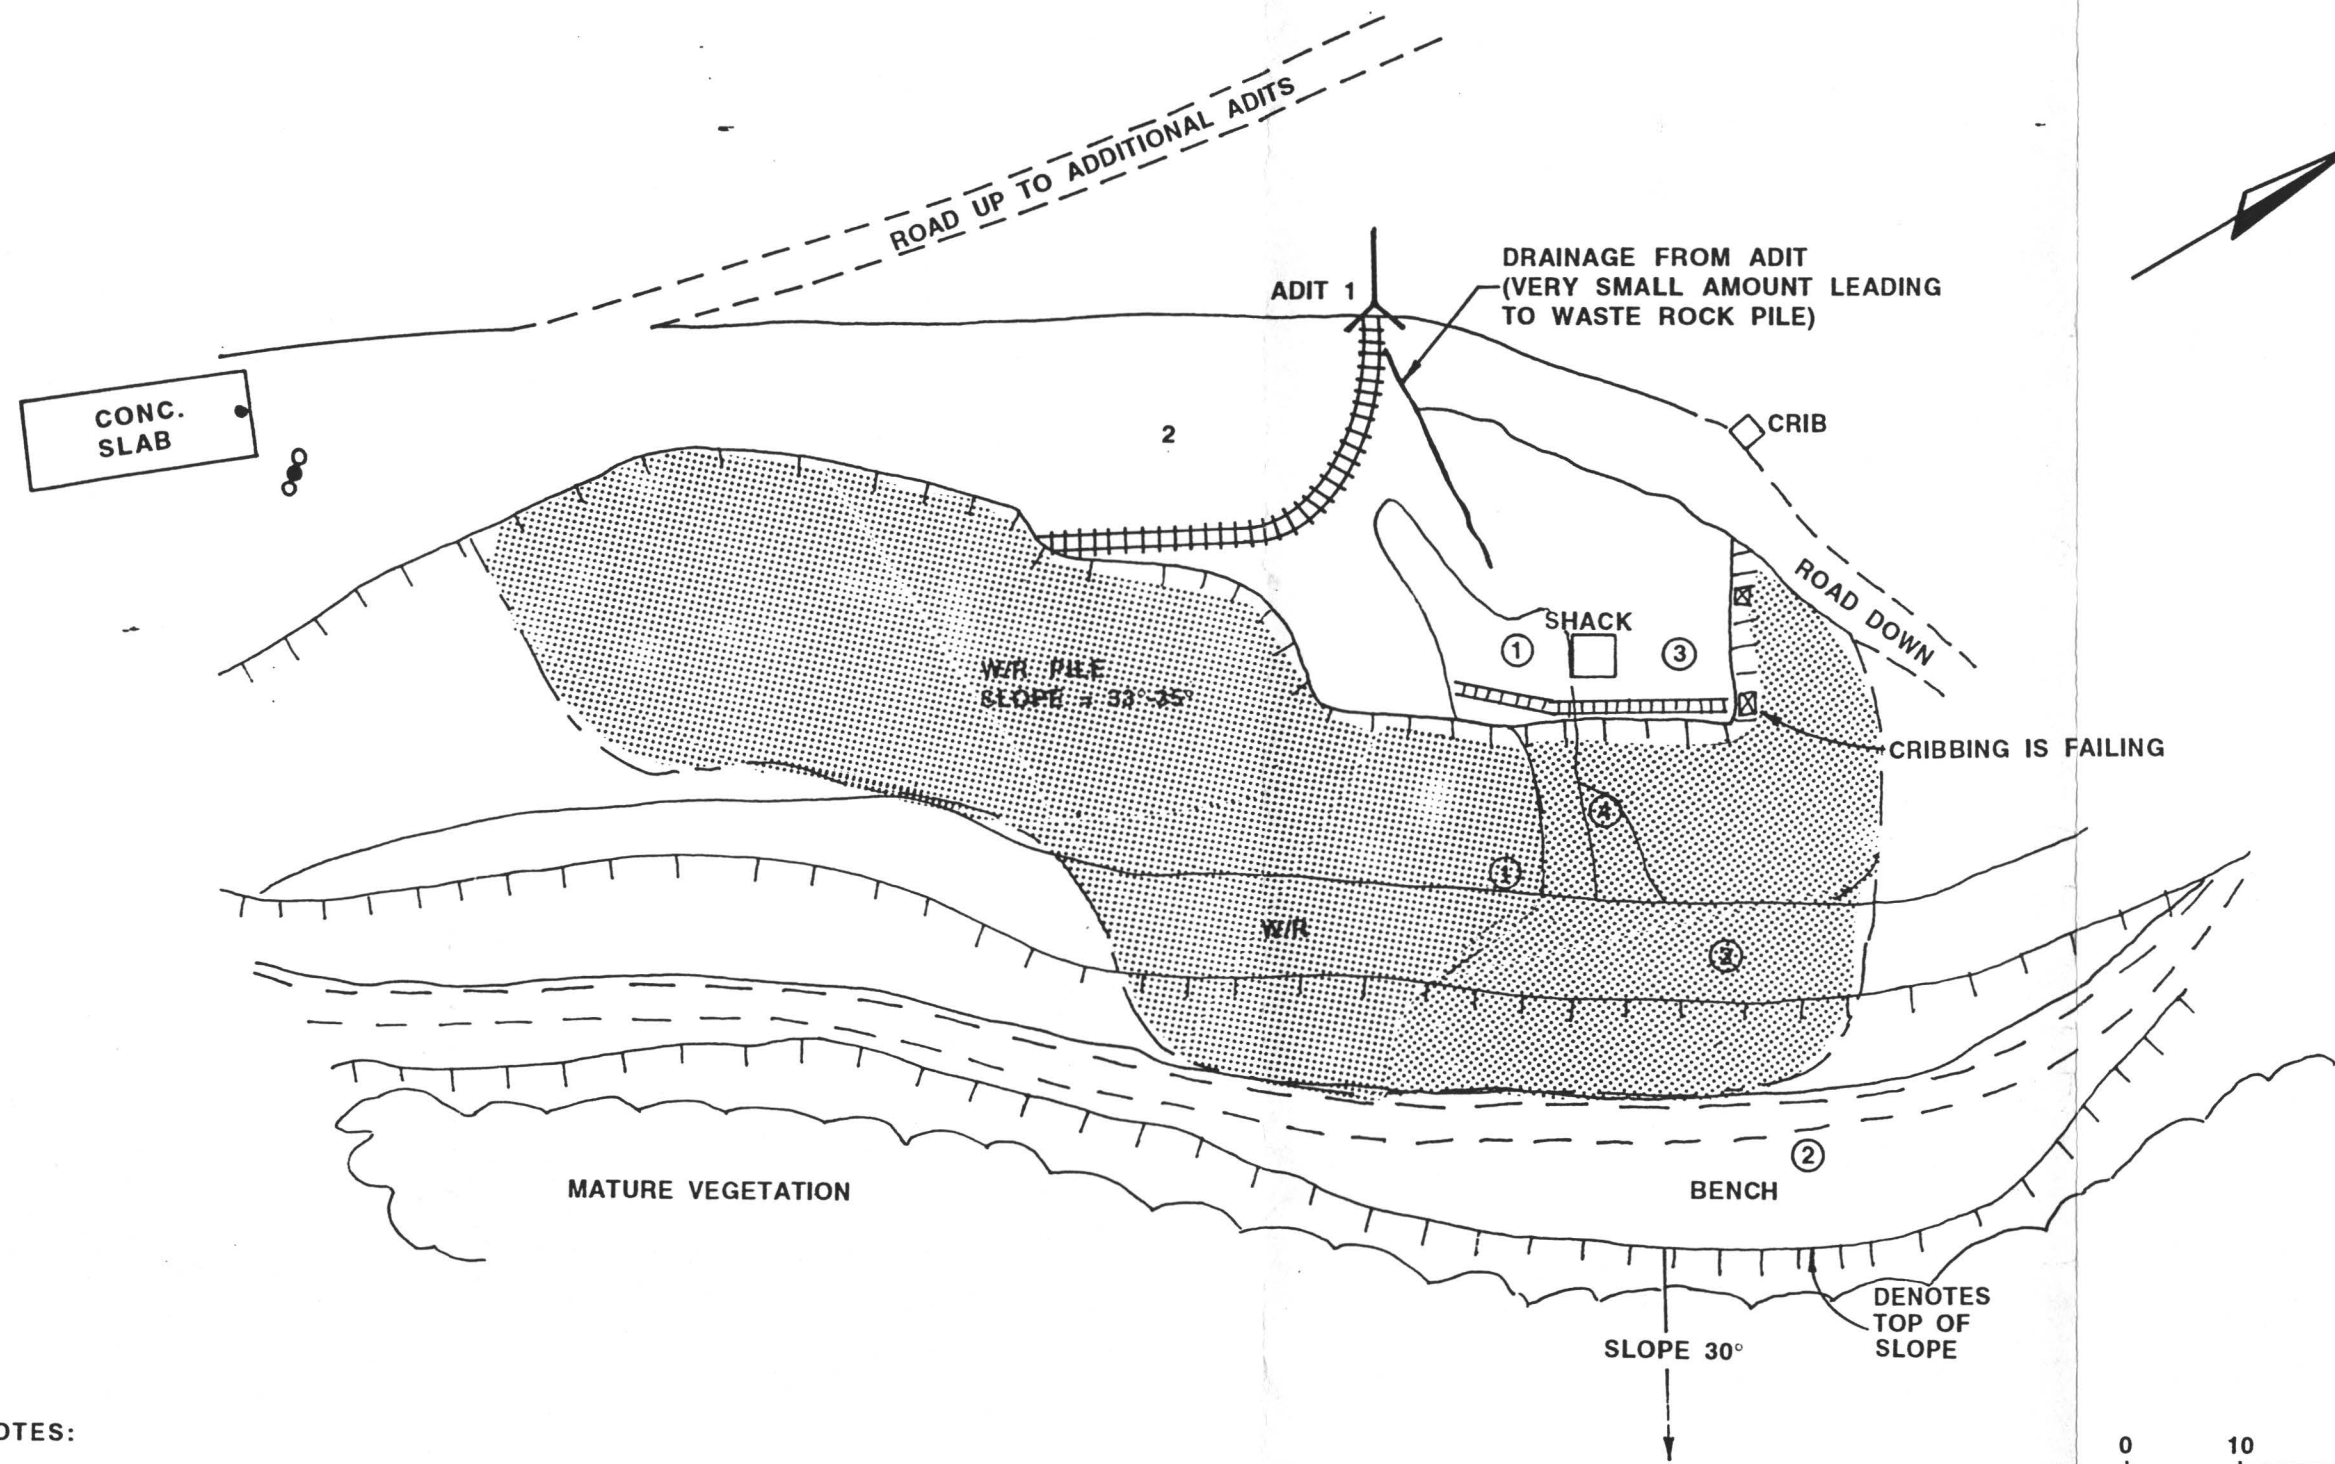
<i>EBA Engineering Consultants Ltd.</i>			PROJECT GEOTECHNICAL SERVICES YUKON ABANDONED MINES SITES		
CLIENT PUBLIC WORKS & GOVERNMENT SERVICES CANADA			TITLE SITE PLAN OF VENUS MINE SITE AREA OF ADIT 1		
DATE	97/10/08	DWN.	MEB	CHKD.	MEB
FILE NO.			12953-11	0201-97-12953

- ① STOCKPILED PIPE AND RAIL TRACKS.
- ② BENCH (FLAT AREA).
- ③ NO EVIDENCE OF EXTENSION CRACKS AT TOP OF SLOPE, WASTE ROCK SLOPE APPEARS STABLE.
- ④ SAMPLE VENUS 1 TAKEN 10.0m DOWN SLOPE FROM EDGE OF TRACKS DIRECTLY BELOW SHACK.
