**FINAL REPORT  
ASSESSMENT OF REMEDIAL MEASURES FOR  
ARCTIC GOLD & SILVER TAILINGS SITE**

**THE ARTIC GOLD & SILVER WORKING GROUP**

**STEFFEN ROBERTSON AND KIRSTEN (CANADA) INC.**  
Suite 800, 580 Hornby Street  
Vancouver, B.C. V6C 3B6  
Tel: (604) 681-4196 • Fax: (604) 687-5532  
E-mail: [vancouver@srk.com](mailto:vancouver@srk.com) Web site: [www.srk.com](http://www.srk.com)

**FEBRUARY, 1999**

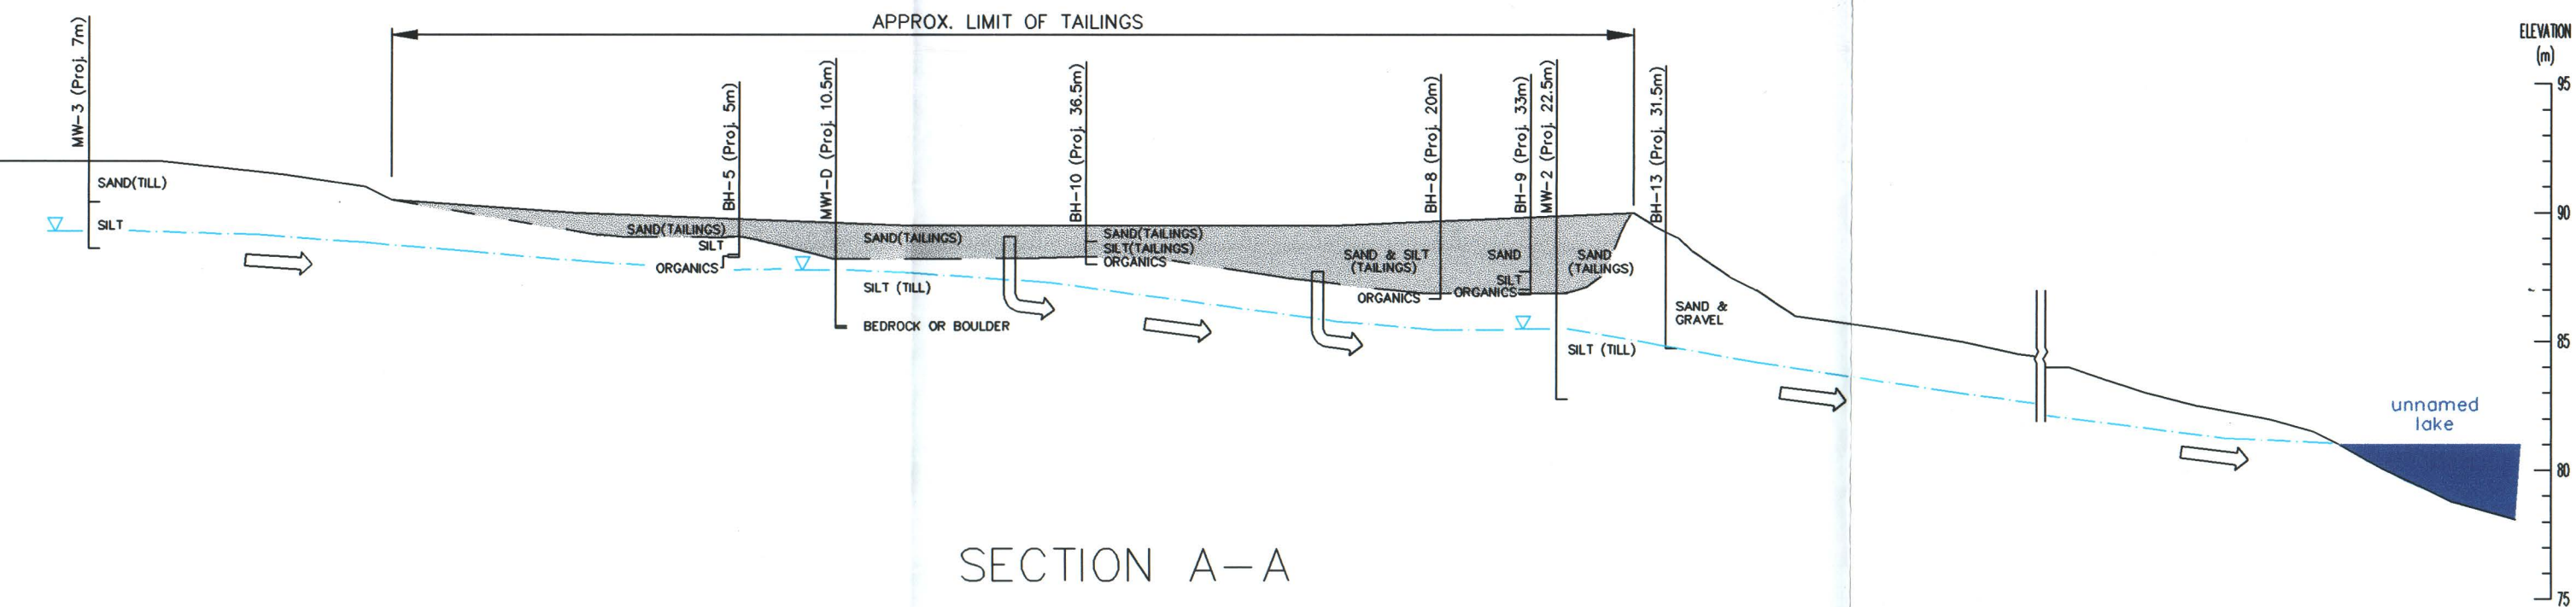
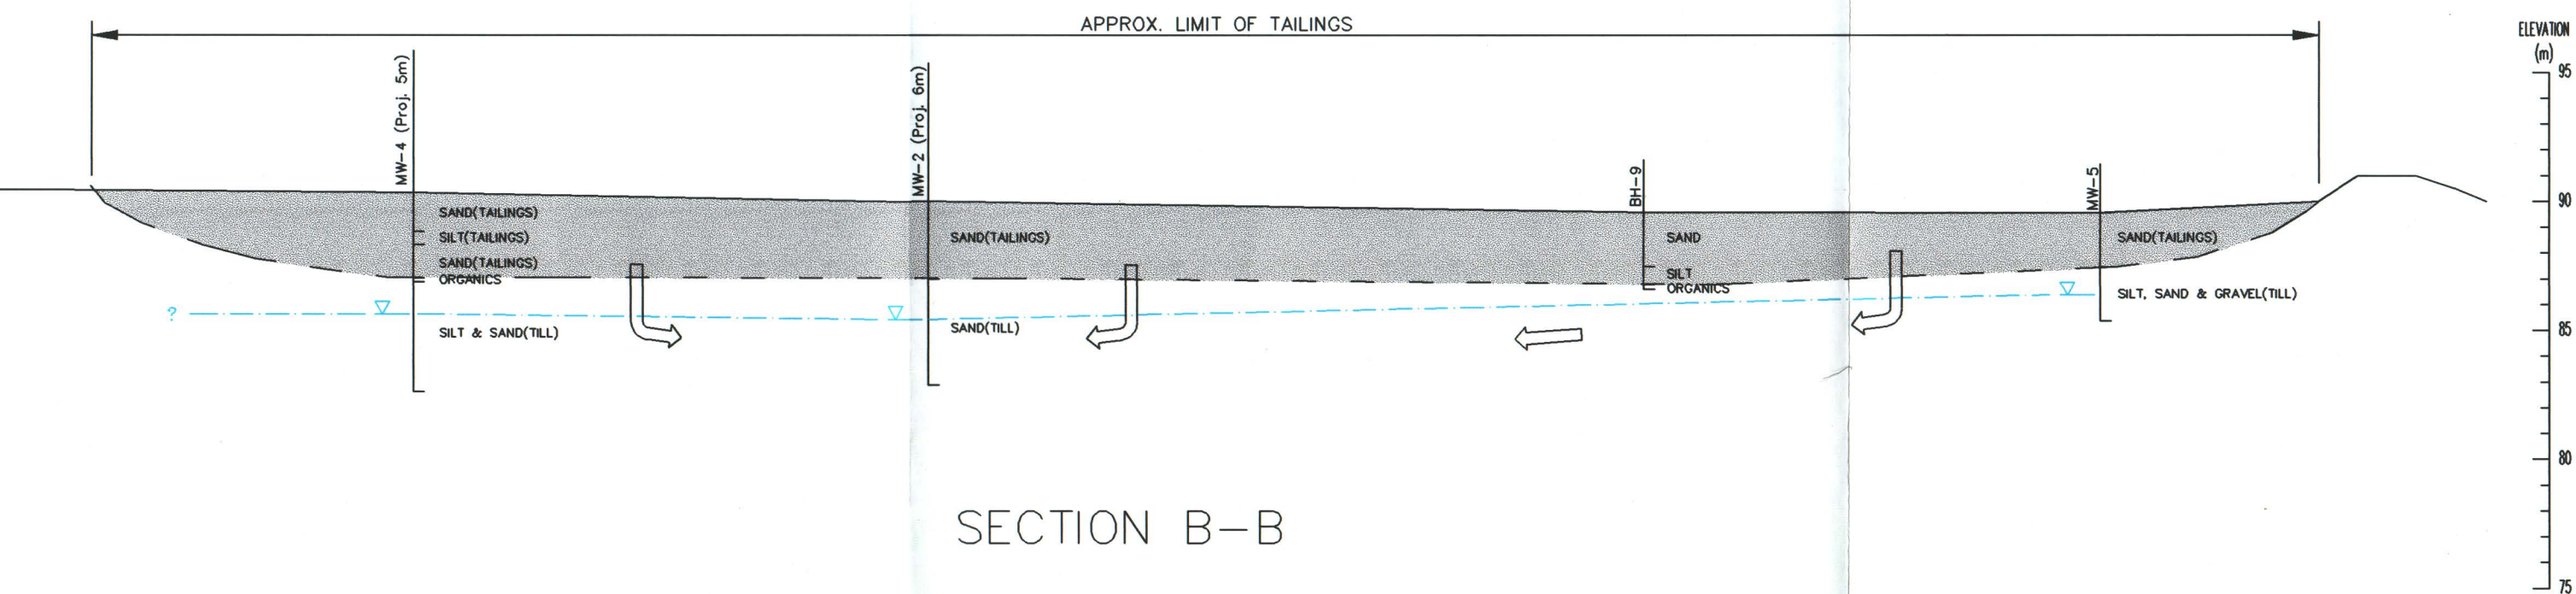
| PROJECT NO.<br>1CP001.07.01 | DATE<br>DEC. 1998 | APPROVED | FIGURE<br>2.3 |

The groundwater table was below the tailings at all points measured (Figure 2.3). Currently, therefore, there is no evidence of groundwater passing through the tailings from the upgradient side. Hence there is no need for additional groundwater or surface water diversions. The water table may rise in spring, but due to the low permeabilities of the tailings and foundation soils, it is unlikely that significant horizontal flow through the tailings would result.

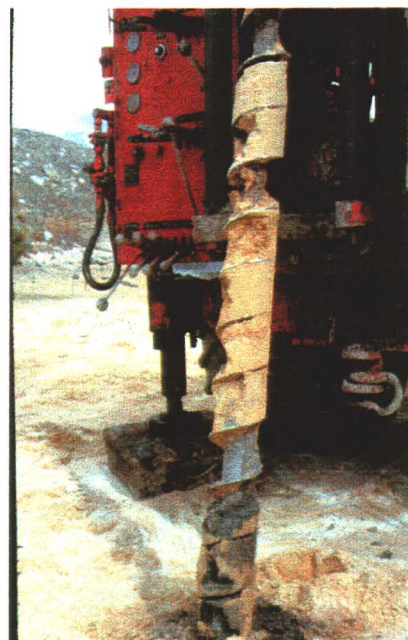
- Ten boreholes were advanced to characterize the depth and characteristics of the tailings material. The tailings consisted of two layers distinguished by the extent of oxidation (as evidenced by the characteristic rust colour associated with the ferric hydroxide presence in the tailings). As seen in Photo 1, the profile of the tailings consisted of an upper surface layer of more oxidized (beige) sand material with an underlying stratum of less oxidized (dark grey) silt and sand material.

- The upper surface layer consisted primarily of fine sand sizes and was damp to moist with moisture contents typically in the order of 10% to 15%. As seen in the representative particle size gradations for samples 2 and 16 in Appendix B, there is over 90% fine sand material in the upper tailings material.

- The lower tailings stratum consisted of finer soil sizes and was moist to wet with moisture contents ranging from 30% to 40%. Refer to samples 8 and 11 in Appendix B for representative particle size gradations of this material. Fines content ranged from 15% to 90% in those samples tested. As could be expected, the higher fines content observed

**Photo 1: Tailings profile.**

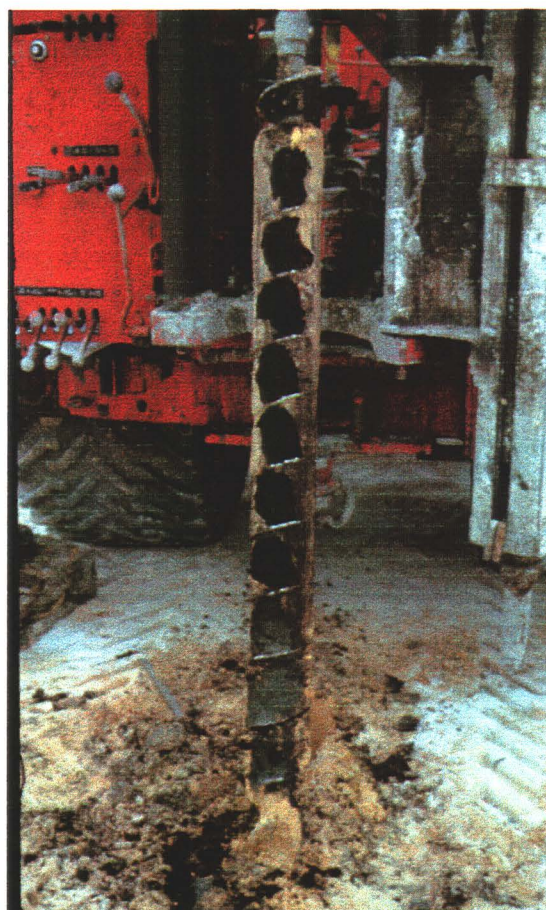
- As seen in Photo 2, the tailings ended at a distinct organic layer. The organic material was wet, dark brown, and partially decayed. The organic layer was underlain by a dense silt, sand, and gravel soil which was inferred to consist of native morrainal till.

- The underlying till material consisted of a characteristically heterogeneous mixture of clay, silt, sand, and gravel with average proportions of 9%, 44%, 25%, and 22%, respectively based on two samples tested.

- There was oversize material within the till matrix which made drilling very difficult. Refusal in the till occurred in all deeper boreholes, with depths of refusal ranging from 1.5 m to 7.7 m and an average depth of 4.6 m.

**Photo 2. Underlying organics and till.**

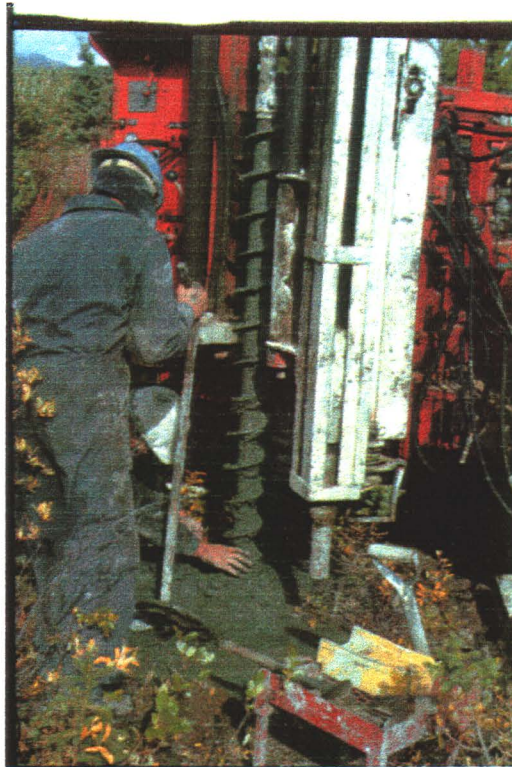
- To assist in the evaluation of ground water flow and water quality outside of the tailings impoundment area, monitors 13563-MW3 and 13563-MW6 were installed. Based on the topography of the site and on an interpretation of drainage features from aerial photos, the locations were inferred as being hydraulically upgradient of the tailings area. This assumption was validated by on-site calculations using accurate survey data of monitors 13563-MW1 through -MW4 provided by Underhill Geomatics Ltd. on 98/8/31. The horizontal direction of ground water flow was determined to be toward the west, roughly in a direction parallel to monitors 13563-MW1D and -MW2. As seen on the well installation details, monitor 13563-MW6 was constructed for piezometric measurements only. It is noted that the static water level at -MW6 was very close to the existing ground surface, with extensive free water observed while removing the solid stem augers (see Photo 3).

Photo 3. Location of MW6

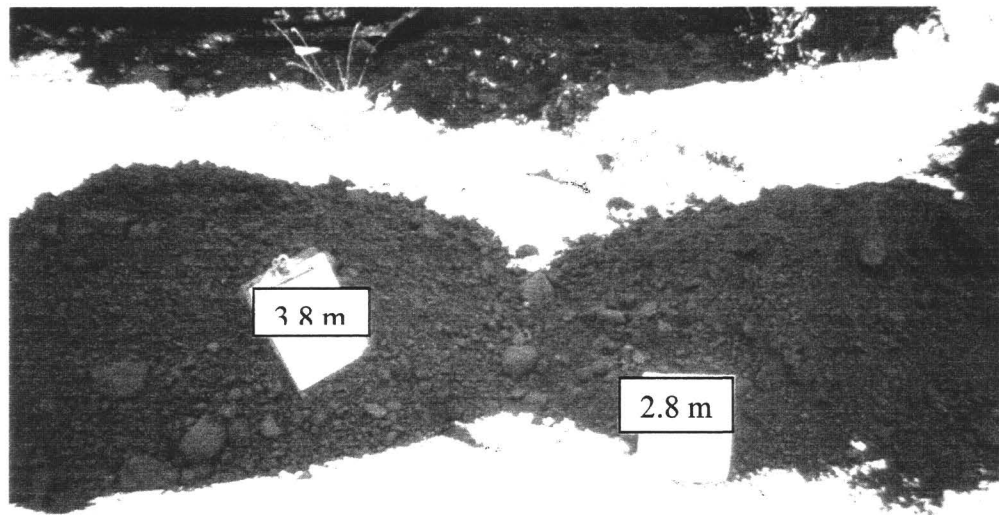
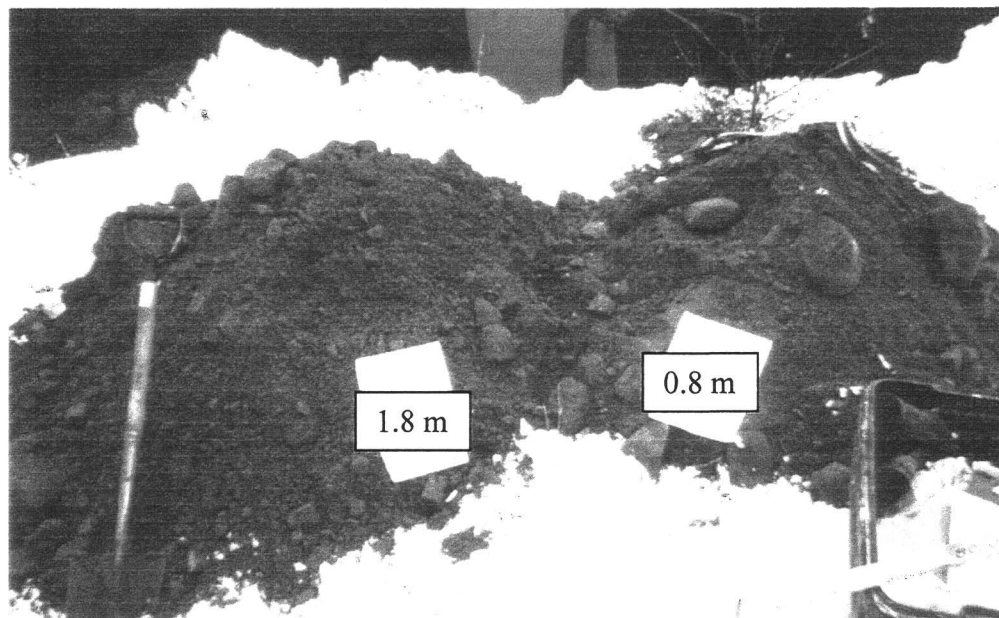
- As seen in the above table, the till is composed primarily of sand and gravel sizes, with an average fines content of approximately 15%. As well, the soil matrix consisted of approximately 5% cobbles by volume to a maximum diameter of 300 mm. A photographic documentation of the typical soils encountered is shown in Photos 3 and 4, following.

Photos 3 and 4. Soil piles from samples at varying depths at 13563-TP4

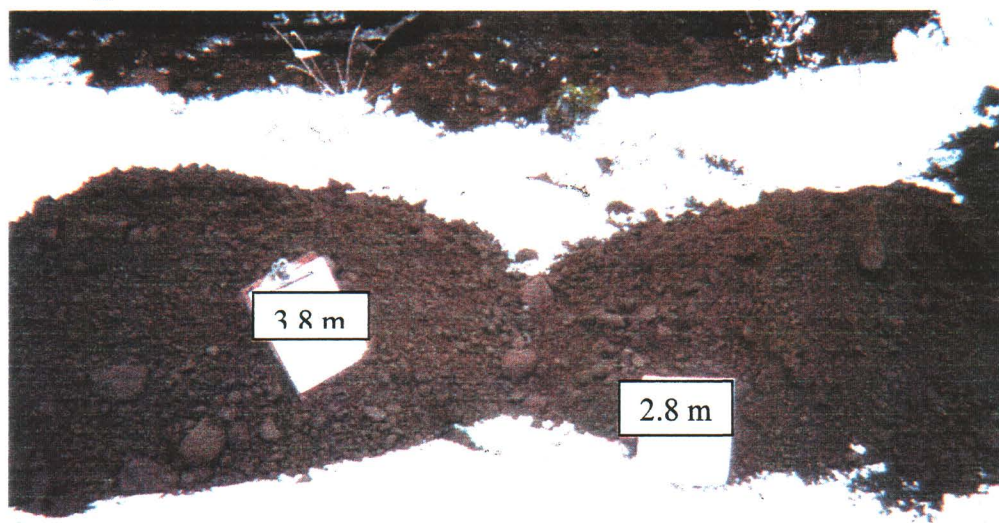
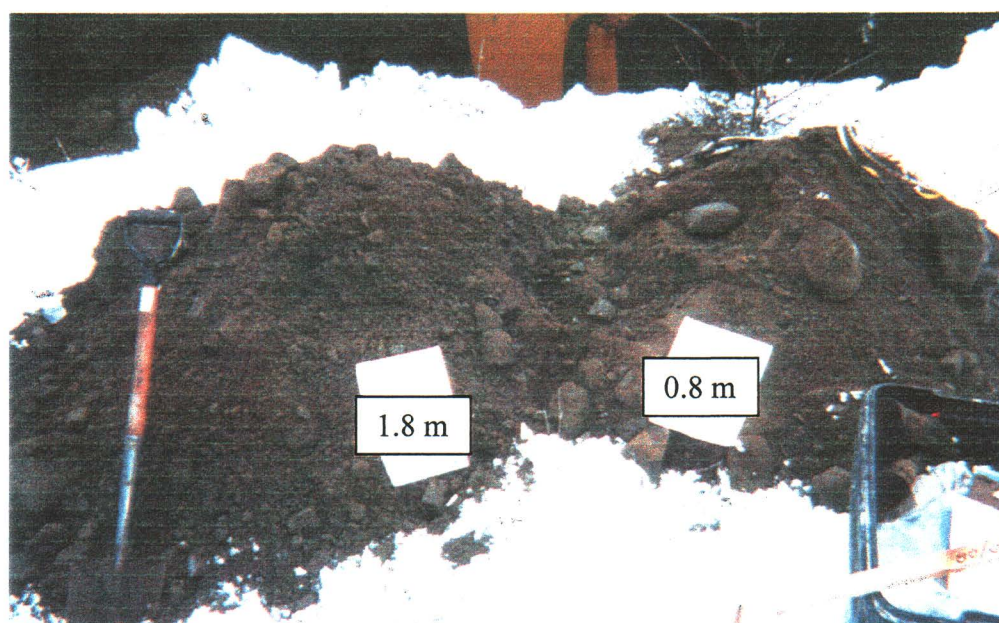
- As seen in the above table, the till is composed primarily of sand and gravel sizes, with an average fines content of approximately 15%. As well, the soil matrix consisted of approximately 5% cobbles by volume to a maximum diameter of 300 mm. A photographic documentation of the typical soils encountered is shown in Photos 3 and 4, following.

Photos 3 and 4. Soil piles from samples at varying depths at 13563-TP4

- The moisture content in the till soil was in the order of 5-8%. Ground water seepage occurred in all test pit locations at depths ranging from 2.1 m to 4.5 m below ground surface. In general, more extensive unsaturated soils were encountered with increased distance to the west of the road.
