SÄ DENA HES MINE

ENVIRONMENTAL BASELINE
AND
GEOTECHNICAL EVALUATION REPORT

Prepared by:
**GEO-ENGINEERING (M.S.T.) LTD.
Calgary, Alberta**

April 2000
G1776

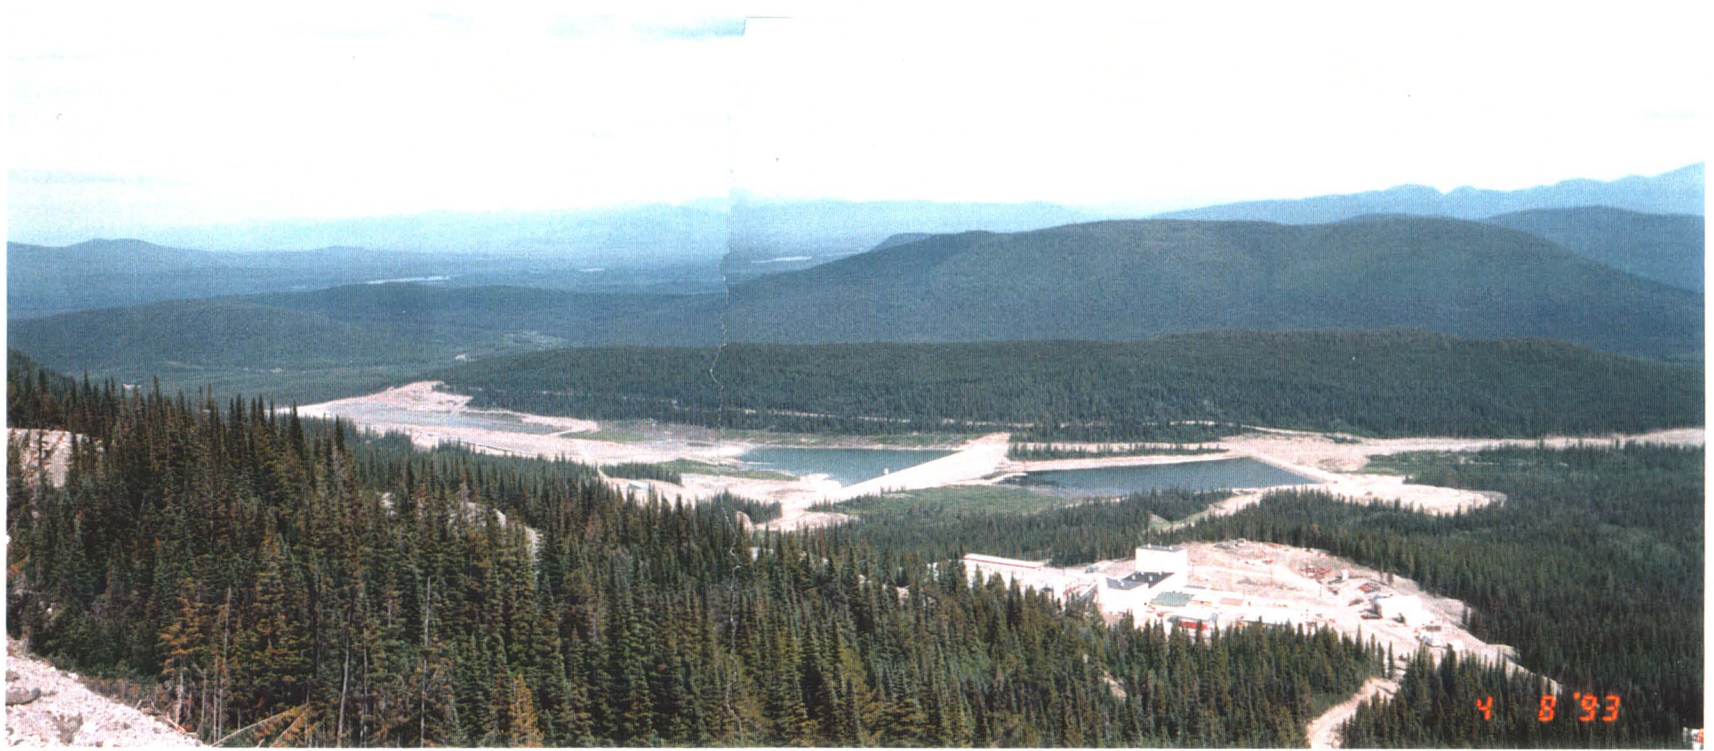
Photo 1; General view of the tailings pond (left), reclaim pond (right) and the mill from the Jewel Box underground mine waste dump.

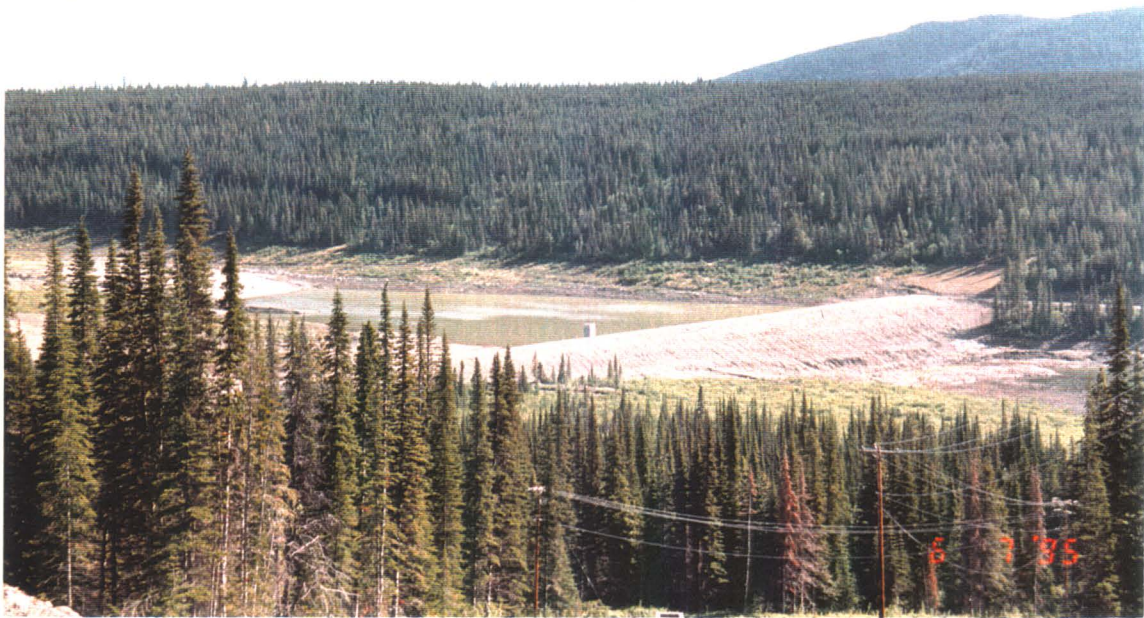
Photo 2: View of the South Dam and deposited tailings.

South dam shows signs of deformations along the upstream dam face. An almost continuous crack was observed on the dam crest, paralleling the face, in 1999. There were four minor and shallow slumps on the upstream dam face which were upgraded prior to the 1999 site visit. Erosion rills are relatively deep on the downstream side of the dam. Water (seepage) was heard to run through the toe berm. It was estimated, prior to the construction of the toe berm, that seepage at the low point of the dam could be in the order of 60 l/min. Heavy seepage was observed discharging from the east abutment.

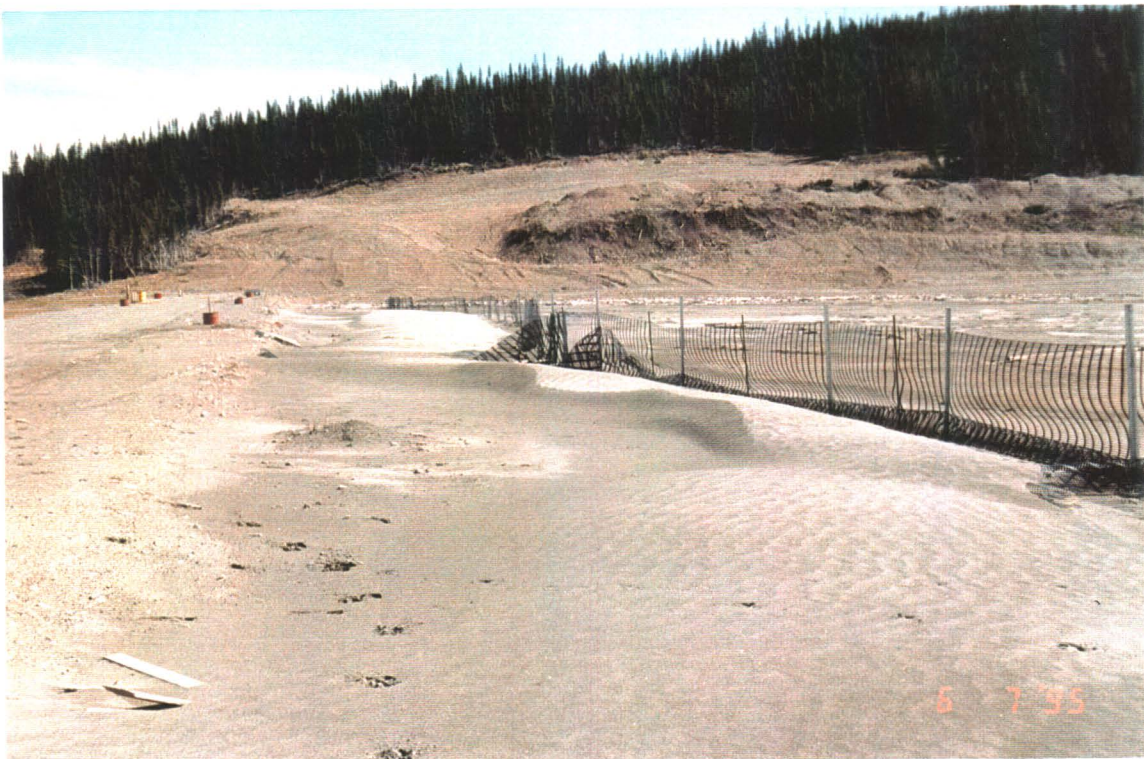
Photo 3: Windblown tailing at the north dam.

Very few changes have occurred at the north dam since its construction. Dry tailings in the pond are at the crest of the dam (elevation 1,098 m) at the west abutment and about 1 m below the crest at the east side. Airborne tailings are deposited on the crest and downslope side of this dam. No cracks or deformations were observed.

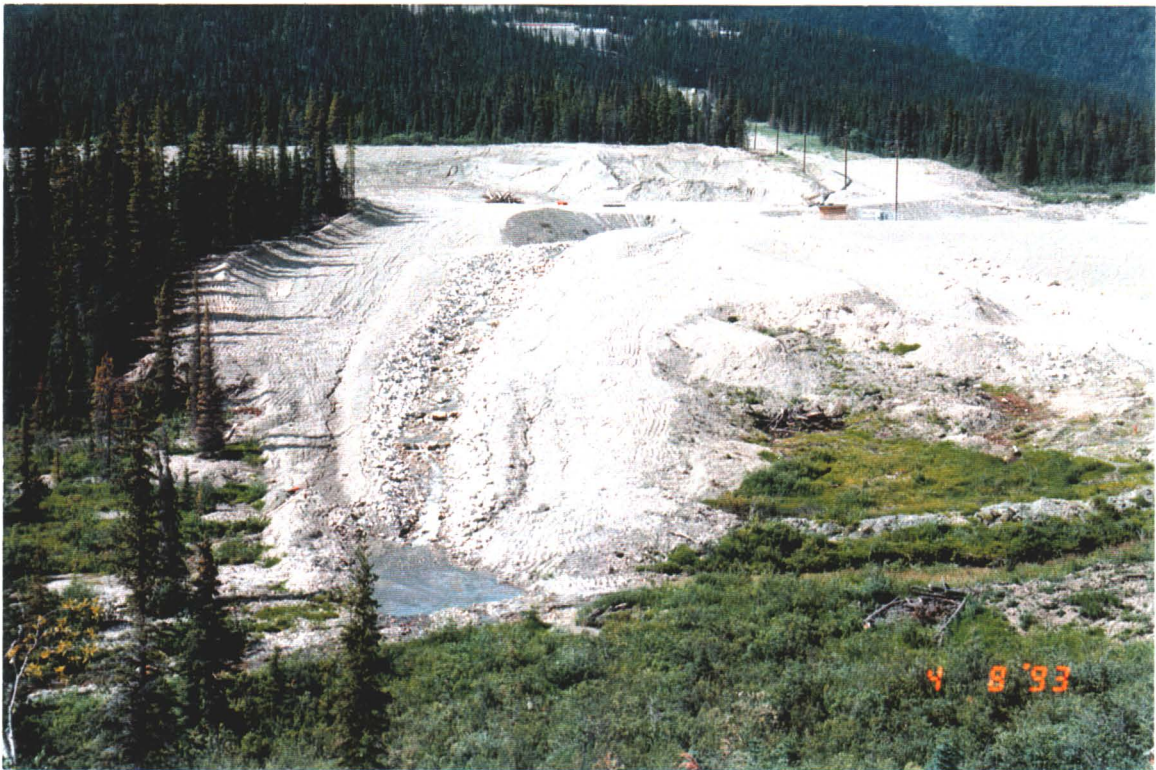
Erosion has occurred at both the outlets and inlets to the spillway CMP's. The erosion at the inlet end is caused by runoff from above the road that flows through the tailings pipeline CMP conduit.

Photo 4 : General view of the reconstructed spillway chute at the Reclaim Pond dam.

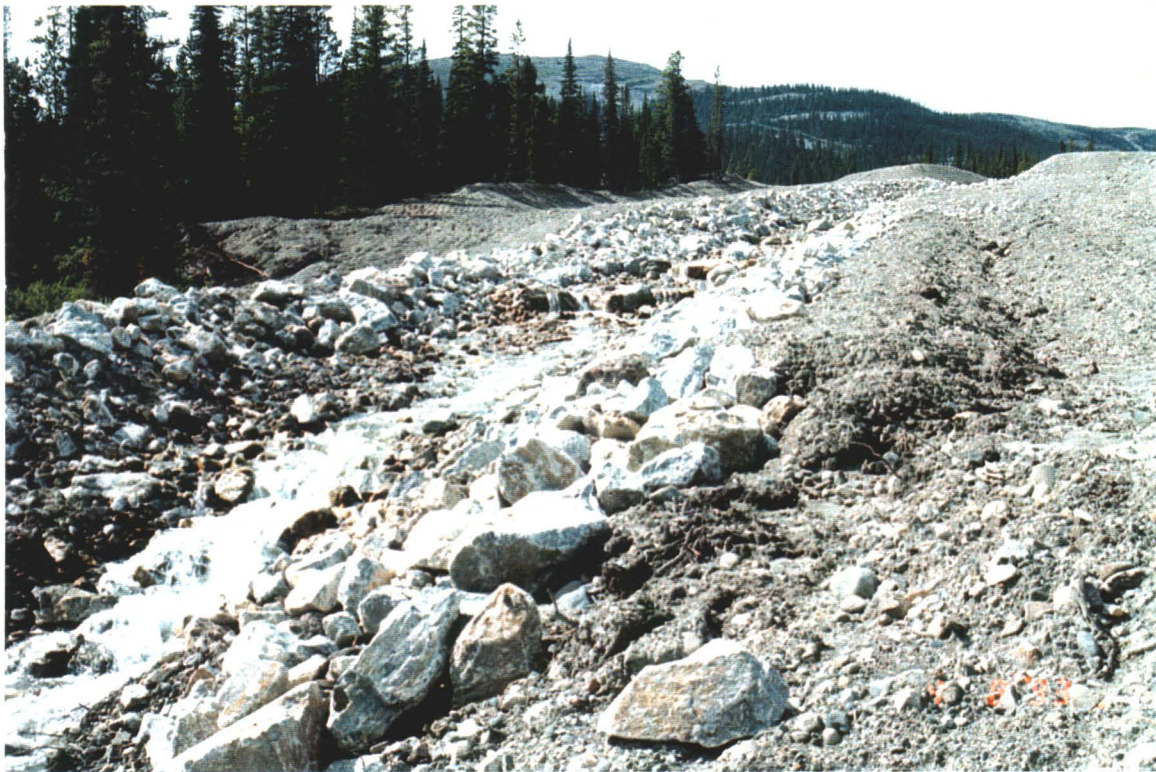
Photo 5 : Detail view of the chute.

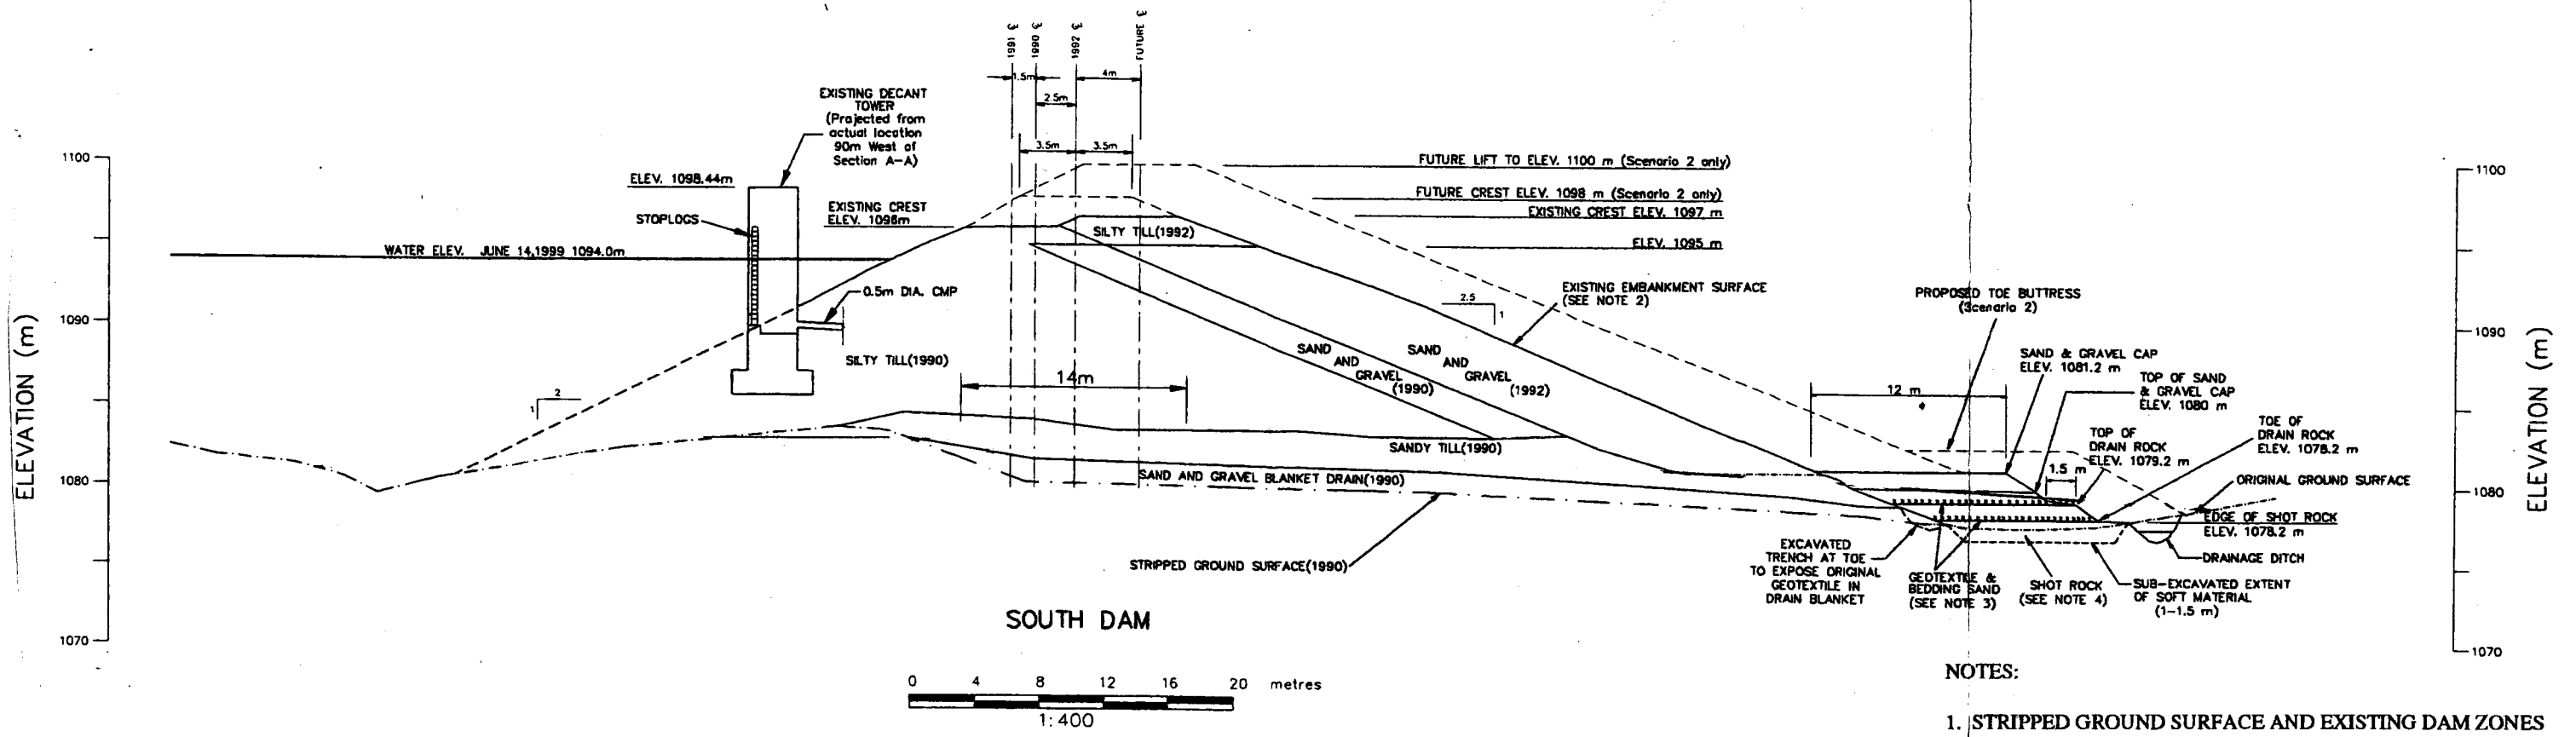
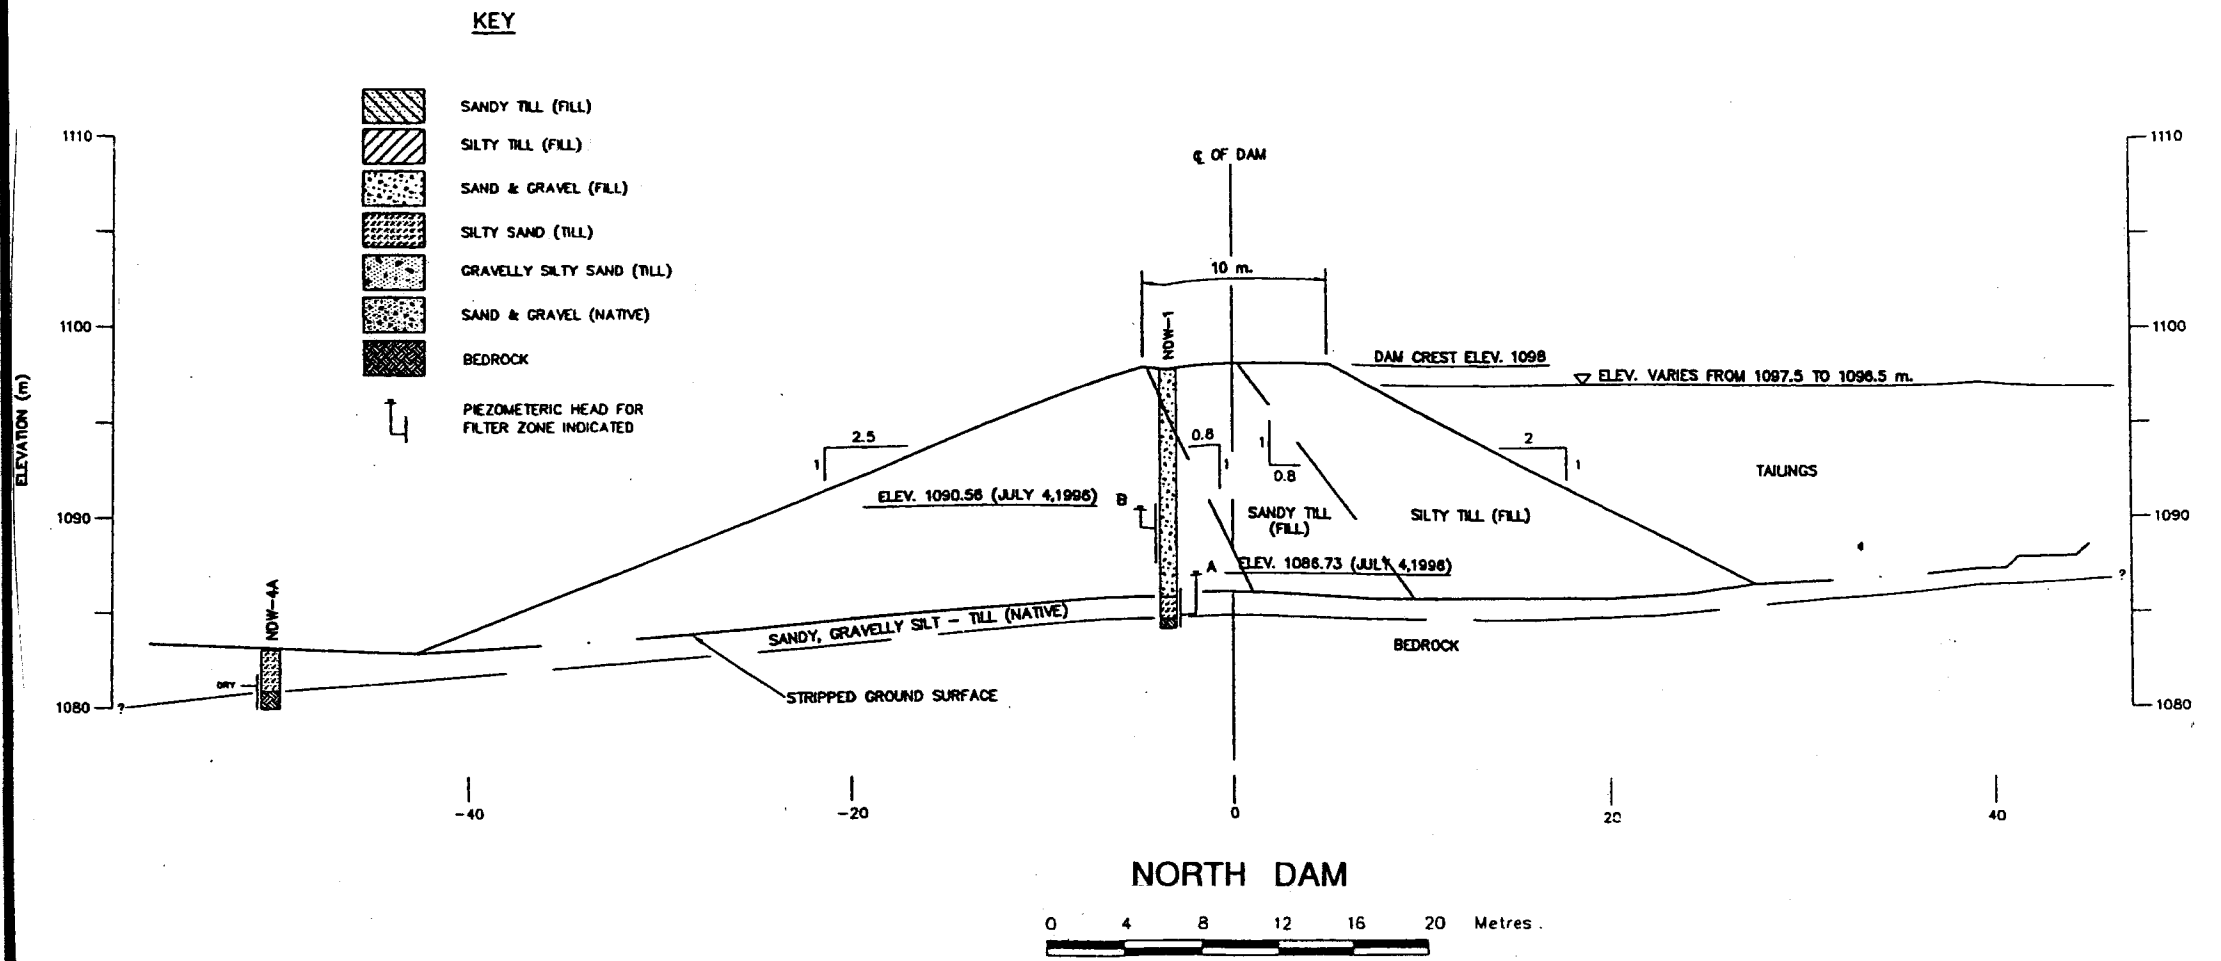
<h1>SA DENA HES MINE</h1>		
<h2>TAILINGS STORAGE TYPICAL DAM SECTIONS</h2>		
SCALE: As Shown	PROJECT No. G1776	FIGURE 4-3

The stability of the proposed extension of the south dam crest to elevation 1,098 m was assessed by SRK in 1992 using the computer program CLARA, Version 2.31. The stability was analyzed along the maximum dam section at Station 0+460 for both static and seismic (dynamic) loading conditions. The dynamic loading conditions were approximated by the pseudo-static method, with a maximum horizontal acceleration of 0.069 g, which has a probability of exceedence in 50 years of 10 percent. The dam material, as well as the foundation soil, were assumed to have an internal friction of 35 degrees and zero cohesion.

The phreatic surfaces were based on the June 1991 piezometer readings. The piezometers indicated that, at the bedrock/till contact, there is a zone of high pore pressure which has been modeled in foundation soil "A". The dam materials were assumed to be to the water table in the embankment. Piezometer readings from the zone of high pore pressure at the reclaim dam indicate that the rise in pore pressure at the downstream toe is approximately half the rise in the pond elevation; this condition was assumed to apply at the south dam. Assuming a 2 m freeboard, the maximum pond elevation for the south dam, with its crest at elevation 1,098 m, will be about 3 m higher than in 1991.

The results of the analyses show the most critical shallow, intermediate and deep failure surfaces. All analyses were run with circular failure surfaces using Bishop's Simplified Solution. The factors of safety (FS) obtained are as shown on Table 5:

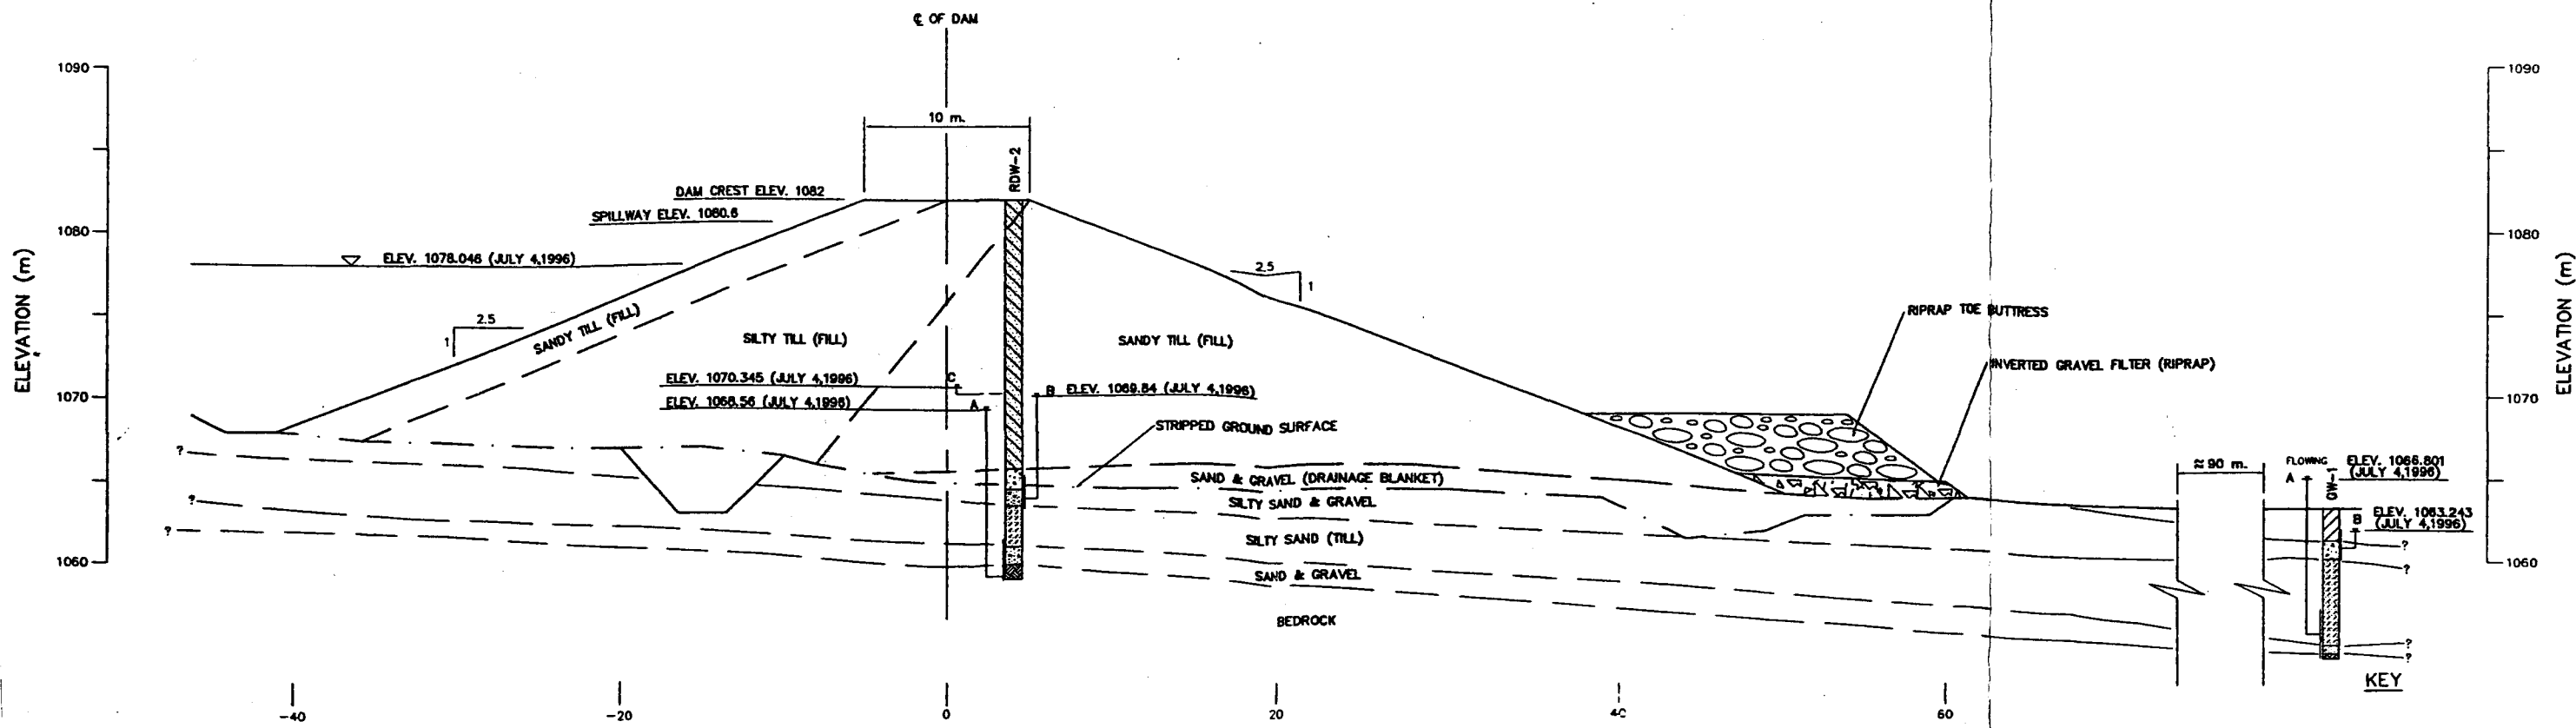
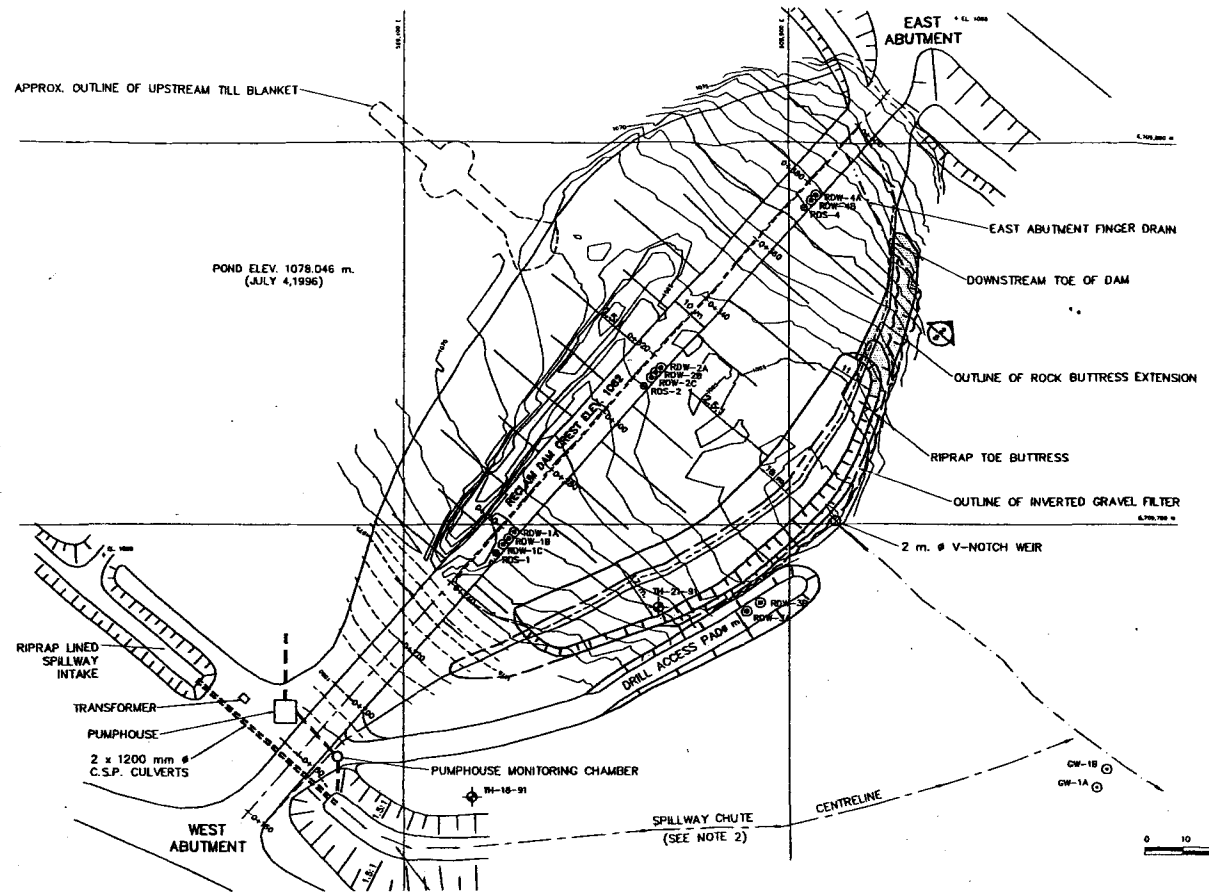
RECLAIM POND DAM
LAYOUT AND SECTION

Foundation conditions at the reclaim pond were found to be complex, requiring modifications of the original design. On the east side of the valley, the bedrock (phyllite) was found 1 to 2 m below ground surface, while on the west valley slope it was encountered at depths of up to 20 m. The overburden materials are stratified and comprise two layers of sand and gravel interspersed with a till layer, capped at the ground surface with another till layer. Significant pore pressures were encountered in granular materials.

Because of high pore pressures in the reclaim dam foundation, the designer (SRK) recommended that the water level in the pond should be maintained at or lower than elevation 1,079.5 m to ensure embankment stability. Monitoring of the seepage at the toe should be continued on Piezometers RDW-2A, 2B, 2C, 3A, 3B, GW1A and 1B.

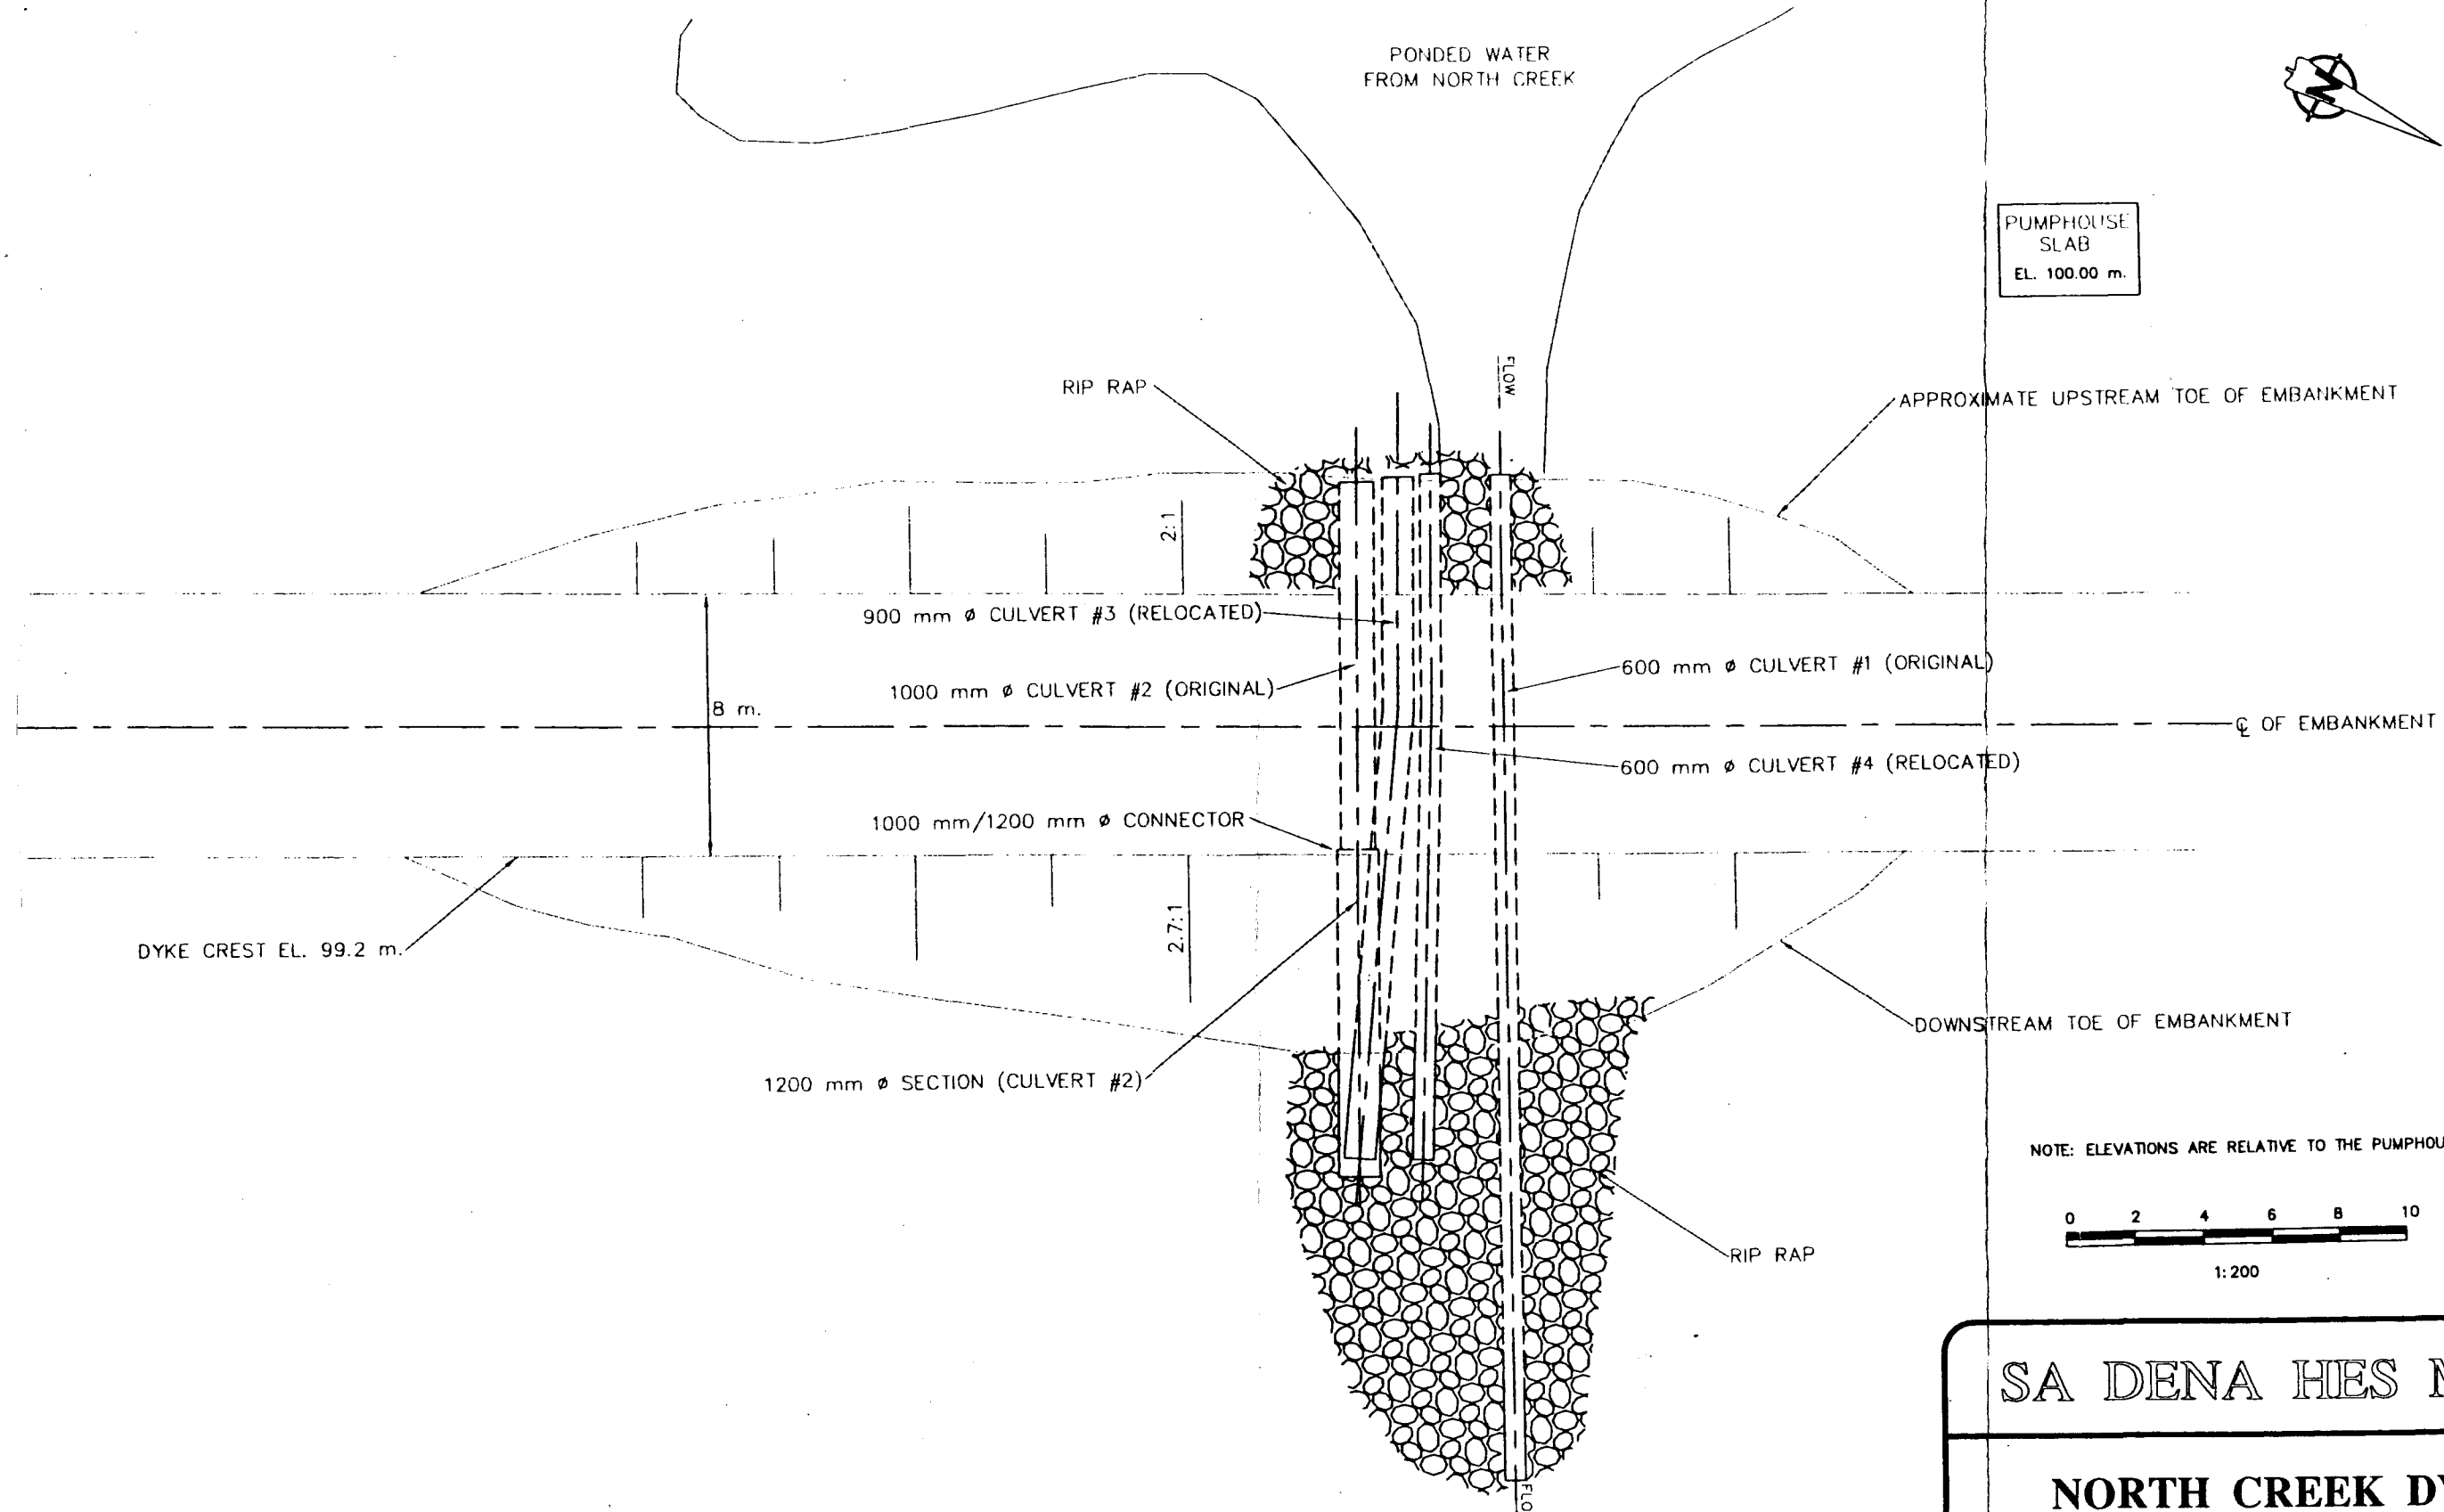
FIGURE 4-6

The dyke has a maximum height above original ground of about 5 m, it is about 50 m long and the crest is 7 to 10 m wide. The dyke slopes are 2.5:1 to 3:1. Fill used to construct the dyke is a silty sandy till and it is estimated that about 200 m³ of this material was placed without significant compaction. This caused settlement and localized shallow sloughing. The dyke was graded several times and recently (1999) appeared to be stable.
