YONO (#70)
(MINFILE# 105M 55)

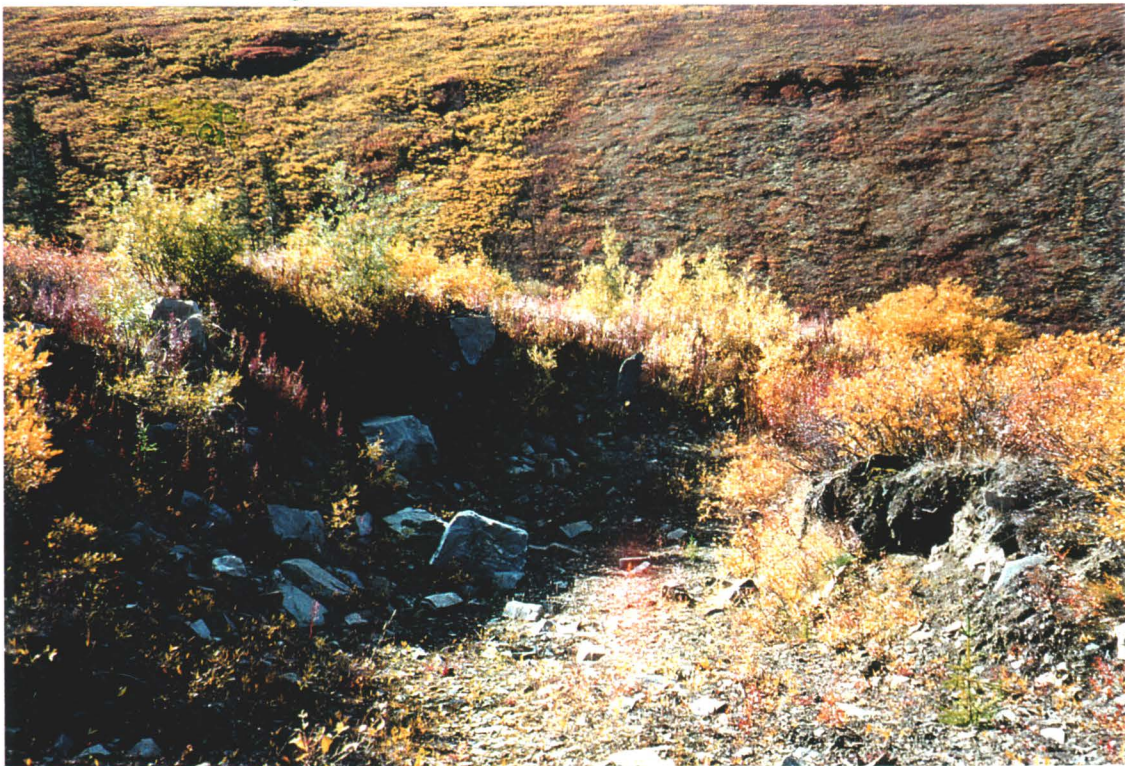
Trench 1 (photo 70-2)

Dimensions: 22 m x 5 m x 0-2 m – longitudinal bearing AZ 189

Condition: stable – 40% revegetated

Photo 70-2: View of Trench 1 at Yono site. (AZ 189)

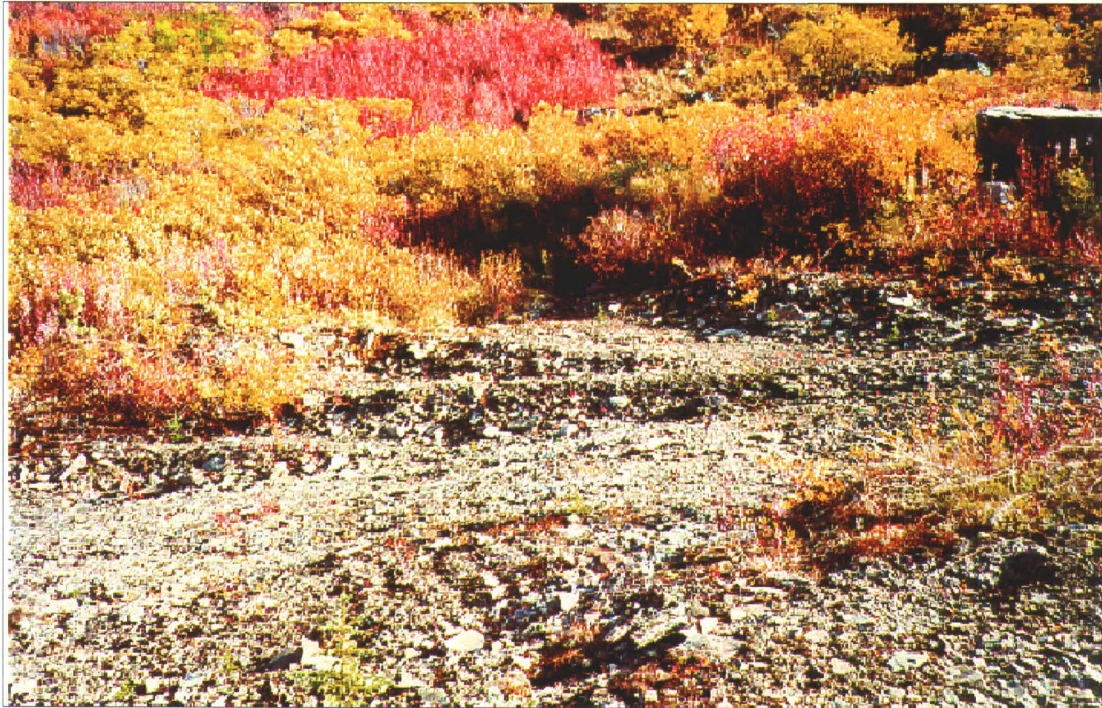
Trench 1 waste rock pile (Photo 70-3)

A pile of waste rock from Trench 1 was bulldozed at the mouth of the trench. It consists mostly of overburden with traces of rusting on 30% of the rocks.

Photo 70-3: Bulldozed overburden at the mouth of Trench 1.
